Assessment of Riparian-Wetland Conditions and Recommendations for Management

*Pueblo Colorado Wash, Hubbell Trading Post National Historic Site,
Arizona*

Natural Resource Report NPS/NRPC/NRR—2010/213

June 2010

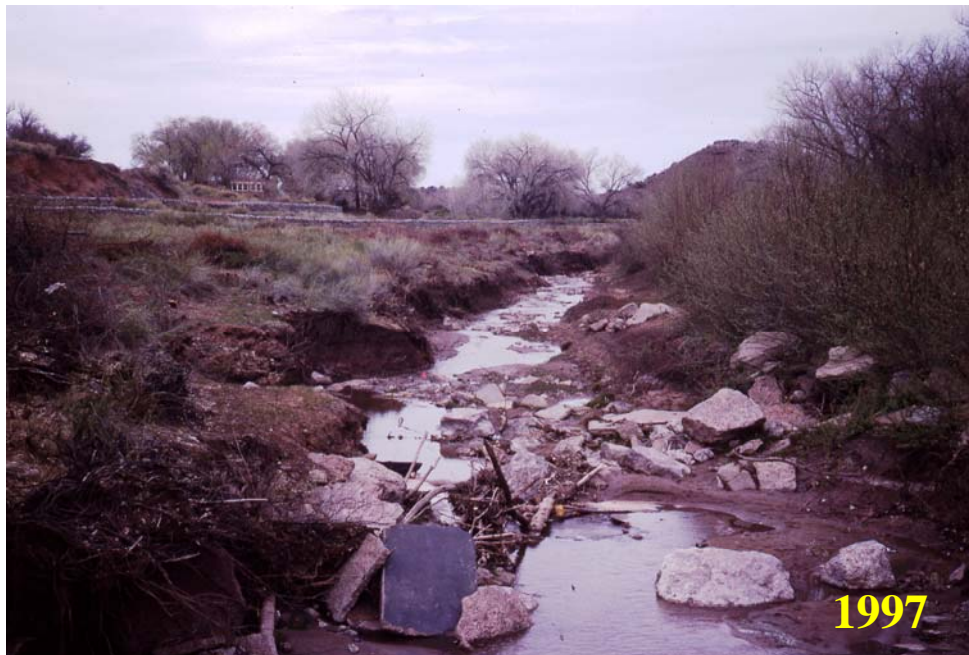
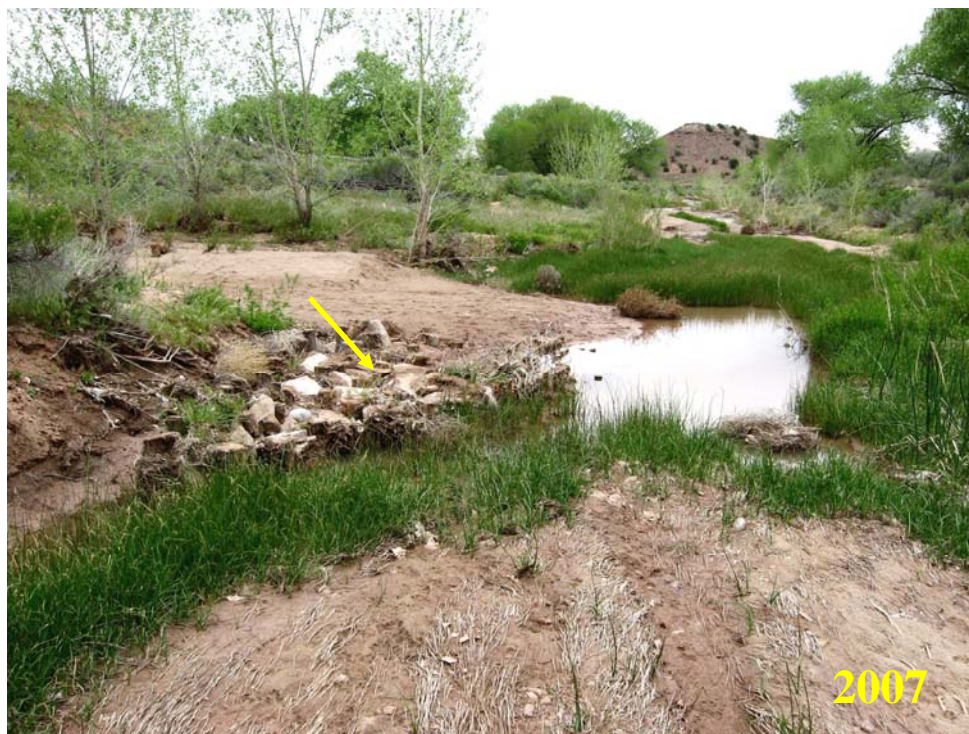
Figure 2 shows a 1997 and 2007 photo pair of Pueblo Colorado Wash. The 1997 photo shows a straight channel undergoing active incision (note vertical, unvegetated banks, unvegetated channel bottom, and large rock/debris that was either transported to this location or exposed by high velocity flows). By 2007, after management actions were taken, the channel has aggraded significantly, the banks have flattened, and native riparian and wetland vegetation cover is increasing in the channel and on the floodplain. One of Bill Zeedyk's channel structures can be seen in the 2007 photo. Figure 3 shows a 1997 and 2010 photo pair of the wash, illustrating the response of the channel to these management actions farther downstream.

Figure 2. Photo pair of Pueblo Colorado Wash within HUTR, 1997 and 2007, looking west toward Hubbell Hill. Note in-channel deflection structure in 2007 photo (yellow arrow points to center of triangular structure). Photos by Joel Wagner, NPS.

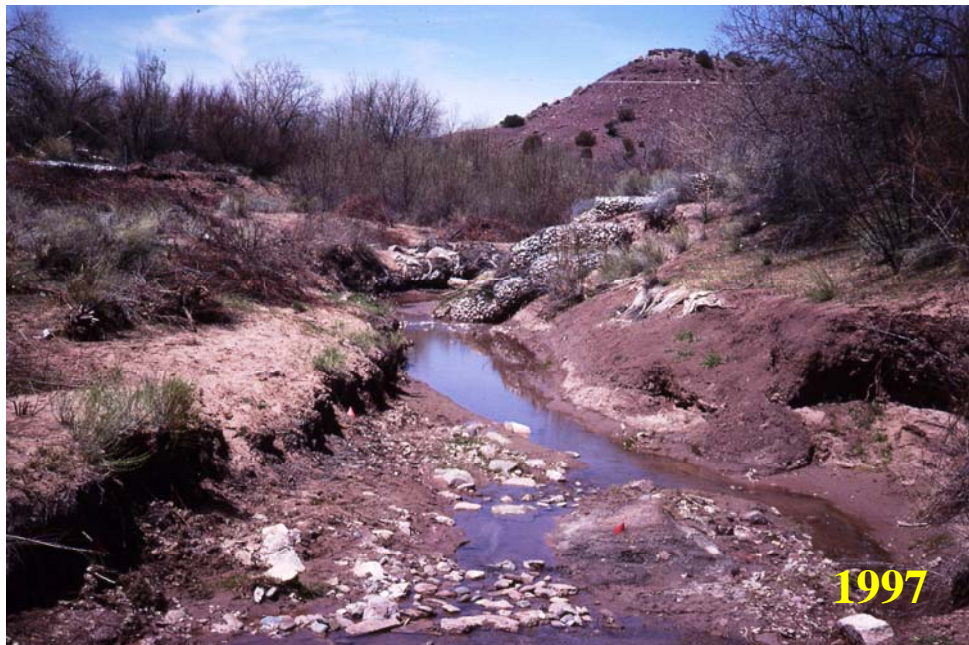
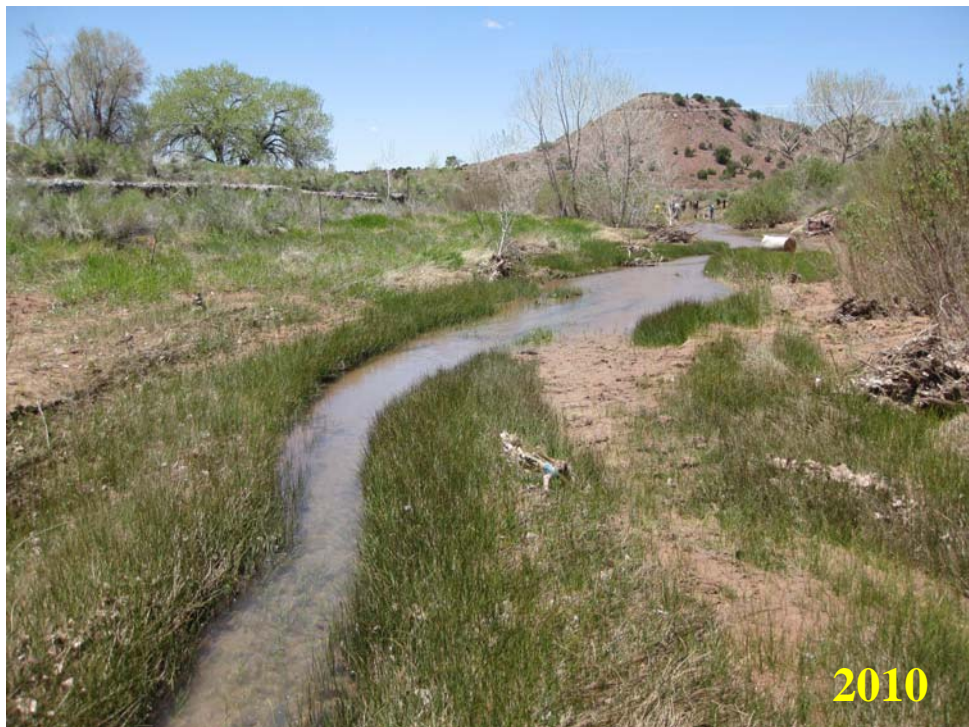
Figure 3. Photo pair of Pueblo Colorado Wash within HUTR, 1997 and 2010, looking west toward Hubbell Hill. (Note failed rock gabion check dam in center of 1997 photo, since removed.) Photos by Joel Wagner, NPS.

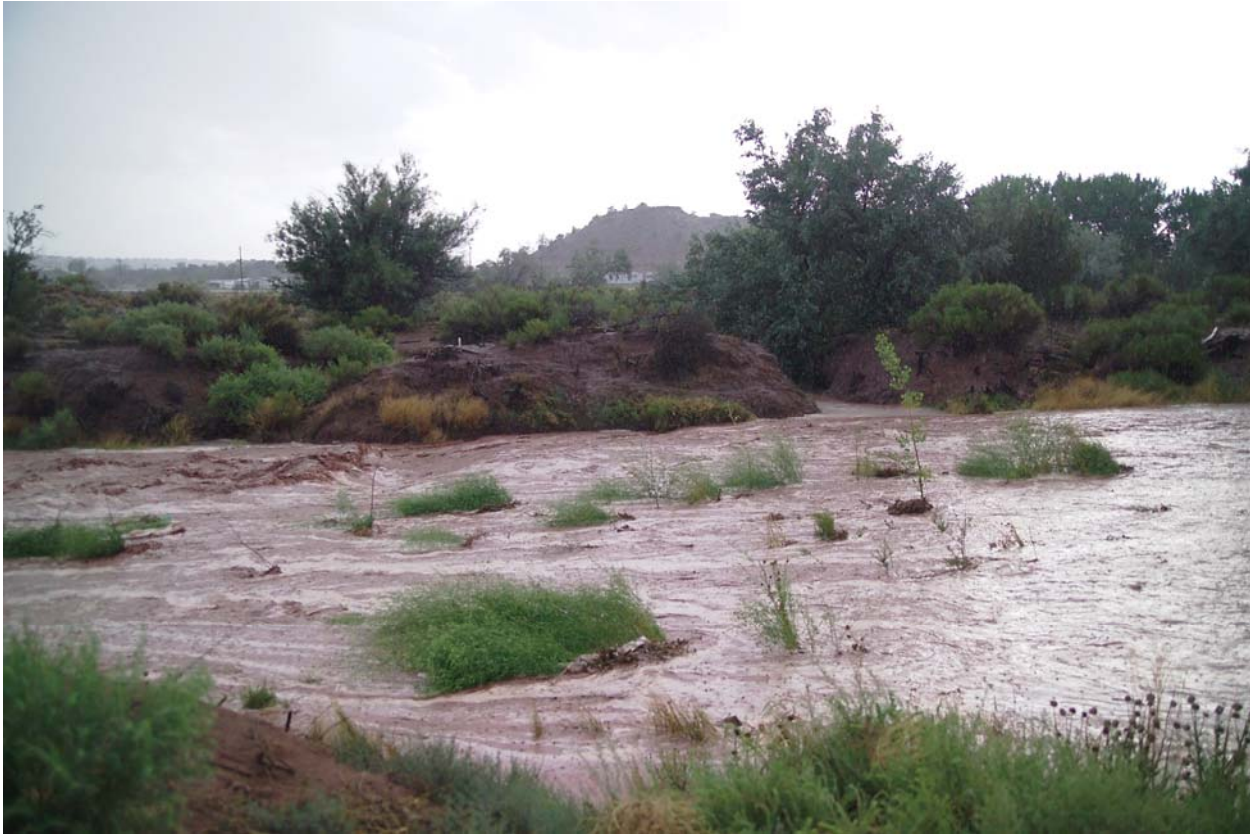
Figure 5. Pueblo Colorado Wash maintained its basic channel form and riparian-wetland vegetation community even after this large runoff event in fall 2007. Photo by Anne Worthington, NPS.
