**UNITED FIRST PARISH CHURCH (UNITARIAN)**

***CHURCH OF THE PRESIDENTS***

**HISTORIC STRUCTURE REPORT**

**Quincy, Massachusetts**

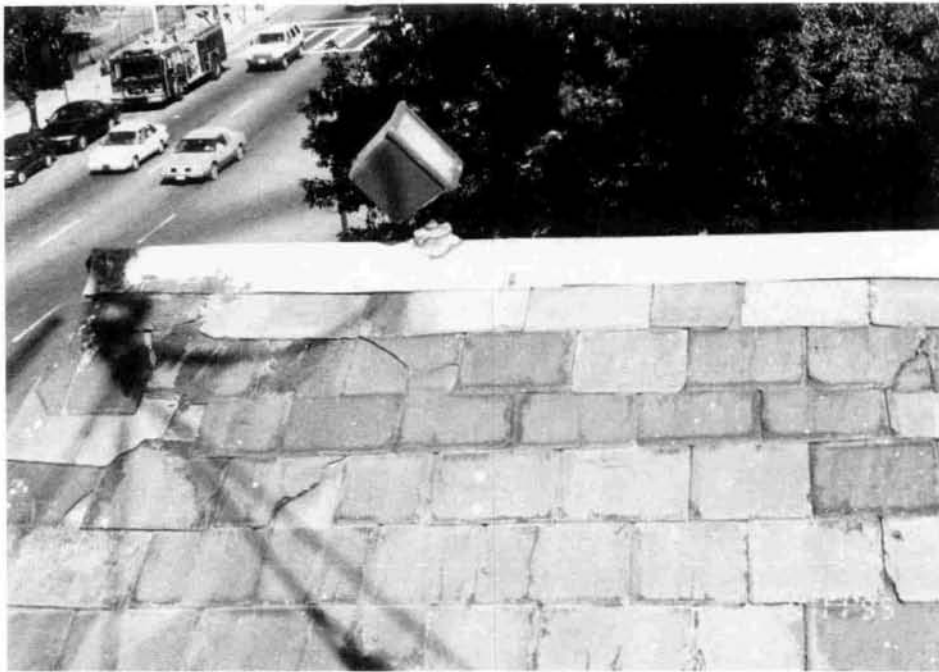
**Figure 67.** Tower exterior: west portico, slate roof with copper ridge cap. Note cracked and repaired slates, bituminous patches, loose copper flashing, and spotlight screwed to ridge cap.

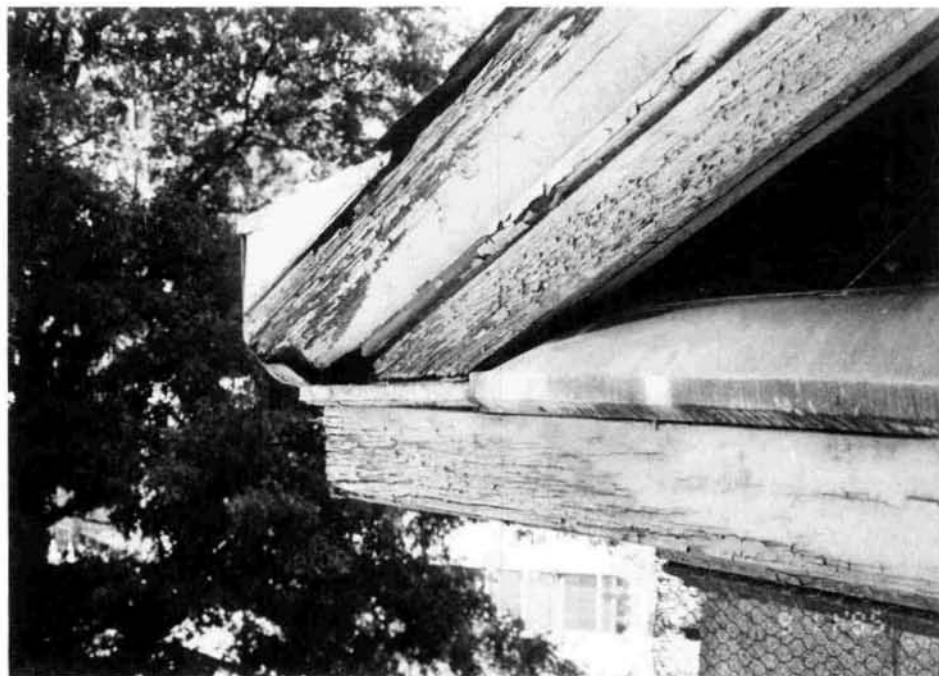
**Figure 68.** Tower exterior: west portico, north end of entablature. Note peeling paint, cracked moldings, open joints, and granite stains from rusting chicken wire.

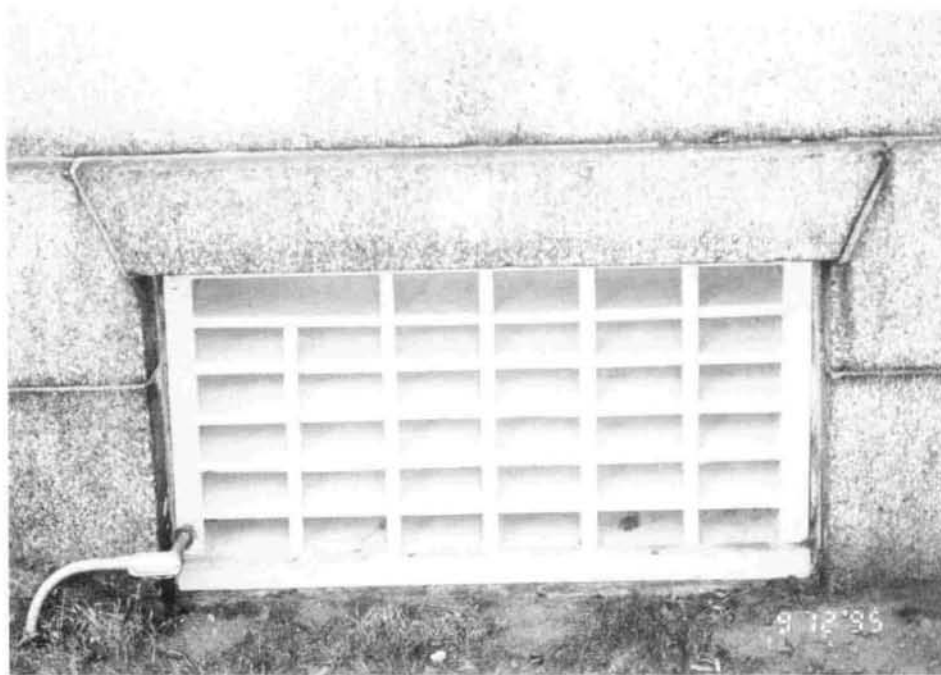
**Figure 89.** Church exterior: north wall, basement window (W016), showing sash replaced with metal furnace room ventilation panel. Note that grade is above sill level.

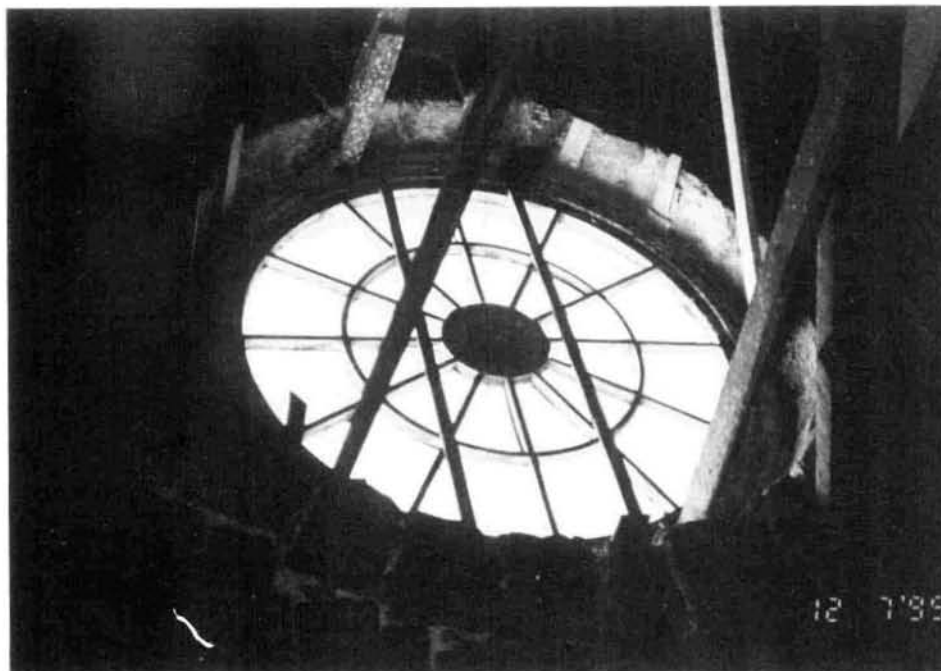
**Figure 90.** Church exterior: east wall, attic oculus (W302), with loose glazing, peeling paint, open joints; now covered with an exterior thermoplastic sheet.

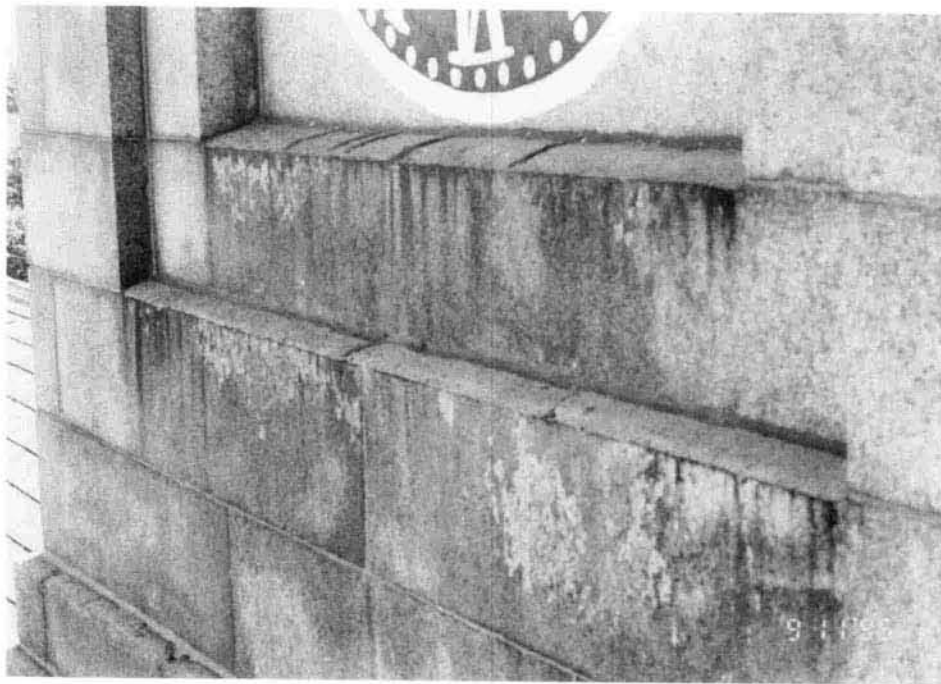
**Figure 95.** Tower exterior: shaft, east side with glazed clock face. Note open joints and stained granite, and spotlight attached to copper ridge cap.

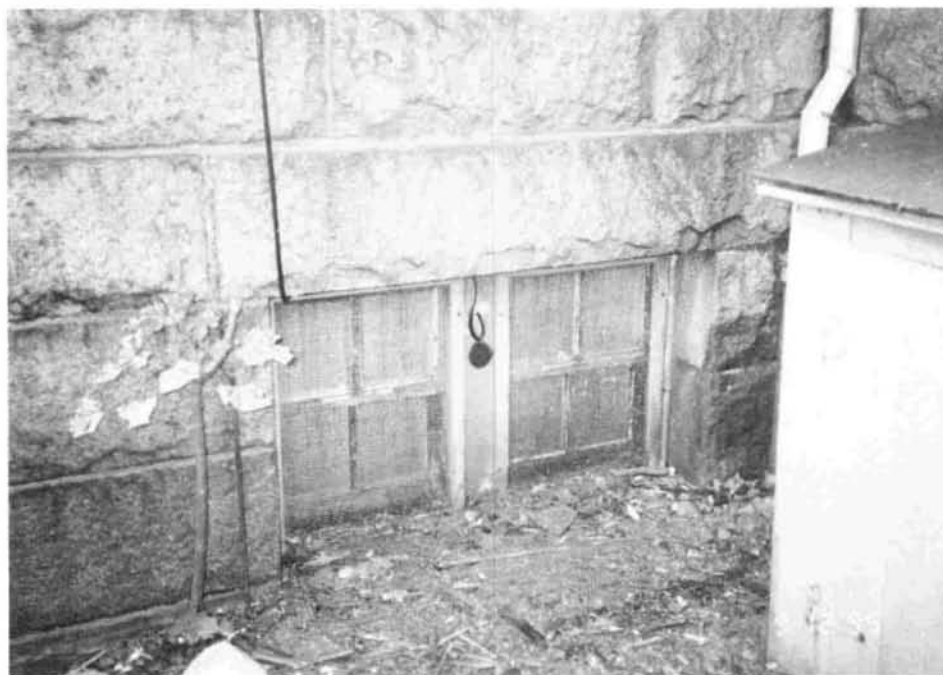
**Figure 108.** Addition exterior: north wall, basement window (W015). Note wire security mesh, soil above sill level, peeling paint, and biological growth, which affect both windows and the granite foundation.

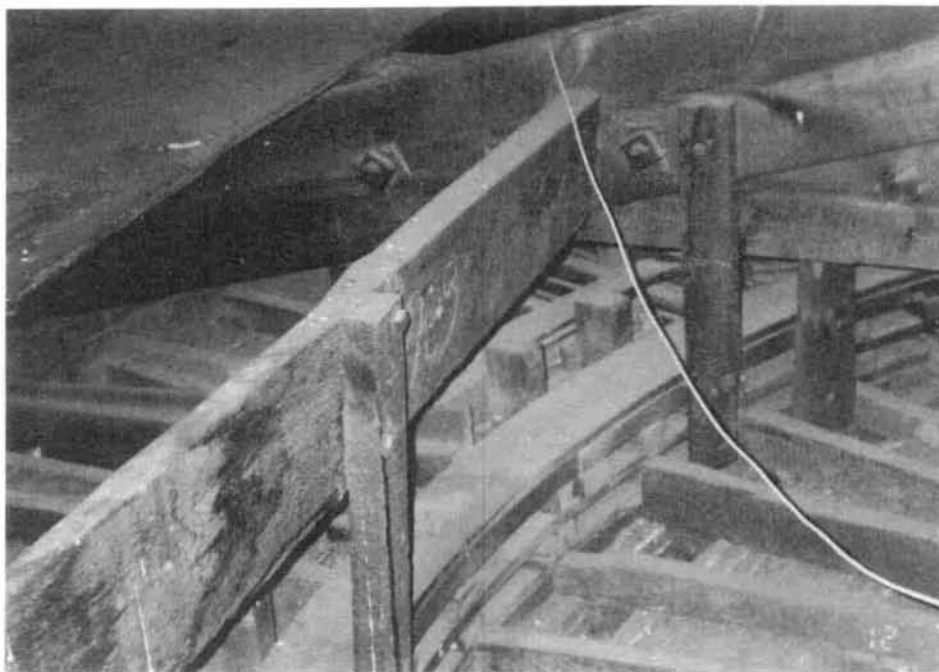
**Figure 109.** Church interior: attic, view of framing of sanctuary's coffered ceiling dome. Note scissors truss and water stains from roof leaks on many of the wooden elements.

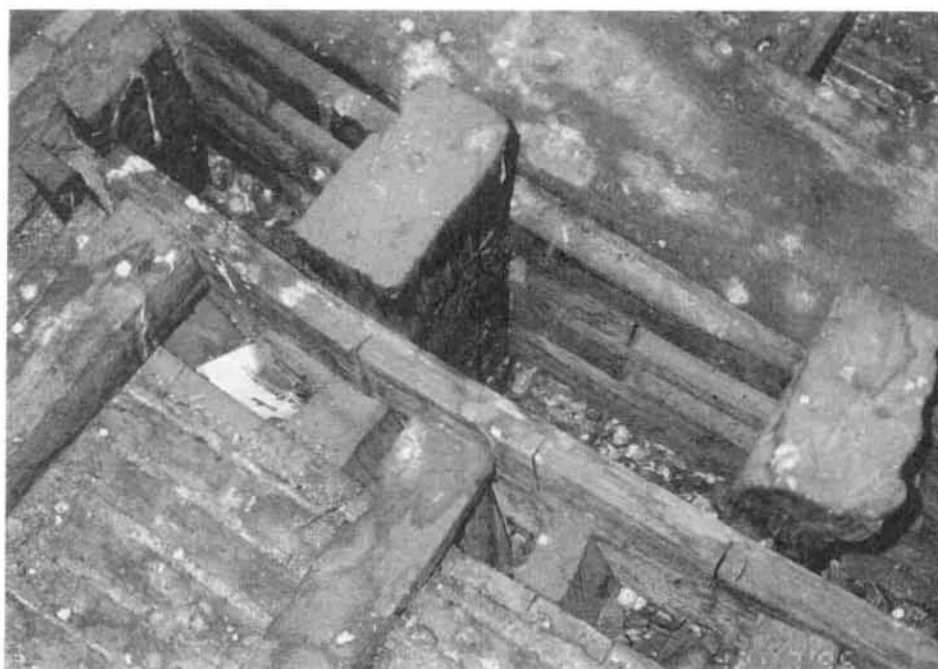
**Figure 110.** Church interior: attic, view of plaster keys of sanctuary's coffered ceiling dome. Note accumulation of debris and pigeon droppings, although bird access now seems blocked.

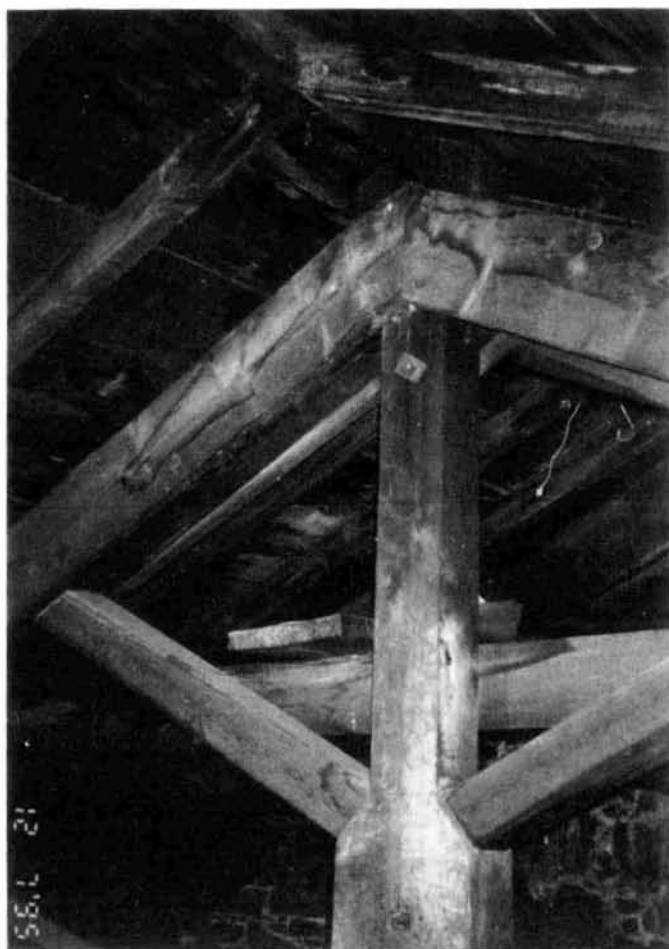
**Figure 111.** Church interior: attic, westward view of king post, rafter, and sheathing. Note water damage from leaks, mold growth, and rusting chicken wire.

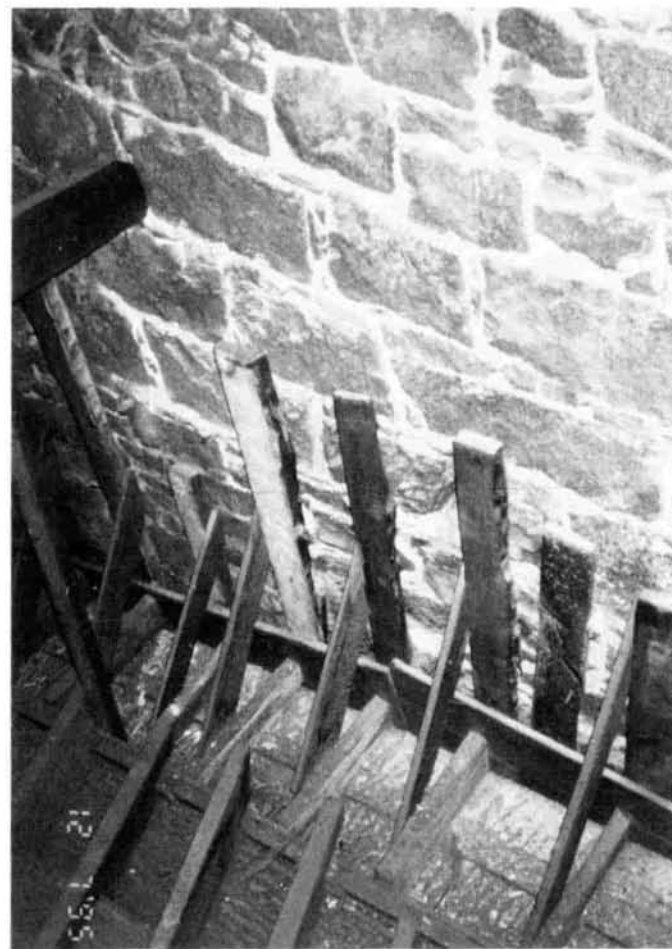
**Figure 112.** Church interior: attic, north end of east wall, at intersection with sanctuary ceiling. Note repointed mortar joints of wall.

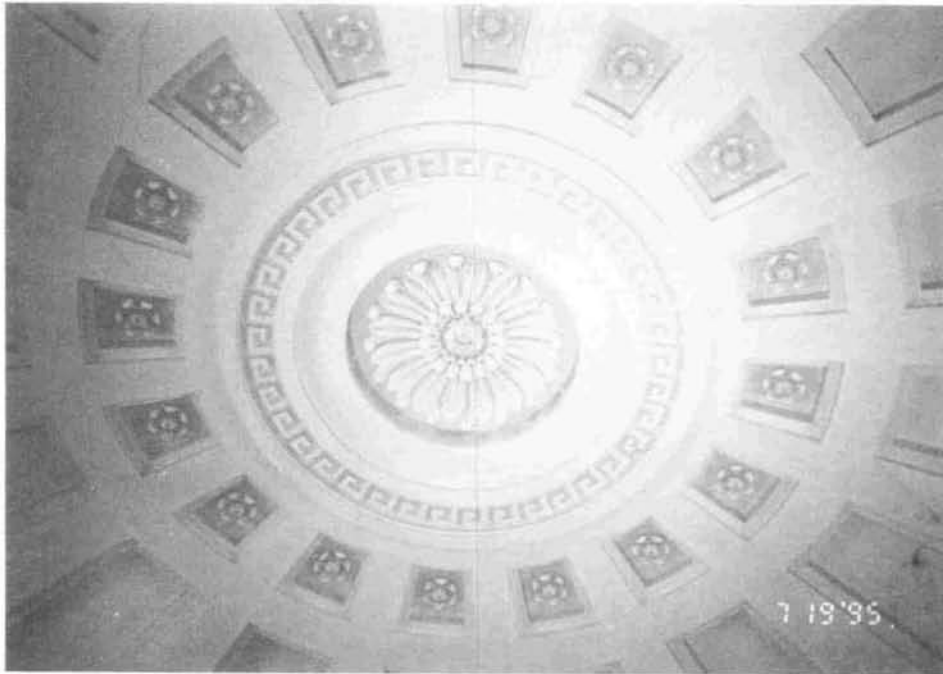
**Figure 115.** Church interior: sanctuary (Room 103), coffered dome ceiling. Note minor areas of diagonal cracks and water stains from roof leaks.

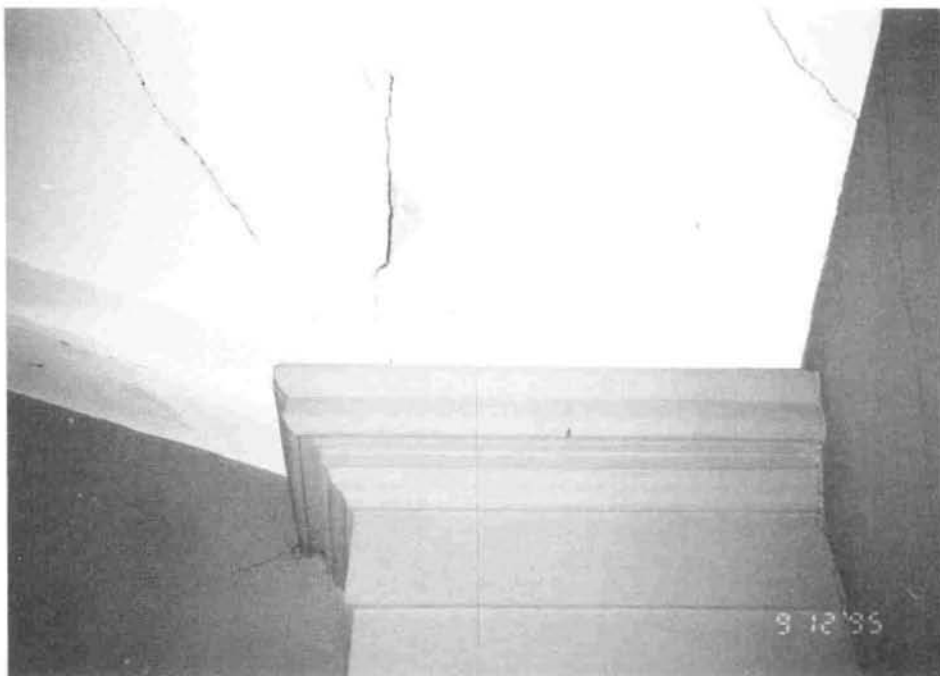
**Figure 116.** Church interior: sanctuary (Room 103), southwest corner at intersection of ceiling and wall pilaster. Note largest plaster-wall crack and water stains from leaks.

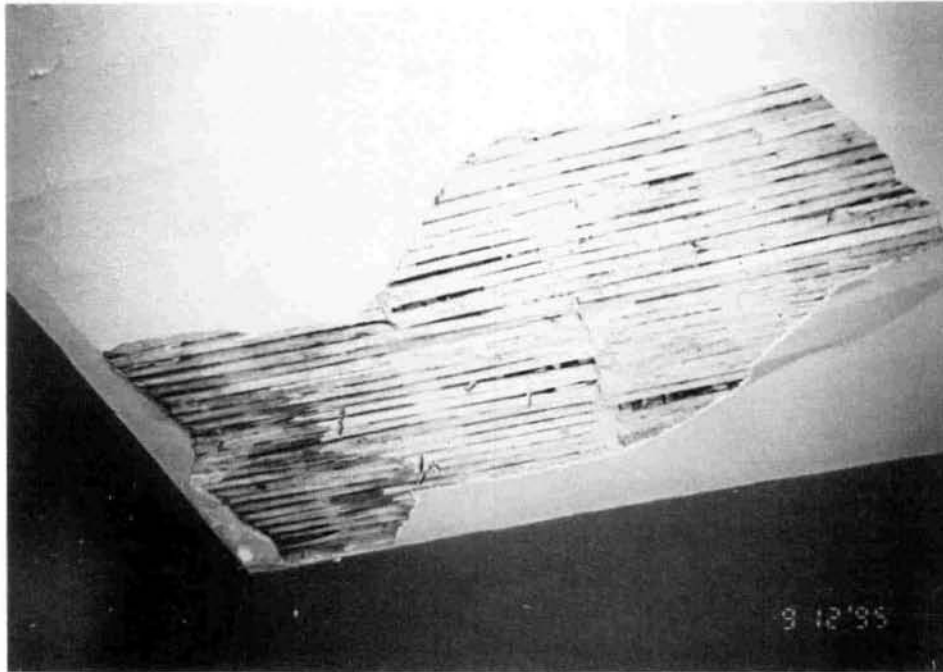
**Figure 119.** Tower interior: second-story vestibule south room (Room 202), southeast corner of ceiling where plaster has fallen due to failed plaster keys due to roof leaks.

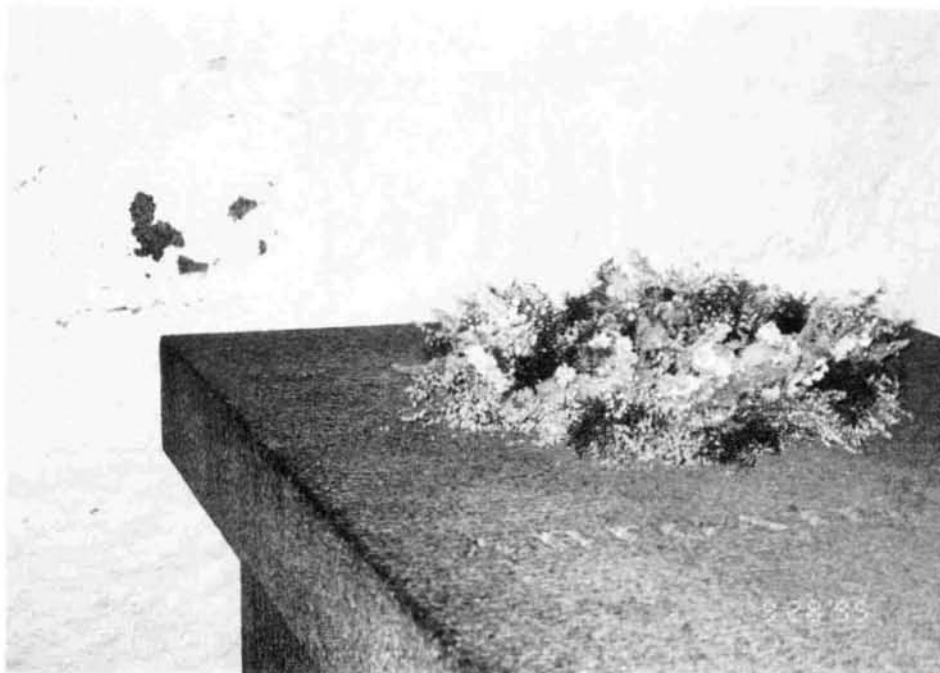
**Figure 120.** Tower interior: basement crypt south room (Room 003), west wall. Note whitewash peeling from granite wall due to moisture penetration of wall.
