FORT HANCOCK GATEHOUSE

Sandy Hook Unit, Sandy Hook, New Jersey
Gateway National Recreation Area

HISTORIC STRUCTURE REPORT

April 2004

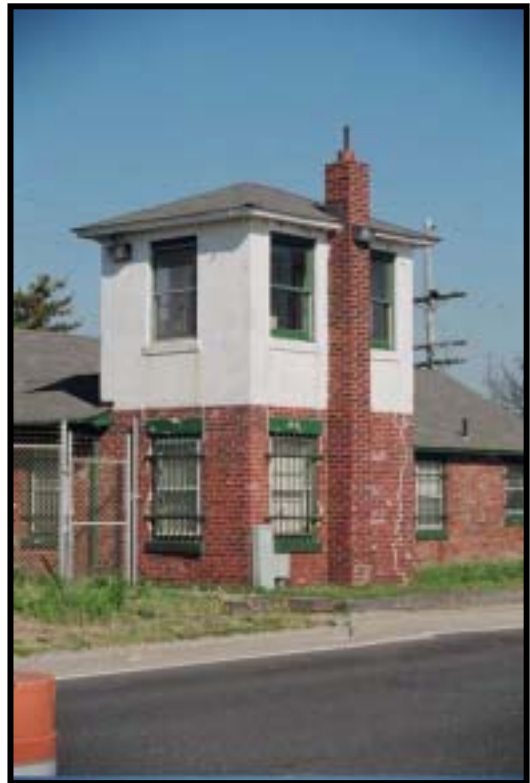
Figure 12. South elevation of annex between Gatehouse's main building at left and watchtower at right.

Note difference in brick types and set back between annex and main building.

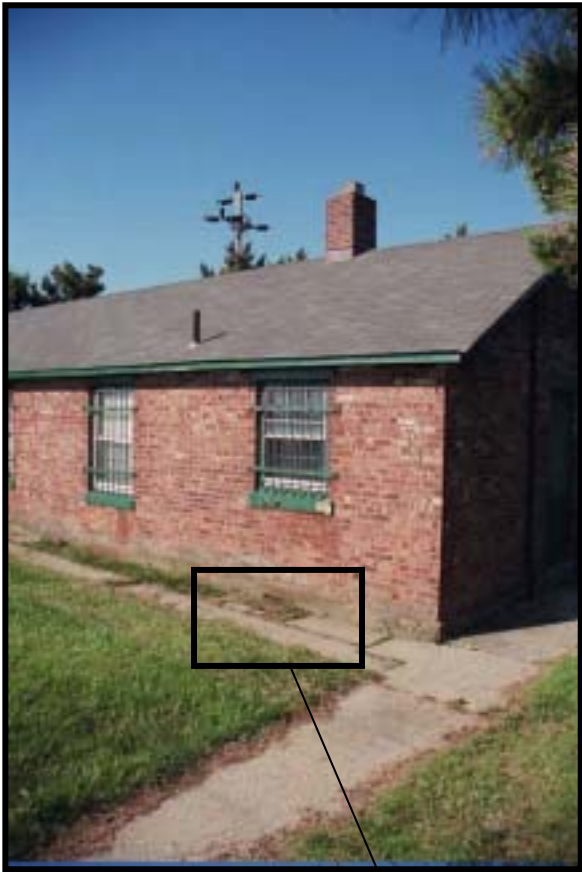
Figures 14 & 15. Detail of opening found in foundation at north end of Gatehouse's east elevation. A second filled in opening is located south of window W- 113 seen at the left side of the picture.

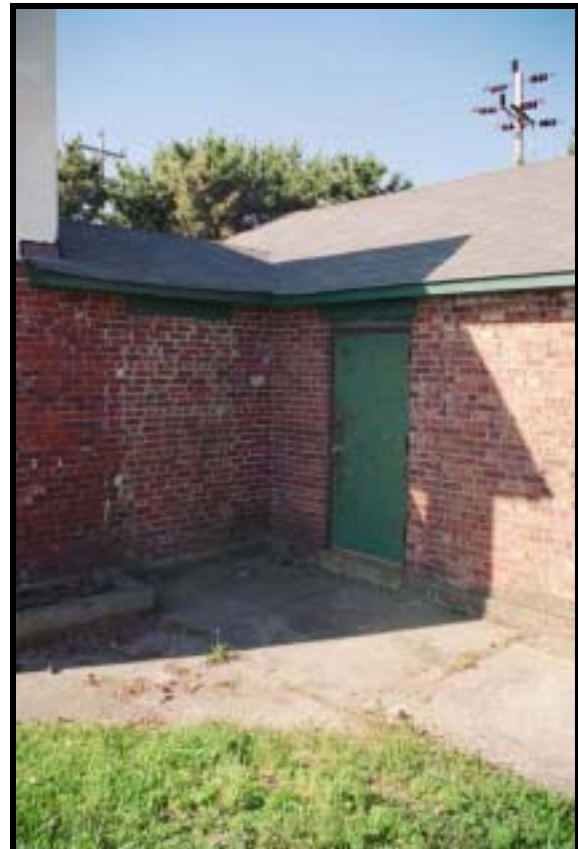
Figure 17. Detail of east entry into Gatehouse. Note original infilled door location at north wall of attached annex.

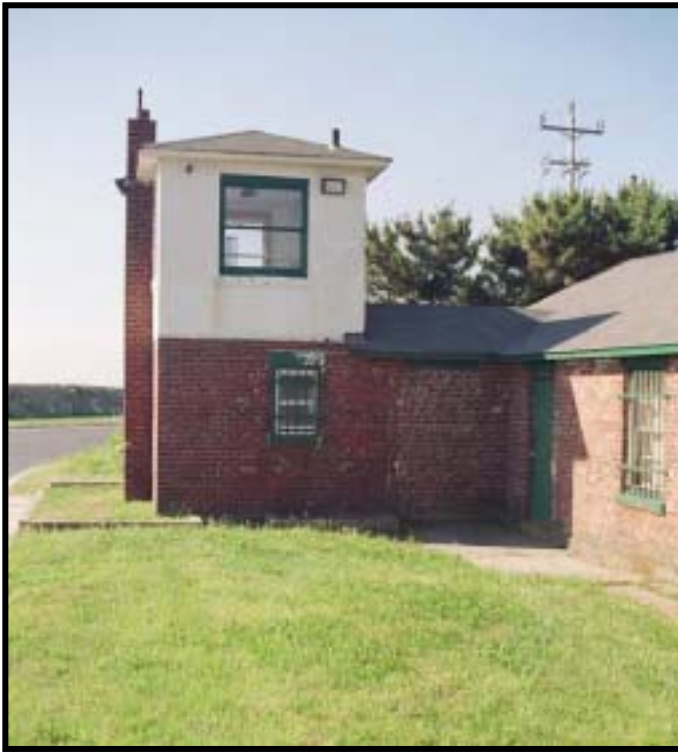
- Doorways: A steel entry door and frame are located just east of the center of the main building's gable- end north elevation. These appear to be replacement elements likely installed in the 1970s or 1980s. What appears to have been an original doorway into the annex has been filled in with brick.

Figure 18 Watchtower and annex at east end of Gatehouse's north elevation. Note original door location at annex wall now in-filled.

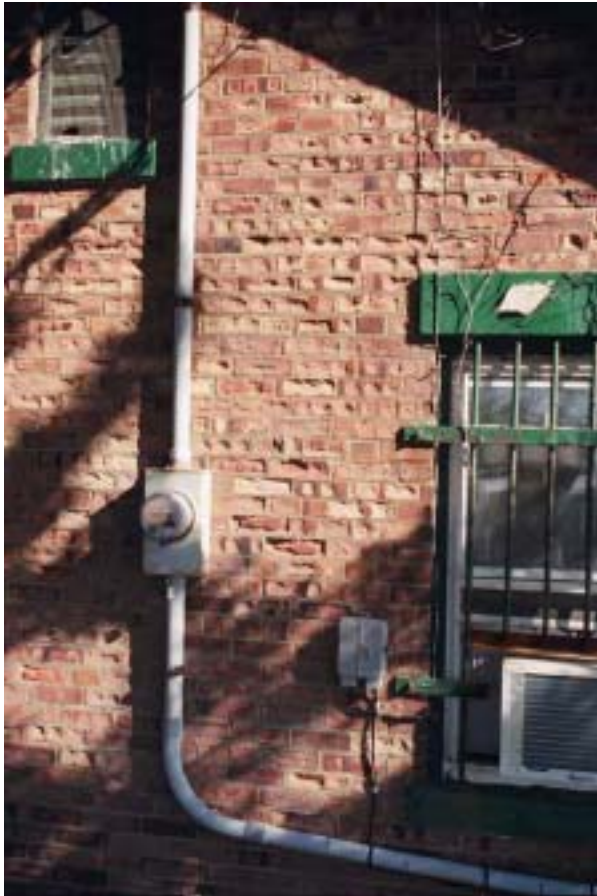
- Doorways:** No doorways are associated with the gatehouse's west elevation.
- Other:** Brick at south west corner of building and along south gable-end wall of gatehouse's main building is extremely weathered, likely due to the building's proximity to the ocean, and the apparently weaker salmon colored brick that was used on this portion of the building (Fig. 22).

Figure 22. Detail of wall at Gatehouse's south elevation, showing severely eroded brick surfaces.

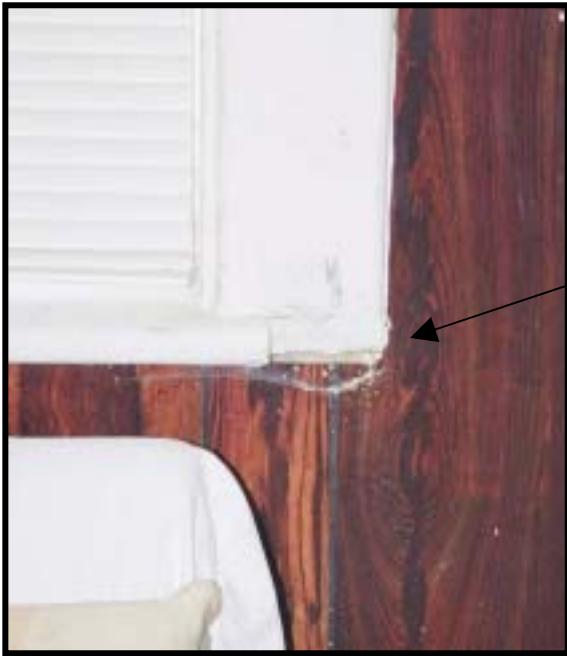
Figure 29. Detail of notch in stool of window W- 114 where original counter or desk may have butted into the east wall of room 103.

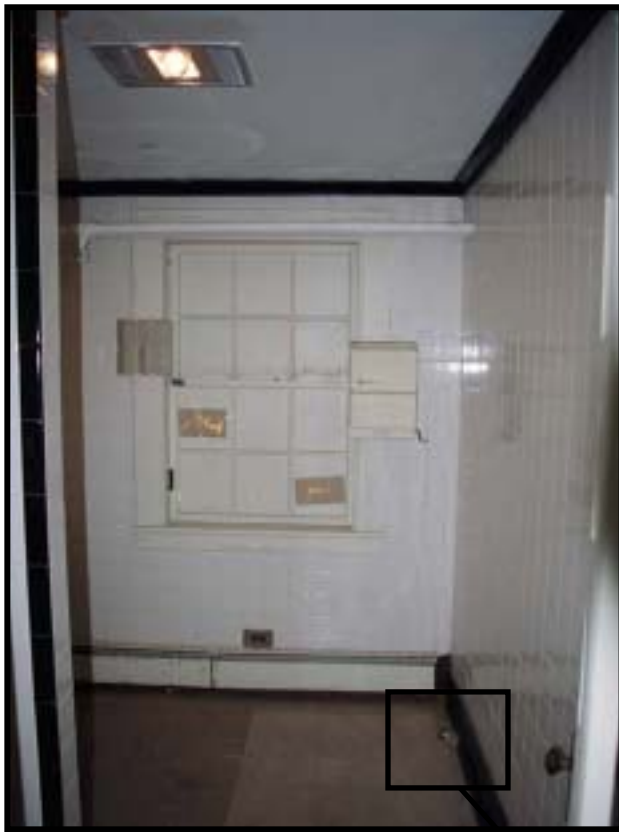
Figure 36. View of southeast corner of bathroom. Note early heating pipes near ceiling of room and differing floor tiles.

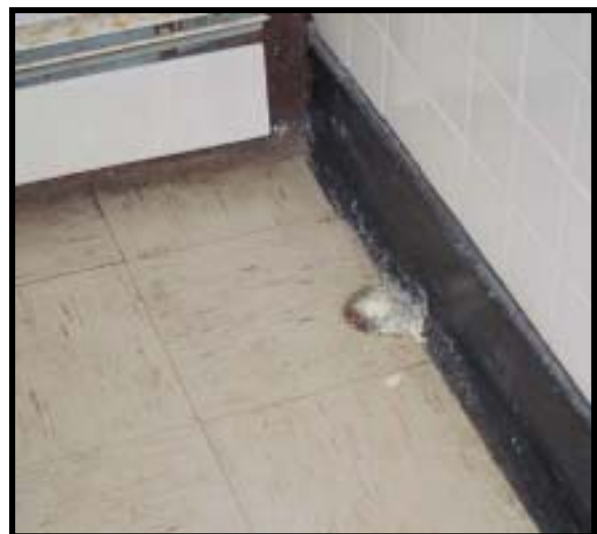
Figure 37. Detail of disconnected drain pipe found in southeast corner of bathroom.

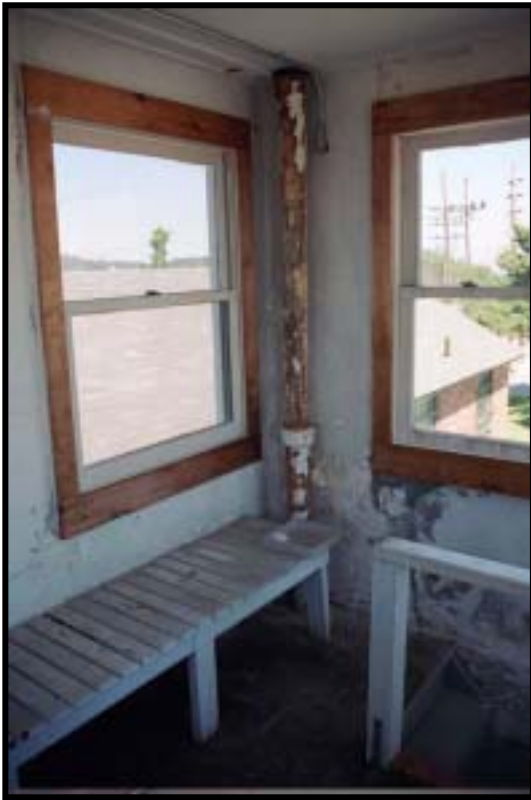
Figure 46. View of northeast corner of room 201, showing cast- iron vent pipe, sentry bench, and replacement windows and trim.
