HISTORIC STRUCTURE REPORT

JAMES MORSE HOUSE
LINCOLN HOME NATIONAL HISTORIC SITE
SPRINGFIELD, ILLINOIS

HISTORICAL DATA SECTION
ARCHITECTURAL DATA SECTION
EXTERIOR RESTORATION PROPOSAL

ALAN W. O'BRIGHT

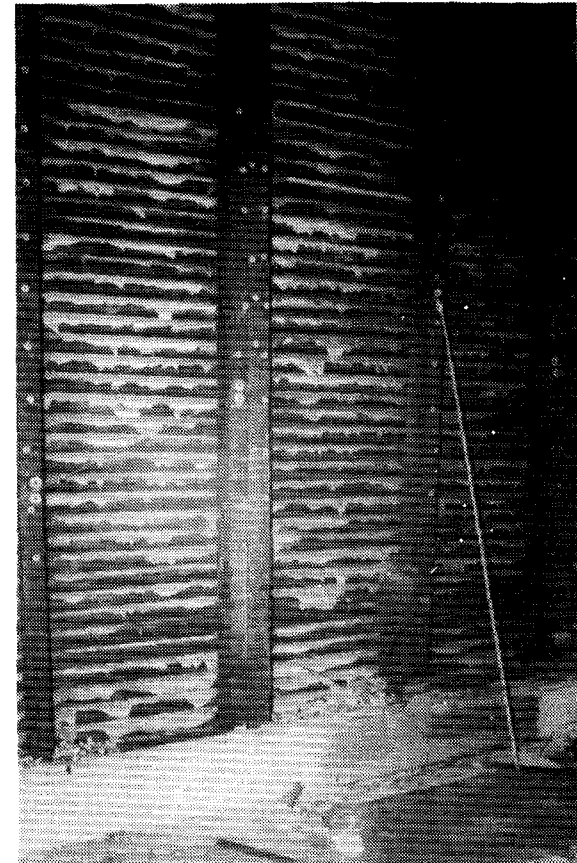
brick cellar. Physical evidence shows that a second floor window was removed and blocked so that a gable roof could be attached to the structure's south elevation (see Figure No. 5 and Existing Conditions Drawings, Sheet 18, Hall 204). A chimney was built into the addition's south wall, and there was probably a porch at the crux of the ell formed by the two building masses, although the first evidence of a porch dates to 1884. This south wing may have been added in 1865, when Morse took a \$500 mortgage on his property, perhaps to accomplish the improvements.⁸ Once the south wing was added, it is unclear whether the building continued to function as an office or rental housing. The massing of the "Morse House" remained relatively unchanged until the mid-1870s (see Figure No. 6).

North wall of Room 204 showing pitch of the former
south wing roof line and sealed window.

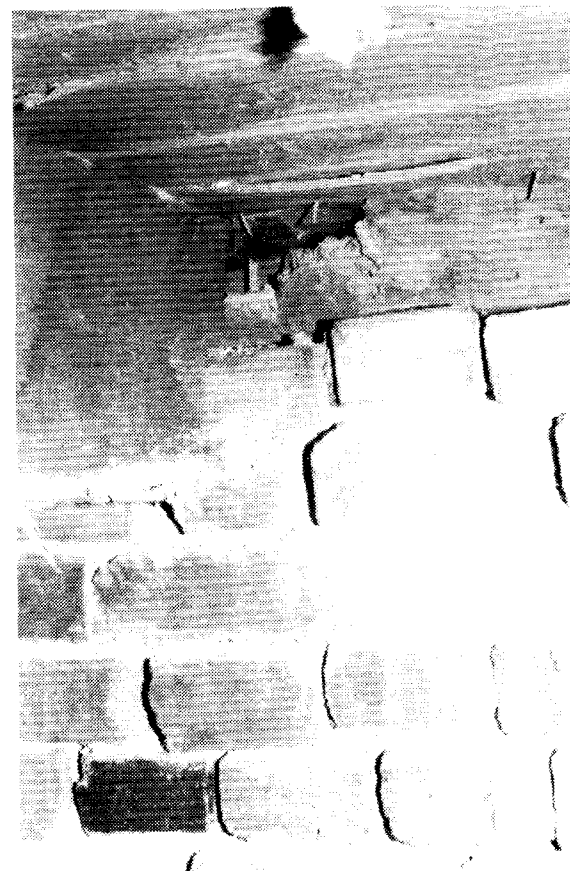
The existing red brick foundations are in no immediate danger of collapse. Although there are no major cracks or signs of settlement, areas of deterioration exist. Single course, triple wythe brick footings exist beneath all foundation walls which are all double wythe. (See Detail 2/20, p. 74). The damp condition of the soil and age have decayed the mortar joints, especially in the full cellar area. The mortar joints at the sill header course have failed in many places, especially along the south and north walls of Crawlspace 002. Some of the bricks have partially slipped out from beneath the wood mud sill (see Figure No. 12). Two top courses of foundation brick were removed

View of the south wall of Crawlspace (002) at the
mud sill. Note the deteriorated joist end and sill
pocket. This condition is typical of nearly the
entire south wall.

The mud sill at the eastern half of the south wall of Room 002 is decayed. Water probably infiltrated the wall before the adjacent porch was enclosed to form a foyer and stairhall. Many of the joist pockets and ends are gone (see Figure No. 12).

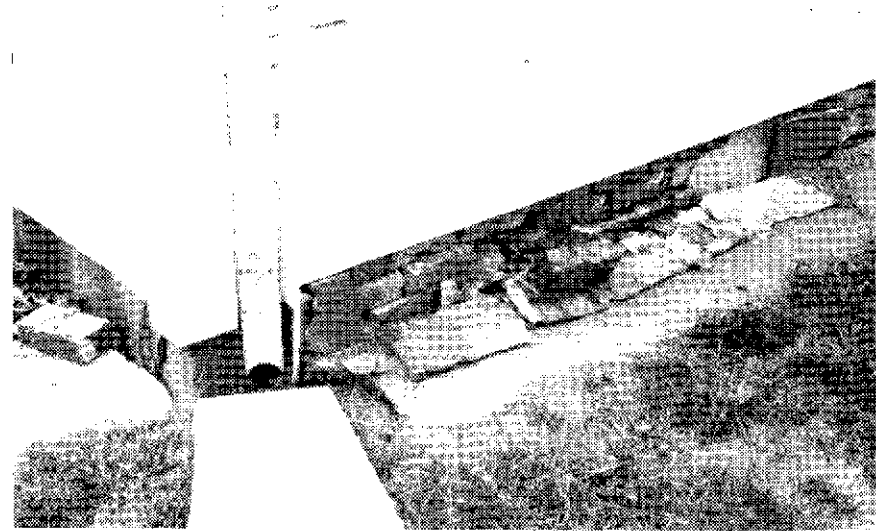
Pargetting was troweled to all exposed surfaces of the foundation at the exterior. The mortar is very hard and is virtually impossible to remove without severely damaging the brick and mortar joints. Some has spalled at the exterior southwest corner of Crawlspace 006 due to an unrepaired downspout and freeze-thaw cycles. The mortar bonded so well that whole bricks have fallen out with sheets of the mortar still clinging (see Figure No. 13).

View of the exterior southwest corner
of Room 107 showing deteriorated brick
foundation and flaking of siding paint.

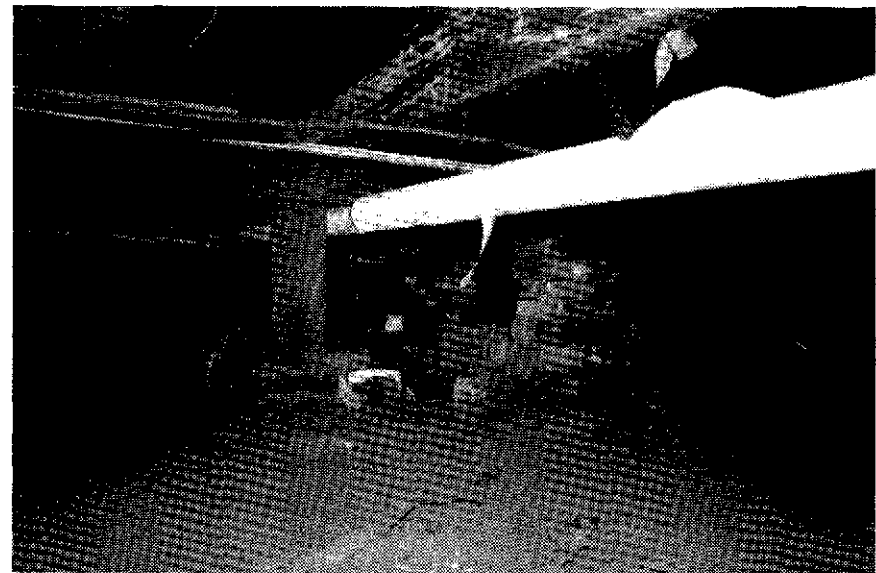
FIGURE NO. 14

View to the northeast in Crawlspace (002)
showing termite damage to floor joists,
beam supported by mechanical pipe, and
brick piers supporting a single floor
joist.

The 2- by 8-inch oak joists beneath Rooms 102 and 103 have been damaged by termites over their entire length (see Figure No. 14). The termite damage, an added interior partition, a concrete topping to the floors, and 16-foot joist spans have added an immense strain on the floor's structural system. The termite damage emanates from the north foundation wall of Crawlspace 002. The materials' advanced age may be responsible for mortar joint failure at the mud sill along the south foundation wall of Room 002 (see Figure No. 12). Previous owners attempted to shore up the joists at mid-span. Dry-laid brick and concrete block piers were constructed beneath the partition separating Room 102 from Room 103. A 4- by 4-inch beam in Room 002 at mid-span is supported at both ends by mechanical system piping (see Figure No. 14). Similar measures were taken in Crawlspace 001. The remainder of the joists on the first floor are in good condition.

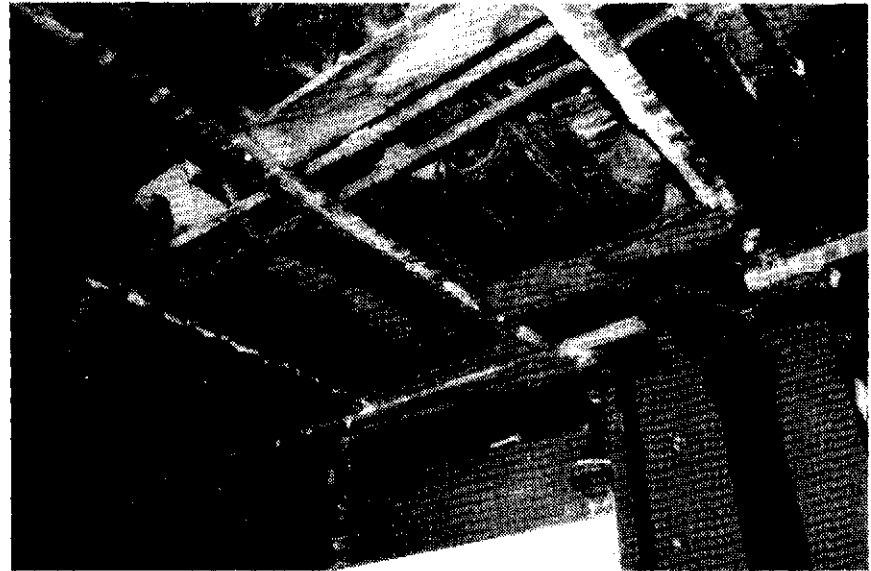
View of the ceiling at the east wall of Room 104 showing the plumbing tree to the second floor bathroom, and the poorly constructed header over Door 104-D1. Note also the wall plate cut to accommodate the waste stack.

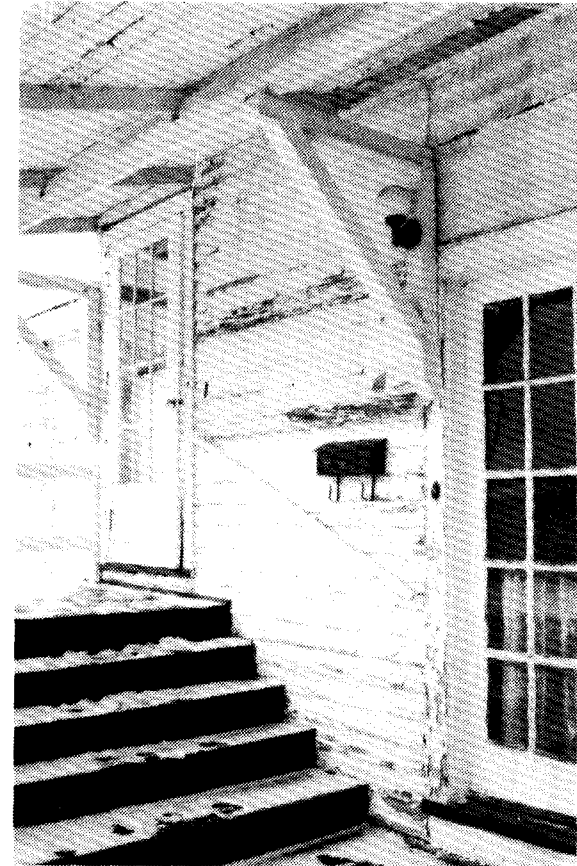
View of the east exterior elevation beneath
Porch (111) roof showing water damaged paint
finish and siding.

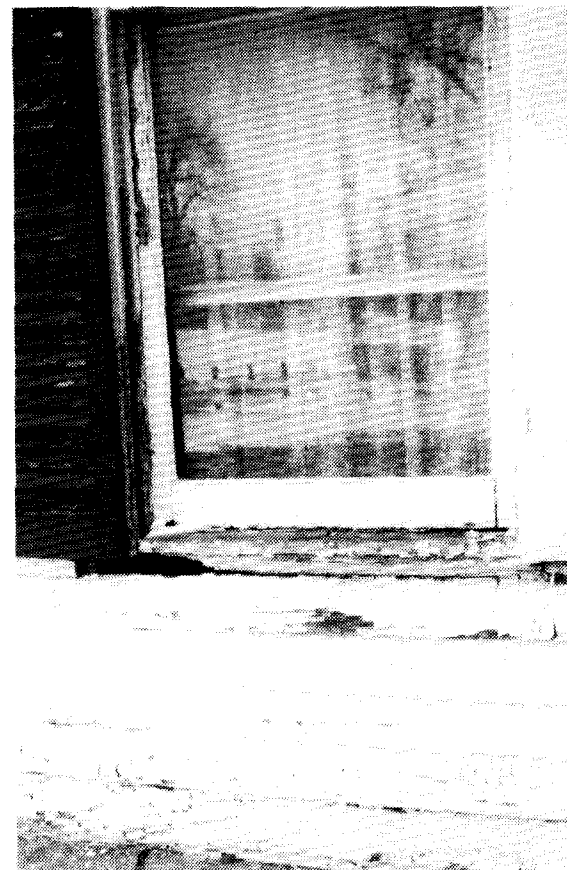
Exterior view of Window 101-W1 showing extensive
deterioration of sill and jamb. Most windows
throughout the structure are in poor condition,
similar to the one shown.

include rotting at all wood components, sash painted shut, dried out and cracked putty, misaligned sash, and weak or totally rotted joints (see Figure No. 21). Other than sash weights and spring loaded sash pins, no historic window hardware remains. Factory built aluminum triple track storm and screen units have been installed by contractors at the interior frames of all windows. No wood screen or storm windows exist.

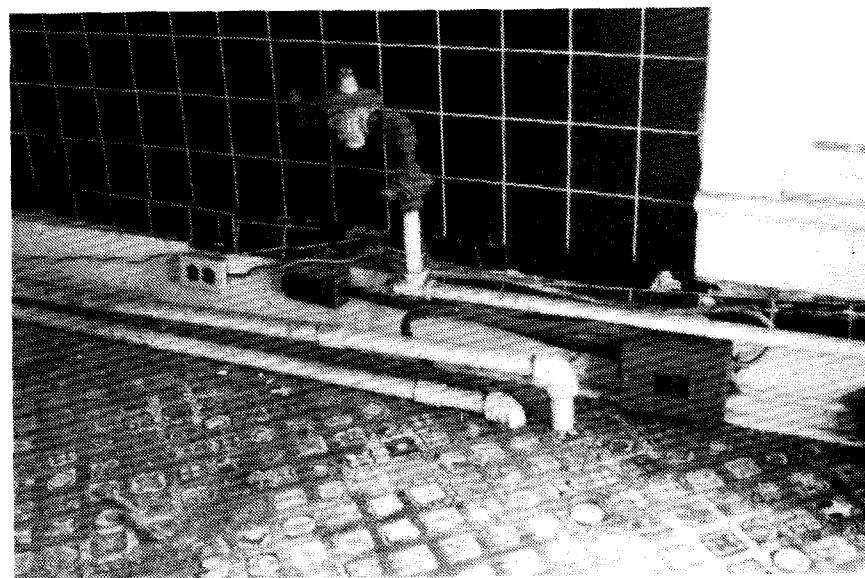
View along the south wall of
Kitchen (206) showing the dangerous
condition of the electrical system.
Also shown are mechanical pipes, and
a gas supply pipe with valve.

The meter and breaker panel replaced fuse boxes in 1978. Insulated branch circuit cable was installed at various times since 1926 and is in a dangerous operational state (see Figure No. 22). There are a variety of receptacle types, few of which appear to meet current code standards. There are a variety of types and ages of light fixtures, wall and ceiling mounted, none of which is noteworthy. General service to the house is currently shutdown to reduce the chance for fire, although one receptacle in the basement remains active and the fire detection system is switched on at the main breaker panel box.
