HISTORIC STRUCTURE REPORT

JULIA SPRIGG HOUSE (HS-11)

Lincoln Home National Historic Site
Springfield, Illinois

May 1995

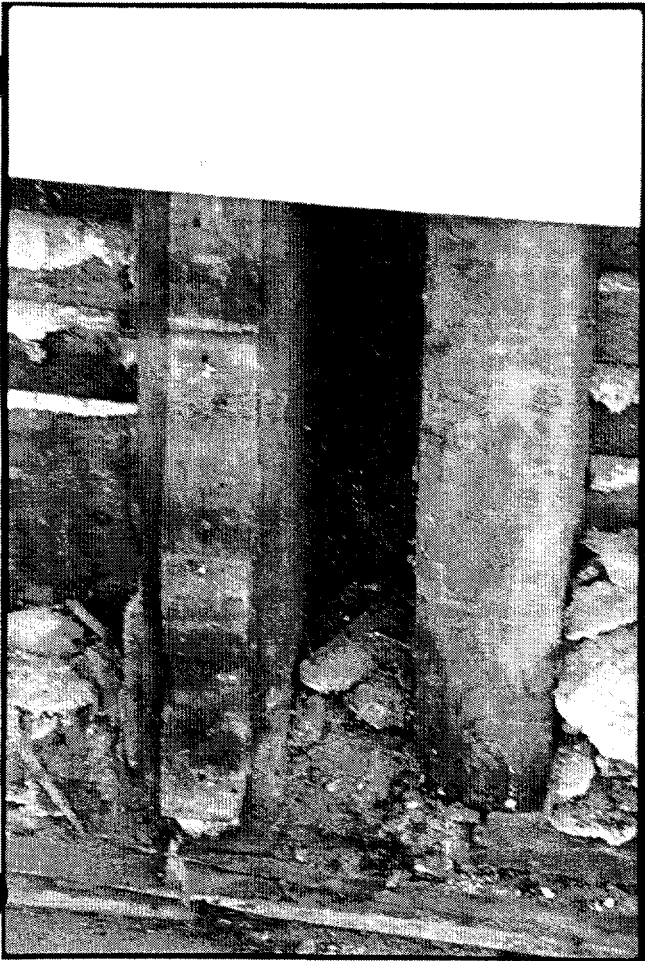
**FIGURE 3.17 VIEW OF
THE STUDS AT THE
1851 COTTAGE**

This doubled stud condition is found at numerous places throughout the house and generally occurs at an interior wall (or evidences an 1851 cottage interior wall). Where it occurs, this condition probably indicates the location of the interior walls of the 1851 cottage.

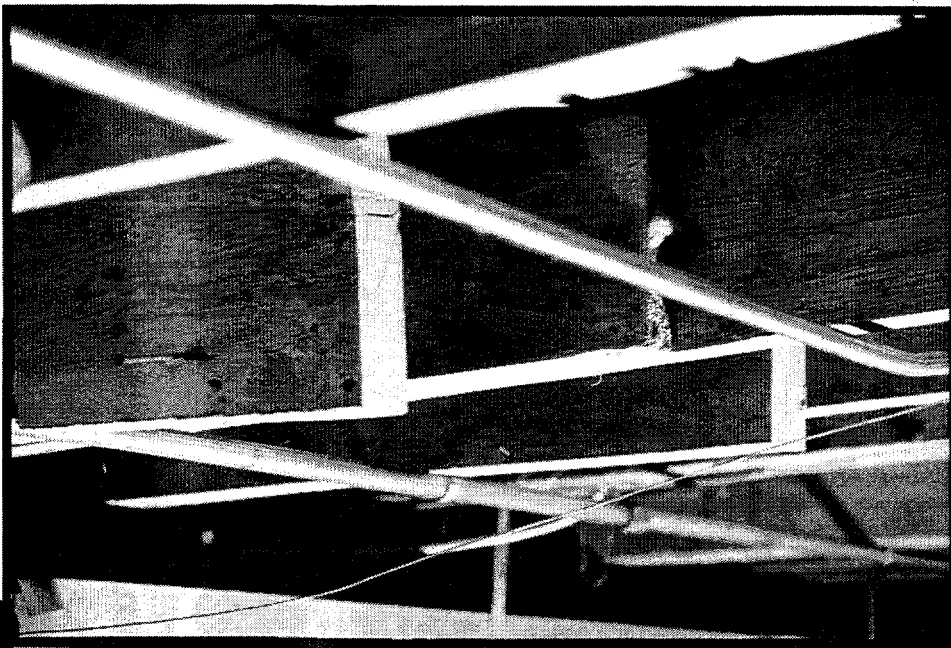
**FIGURE 3.18 JOISTS
AT THE SOUTHWEST
PORCH**

These floor joist ends are at the north limits of the southwest porch of the 1851 cottage.

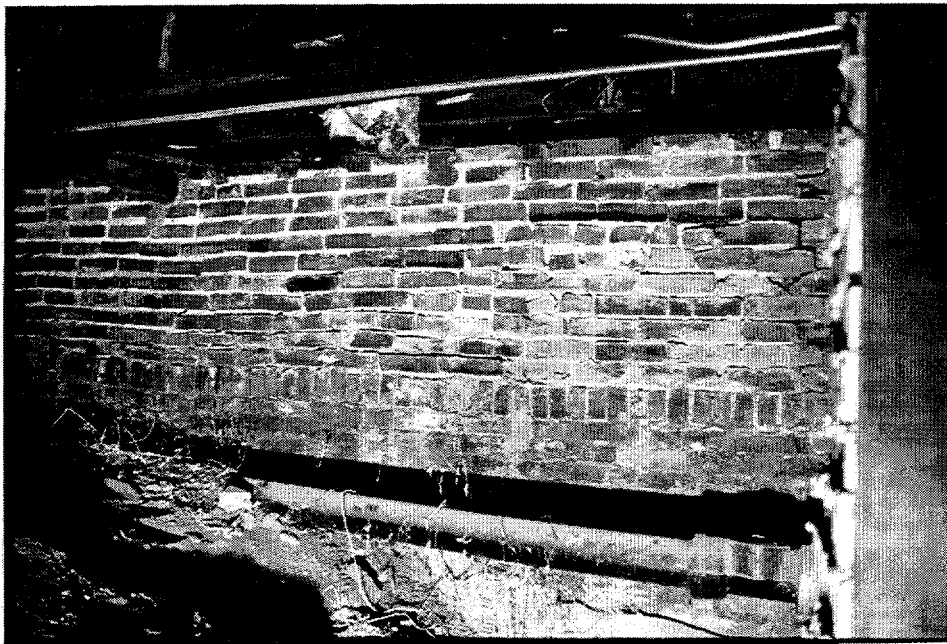
**FIGURE 3.20 FOUN-
DATION WALL AT
THE 1874/1879 ADDI-
TION**

This is a view of the south foundation wall at Crawl 001 (near the southwest corner). Note the deterioration of the mortar joints and the general failure of the wall itself. Some sunlight can be seen through this wall.

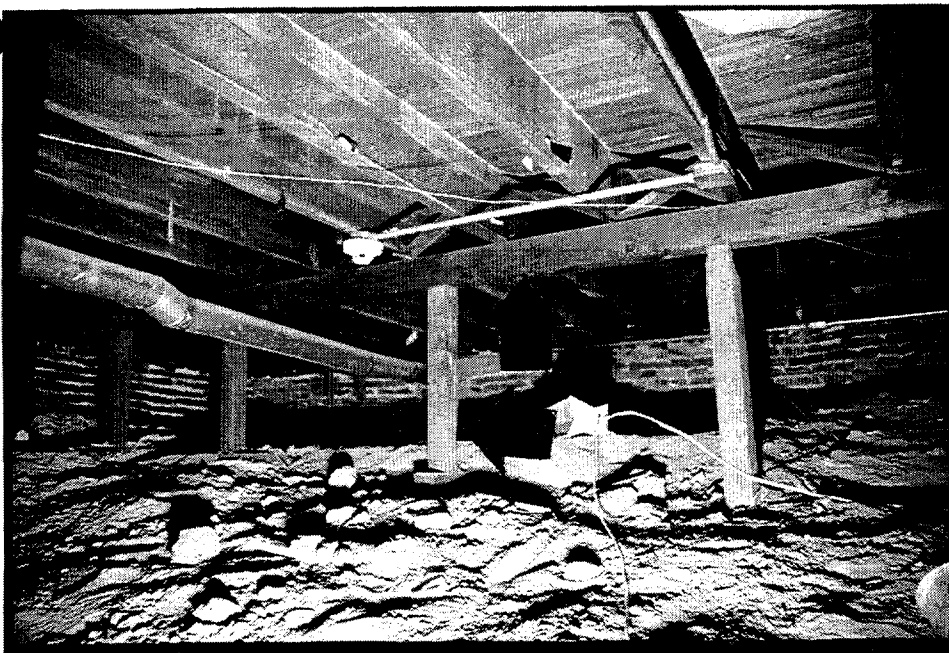
FIGURE 3.21 FIRST FLOOR JOISTS AT THE 1874/1879 ADDITION

This is a view of the first floor joists at Crawl 001. Note the supplemental framing added at mid-span.

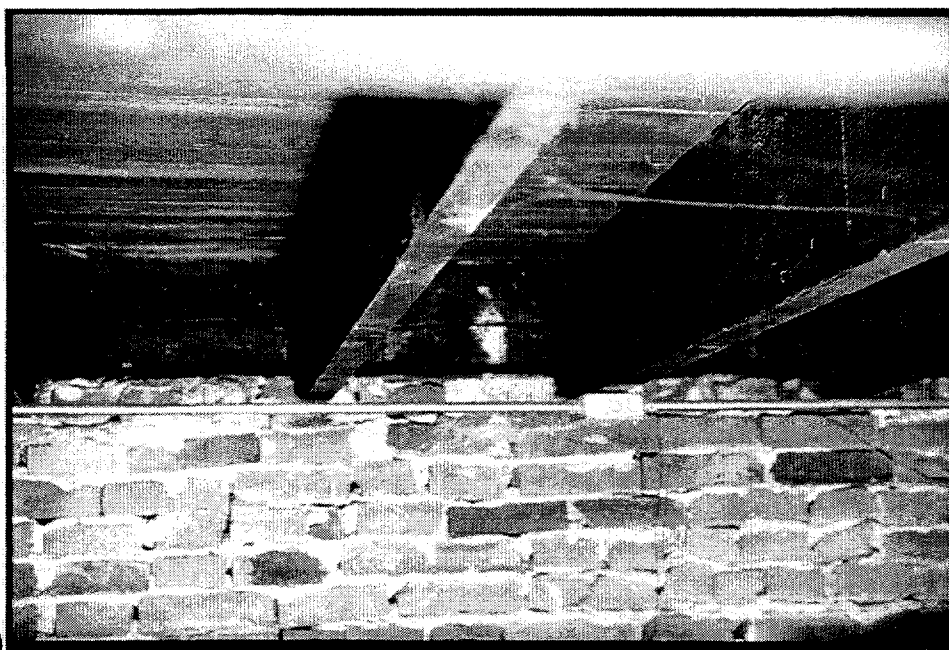
FIGURE 3.22 FIRST FLOOR JOISTS AT THE FOUNDATION WALL

This view shows the bearing condition at the east end of the first floor joists of the 1874/1879 addition in Crawl Space 001.

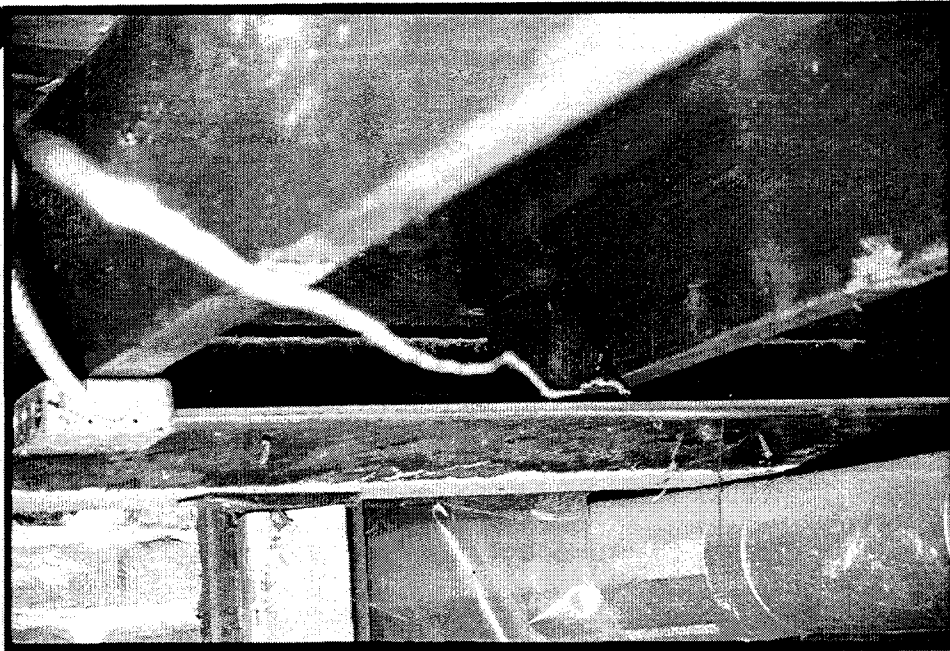
FIGURE 3.23 FIRST FLOOR JOISTS AT THE WEST SILL BEAM

This is a view of the bearing condition at the west end of the first floor joists of the 1874/1879 addition in Crawl Space 001.

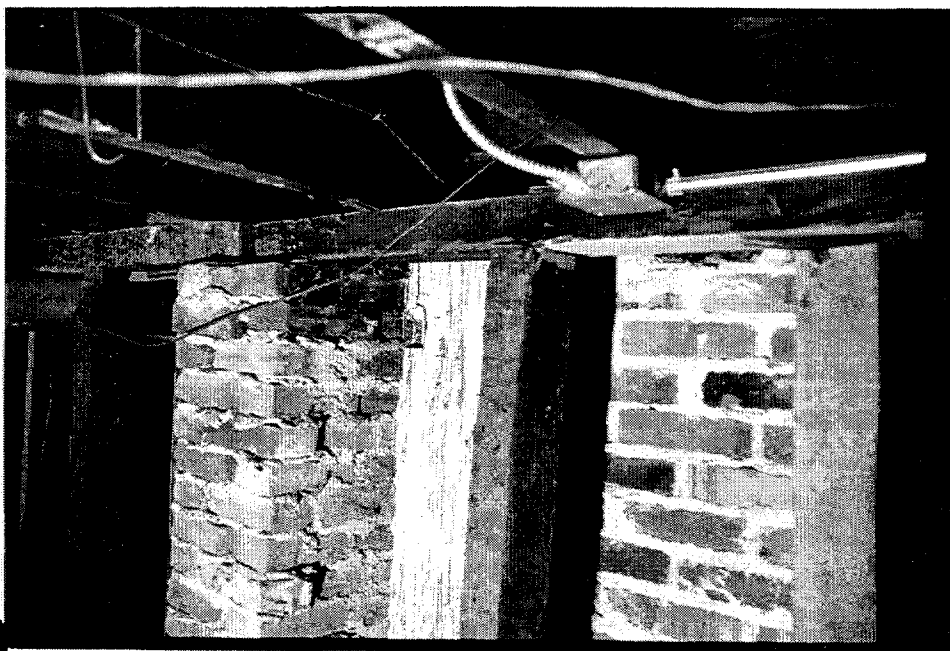
FIGURE 3.24 FIRST FLOOR JOISTS AT THE WEST SILL BEAM

This is a view of supplemental framing added under the west ends of the first floor joists of the 1874/1879 addition in Crawl Space 001. This beam rests on brick columns.

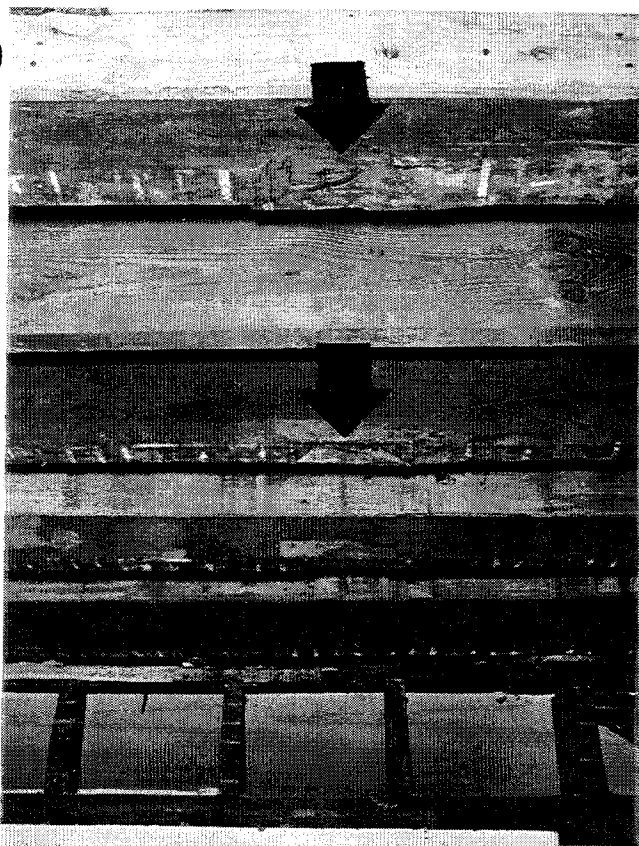
**FIGURE 3.35 1851
COTTAGE CEILING
JOISTS AT ROOM 103**

This notched condition occurs at each of the 1851 ceiling joists at Room 103. Additionally, there are existing extra large cut nails (or spikes) at each notch. These notches indicate the location of an interior partition wall aligned with a non-extant intermediate east wall post and the north wall of the southwest porch.

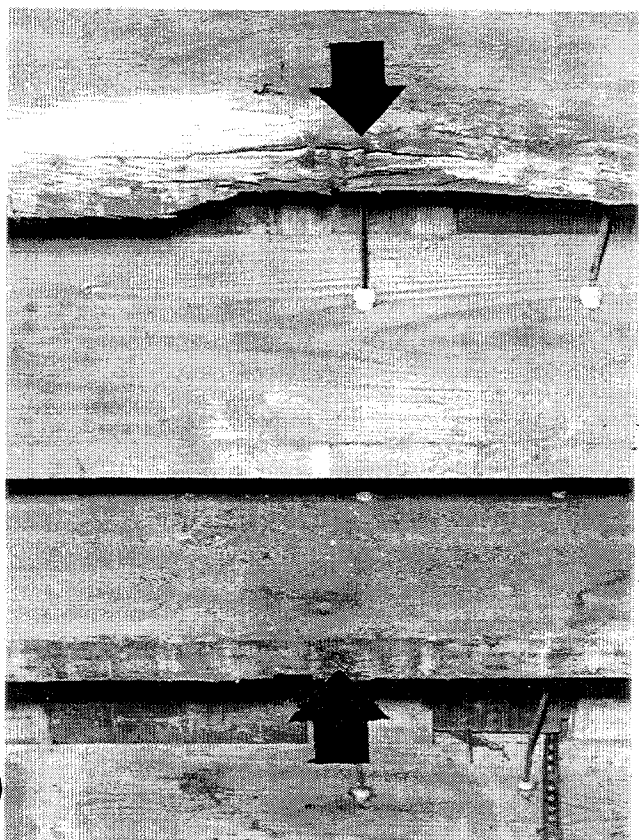
**FIGURE 3.36 1851
COTTAGE CEILING
JOISTS AT ROOM 107**

These extra large cut nails (or spikes) occur at each of the 1851 ceiling joists at Room 107, indicating the location of the north wall of the southwest porch. Additionally, this wall aligns with not only the interior partition wall indicated in Figure 3.35, but also with a braced corner post at the west wall.

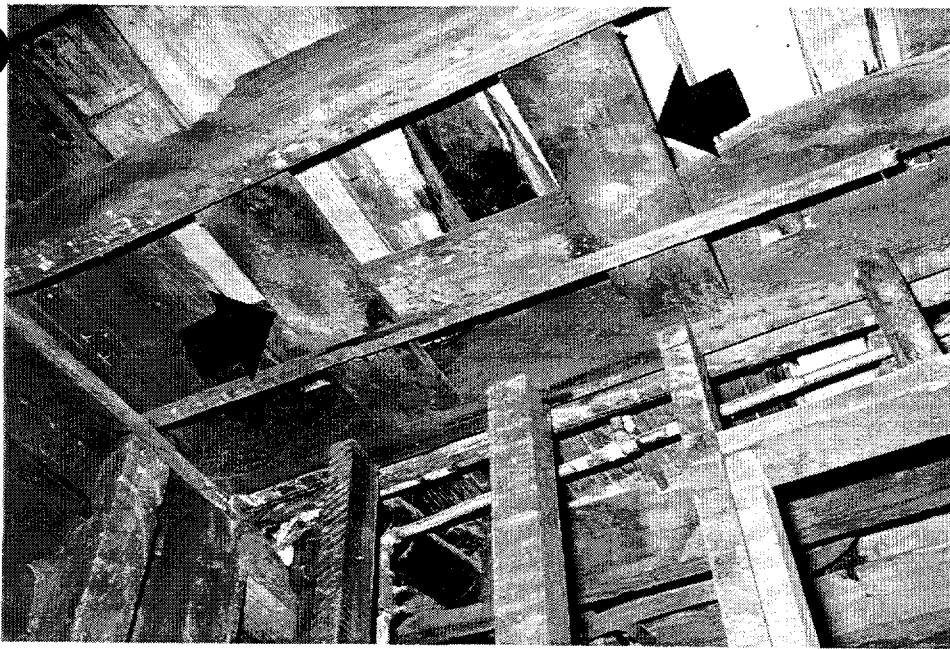
**FIGURE 3.37 FRAM-
ING AT CEILING OF
ROOM 103**

This unusual condition occurs at the 1851 ceiling framing at the west end of Room 103. The areas between the flat laid 1"x (see arrows) may be a framed void for the passage of flues from heating stoves at this area.

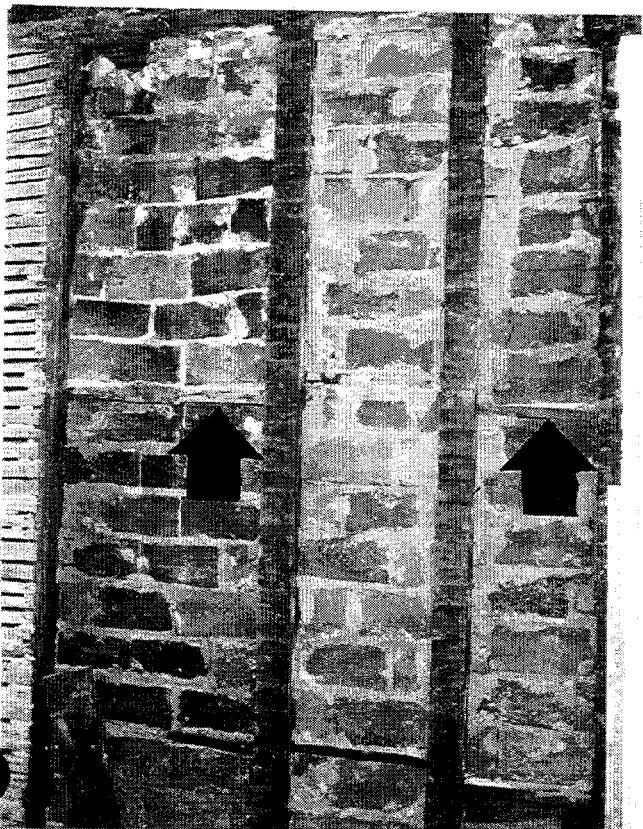
FIGURE 3.40 BRICK NOGGING

This brick nogging was found inconsistently throughout the north and east exterior walls of the cottage. Note the wood shelves (see arrows) at varying locations in the nogging.

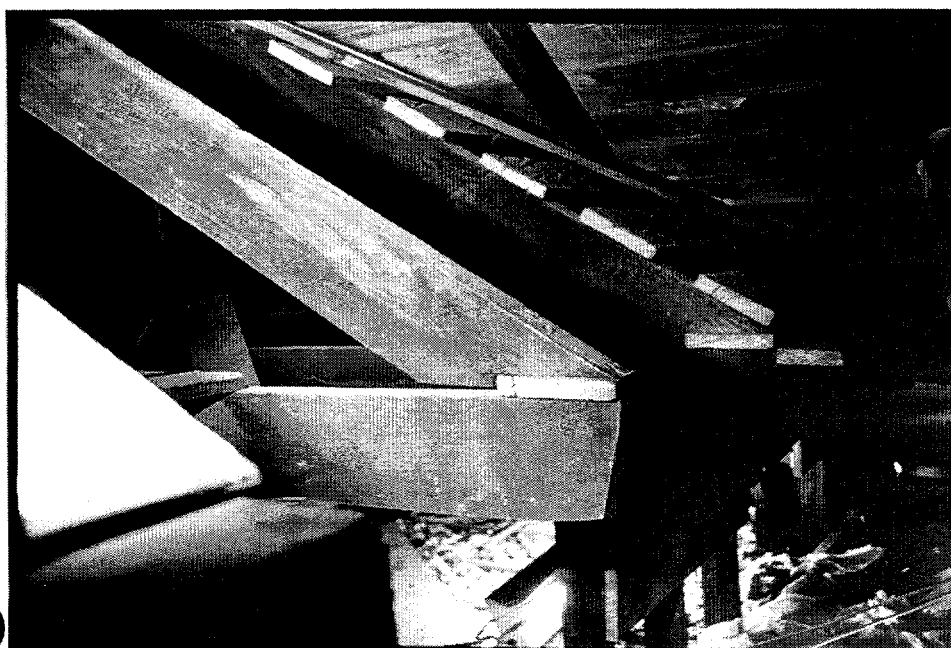
**FIGURE 3.68 RAFTER
AT JOIST END FRAM-
ING**

This is a view of the roof rafter bearing condition at the joists of the 1874/1879 addition.
