Lake Area Fish Hatchery

Historic Structure Report

Prepared by Sievert & Sievert Cultural Resource Consultants
in conjunction with the Montana Preservation Alliance

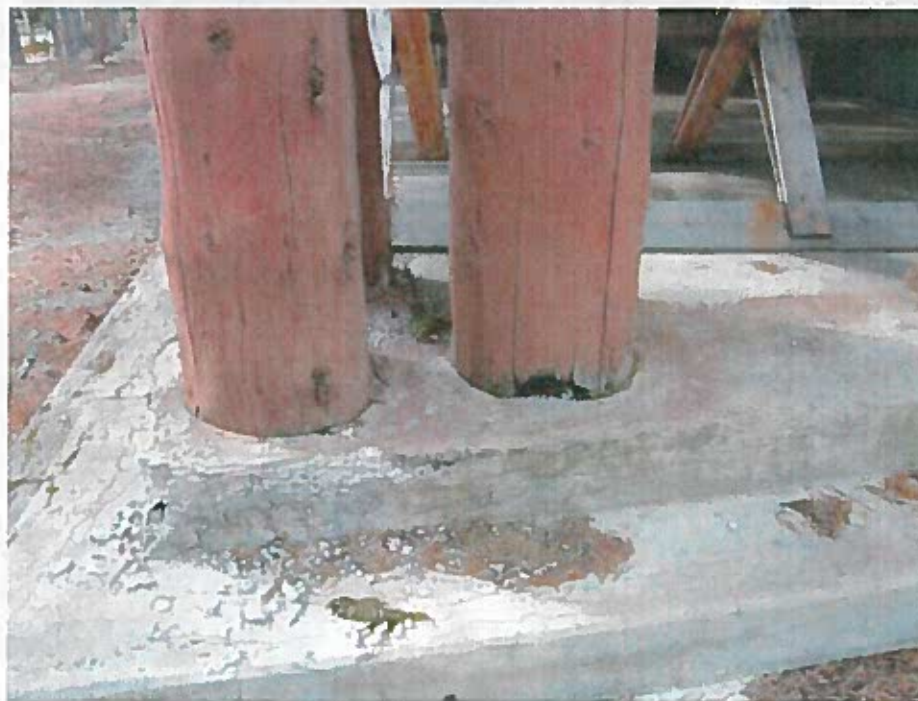
Detail of base of columns above; note deterioration at base of right column member. Photo by Herbert Dawson, November 2007.

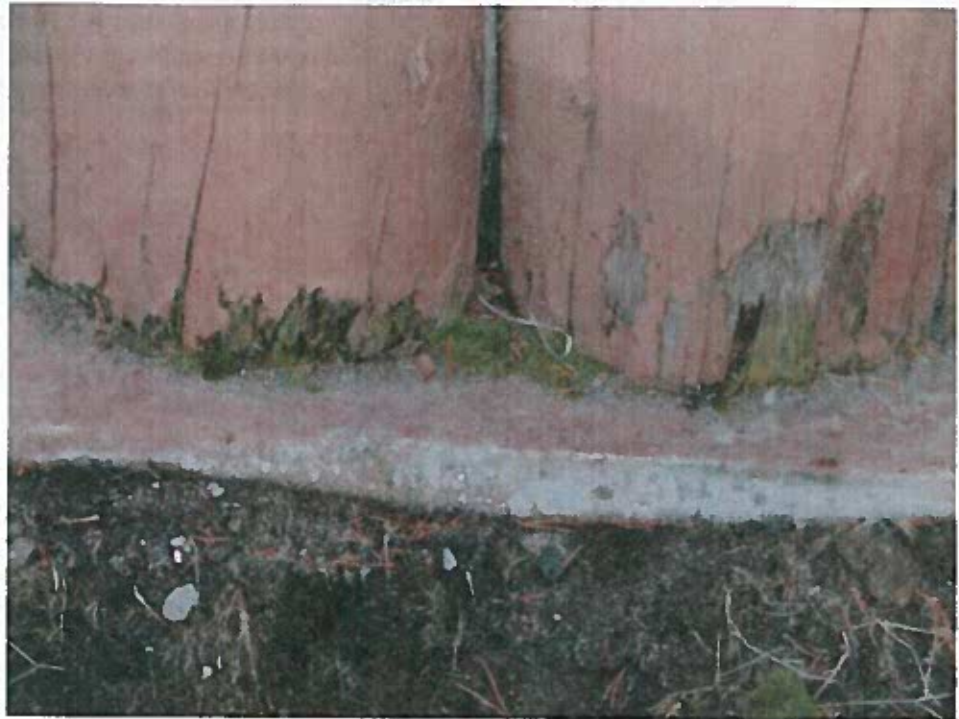
Coupled log columns
along north side of struc-
ture; note moss at inter-
section of column bases.
Photo by Herbert Daw-
son, November 2007.

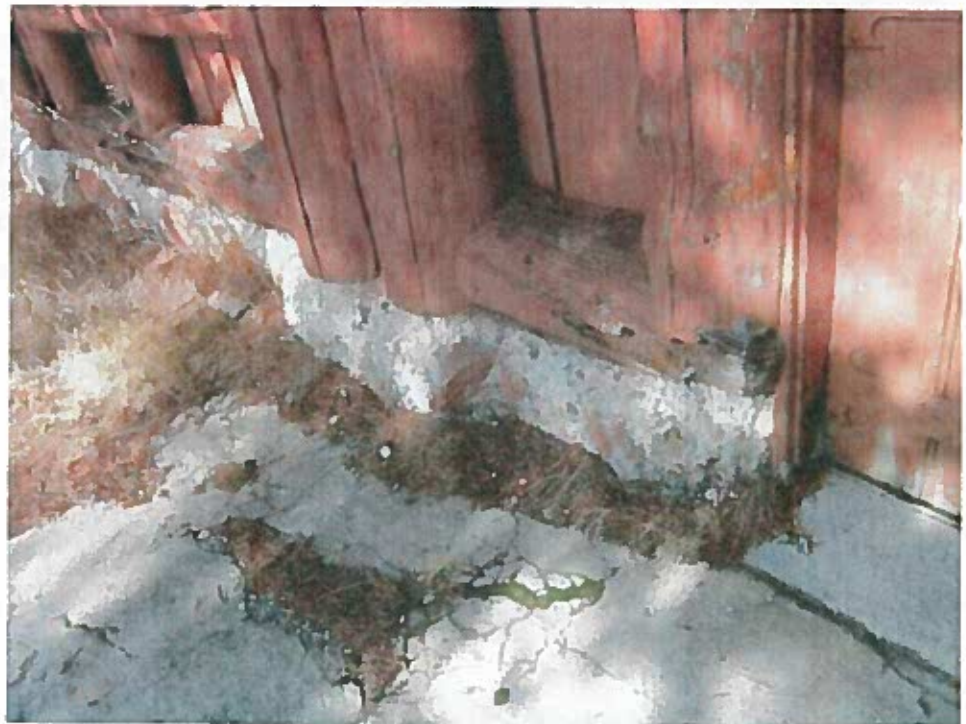
Coupled log columns
along south side of struc-
ture; columns are in fair
condition although sill log
and concrete are badly
deteriorated. Photo by
Herbert Dawson, Novem-
ber 2007.

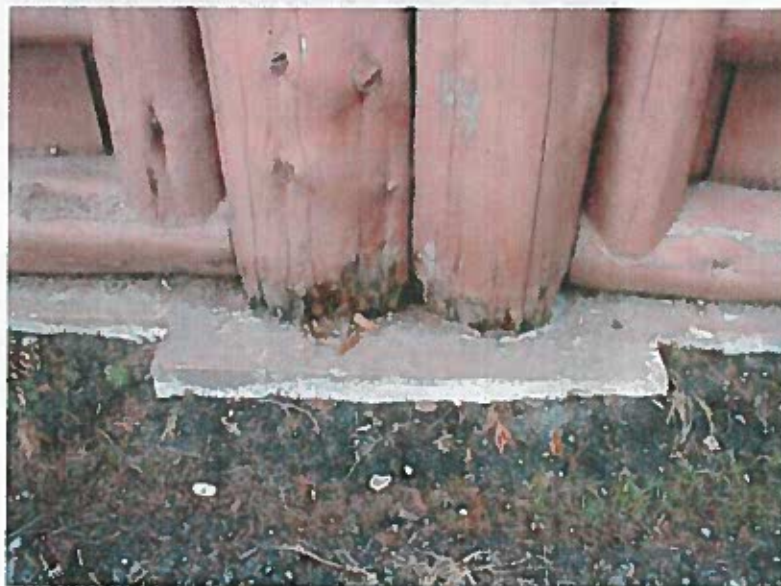
Additional coupled log columns along north side of structure; column bases are badly deteriorated; see text for repair/ replacement alternatives. Photo by Ken Sievert, November 2007.

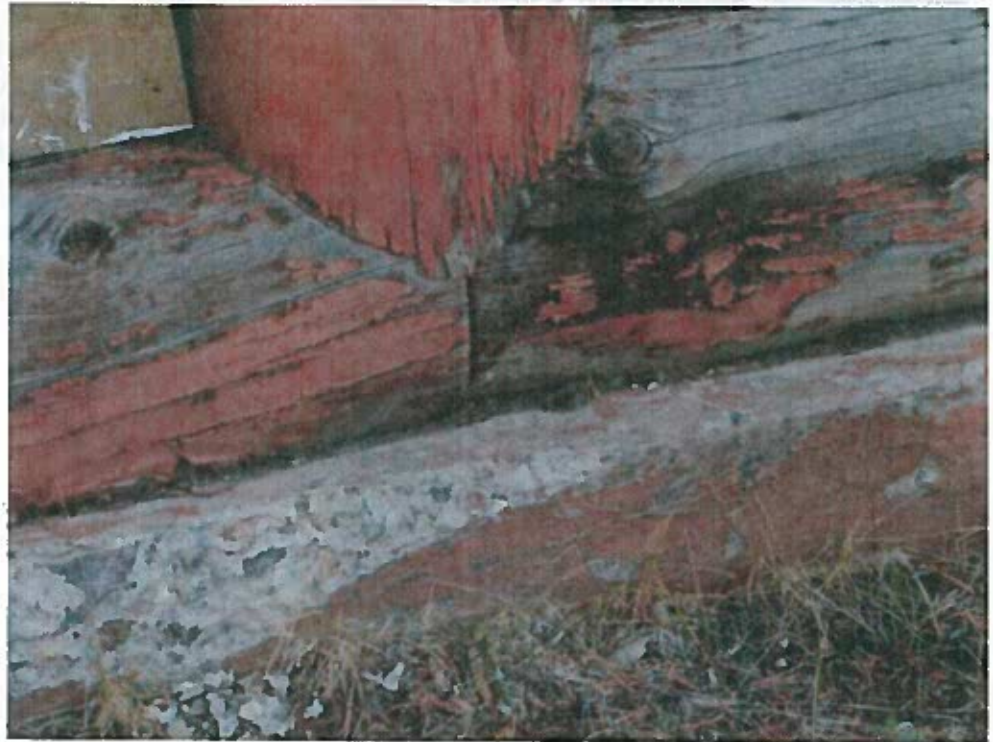
Sill log detail showing condition where sill log extends beneath secondary log wall column; a high degree of craftsmanship is visible where column logs are coped over sill members. Photo by Herbert Dawson, November 2007.

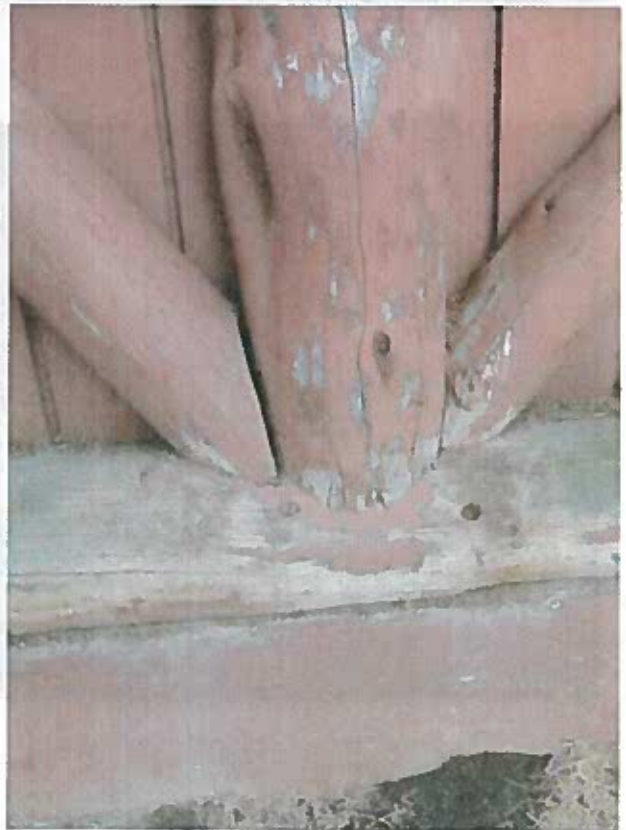
Log joinery where sill, column, and log braces intersect. All members appear to be in fair condition at this joint although unprotected and without sealants at joint locations. As noted in the caption above these members have been carefully fitted. Photo by Herbert Dawson, November 2007.

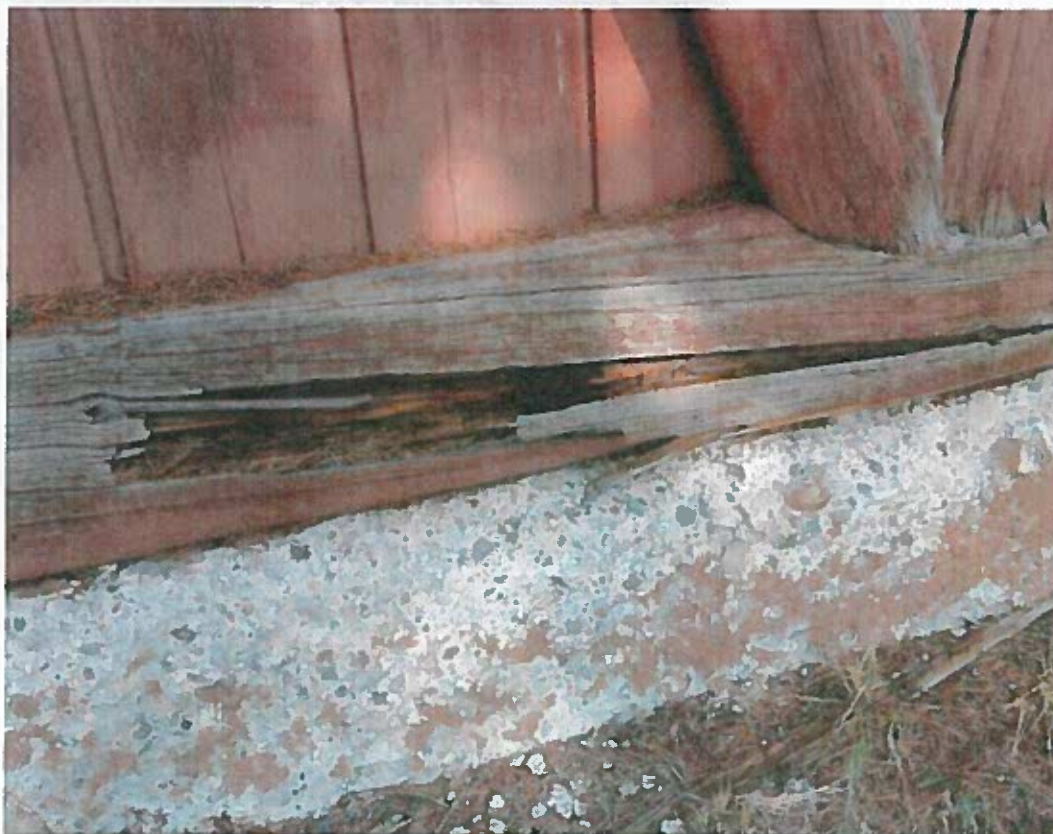
Deteriorated sill log adjacent to corner condition shown in photograph above. Exposed concrete is also severely weathered at this location. Photo by Herbert Dawson, November 2007.

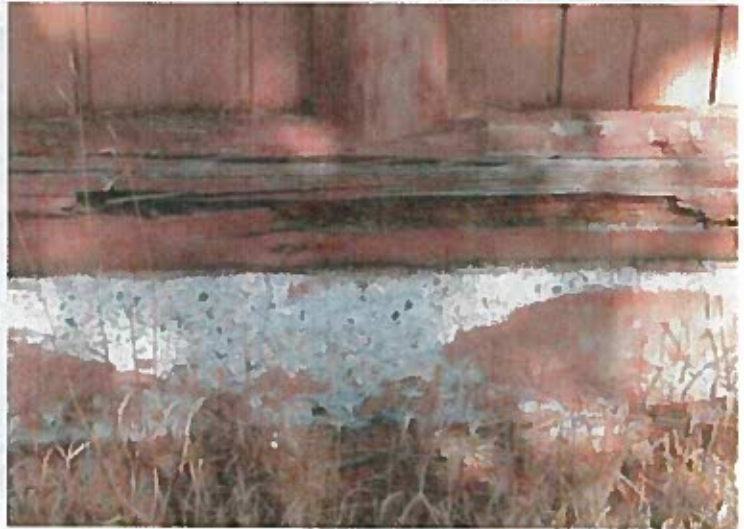
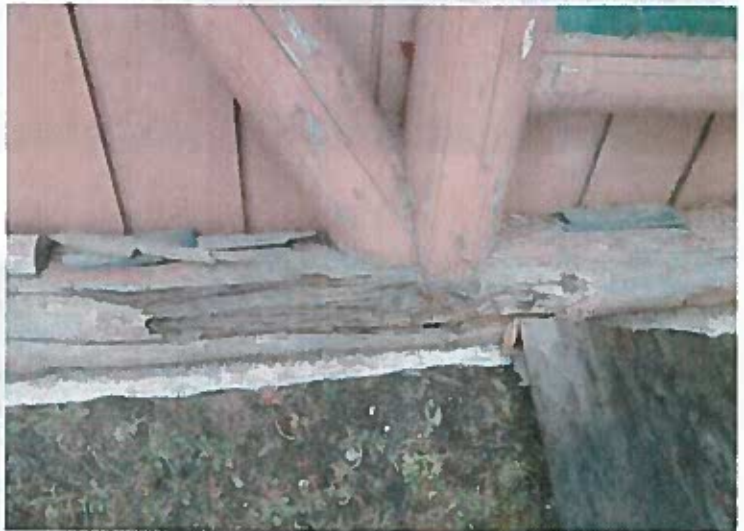
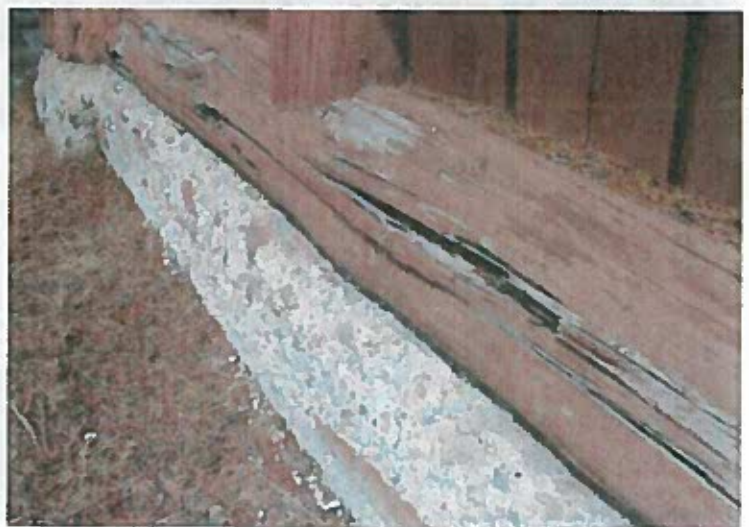
Additional examples of deteriorated sill logs around the perimeter of the structure. Although the reasons for the conditions are not readily apparent, the log column bases are the most severely deteriorated along the north (shoreside) wall of the structure and the sill logs are most severely deteriorated along the south (lakeside) of the structure. Photo by Herbert Dawson, November 2007.

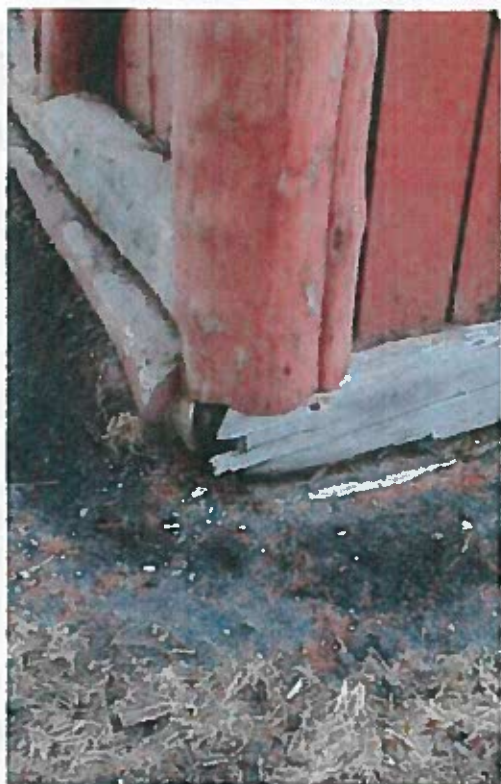
Sill log condition at the northwest corner of the structure. The concrete sub-structure steps up 12" +/- at this location and that the lower sill log turns the corner for the width of the foundation wall. Photo by Ken Sievert, November 2007.

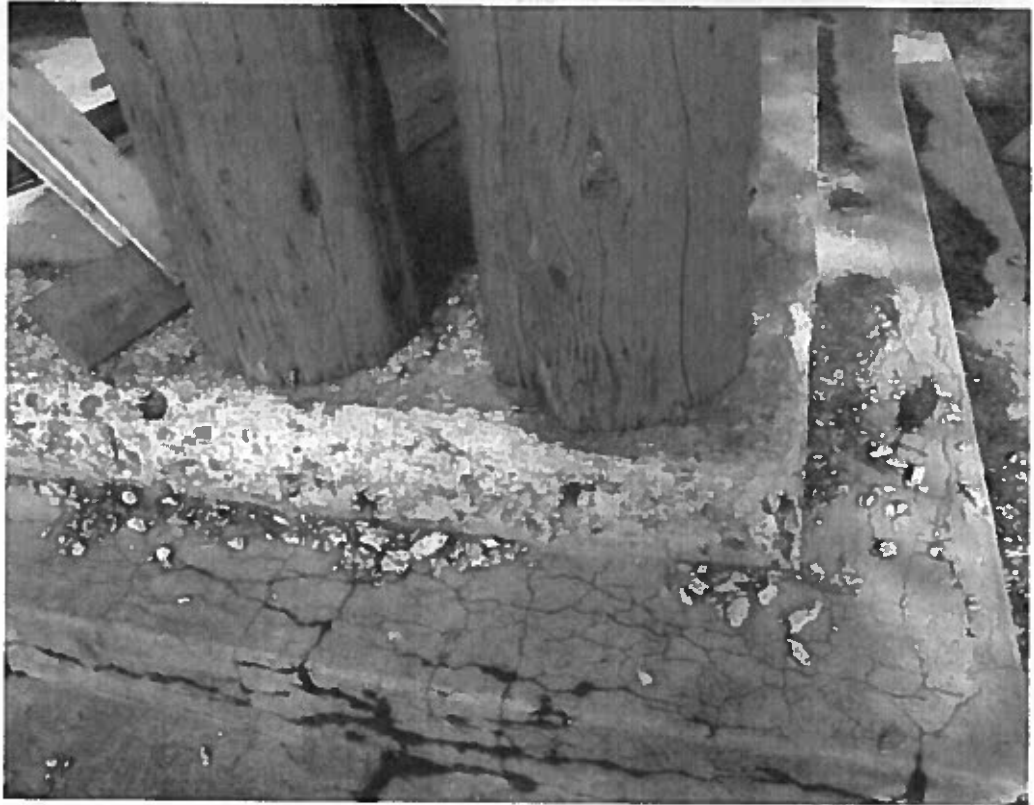
Additional photo at same location; note alligatoring in concrete surfaces on both horizontal and vertical faces. Moss is growing in the cracks further accelerating the deterioration. Photo by Ken Sievert, November 2007.

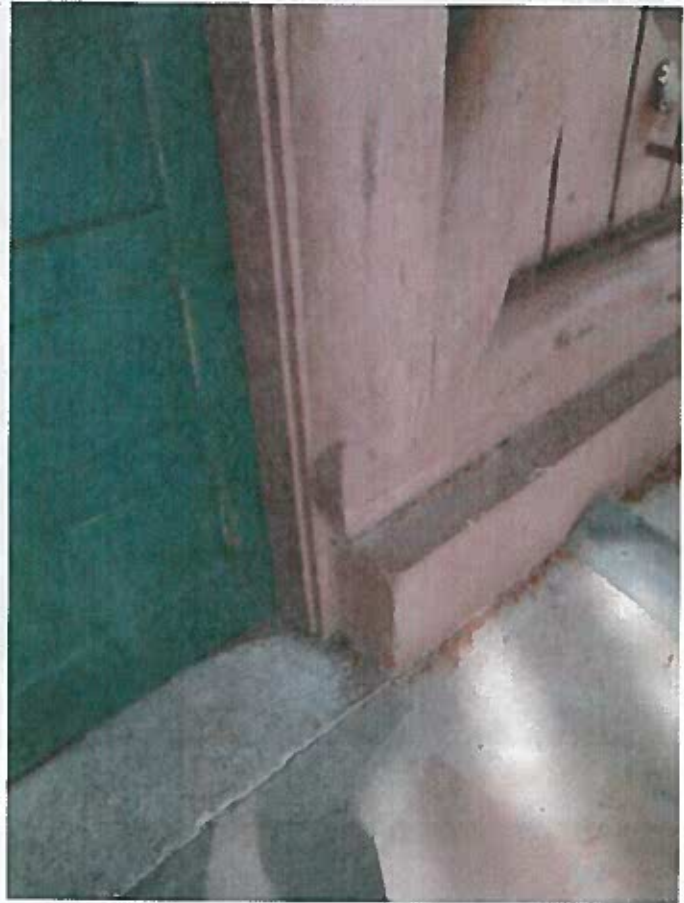
Note the crispness of the concrete forming on the perimeter grade beam. Photo by Ken Sievert, November 2007.

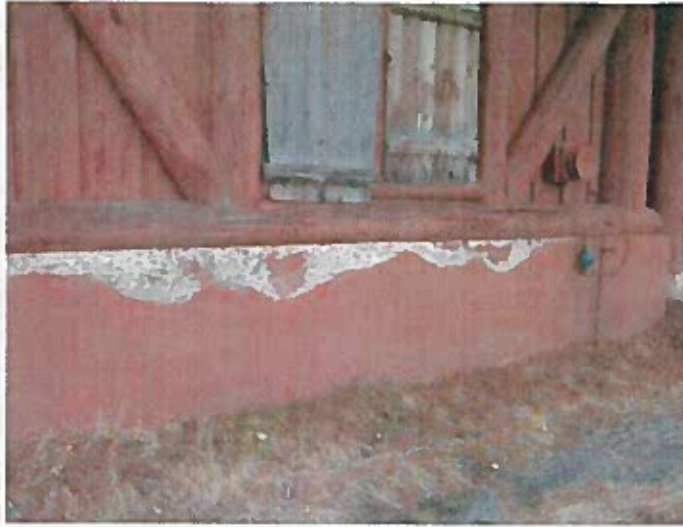
Concrete stem wall along the south side of the office area of the hatchery (located in the center 1/3 of the south elevation). The upper part of the wall is beginning to show significant deterioration from weathering and will require intervention soon if it is to be preserved. Photo by Herbert Dawson, November 2007.

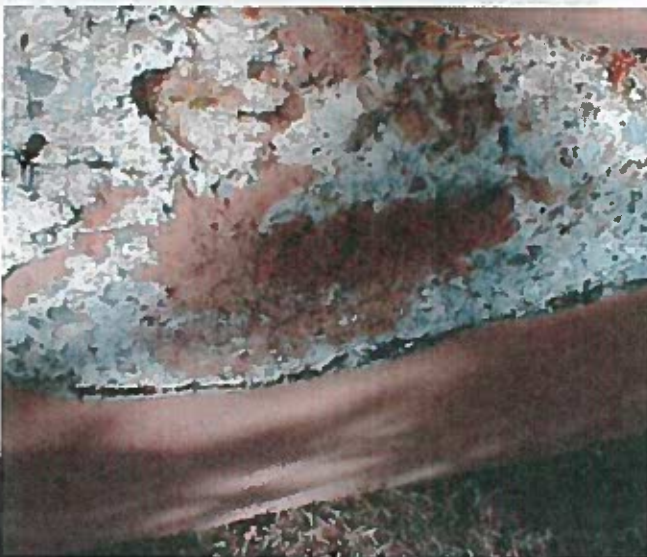
In this photo of the same wall the paint layer is acting as a mechanism to trap moisture against the face of the concrete and the paint may actually be accelerating the deterioration of the hardened face of the concrete. The concrete used in this structure was not air-entrained and is more vulnerable to freeze-thaw cycles than air entrained concrete. Photo by Ken Sievert, November 2007.

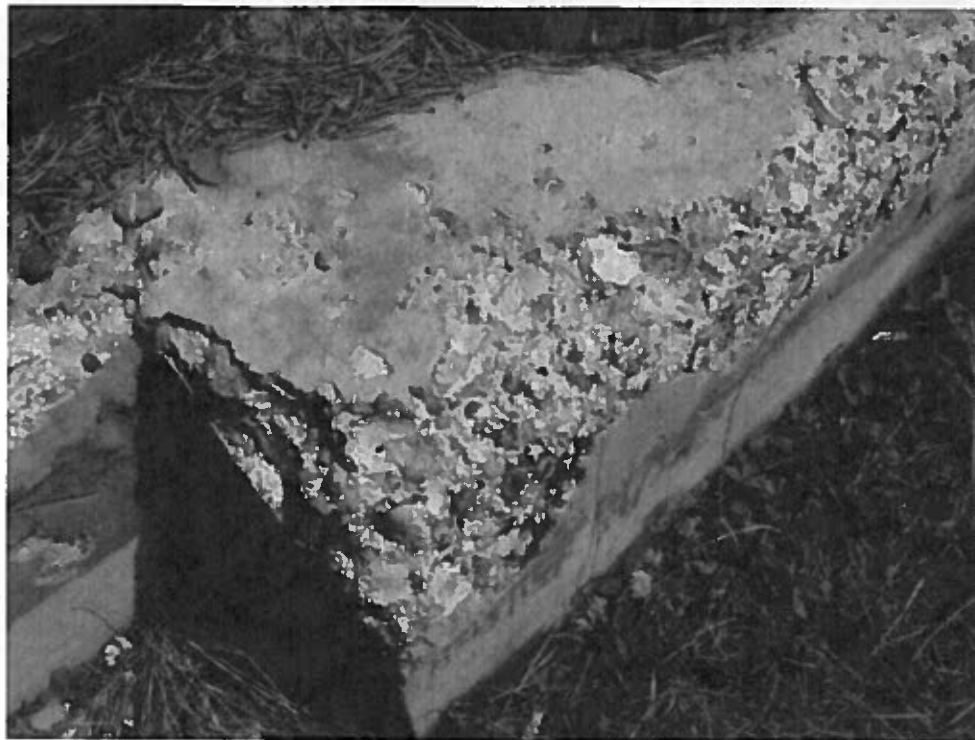
Steps and edge grade beam along the south side of the entrance terrace. Deterioration is advanced in these concrete elements, particularly within the steps. Photo by Ken Sievert, November 2007.

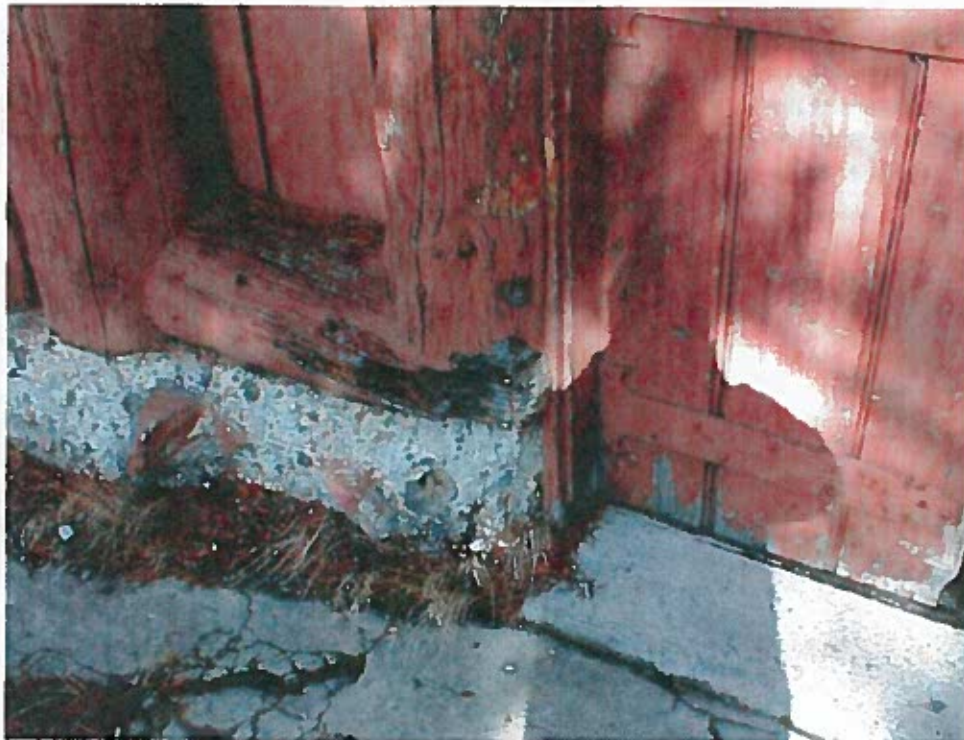
Concrete deterioration adjacent to the side entry doors into the hatchery raceway area. Concrete at this location is in an advanced state of deterioration and is becoming soft and "punky." Photo by Ken Sievert, November 2007.

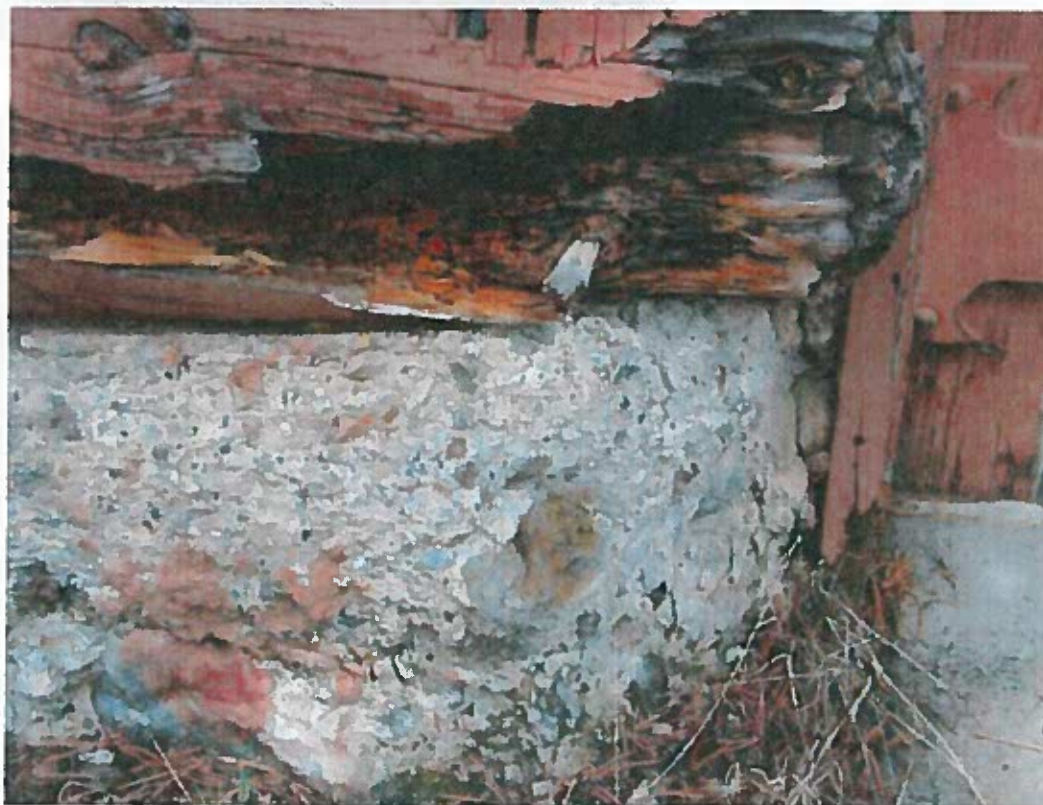
Detail of location in photograph above. Note that there is some very large aggregate within the concrete mix. Photo by Herbert Dawson, November 2007.

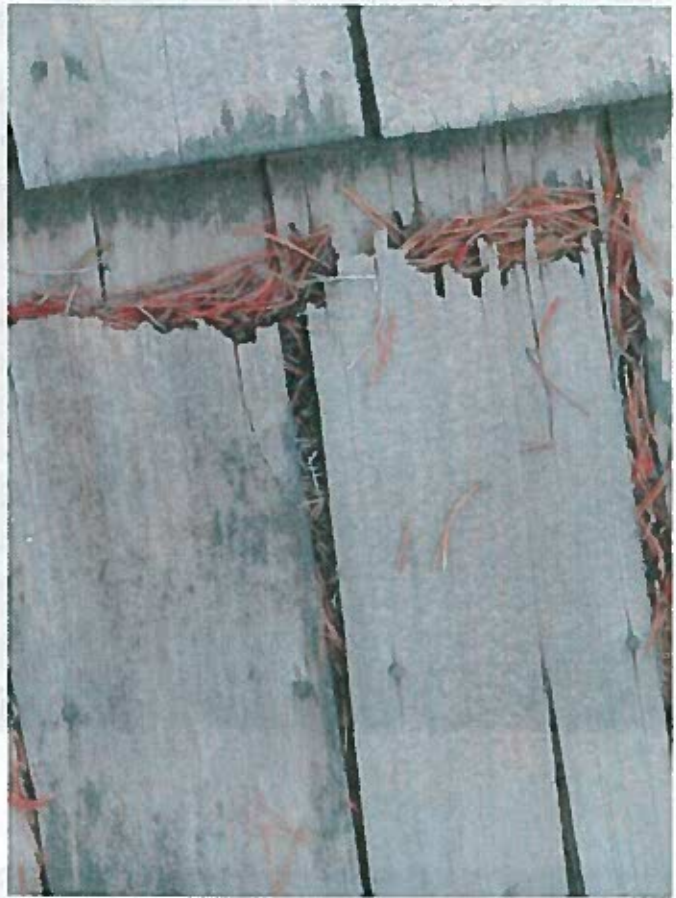
Similar to photo above.
Remnants of NPS green
shingle stain can be seen on
some of the shingles. Photo
by Herbert Dawson, Novem-
ber 2007.

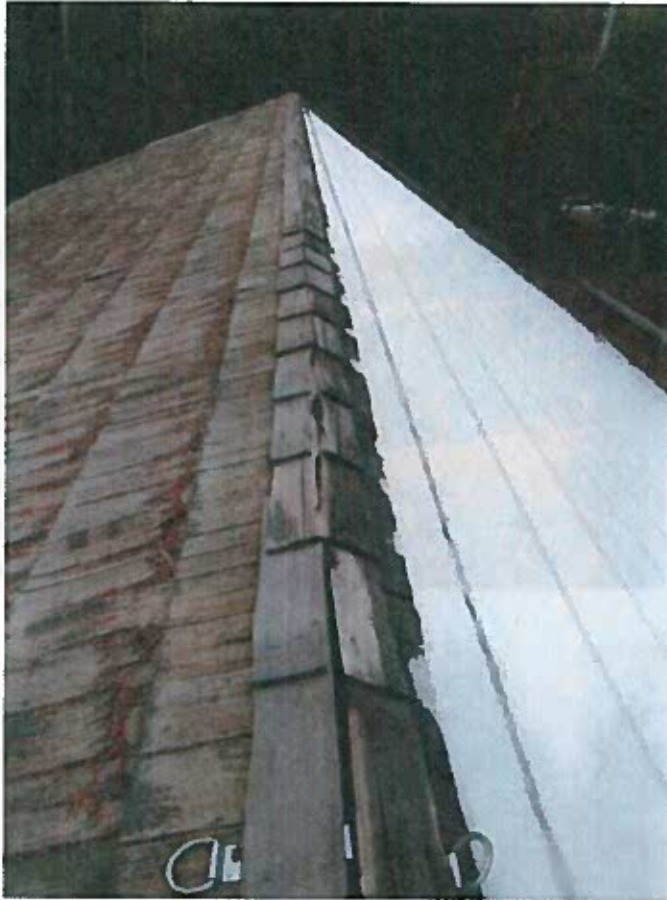
Condition of roof shingle ridge; it appears that the lap was intended to be a Boston Lap although the gap at the ridge is inordinantly large. Note the deteriorated shingles midway down the ridge. Tie-offs for ropes can be seen at periodic intervals along the length of the ridge. Photo by Herbert Dawson, November 2007.

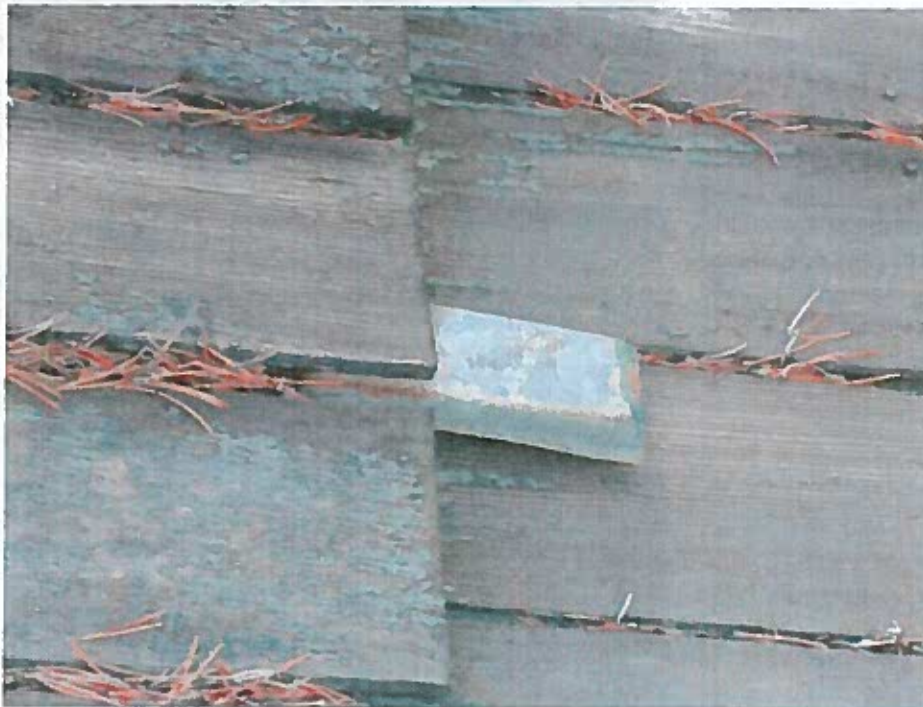
Metal tab from a previous roof repair. Photo by Herbert Dawson, November 2007.

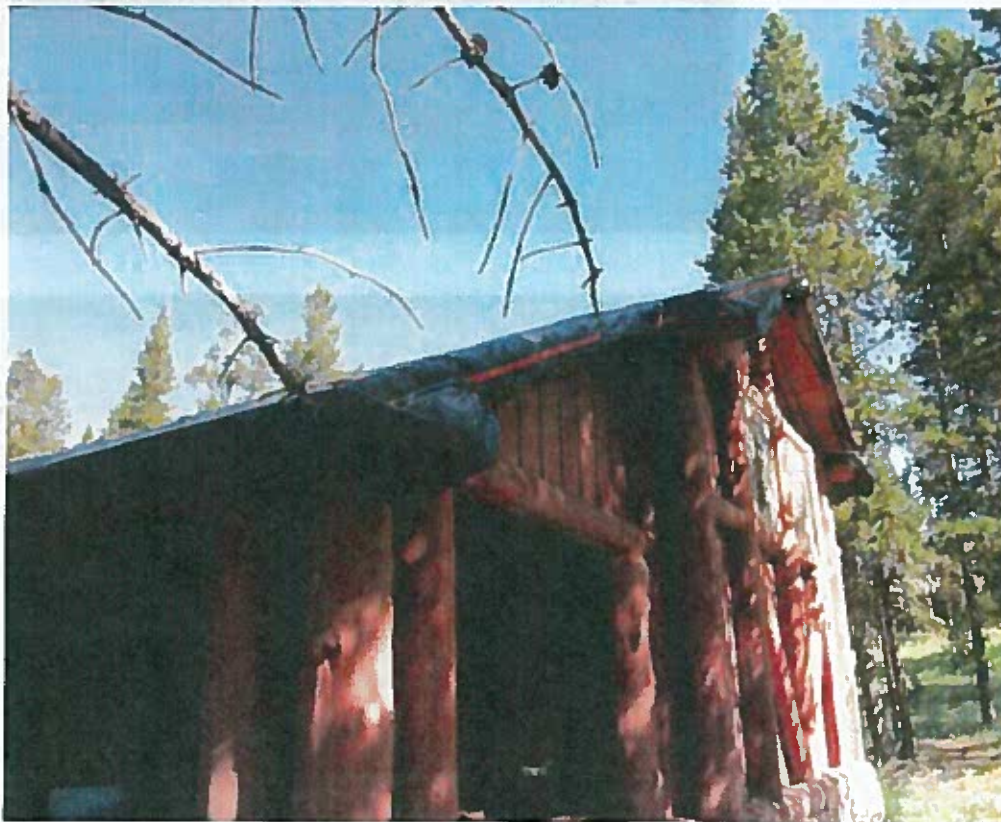
Similar to above photograph—as a footnote, the temporary roofing has exhibited significant failure in the intervening time between May 2006 and when the facility was reviewed in Nov. 2007. Photo by Herbert Dawson, November 2007.

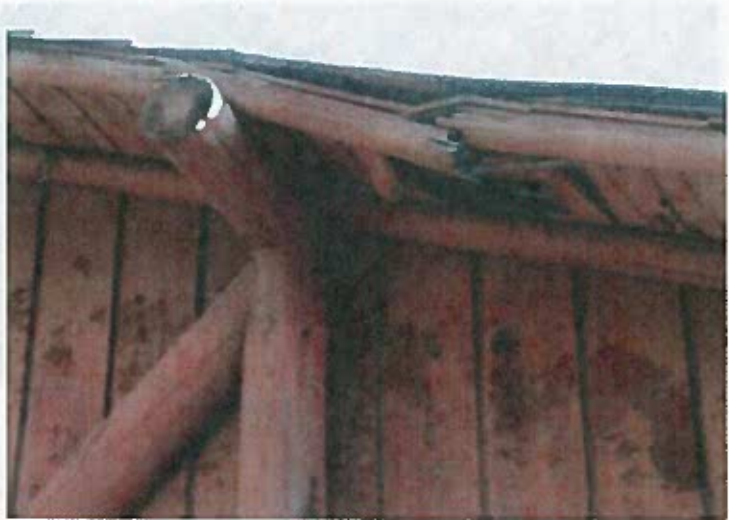
Condition of rafter tails along edge of roof—all rafter tails exhibit deterioration and require repair or replacement (see text). Photo by Herbert Dawson, November 2007.

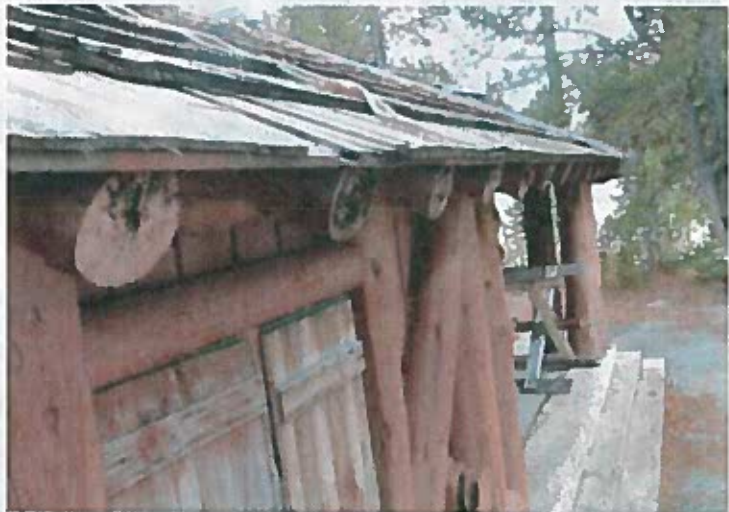
Soffit areas (underside of edge of roof) exhibit peeled paint, minor weathering, and areas of "spongy" wood. Replacement of some edge sheathing will be required. Photo by Herbert Dawson, November 2007.

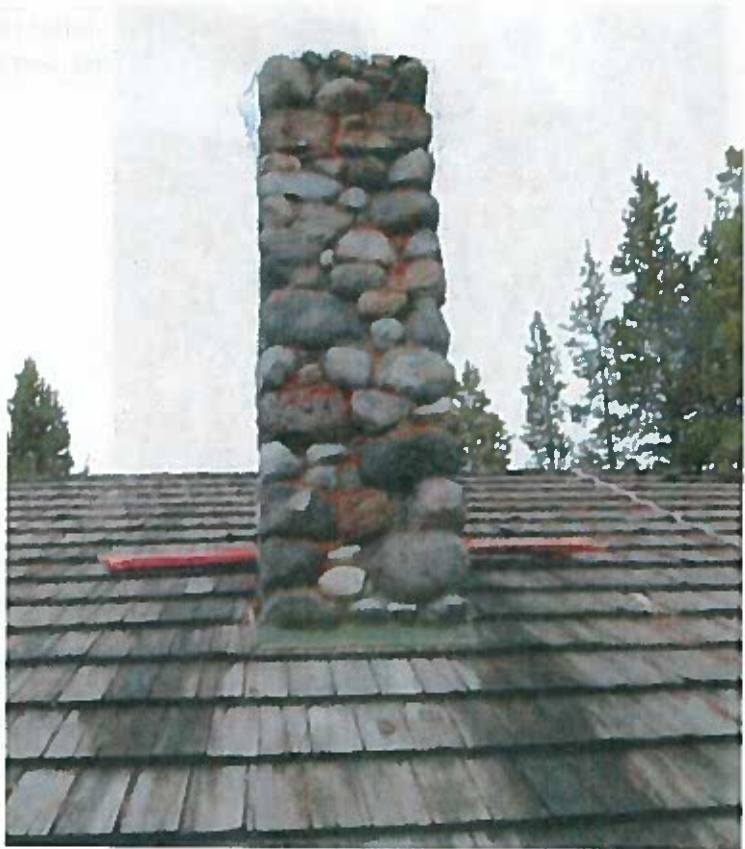
Bird/squirrel protection wire at top of chimney. A more permanent protection system is recommended at the time that the roof is replaced. Photo by Herbert Dawson, November 2007.

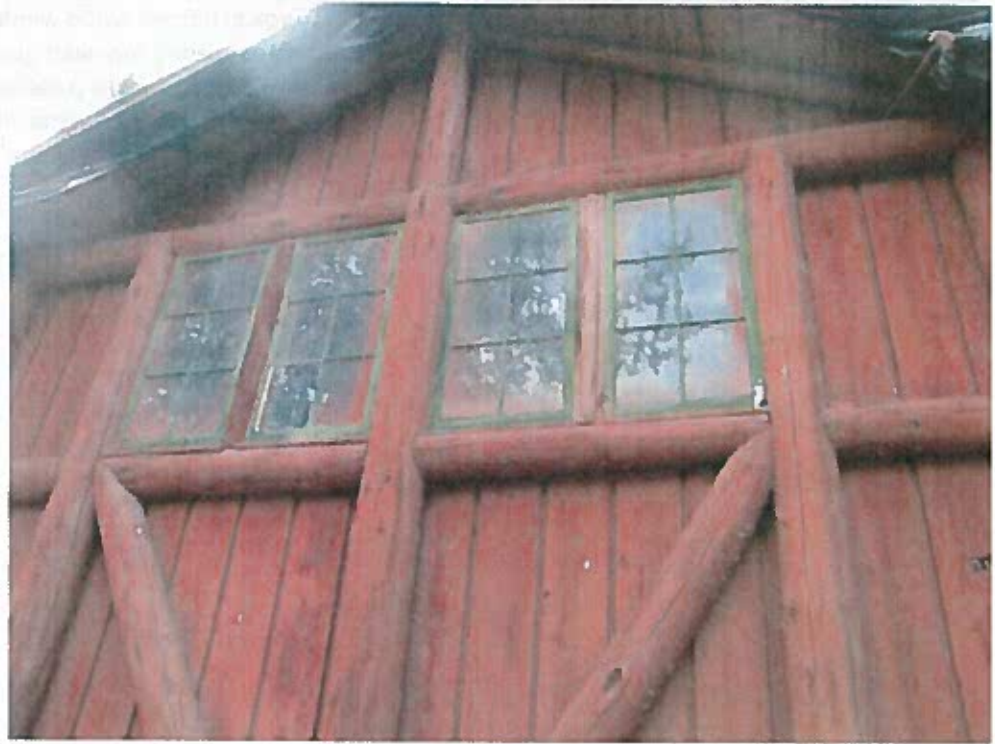
Wood shutters have deteriorated or have been replaced with improvisational coverings. It is recommended that they be replaced including the attachment hardware. Photo by Herbert Dawson, November 2007.

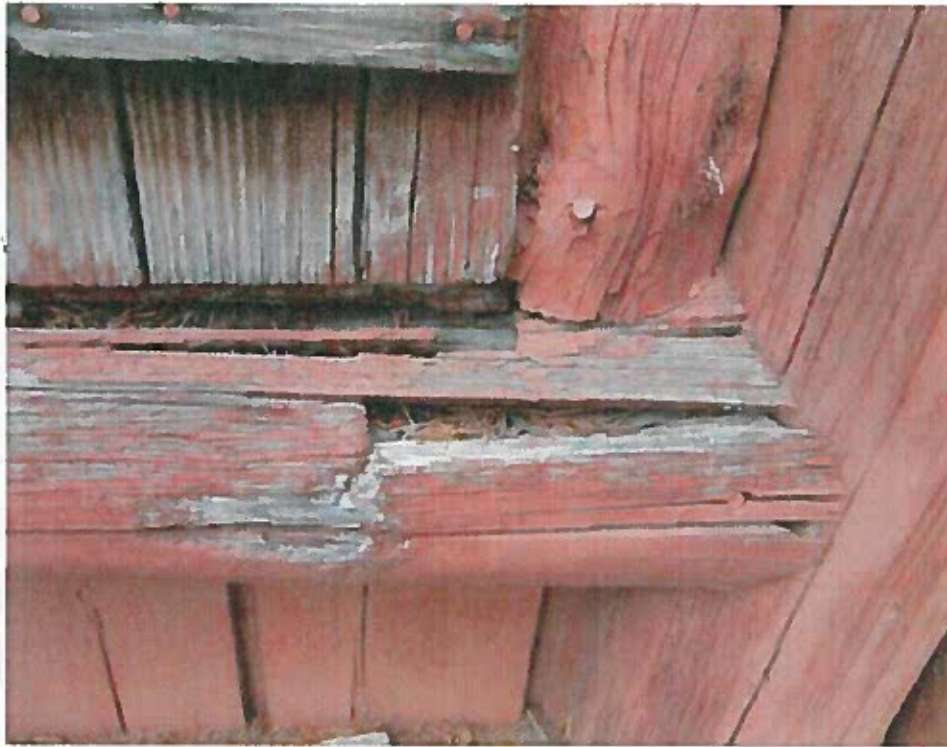
Window sill log that requires replacement. Note that dimensioned lumber sill plate for window is also partially missing. Photo by Herbert Dawson, November 2007.

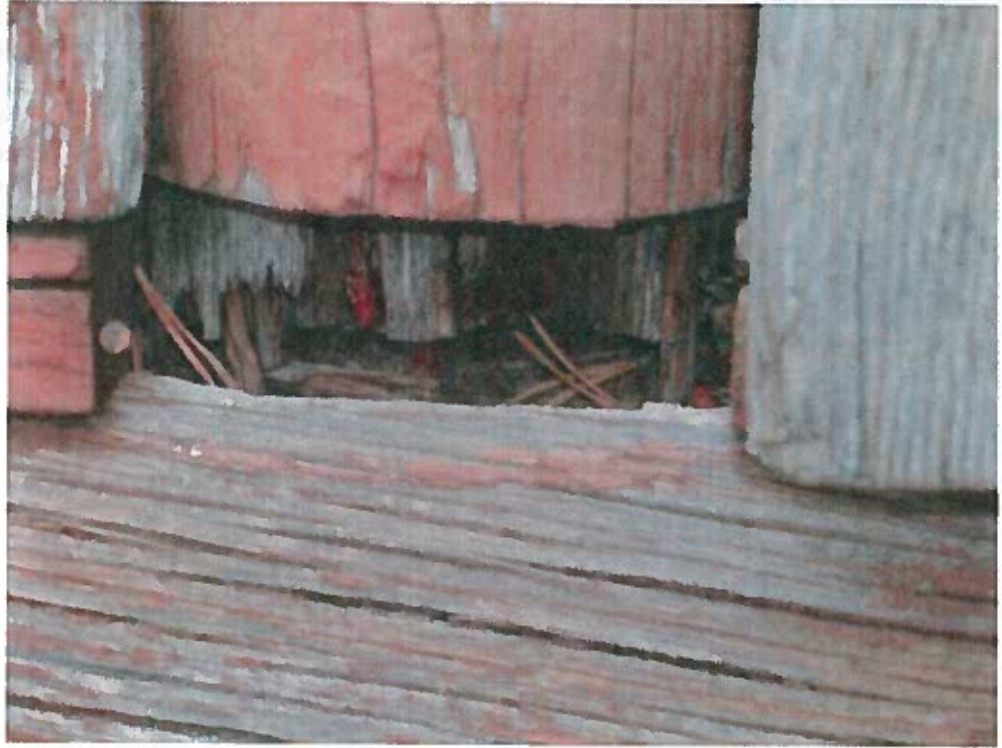
Window with trim piece described above in-situ. Due to the small size of the trim piece and difficulty of achieving mechanical connection, this detail may require re-evaluation. Photo by Herbert Dawson, November 2007.

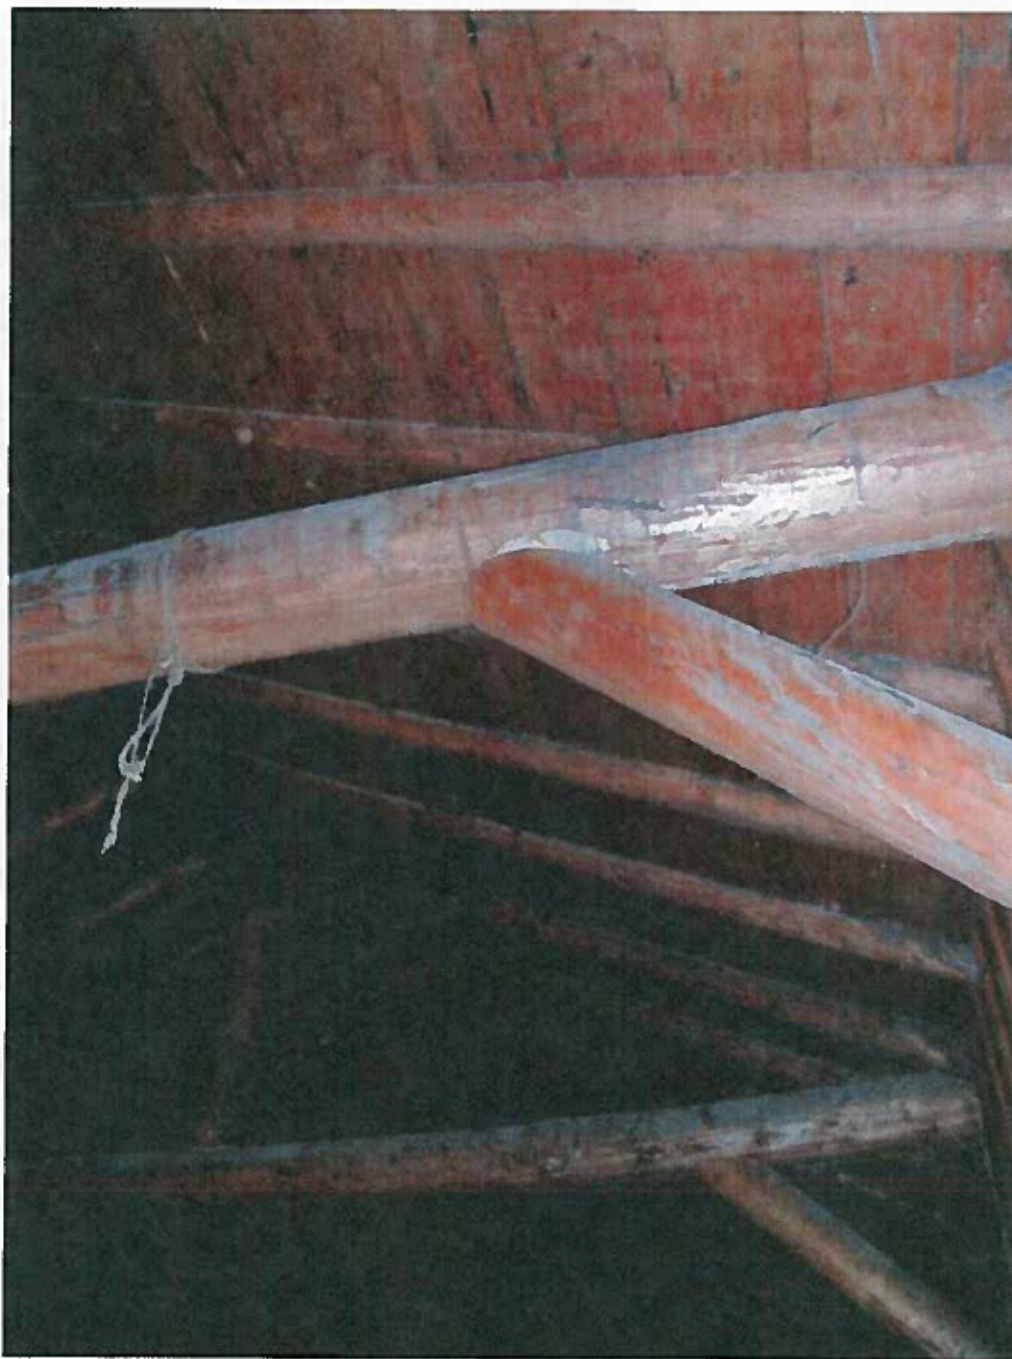
Knee brace details at the aquarium King-post truss; note that these braces were nailed only and that this brace has slipped out of position and requires (minor) repair and stabilization to be effective. Photo by Herbert Dawson, November 2007.

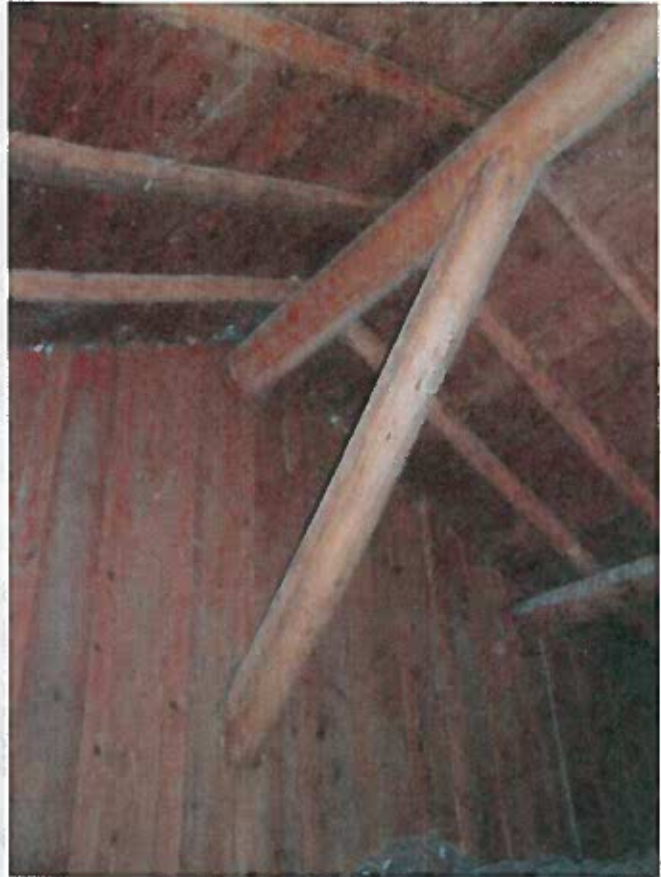
Knee brace detail between the roof ridge purlin and one of the King-post trusses. Note that this bracing detail occurs at only one location (near the balcony) and that the brace connection is totally reliant on nailing. Photo by Herbert Dawson, November 2007.
