HISTORIC STRUCTURE REPORT
HAMILTON / LAKE GENERAL STORE
Yellowstone National Park

June 26, 2008

HAMILTON STORE, YELLOWSTONE LAKE

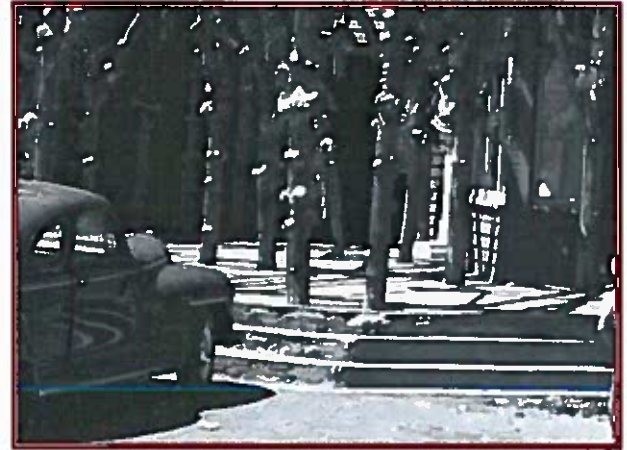
This c.1950 photograph shows the spalled steps of the concrete entry deck before the 1954 repairs. Photograph courtesy of the National Park Service, Yellowstone National Park, YELL #30089.

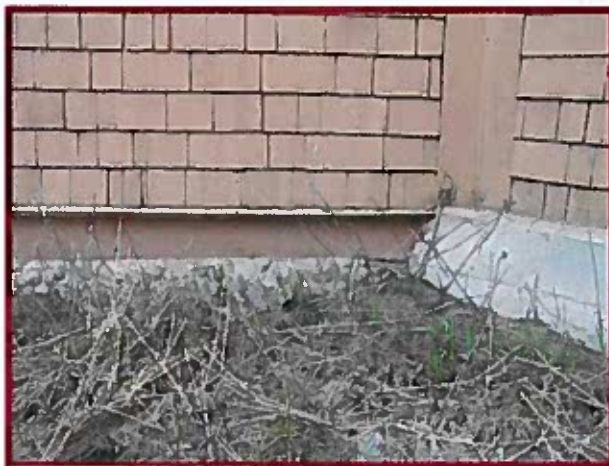
Condition: Where the watertable remains, it is generally in good condition. The protective paint coating is typically worn – often to bare wood – warranting preparation and repainting of the watertable and cap. Along the east end of the east wing, the cap has split with the grain and is falling away from the wall.

Inside corner where the west wing meets the north. Original watertable and stone facing at the left; concrete facing without watertable on the right.

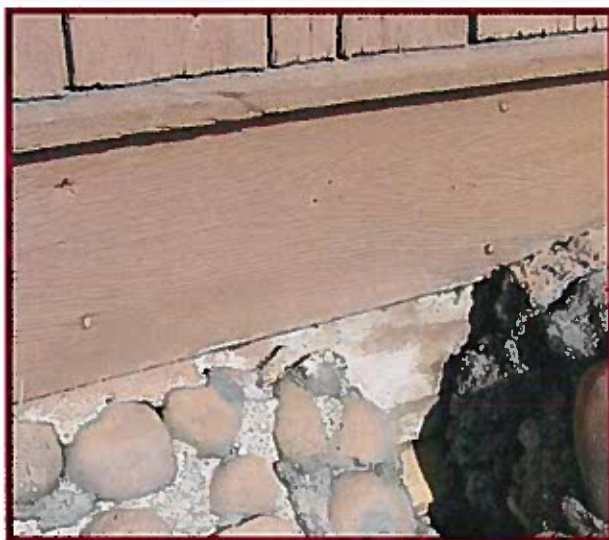
East end of east wing, 2007. Watertable is split.

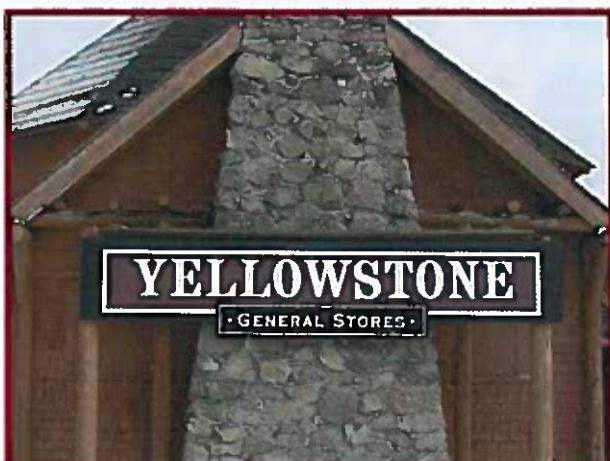
Condition: The logs are generally in good condition. At the bearing points – as noted above – some of the columns has shifted off the concrete base, and all have wicked up moisture. The log beams at the chimney end are rotting from excessive moisture, probably coming with the prevailing winds off the lake.

The log beams at the chimney end have deteriorated from moisture penetration.

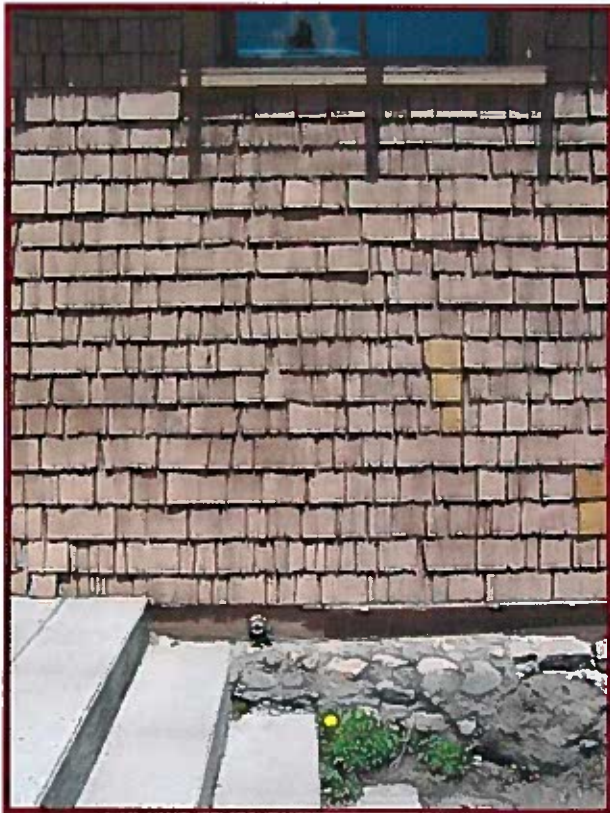
The shingles at the south wall of the east wing are heavily worn and loosening.

Recommendations: Replace the thin and warped shingles. Refasten or replace the shingles that have slipped. New shingles shouldn't be wider than 6", in order to prevent warping. If wall surfaces are replaced for structural reasons, integral flashing should be installed at the windowsills.

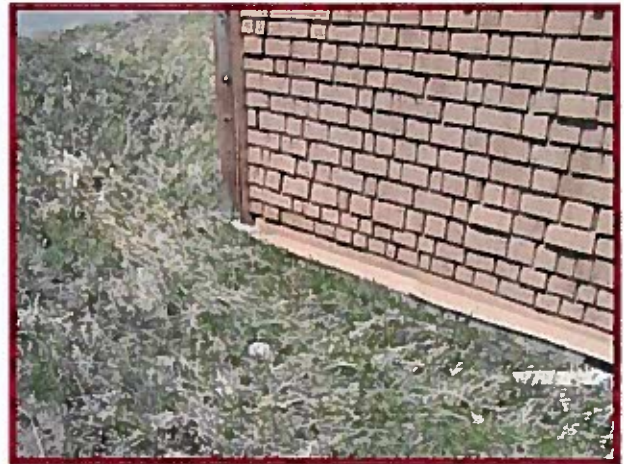
Close-up of new shingles at south wall of west wing. The wider shingles are warping.

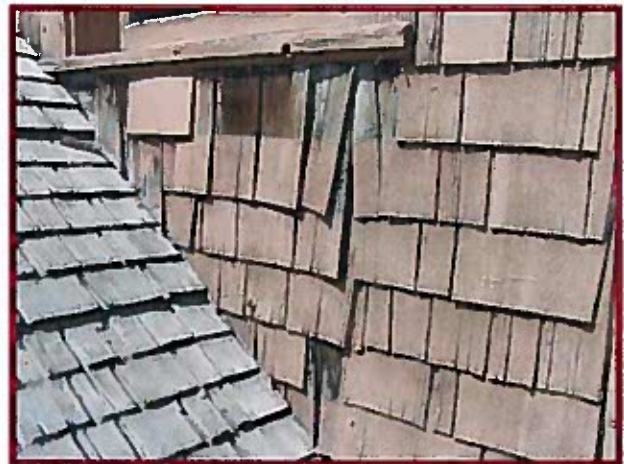
The shingles on the walls beneath the windows are typically deteriorated, if they haven't been replaced. The windowsills are not flashed.

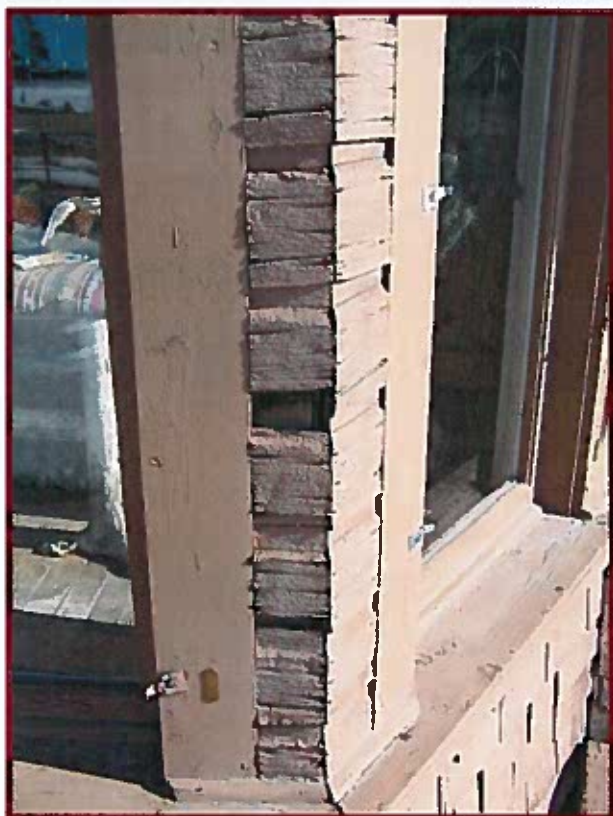
The degradation of the novelty siding at the east window bay is typical for both bays.

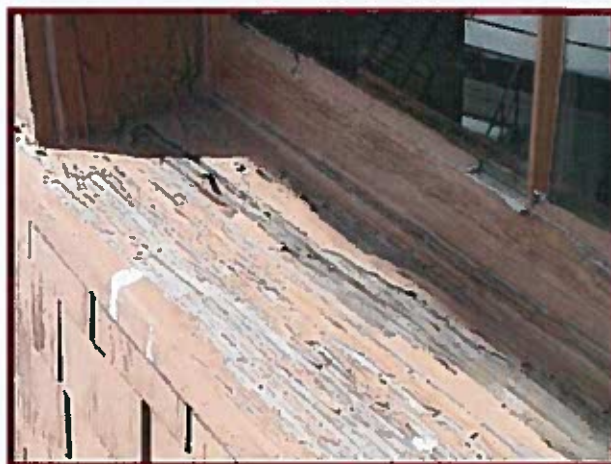
Several of the windowsills are degraded to bare wood and lignin. The windowsills of the clerestory were not typically accessible for inspection.

Windowsill at clerestory above south wing, showing typical sill, sash, and putty deterioration.

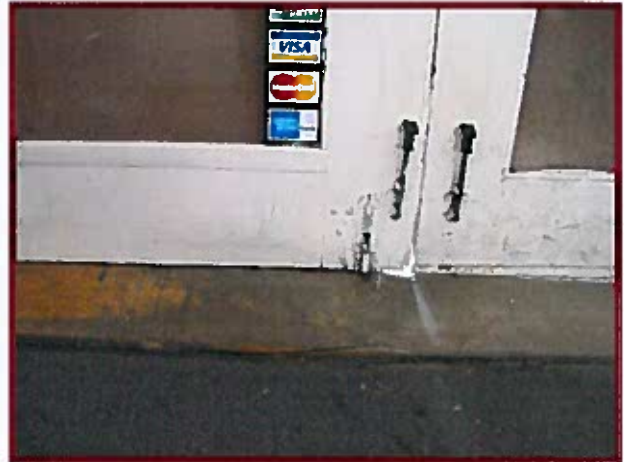
The bottom rail of the entry doors are scuffed from toe kicks, and the joint has been refastened.

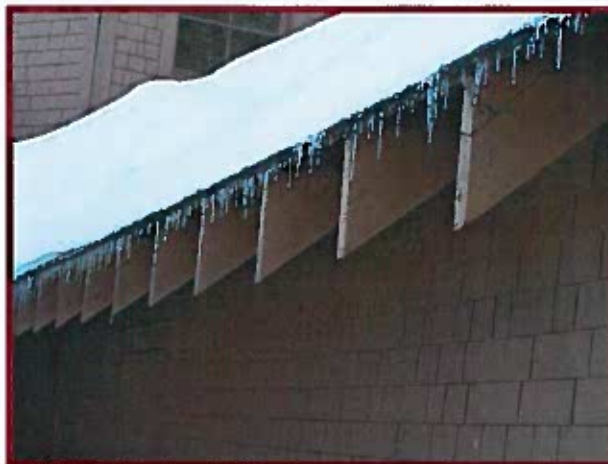
Exposed rafter tails at the north side of the west wing, where some of the tails are split.

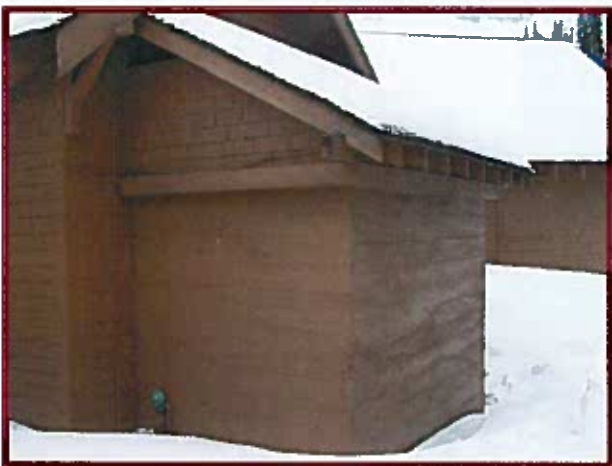
The vault's shed roof framing is supported on a beam, the ends of which are rotting. The fascia of the office wing is seen in the upper right.

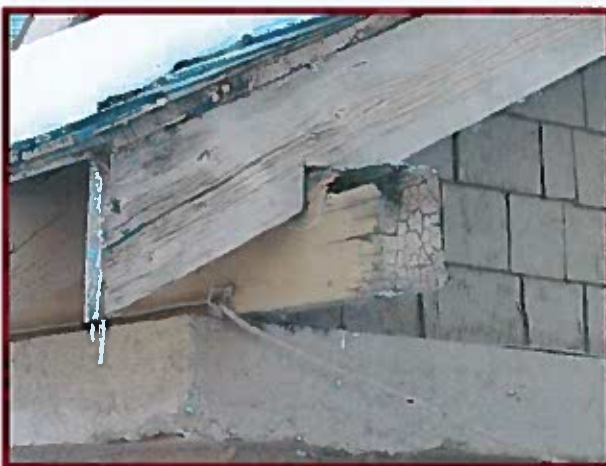
The end grain of the support beam at the concrete vault has rotted from snow and water.

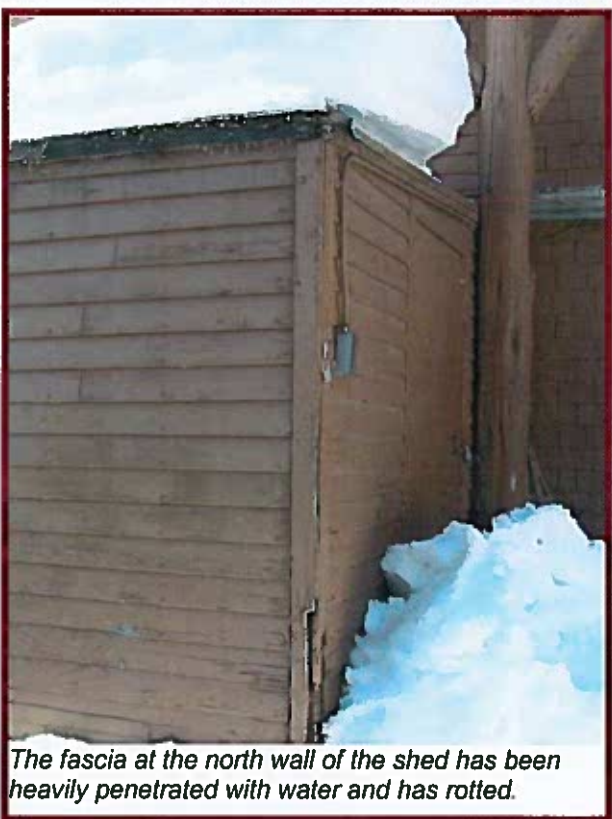
The fascia at the north wall of the shed has been heavily penetrated with water and has rotted.

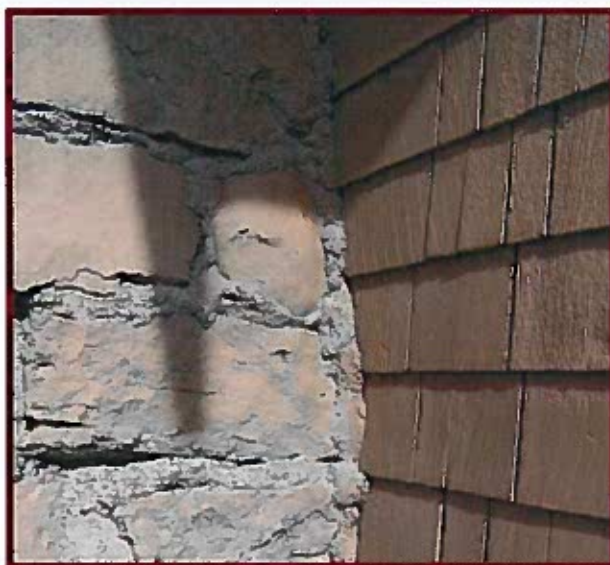
Some of the chimney stone has been overpainted.

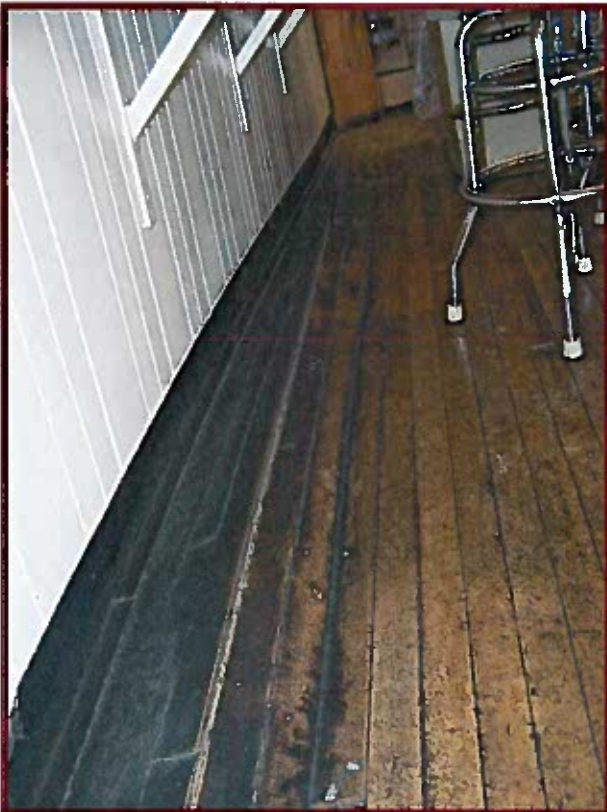
The flooring along the south wall of the Snack Area has buckled 2-1/2".

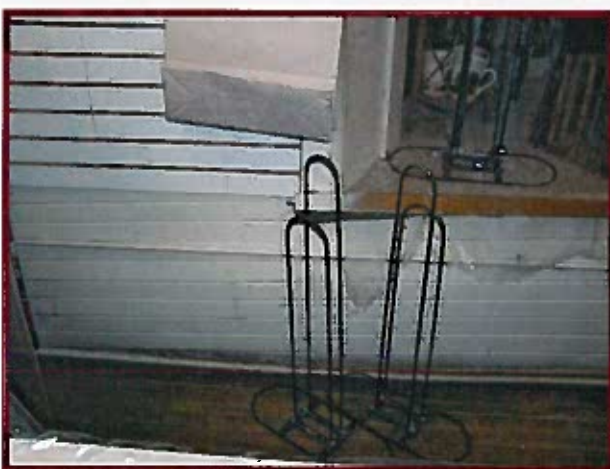
The floor slopes down from left to right, below the south bay window.

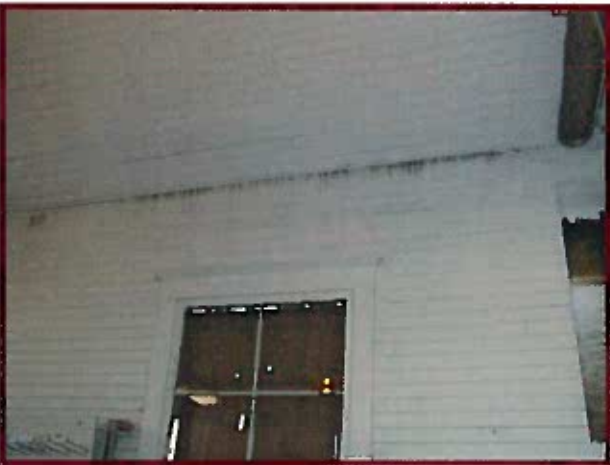
The south wall of the west wing is stained from roof run-off.

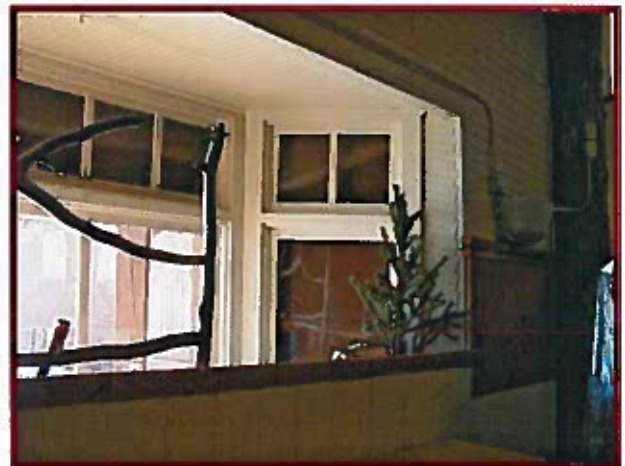
The beadboard and the window at the west side of the east bay slopes down toward the room.

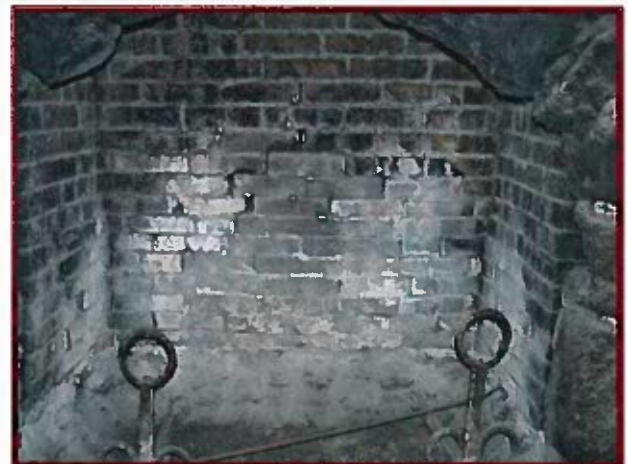
The mortar joints in the firebrick are open along the lines of the crack.

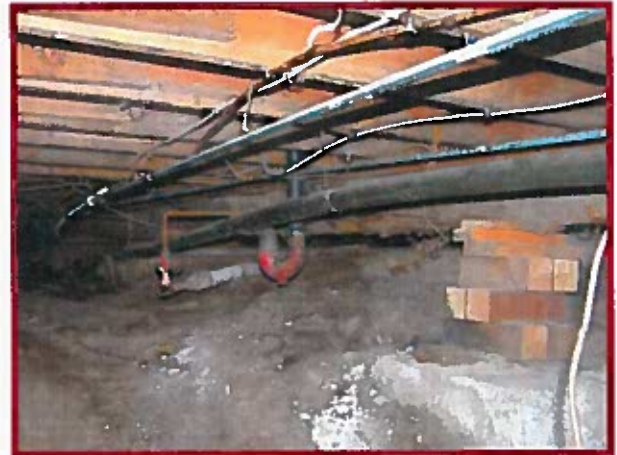
Interior supports for the beams in the crawlspace are not stable, nor reliable.
