HISTORIC STRUCTURE REPORT

NICHOLS RESIDENCE Mammoth, Wyoming

August 5, 2008

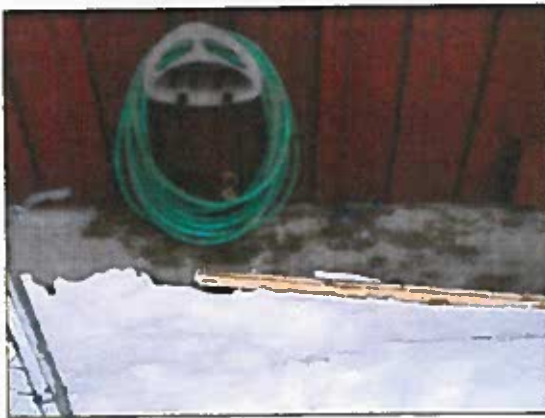
With two exceptions that follow, the majority of the watertable is in excellent shape. There are also isolated locations of minor cracking. The watertable at the inside southwest corner at the building (at Gridline intersection 2C) is level with grade and subject to much water penetration. The resultant spalling exacerbates the deterioration. It appears that this inside corner is at a lower elevation than the hill that rises to the south and west. In addition, the watertable along the east wall of the Kitchen wing has water penetration as well – probably from a dripping hose bibb - resulting in spalling concrete and organic growth (not uncommon for a north-facing wall). The water penetration has rotted the end of at least one of the floor joists that bears on this wall.

Figure 64. Spalled concrete watertable at east wall of the Kitchen.

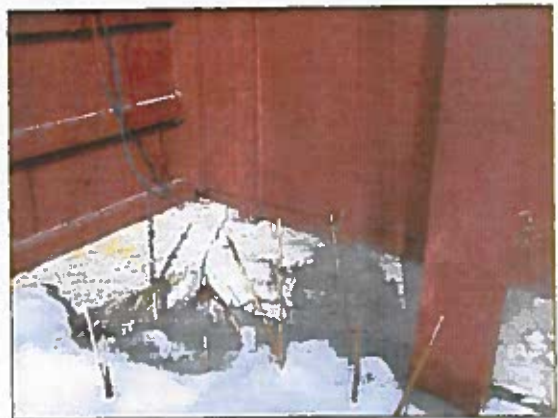
Figure 65. The top of the watertable at the southwest inside corner is spalling off the base. Due to excessive water and ice build-up at what is presumably a lowered grade.

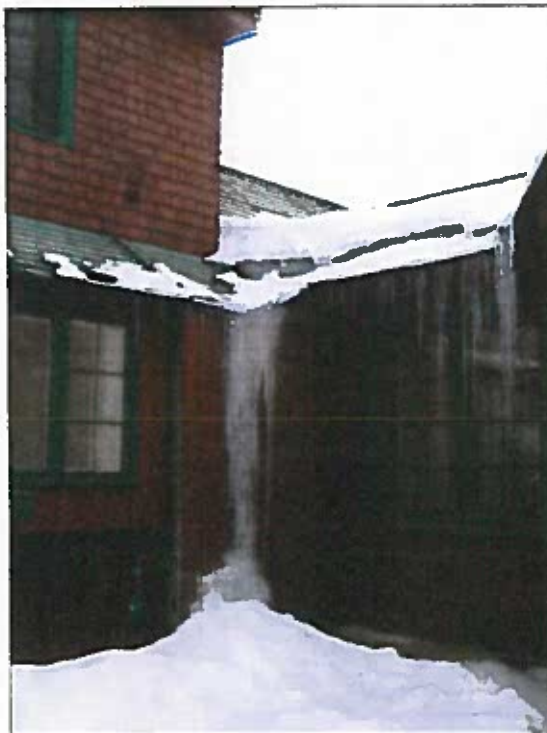
Figure 66. The interior southeast corner receives run-off, which freezes, from the roof.

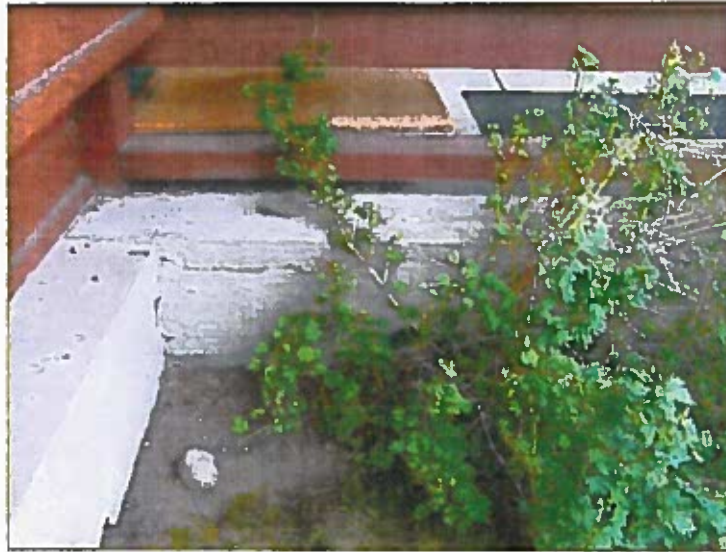
Snow and ice build-up occurs at all the inside corners where the roofs meet. The concrete watertable's top surface – where it extends from the face of the finish wall above - is typically spalling, due to entry of water which freezes and expands. During the winter season, snow and ice accumulate at and over the watertable. Excessive vertical ice build-up at the southeast corner prevents operation of the door to the exterior closet during the winter months. Ice build-up at the northwest corner is considerably less; yet is approximately 2"-3" thick.

Figure 67: Northeast inside corner of the watertable, with typical spalling of top horizontal surface of the concrete watertable.

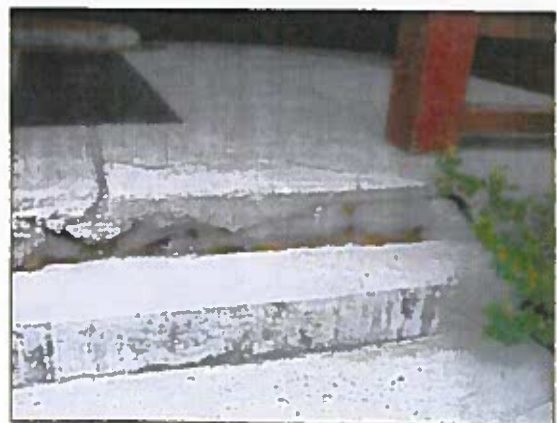
Figure 68: The front entry concrete is heavily spalled from freeze-thaw.

For long-term repair, the two deteriorated sections of concrete landing (two 4' x 5' sections) should be replaced for their full thickness and sealed with a clear penetrating breathable sealant.

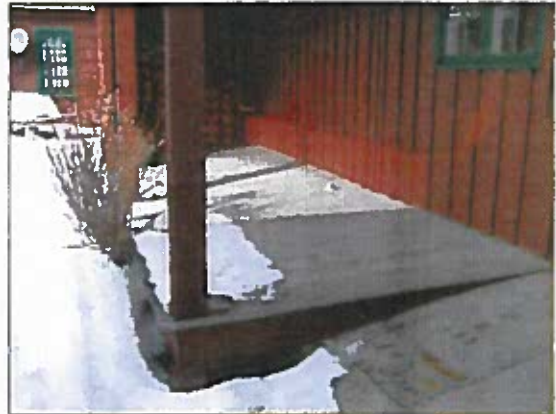
Figure 69: The west porch has an actively sloped floor.

Repaint the flooring of the west Kitchen porch. Replace the exit stairs from Corridor #105 with a landing and stairs more in keeping with the Craftsman style of the house.

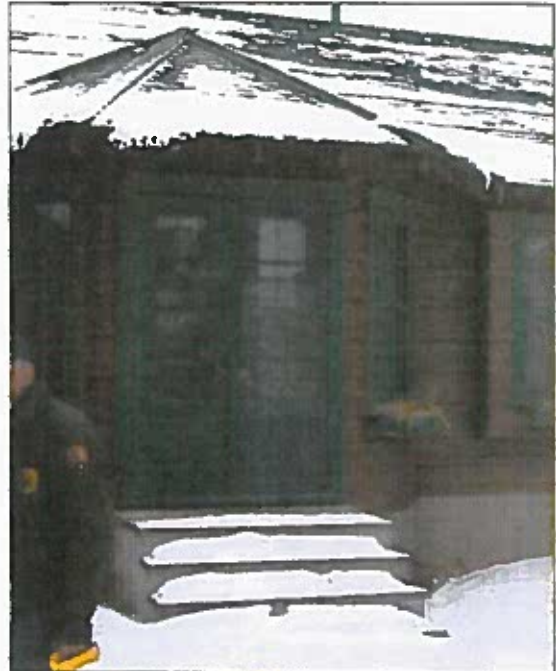
Figure 70: The exit stairs from Corridor #105 appear to be a temporary solution.

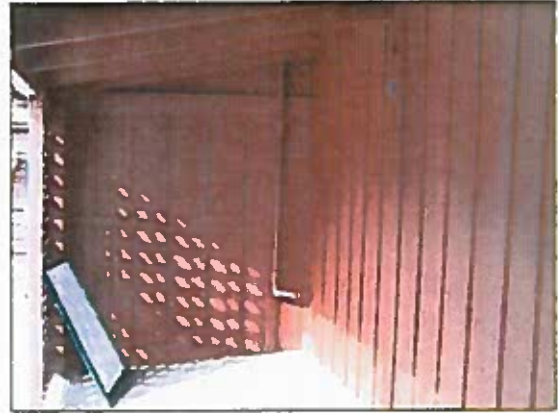
Figure 71: The west wall of the Kitchen has had a number of vertical boards and battens replaced; some were deteriorated, and some filled in prior openings.

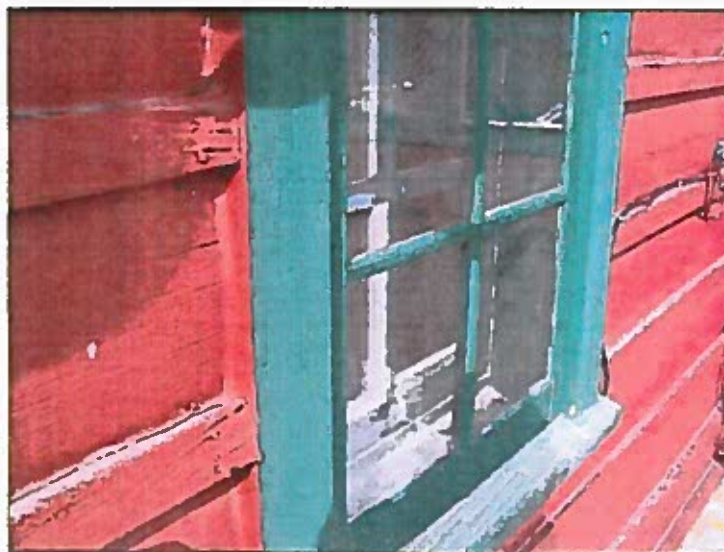
Figure 72: South wall of the west wing, where the wood has expanded and swelled due to moisture penetration and UV-degradation. This area has a shallow roof overhang above.

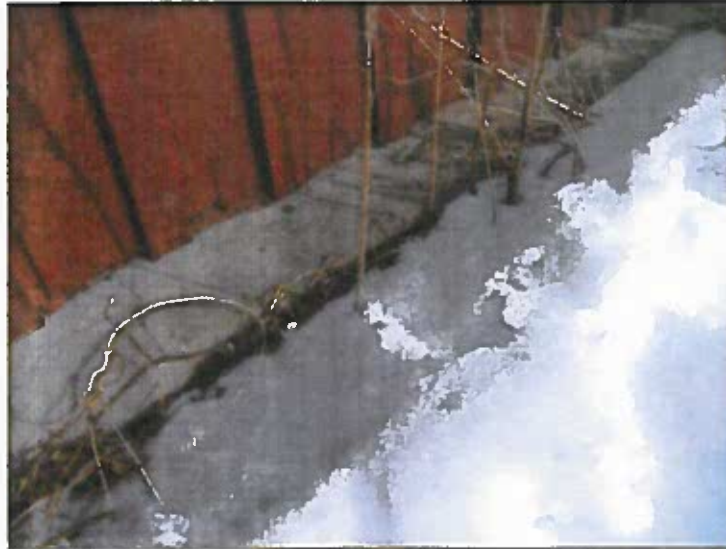
Figure 73: The lower portion of the west wall of the Dining Room has been subject to water splash from grade and moisture from snowpack.

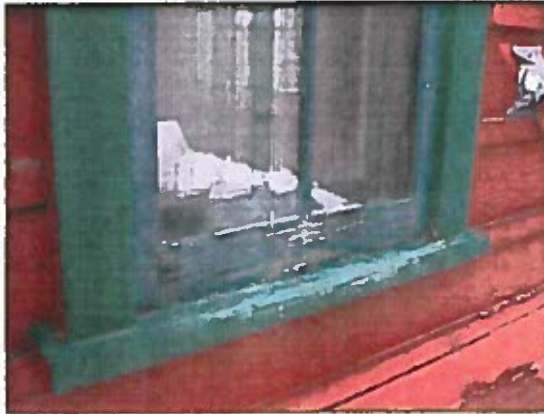
Figure 74: Typical condition of storms and trim at southern exposure.

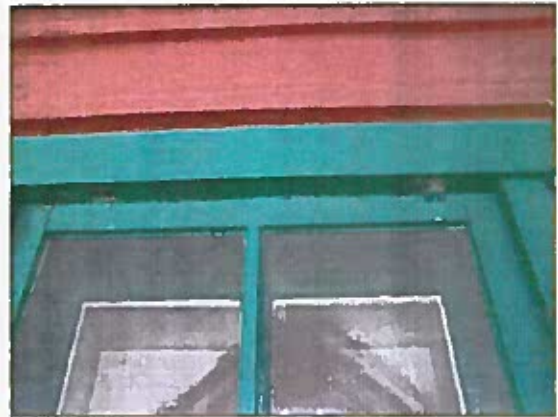
Figure 75: Hinges at top of storm sash are under-sized and bent.

The hinges of the storm sash should be replaced and missing and broken portions of the hinge arms should be replaced. The hinge arms should be lubricated to ensure smooth operation.

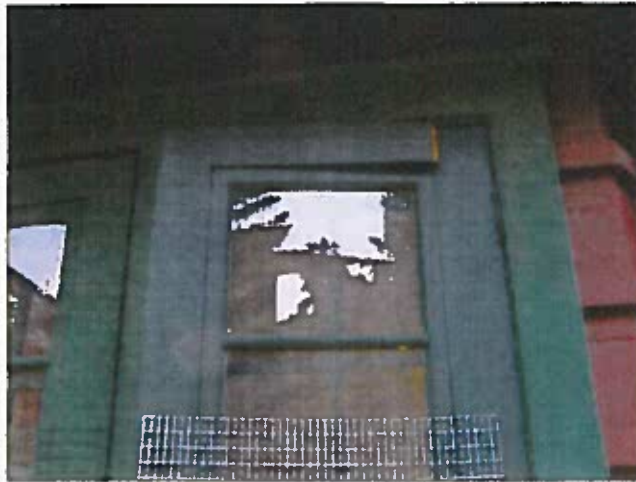
Figure 79: The joint between the rail and stile is broken at the exit from Corridor #105.

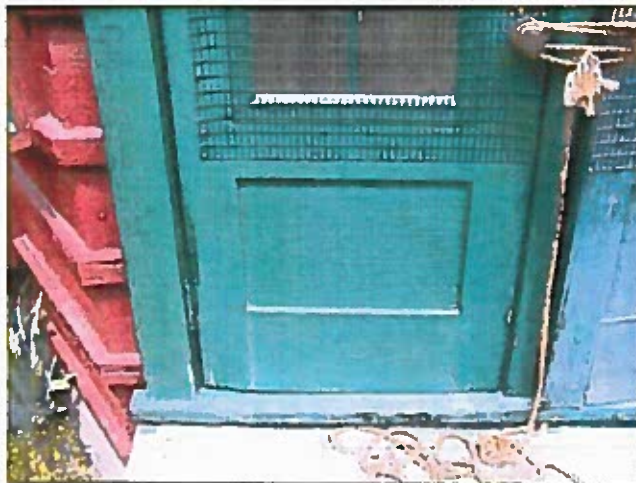
Figure 80: The joints between the bottom rail and stiles are coming apart.

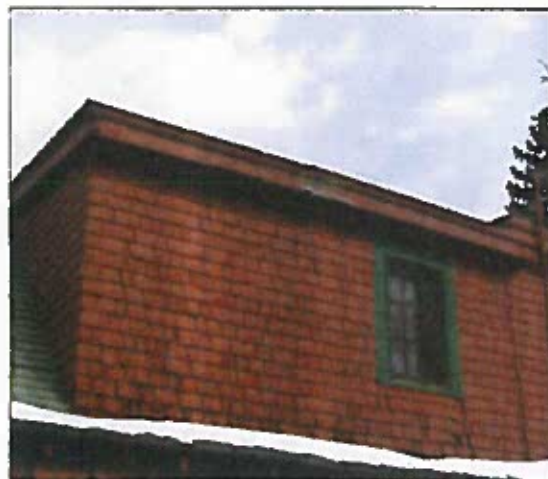
The wood of the soffits, rafters, and fascias appears to be in good condition, primarily due to the protection afforded by the depth of the soffit. Several of the fascias though are worn to bare wood.

Figure 82: The fascia of the lower sloped roof, west wall of Kitchen wing.

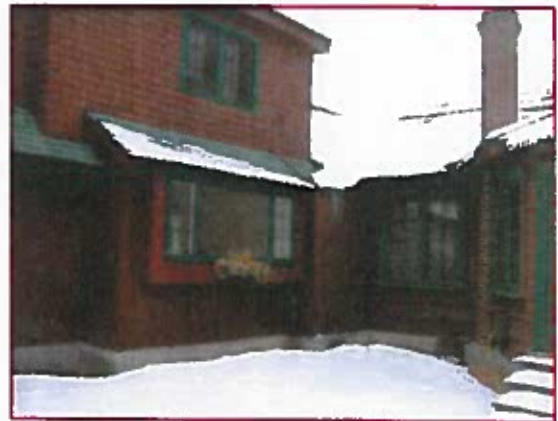
Figure 83: The brick chimney at the south elevation of the east wing.

The open mortar joints should be repointed.

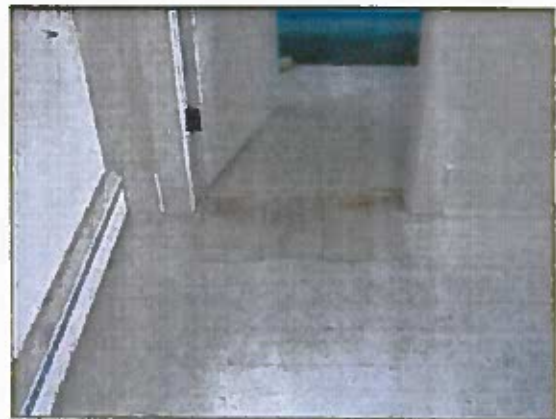
Figure 87: The fir flooring of Bedroom #107 has been painted from overspray.

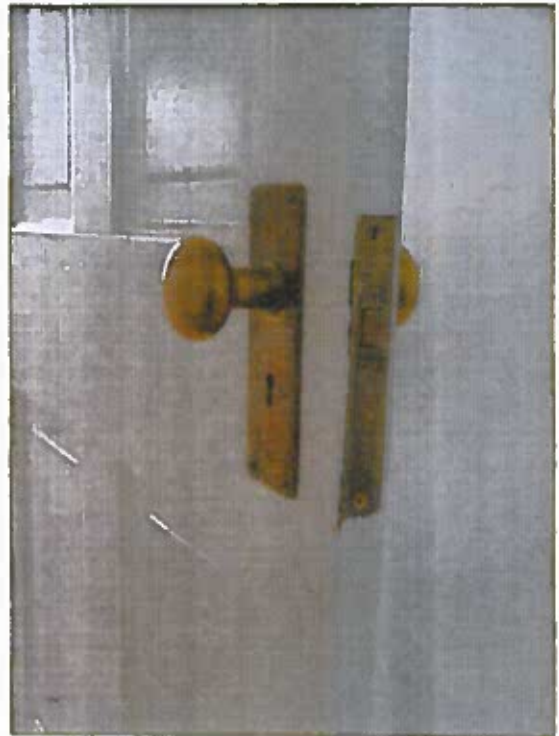
Figure 89: The latch stile of the door to Bedroom #104 has split at the mortise casing.

Repair the doors whose stile has split from the mortise casings.

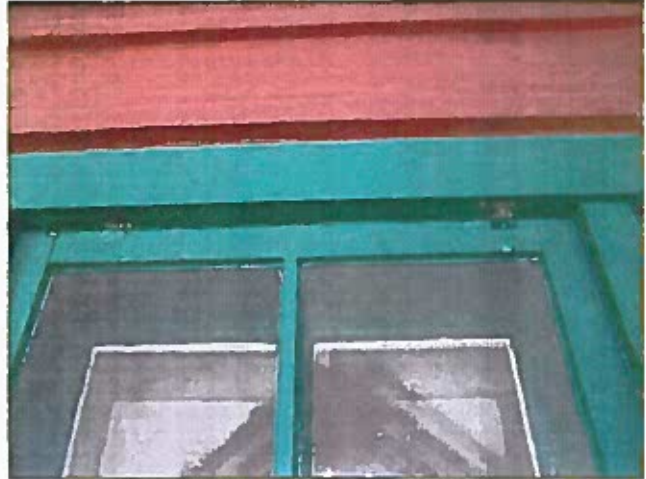
Figure 90: Typical wood storm window on first floor is held by undersized hinges.

Remove the excess paint that prevents operation of the windows. If it is intended to have the storm windows operate, remove the screws, replace the broken vent operators, and replace all the top hinges.

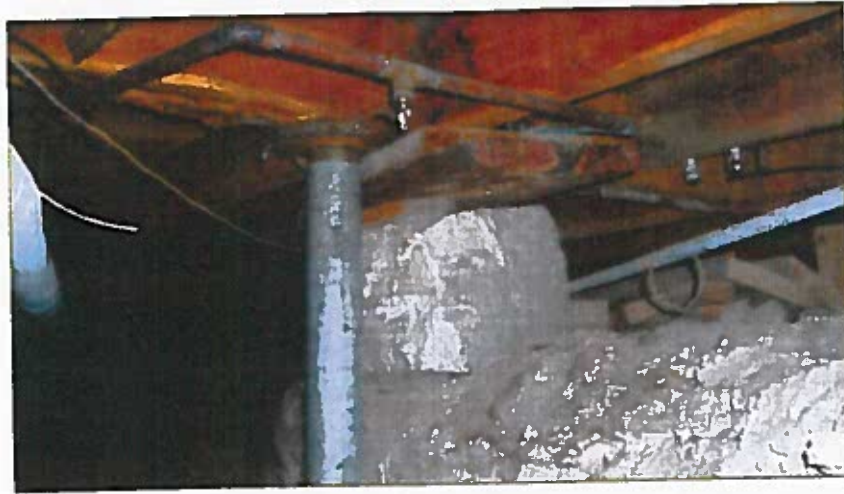
Figure S-3: Floor beam lap splice beyond pier and wood debris shim

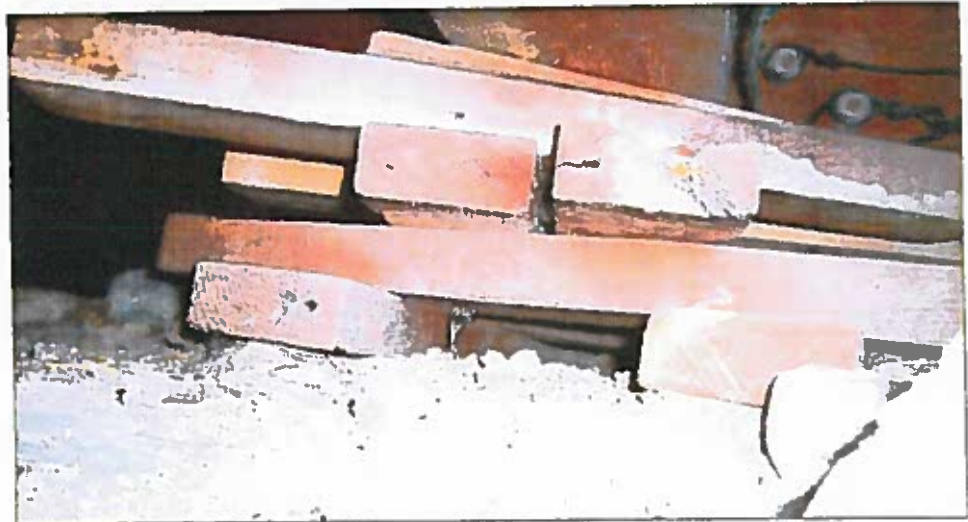
Figure S-4: Wood debris shim

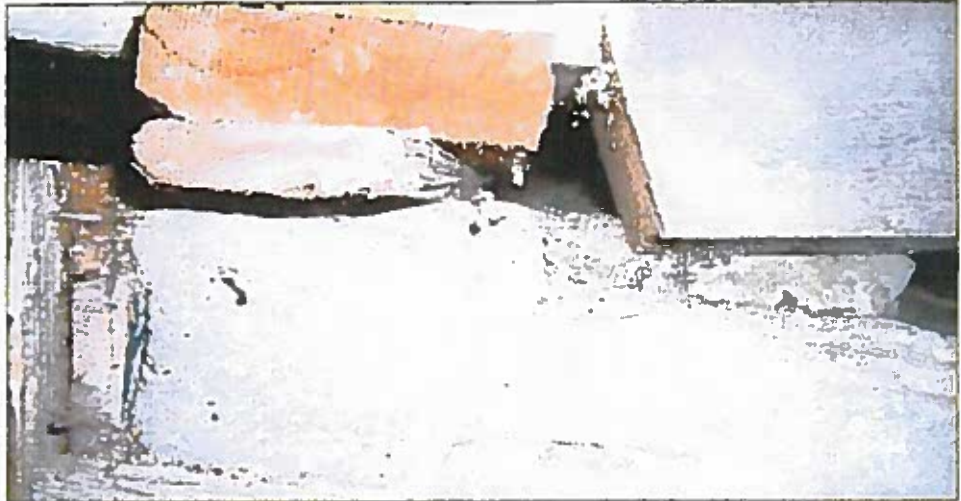
Figure S-5. Damaged Pier at floor beam bearing

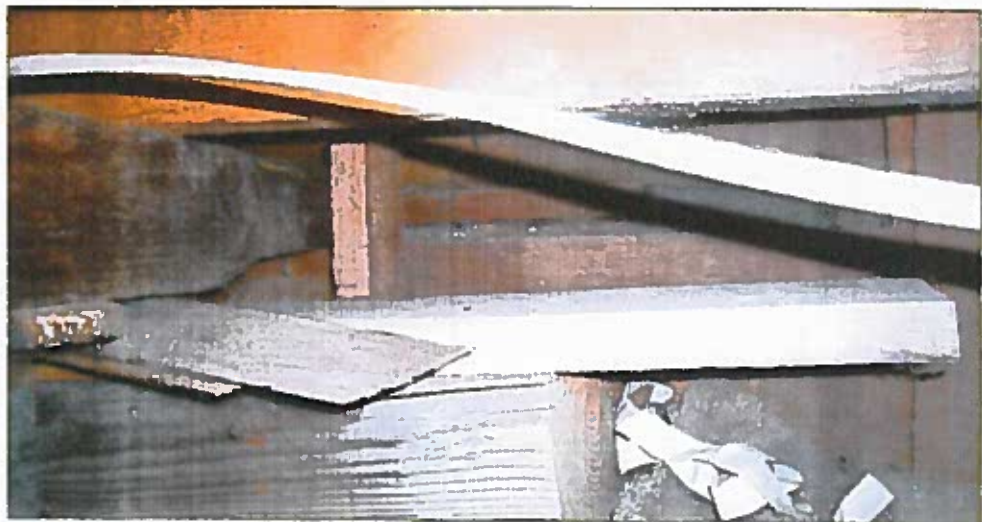
**Figure S-6:
Degradation of
floor beam at
foundation
beam pocket.**

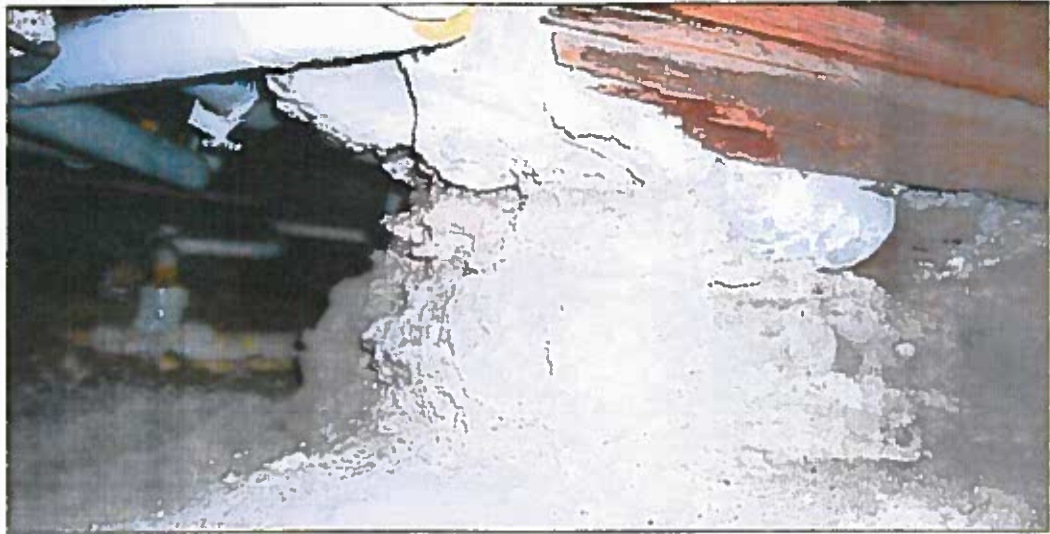
Figure S-7: Degradation of Concrete foundation wall at interior corner

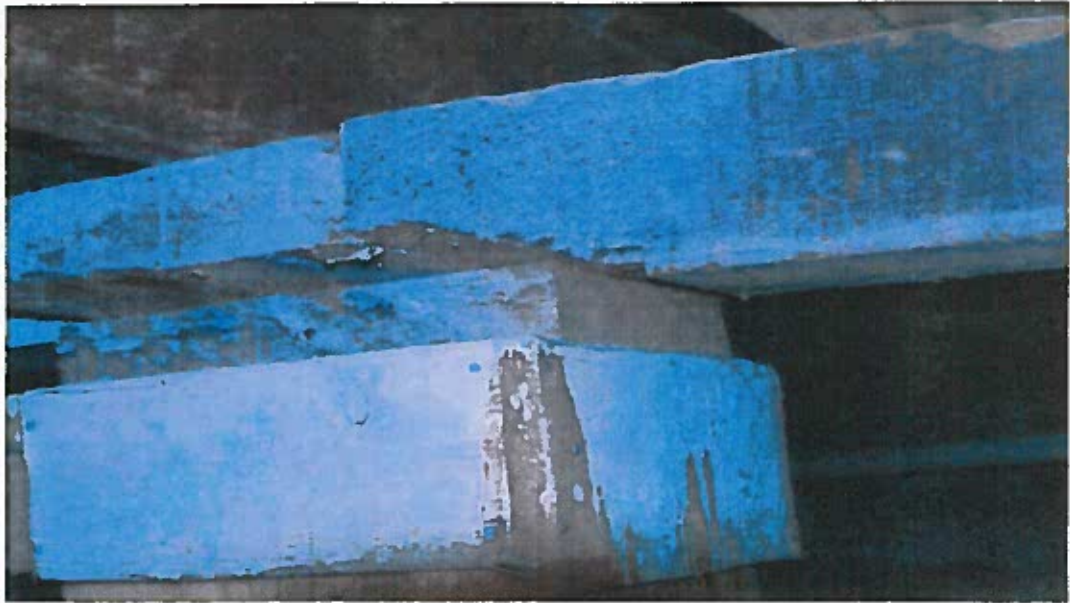
Figure S-8: Floor beam butt splice over pier in Zone E.

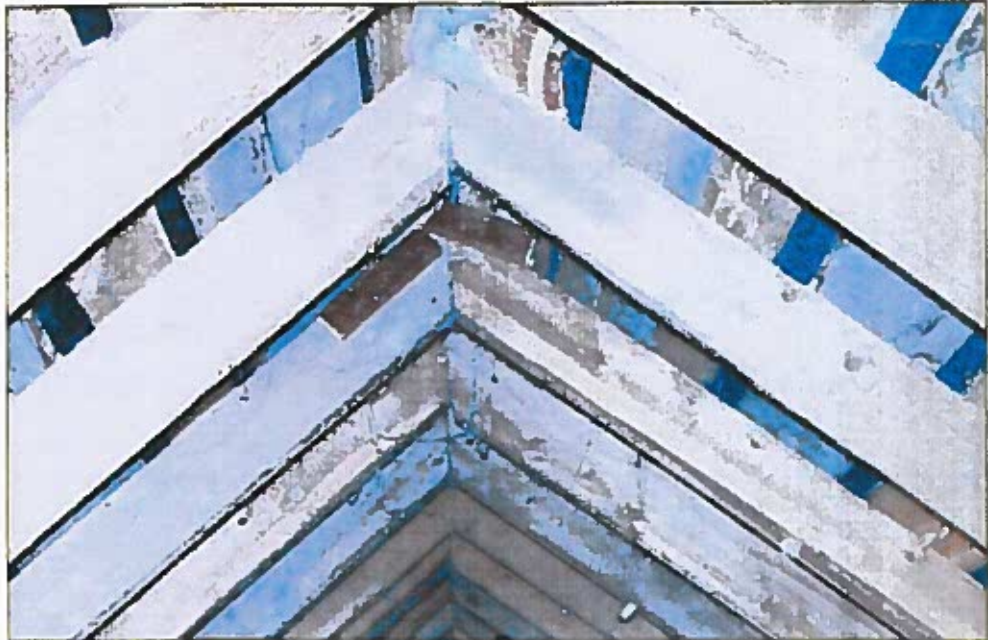
Figure S-17: Zone K & L ridge member separation.

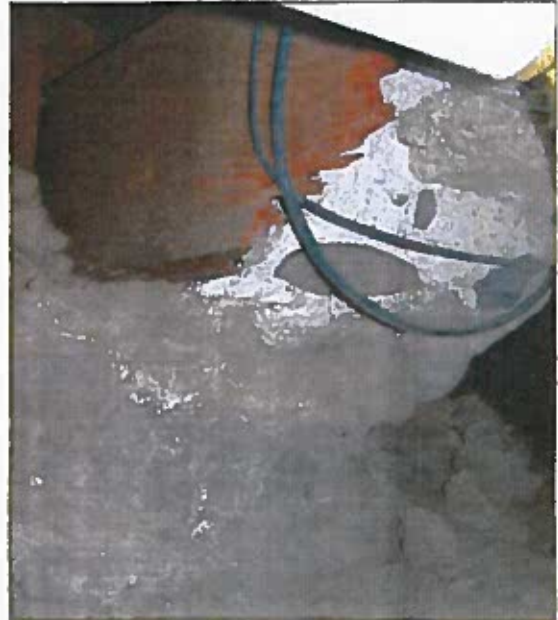
Figure 95: Excessively large aggregate in the concrete mix of the foundation. Photograph taken looking southwest into the crawlspace below Bathroom #108.

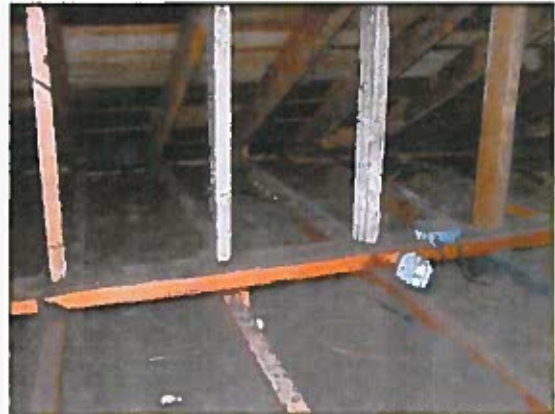
Figure 97: Loose Rock-wool in the easternmost portion of the attic.

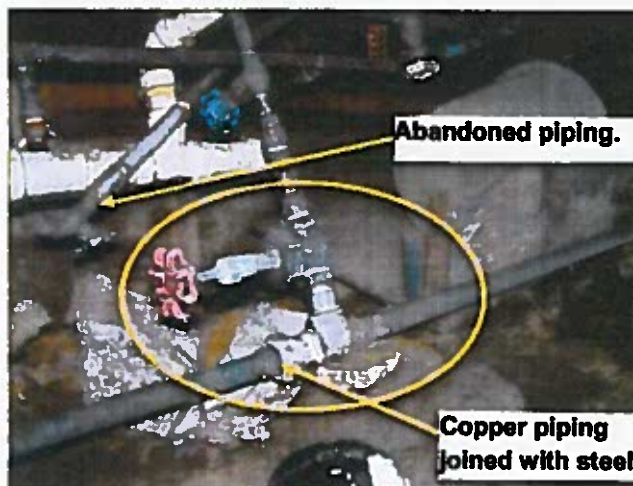
Figure P-1: Piping with dissimilar piping material, abandoned lines and corrosion

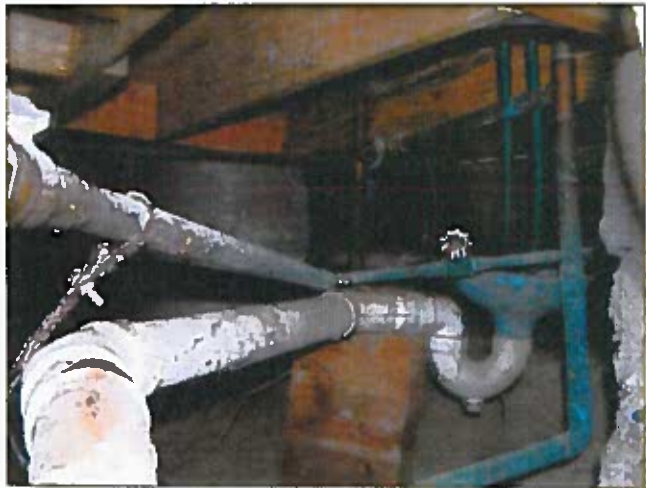
Figure P-4: Indirect drain connection and pipe corrosion

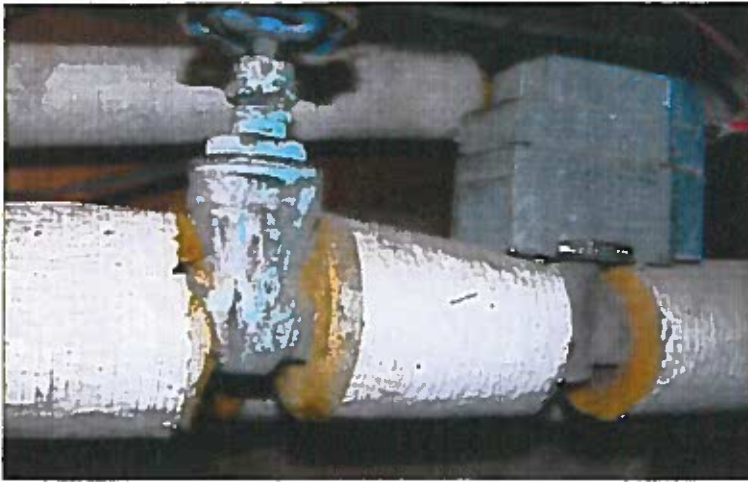
Figure M-3: Corroded hydronic valve

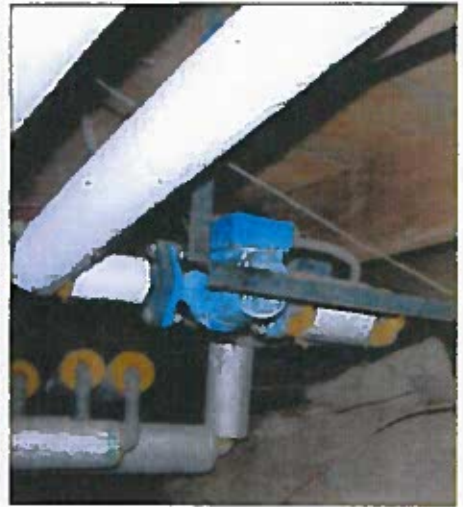
Figure M-4: Pipe not fully insulated

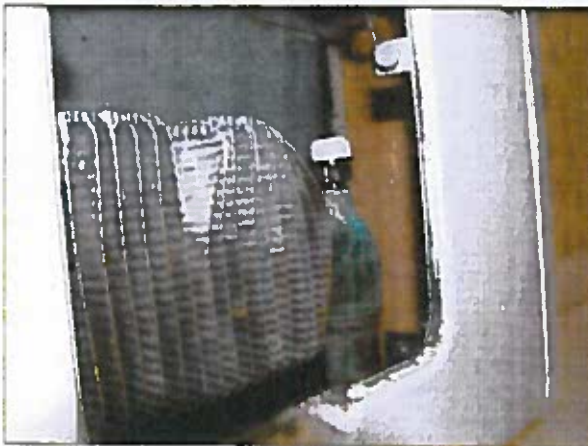
Figure M-5: Corroded hydronic valve

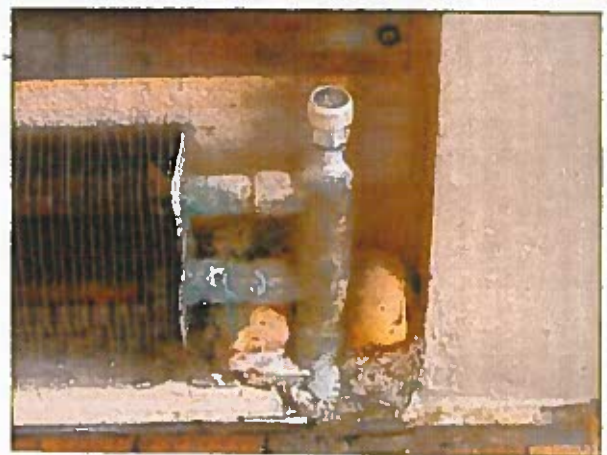
Figure M-6: Corroded hydronic valve

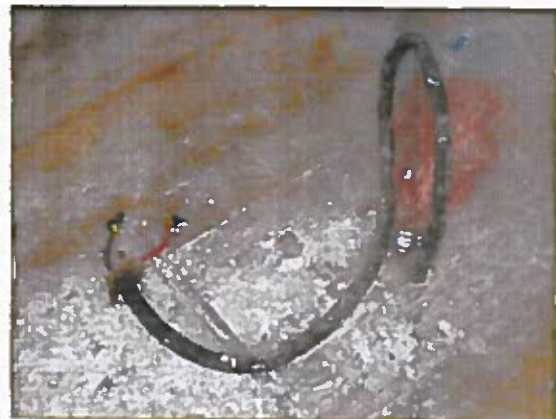
Figure E-8: Example of exposed wiring. This is evident throughout Kitchen and in upstairs hallway.

All "knob and tube" wiring and all wiring with braided type insulation should be abandoned and removed throughout the building. All circuits should be wired with NM type insulated wires throughout. All circuits not connected should have the wires pulled back to a junction box and capped, or pulled back to the source completely. An example of this shown in Figure E-8 below.
