HISTORIC
STRUCTURES REPORT

LAKE LODGE

YELLOWSTONE
NATIONAL PARK,
WYOMING

July 1997

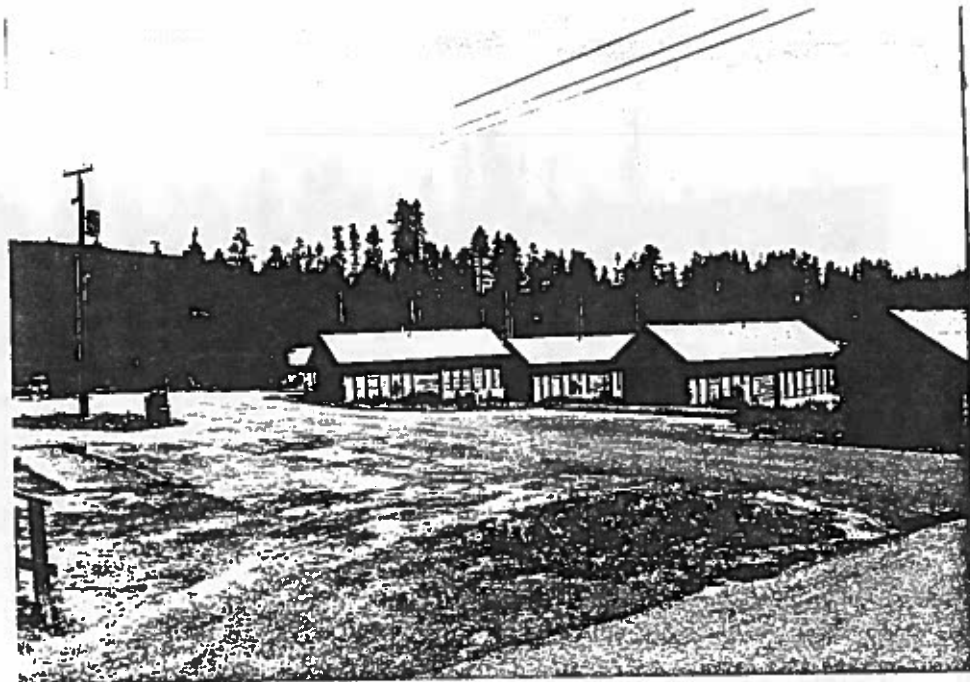
Figure 20: Looking west at a typical roadway between C and D cabins. Note the large gravel area, electrical lines and trash cans.

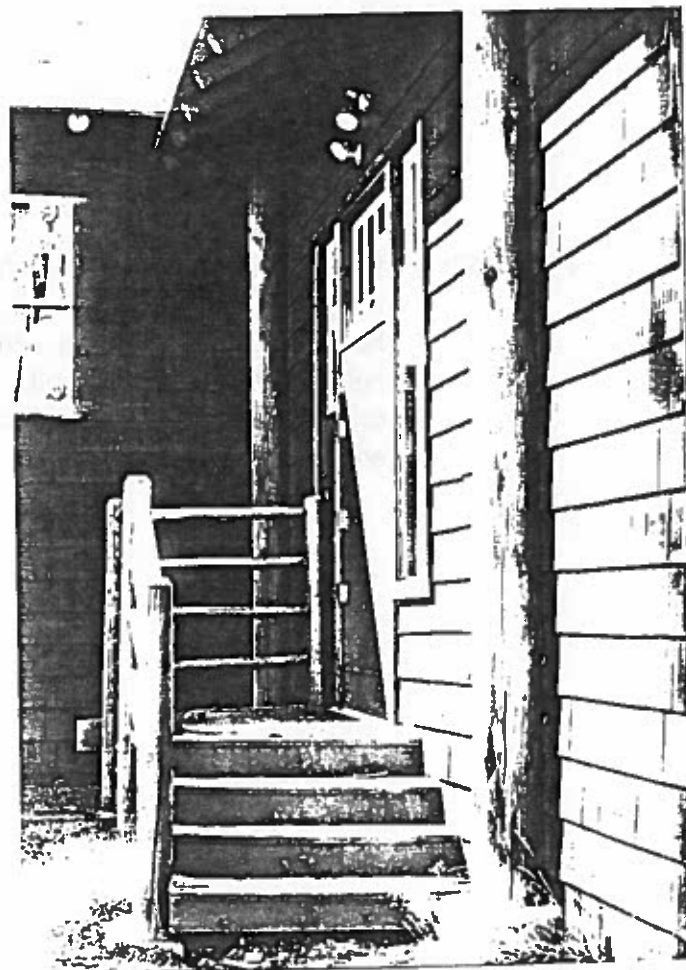
Figure 54: Looking west at the exit door and steps that were added to the Recreation Hall in 1984.

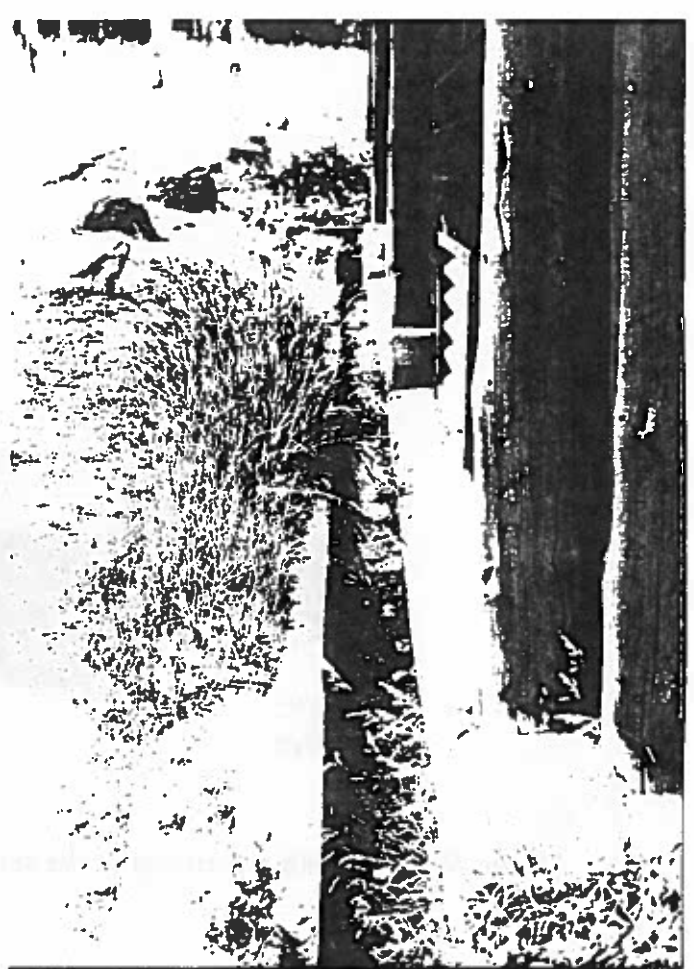
Figure 56: Looking northeast at the west side of the Lodge. Note the concrete drainage ditch that collects and holds water against the building. The base materials are deteriorating along the wall.

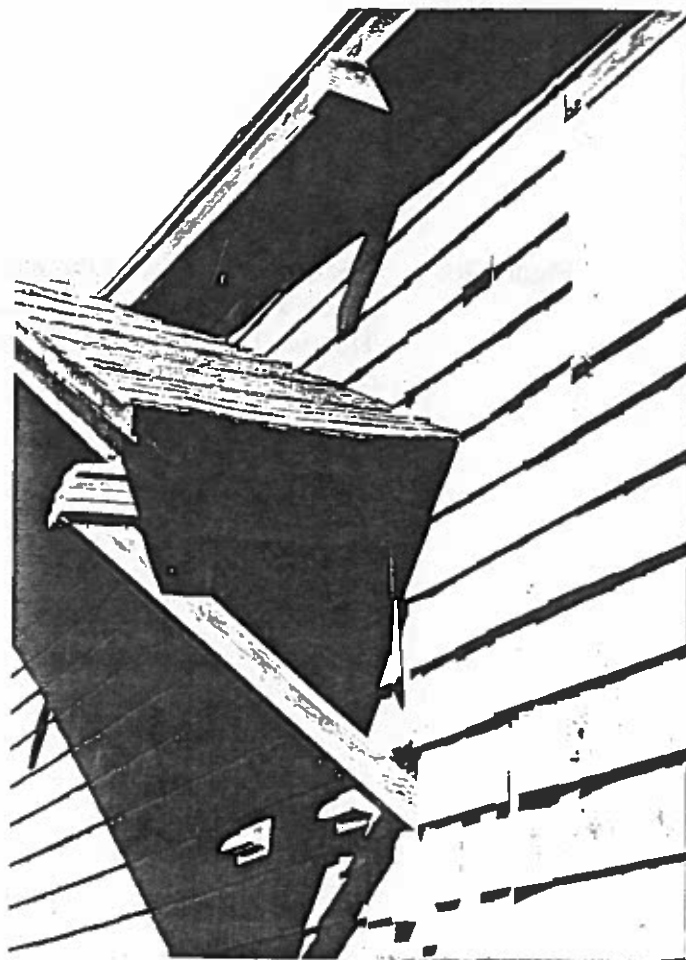
Figure 69: Looking at a detail of rot on the fascia boards on the west side of the building.

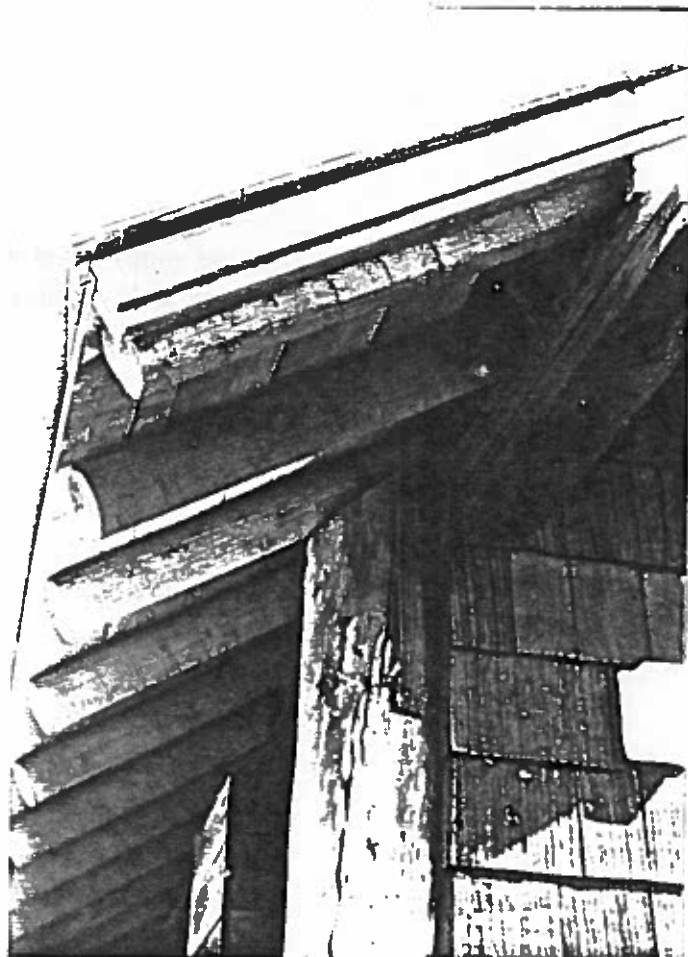
Figure 73: Looking southeast at a section of the north wall of the Lodge at the entrance to the Kitchen. Note the deterioration along the base of the building.

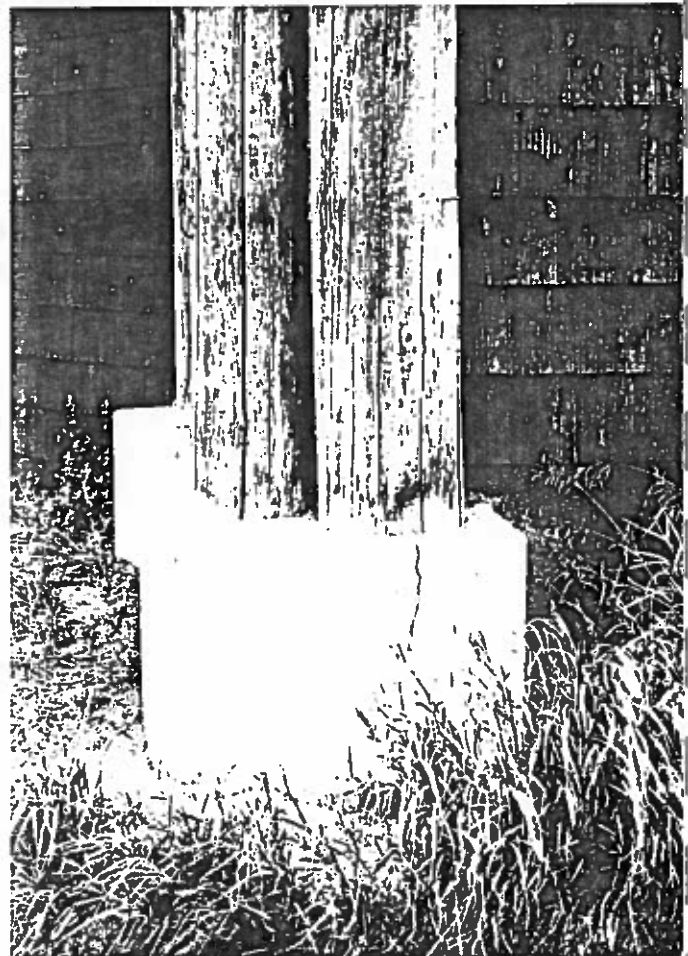
Figure 79: Looking at the shingle base on the front bay of the cafeteria. Note the poor drainage and the deteriorated shingles along the wall.

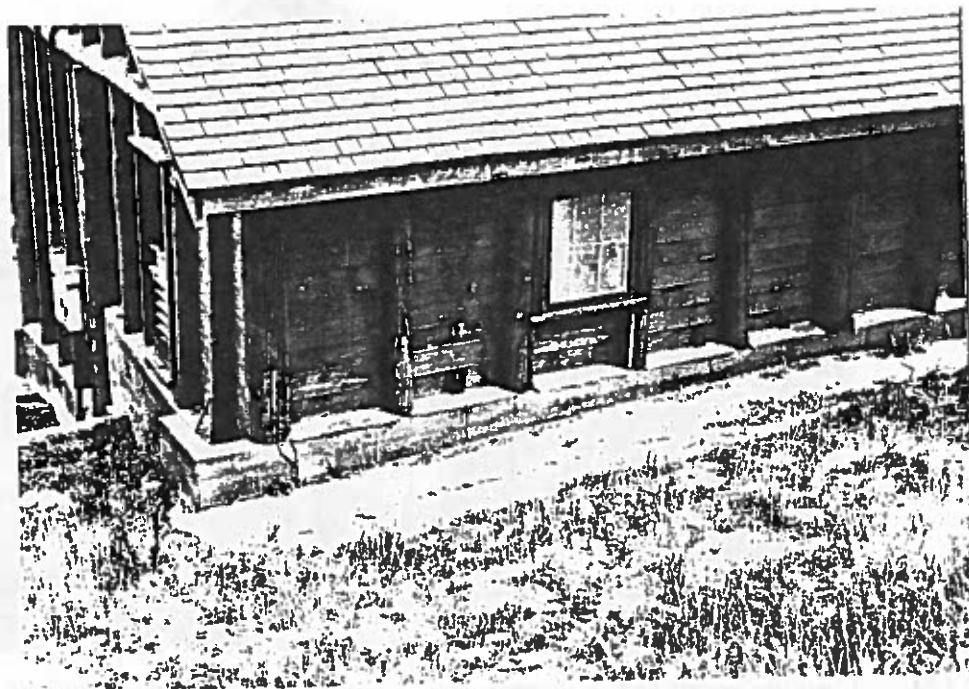
Figure 126: Looking east at the west wall of the building. Note the cracked concrete base and the concrete swale designed to move water away from the building.

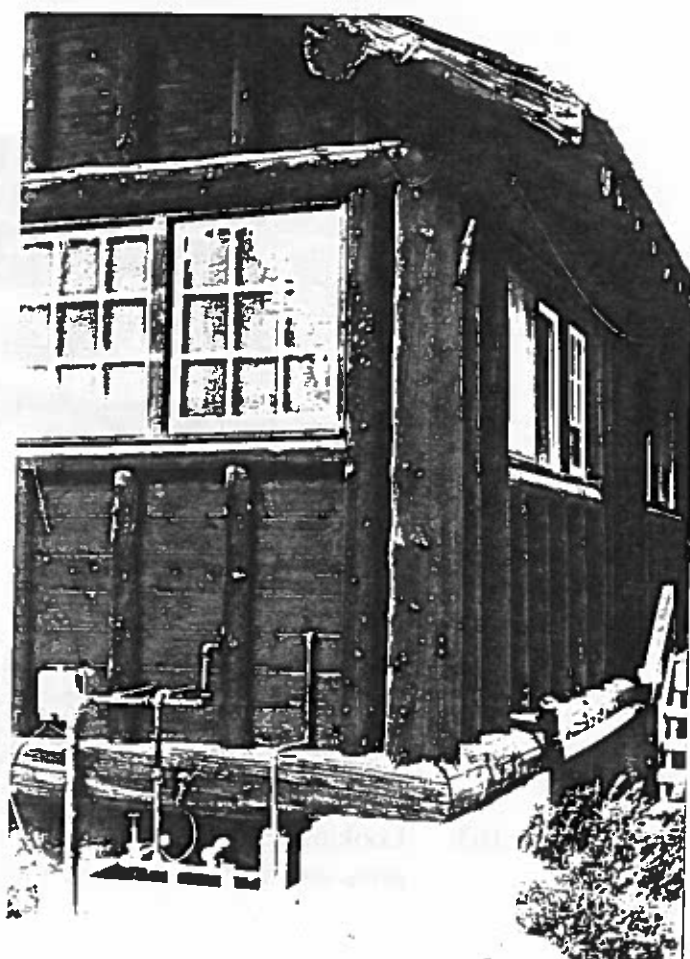
Figure 181: Looking north at a corner of the Pub. Note the rotted purlins and rafter ends at the eave.

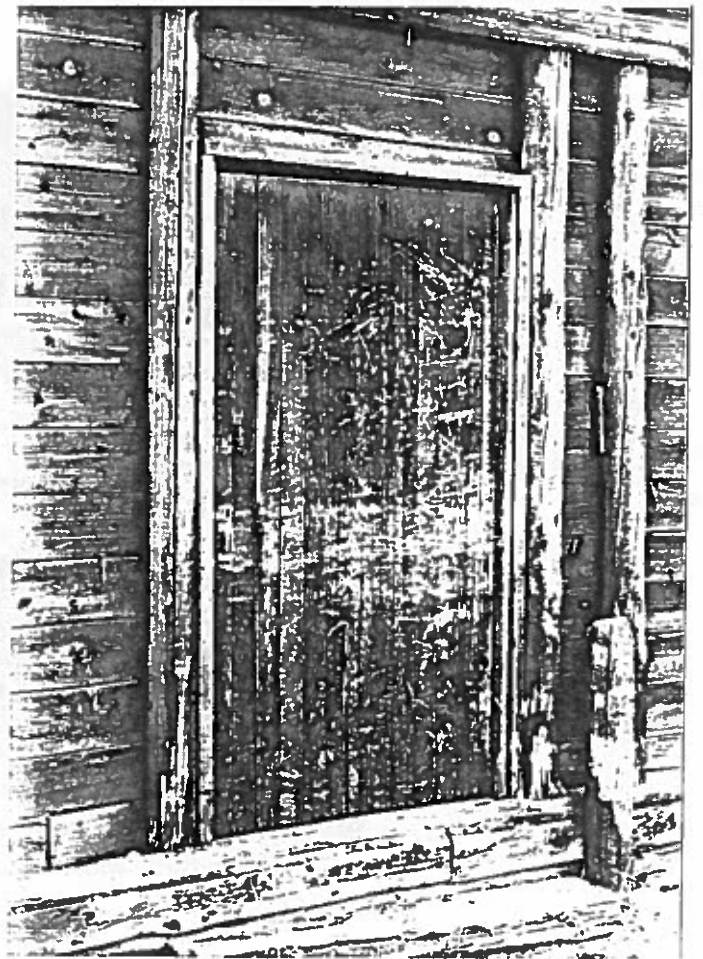
Figure 193: View of the door on the west side of the Linen Building. Note the weathered wood on the door and surrounding materials.

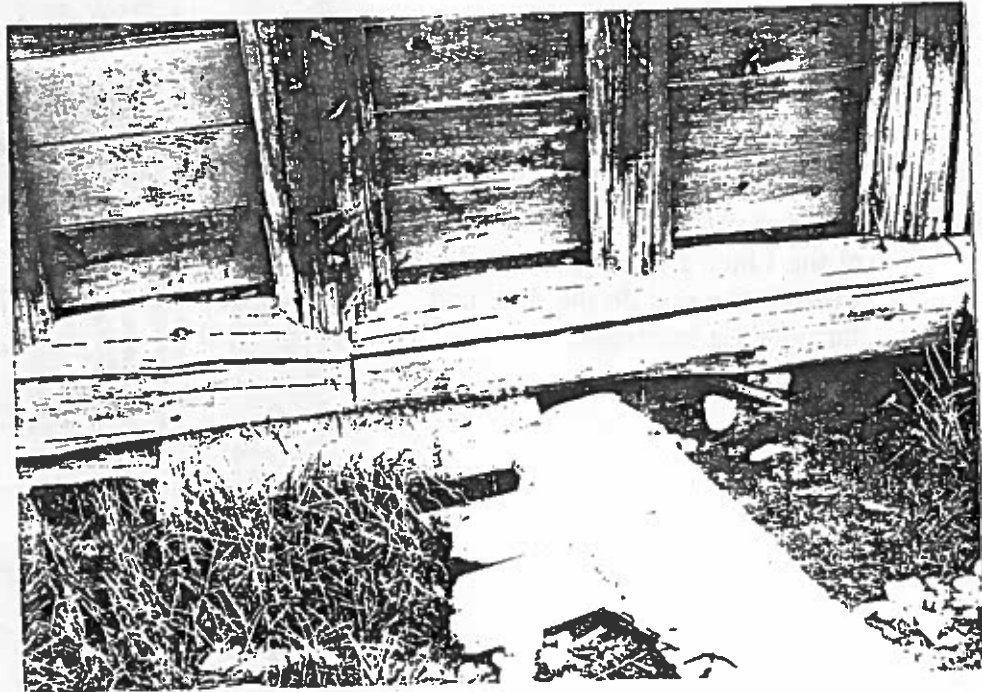
Figure 195: Looking at a typical foundation detail on the west side of the Pub Building. Water flowing from the large parking area on the west flows into the crawl space and against the foundation and sill logs.

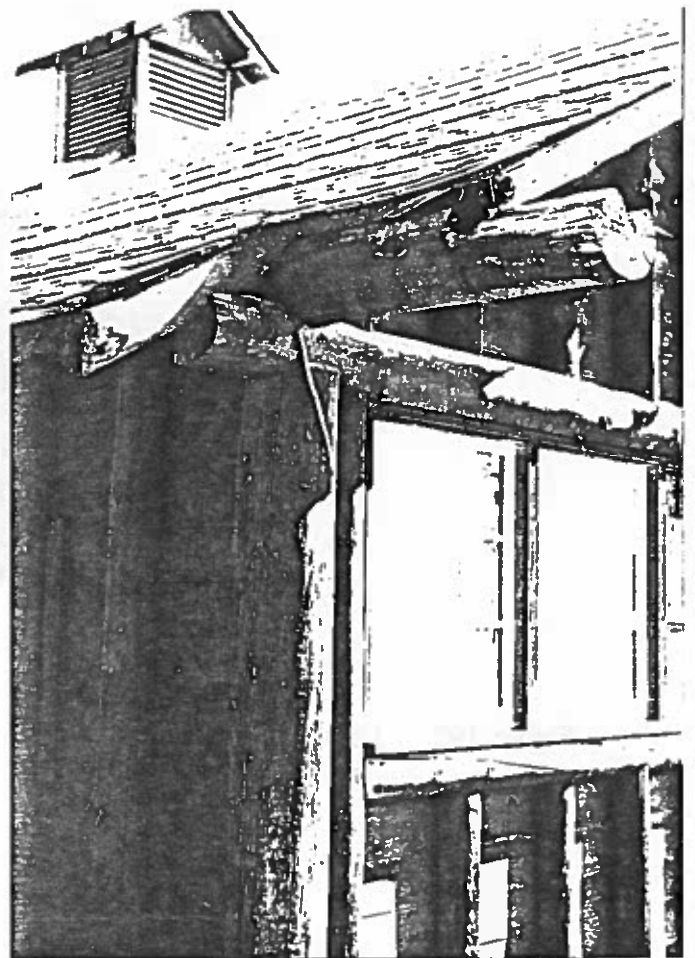
Figure 199: Looking at a corner of the Pub showing rotted purlins and rafters.

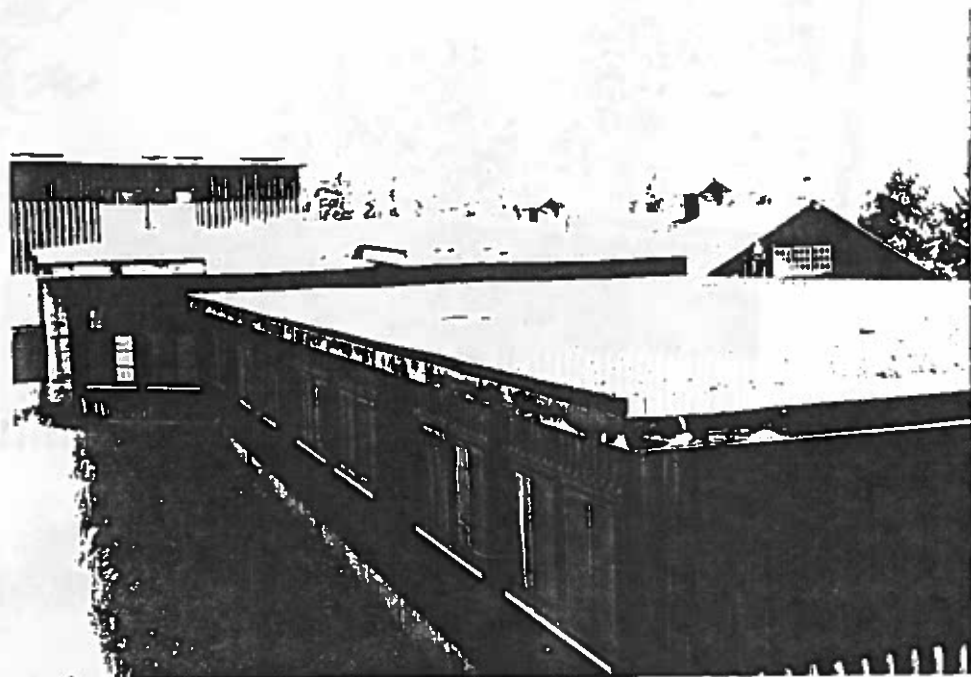
Figure 215: Looking north at the flat gravel built-up roof on the dorm. The roof appears to be in fair condition.

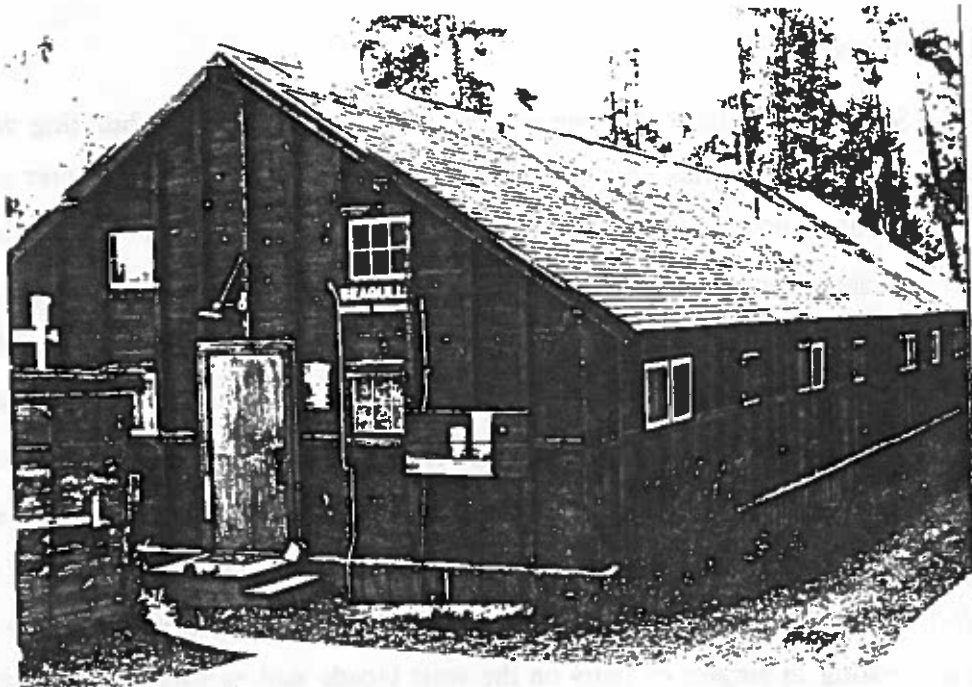
Figure 220: Looking southeast at Seagull Dormitory (HS #7006). Note the weathered wood especially along the base which also contains some rot.

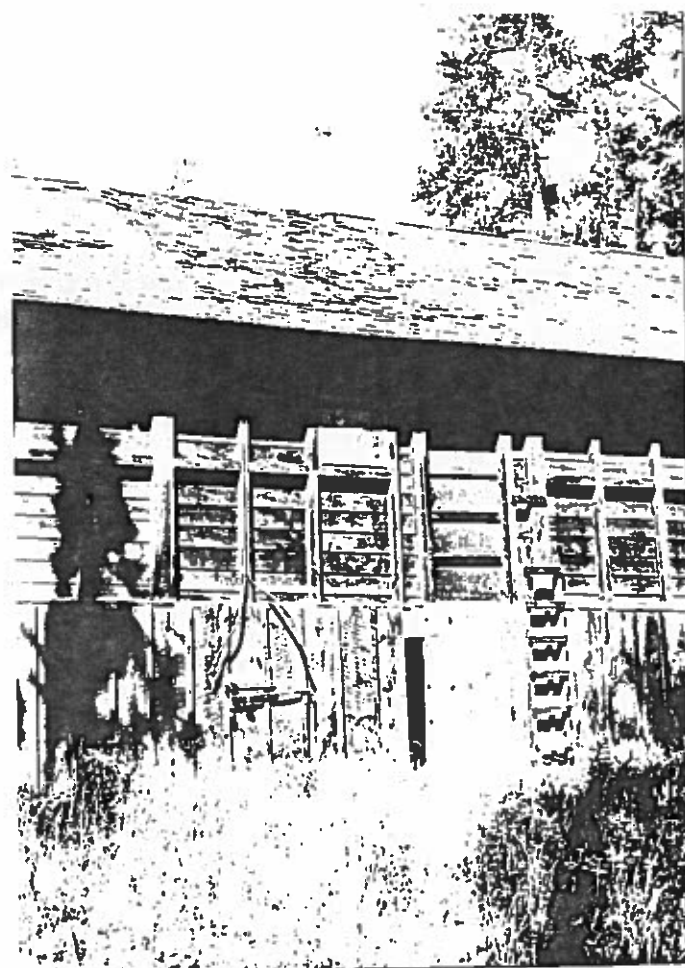
Figure 225: Looking west at the center section of the dorm. Note the poor condition of the shingles on the roof, and the weathered wood elements.

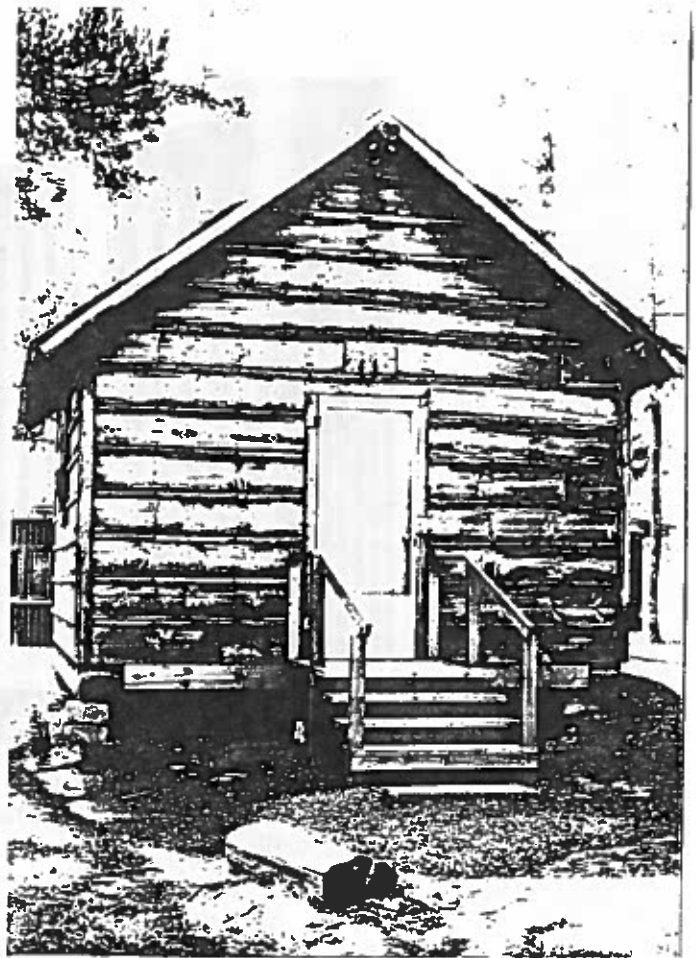
Figure 238: Looking northeast at Cabin 00. The windows and doors are weathered and require repair.

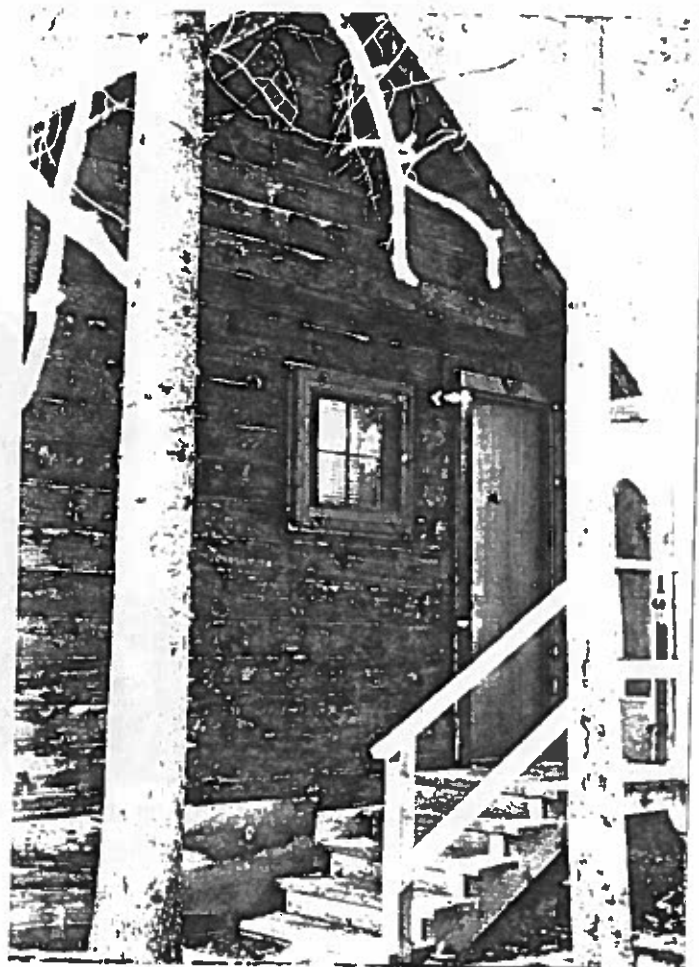
Figure 240: Looking northeast at Cabin 000 (HS #7023). Note the weathered wood siding.

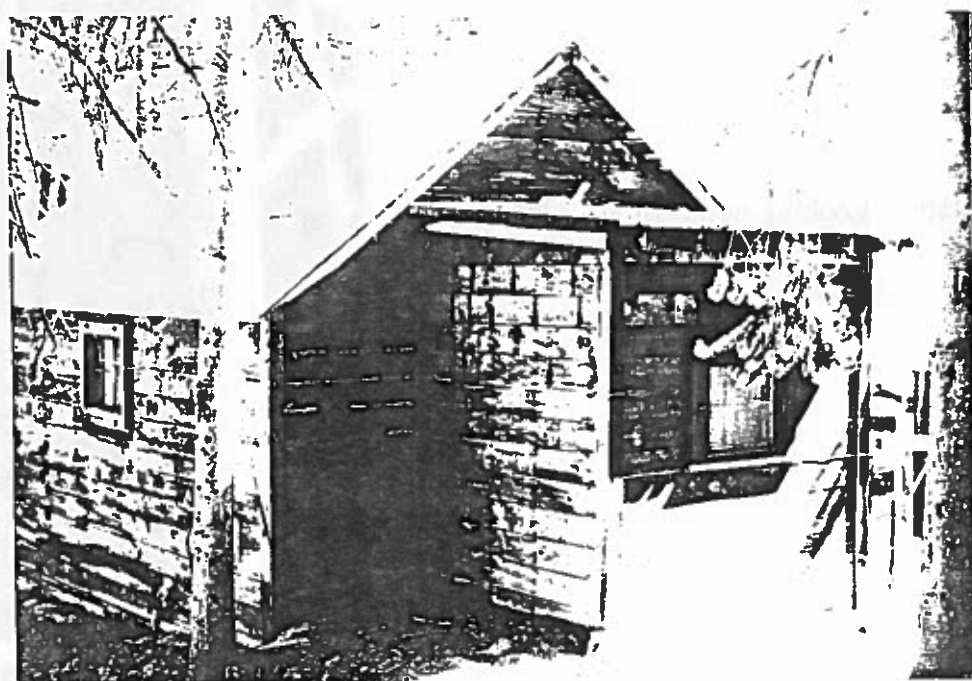
Figure 242: Looking southwest at Cabin 000. Note the high grade around the back of the building up onto the siding.

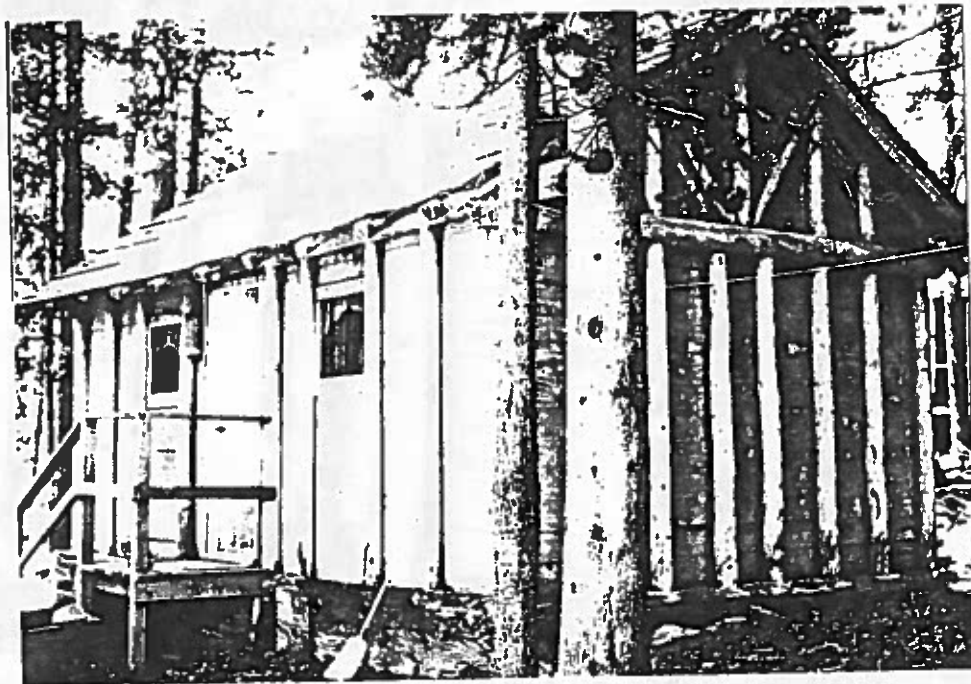
Figure 249: Looking southeast at Cabin 2. Note the high grade around the building causing moisture to be held against the base. There is rot in the sill log, the bottom of the logs and the siding.

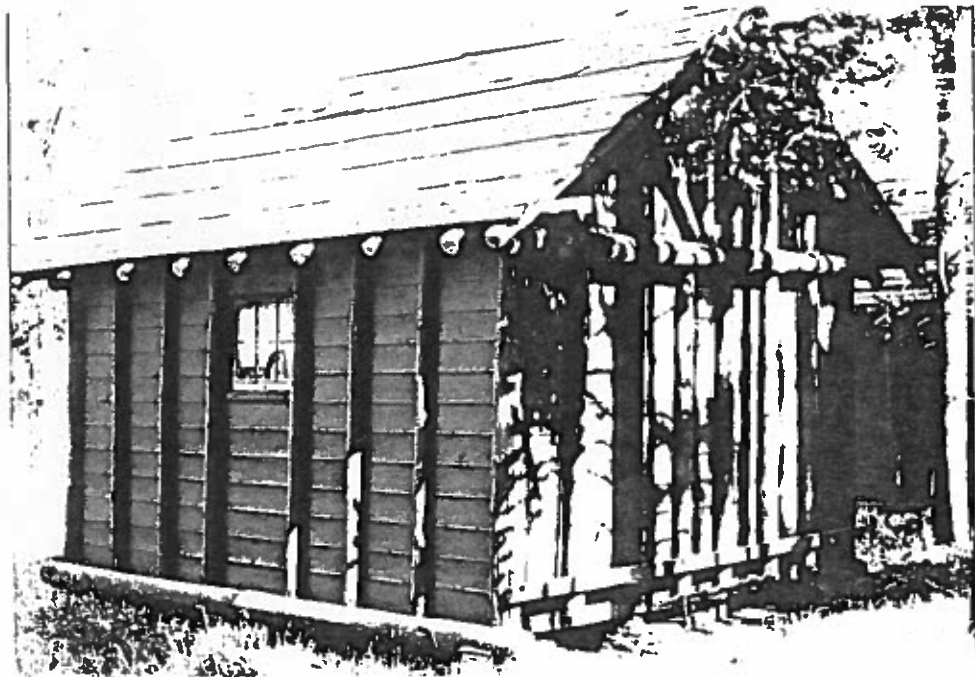
Figure 260: Looking northwest at the second building. Note the temporary piers and high level of the grade along the back.
