HISTORIC STRUCTURES REPORT

**MOUNT WASHBURN
FIRE LOOKOUT
Yellowstone National Park**

April 2011

Prepared by Sievert & Sievert CRC
in conjunction with
Montana Preservation Alliance

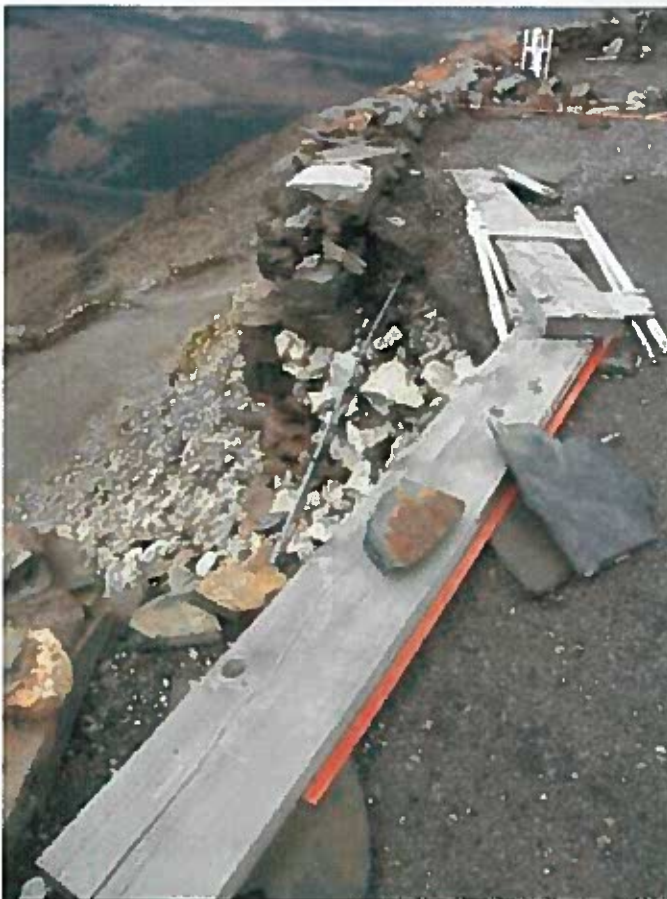
BREACH IN NW CORNER OF RETAINING WALL AROUND PARKING AREA; NOTE STEEL PLATES AND ANCHOR BOLTS IN CENTER OF WALL. Photo credit: Herb Dawson, NPS.

- Repair failed stone retaining wall.

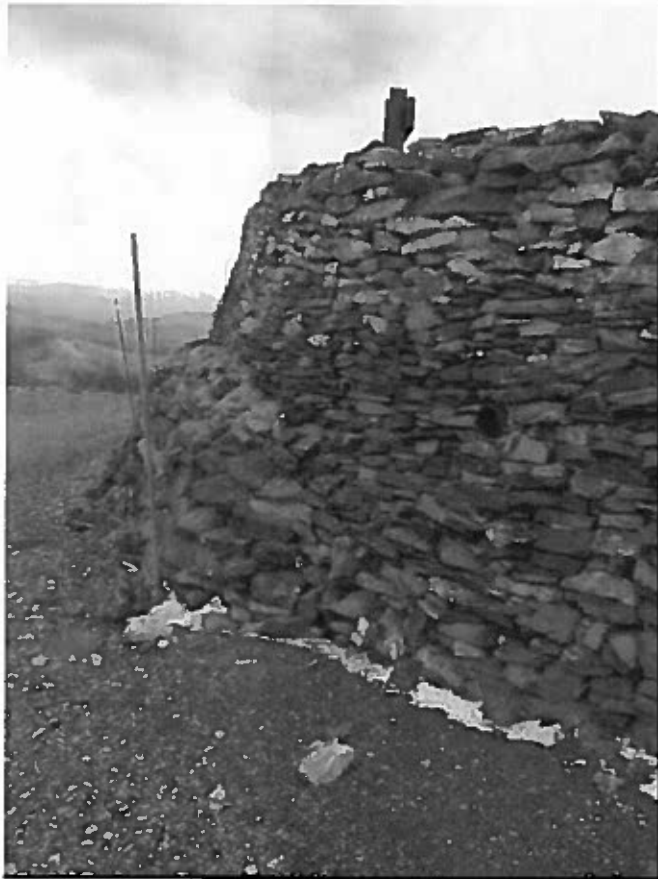
VIEW OF SECTION OF FAILED RETAINING WALL FROM ABOVE. Photo credit: Herb Dawson, NPS.

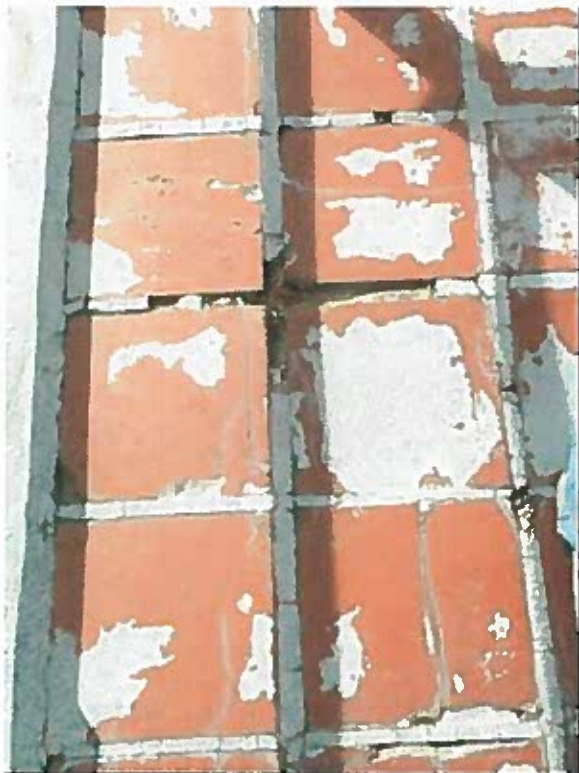
DETAIL OF TILE SURFACING AT PROMENADE SHOWING CURRENT DEFICIENCIES IN THE GROUTING AND MORTAR SETTING MATERIALS. Photo credit: Herb Dawson, NPS.

- Repair deteriorated concrete bearing walls & details at 1939 portion of structure.
- Provide & install coating over concrete after repaired.
- Repair / replace tile walking surface at Firewatch promenade.

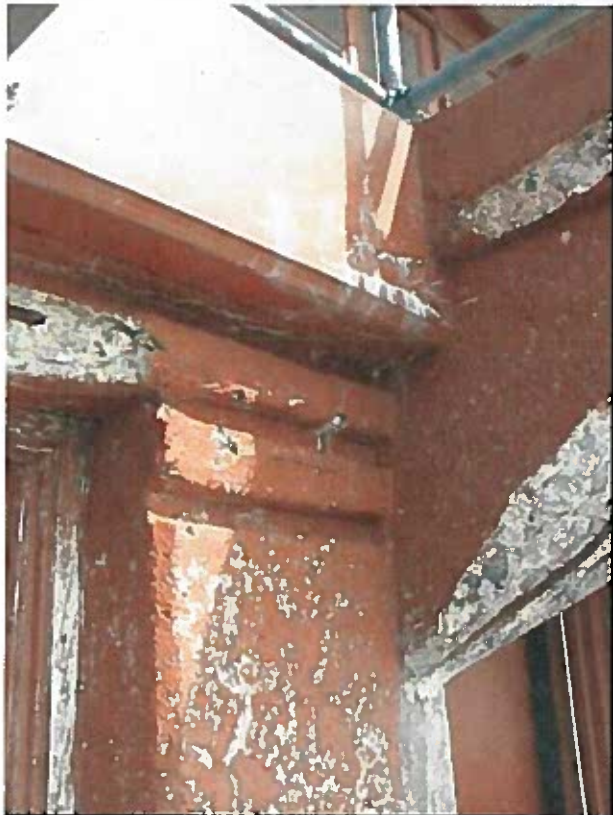
NOTE THAT THE DETERIORATION IN THE CONCRETE SURFACES IS LESS AT LOCATIONS WHERE IT RECEIVED A SMOOTH FINISH AS OPPOSED TO LOCATIONS THAT WERE BUSH HAMMERED. Photo credit: Herb Dawson, NPS.

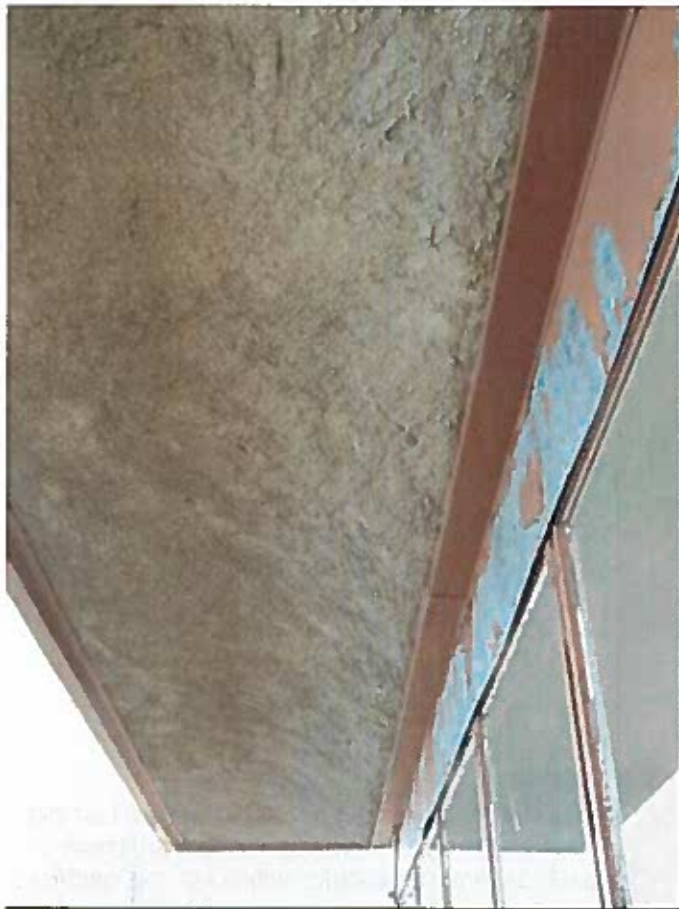
VIEW OF THE ORIGINAL PLASTER SOFFIT BENEATH THE OVERHANG AT THE ROOF OF THE FIREWATCH. THE ORIGINAL METAL VENTILATORS THAT WERE LOCATED ABOVE THE WINDOWS HAVE BEEN COVERED BY GALVANIZED TIN (AREA WITH FLAKED PAINT). Photo credit: Herb Dawson, NPS.

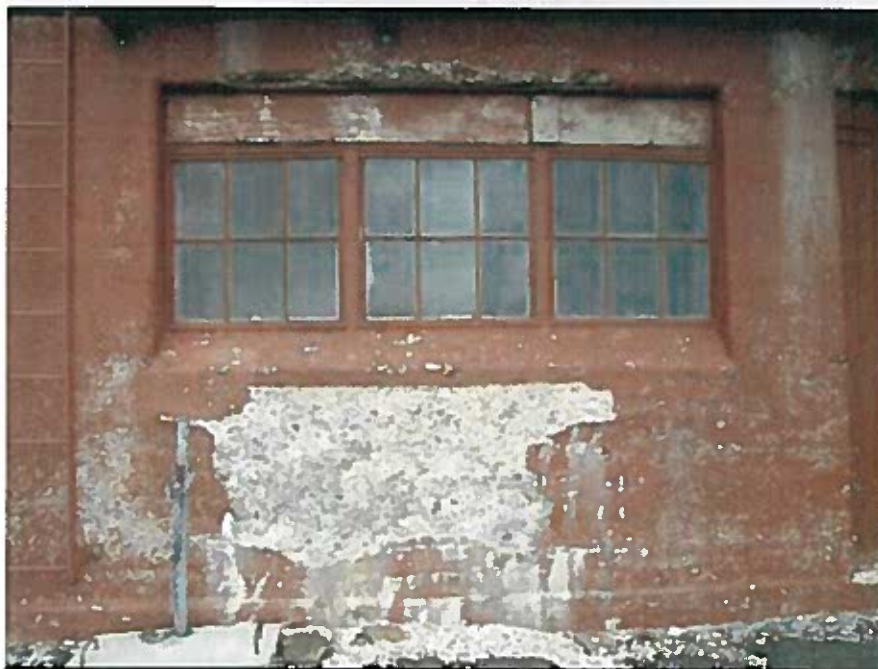
WEST FACING WINDOW FROM THE WOMEN'S RESTROOM; THE ARCHITRAVE OF THE WEST ENTRY CAN BE SEEN AT THE EXTREME RIGHT SIDE OF THE PHOTO AND THE EMERGENCY ESCAPE LADDER FOR THE FIREWATCH IS VISIBLE TO THE LEFT. NOTE THE BADLY SPALLED CONCRETE BELOW THE WINDOW. Photo credit: Herb Dawson, NPS.

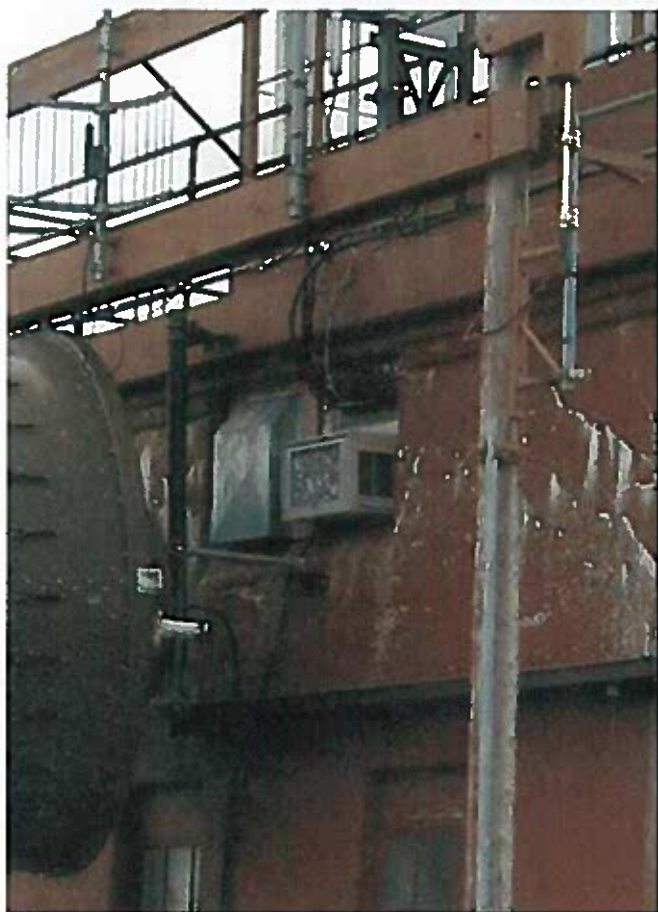
WINDOW INFILL AT THE SE CORNER OF THE SECOND FLOOR (ORIGINAL RESIDENCE AREA). THE INFILL PROVIDES VENTILATION FOR THE EQUIPMENT INSIDE BUT IS MADE OF MATERIALS WITH A SHORT LIFE EXPECTANCY. Photo credit: Herb Dawson, NPS.

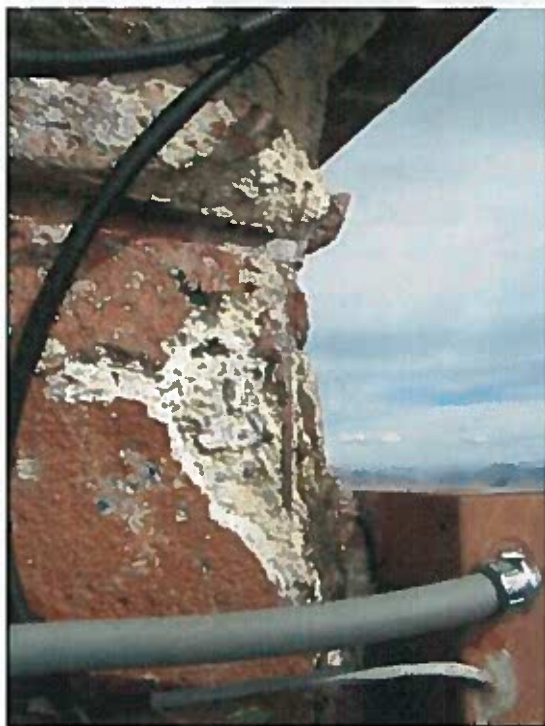
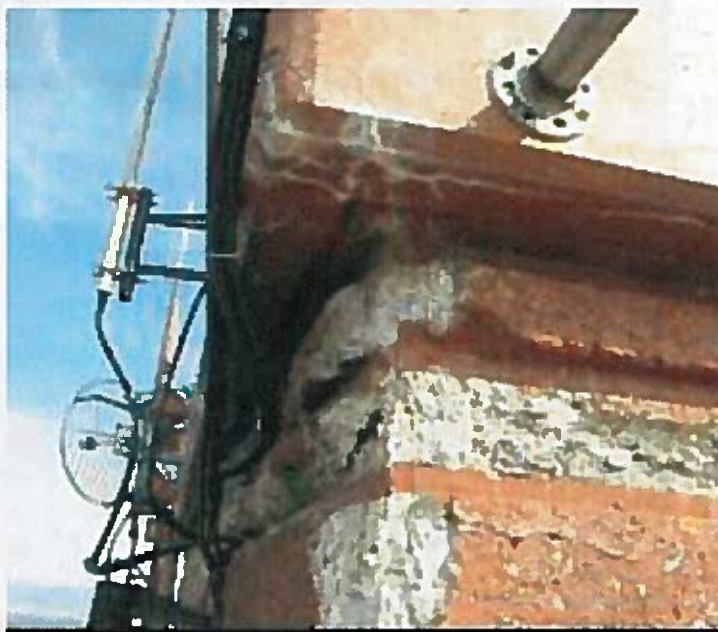
DETERIORATION AND SPALLING OF CONCRETE AT CORNERS AND ARTICULATIONS OF 1939 STRUCTURE; REFER TO DETAILED DESCRIPTIONS REGARDING CONCRETE IN TEXT. All Photo credits: Herb Dawson, NPS.

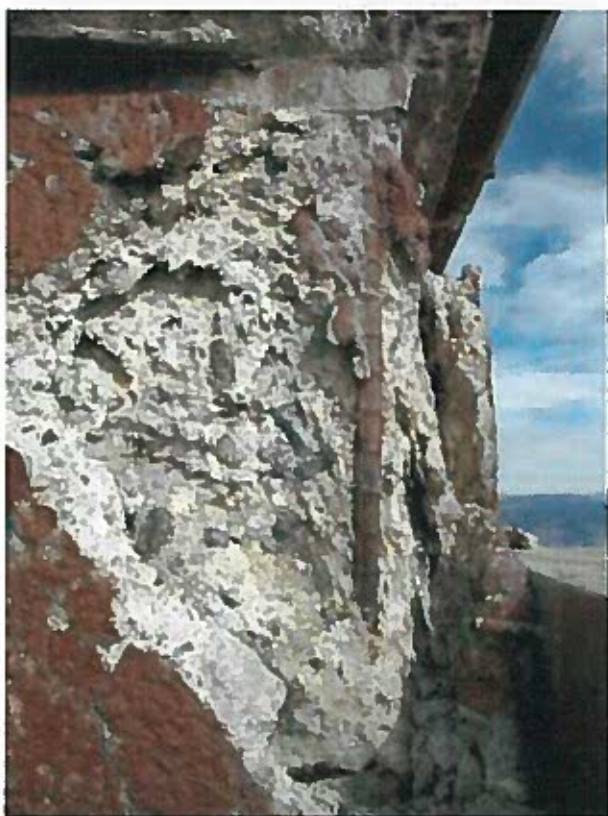
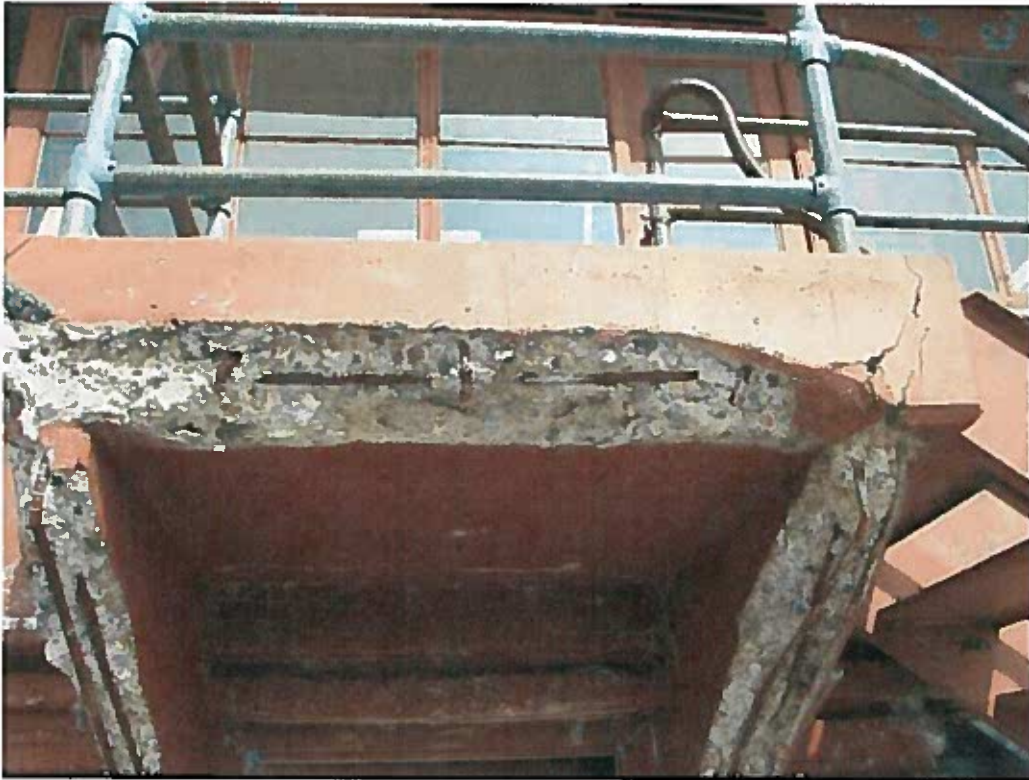
THE CANTILEVERED SUPPORTS FOR THE EXTERIOR STAIR TO THE FIREWATCH EXHIBIT THE MOST EXTENSIVE DETERIORATION OF THE CONCRETE USED THROUGHOUT THE 1939 STRUCTURE. FLEXURAL REINFORCING STEEL IS EXPOSED AND THE DETERIORATION HAS PENETRATED DEEPLY INTO THE BASIC CONCRETE MATERIALS.
 Photo credits: Herb Dawson, NPS.

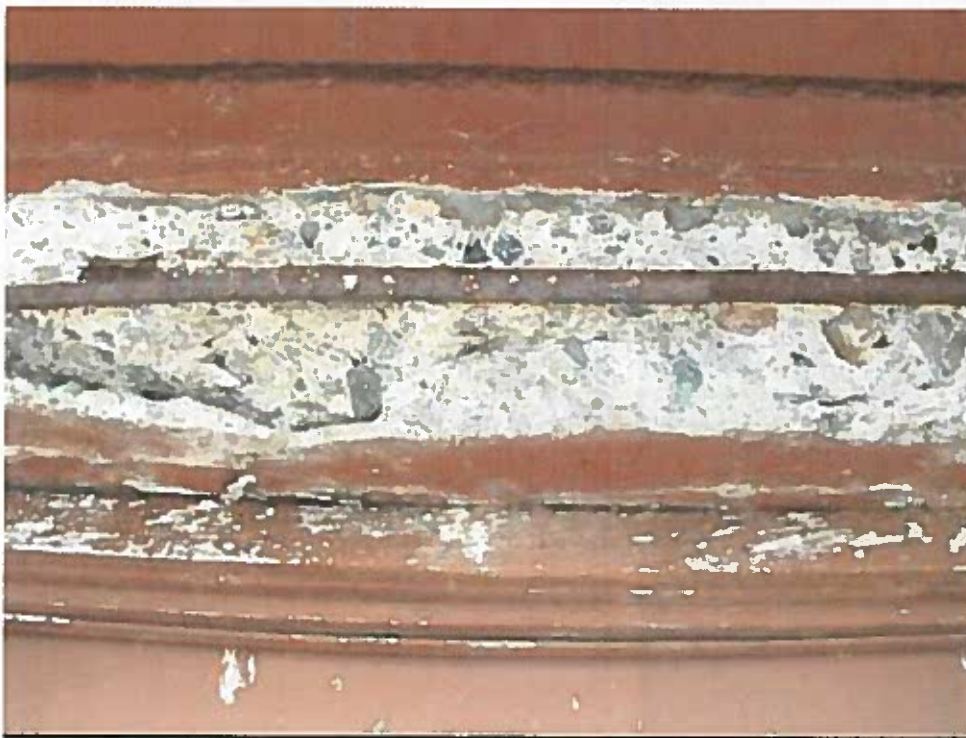
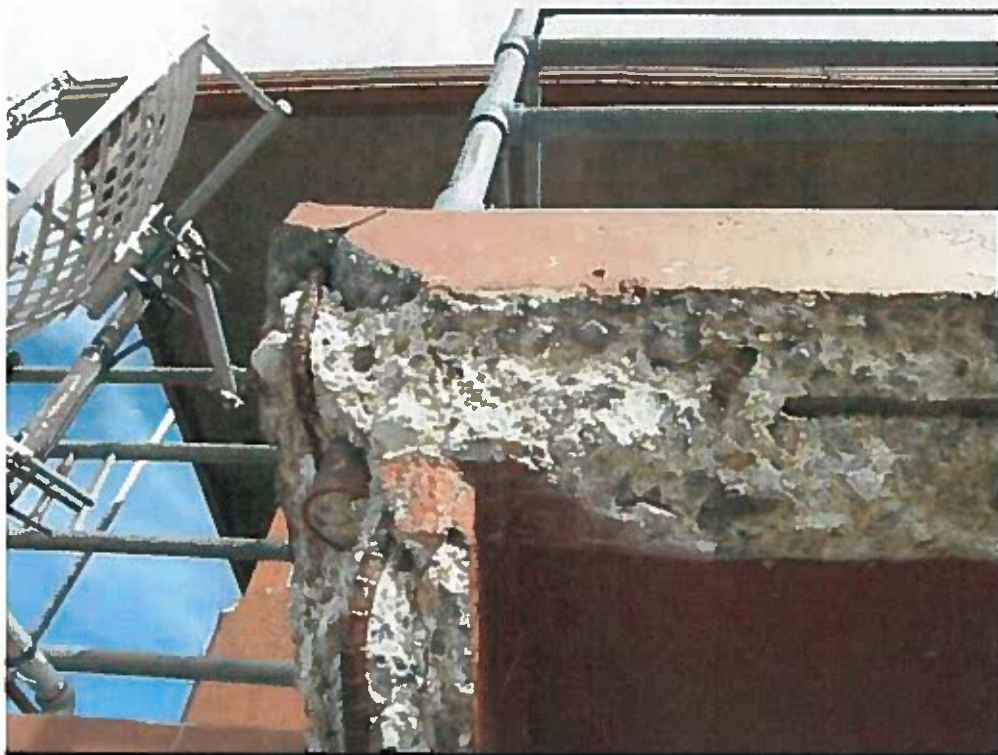
SW CORNER OF THE UPPER LANDING AT THE EXTERIOR STAIR; THE EMBEDDED SUPPORT FOR THE RAILING AT THE LANDING HAS BEEN EXPOSED BY SPALLING OF THE CONCRETE. Photo credit: Herb Dawson, NPS.

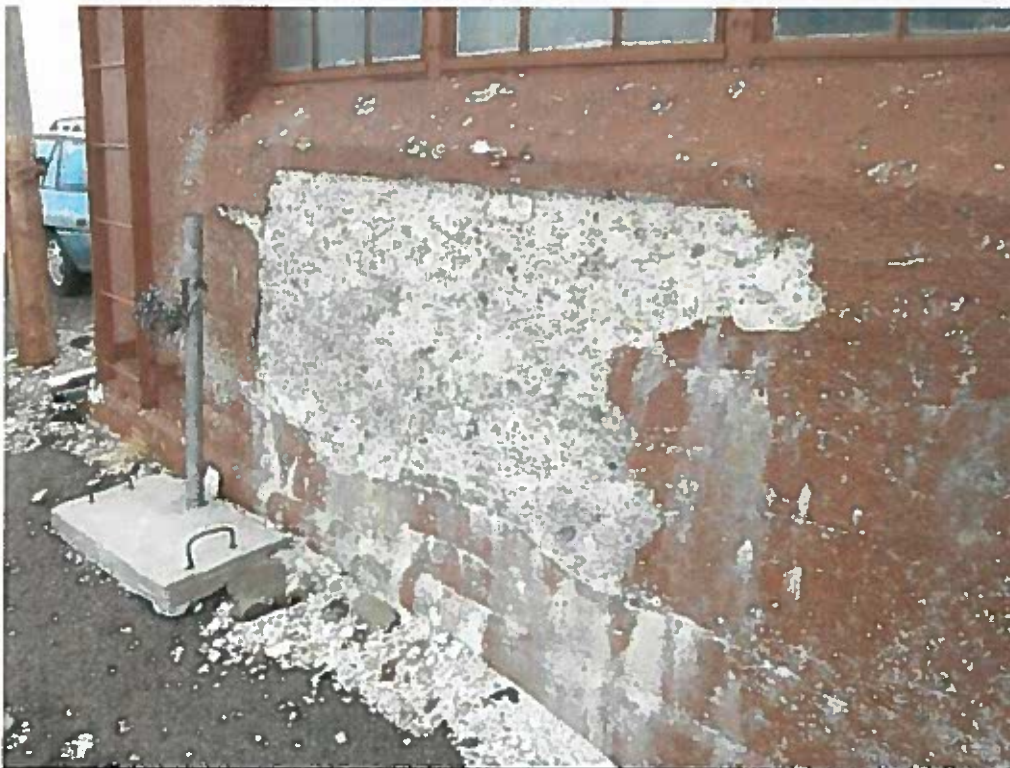
SURFACE SPALLING AT LOWER WEST WALL BELOW WINDOWS INTO LADIES RESTROOM; LOWER WALLS ARE SUBJECTED TO SNOWDRIFTS FOR EXTENSIVE PERIODS OF TIME, NOTE SECONDARY ESCAPE LADDER AT NORTH END OF WALL. Photo credit: Herb Dawson, NPS.

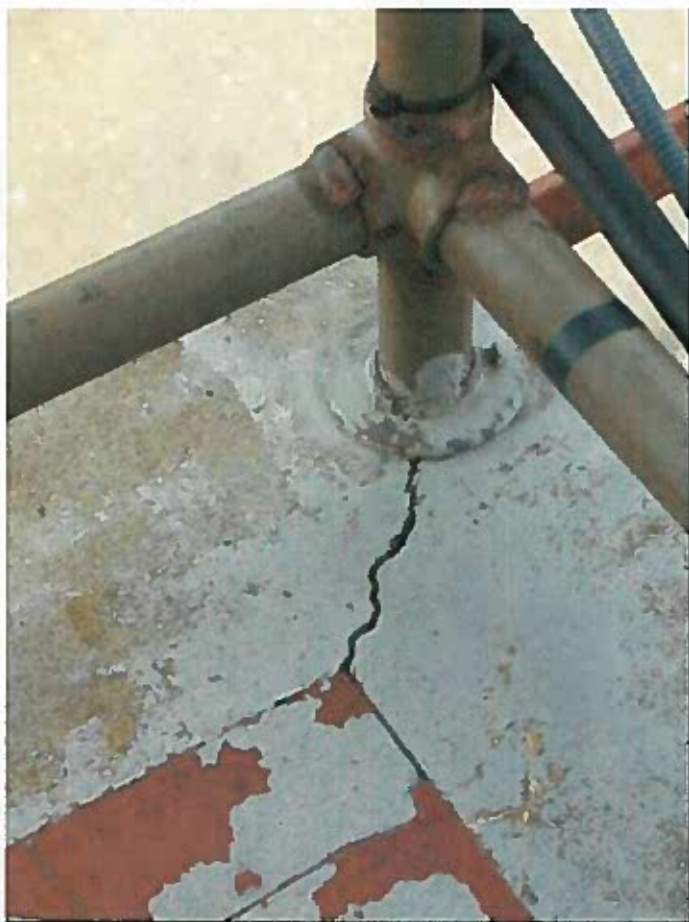
CRACK IN SW CORNER OF PROMENADE AT WALKWAY AROUND FIREWATCH AT TOP OF LOOKOUT. Photo credit: Herb Dawson, NPS.

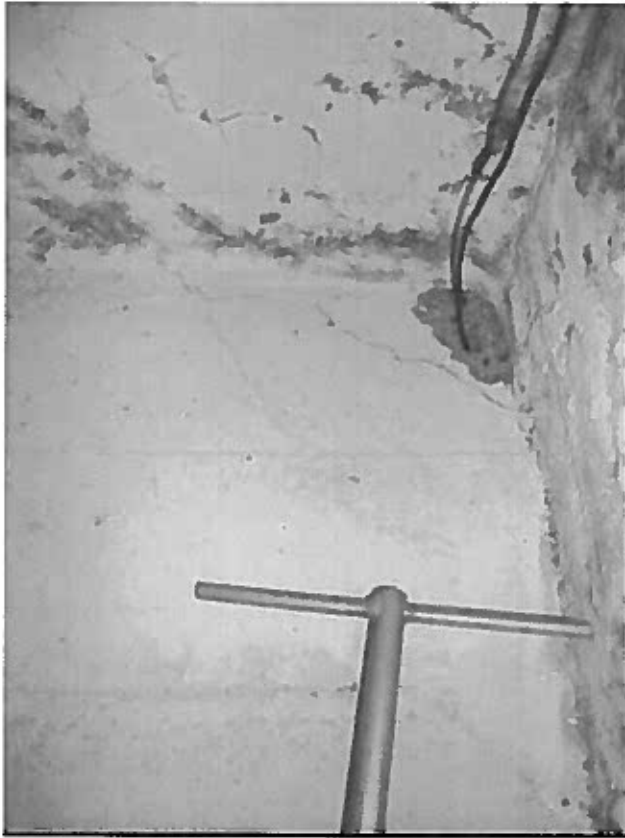
CRACK AT WEST CORNER OF NORTH WINDOW IN MENS ROOM, ATTRIBUTED TO TYPICAL STRESS CONCENTRATION FROM SHRINKAGE THAT OCCURS AT OPENINGS. Photo credit: Herb Dawson, NPS.

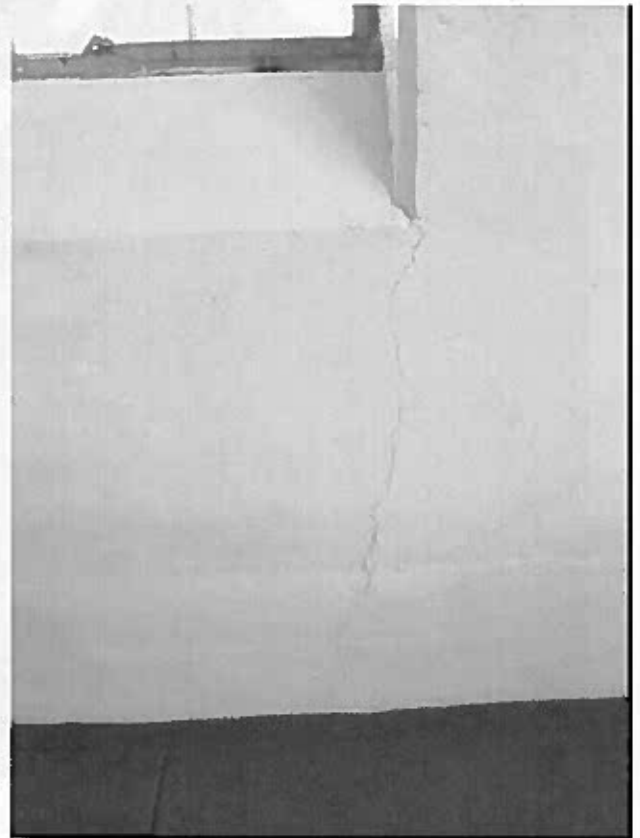
A SIMILAR CRACK AT THE EAST SIDE OF THE SAME WINDOW. Photo credit: Herb Dawson, NPS.

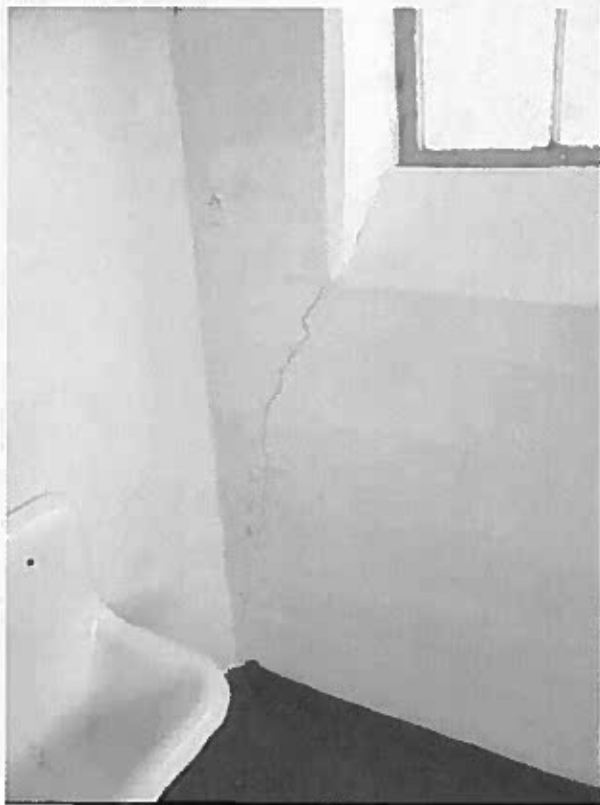
CEILING AND WALL AT INTERIOR OF UTILITY ROOM; THE CONCRETE IS PAINTED AND EXHIBITS NUMEROUS SHRINKAGE CRACKS. Photo credit: Herb Dawson, NPS.

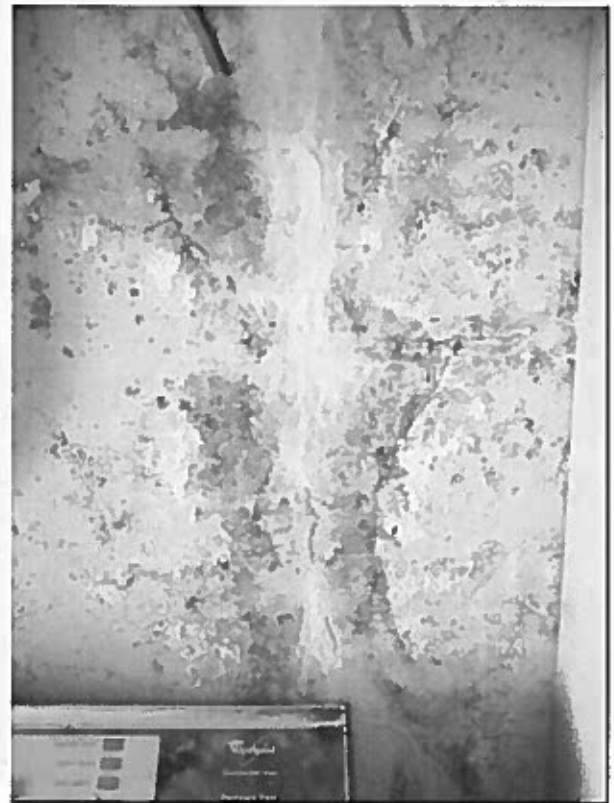
SURFACE OF WEST CONCRETE WALL IN UTILITY ROOM. EFFLORESCENCE HAS FORMED AT THE LARGER CRACKS INDICATING THAT MOISTURE HAS WICKED SOLUBLE SALTS IN THE CONCRETE TO THE SURFACE OF THE WALL. Photo credit: Herb Dawson, NPS.

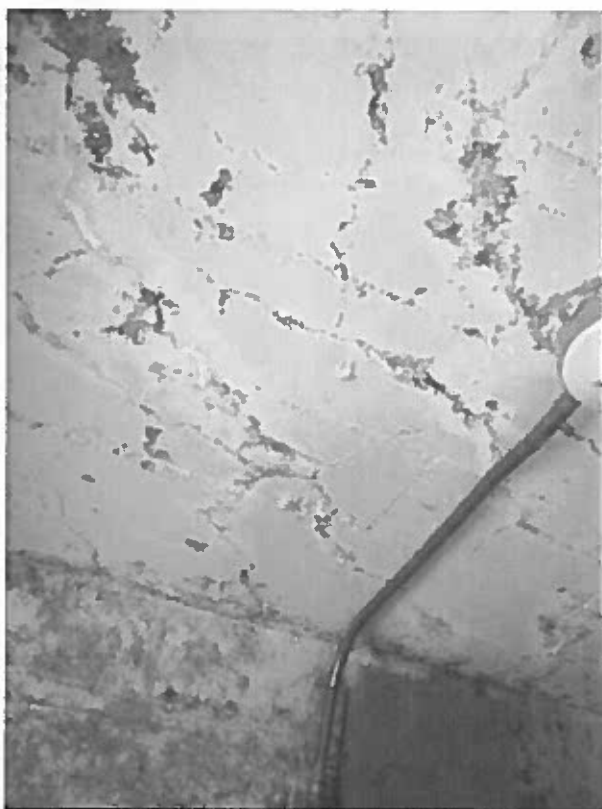
DIAGONAL CRACK AT SE CORNER OF UTILITY ROOM.

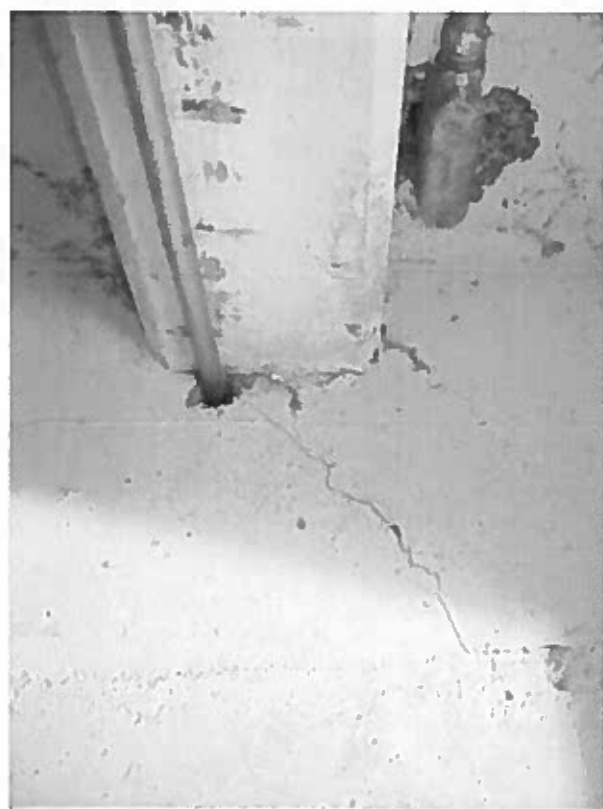
DIAGONAL CRACK BELOW STIFFENING BEAM THAT IS LOCATED BELOW THE EXTERIOR GLAZED WALL OF THE FIREWATCH SPACE ABOVE. CRACK IS ADJACENT TO THE DIAGONAL CRACK PICTURED ABOVE. THE PENETRATION OF THE CONDUIT MAY HAVE CONTRIBUTED TO THIS CRACK AND WAS INAPPROPRIATELY LOCATED AT A HIGH STRESS LOCATION WITHIN THE STRUCTURE. Photo credit: Herb Dawson, NPS.

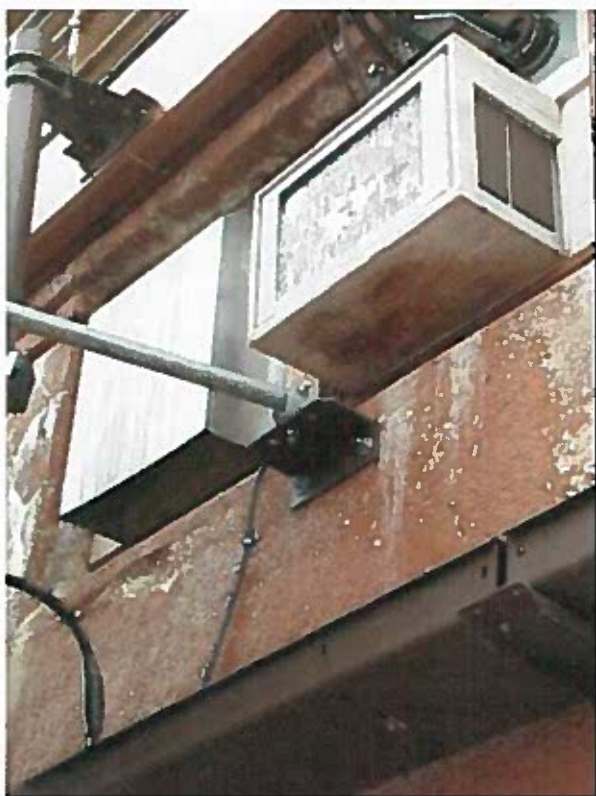
PORTABLE AIR CONDITIONER AND EXHAUST DUCT INSERTED INTO ORIGINAL WINDOW OPENING AT N WALL OF SECOND FLOOR EQUIPMENT AREA. Photo credit: Herb Dawson, NPS.

- Maintain/repair roof membrane over Firewatch.
- Paint steel stairs and railings on exterior of structure.
- Rehabilitate windows; replace selected doors.
- Redesign installation of AC units in window openings.
- Apply caulking (sealants) throughout exterior joinery.
- Consolidate / eliminate unused / improve appearance of selected attached antenna.
