REPORT ON THE REHABILITATION  
OF SITE 80-6

REDWOOD NATIONAL PARK

by  
Patrick Teti

June 1981

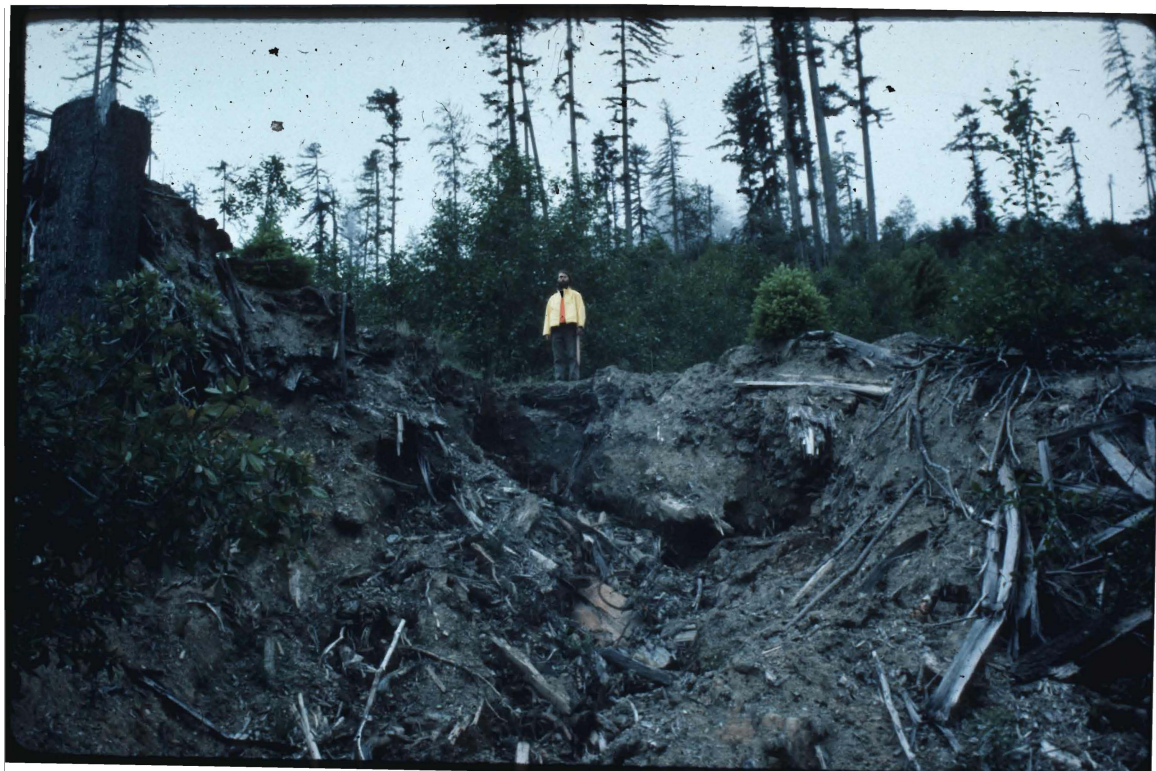
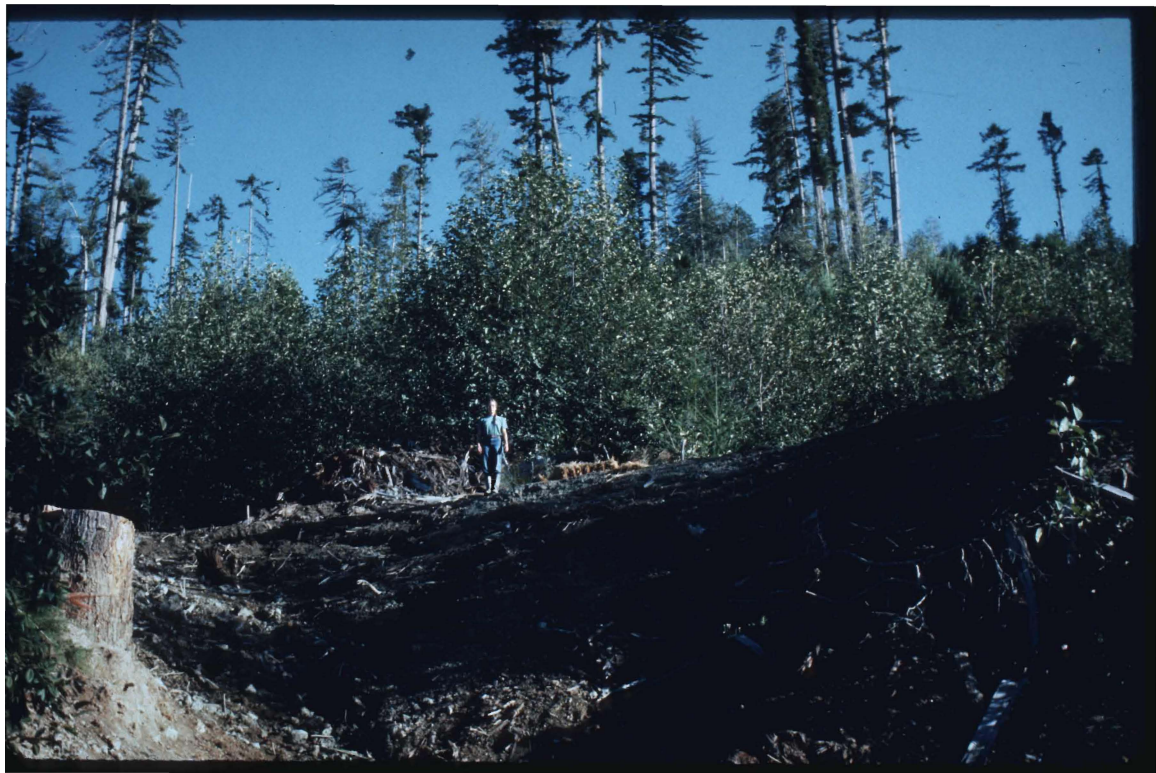
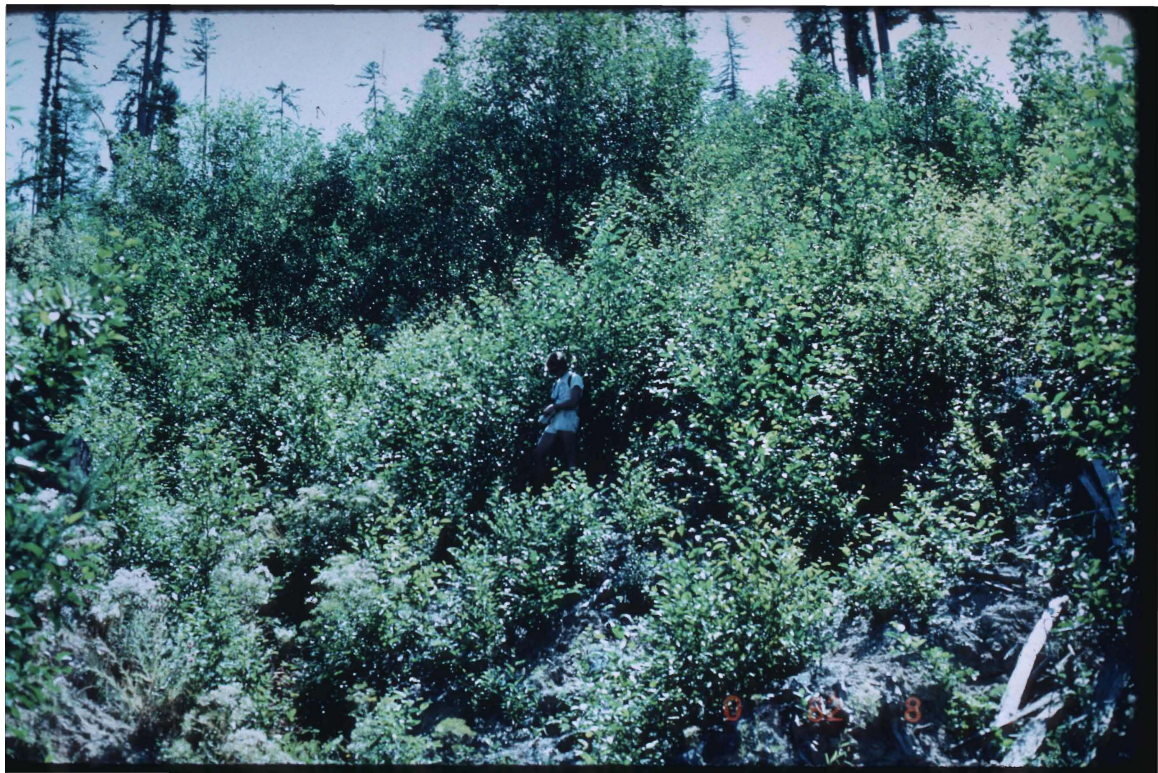
Unit: 80-6 PP#8 6/24/80 P.T.

| <u>Photo<br/>Point No.</u> | <u>Subject/Location</u> | <u>Dates of Photos</u> | <u>Film/Lens</u> | <u>Comments</u> |
|---|---|---|---|---|
| 8 | Site 9/on top of fir stump, left bank, downstream end of excavation. | 24 June 1980<br>27 October | | Before and after treatment. |

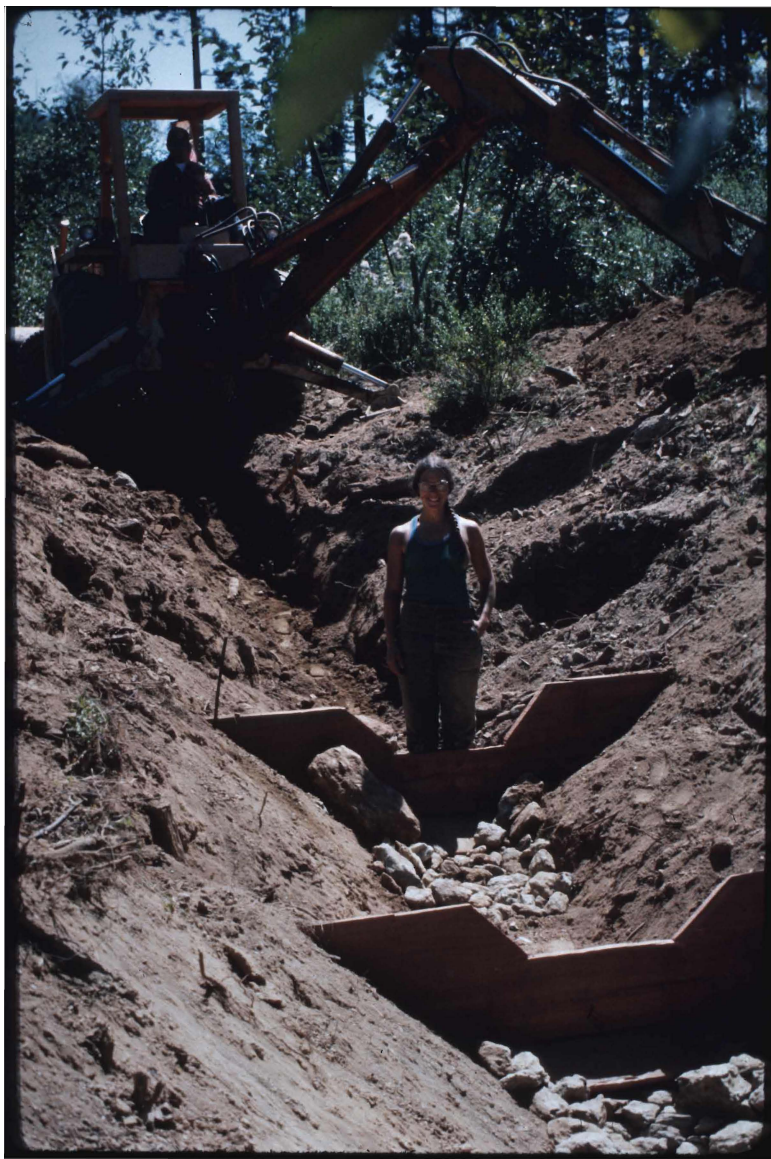
Unit: 80-6 Site 20 8/18/80

| <u>Photo<br/>Point No.</u> | <u>Subject/Location</u> | <u>Dates of Photos</u> | <u>Film/Lens</u> | <u>Comments</u> |
|---|---|---|---|---|
| 6 | Site 20/a few feet from channel right bank, downstream end of check dam reach, stake in ground. | 29 July 1980<br>18 August | slide/50mm | Before and after excavation.<br>Backhoe assisting in check installation. |

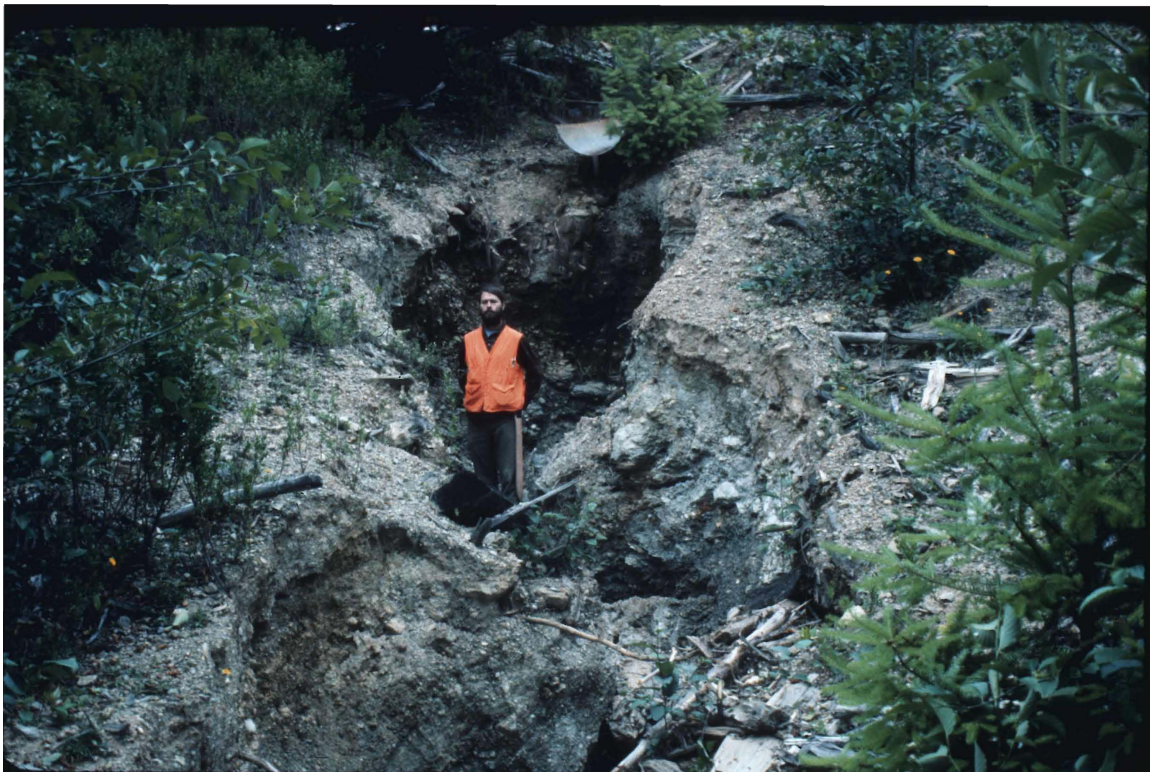
Unit: 80-6 PP#7 Gully at culvert outlet, Pre H.E. 1980

| <u>Photo<br/>Point No.</u> | <u>Subject/Location</u> | <u>Dates of Photos</u> | <u>Film/Lens</u> | <u>Comments</u> |
|---|---|---|---|---|
| 7 | Gully at outfall of culvert 600 feet down the M-7-5 road from site 31/left bank, 50 feet from the road. | 24 June 1980 | | This gully was de-watered by installation of culvert at site 31. |

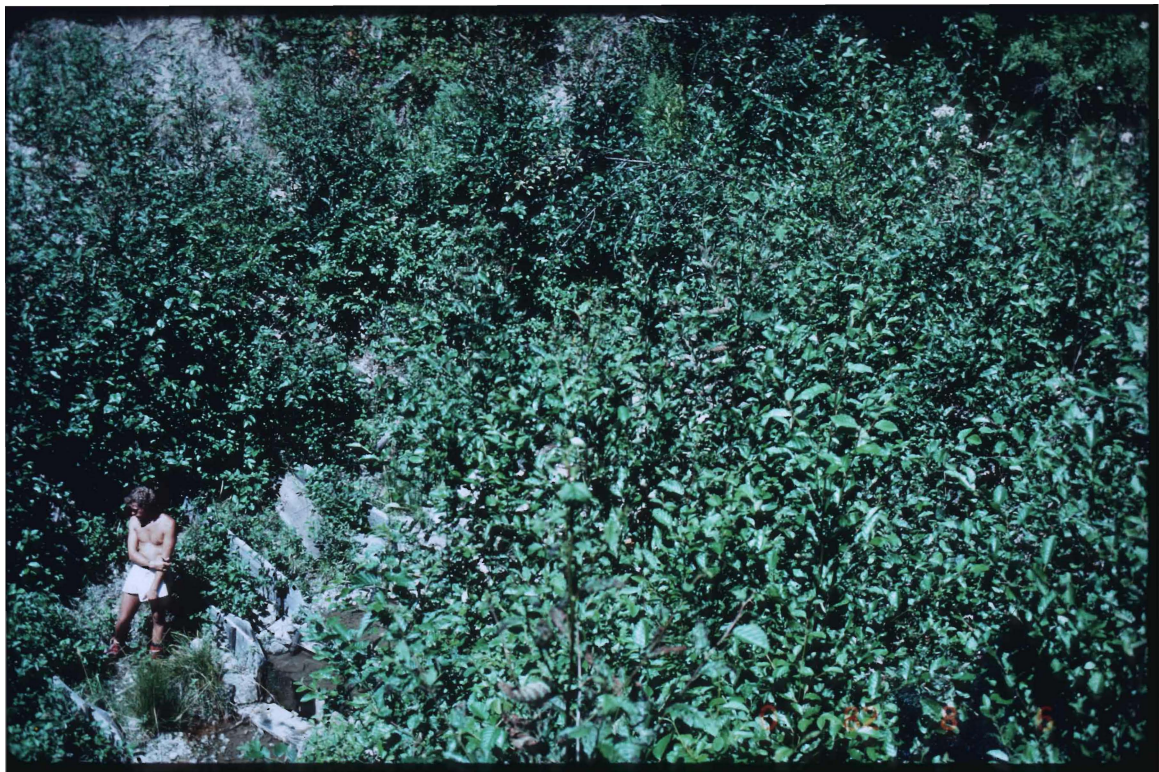
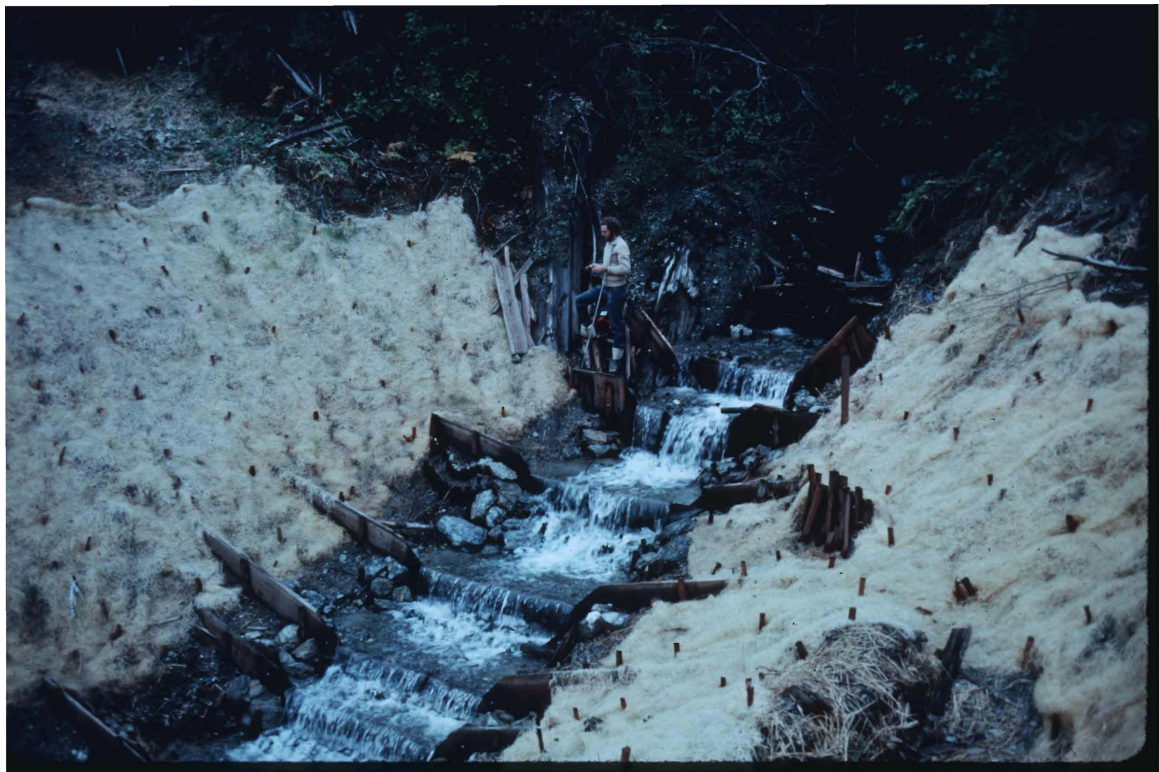
Unit: 80-6 PP#17 Site 12. 2/17/81

| <u>Photo<br/>Point No.</u> | <u>Subject/Location</u> | <u>Dates of Photos</u> | <u>Film/Lens</u> | <u>Comments</u> |
|---|---|---|---|---|
| 17 | Site 12/on top of stump, left bank | 23 July 1980<br>17 Feb. 1981 | B&W/35, 50 mm<br>slide/35 mm | Before and after excavation. |

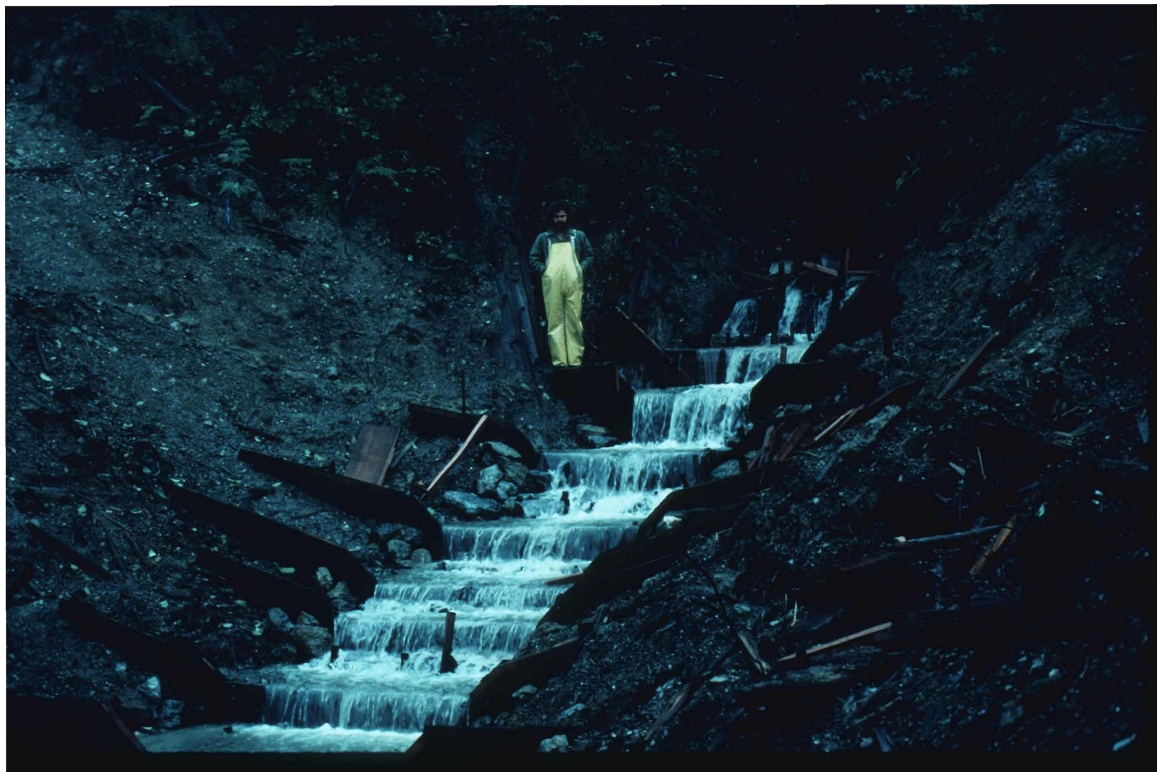
Unit: 80-6 PP#12 12/4/80

| <u>Photo<br/>Point No.</u> | <u>Subject/Location</u> | <u>Dates of Photos</u> | <u>Film/Lens</u> | <u>Comments</u> |
|---|---|---|---|---|
| 12 | M-7-5-1 1/2 road/on top of 5 ft. RW stump at top of cut bank, 1,250 feet from north end of road. | 25 June 1980<br>3 September<br>27 October | | Before, during, and after cross road drain construction. |
