# **SOIL EROSION STUDY**

**HUBBELL TRADING POST, NATIONAL HISTORIC SITE**

**Ganado, Arizona**

SOIL EROSION STUDY  
HUBBELL TRADING POST NATIONAL HISTORIC SITE  
GANADO, ARIZONA  
CX 702930008

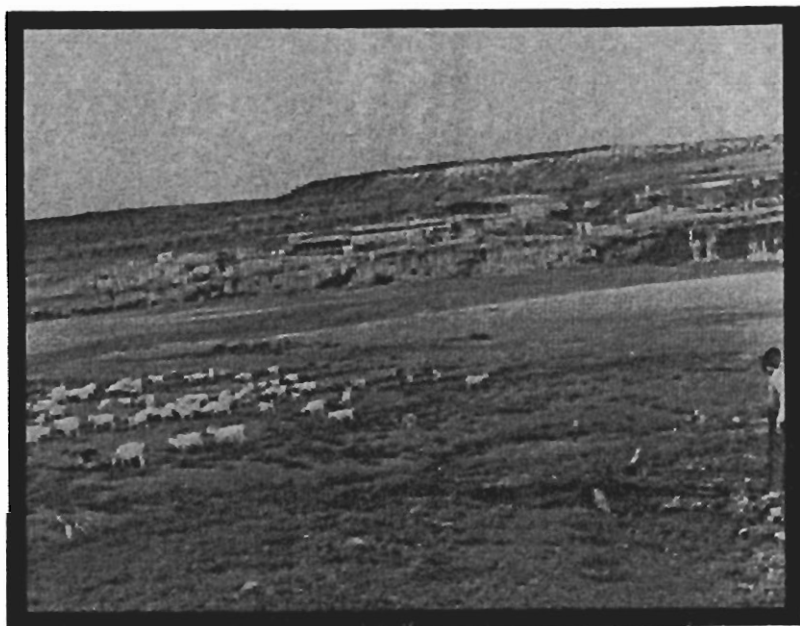
A striking feature of all the historic photographs, particularly in comparison with existing conditions (cf. Photo 18) is the lack of vegetation inside the banks of the wash. Photo 2 shows the limited scrub vegetation characteristic of the wash at this time. These photographs also demonstrate that the inner terraces (Units Qa<sub>1</sub>, and Qt<sub>1</sub> to Qe<sub>4</sub>) mapped on Plate 1 are recent geomorphic features that postdate 1920. Older upper terrace units are apparent above the banks of the wash (Photos 3, 5, 6, and 7), and correspond to units Qt<sub>5</sub>, Qt<sub>6</sub>, and Qoal on Plate 1. These upper units, based on the description of Ives (1861) and the photographic evidence (Photos 2, 8), were extensively grazed during this period. Furthermore, Gregory (1917, p. 89) reported that:

Photo 2: A view (ca. 1910) looking southeast from across the Pueblo Colorado Wash. The streambed is unvegetated and cut banks are shown on the south bank west of the Trading Post.

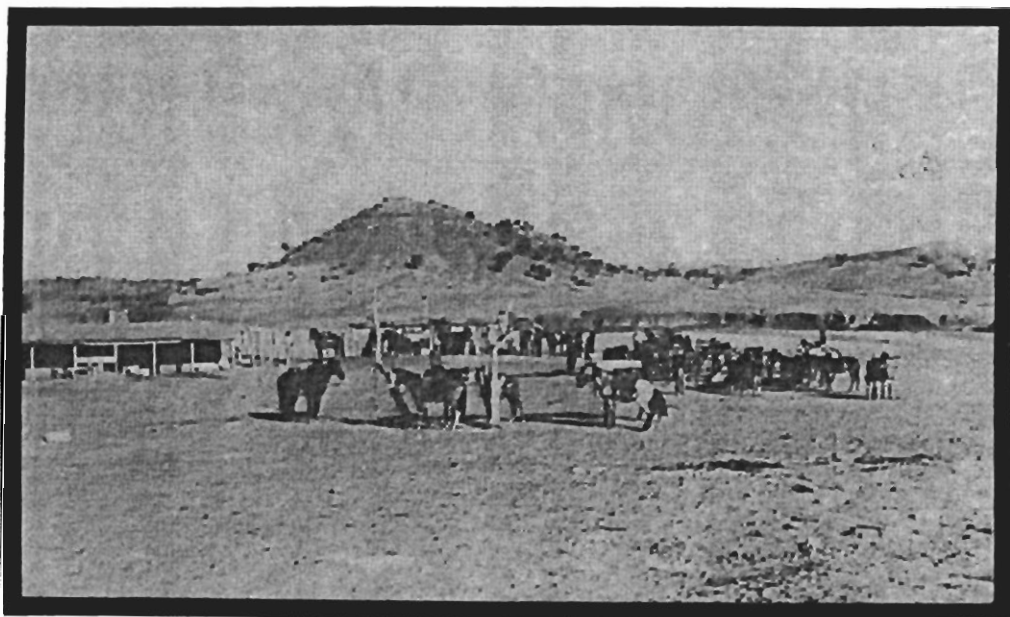
Photo 6: A view from the Trading Post (ca. 1913) toward Hubbell Hill. Moderate banks are noted on the north bank of the wash; these were undetected in previous photos taken from the north side of the wash.

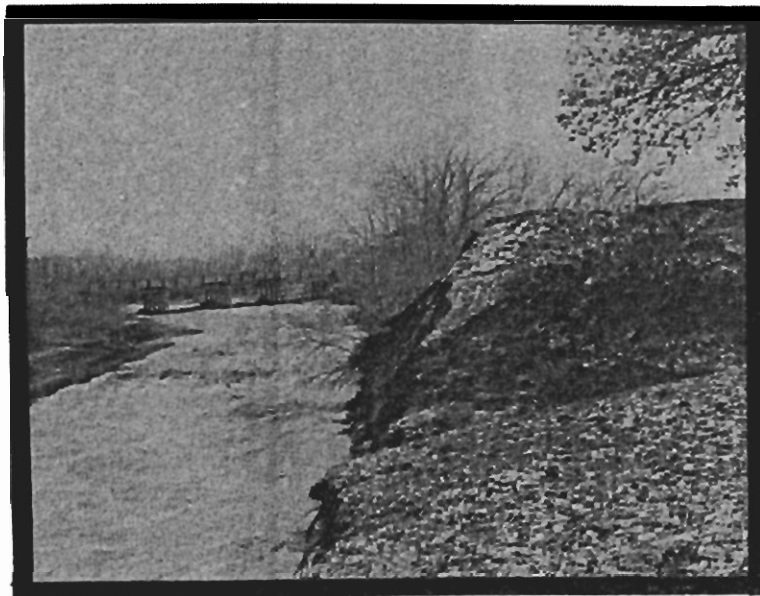
Photo 10: Documentation of the erosion of Wide Reed Ruins. Highway bridge upstream, viewing northeast (April, 1973).

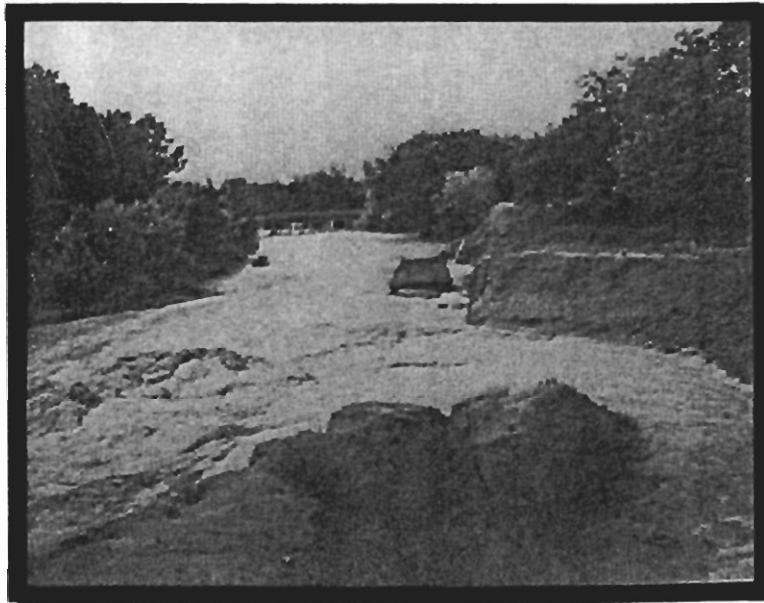
Three photographs (Photos 13, 14, and 15) dated from early summer, 1974, document flooding in Pueblo Colorado Wash and the beginning of the failure of the engineering structures.

Photo 13: View upstream (northeast) showing flood crest, standing waves, and bankcutting near Wide Reed Ruins.

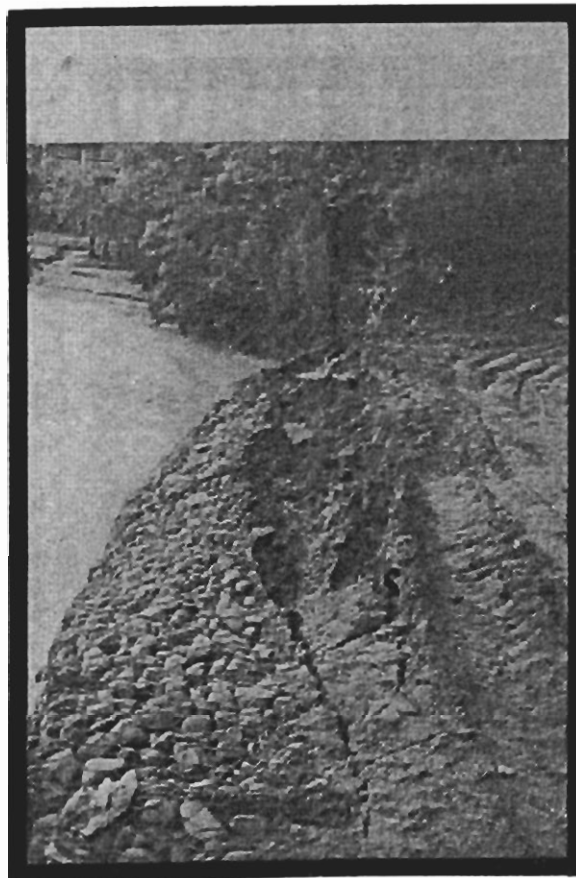
Photo 14: Close-up of failure of gabion wall after partial subsidence of the flow.

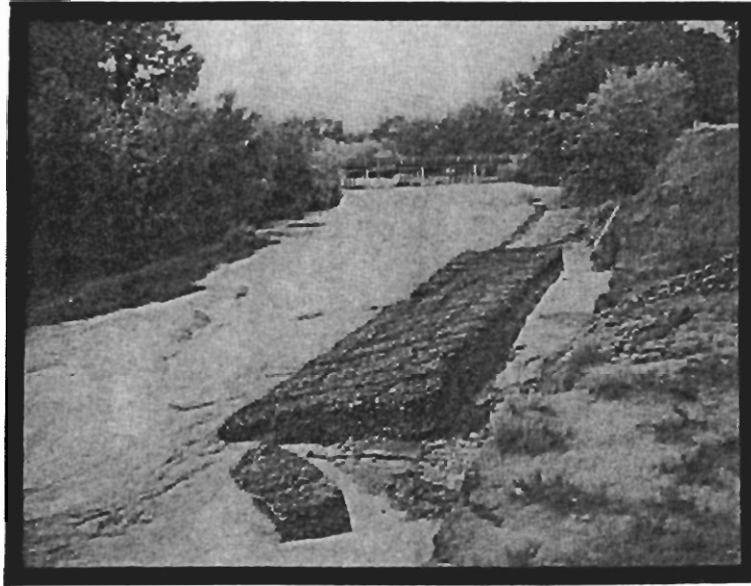
Photo 15: Close-up of subsidence of the engineering structure, due to undercutting, and the pulling away from the bank.

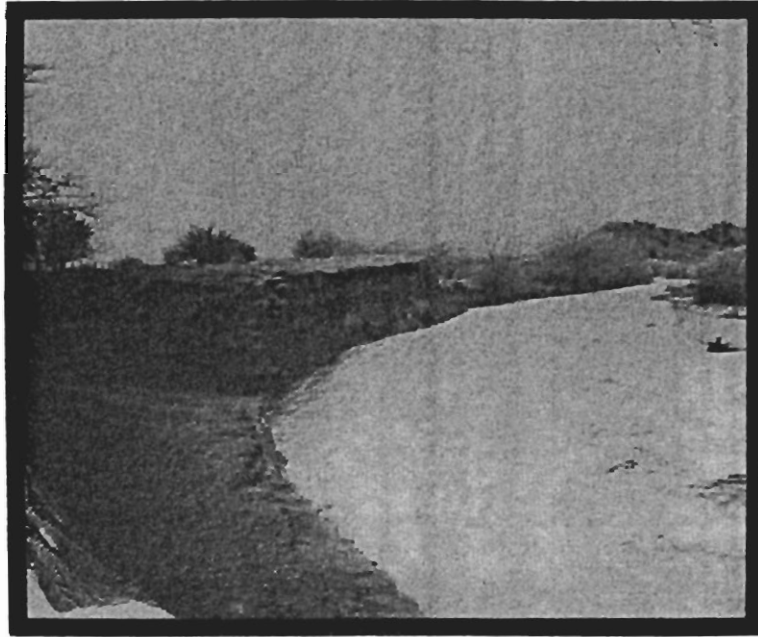
On a more localized scale, the Sand Dune site is currently undergoing accelerated soil erosion, partly as a consequence of the diversion of flow toward the Pueblo Colorado. However, as this problem is so closely connected with the undercutting of this site by the Pueblo Colorado, the proposed mitigation measures have been included in the large program (see Sections 6.0 and 7.0).

Photo 17: The cutbank caused by erosion at the Sand Dune Site (Dec. 1978).

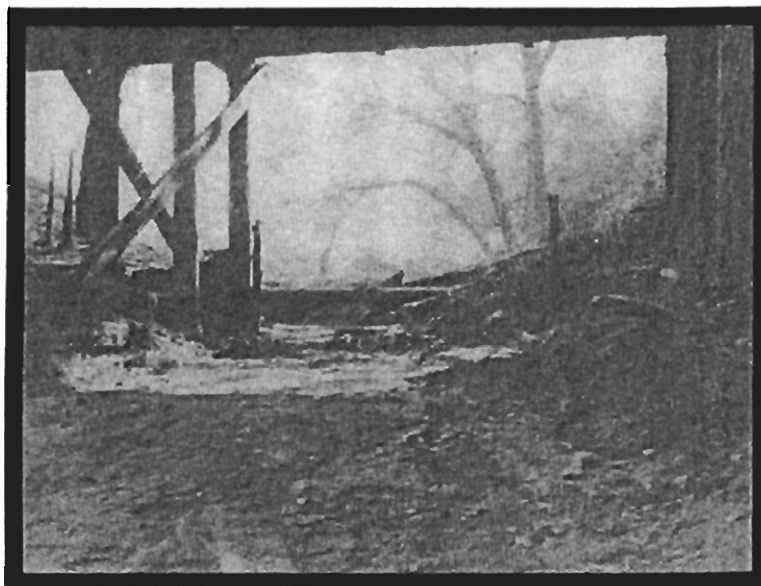
Photographs taken since the mid-1970s (e.g. Photo 19) have documented a recent cycle of headcutting at the mouth of the Upper Tributary. This has resulted in the undermining of the pilings which support the bridge providing access into the Trading Post. National Park Service personnel reported that this headcut was repaired with temporary fill in 1982. This

Photo 19: Headcutting (including undercutting of a utility line) in the Upper Tributary beneath the access bridge (November 1974).

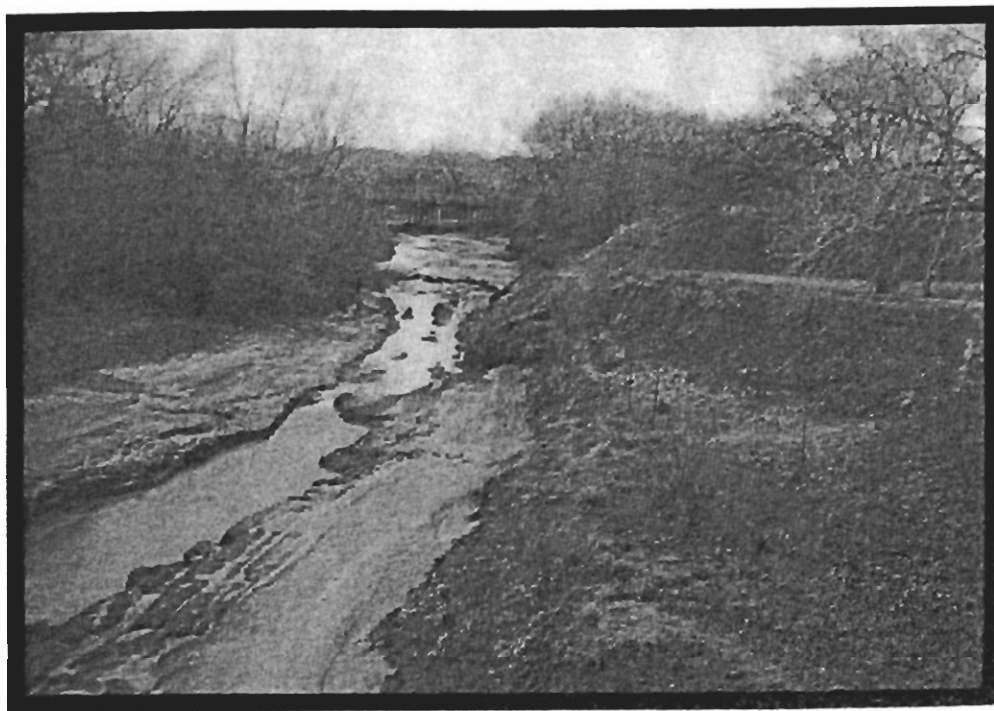
Photos 20 and 21 document the recent incision of the wash floor and the continued failure of the engineering control structures. In comparison with the wash in 1974 (Photo 11), the present bed (Photo 20) is deeply incised downstream of the knickpoint in the channel. Upstream of the knickpoint, channel entrenchment has been minimized by the presence of a sandstone cap rock which has also helped to maintain the integrity of the gabion structure (Photo 21). Downstream the stream has also eroded

Photo 20: A view upstream from the Sand Dune Site showing the failing gabion, the highway bridge, and channel incision (May, 1983).

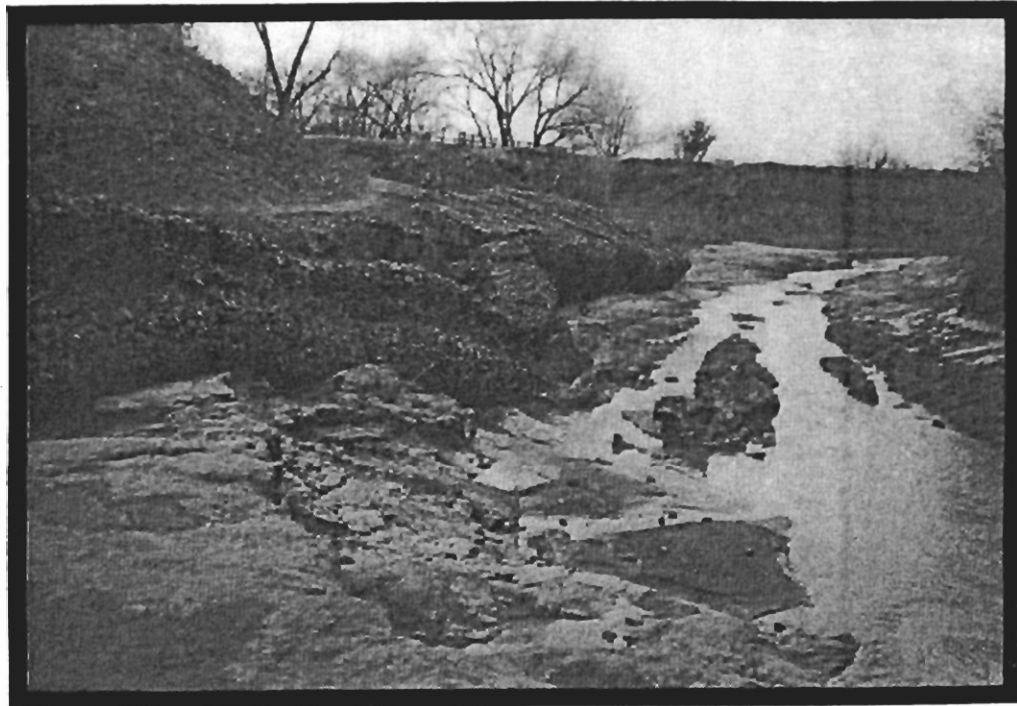
through the alluvial deposits and into the nonresistant mudstone bedrock underlying the channel. This has allowed continued incision and bank erosion resulting in the almost complete failure of the gabion below the knickpoint.

Photo 21: Continued failure of the gabion and channel incision, view downstream (May 1983), southwest.

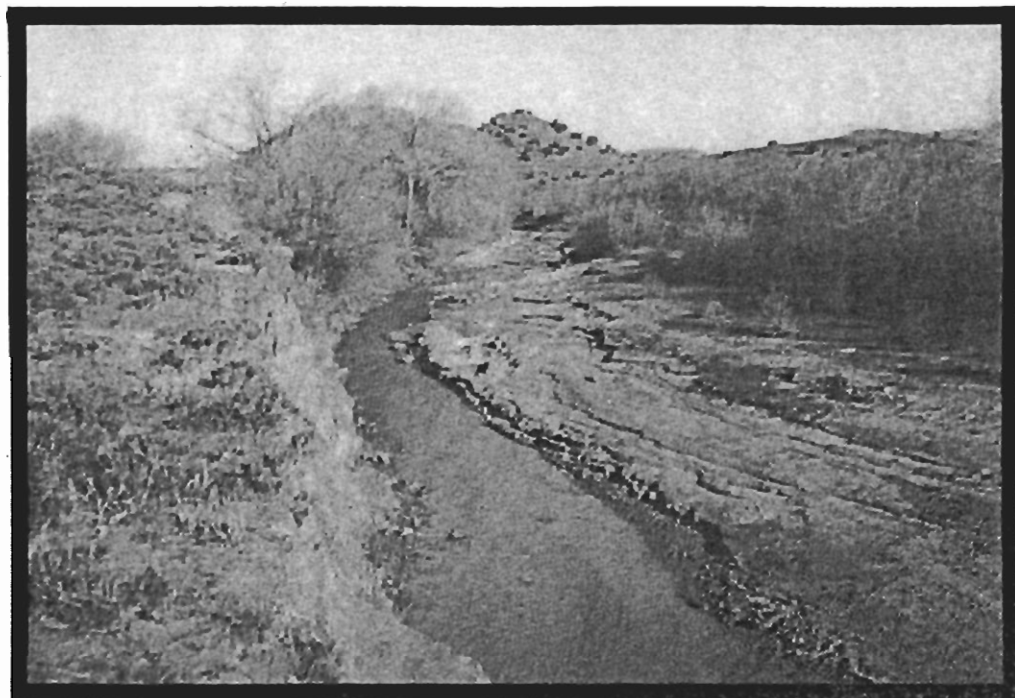
Photo 22: A view downstream from the Sand Dune Site (May 1983); note channel incision.

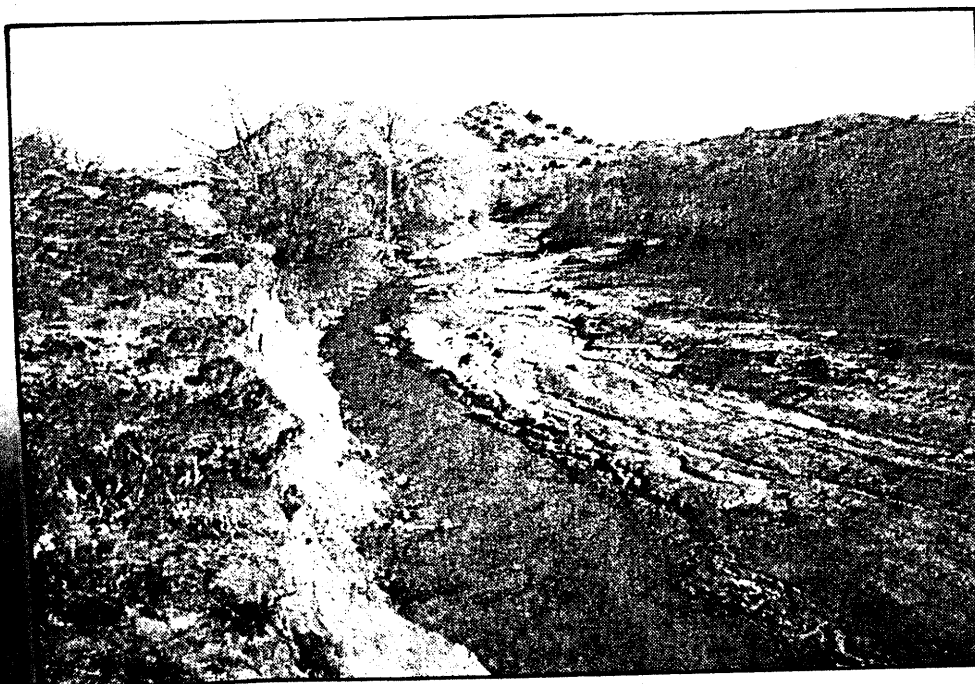
Pueblo Colorado Wash Looking Downstream; Dune Site (Left Center Foreground) Exhibits Steep Erosional Bank Cutting; Stream Terrace (Qt1, Qt2, & Qt3) To Right Of View; Hubbell Hill Center Background.
