SUMMARY OF EROSION-CONTROL REHABILITATION WORK

UNIT 81-1

NORTH COPPER CREEK AND MANEZE PRAIRIE

March 1982

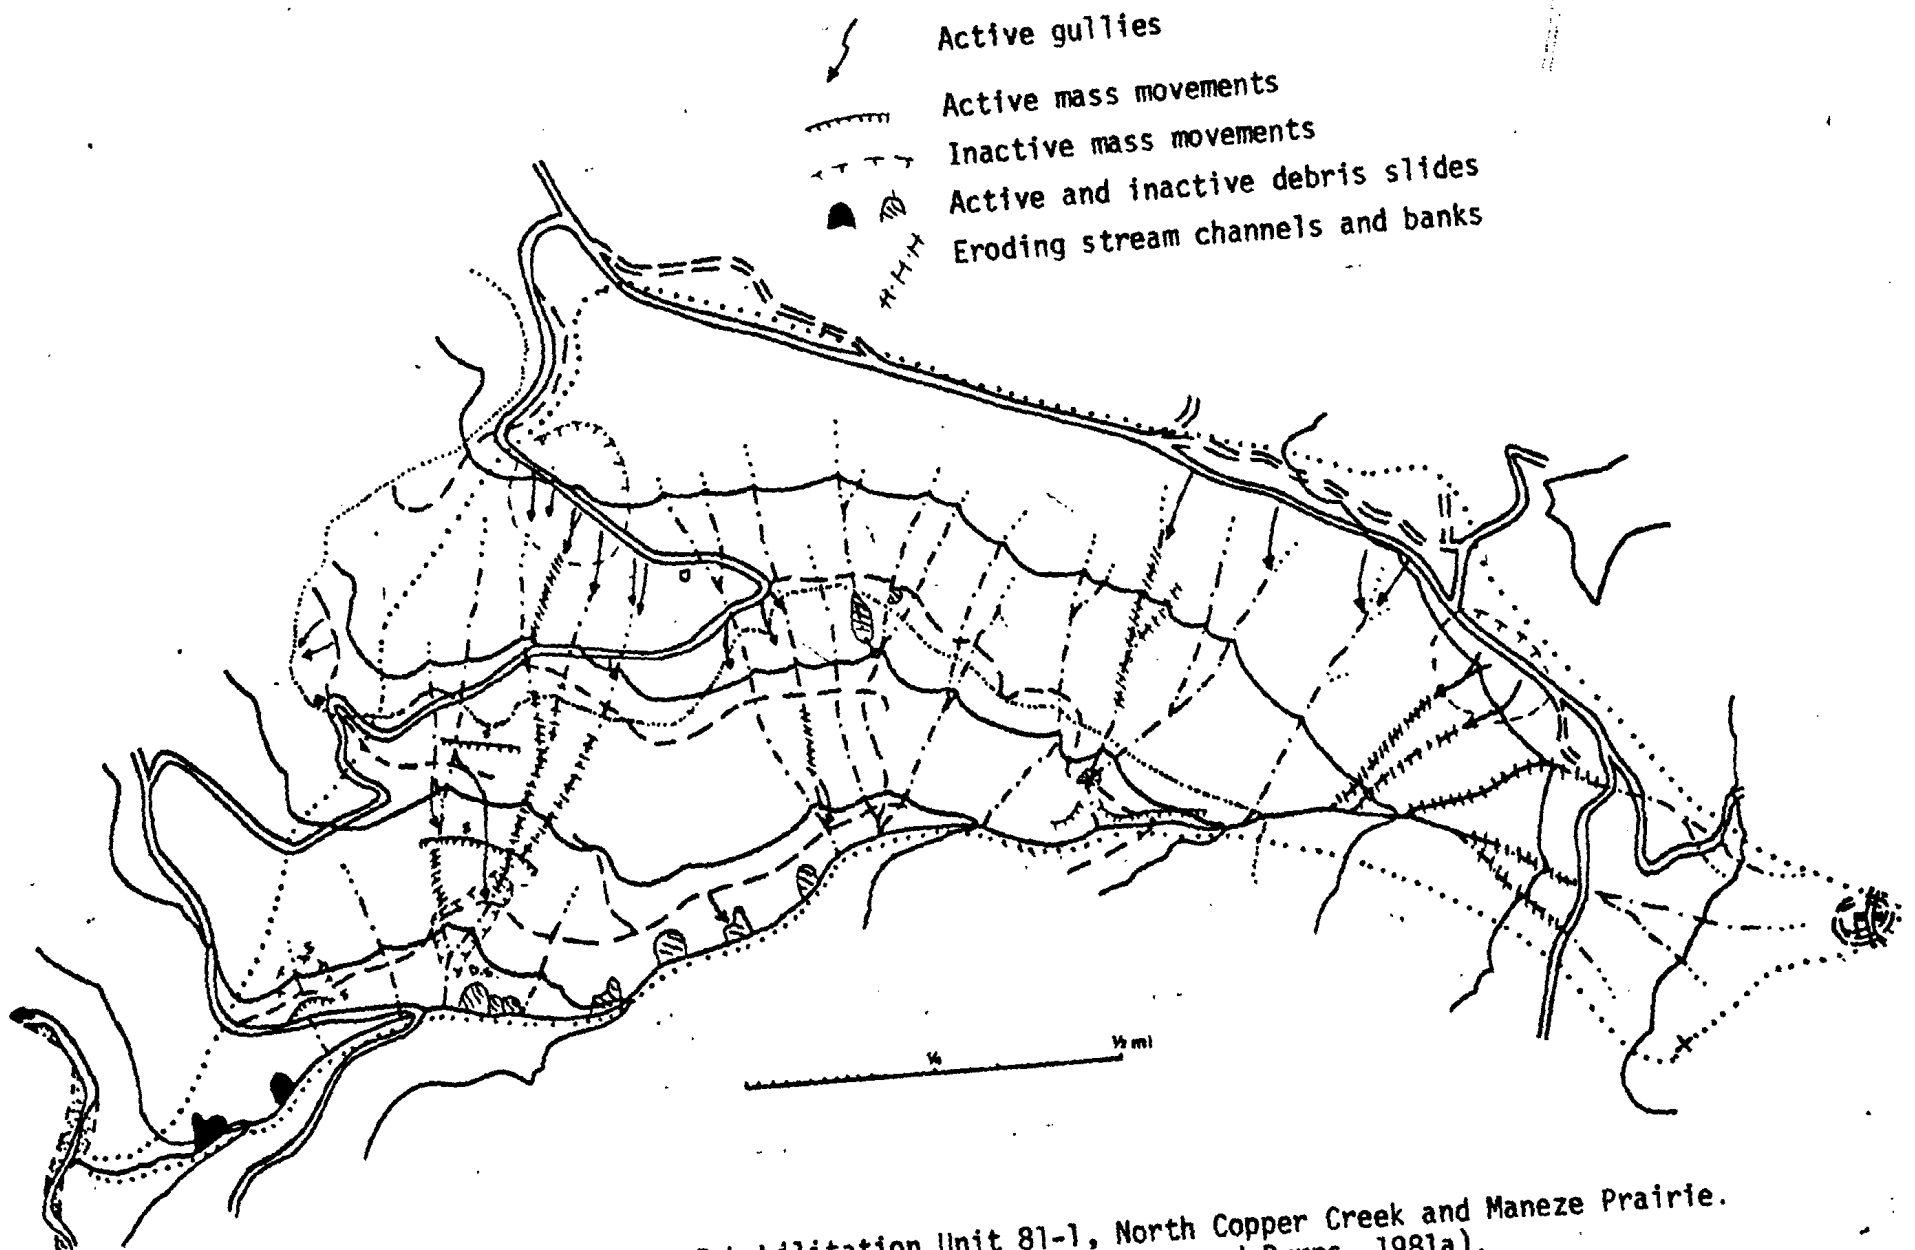
Figure 3. Erosion features, Rehabilitation Unit 81-1, North Copper Creek and Maneze Prairie.  
Based on 1:12000 detailed geomorphic maps (Utley and Burns, 1981a).

In the forested lands, several areas show presently active mass movement. An area of slumping occurs below the first stream crossing along the lower road (Fig. 3). The causes of this feature are not clear, but may be related to an older road failure which occurred downslope along the K & K. A large area adjacent to and between the two stems of the third intermittent tributary to Copper Creek is undergoing complex slumping and debris sliding (Utley and Burns, 1981a). The causes of these features may have been drastic landscape and drainage modification upslope created by the 1954 timber harvest. Further upslope along these tributaries, additional slumping is occurring near the prairie/oak woodlands boundary (Fig. 3). This also appears to have been induced by landscape and drainage alteration caused by the 1954 timber harvest.

The largest and most erosive mass movement area is adjacent to Copper Creek in the middle and upper basin (Fig. 3). Large scale slope instability occurs as slumping and compound debris sliding (Utley and Burns 1981a). This appears to have been induced by extensive landscape modification and timber removal from a very steep, unstable hillslope.

Smaller mass movement features occur across the unit ranging from sidecast-fill slumps along haul roads and landings, to larger debris slides from steep, stream-bank slopes (Fig. 3; Utley and Burns, 1981a). Numerous of these slides occur along the steep slopes of the "inner gorge" of Copper Creek. Most appear to have been induced by landscape modification, timber removal, and log jam formation.

Elsewhere in the forested lands, a single, large, active gully occurs in the middle basin (Fig. 3). This was caused by a skid-trail diversion of a stream following 1970 timber harvest. Several inactive gullies occur upslope of this area below Maneze Road.

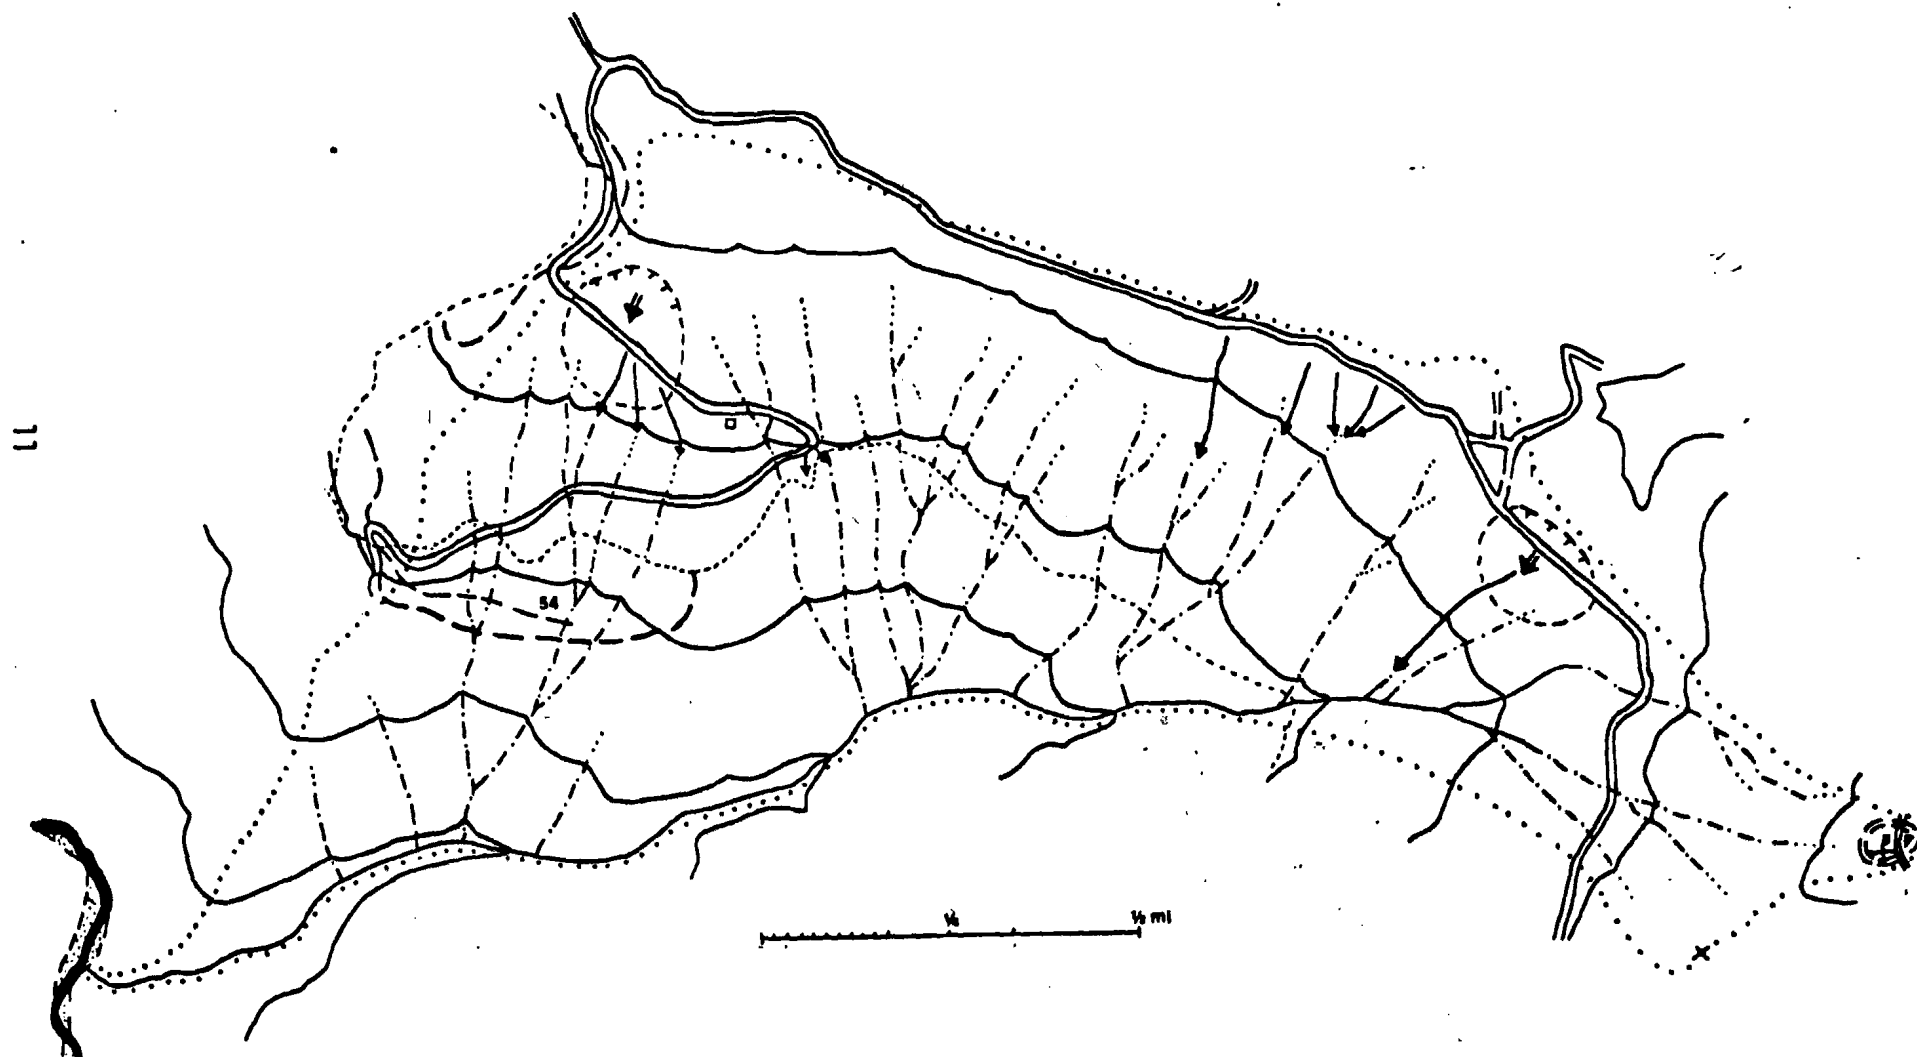
Figure 4. Erosion features 1954 - Rehabilitation Unit 81-1, North Copper Creek and Maneze Prairie. From aerial photographs August 1954 and topographic map information.

Gullies and eroded stream channels existed below the old alignment of Bald Hills Road just west of Schoolhouse Peak. The earthflow in this area was present and several small gullies extended downslope from it. The remainder of the basin remained in old growth forest with no obvious erosional features visible through the forest canopy. Presumably, in the summer of 1955 the other middle road was constructed and timber harvest occurred (Fig 4). In December 1955, a major storm occurred.

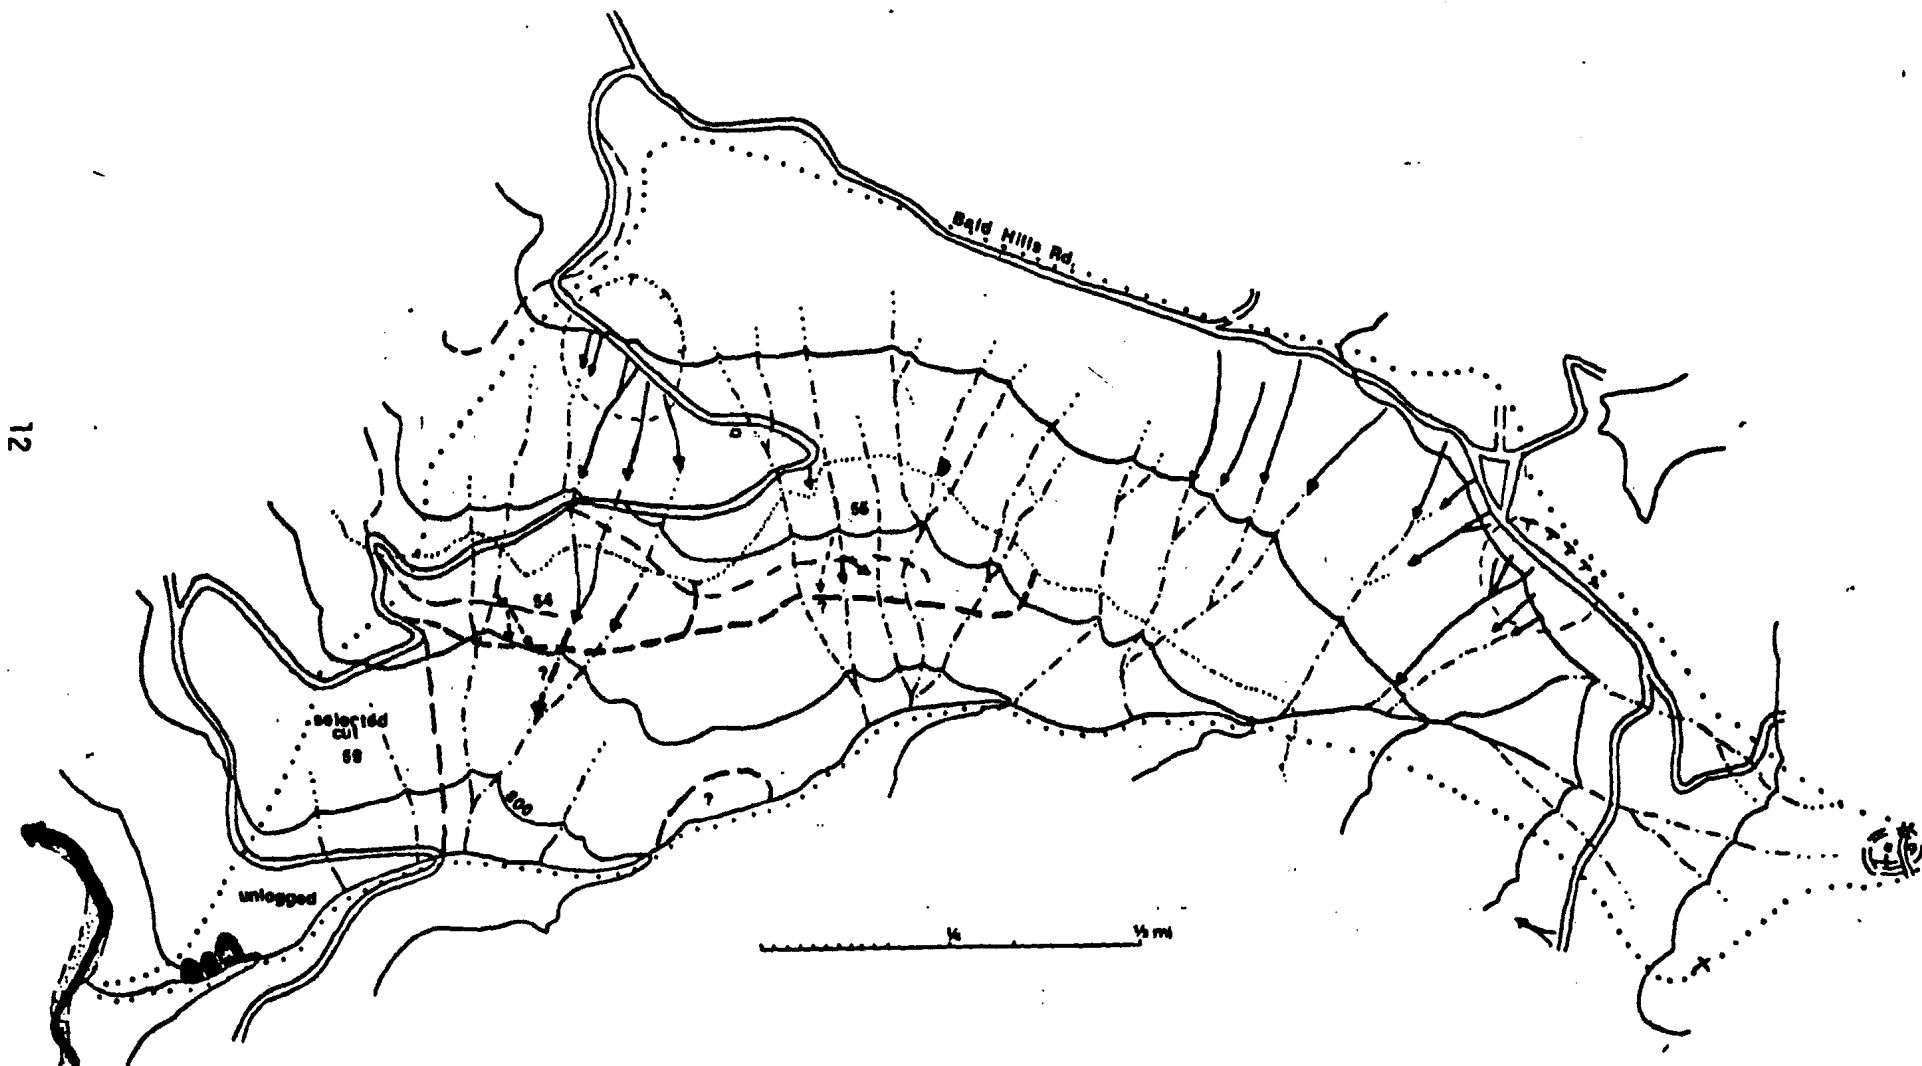
Figure 5. Erosion features 1962 - Rehabilitation Unit 81-1, North Copper Creek and Maneze Prairie. Shows effects of 1950's logging and major storm of December 1955. From aerial photographs 1962.

The erosional features presumable brought on by the December 1955 storm are visible in the 1962 photos. On the prairies, gullies continued to erode and several new gullies were formed (Fig. 5). A small slump had occurred on the prairie just below the future alignment of the upper road. This apparently was a naturally occurring feature. In the 1954 and 1955 logged areas, stream channel erosion was occurring upslope of the lower middle road. A stream was being diverted down this road and possibly forming gullies into the old growth below as evidenced by down timber and linear breaks in the canopy. The upper middle road showed few erosional features although the stream crossings may have eroded in part. Some gully or stream channel erosion may have occurred on one stream (Fig. 5).

Downstream from the K & K on Copper Creek several debris slides had occurred (Fig. 5).

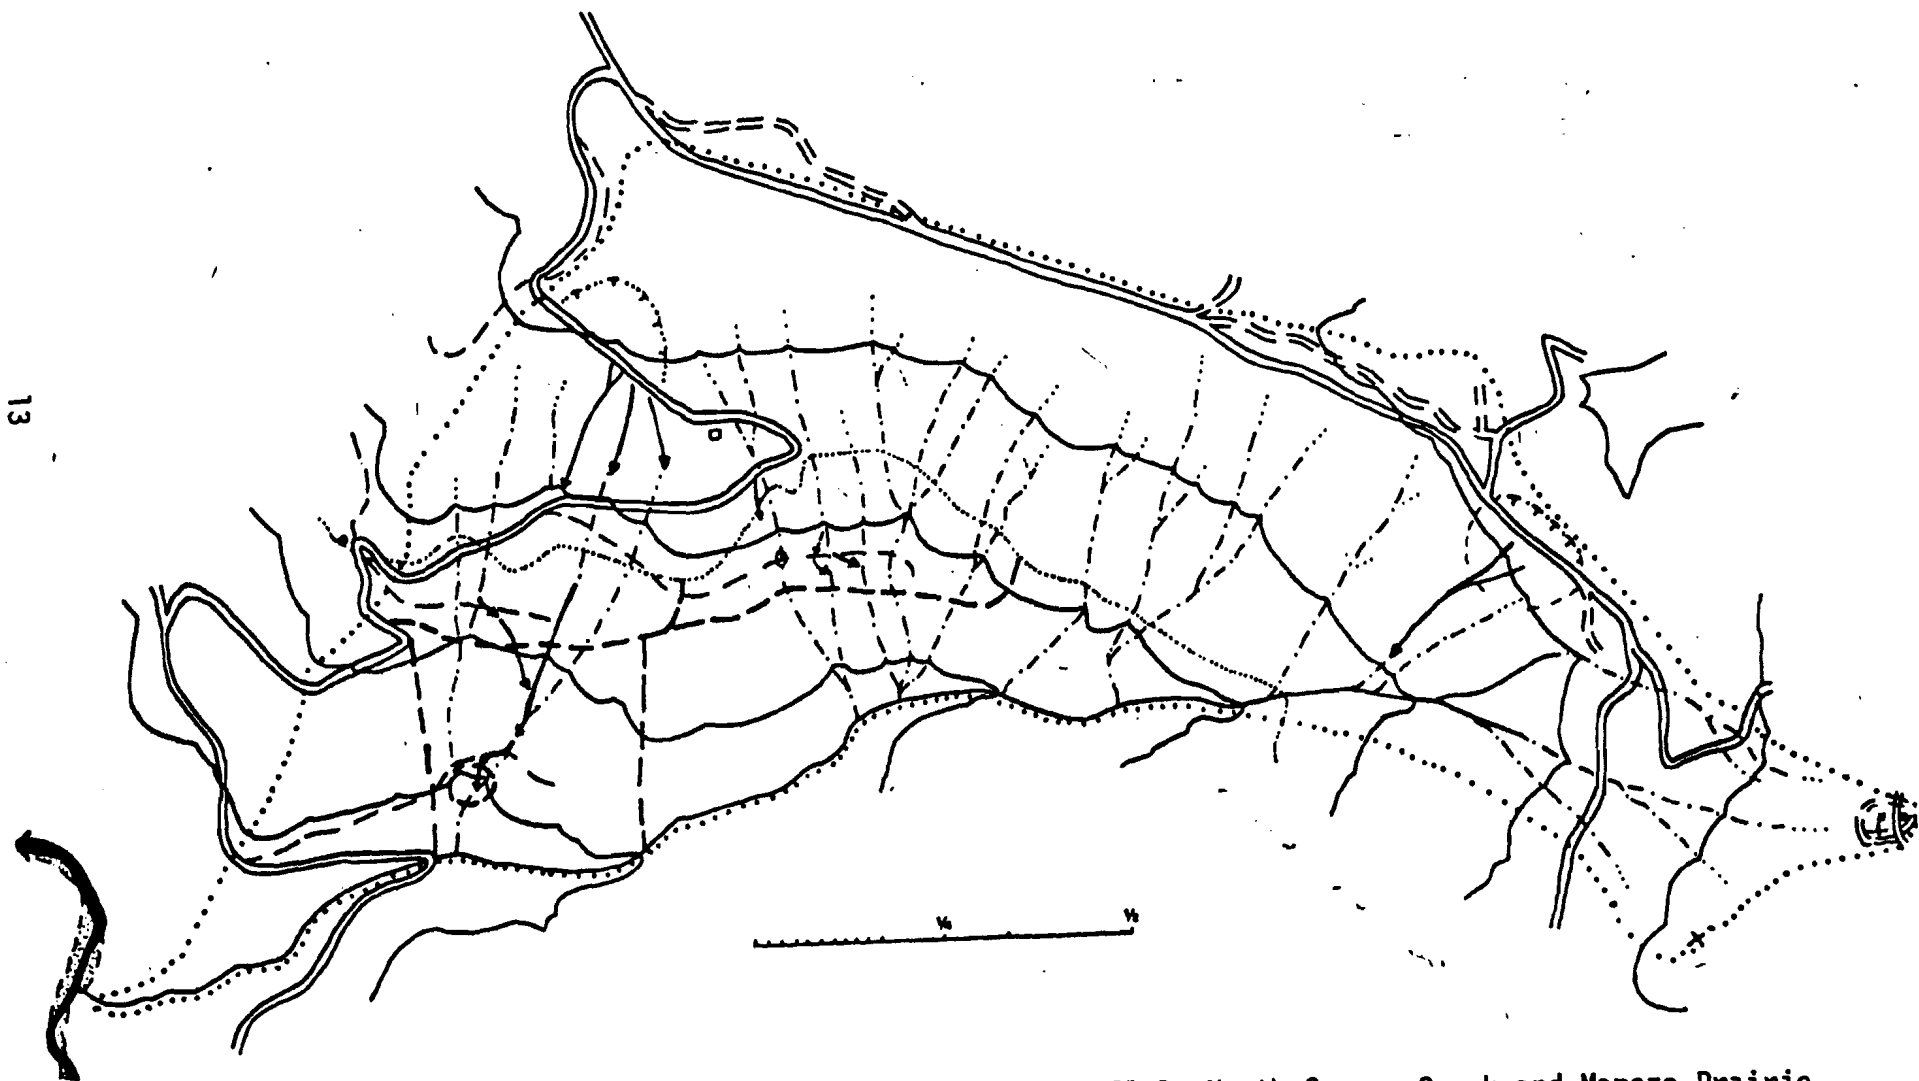
Figure 6. Erosion features 1968 - Rehabilitation Unit 81-1, North Copper Creek and Maneze Prairie. Shows effects of logging and major storm of , 1964. From aerial photographs 1966 and 1968.

The single most obvious effect of this storm on the prairie lands was the extensive erosion in two gullies on the earthflow below Bald Hills Road. Another gully was formed below Maneze Road by a stream diversion at a road crossing. Elsewhere on the prairies, some stream channel and gully erosion occurred but is less conspicuous.

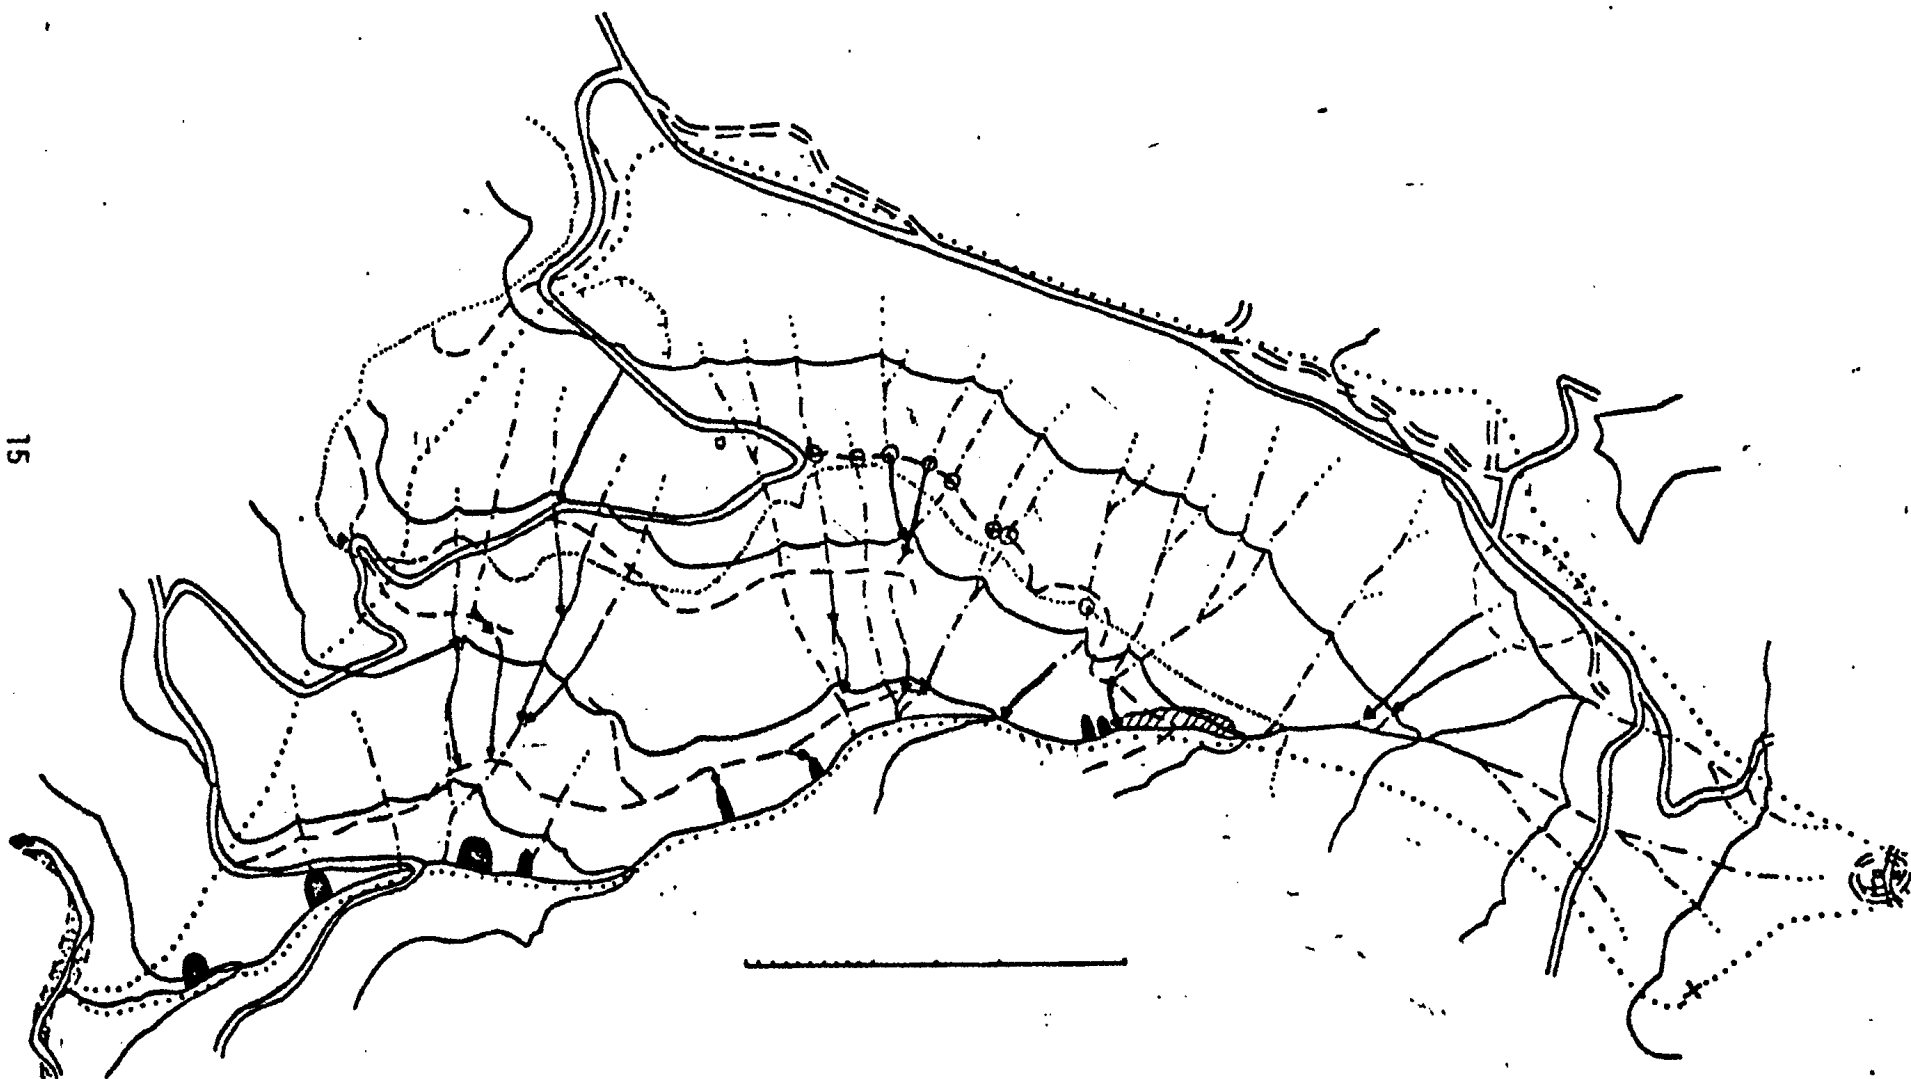
Figure 7. Erosion features 1973 - Rehabilitation Unit 81-1, North Copper Creek and Maneze Prairie. Shows effects of logging and major storms of January and March 1972. From aerial photographs 1972 and 1973.

The prairie lands were the least impacted, showing only continued gully erosion on the earthflow below Bald Hills Road (Fig. 7). All of the road-stream crossings on the upper road were eroded, although without any stream diversions. Some extensive stream bank channel erosion occurred below two crossings along the upper road. Stream bank erosion occurred along the large gullied channel on Maneze Prairie.

In the forested land, widespread channel and bank erosion occurred on most streams in the middle basin (Fig. 7). One stream was diverted by a skid trail and eroded a large gully. In the lower basin, stream channel and bank erosion was extensive. The stream diverted by the lower middle road eroded a large gully system down to and across the lower road (Fig. 7). Large debris slides occurred in the drainage below the lower road. All road crossings along the lower road were eroded to varying degrees. Many debris slides both large and small occurred along the "inner gorge" slopes of Copper Creek (Fig. 7). A large area of many interrelated slides occurred in the upper basin destabilizing a large stretch of stream side slopes (Fig. 7).

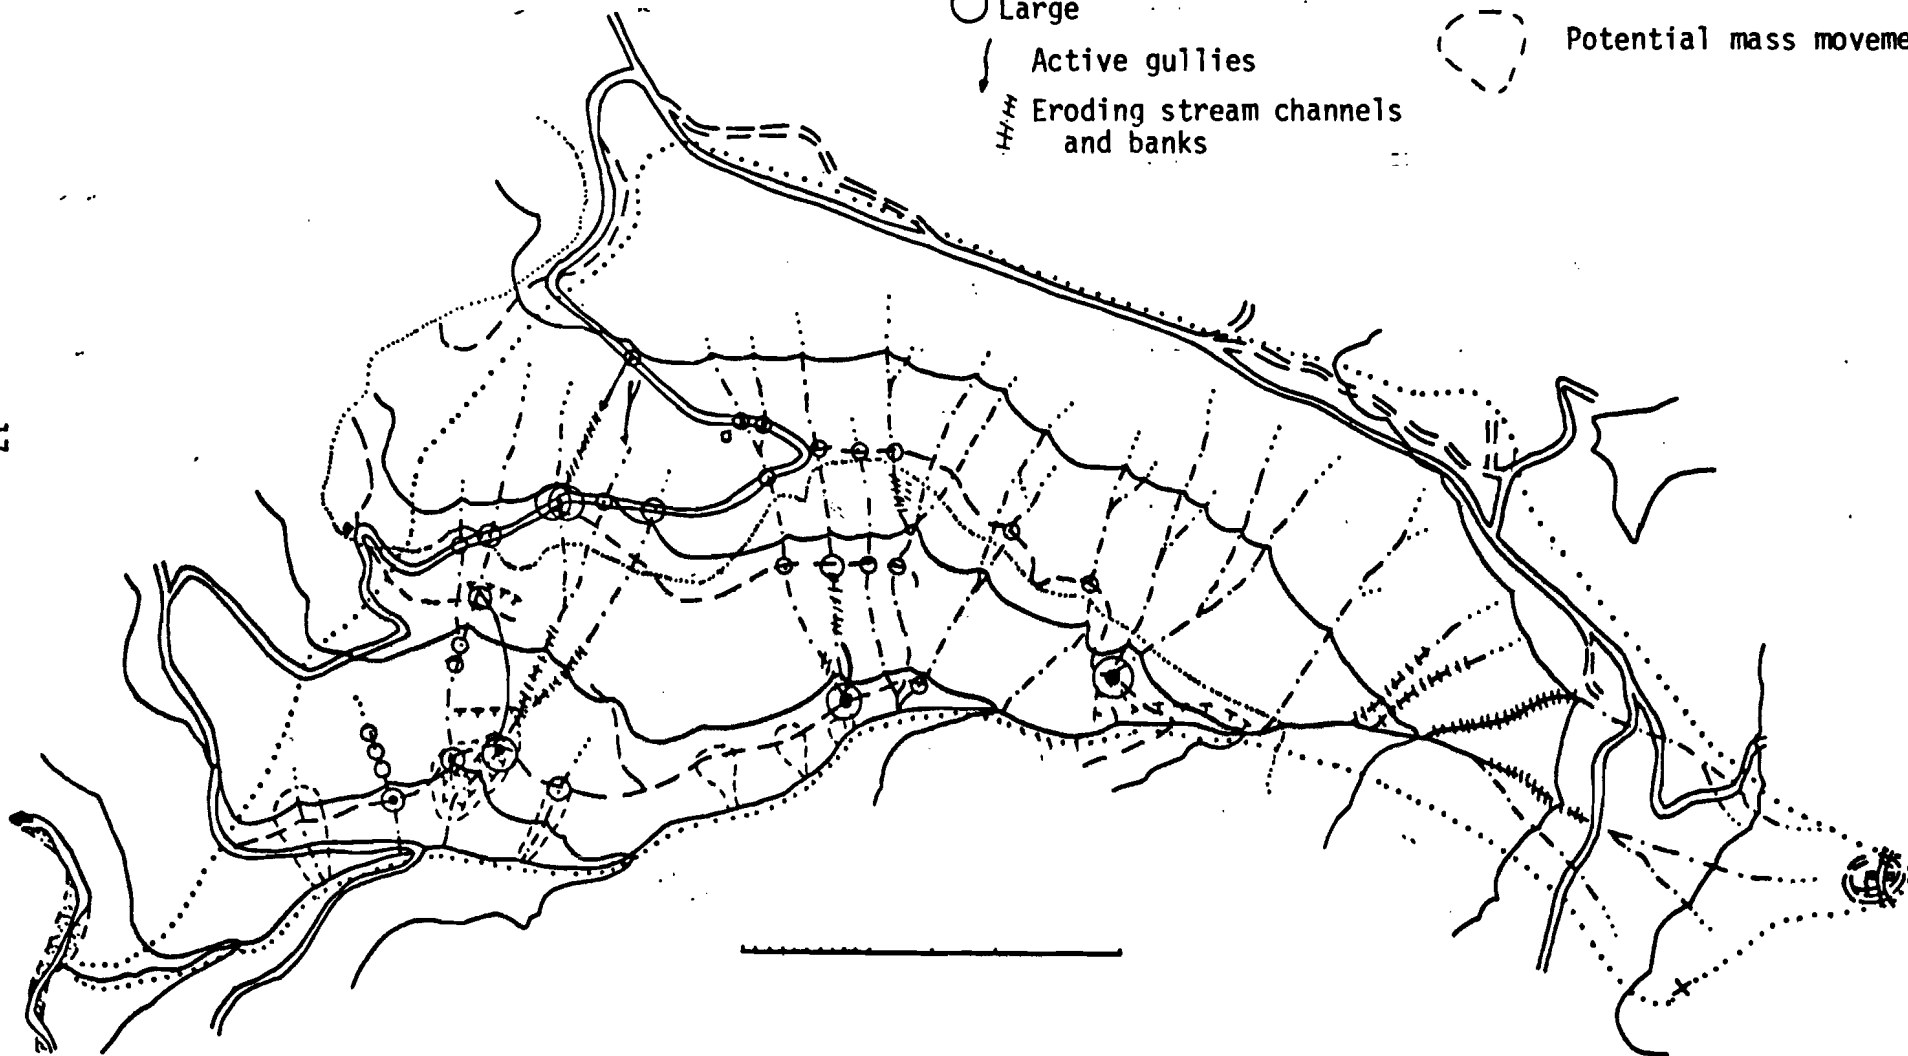
Figure 8. Sediment sources - Rehabilitation Site 81-1, North Copper Creek and Maneze Prairie. From aerial photographs 1978 and detailed field mapping 1980-1981. Shows active and potential sediment sources both natural and man-caused.

From the detailed field mapping, the major sediment sources on the unit were inventoried (Fig. 8). These could be divided into two classes: active and potential sources. Active sediment sources were those which were undergoing erosion or would undergo erosion during a storm event. Potential sediment sources were those which could undergo or cause extensive erosion during major storm events in the future.

Along the upper road on this unit, all of the haul road crossings were determined to be only small potential sediment sources (Fig. 8). However, the large skid trail crossing at the end of the road (SX-1) was established as a large active sediment source and even larger potential source.

Along the upper middle road all of the crossings were assessed to be small potential sources, except for RX-13 and RX-14 which were predicted as medium and large potential sources. RX-14 would be from continued fill erosion and RX-13 from potential gully erosion by stream diversion.

On the lower road, haul road crossings RX-20, 21, 22, 23, and 24 were established to be active sediment sources and predicted to be large potential sources (Fig. 8). All of the potential erosion was predicted to be of continued fill crossing erosion. Additionally, along the lower road large potential sources were predicted at a landing (L-2) and two road segments (R-16 and 18) by debris sliding directly into Copper Creek (Fig. 8). In each of these cases, several thousand cubic yards of material was predicted to be ultimately eroded. Also at landing L-6, active gully erosion and potential gully and mass movement erosion were predicted of several thousand yards.

Along Maneze Road large potential sediment sources were predicted at several crossings by culvert failure and gullies caused by subsequent stream diversions (Fig. 8). Several others were predicted to cause large potential sources by erosion of the road crossing fill (Fig. 8). Even with continued road maintenance, large gully erosion was predicted during future major storms because of the highly erodible nature of the prairie soils. In addition to these predicted road-related gullies, the large gully (G-6) would remain active by side bank erosion for a considerable time.

All of the active and potential sediment sources mentioned above were treated and, at least in part, removed as sediment sources by the rehabilitation work. As seen in Figure 8, several large active and potential sediment sources were not deemed treatable. The gullies and eroding stream channels below Bald Hills Road were inaccessible to heavy equipment. The area of unstable, steep slopes adjacent to Copper Creek in the middle and upper basins, also was deemed untreatable because of its size and degree of development. The active gully upslope of RX-20 was untreated because of lack of stable channel course and degree of gully development.

On the upper road the main objective was to remove the large sediment source posed by the skid trail at its end (Fig. 8; SX-1). The rest of the road was to merely remove the small road crossings and the physical scar of the road itself. On the upper middle road, the objectives were to remove the two remaining potential sediment sources at RX-13 and 14 (Fig. 18), and the physical scar of the road on Maneze Prairie.

On the lower road, the objective was to treat the large potential sediment sources of the haul road crossings and potential mass movements on landings and road segments. Additionally, drainage improvement across the road bench was desired by minor outsliping and cross road draining the road. Of particular importance, was the removal of the lower road in the third drainage area in the lower basin. This in conjunction with skid trail removal upslope was directed towards stabilizing the gully systems and mass movement features in this drainage area.

On Maneze Road and Prairie, the potential erosion was deemed to remain until the road was removed. The main objectives of the work was to remove the causes of these potential sediment sources (Fig. 8). These causes were analysed as the concentration of flow by the inboard ditch and diversion potential of streams at road crossings. Additionally, the removal of the road as a visual scar across Maneze Prairie was deemed aesthetically desirable. Also the stabilization and visual removal of the gully scars caused by the road were desirable to restore a more natural scene.
