SUMMARY OF EROSION CONTROL REHABILITATION WORK

LOWER SLIDE CREEK

UNIT 81-2

May 1982

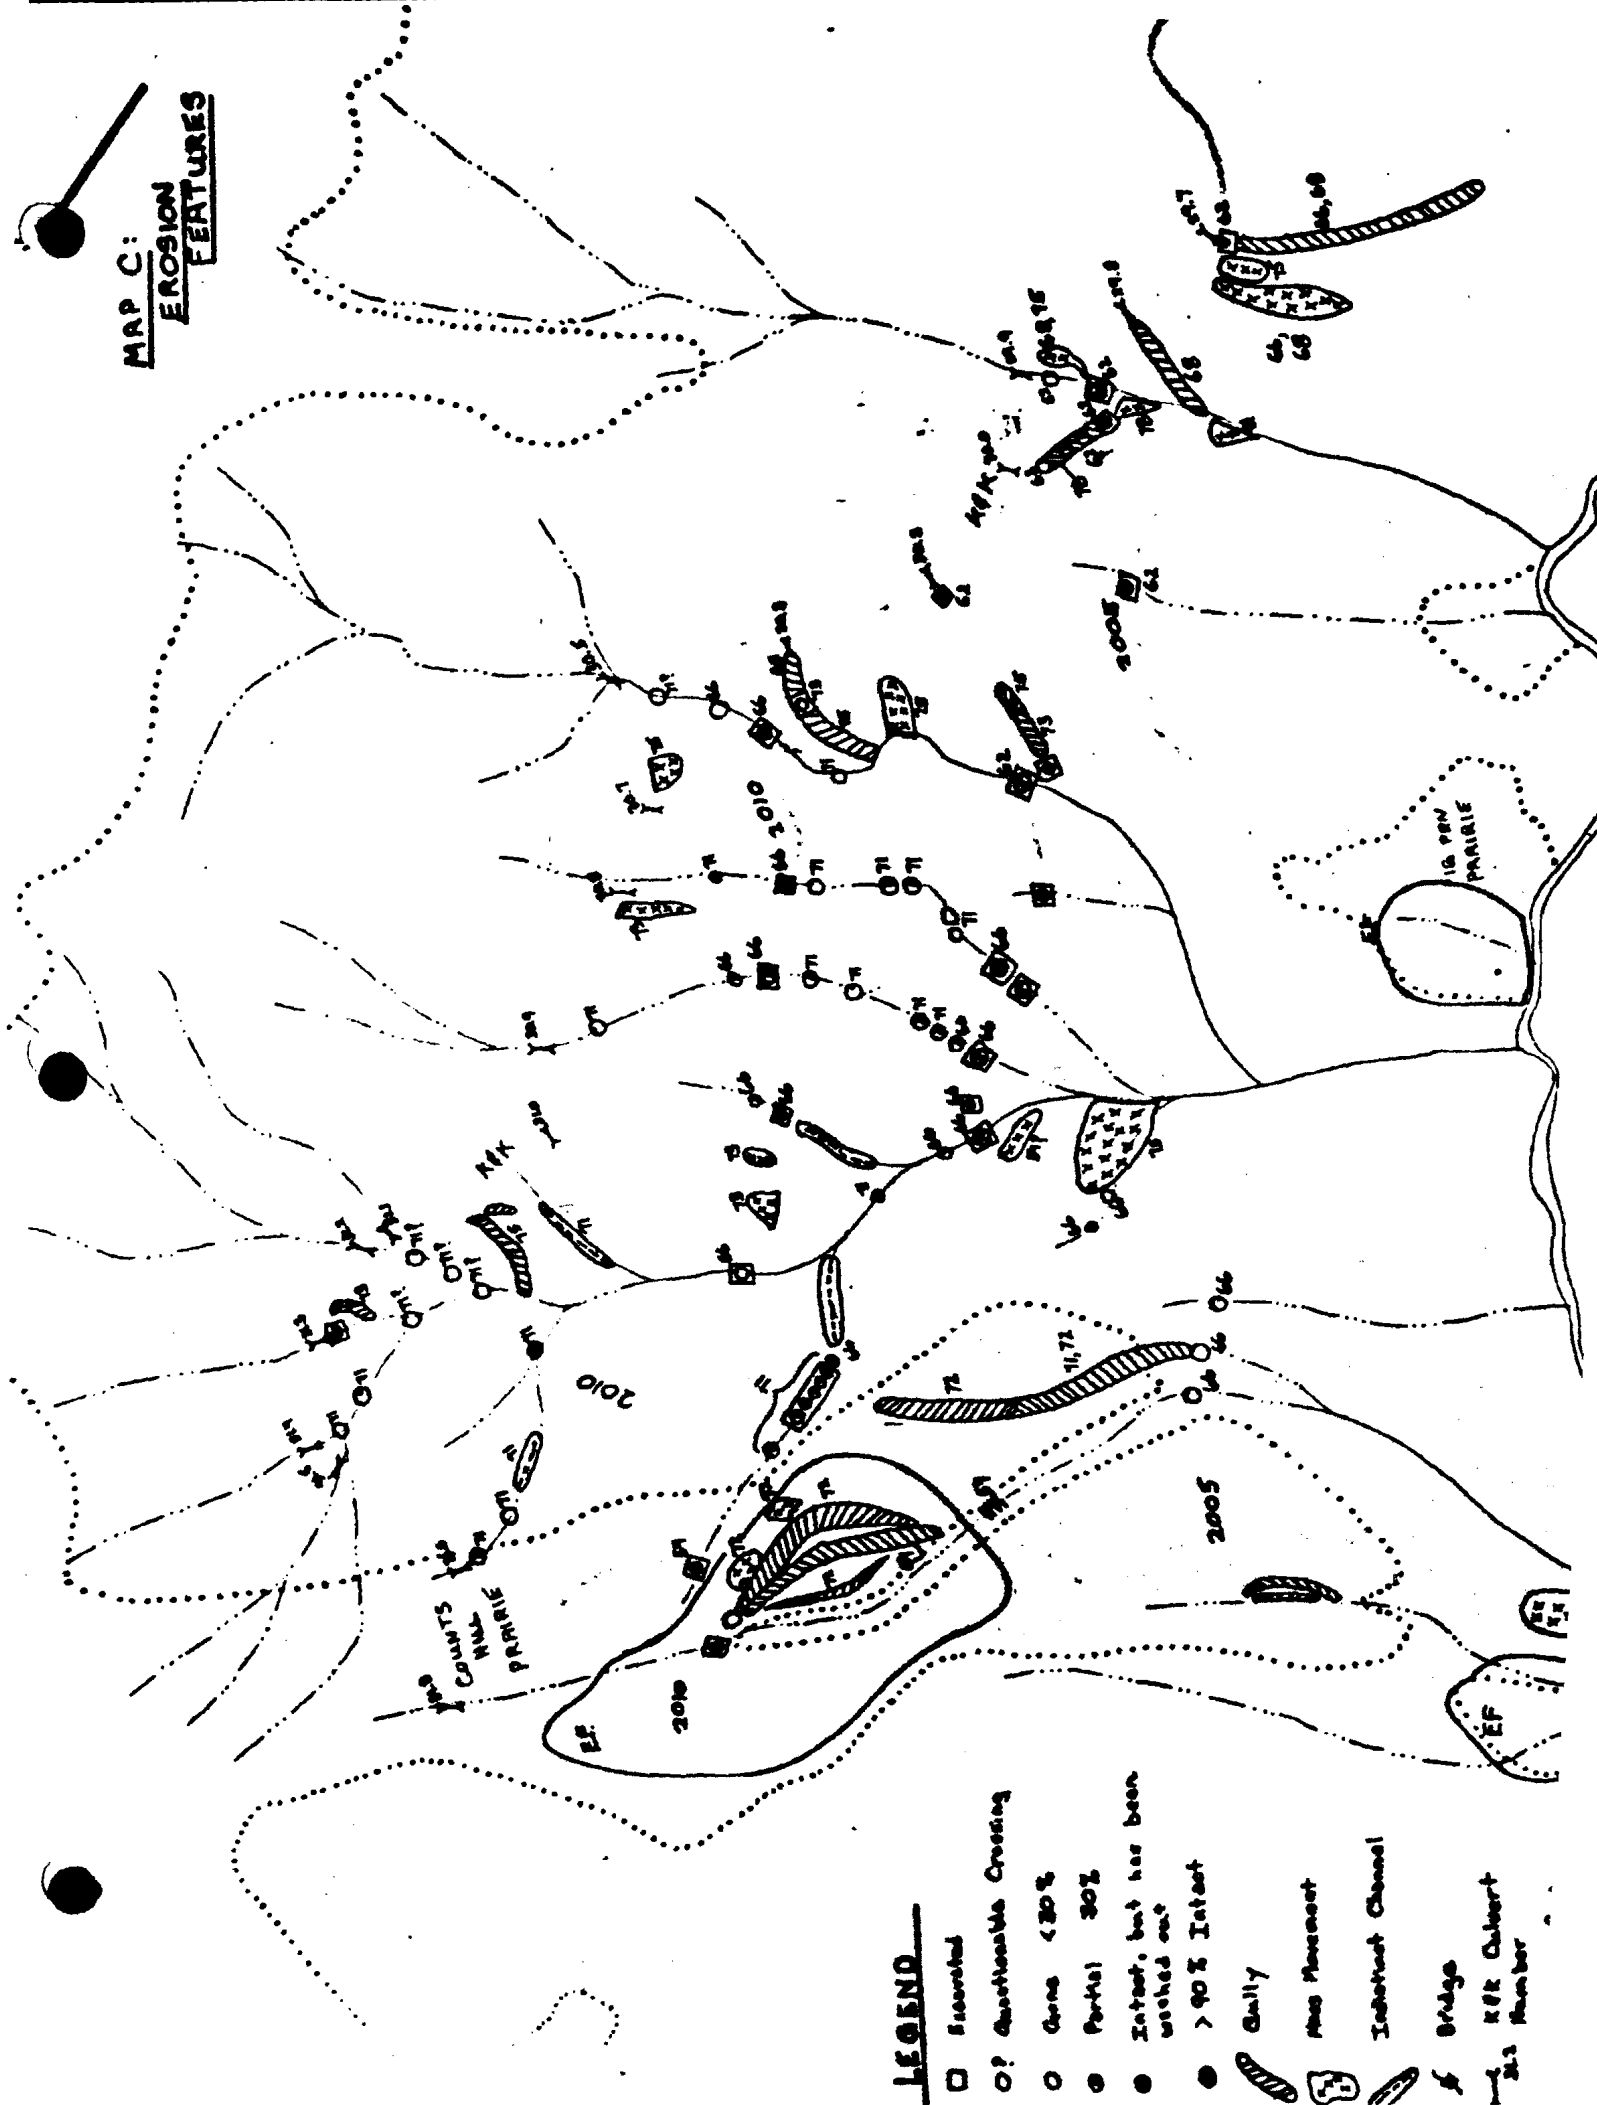
MAP C:  
EROSION  
FEATURES

The largest erosion features on the Lower Slide Creek Unit are gullies resulting from flow diversions. The majority of these gullies are due to undersized culverts that received insufficient maintenance during major storm or runoff events. Culverts or their trash racks either plugged with organic debris and bedload (in December, 1981 storm, bedload commonly was what plugged up trash racks) or could not handle the amount of runoff received. In either case, depending on local road gradient, streams were diverted, and/or washed out the road prism.

Other erosion features on the unit include stream bank failures, landslides and an active earthflow. All stream channels have been severely impacted by logging activities. Channel reaches especially, in the logged areas where massive amounts of organic debris were added, have aggraded several feet or more. Aggradation has also occurred in the old growth.

On the K & K, streamflow from plugged culverts was usually diverted. The K & K consistently has a gradient of 5 to 13 percent to the south as it passes through the Slide Creek drainage, making these diversions a common occurrence. Flows from large streams far exceed the "channel" capacity of the inboard ditch, so flow runs down the road (and gullies the ditch), and veers off the road via outboard drains or wherever road slope allows. Massive gullies formed on the slopes below until the flow reentered the natural channel. The large amount of sediment introduced from the gullies has caused additional problems in the natural channels; this is discussed under streambank failures. Large gullies below the K & K associated with culvert malfunctions are found on No Name Creek (culvert number 29.9) and on three of the north forks of Slide Creek (culvert numbers 31.1, 31.3, and 31.4; two culverts at 31.4, 31.5)

Gullies have also developed below the K & K where slope and inboard ditch flow has been concentrated by an insufficient number of culverts in inappropriate locations. Large gullies of this origin, some feeding directly into major stream channels, are found beneath culverts number 30.3 and 30.0, 29.8, 29.7.
