SUMMARY OF EROSION CONTROL WORK  
UNIT 82-1  
C-30 ROAD AND SLOPE, EMERALD CREEK BASIN

Redwood National Park  
Orick, California

by  
Terry Spreiter  
and  
Louise Johnson

February 1983

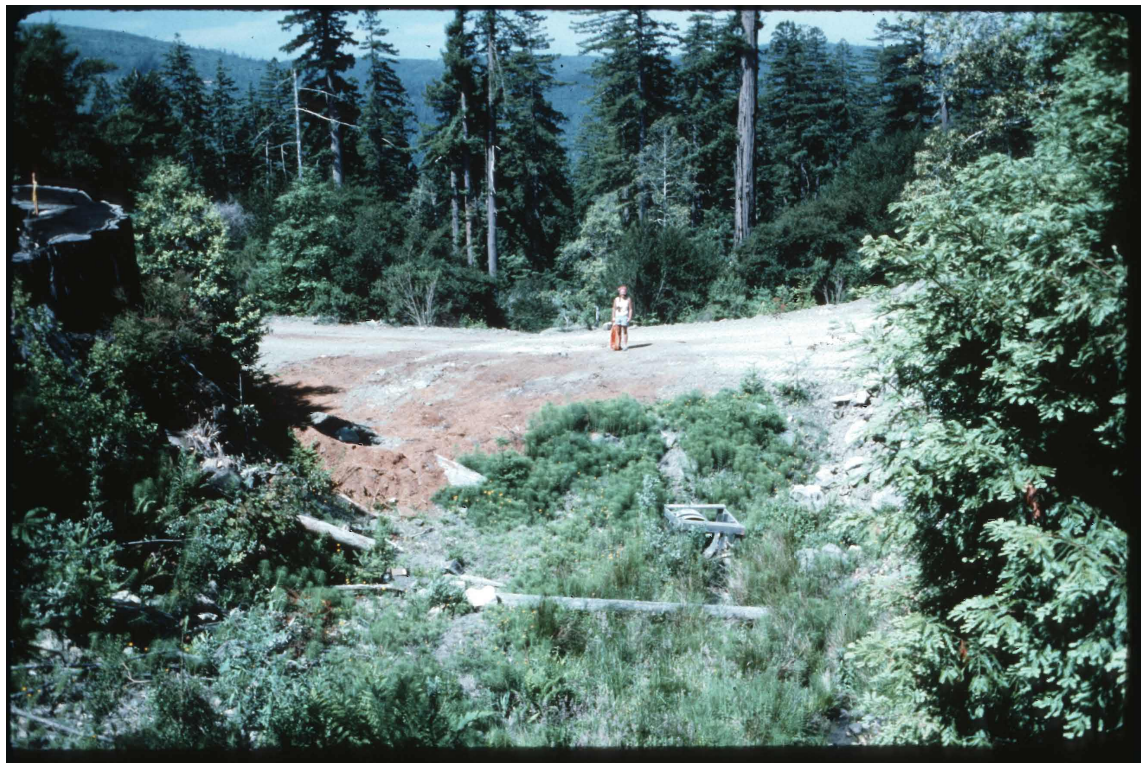
82-1 SOC PP9 RX-3 Pre H.E.

The remaining failure (near RX-3) was probably caused by a combination of ground saturation and removal of slope support by road construction.

| <u>Location</u> | <u>Year</u> | <u>Description and Probable Cause</u> |
|---|---|---|
| RB of RX-3 &<br>SX-3A | 1982 | Area 250' x 250' dropped >5 feet. Caused by wet ground conditions and removal of slope support by W-Line cutbank. |

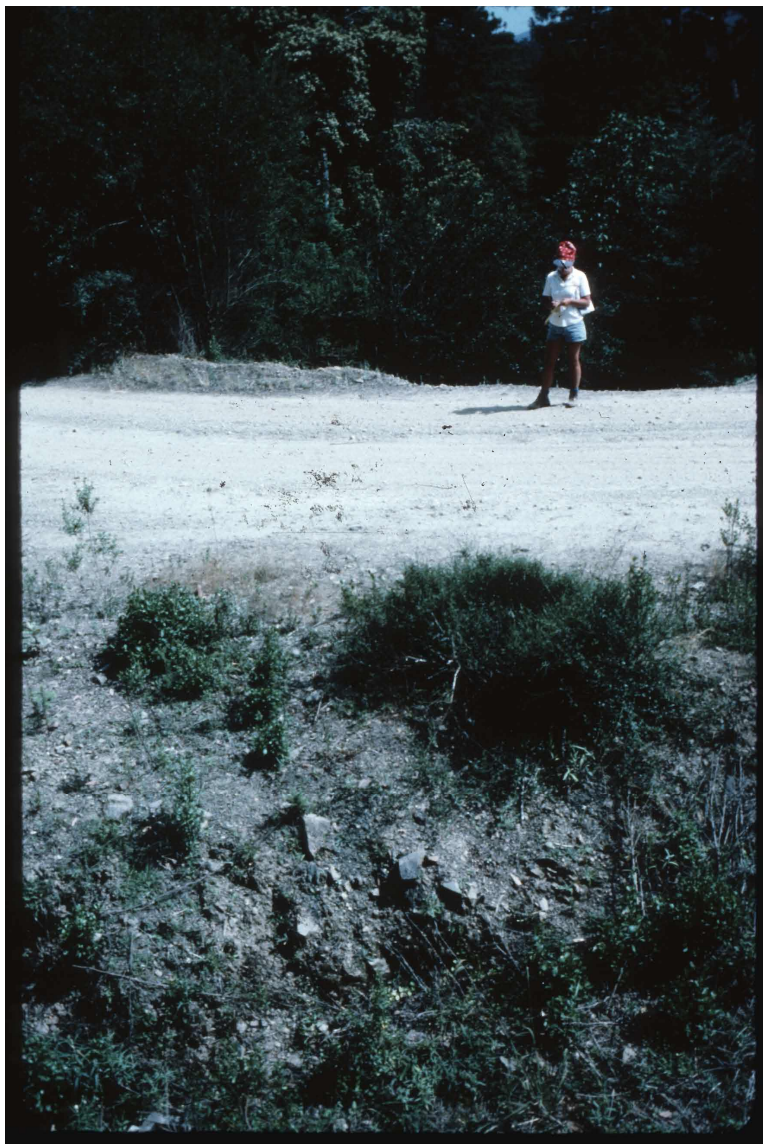
82-1 SOC PP37a RX-12 Pre H.E.

| <u>Location</u> | <u>Year</u> | <u>Description and Probable Cause</u> |
|---|---|---|
| Slope above and<br>to east of RX-12. | 1981 or 2 | Shallow failures on an ancient landslide feature caused by numerous skid trails crossing and undercutting the slope, and minimal root strength. |
