SUMMARY REPORT

1820, 1821, and Lower 1800 Road  
REHABILITATION UNIT 84-3

Resource Management Division  
Redwood National Park

November, 1985

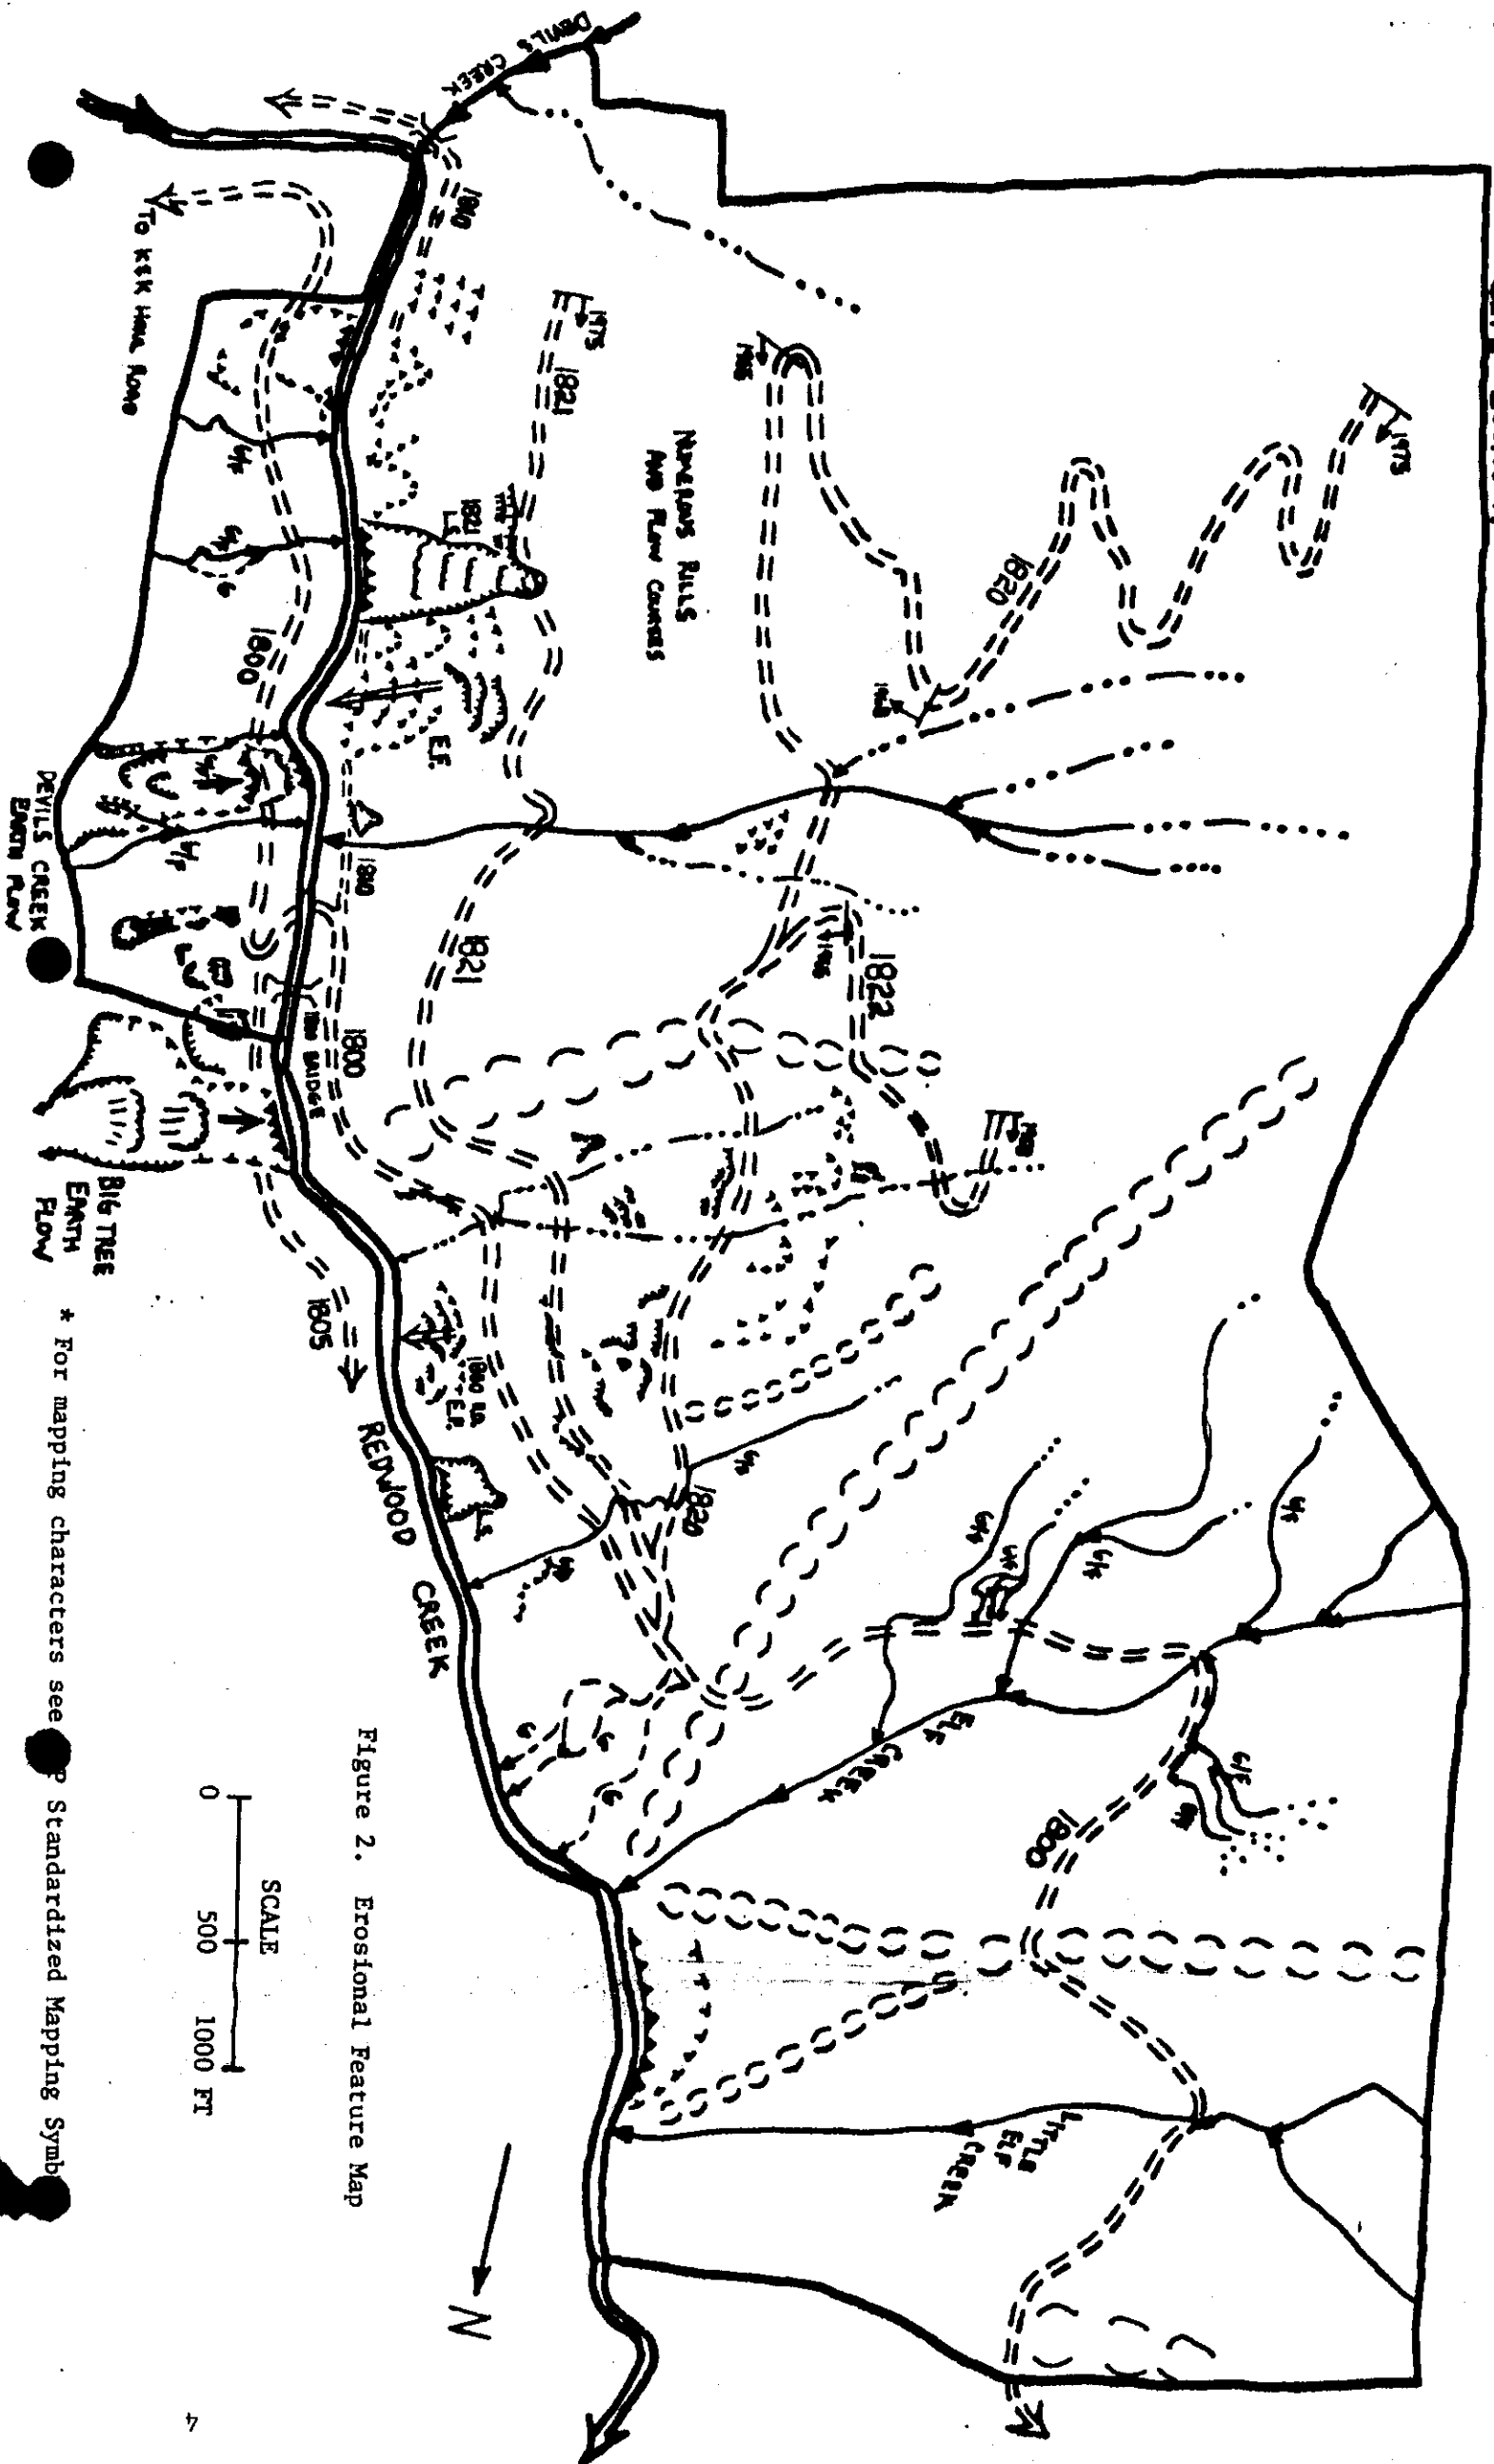
Figure 2. Erosional Feature Map

At the location of the present day 1821 landslide (Figure 2) there is a break in the forest canopy with down trees on the slope suggesting that a mass movement landslide is active. However no visible scarps can be detected from the photographs. Breaks in the canopy also exist upstream from the 1821 L.S. where there is a present day earthflow. Below these breaks in the canopy Redwood Creek is being deflected into the opposite bank and there is a considerable amount of boulder lag in the channel. Other breaks in the canopy also occur between the 1800 and the 1821 roads in locations where the mapping in the winter of 1983-84 indicate mass movements (Figure 2). The hillslopes on the east side of Redwood Creek also exhibit mass movement features in locations where there are now very active earthflows. (Figure 2). In view of these geomorphic expressions, the hillslopes on the 84-3 rehabilitation unit had a history of mass-movement prior to any logging activities.

A gully system below the 1800/1820 intersection was laterally developing, incising, and prominent in the aerial photographs. This gully system was a result of water being captured by the 1800 and 1820 roads. Flow crossed the 1800 road and diverted down numerous skid trails. All other major gully systems were developing and were primarily a result of subsurface flow emerging from skid trail cutbanks and becoming overland flow.
