SUMMARY REPORT

LOWER D-LINE ROAD AND SLOPE  
REHABILITATION UNIT 82-5

Resource Management Division  
Redwood National Park

February 1983

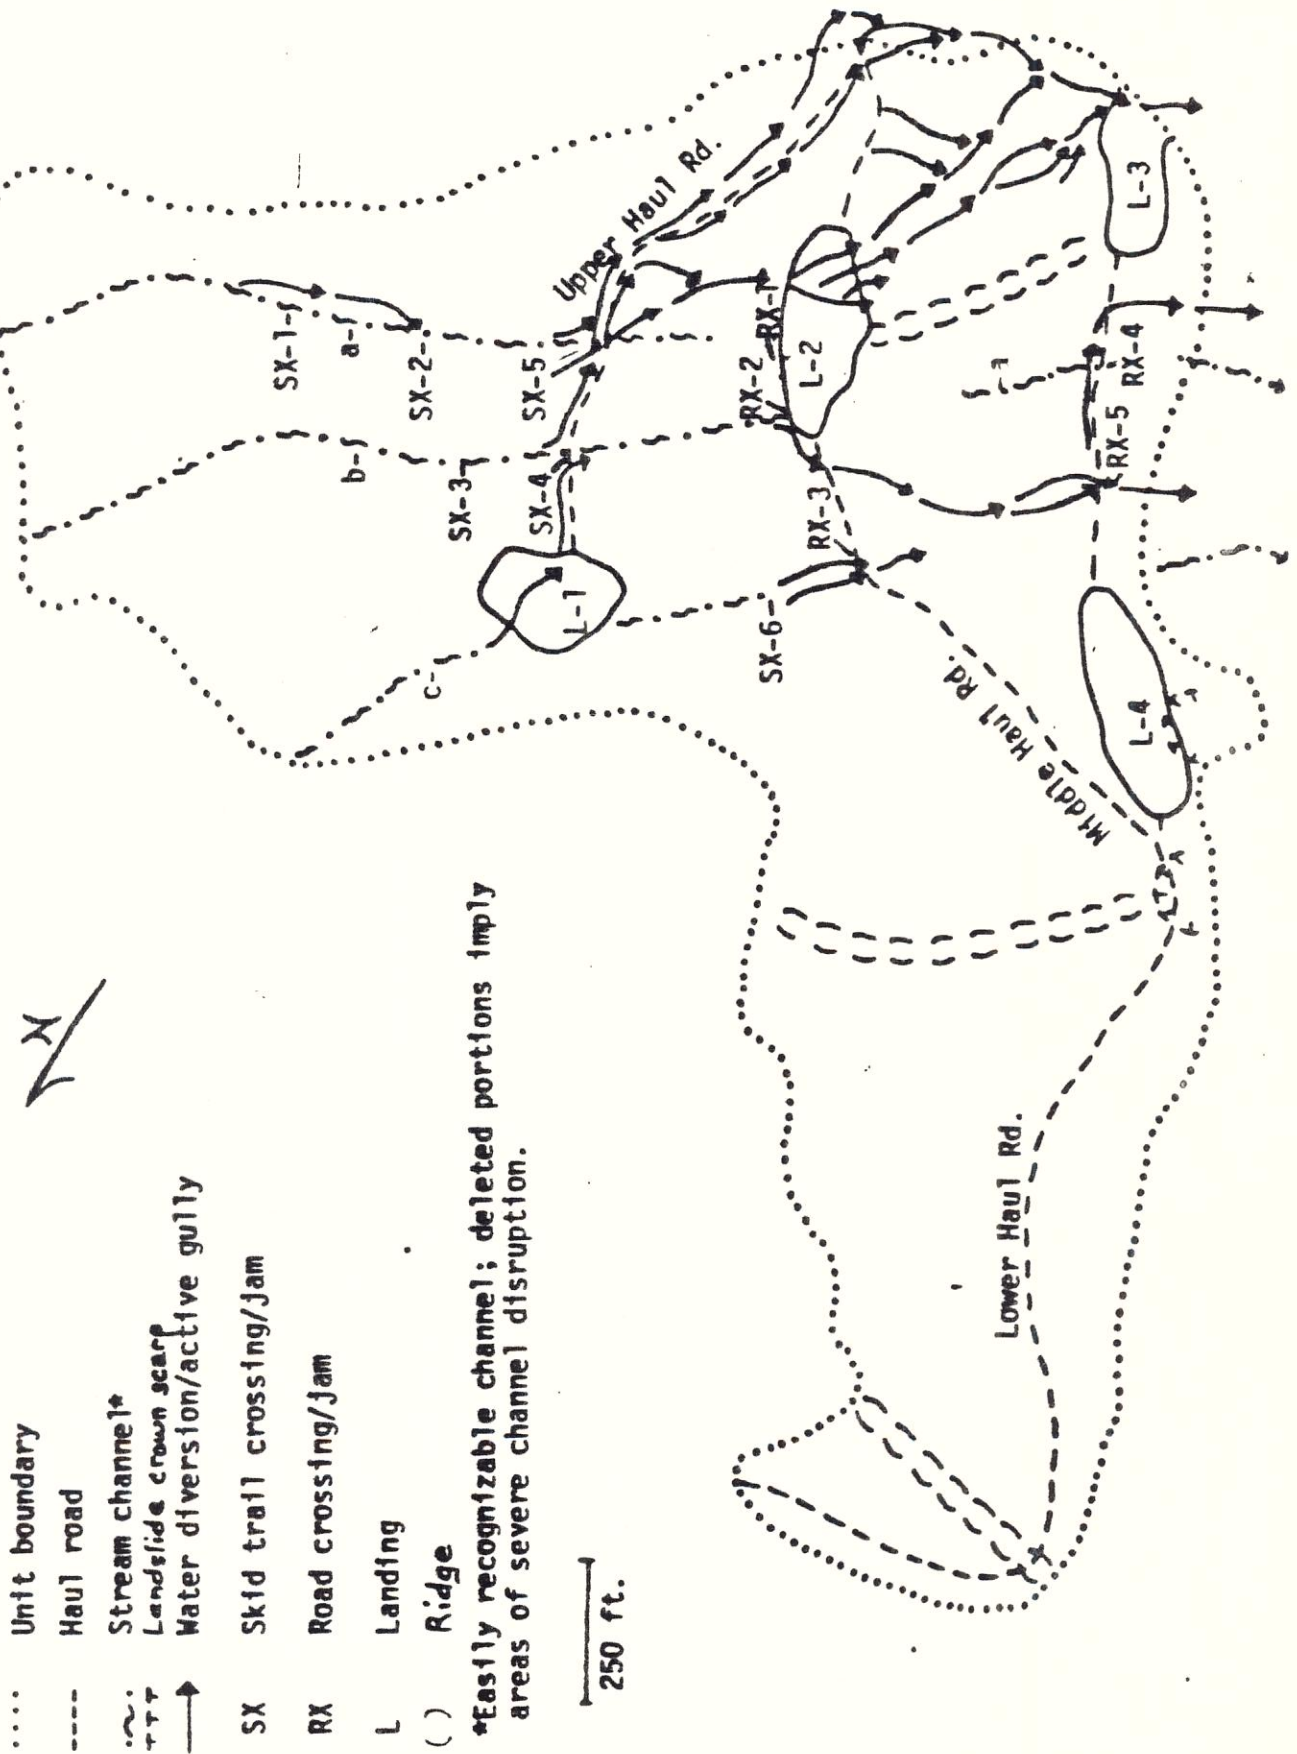
Figure 2. Erosion Features 1972 - Rehabilitation Unite 82-5.

The 1972 photo flight was flown several days after the second major storm of 1972 and site coverage is incomplete. Fortunately, most of the site was photographed with portions of the northern and western sections not covered. By March, when the photographs were taken, the site had undergone severe channel disruption and surface erosion. Stream channel disruption was largely due to multiple haul and skid road crossings. Also, portions of

channel were used as skid road ways and as fill sites for road excavations and logging slash. Each of the three major drainage channels within the site was affected by multiple diversions resulting in gully formation, ponded water, and areas of water saturated hillslope. Diversions are typically associated with haul road crossings where culverts plugged or were never placed in crossings, or where inboard ditches plugged and diverted water across road.

Channel "a" had approximately 23 skid road crossings above the lower haul road, some massive; four secondary haul road crossings; one landing; and sections of channel were clogged with road fill and logging slash. There were three diversions from this channel: 1) up-channel of SX-1 a diversion followed a skid road adjacent to the channel for approximately 200 feet before re-entering the channel at SX-2; 2) at the intersection of the channel and SX-5 the water was diverted down the inboard ditch to the switchback between the middle and upper haul roads. The water crossed the road and formed a braided gully system leading downslope across L-3; and 3) the inboard ditch along the lower haul road intercepted drainage a short distance down road of RX-5 past RX-4, and included the drainage that occurred in channel "a" below L-2. Downroad from RX-4, the inboard ditch plugged and diverted water across the road resulting in a downslope gully through the old growth forest.

Channel "a" disappeared for about 300 feet where L-2 was constructed, then reappeared for about 100 feet between L-2 and the lower haul road. The 100 feet of channel above the lower haul road was very disfigured due to multiple skid road crossings and fill/slash storage. Photo coverage is not available below the lower haul road.

Channel "b", prior to timber harvest, joined channel "a" in the vicinity (100 feet below) L-2. On channel "b", there were approximately 20 skid road crossings, 3 haul road crossing, and sections of channel were clogged with road fill and slash. Where the channel intersects SX-4 the drainage was diverted along the upper haul road forming two parallel diversion gullies, possible occurring from the same storm event but probably at different times. One diversion flowed down the inboard ditch and joined with the diversion from channel "a" at SX-5 to continue diverting down the inboard ditch. The other diversion gullied along the outside of the road prism, bypassed channel "a" over the road fill, and diverted approximately 200 feet downroad creating a large gully above L-2. Where the gully intersected L-2, a large alluvial fan, multiple small gullies and rills developed on the landing and diverted flow downslope to the large gully on L-3 where the second diversion from channel "a" and the upper diversion of channel "b" emptied.

Channel "c", approximately 200 feet below the origin of easily definable channel (the boundary between the prairie and conifer forest), is covered by L-1 for about 200 feet. The channel reappears below the landing for about 150 feet with skid roads on both side then is undetectable under a melange of skid roads, haul roads, and debris for the remainder of the site. Drainage from channel "c" became braided rills diverting across L-1 then entered the inboard ditch along the upper haul road between L-1 and SX-4. Water from the inboard ditch was diverted across the upper haul road

immediately uproad of SX-4 and entered channel "b". The diverted drainage followed channel "b" downslope and again diverted, this time along the inboard ditch of the middle haul road. About 60 feet uproad of channel "b" the inboard ditch plugged and the water routed at several places along the road and downslope, primarily gullying along a downslope skid road. This drainage diversion crossed the lower haul road at RX-5 and initiated an active gully which was responsible for the falling of number of old growth redwood (Note Plate 1).

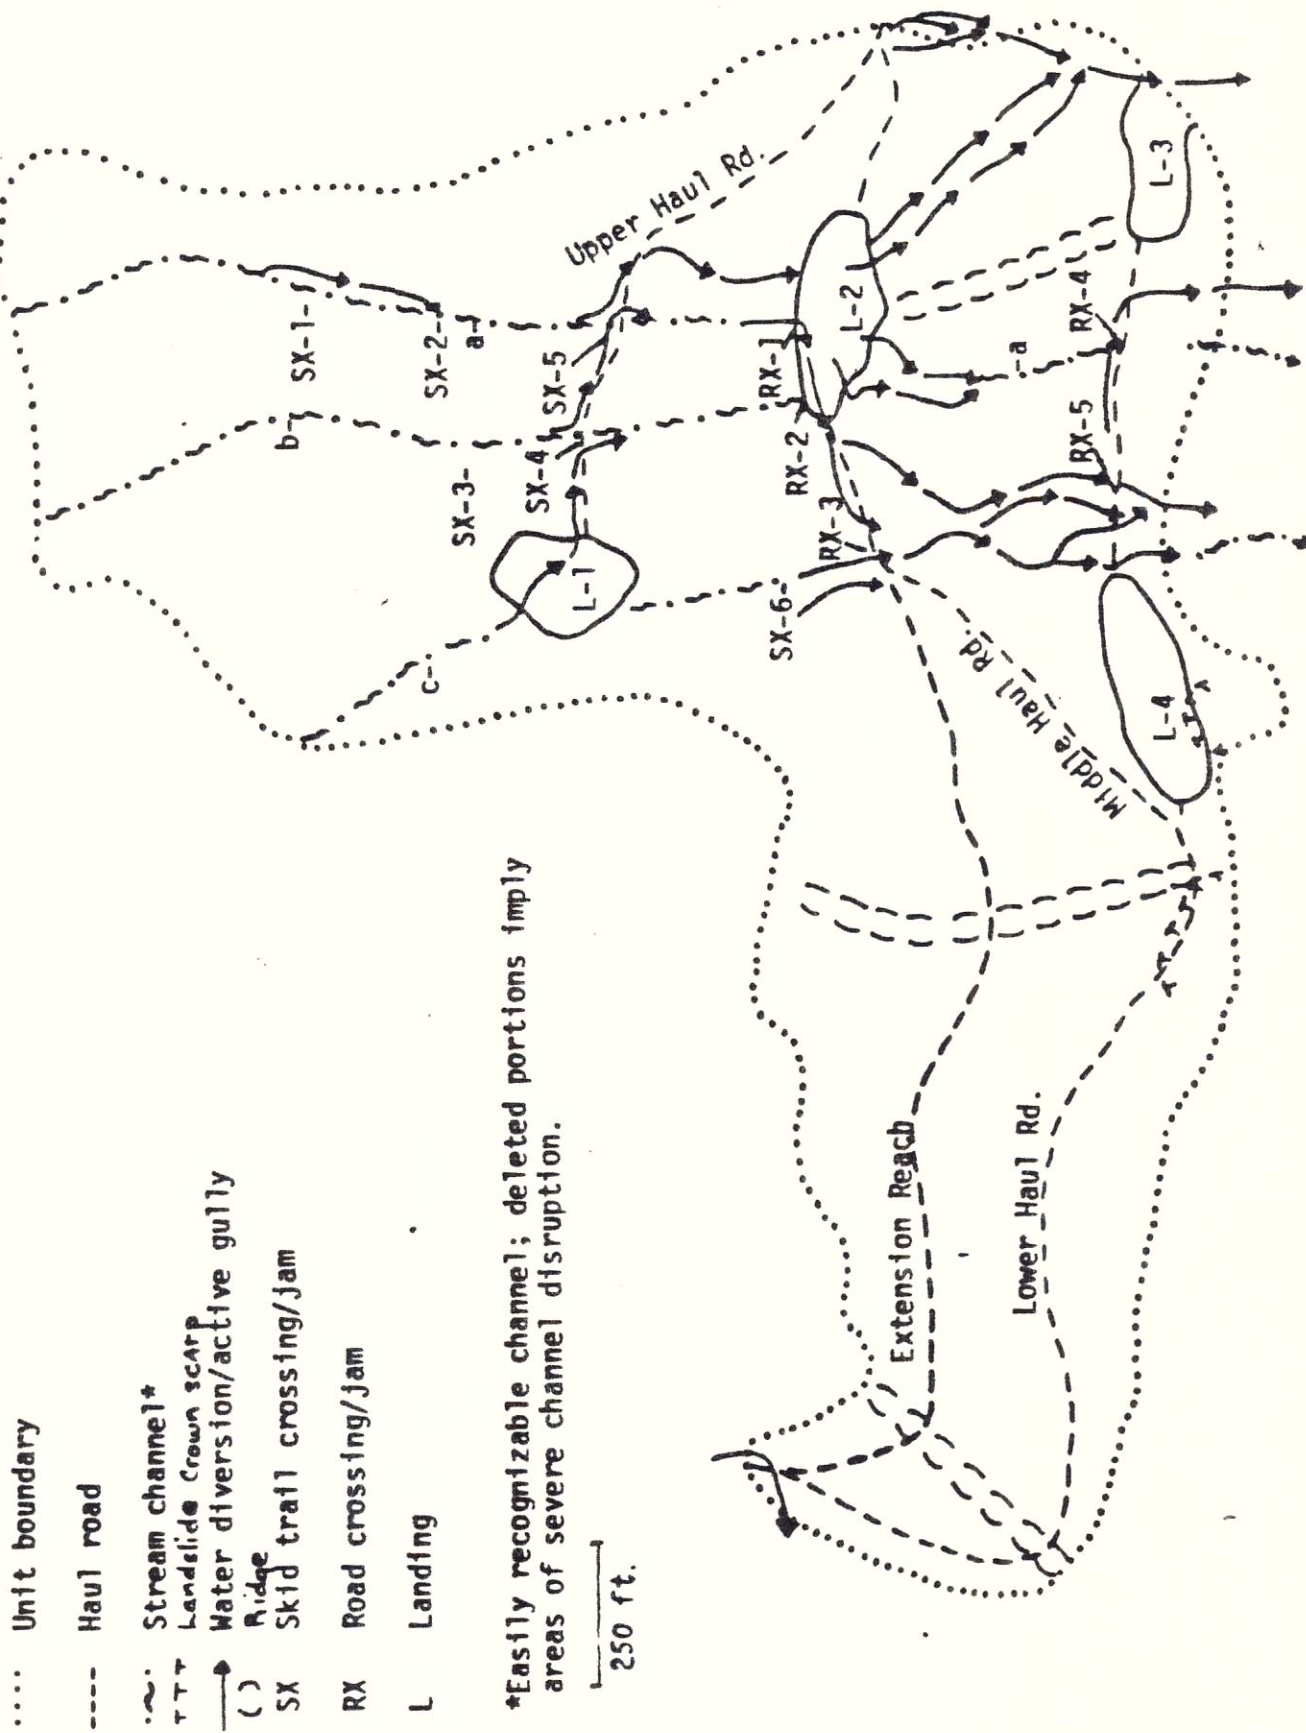
Figure 3. Erosion Features 1974 - Rehabilitation Unit 82-5.

Several new diversions had occurred since 1972. All involve new water routes from previous diversions and appear to be related, for the most part, to corrective work on the haul road where water was again routed along inboard ditches.

In 1972, water from channel "a" flowed down the inboard ditch at SX-5 to the switchback between the upper and middle haul roads, then down slope. By 1974, water from channel "a" had diverted again, this time to a gully formed during 1972 by water diverted from channel "b". This diversion, about 75 feet uproad of SX-5 diverted flow down slope across L-2 and eventually to the large gully on the downroad end of L-3.

Channel "b", which in 1972 was diverted along the upper haul road in two places, both gullying through L-3, was rediverted by 1974. This new diversion entered channel "a" at the outboard edge of SX-5 and followed the channel to L-2. At L-2 the water was diverted in two directions. One diversion went down the inboard ditch of the middle haul road towards RX-3. From the inboard ditch, water was diverted again in two places across the road, one about 90 feet uproad of channel "b" and the other at RX-3. Both of these diversions across the middle haul road intersected downslope above RX-5 of the lower haul road. Below RX-5 the watercourse remained the same as in 1972. The other diversion at L-2 crossed the landing in two places, both ultimately entering channel "a" above the lower haul road and intersecting the diversion extending downroad from RX-5 past RX-4.

Channel "c" did not appear to have changed course since its initial diversions in 1972, however, erosion activity of the diversion channels, as was typical of the site, was considerable.

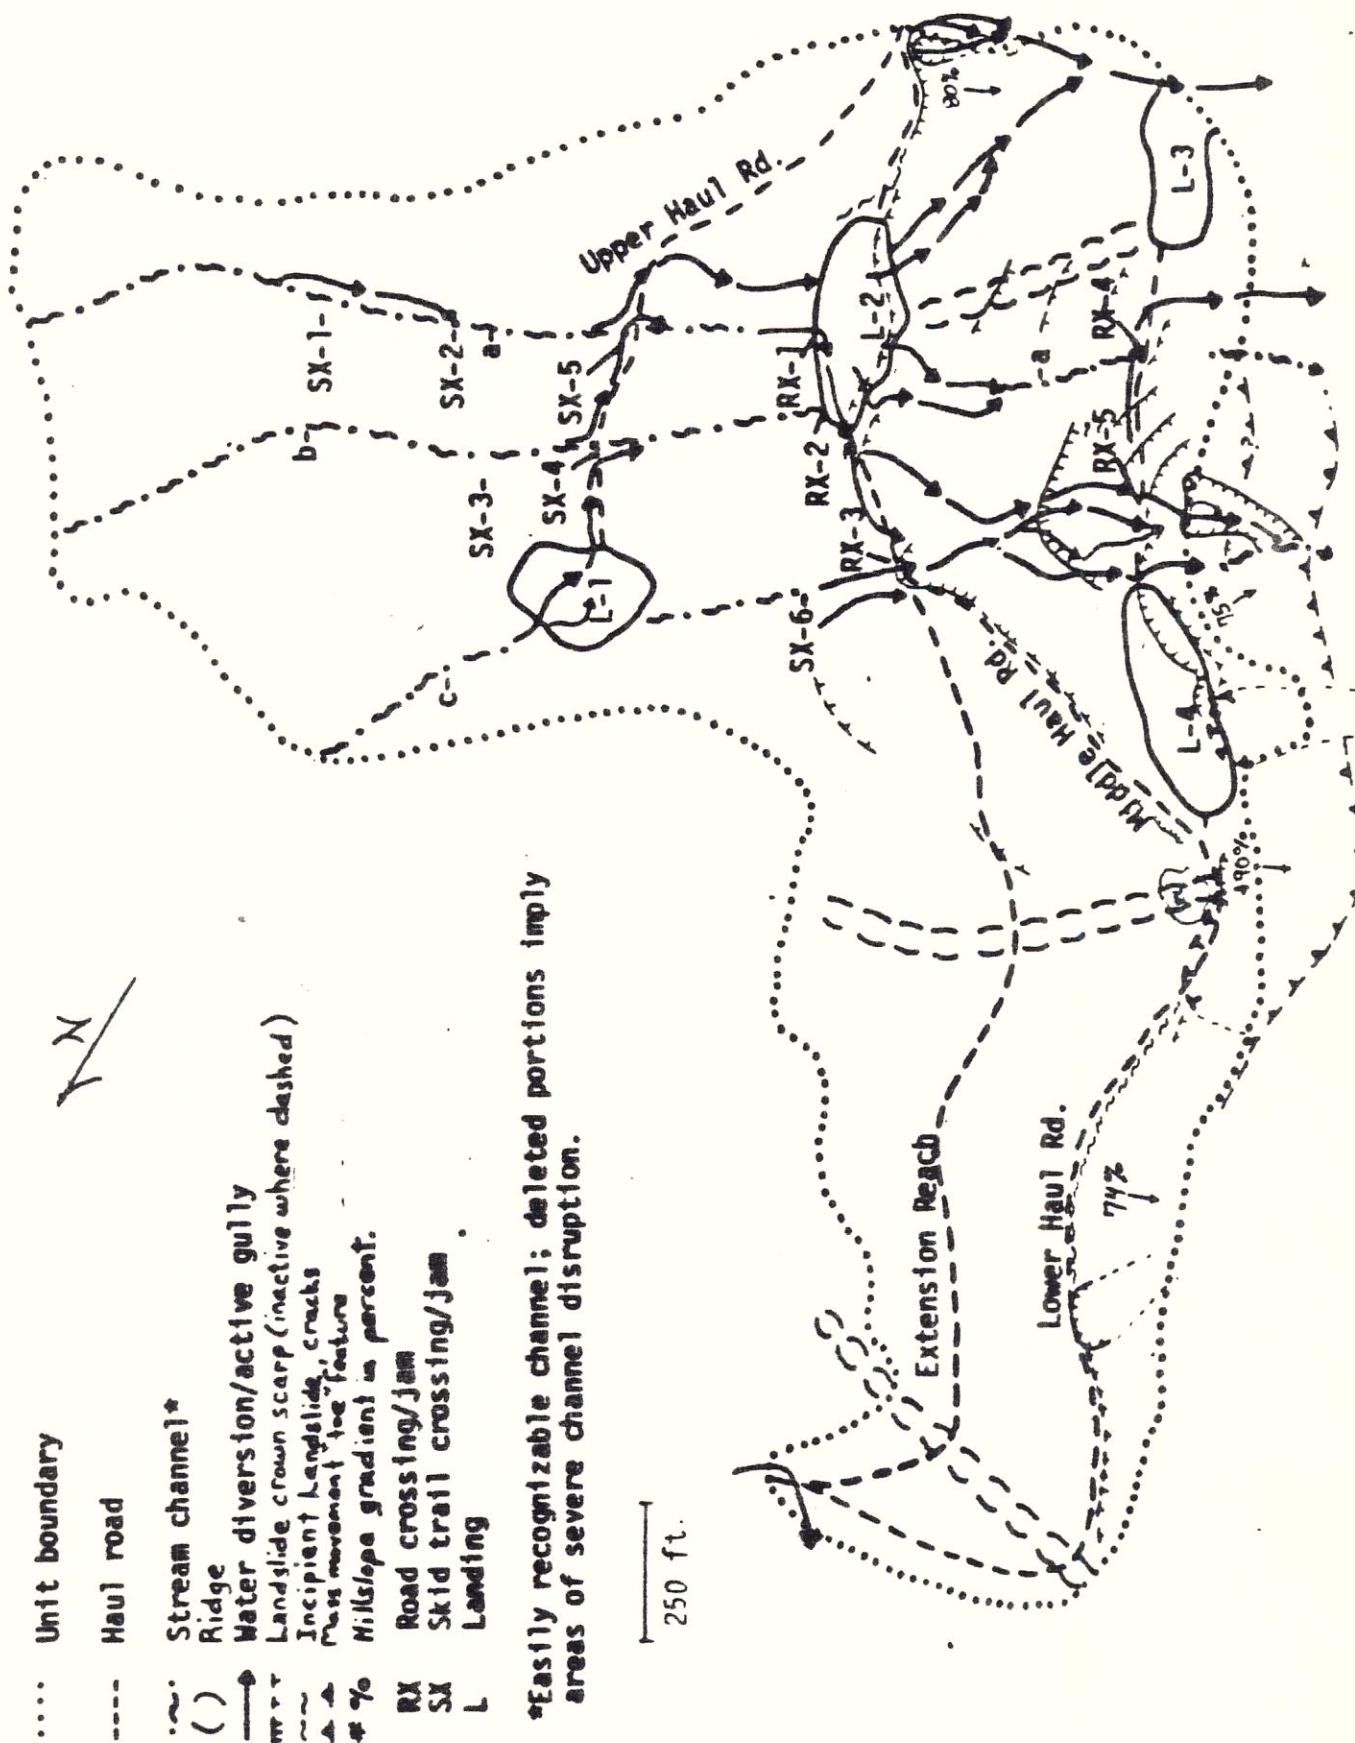
FIGURE 4. EROSION FEATURES: 1982 REHABILITATION UNIT 82-5.

In the spring of 1982, field evaluation of the rehabilitation unit began. Erosion features were mapped on an enlarged 1978 air photograph at the scale of 1:2,200 (see detailed map). Figure 4 shows the more prominent erosion features during this time (see Figure 5 for complete site locations).

Channel diversions remained virtually unchanged since 1974, however, diverted channels had enlarged. Roadways and landings continued to deteriorate, especially along the lower haul road (R-1, R-4) and the outer end of the middle road (L-2) where the roads traverse steep slopes. On one portion of R-1, between RX-4 and RX-5, several approximately 16 inch scarps developed traversing the roadway. Along R-4, recent tension cracks with minor failure extend the length of the reach on the fill side of the road. Both L-2 and L-4 were still actively failing at the time of mapping. One scarp adjacent to the 1972 debris avalanche on L-4 was approximately 10 feet high. The active gully below RX-5 has enlarged significantly, continuing to fall old growth redwood trees, and eroding approximately 1,260 cubic yards of material (Alpert, 1982 pers. comm.). In the vicinity of SS-1 a large persistent landslide (slump) had developed, crown scarp approximately 4 feet high with sag ponds and multiple channel diversions. Another slump occurred at the junction of R-2 and R-3 of moderate size. The body of the slide was saturated and channel "c" flows across it. Along the ridge between channel "a" and L-3 several en echelon tension cracks and scarps were observed. Further advanced study, beyond the scope of this report, is required to assess the relationship of these features with the rest of the scarps features on the unit.
