Summary Report  
WATERSHED RESTORATION UNIT 97-1  
C-LINE SOUTH

Becca Smith  
Redwood National Park  
February, 1999

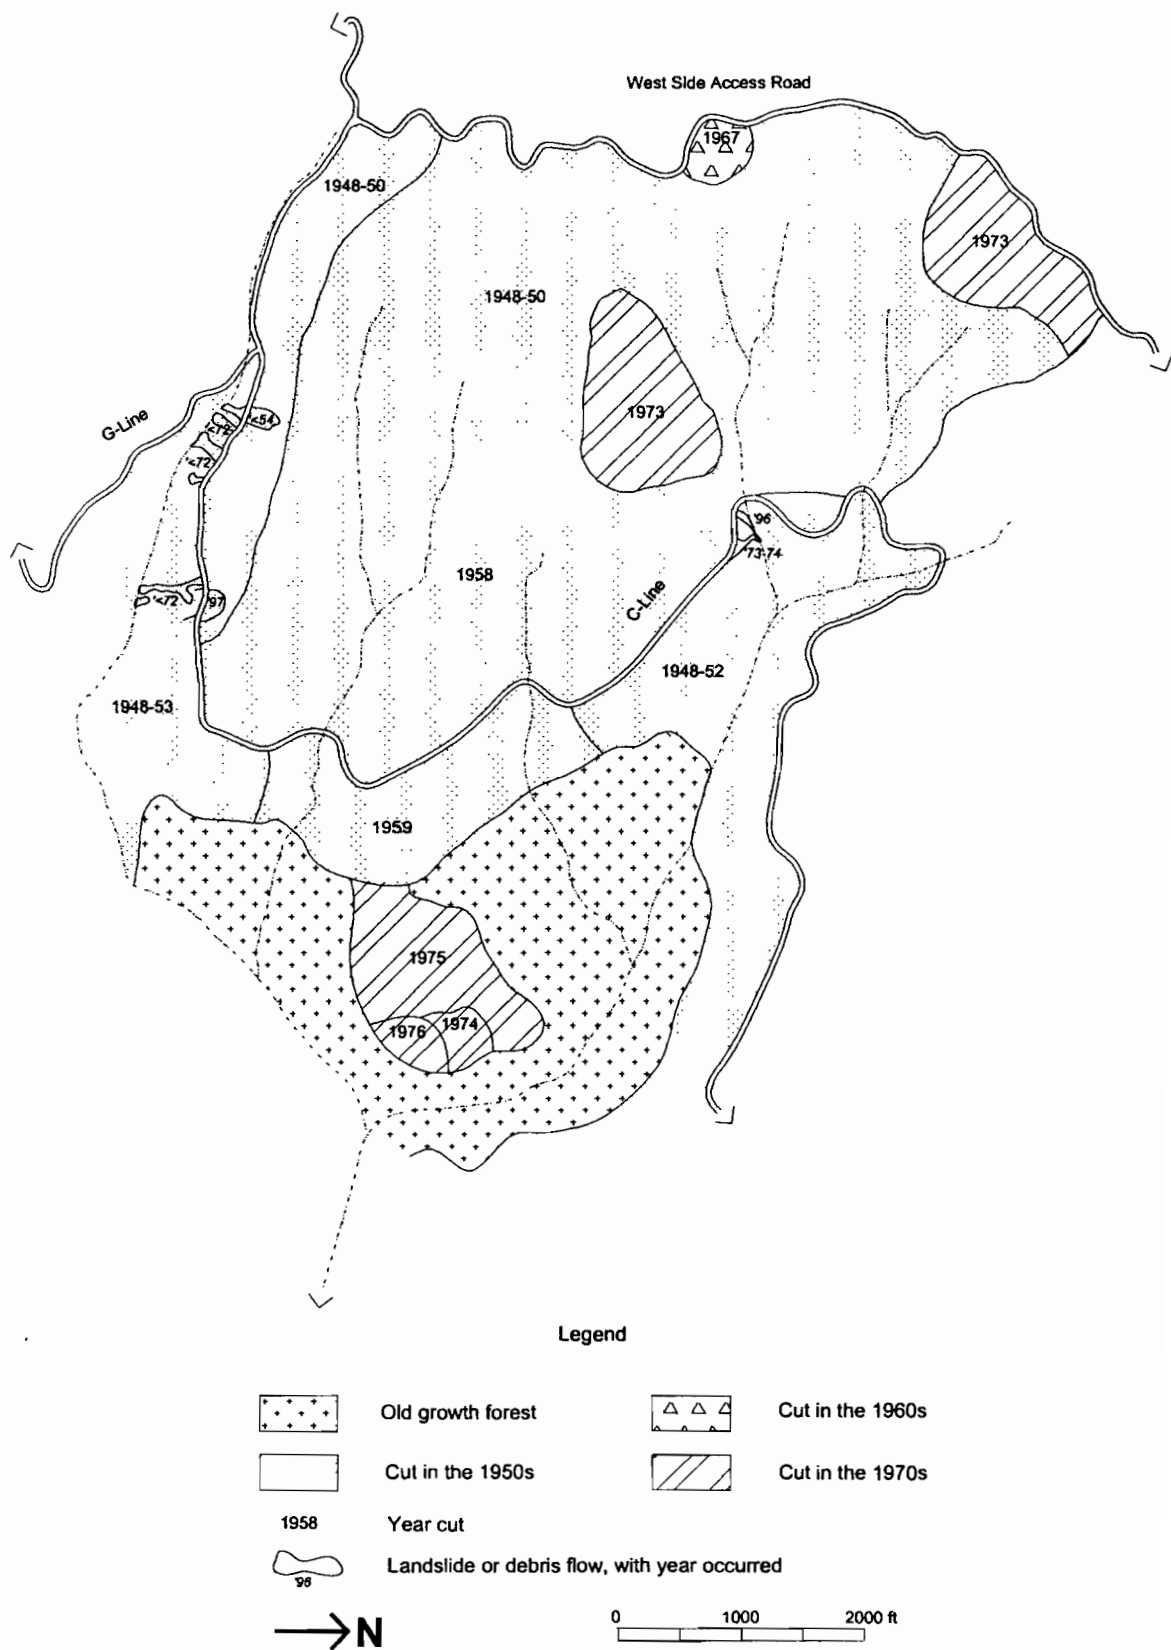
Figure 2. Timber Harvest History and Recent Mass Movement Features

The most dominant erosional features are landslides and debris flows (Figure 2). The 1954 air photos show one recent slide originating above the C-Line in a cable yarded unit just east of the intersection of the G-Line. The 1972 photos show four recent land slides/debris flows that originated on the outboard edge of the C-Line and terminated at the creek, east of the intersection with the G-Line. Between 1972 and 1973, immediately following clearcutting of an old-growth patch and construction of very large skid roads above the C-Line, a debris flow occurred originating on the outboard edge of the C-Line and terminated in the creek below RX-1 and RX-2. Between December 5 and 9, 1996, the outboard edge of the road at RX-2 failed and debris flowed into the creek. During the New Year's storm on January 1, 1997, a section of the C-Line east of the G-Line intersection slumped, dropping the road bed approximately five feet. In addition, the soils below the C-Line are very prone to gulleying. A ditch relief pipe at station 73+80 discharged water onto the hillslope at a ridge. This water created a gully with dimensions up to 5' wide by 3' deep running all the way down to the creek.
