**SUMMARY REPORT**

**REHABILITATION UNIT 82-2:  
C-20 ROAD & SLOPE AND C-LINE LANDING #2**

**Resource Management Division  
Redwood National Park**

**February 1983**

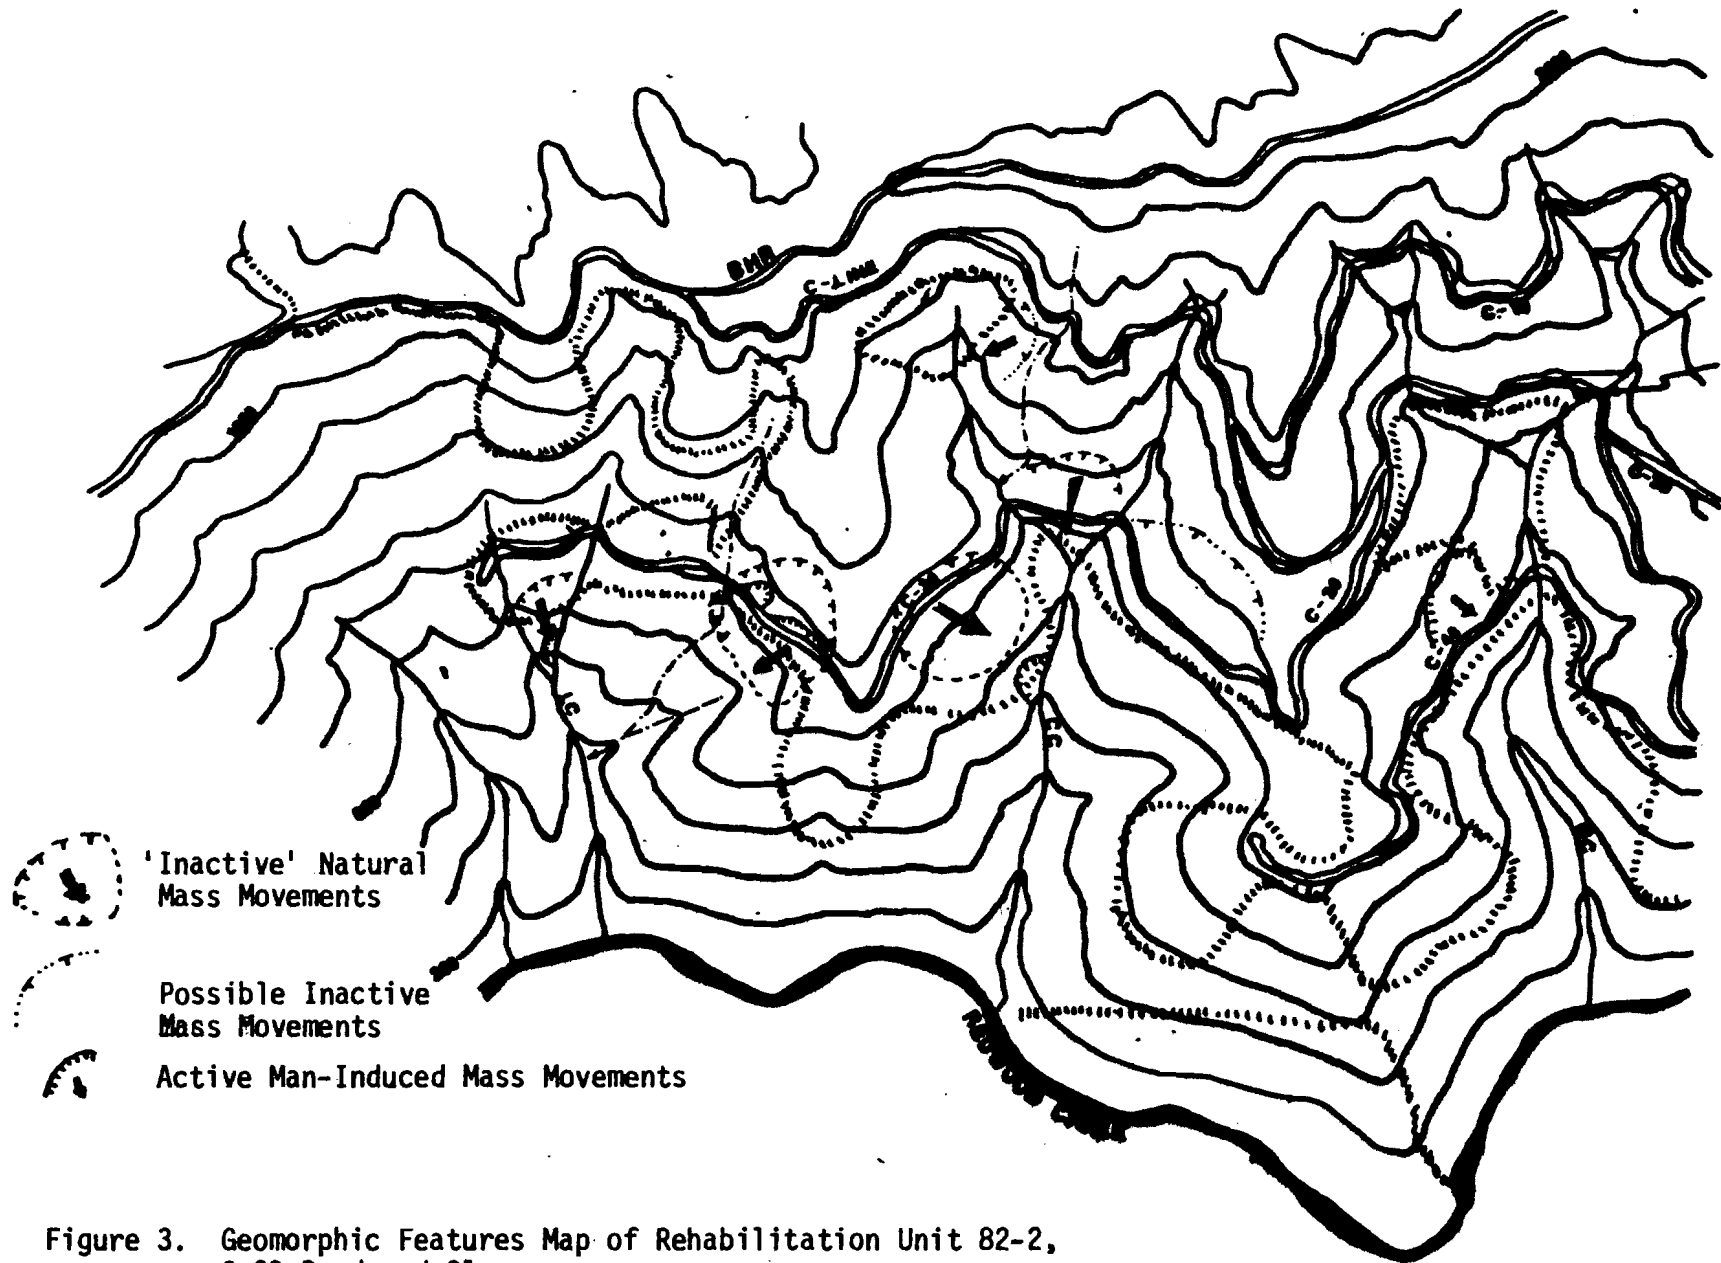
Figure 3. Geomorphic Features Map of Rehabilitation Unit 82-2, C-20 Road and Slope.

At the downslope terminus, these features may end in an incised stream valley where large boulders may represent lag deposits which the stream is incapable of removing. Some features blend downslope into the general hillslope trend before reaching a main stream. Infrequently will bulbous 'toes' of these large mass-movements be preserved. I believe examples of each of these types of downslope terminus are present on this hillslope (Fig. 3).

The most poorly located section of road along the C-20 was that between L-3 and L-5 (Fig. 3; Plate 1). This section traverses across large, inactive mass movement feature and locally steep slopes. Ephemeral streams crossing the road were either not identified or ignored during construction. Hillslopes above the road were tractor clearcut logged before road construction and complete destruction of the subtle drainage patterns resulted. The incoherent mass movement material, steep slopes, disrupted drainages, and high cutbanks resulted in gradual road failure and cutbank slumping. Because of the size of the feature and the fact that little of the failing material could enter stream channels, minimal rehabilitation work was done on this area. However future continual slumping may cause the ultimately disturbed area to be quite large. The possibility exists that a portion of the older, larger mass movement may become reactivated because of the logging of this hillslope and road construction.

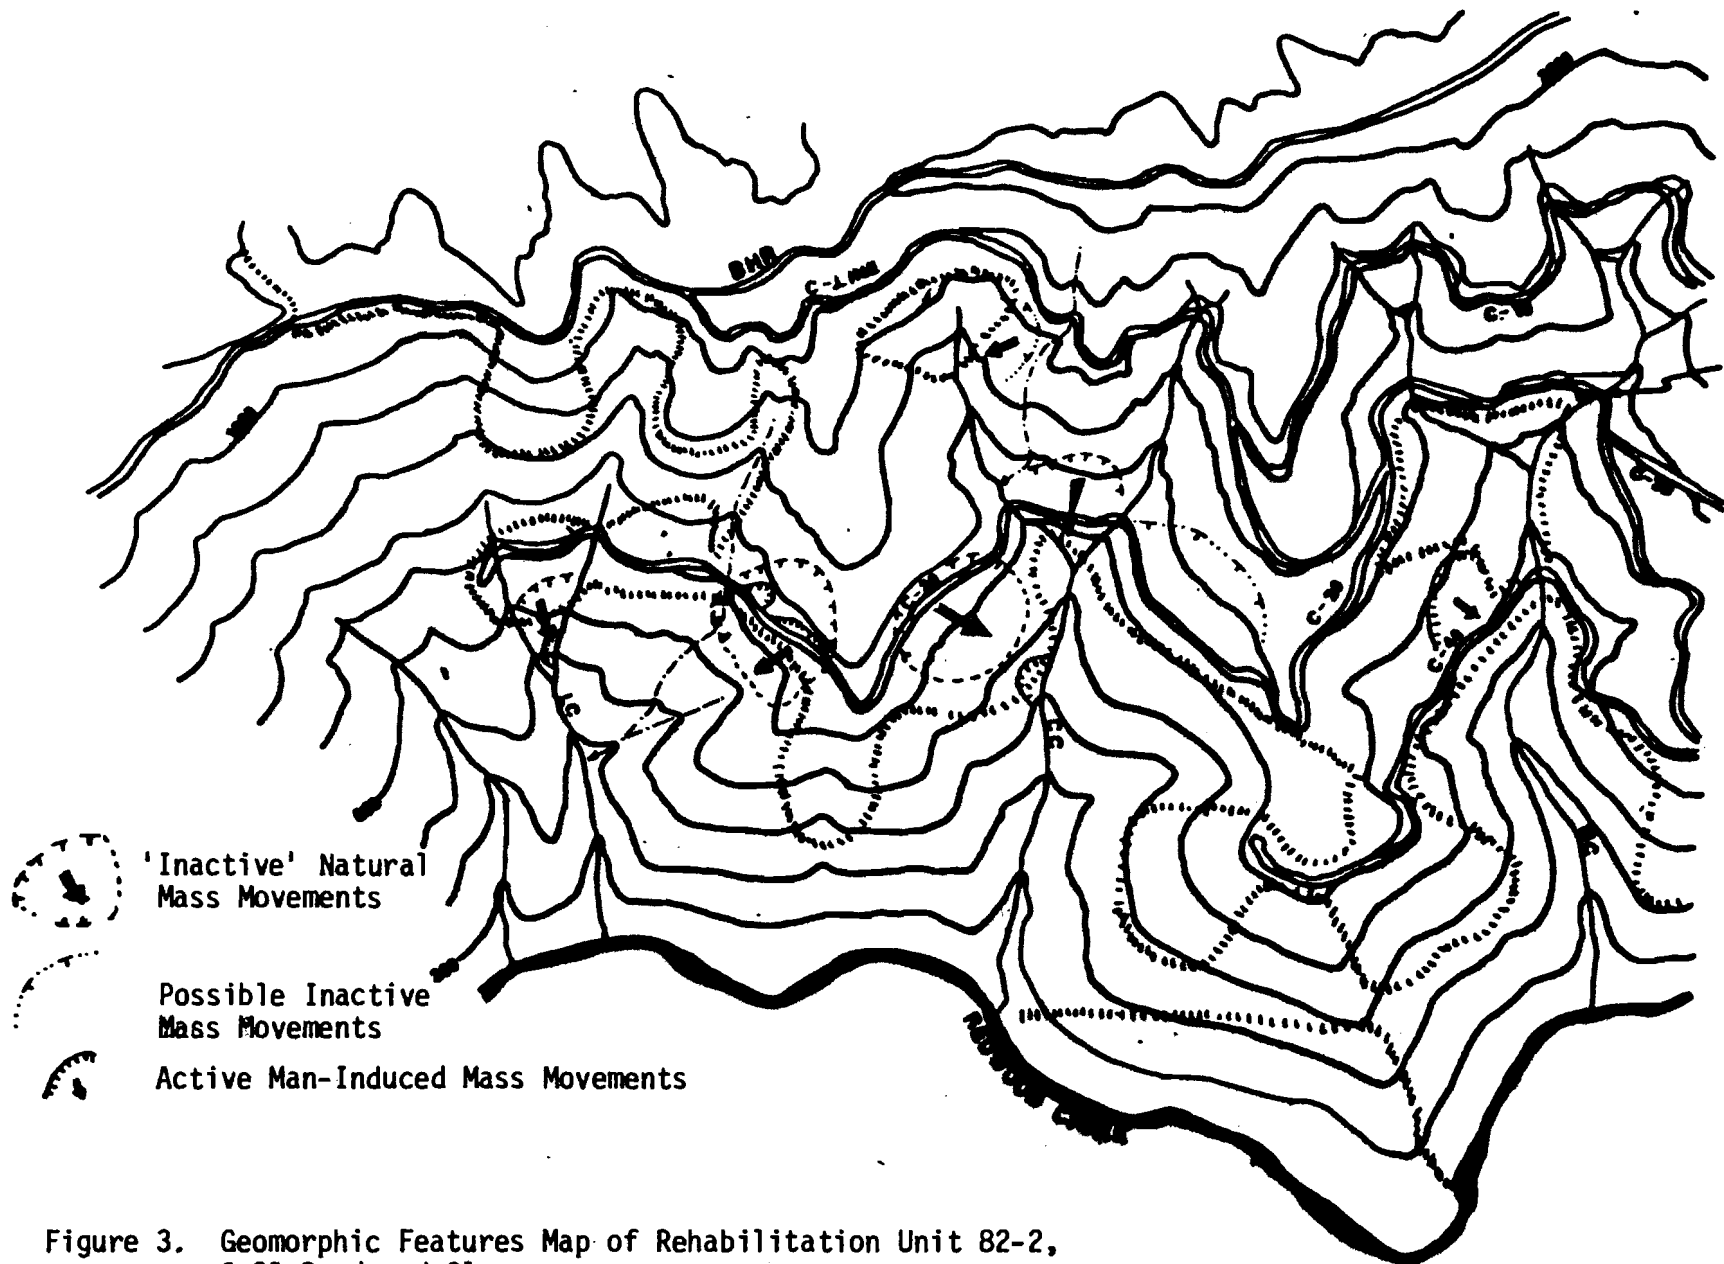
Figure 3. Geomorphic Features Map of Rehabilitation Unit 82-2,  
C-20 Road and Slope.

At the downslope terminus, these features may end in an incised stream valley where large boulders may represent lag deposits which the stream is incapable of removing. Some features blend downslope into the general hillslope trend before reaching a main stream. Infrequently will bulbous 'toes' of these large mass-movements be preserved. I believe examples of each of these types of downslope terminus are present on this hillslope (Fig. 3).

The most poorly located section of road along the C-20 was that between L-3 and L-5 (Fig. 3; Plate 1). This section traverses across large, inactive mass movement feature and locally steep slopes. Ephemeral streams crossing the road were either not identified or ignored during construction. Hillslopes above the road were tractor clearcut logged before road construction and complete destruction of the subtle drainage patterns resulted. The incoherent mass movement material, steep slopes, disrupted drainages, and high cutbanks resulted in gradual road failure and cutbank slumping. Because of the size of the feature and the fact that little of the failing material could enter stream channels, minimal rehabilitation work was done on this area. However future continual slumping may cause the ultimately disturbed area to be quite large. The possibility exists that a portion of the older, larger mass movement may become reactivated because of the logging of this hillslope and road construction.
