Summary Report  
WATERSHED REHABILITATION UNIT 88-1  
LOWER MAY CREEK

David L. Steensen  
Redwood National Park  
February, 1989

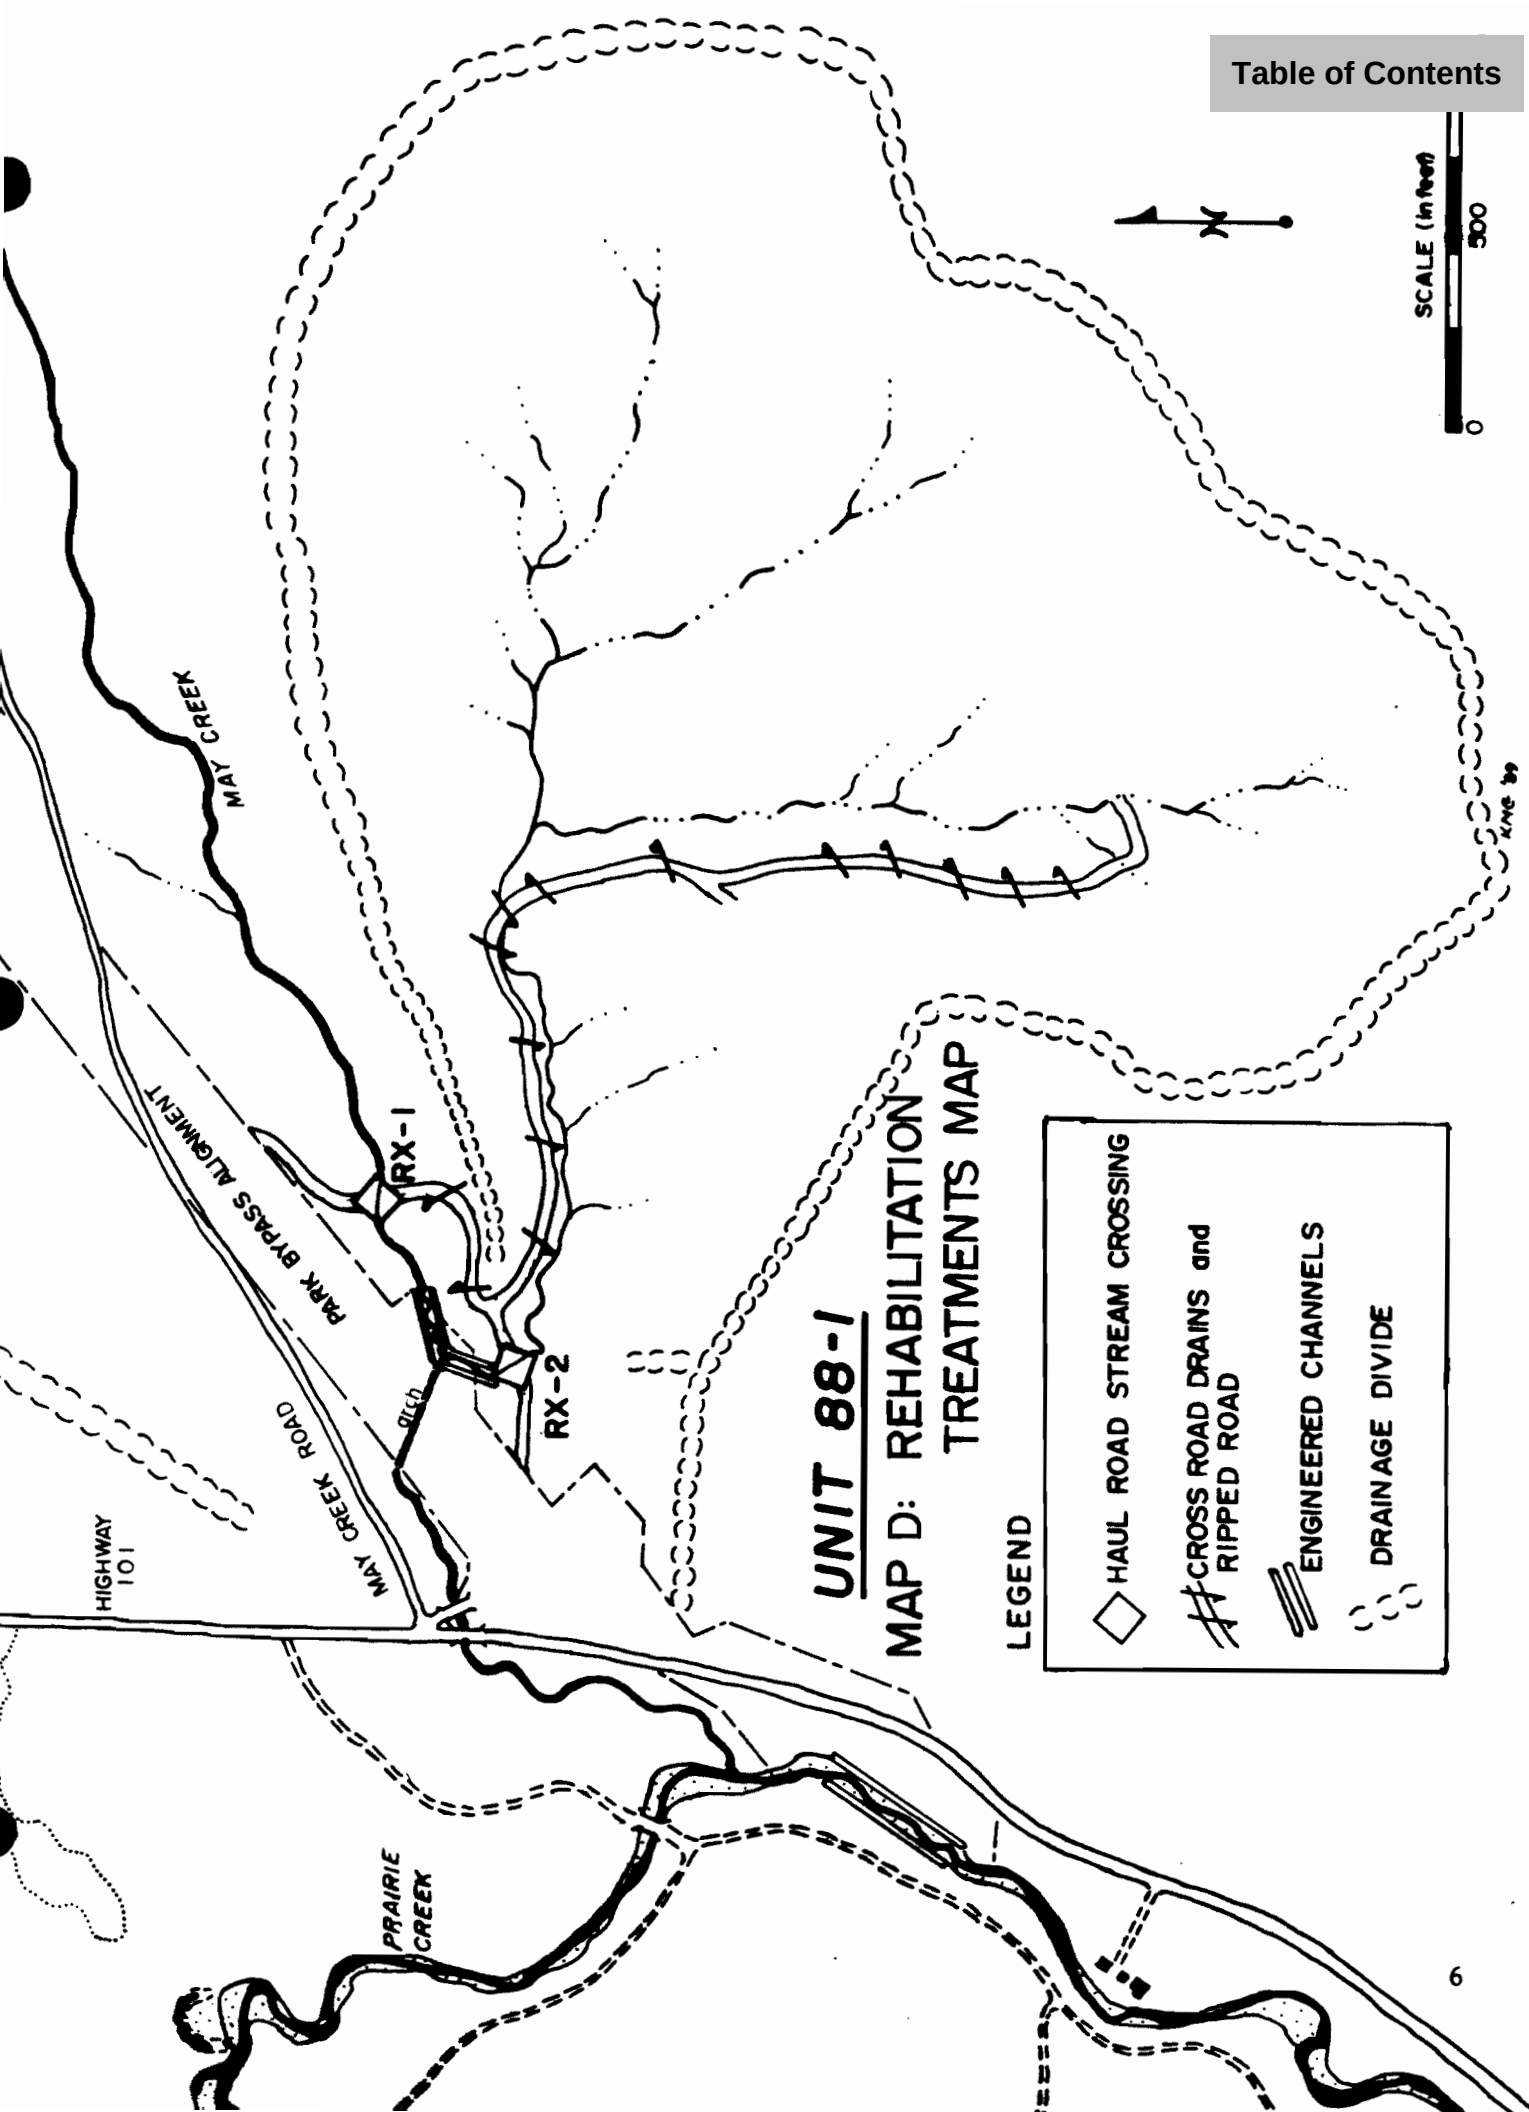
Rehabilitation treatments were oriented toward reducing existing and potential erosion and resulting sedimentation that could impact the main-stem of May Creek. The primary treatments consisted of removing one log bridge, removing one "Humboldt Crossing", and decompacting 0.7 miles of haul road (Map D). Secondary treatments included placing rock bank armor and applying straw mulch (Table 1).

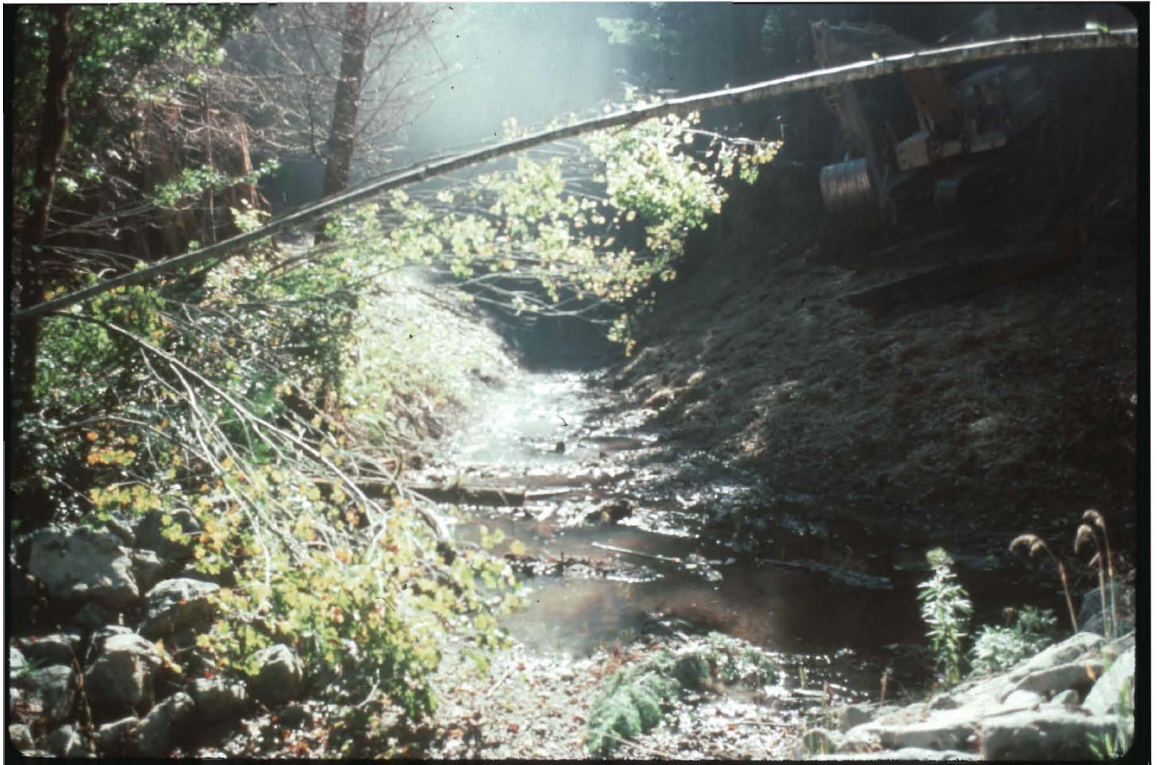
Unit: 88-1 PP1A 10-15-88 RX-2 Upstr Pre-Rock, Post HE DLS 35mm

RX-2 was a Humboldt Crossing that spanned the tributary drainage immediately upstream of the inlet to the engineered channel. The crossing had a large sink hole where fill had collapsed into the stream below. The potential for catastrophic failure, in this case massive gullying, was a scenario easy to envision. If the Humboldt functioned poorly during a storm event (drainage area is 258 acres) and backed-up water overtopped the fill, a large amount of material could be quickly introduced to May Creek. With the threat of erosion clearly present, it is interesting to speculate on the degree of pre-construction planning of the engineered portion of the channel downstream (discussed further under *Rock Armor*).

After the Lower May Creek Unit was completed, Fish and Game Enforcement Staff reviewing the site noted and made comments to RNP Administration on the newly exhumed stream valley at RX-2. They cited possible erosion from the unprotected stream banks as a primary concern. However, an apparent anxiety may have revolved around justifying the type of engineered channel they designed to others (i.e. CalTrans) who might see both approaches side by side. Ostensibly, CalTrans might wonder why CDFG required them to create an expensive channel reach when other resource managers use a much less intensive approach. Probably to avoid confrontations, RNP Administration made the decision to re-enter RX-2 and place rock armor.

Several draft options by RNP Rehabilitation and Geological Services Staff were presented to CDFG Fisheries Biologists and were discussed on-site. The design chosen was an extension of the rip-rap of the CDFG channel up the stream to better tie-in with the defined stream banks of RX-2. The final design entailed placing about 65 yd<sup>3</sup> of rock (0.5 to 2.5 ft. dia.) on each bank along the lower 40 feet of the channel. Toe trenches were excavated two feet deep and the rock was layered about two to three feet thick and four to five feet up each bank. Keys were created at the upstream end by excavating five to six foot long trenches and "stuffing" them with rock.

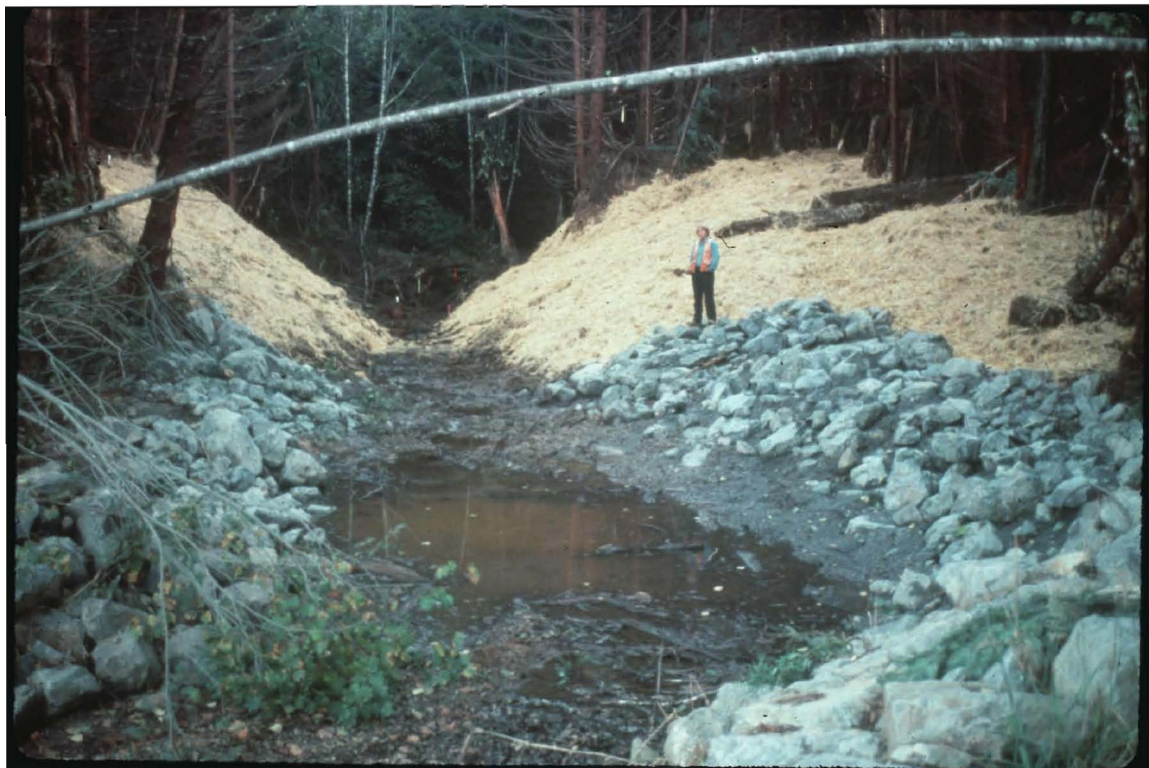
Unit: 88-1 PP1A 10-17-88 RX-2 Post Rock, DLS &LEJ 35mm

Overall, the rock armoring has produced a more stable channel system and has reduced the risk of scour behind the original CDFG rip-rap. However, cost-effectiveness is likely to be minimal since, based on the low energy environment that exists at RX-2, that risk was quite small to begin with.
