**Summary Report**  
**WATERSHED REHABILITATION UNIT 90-2**  
**LOWER K&K, CAMP, AND SPUR ROADS**

**David L. Steensen**  
**Redwood National Park**  
**February, 1992**

WATERSHED REHABILITATION UNIT 90-2  
Lower K&K Road and Slope

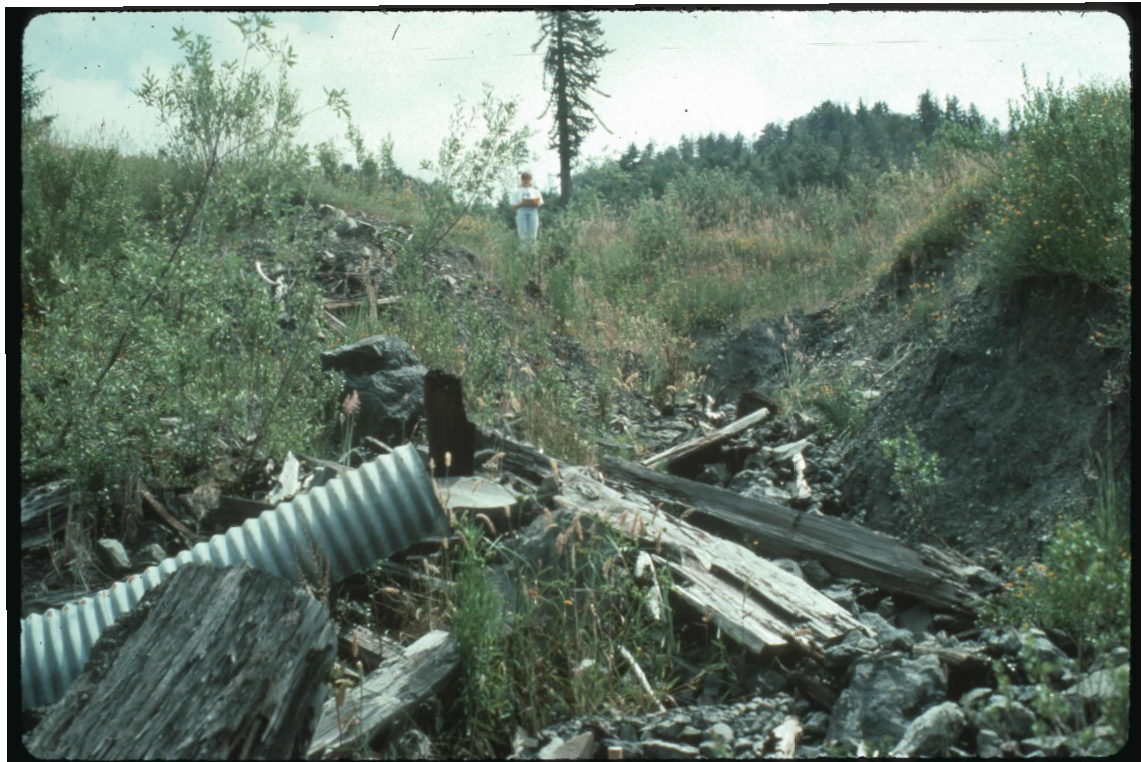
90-2 PP3 6/27/90 50mm K+K Road upchannel from RX11 L8 DLS

Rehabilitation work at RX-11 entailed stabilizing a small stream that flows through the axial portion of the Big Tree Earthflow which has been the most active earthflow during the 1980's. The crossing was over-excavated in comparison to the design which resulted in minor slope adjustments the winter of 1991-92. In retrospect, the functioning of this crossing would have been

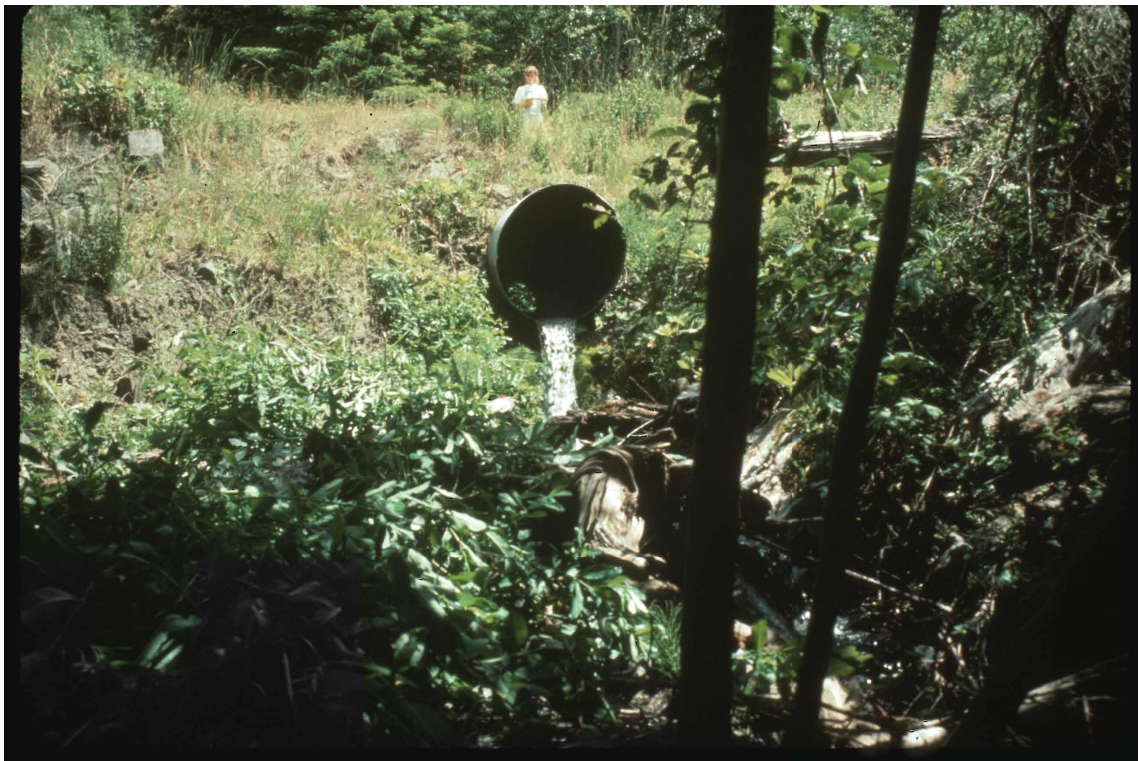
90-2 PP11 6/27/90 35mm K+K Road upchannel CL RX12 DLS

An interesting phenomenon took place during the course of excavation at RX-12. Relocating and concentrating mass on the earthflow destabilized the landslide beyond a threshold of failure. After one weekend, while work was not in progress, numerous and sizeable tension cracks (1-3 ft. wide, and 1-10 ft. deep) developed about one hundred feet upslope of the newly created levee and a circular arc failure developed that was observed by upthrust earthflow material into the channel. Approximately two to three feet of offset occurred. At this point a decision to alter the original design was made by cutting the levee crest down and endhauling the material to a stable fillsite. A judgement was made on how much of a levee to leave which required a balance between controlling the channel while not destabilizing the overall area such that earth movement would potentially result in channel destruction as well. A levee crest about two-thirds the height of the original design was the ultimate finished product. Some minor movement has taken place since the excavation was completed but the crossing is functioning as desired.
