**Summary Report**  
**WATERSHED REHABILITATION UNIT 93-2**  
**K&K ROAD AND SPURS**

**James K. Dame**  
**Redwood National Park**  
**May 1994**

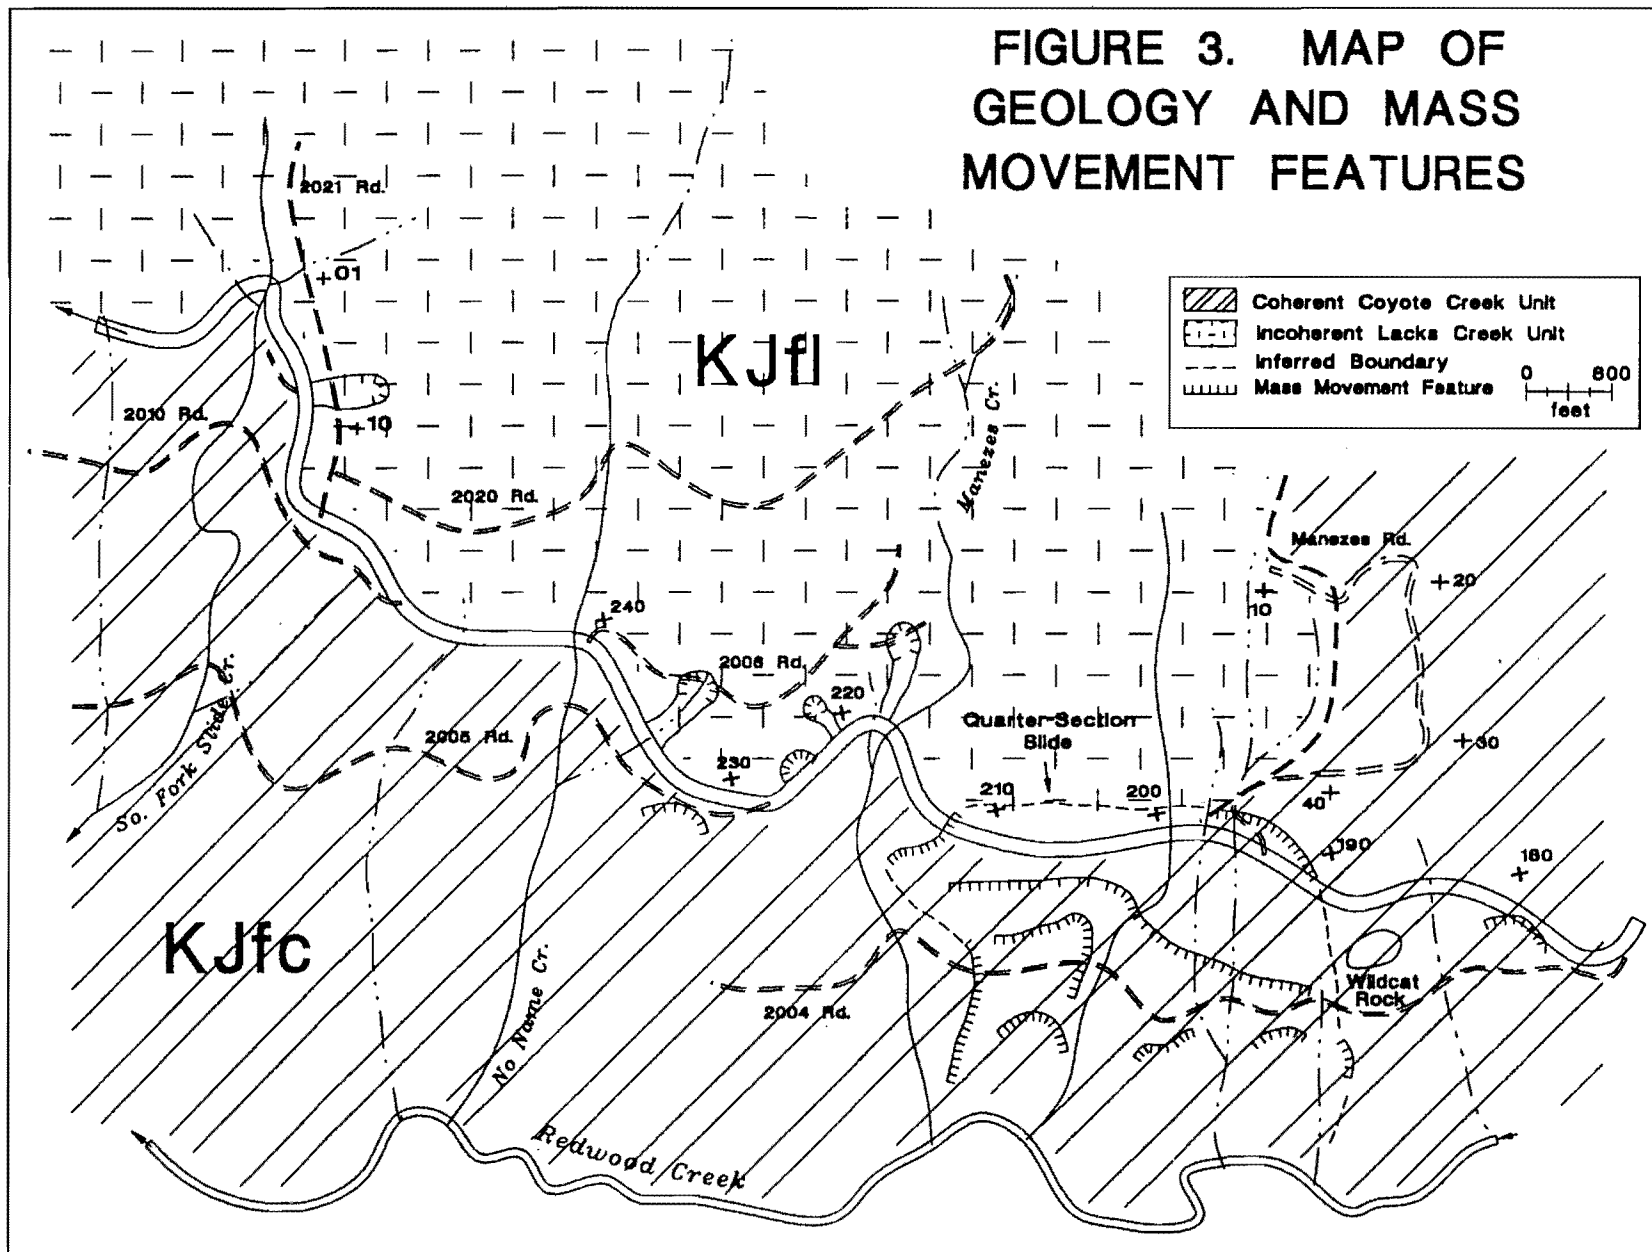
**FIGURE 3. MAP OF  
GEOLOGY AND MASS  
MOVEMENT FEATURES**

For the most part, erosional features associated with the slopes above and below Unit 93-2 were addressed in previous rehabilitation projects (Spreiter and Johnson, 1981; Bundros and Huber, 1981; Wosika, 1980). However, potential erosion sites along the corridor of the K&K road in this reach were not fully treated until this year (Figure 3).

Mass movement features were also a prevalent problem within the project area. The 2006 and K&K roads were built across a moderately sized debris slide along EOS 234+56. The seepy, mobile hillslope associated with this slide produced a road failure along the 2006 road near station 00+06. Another debris slide extended upslope to just below the K&K road at EOS 230+85. Oversteepened landings were responsible for a debris slide above the 2021 road near station 00+10, and a debris torrent (along the 2006 road) which directly impacted the right bank of Manezes Creek. In addition to these, several large cutbank failures were present along OS 219+21 (right drainage divide of Manezes Creek) due to undercutting the slope during road building. These features originated between 1966 and 1968 except for the debris torrent which occurred between 1972 and 1974. A small fill failure was present at EOS 177+09, and resulted from the K&K road intercepting minor seeps along the cutbank. No significant evidence of this failure existed prior to the spring of 1993 when cracks, and eventually small scarps, developed along the sagging road reach.

By far the most impressive mass movement feature in this area is the Quarter Section Slide. It is a large, ancient slide that continues to show adjustments in the form of smaller scale active scarps within the boundaries of the main slide (Wosika, 1980). Harden et al. (1978) place the upper portion of the slide in the vicinity of the 2004 road. However geomorphic mapping (Wosika, 1980) and air photo analysis suggest that large scarps (up to 15') are extensive upslope of the 2004 road and diminish (1 to 2') above the K&K road.

For the purposes of this project, the Quarter Section Slide is interpreted as extending downslope from an area just above the K&K road. A 1-2' scarp represents the slide's most upslope expression, and was evidenced by a sag on Manezes road around station 43+00. The slide's right boundary was well defined along the K&K road by a 1-2' scarp near station 211+50. The left margin is less obvious, but air photo analysis indicates its location to be in the vicinity of Wildcat Rock.

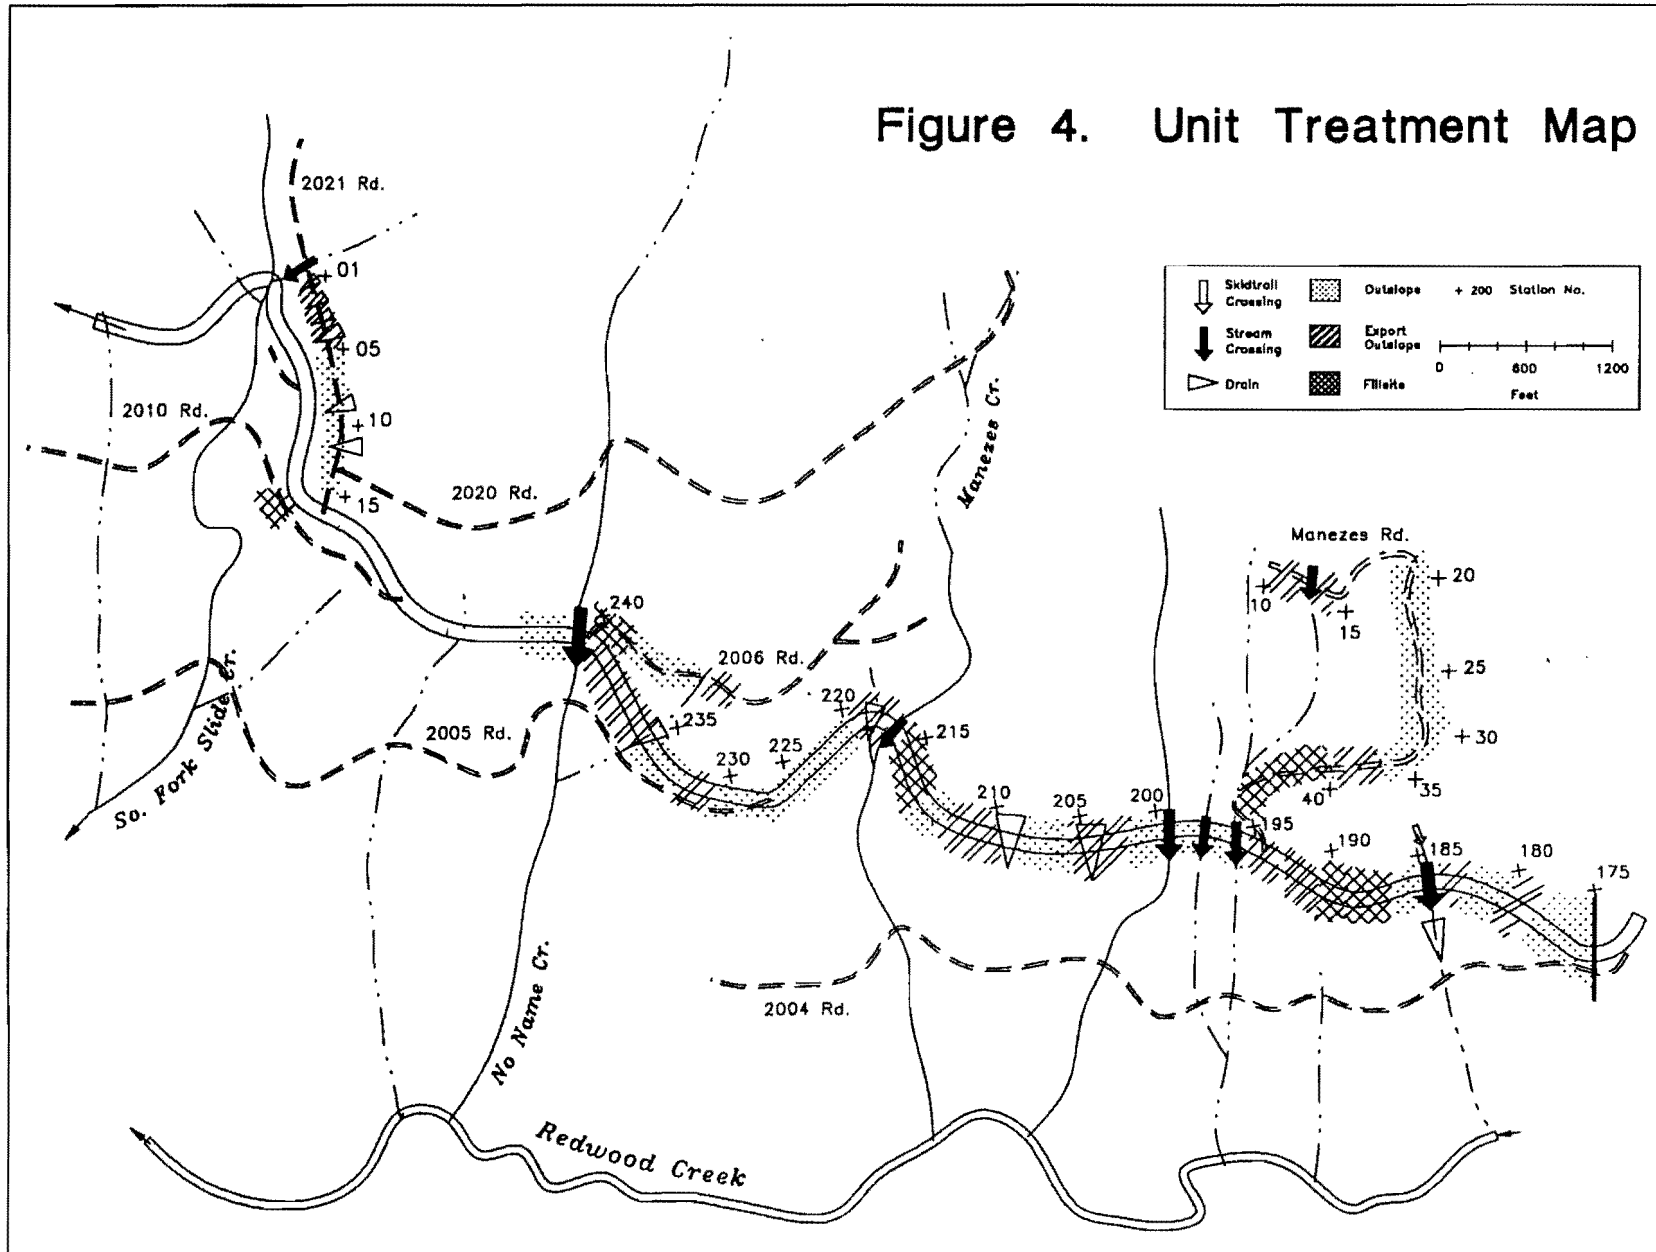
Figure 4. Unit Treatment Map

Primary rehabilitation treatments included the excavation of nine stream crossings, 3031 feet of exported outsloping (fill material is endhauled), and 7028 feet of outsloping (Fig 4). Miscellaneous bid items included the following: construction of a hillslope channel; salvage and hauling of aluminum culverts, logs, and rock; placement of rock in finished stream channels; removal and burial of asphalt surfacing; ripping roads; winterization of site.
