Summary Report  
WATERSHED REHABILITATION UNITS 95-1 and 95-2  
AH PAH ROAD COMPLEX

Becca Smith  
Redwood National Park  
June, 1997

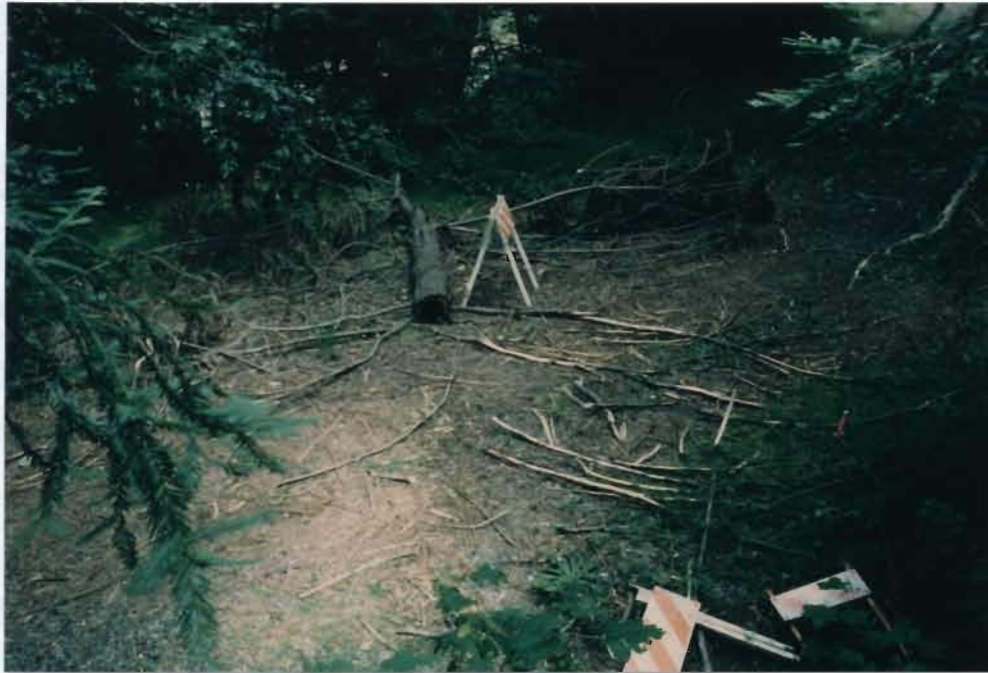
RX-1, Photo Point 7B, 8/16/95. The cut log is part of a tree that was illegally cut down and a section of the trunk was stolen from the park.

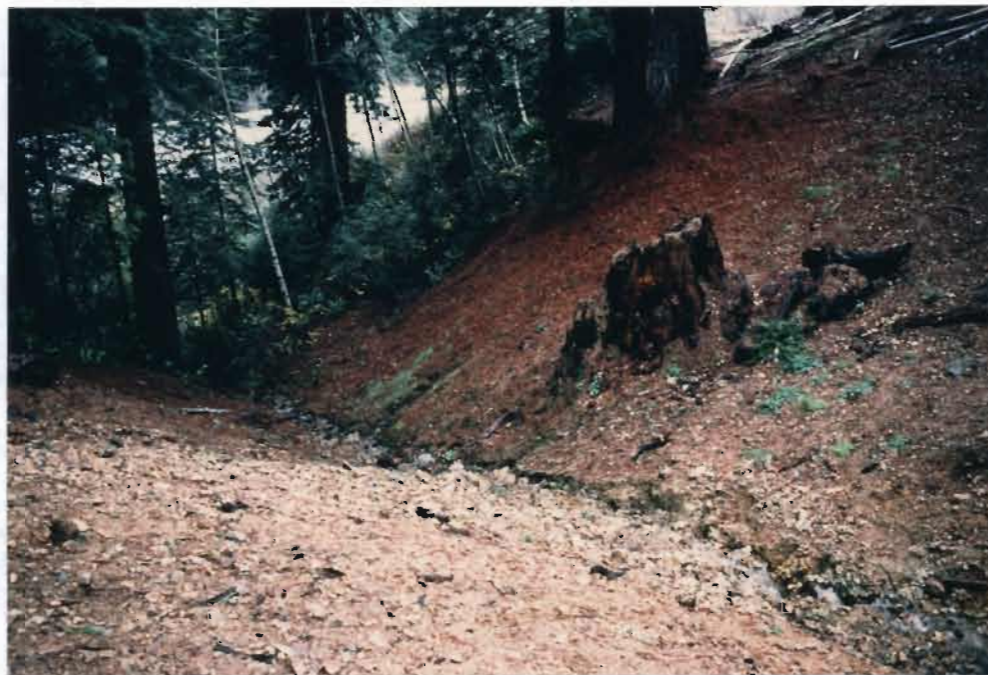
RX-1, Photo Point 7B, 12/23/96. The stump had been completely buried in the road fill and was uncovered during excavation. The U.S. Highway 101 Bypass is in the background through the trees.

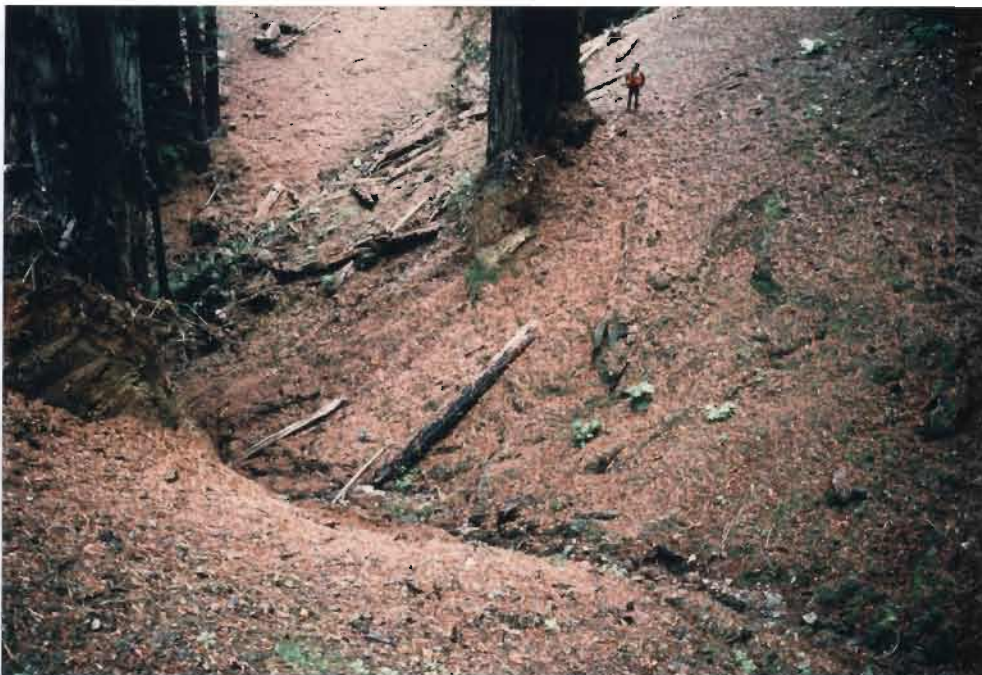
RX-4 and RX-3, Photo Point 22, 11/6/96. The stream channels of RX-3 and RX-4 merged at the base of the road fill. This photograph is taken looking across RX-4 with RX-3 coming down the hill behind the old growth tree in the center of the photo.

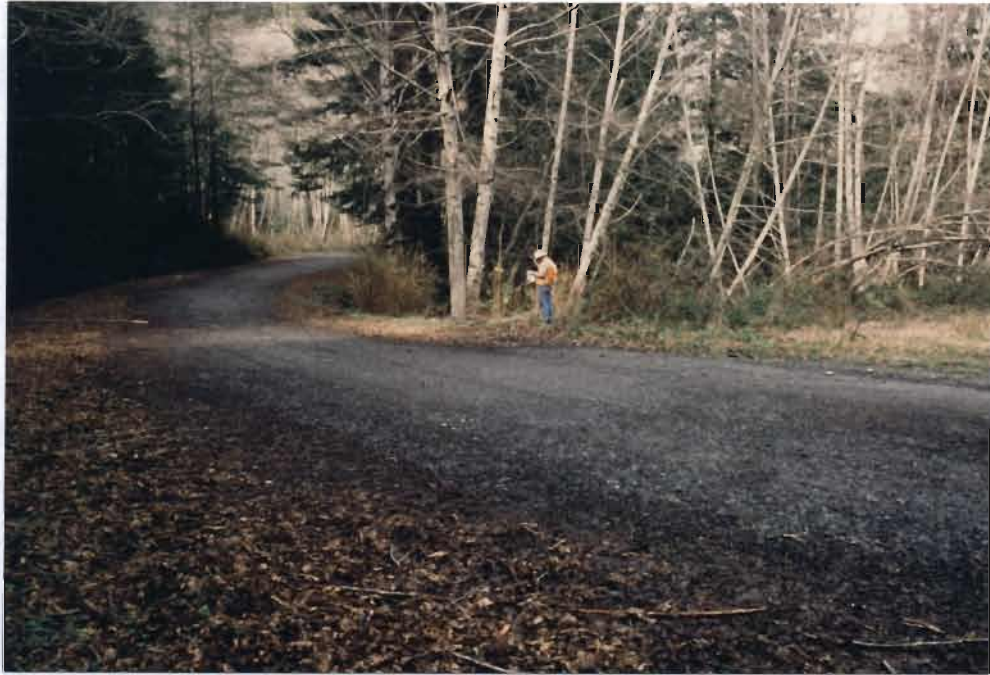
RX-7, Photo Point 35, 3/1/94. This crossing is at the left edge of the large landing on Ah Pah Road.

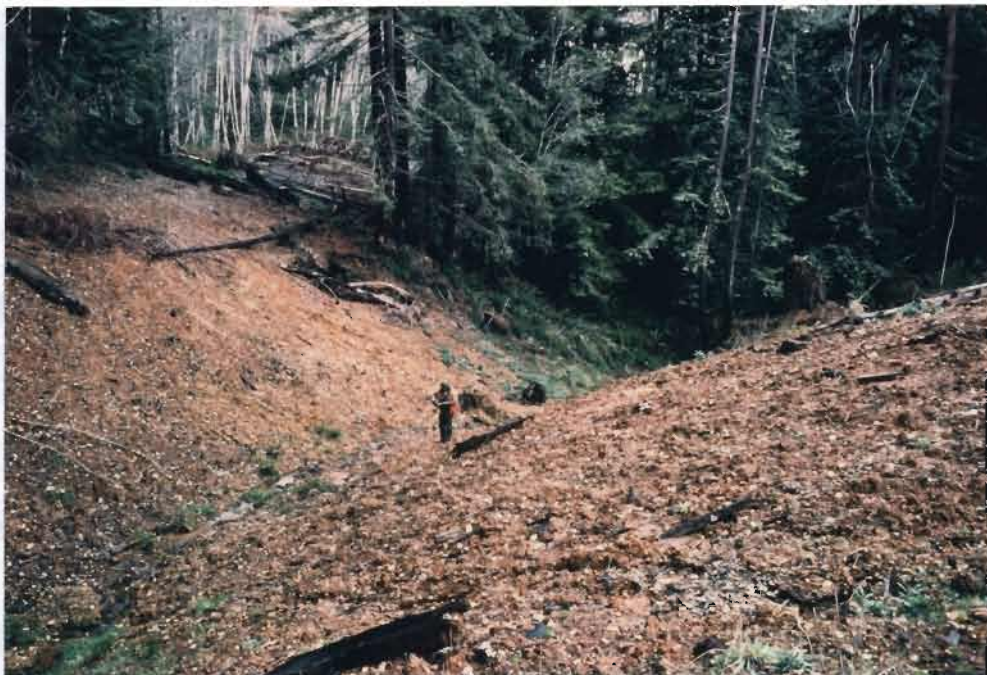
RX-7, Photo Point 35, 12/2/96. A large amount of wood, root wads, tires, and metal debris that had been pushed off the edge of the landing into the crossing has been removed and the edge of the landing pulled back to recreate the valley slope.

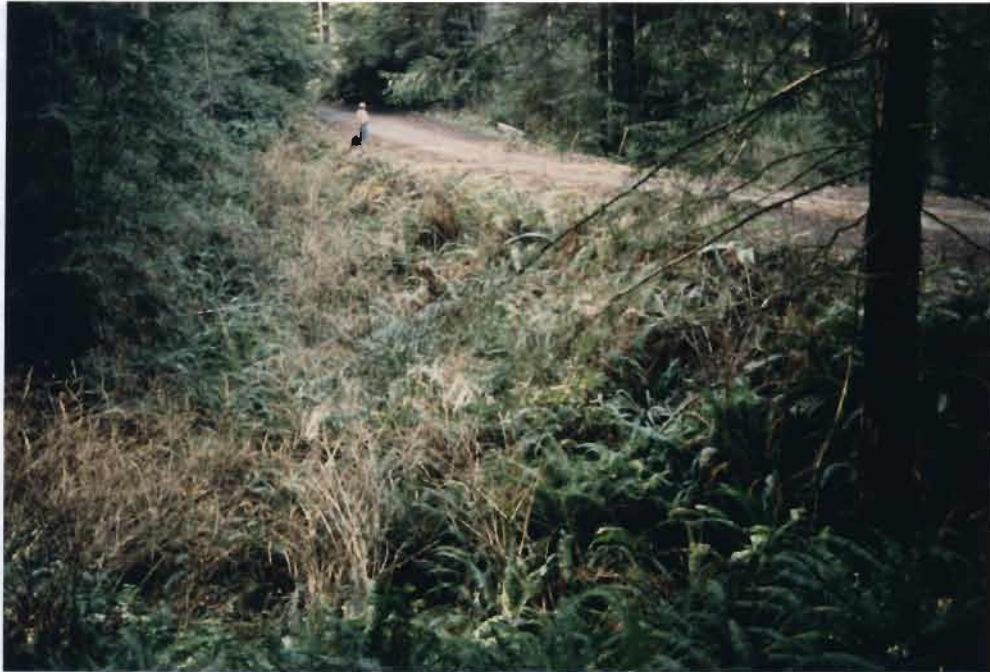
RX-8, Photo Point 43A, 3/1/94. This photograph is taken from the right bank of the crossing on the inboard side of the road fill.

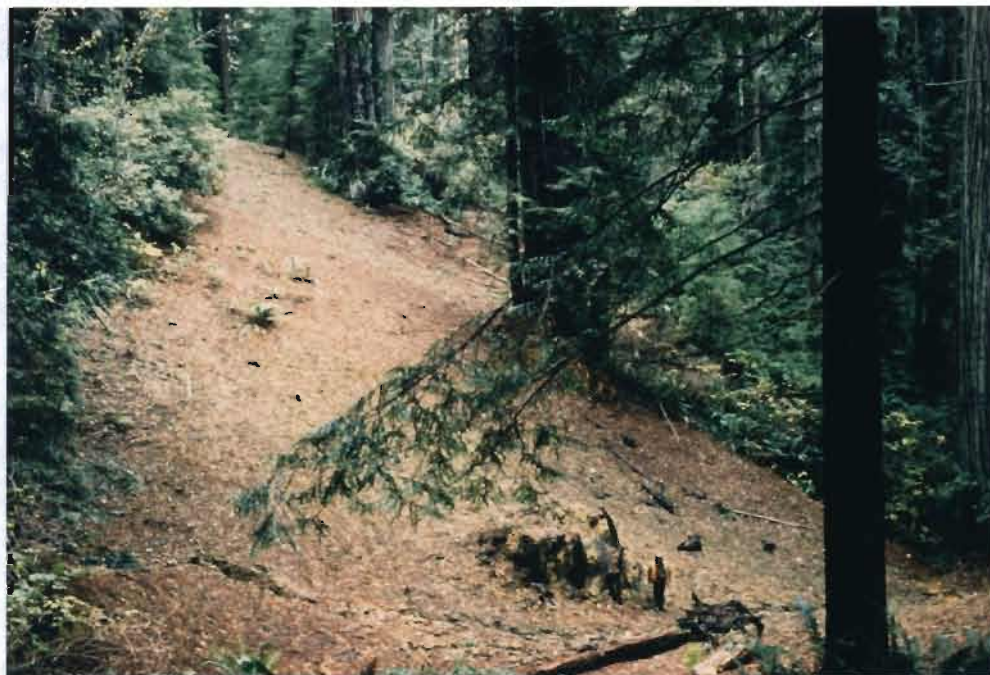
RX-8, Photo Point 43A, 12/2/96. A stump (to the left of the person) was uncovered during excavation. The stream channel is just in front of the person.

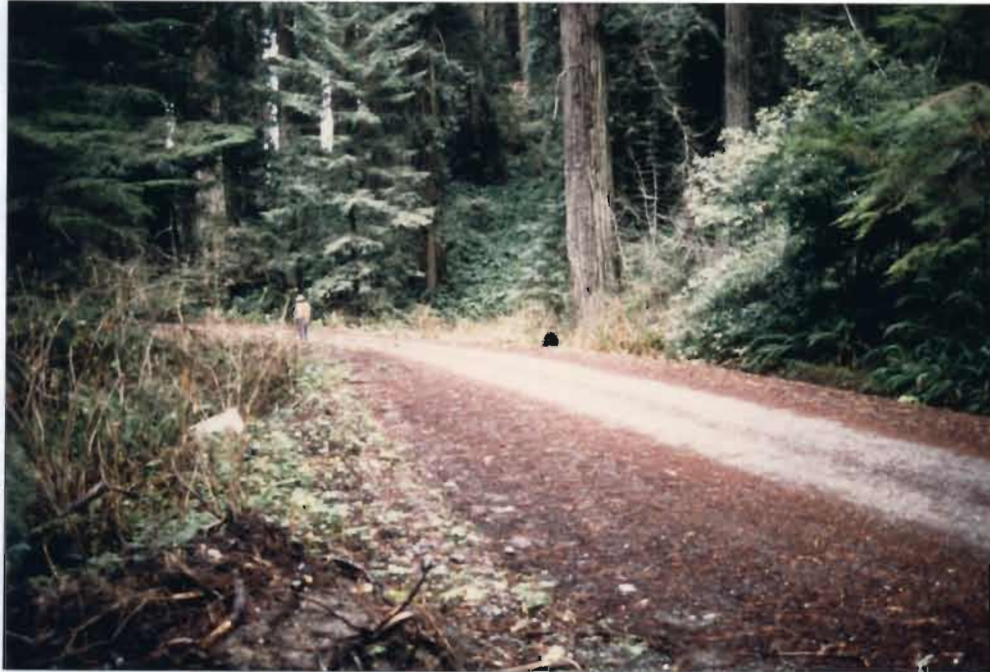
RX-8, Photo Point 45, 3/1/94. This photograph is taken from the left side of the crossing on the outboard edge of the road.

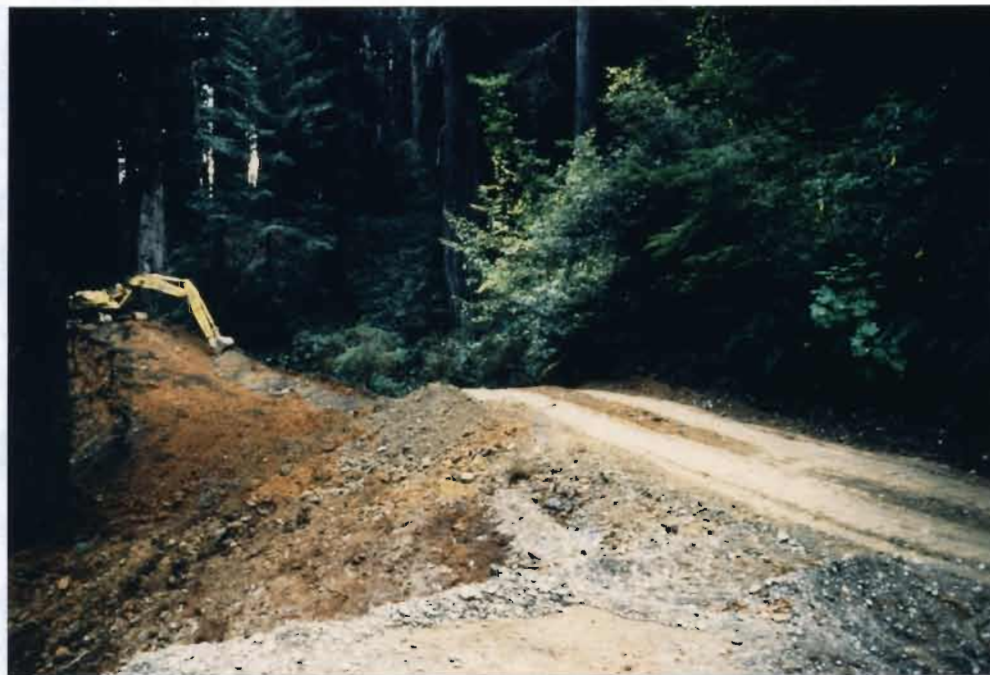
RX-8, Photo Point 45, 11/2/95. This photograph was taken during heavy equipment work. The large excavator is excavating fill from the upper end of the crossing and passing it to a bulldozer behind it that pushes the fill to a fillsite.

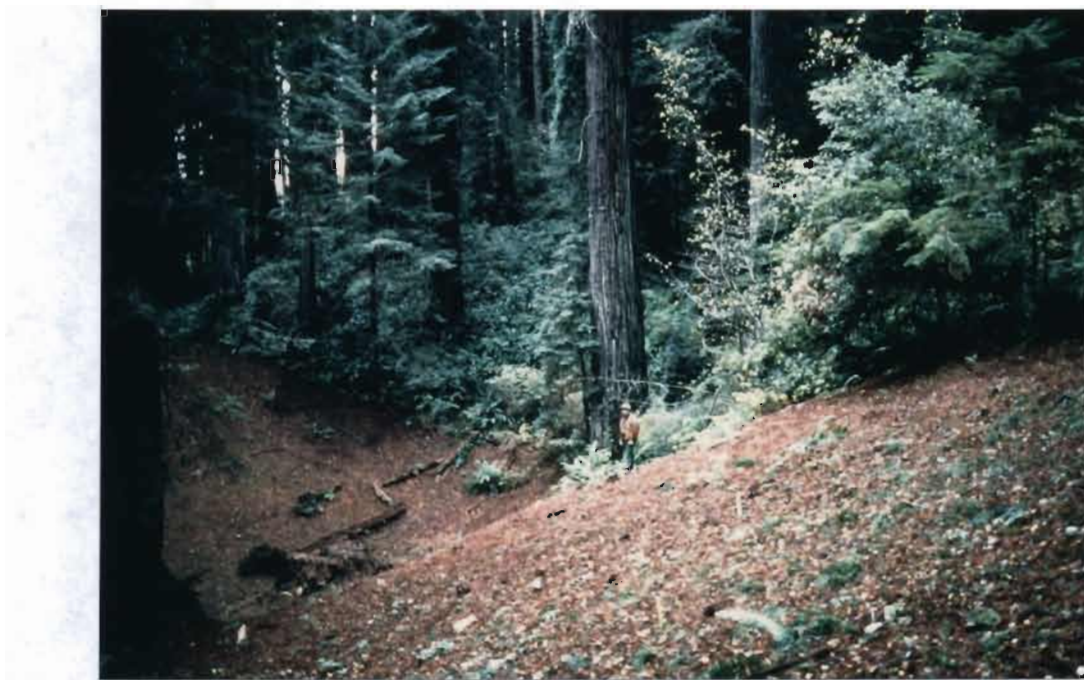
RX-8, Photo Point 45, 12/2/96. The stream channel runs from the base of the old growth tree in the middle of the photograph to the lower left below the woody debris.

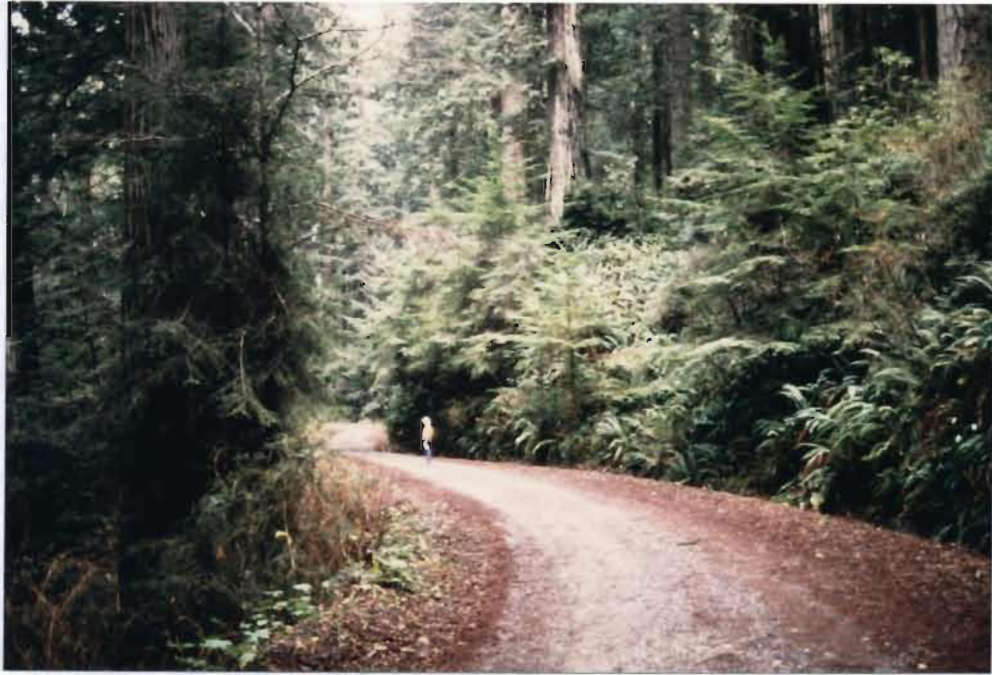
OS 58+00, Photo Point 46, 3/1/94. This is a view downstation taken from the gate.

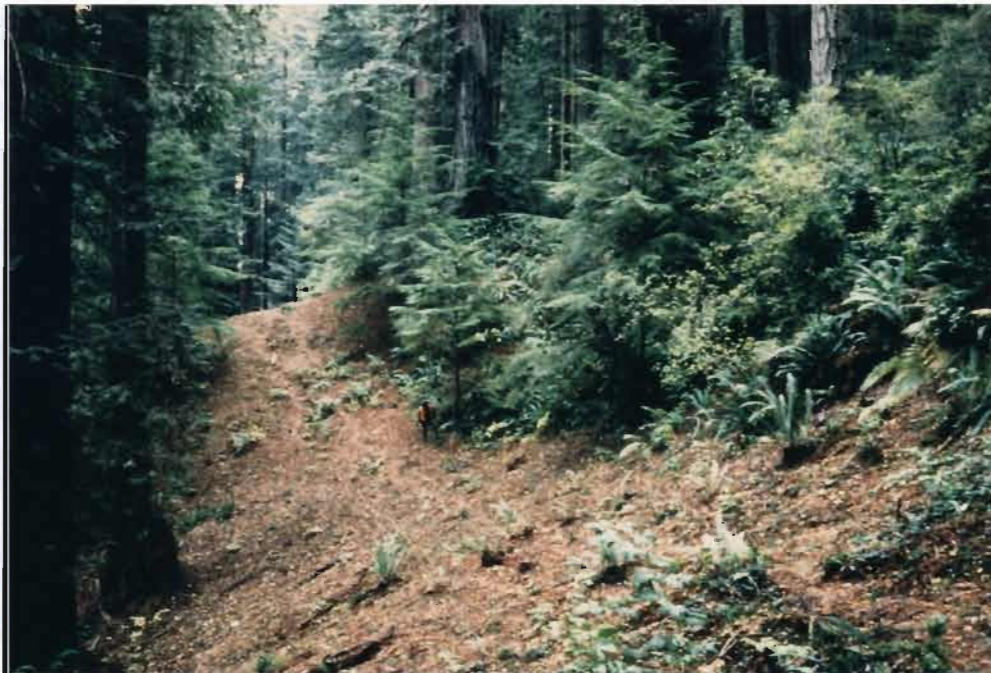
OS 58+00, Photo Point 46, 12/2/96. Natural revegetation is particularly vigorous in this area.

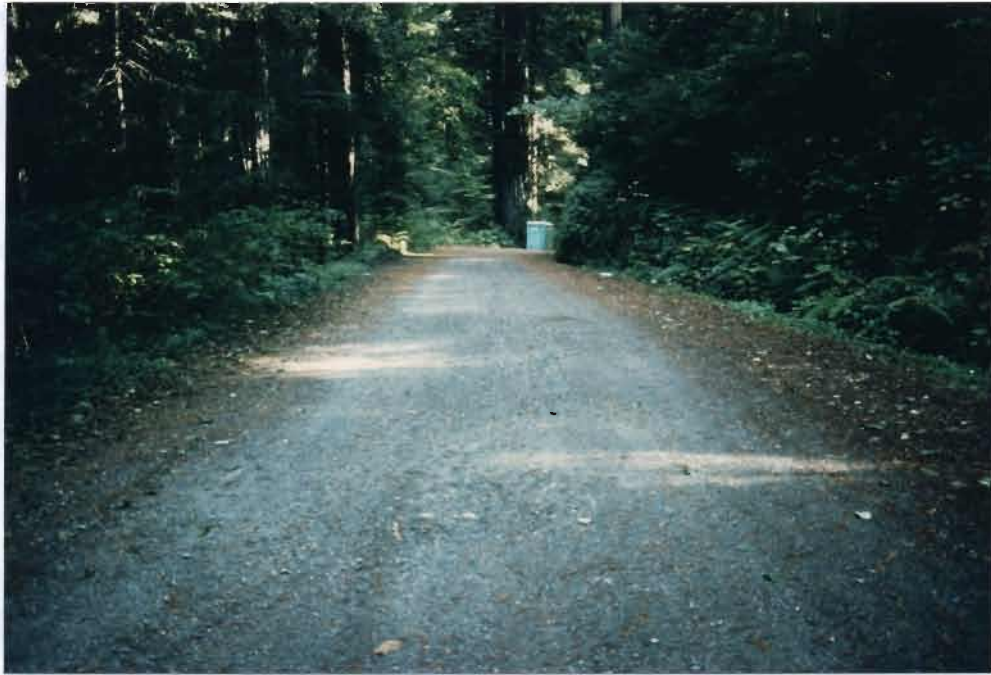
OS 60+00, Photo Point 46.5A, 10/28/95. This is a view downstation taken from the end of Ah Pah Road at the Newton B. Drury Scenic Parkway.

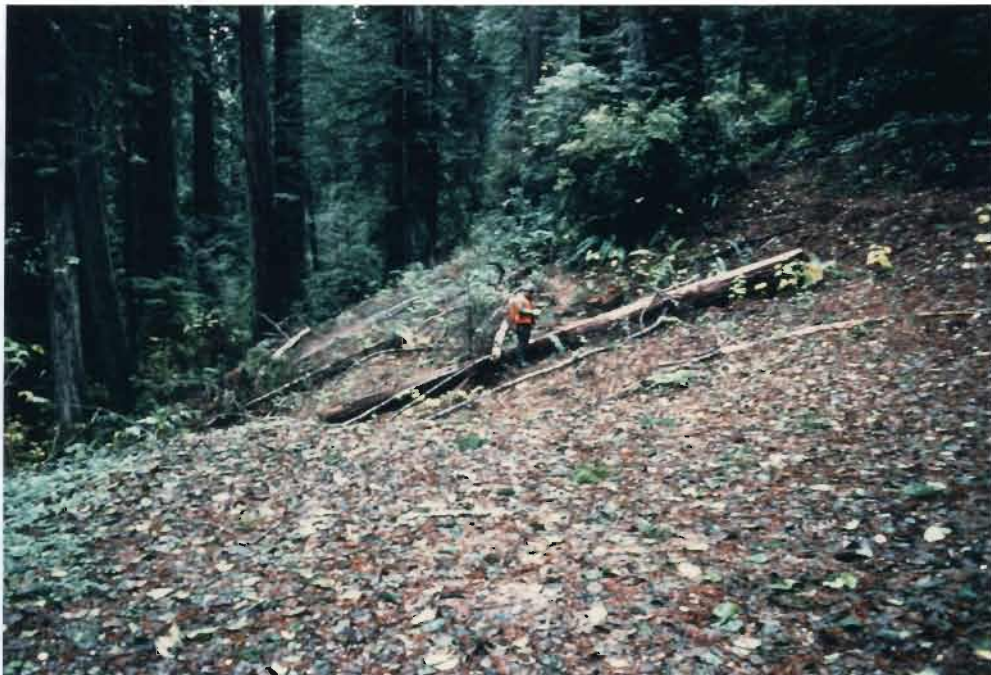
OS 60+00, Photo Point 46.5A, 12/2/96. This is a view of the restored road corridor that was taken from what is now the parking area and trailhead.
