REPORT NO. 80-2

AZTEC RUINS WATER INVESTIGATION

Paul K. Christensen  
National Park Service  
Southwest Region  
November 1979

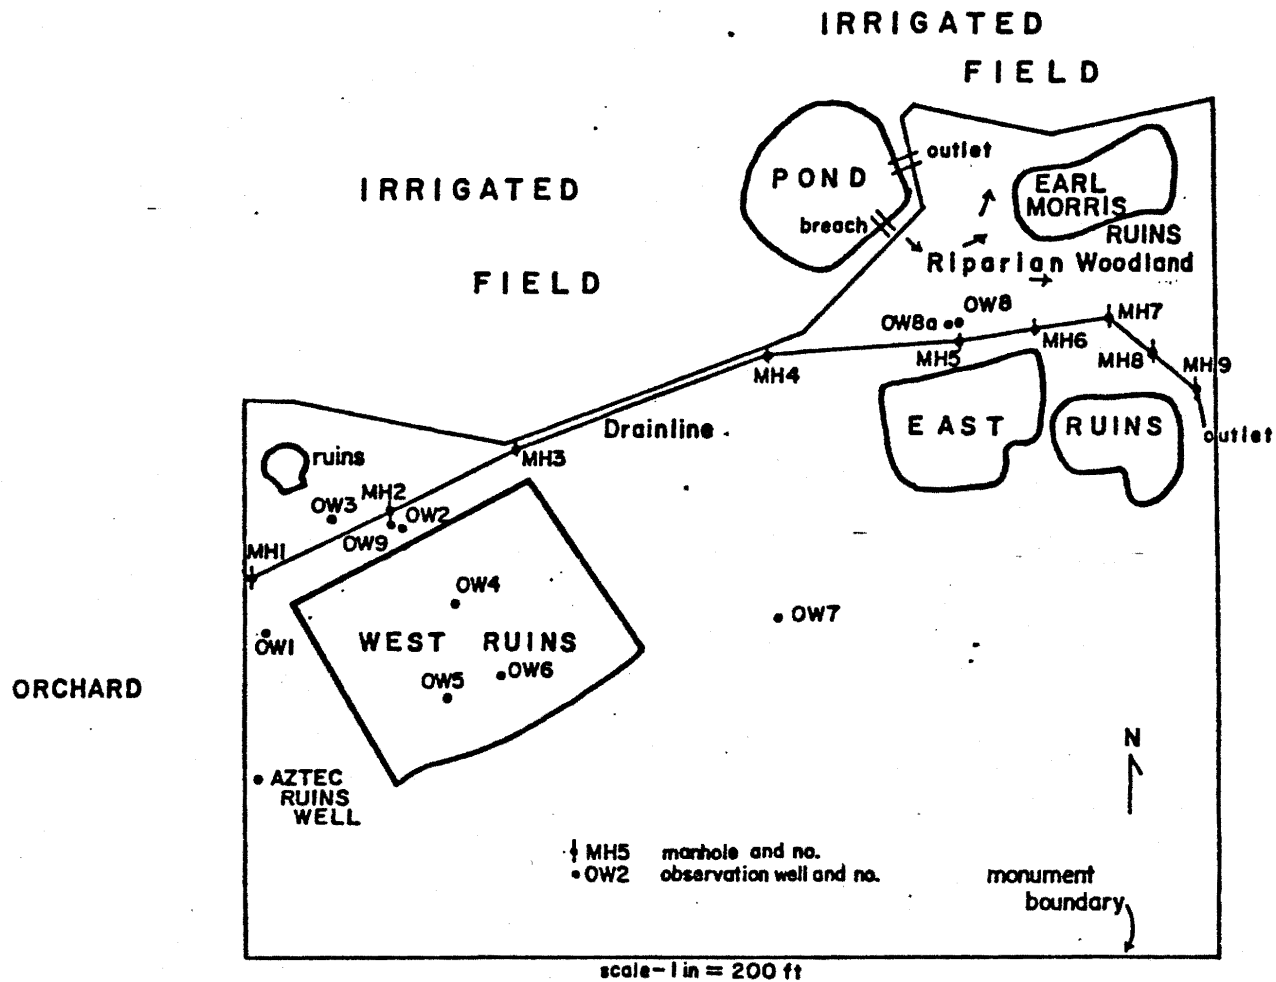
FIGURE 2. Map of Aztec National Monument showing local features mentioned in report.

A riparian woodland has encroached upon the northeast corner of the monument since 1962 as evidenced by aerial photographs taken in 1962 and 1978. North of the monument are irrigated fields and a stock pond. An irrigation-waste water ditch crosses the central portion of the monument in a north-south orientation. Figure 2 shows locations.

In August 1979, flooding occurred from a breach in the pond across the riparian woodland in the northeast corner of the monument. The water originated from irrigation on fields north of the monument. The eastment ditch intended to collect the irrigation waste water and to guide this water through the central portion of the monument is not used. The water collects in the pond, and flows through the breach out onto the vegetal encroachment. An outlet with a headgate is constructed on the east dike of the pond. However, it also directs overflow onto the concerned area.

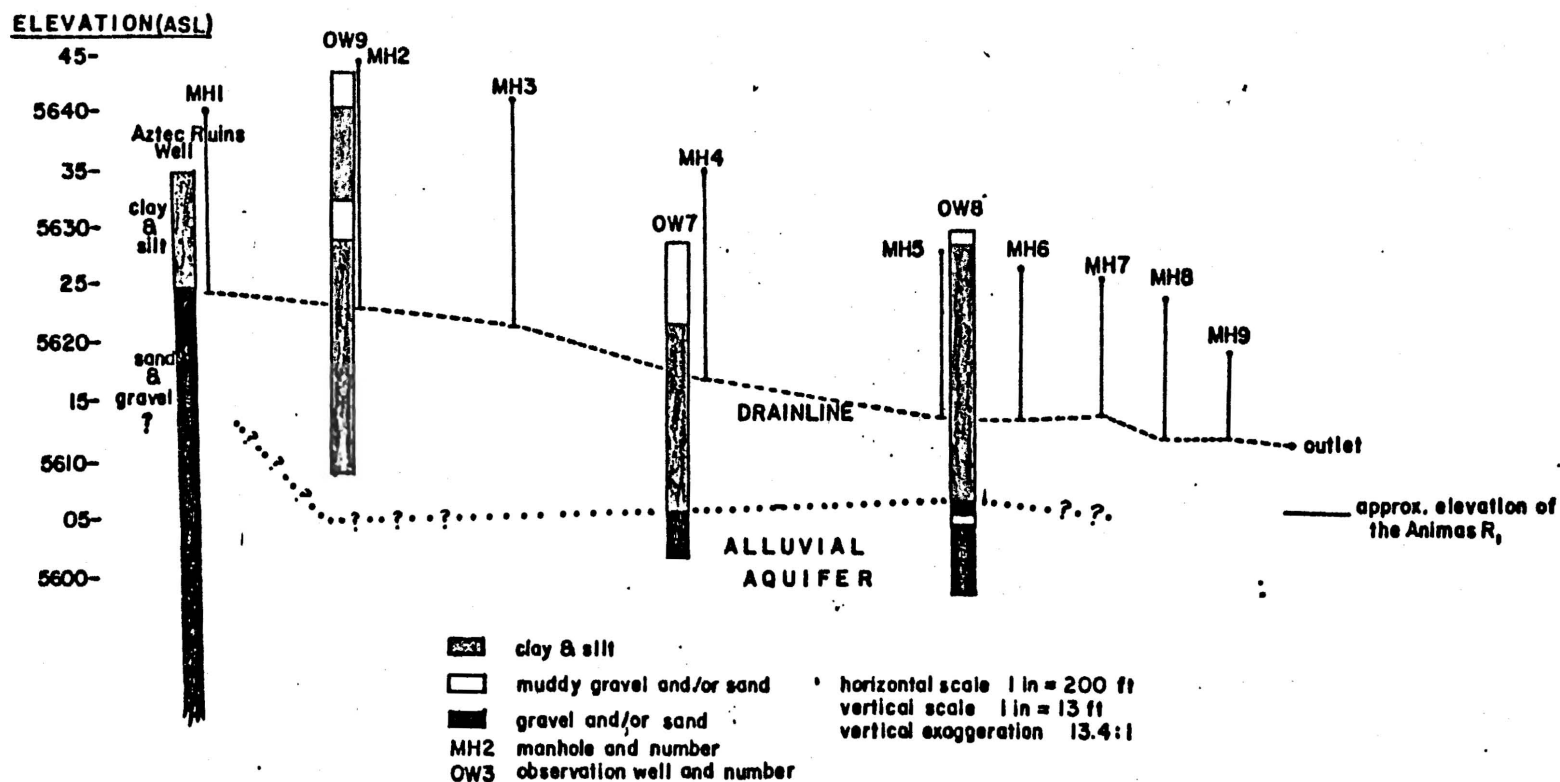
FIGURE 3. Schematic comparison of drainline, observation wells, and Aztec National Monument well/data showing subsurface interrelationships with the alluvial aquifer beneath the monument.

Figure 3 demonstrates the positional relationship between observation wells nos. 7, 8, and 9, the drainline, and Aztec Ruins well. The drainline is situated in the clay aquitard above the gravel-sand alluvial aquifer and is ineffectual on lowering the static water level of said aquifer. This sand-gravel aquifer is situated deep enough below the surface to present no problem to the preservation of the archaeological sites and is sealed off from significant upward movement by the clay aquitard. Data from observation wells nos. 6, 7, 8, and 9 and the Aztec Ruins well suggest that the monument sits on a clay aquitard. The clay aquitard is overlain by various sand and silt units which vary from 3 to 11 feet thick.

Static water levels taken at observation wells nos. 1, 3, 4, and 5 represent the piezometric head of the gravel-sand aquifer or water derived from the aquitard. The exact depths to which observation wells no. 1 through 5 were drilled is not known due to backfill, thus the origin of the water in

the holes is not known. The aquitard does bear water, but is severely limited in rapidly transmitting ground water.

A sandy unit exists about 10-13 feet below the surface at observation well no. 9. The unit appeared dry, but will probably produce some water as do the clay units. On both upper and lower contacts, this sand unit is sealed by clay. This sand unit may emit water into the observation wells around West Ruins. Since water is present in the drainline (Table I) and a very small flow is observable at the outlet of the drainline, the drainline does remove minor quantities of water from the aquitard. Seepage into the drainline is through perforations and manhole pipe connections.

The proximity of irrigated fields and observed flooding across the vegetal encroachment suggest that the water problem is of a surface nature. Groundwater probably has little or no effect upon the archeological sites on the monument.

To present further evidence that the sand-gravel aquifer is buried deeply enough to avoid damage to the ruins, it is suggested to conduct an electrical resistivity survey on the monument and immediate vicinity to determine the depths to the sand-gravel aquifer and the nature of alluvium beneath the monument, based on sample analysis of wells nos. 7, 8, and 9.
