AN EVALUATION OF 1978 REHABILITATION SITES  
AND EROSION CONTROL TECHNIQUES IN  
REDWOOD NATIONAL PARK

NATIONAL PARK SERVICE  
REDWOOD NATIONAL PARK  
ARCATA, CALIFORNIA  
JANUARY, 1980

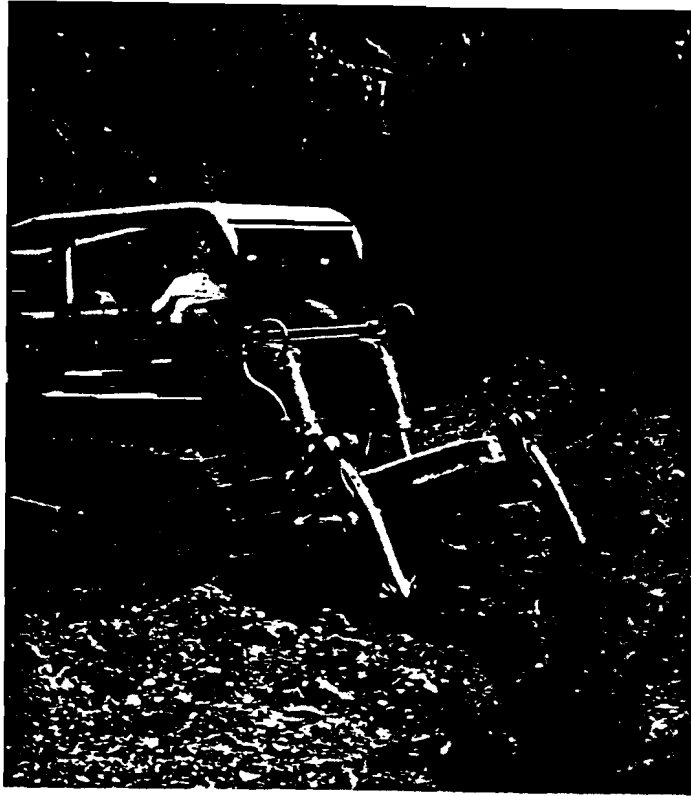
Figure 4: Most logging roads are surfaced with eight to twelve inches of rock and must be disaggregated to promote infiltration and revegetation. Here, a D-8 Cat decompacts the C-10 road with its ripper teeth.

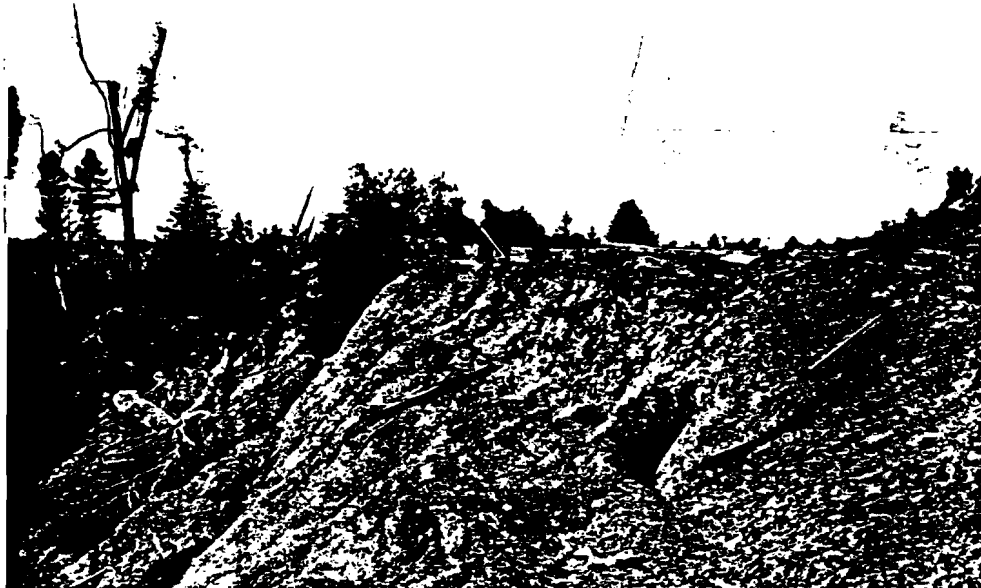
Figure 12: PP3 8/22/78  
Before photograph of oversteepened edge of log landing. Some fill material and organic debris have already failed downslope. In addition, water continued to pond on the landing, and tensional cracks suggested future failure of the hillslope.

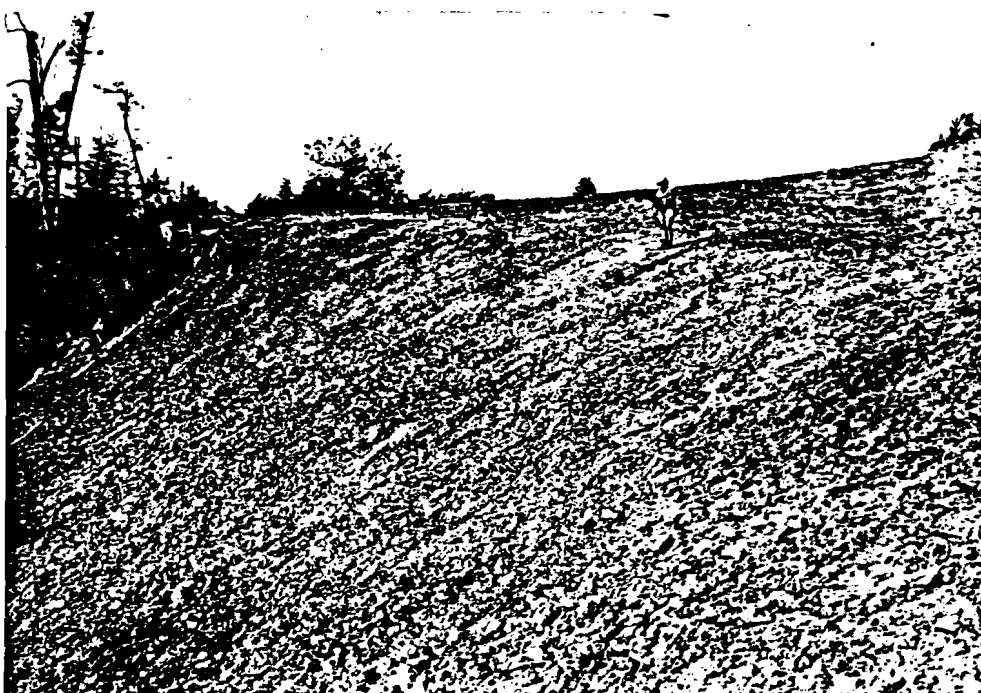
Figure 13: PP3 3/12/79  
After photograph of log landing. Edge of landing has been pulled back and fill material was outsloped. Drainage of runoff from the landing has been improved. Willow wattles were planted on the steep slopes below the former landing.

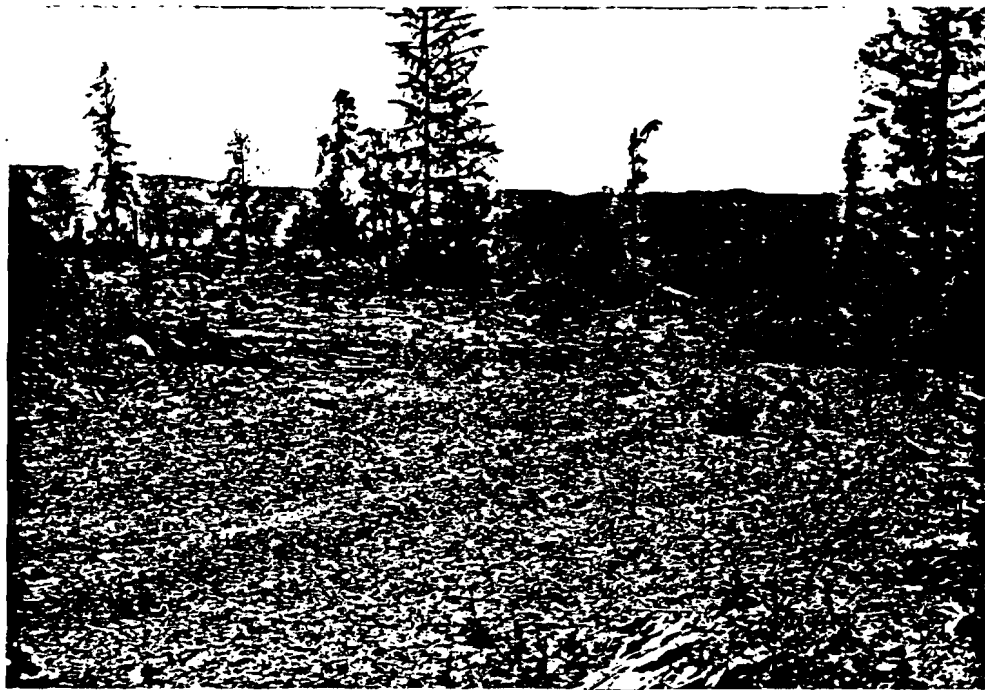
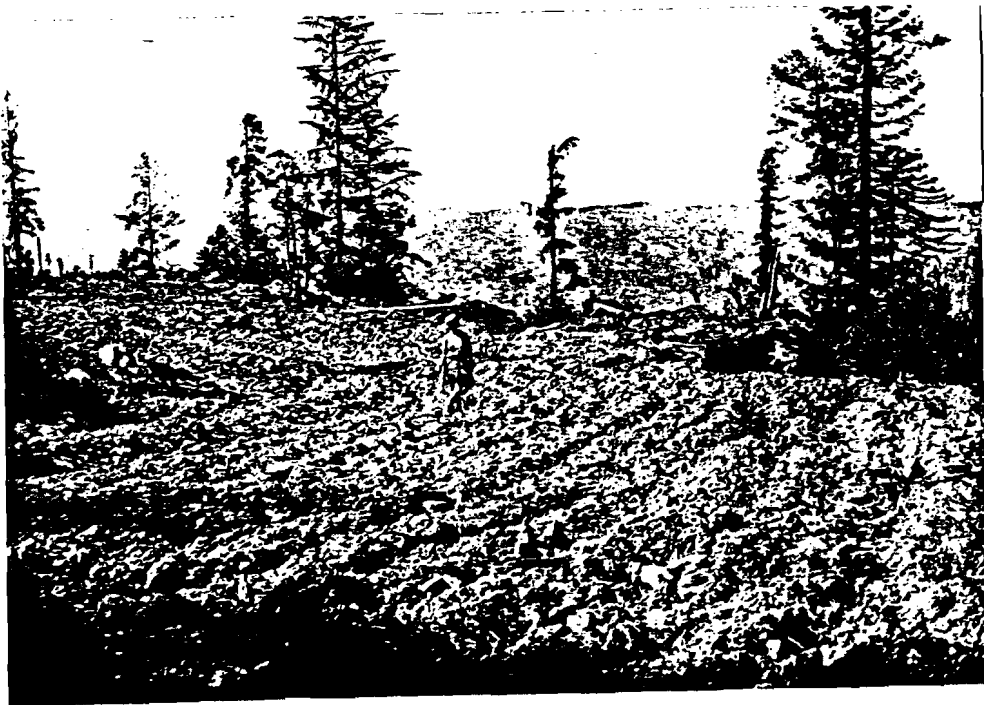
Figure 16: PP22b 8/22/78  
 Before and after sequence of a rocked haul road that was disaggregated (ripped) by a D-8 cat tractor to promote revegetation and infiltration of runoff. Note the paucity of vegetation on the compacted road surface even following 5 to 7 years of non-use.

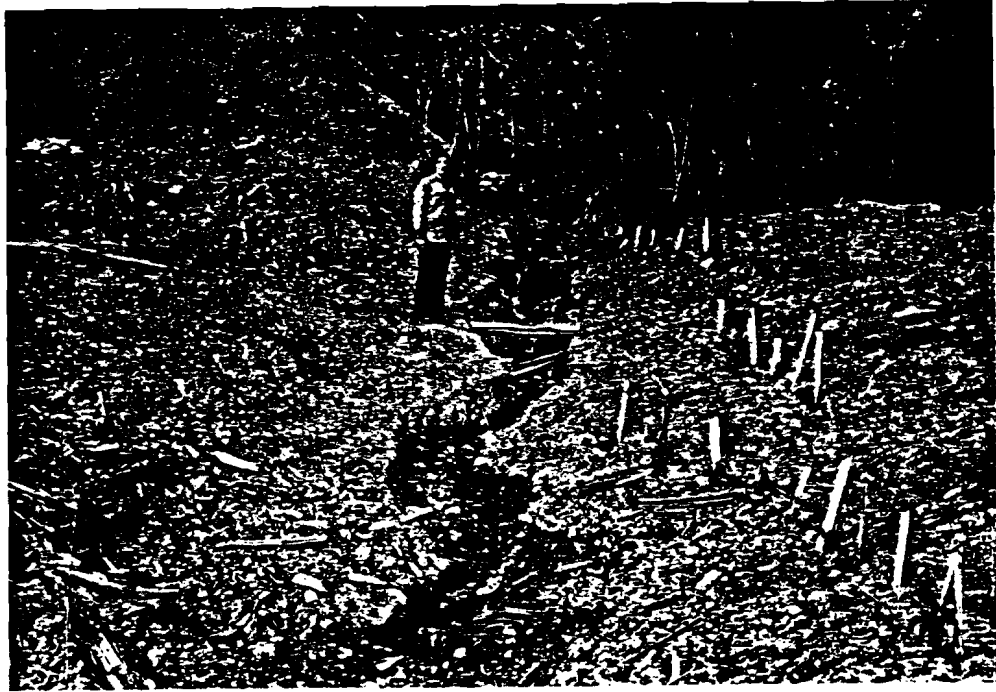
Channels were excavated down to the estimated level of the original streambed. In three cases, the excavation was not deep enough and streams have since downcut 6 to 18 inches during the winter (Figure 18). As the stream downcut, a lag of rocks collected on the channel bed and began to armor the bed, inhibiting further downcutting. Channel bed stabilization is a high priority because channel downcutting can also lead to streambank failure as the toes of the slopes are undercut. Checkdams were needed to prevent vertical incision in some channels.

Figure 18: Drainage 5 in the Miller Creek Unit. Downcutting occurred in channel that was cleared of debris and road fill. The channel was not protected by an armor of rock prior to downcutting, although a lag of rocks is now beginning to form on the channel bed.

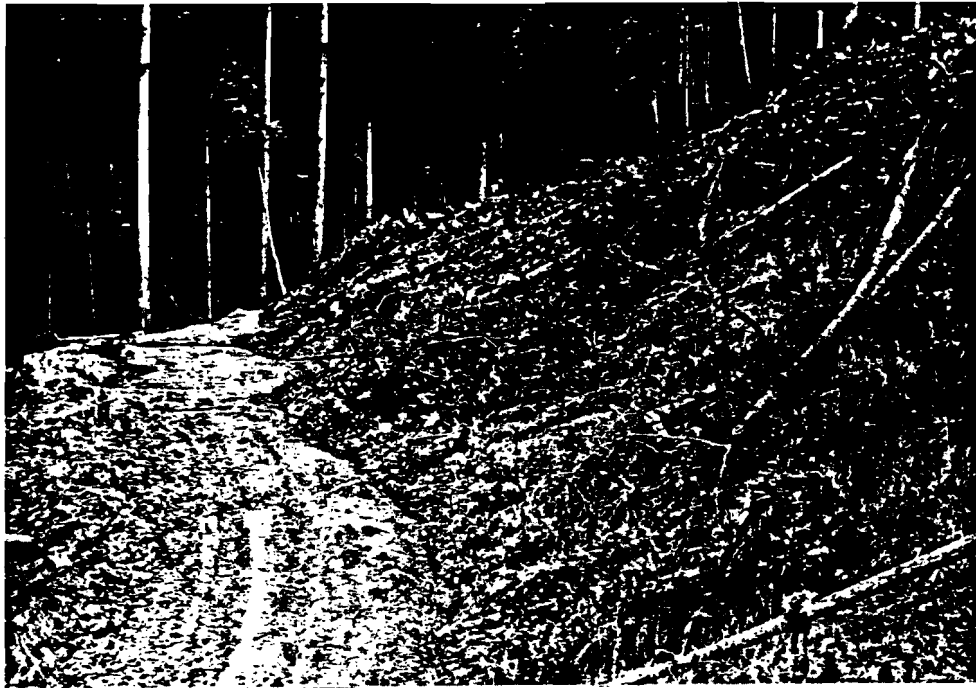
Figure 21: PP16a 8/23/78  
C-90 road prior to rehabilitation is showing signs of instability. Small cut bank failures are blocking the inboard ditch. Note the scarp of a road fill failure behind the person at the left of the photo.

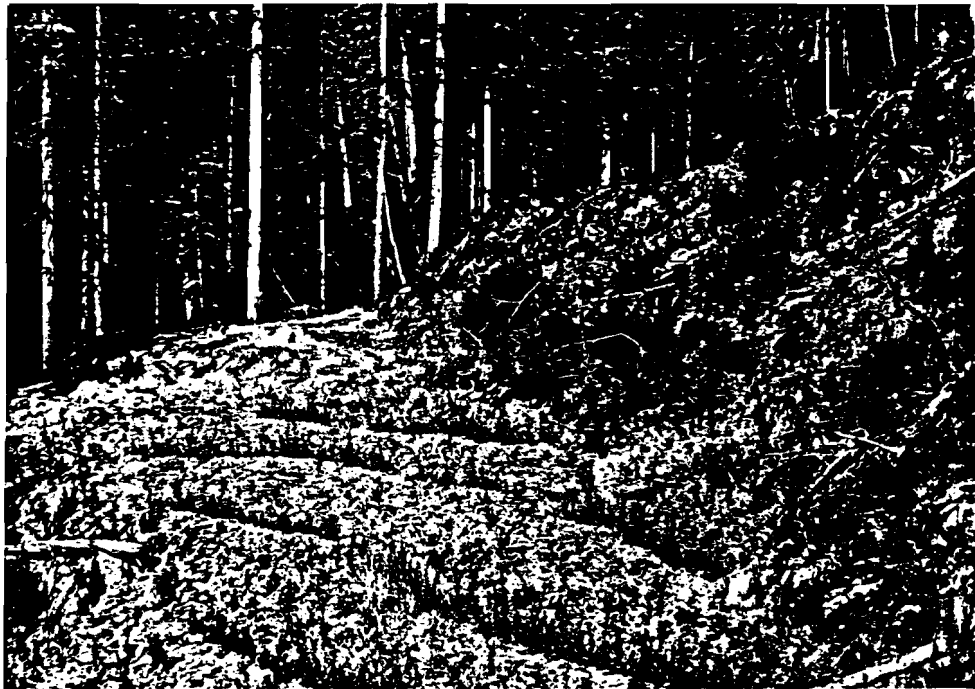
Figure 22: PP16a 10/1/79  
C-90 road after rehabilitation. The road has been decompacted, road fill has been pulled back, and the material has been outsloped. Note the rock cross drain behind the people, and the rows of willow wattles on the outsloped road.

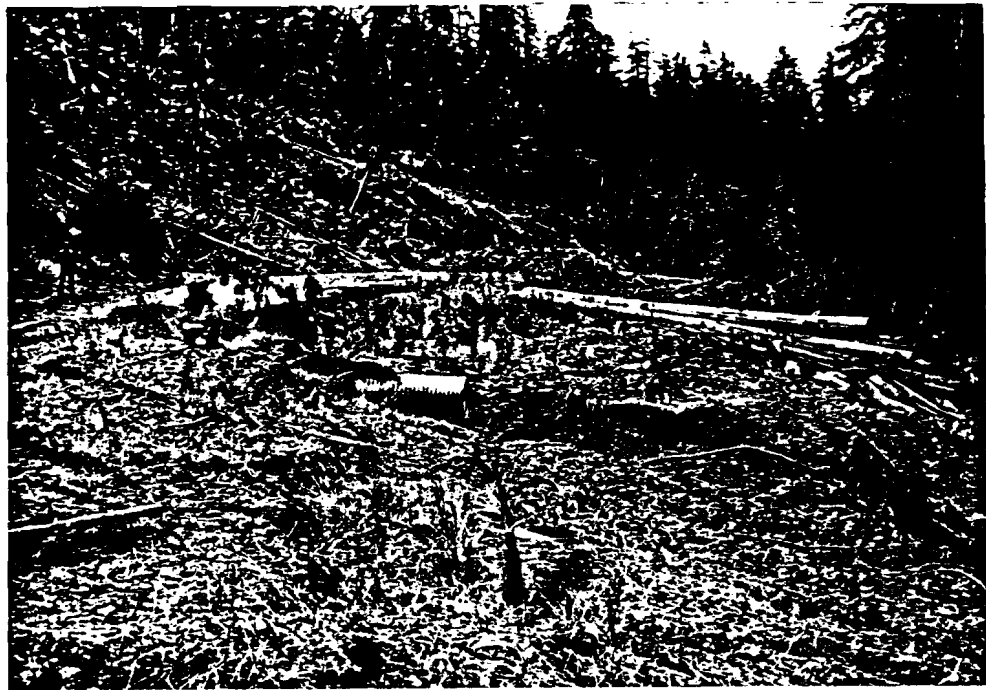
Figure 29: PP14d 8/23/78  
Prior to rehabilitation, log landing is truncated by the scarp of a major failure. Culvert is no longer operational.

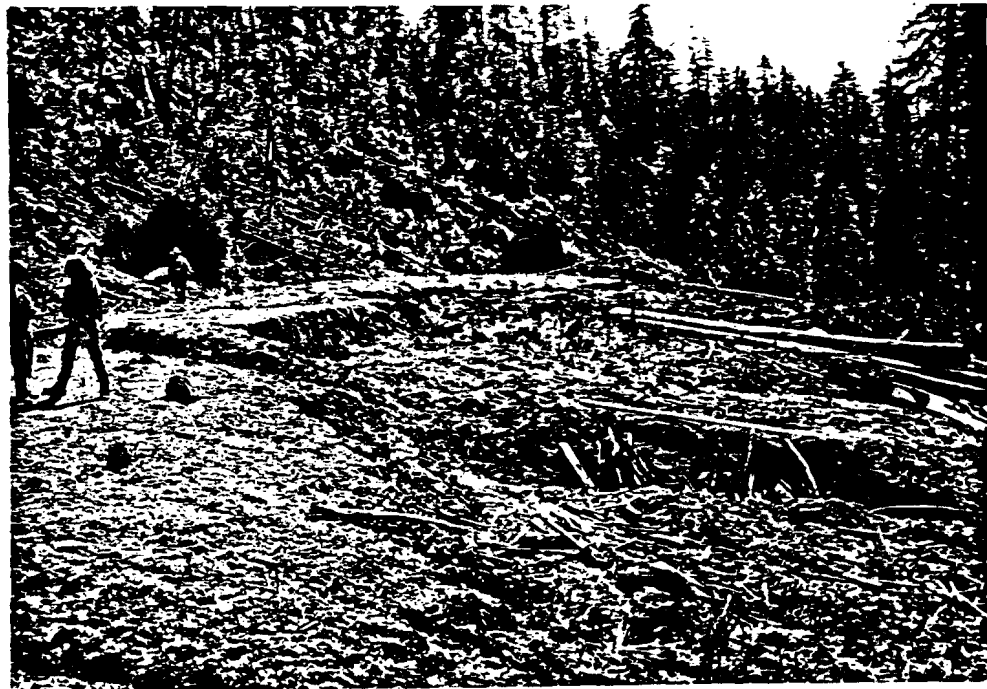
Figure 30: PP14d 3/19/79  
After rehabilitation, culvert has been removed and cross road drains have been constructed to drain surface runoff from the site of the failure. In addition, a drainage ditch was dug at the toe of the cut banks to direct runoff into cross road drains. The deep-seated failure was not addressed except through upslope drainage diversions.

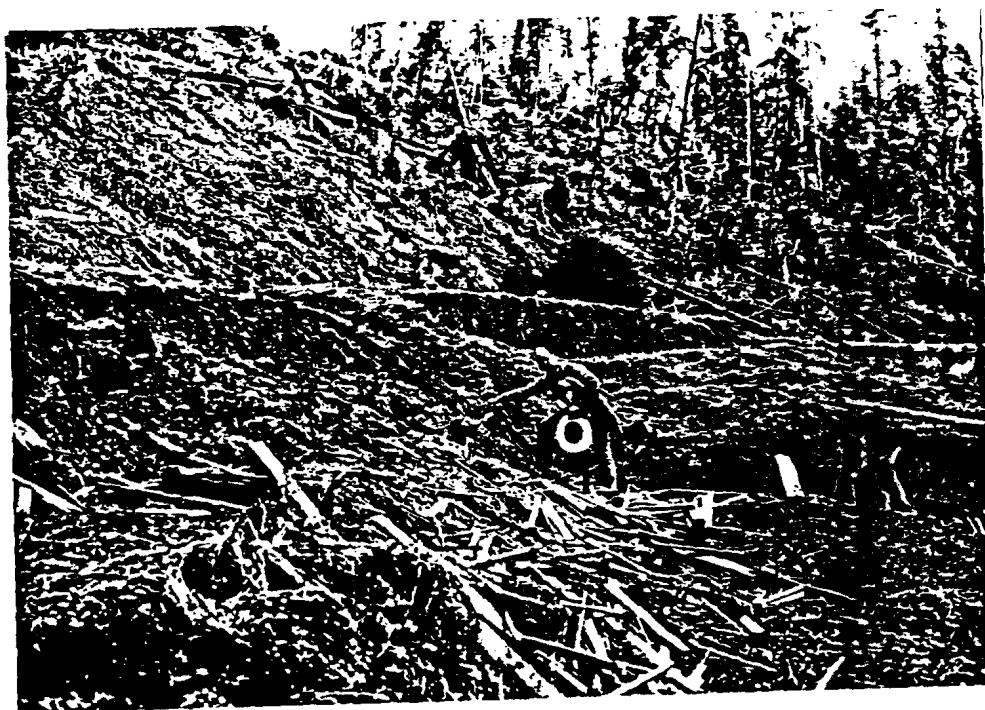
Figure 32: April, 1979.  
The outside edge of a landing failed where instability had previously been seen (see Figure 30 for comparison). The man's hand points to a cross road drain that has been truncated by the scarp of this failure.

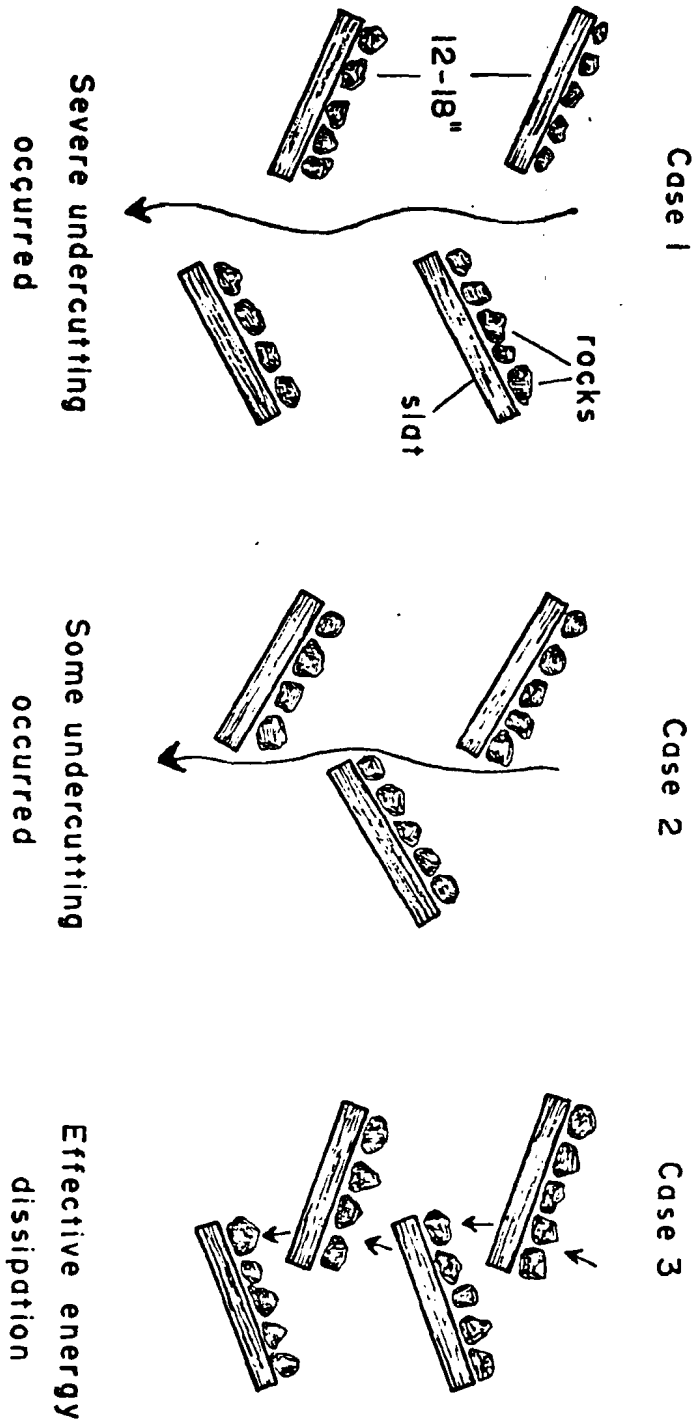
Figure 78: Emerald Creek  
Herringbone energy dissipator  
below cross road drain has  
been undercut. In this case,  
the distance between boards  
was too large, and the  
upstream sides of the slats  
were not protected by rocks.
