**WORK SUMMARY AND COST ANALYSIS REPORT**

**Site 80-5**

**W-Line and Dolason Prairie**

**May 1981**

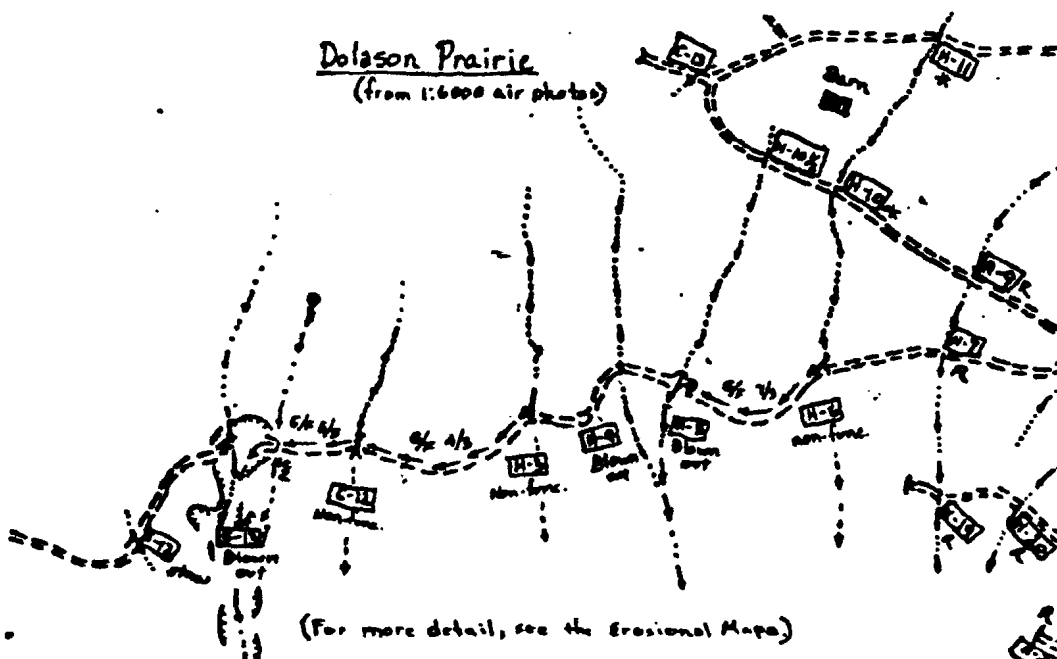
S-13 encompasses two small channels. One (left fork) was simply filled and the flow diverted down the ditch to the other channel (right fork) which had a humboldt crossing. The combined flow from the three non-functional crossings caused the humboldt crossing to wash out. This lowered the base level for the inboard ditch, initiating downcutting. A 12 foot high head-cut developed which retreated 100 feet to the left fork, causing erosion of about 100 cubic yards of the former divide between channels. (The rate of retreat can be observed in old air photos.)

The natural channel was severely gutted for 700 feet downstream, with numerous side bank failures and raw stream banks.

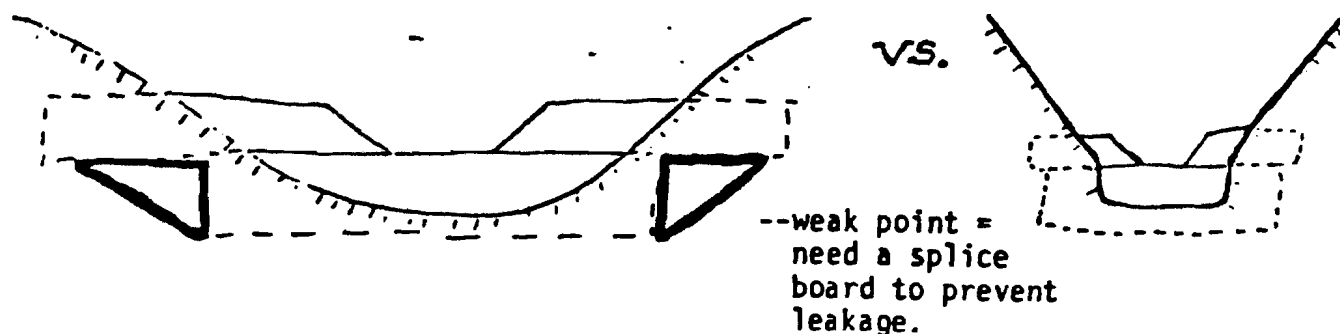
Unit Cost is comparatively high because stream excavations were made to match the natural side slopes above and below, requiring wider check dams than anticipated. Many check dam boards were also narrower than expected, because of splitting during handling and transit (possibly due to being unseasoned wood). In order to build dams to desired effective width and height, much time consuming splicing was required. Also most dams failed at these splice points.

Personnel problems at H-3 helped drive up the cost per check dam. Our original two laborers were to be laid off, requiring new people to be trained. It seems that efficiency goes down when there are more than two people working on a channel (more time tends to be spent "shooting the breeze"). We also had severe motivation problems with one of the laborers who was to be laid off.....he basically refused to work for the last two days. A final factor which increased cost was that rock, used to help protect stream banks, had to be gathered at a greater than average distance from the channel.

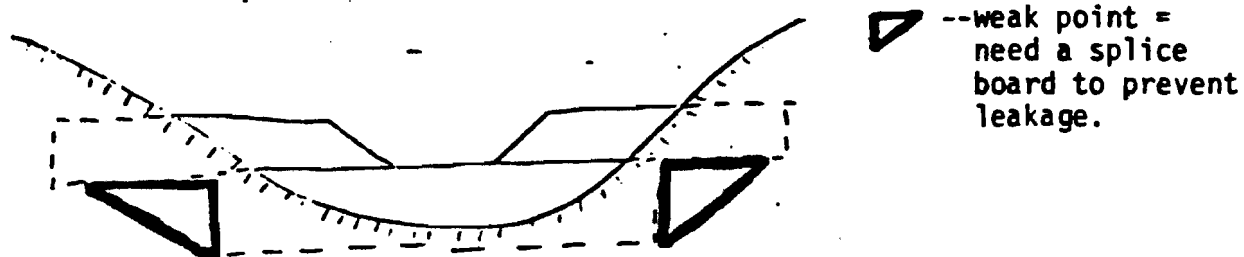
At H-11 we had to remove an entire check dam (bottom one) because the water had blown out around both sides of the bottom board. Failure occurred because the dam was not properly spliced when constructed, and it was packed with large rocks and a small quantity of dirt.

At H-3 and H-11 the splash boards became suspended due to downcutting below. This required lowering the splash boards, thus increasing the effective height of each dam. These mini check dams were an experimental attempt to save on labor costs by reducing the number and size of check dams in prairie channels with a gentle gradient and low flow. They were designed to serve three main purposes: provide frequent stable base levels; keep flow centered in channel; and provide sediment storage for what might wash down from the rehabilitated area. Rather than leveling between dams, they were left with 4-6 inch effective height to catch sediment and minimize fall distance, and thus potential energy, of water flowing over the spillway. The main rock was washed away from the splash boards. Either larger rock or staking the rock in place would have worked. This was tried later at H-11 after the rock was moved by the storm.

The check dam was replaced with as much rock as could be found; rock was staked in place. However, downcutting is continuing below the stakes, and some of the shorter stakes have been undermined, but the rocks so far are remaining. The channel drops off steeply here and it appears that there is at least one log left in the crossing, which either was not visible or was not noticed during excavation. If this had been seen it would have been removed and a steeper, but more even gradient channel would have resulted.

The rocking of the failed check dams needed to be replaced with dirt, and a few needed splice boards.

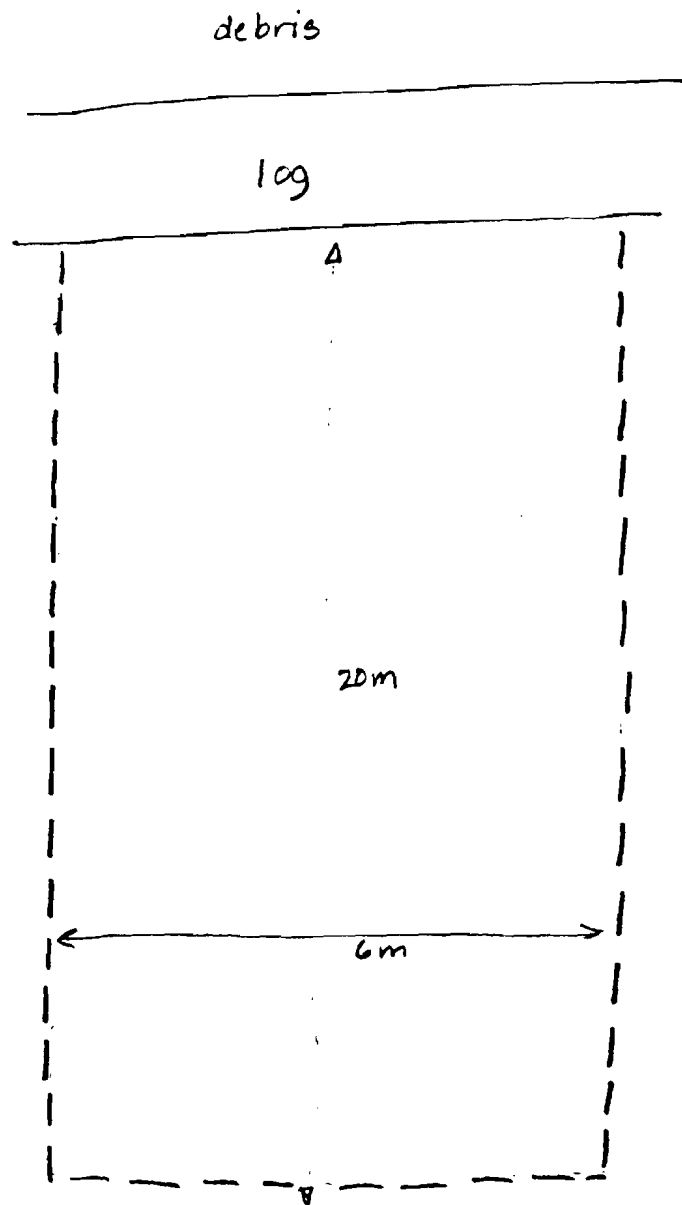
possibly needs additional  
treatment below

seeded, strawed, fertilized
