**ALL-TERRAIN VEHICLE (ATV) TRAIL MITIGATION STUDY:  
COMPARISON OF NATURAL AND GEOSYNTHETIC MATERIALS  
FOR SURFACE HARDENING**

Wrangell-St. Elias National Park and Preserve, Alaska.

Wrangell-St. Elias National Park and Preserve Research and Resource Management Report

No. 2001-1

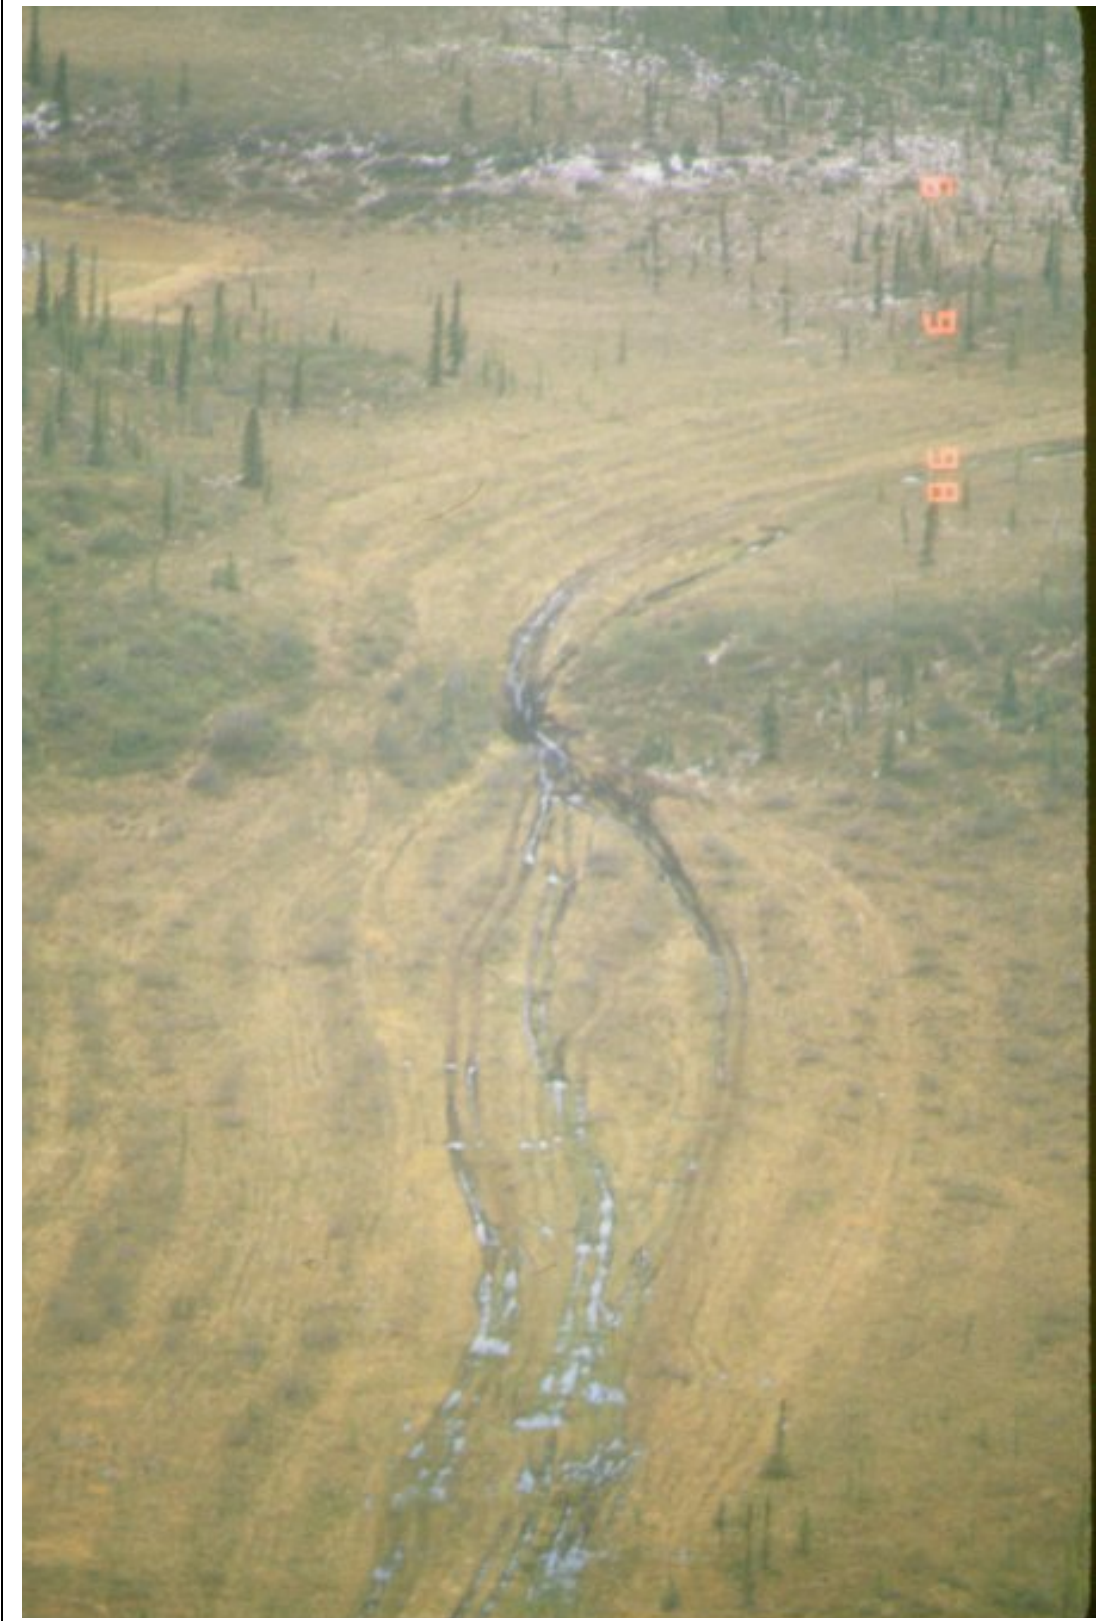
Photo A. Trail braiding on ATV trails in Wrangell-St. Elias National Park and Preserve.

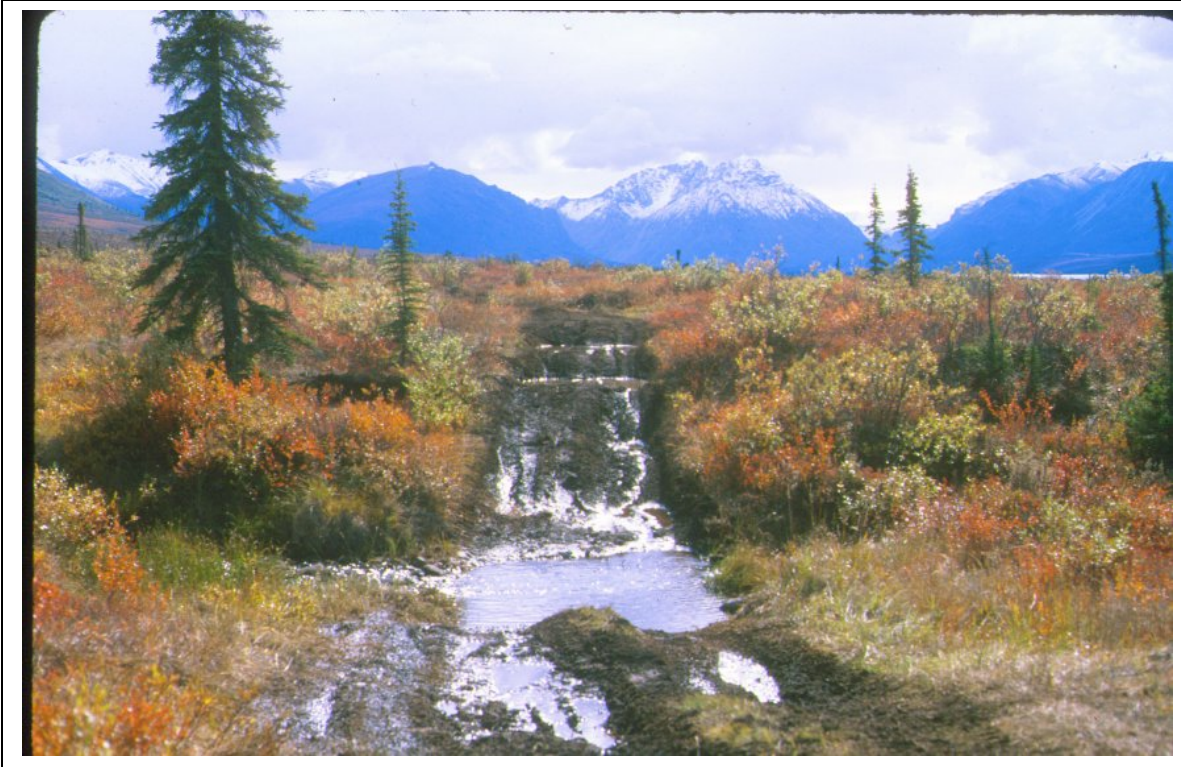
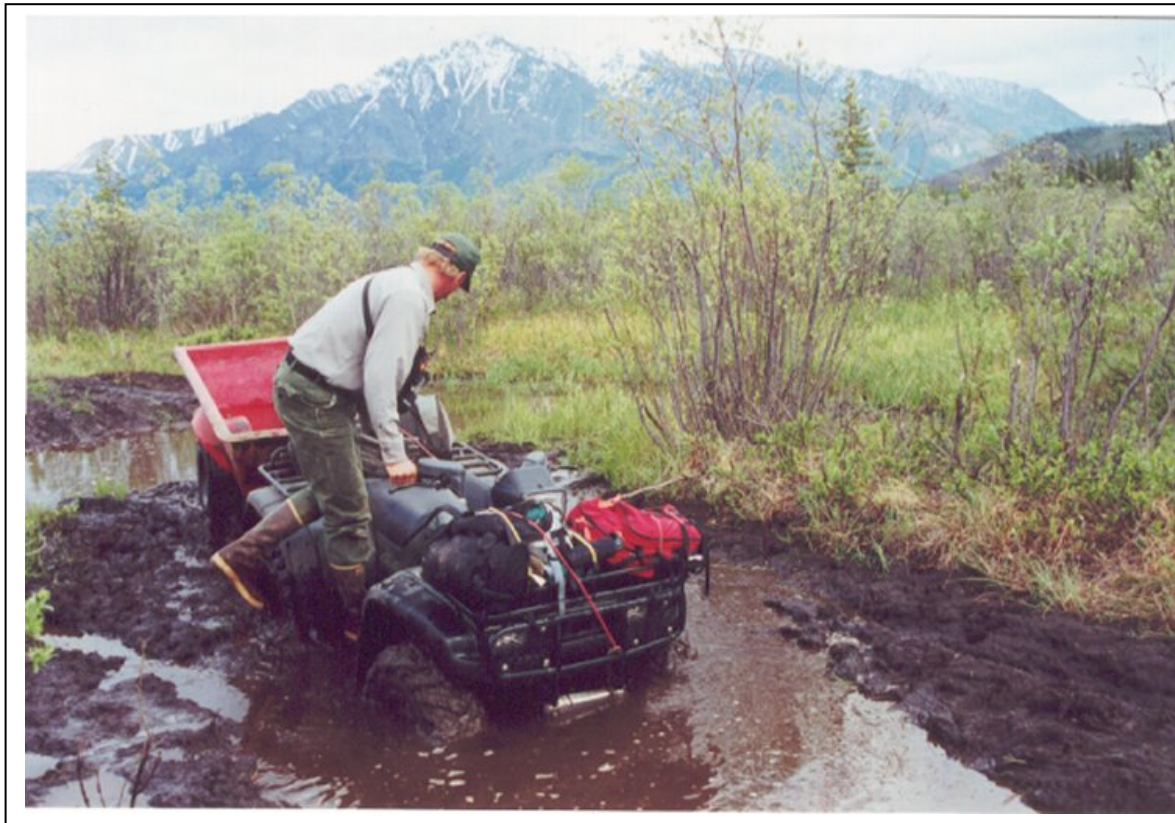
Photos B and C. Thermokarst ponding and bog formation resulting from excessive ATV use on trails with permafrost.

Studies have documented the potential and existing environmental degradation due to all-terrain vehicle (ATV) use in sub-arctic terrain (Sparrow, Wooding and Whiting 1978, Ahlstrand and Racine 1990, Cook 1990a and 1990b, Happe, Shea and Loya 1998). Impacts include vegetation damage or destruction, changes in vegetation community composition and structure, substrate thermal change and permafrost thaw, and soil erosion and subsequent development of thermokarst features and terrain degradation (Slaughter et al. 1990). One of the most evident effects of prolonged ATV use in sub-arctic and arctic tundra is the development of extensive trail braiding (Photo A). Trail braiding results from alternate trails that are created by users in order to avoid mud bogs and standing water (ponding) that develop on ATV trails which are underlain by ice ridge permafrost (Photos B and C).

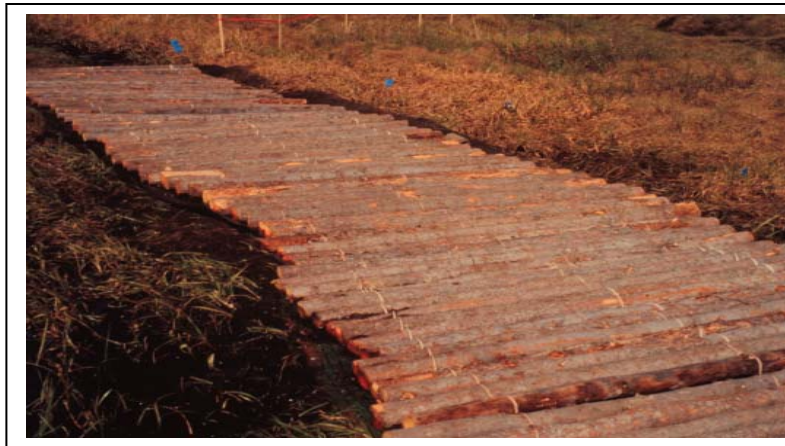
Corduroy worked well in terms of trail stabilization and support for all-terrain vehicle use. Corduroy did not re-vegetate as well as other materials, but the logs may contribute to soil insulation similar to vegetation. In this study, corduroy was constructed using nylon rope to weave the logs together (Figure B). In areas of heavy ponding (standing water), the corduroy floated over the water and presented unstable walking conditions. The material costs and labor costs for corduroy were low in this study. The labor crew considered this material the easiest to install: leveling of the trail was only necessary at one of four sites for installation and the materials were pre-cut, limbed, measured and packaged as part of the original purchase cost of the material. The purchase of pre-cut and prepared logs significantly reduced the labor time in the field normally associated with using raw on site materials. However, after four years, the logs have begun to show signs of weathering and rot at all of the sites. Therefore, the longevity of this material appears shorter than the geosynthetics. This material provides a good, but short term option for trail stabilization.

Figure B. Woven Corduroy tested for ATV trail mitigation in Wrangell-St. Elias National Park and Preserve.

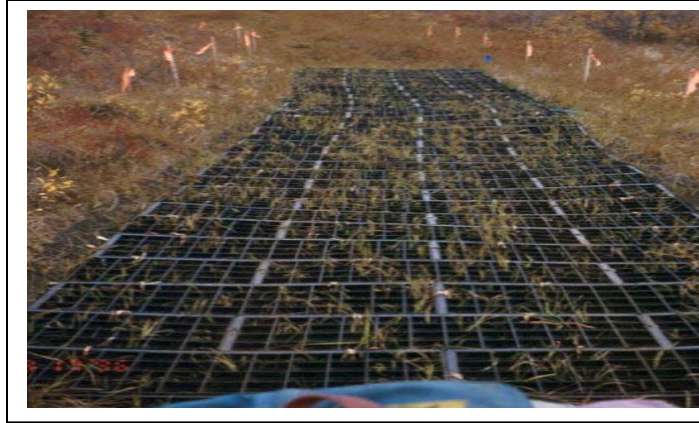
Both Geoblock® 1 ¼" and 2" (Figure C) provided good trail stabilization, riding surface and re-vegetation potential. The initial purchase of the materials was expensive, and was somewhat labor intensive to install. The material is fairly rigid and does not conform to the terrain readily. Therefore, excavation and leveling was required at sites with uneven terrain and extensive thermokarst features. However, this material provided excellent stability and appears to be more durable than Corduroy or Polynet/Pyramat. The current dimensions and specifications of the Geoblock® 2" allow for easier installation than the material that was used in 1996. Except for the initial cost, this material provides a good option for long term trail hardening.

Figure C. Geoblock® material tested for ATV trail mitigation in Wrangell-St. Elias National Park and Preserve

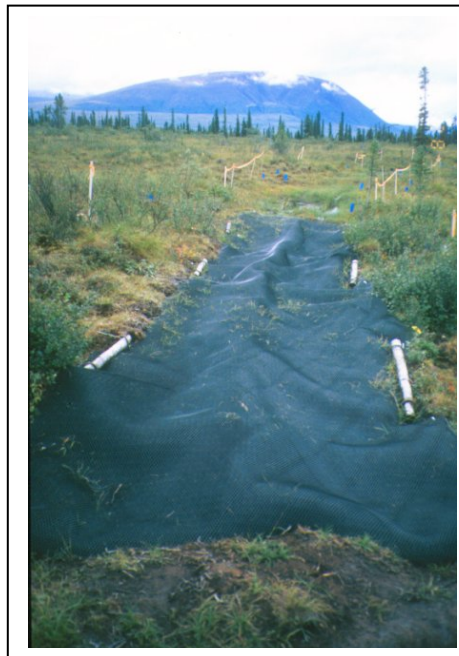
Polynet PN-3000/Pyramat™ (Figure D) had the lowest cost for materials, conformed well to the terrain and required minimal trail leveling to install. It provided moderate trail stabilization if re-vegetation occurred. However, it had a low rating in terms of ability to support ATV use, maintenance and safety. Due to its flexibility and light weight, the material had a tendency to bunch up and catch under ATVs, even when anchored with rebar and duckbills (a j-hooked anchoring device held by cables). In areas underlain with permafrost, the anchoring materials frequently frost jacked and caused trail hazards. These materials work well as an underlaying drainage or flotation material, but does not provide a suitable trail surface when used separately.

Figure D. Polynet PN-3000/Pyramat™ tested for ATV trail mitigation in Wrangell-St. Elias National Park and Preserve

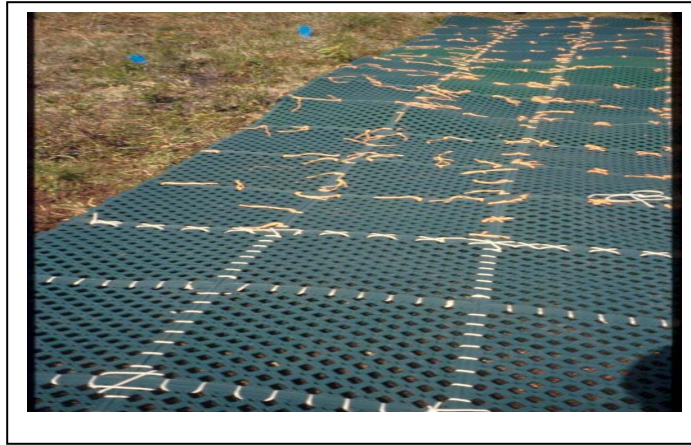
Safety Deck® (Figure E) was the most expensive material to purchase initially and was fairly labor intensive to install because the 19 ¾" x 19 ¾" size tiles were woven together both lengthwise and crosswise with nylon parachute cord. Safety Deck® material conformed well to uneven terrain and required minimal site preparation for installation. The material provided an excellent riding and walking surface, stabilized trail degradation and allowed for vegetation regeneration. It was the most popular material among surveyed trail users. Unfortunately this material is no longer available.

Figure E. Safety Deck® material tested for ATV trail mitigation in Wrangell-St. Elias National Park and Preserve.

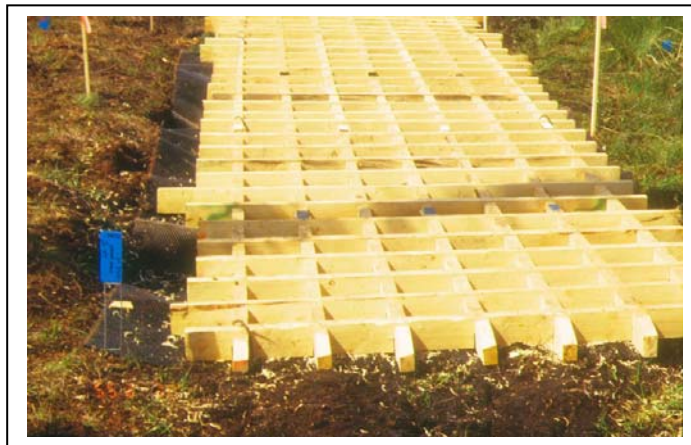
Wood matrix (Figure F) had the poorest performance in terms of labor costs, maintenance and safety. The construction from raw materials was time consuming, and the green, untreated lumber showed signs of wear within the first year (broken joints and rot). Concern was voiced by users that the 8" x 8" open grid presented a risk of entrapping the hooves of wildlife and horses. The material did provide a stable, although rough, ride and supported vegetation re-growth within the first year.

Figure F. Wood Matrix material tested for ATV trail mitigation in Wrangell-St. Elias National Park and Preserve.

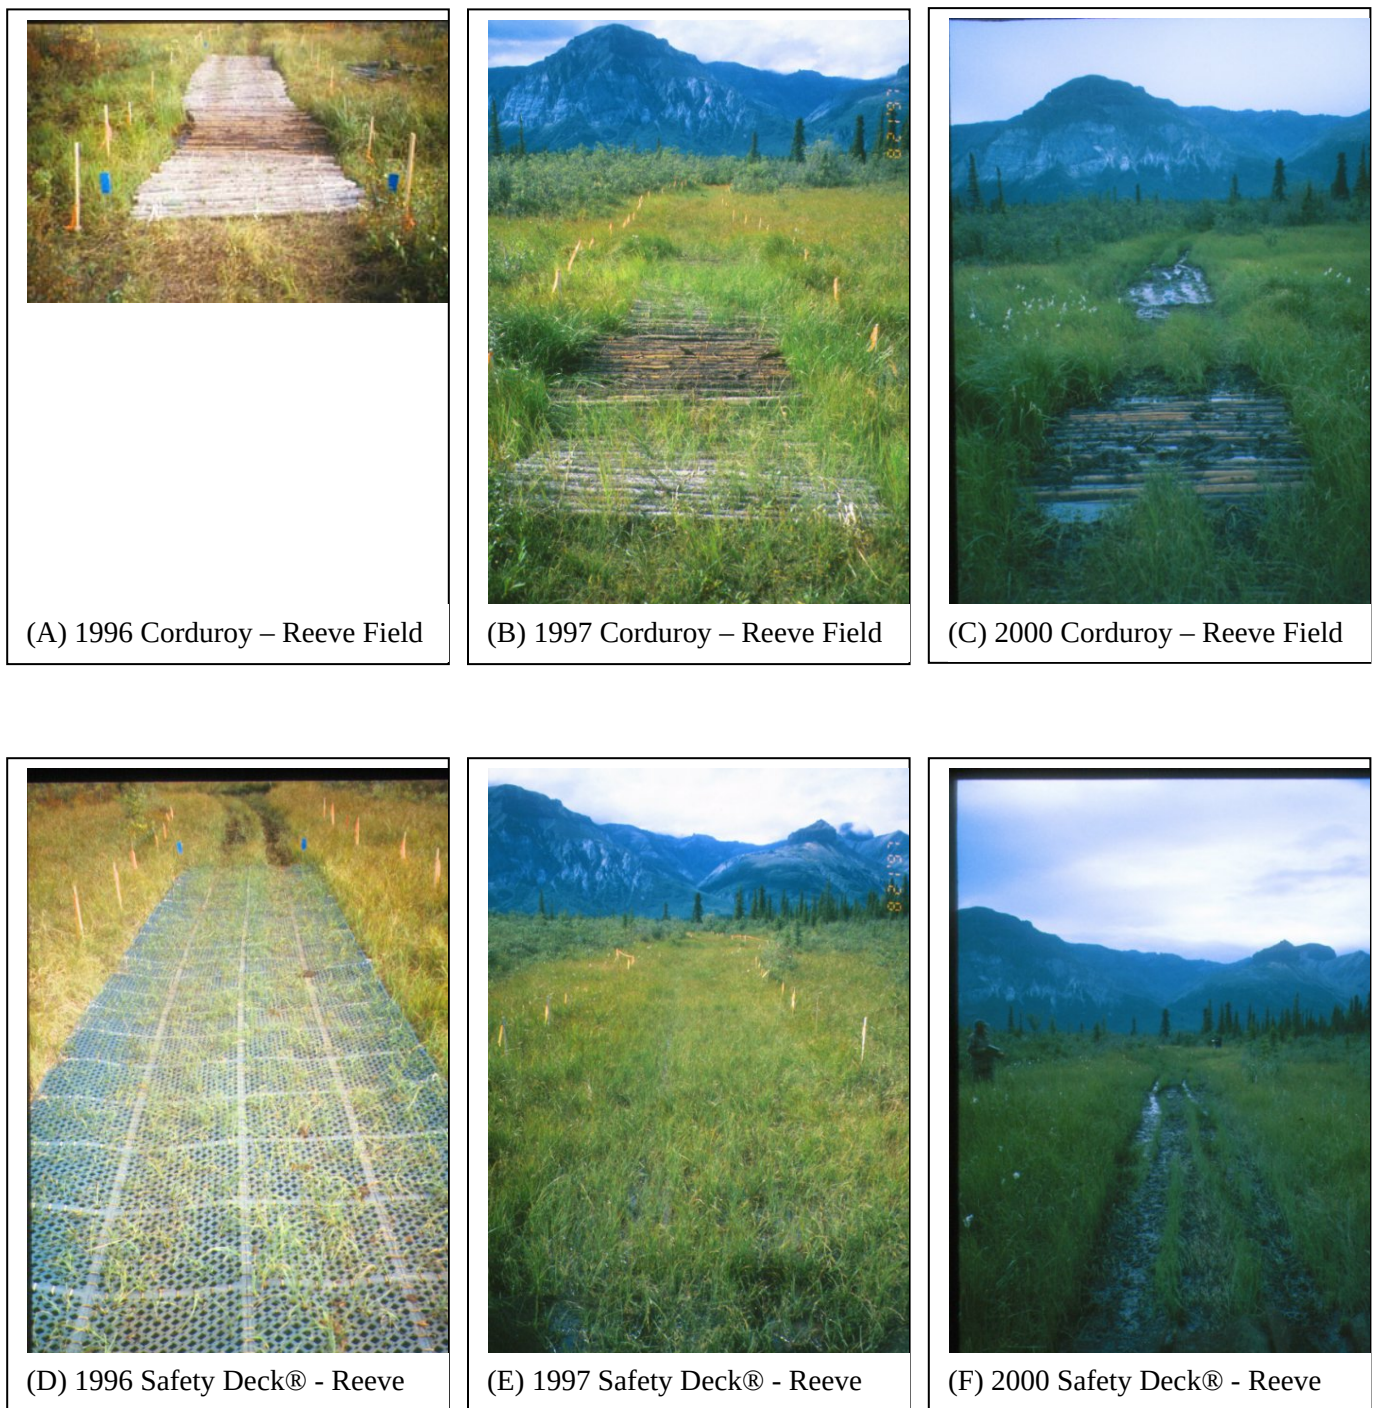
Figure 17. Photo series of Corduroy (A-C) and Safety Deck (D-F) hardening material plots between 1996 and 2000 at Reeve Field study site in Nabesna District, Wrangell-St. Elias National Park and Preserve, Alaska.

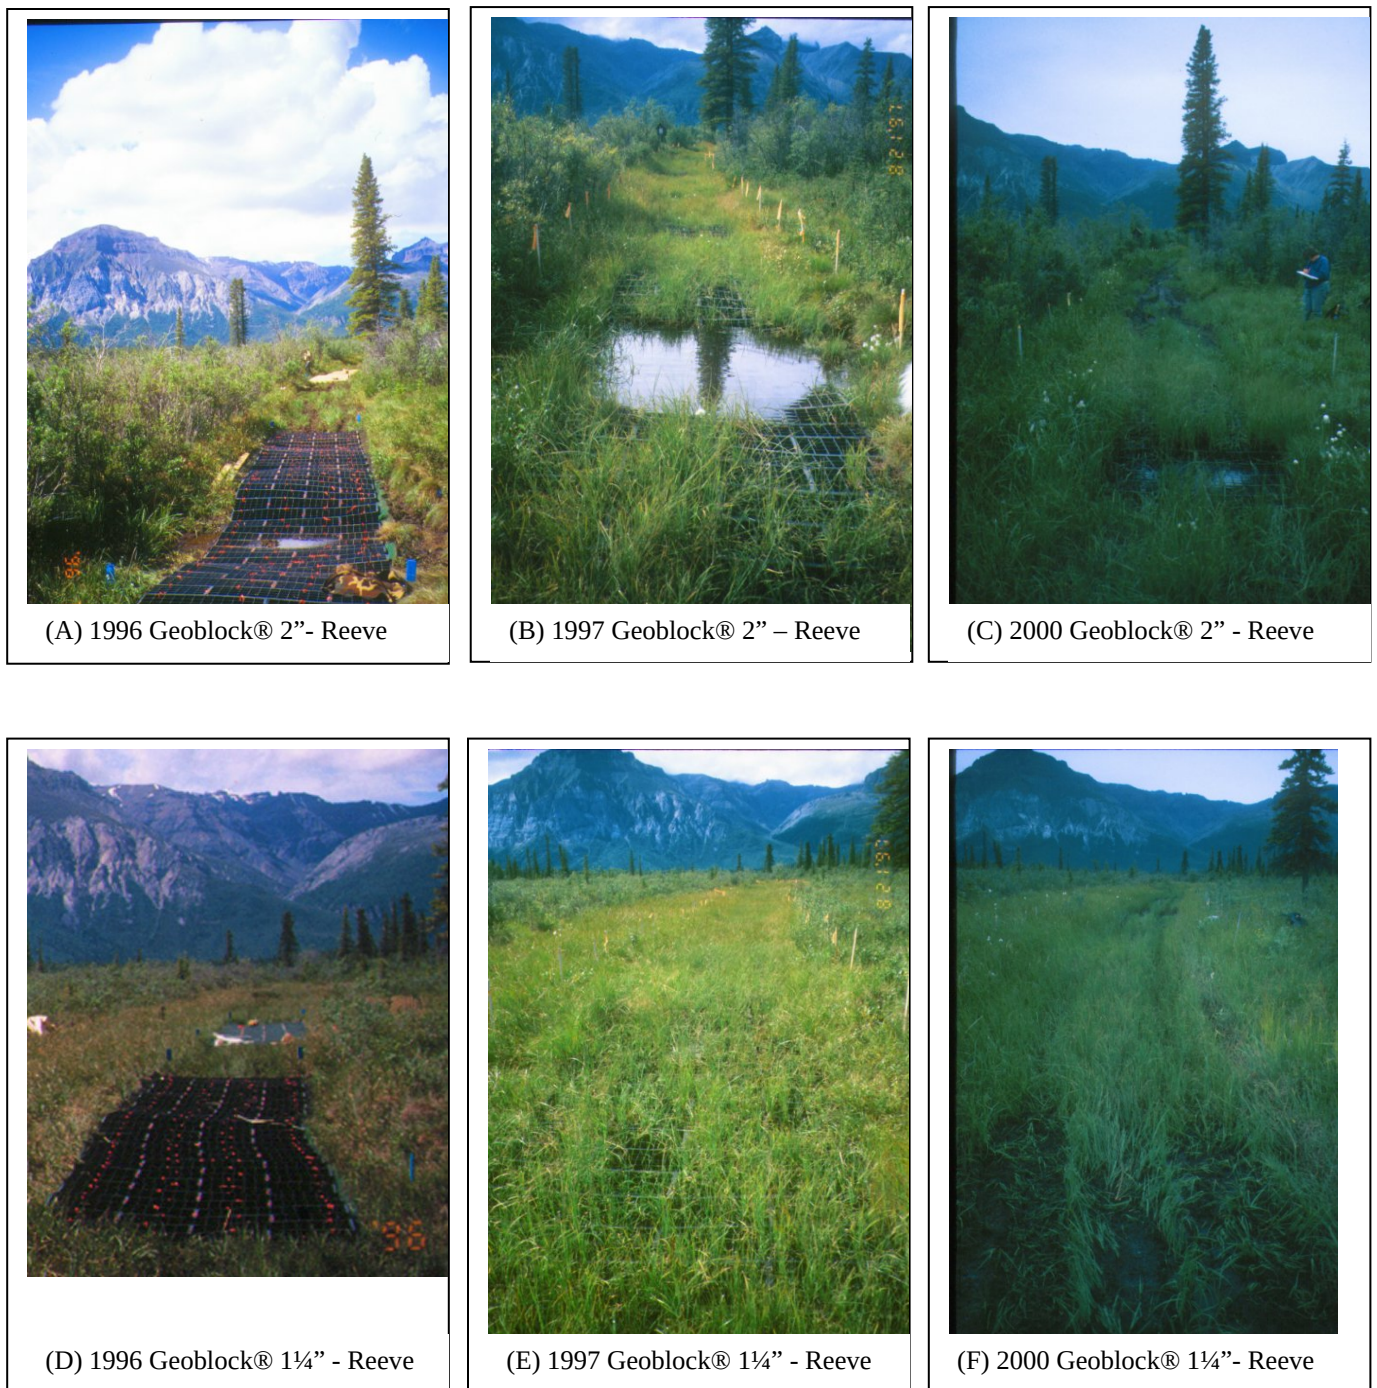
Figure 18. Photo series of Geoblock® 2" (A-C) and Geoblock® 1 1/4" (D-F) hardening material plots between 1996 and 2000 at Reeve Field study site in Nabesna District, Wrangell-St. Elias National Park and Preserve, Alaska. This study site had ATV traffic for all four years.

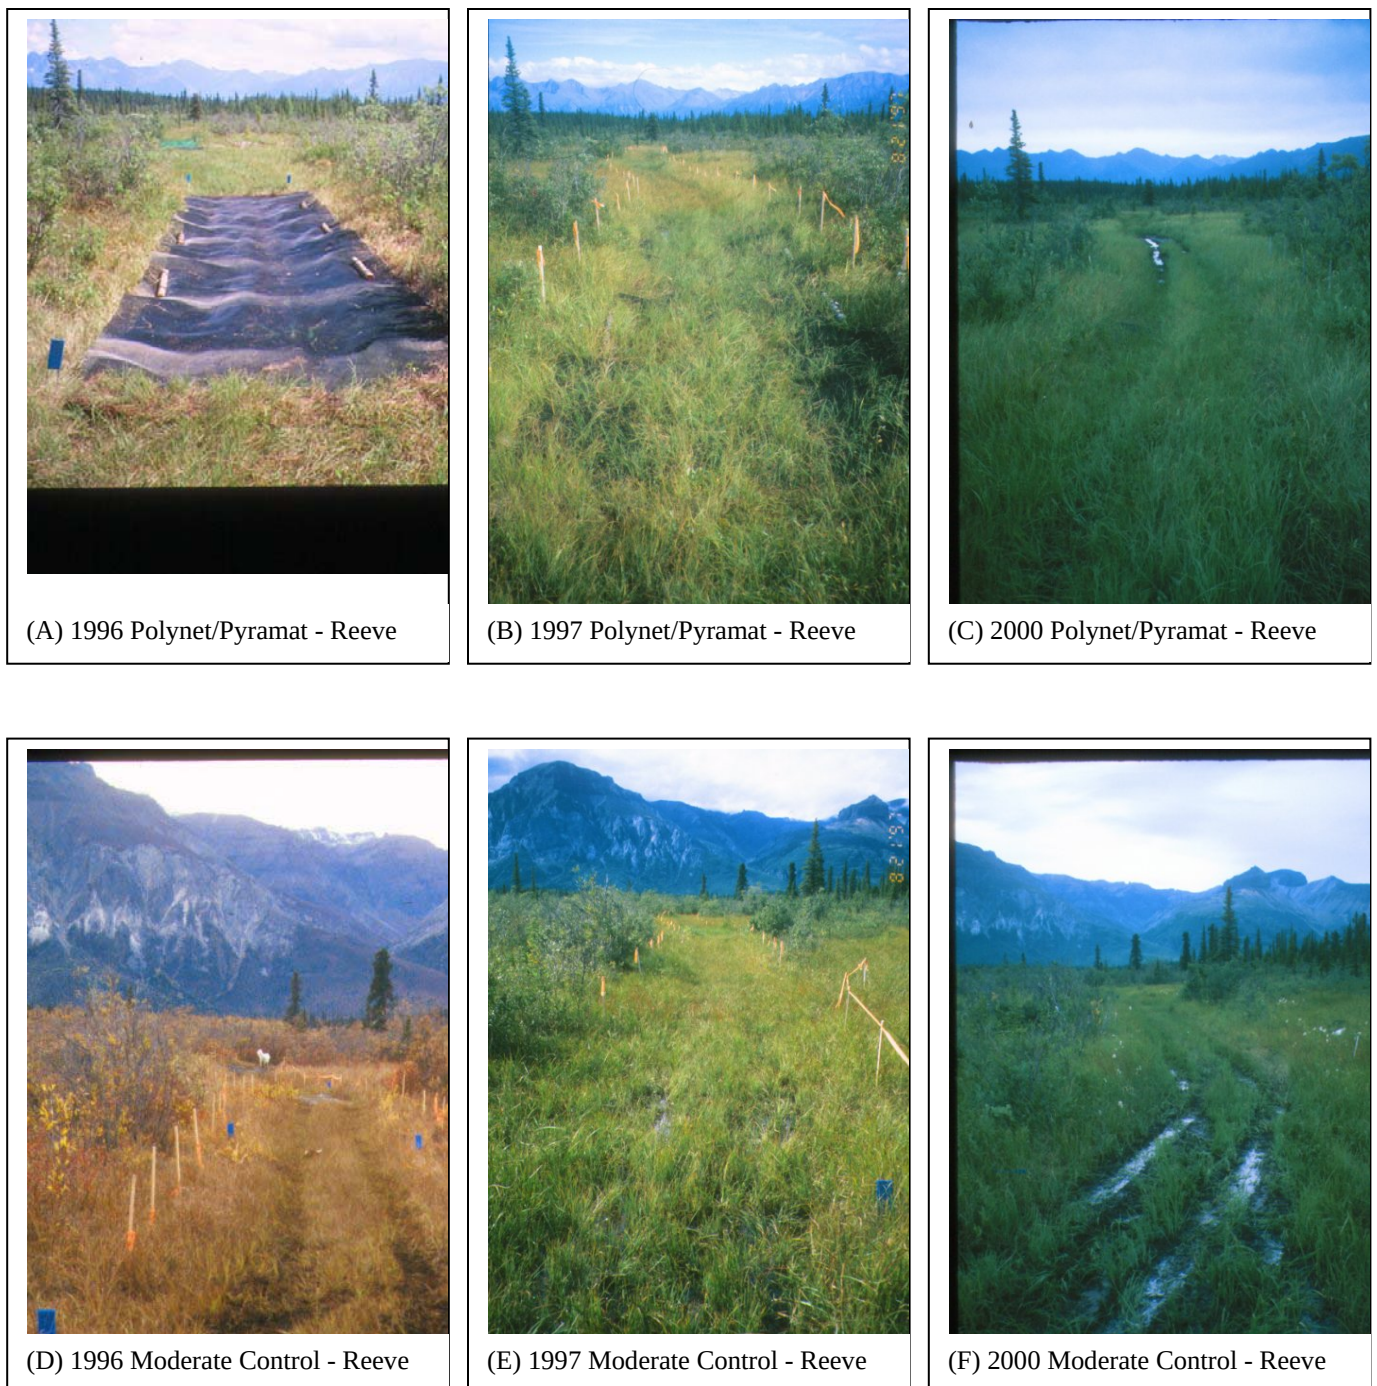
Figure 19. Photo series of Polynet PN-3000/Pyramat™ (A-C) hardening material plot and Moderate Control (D-F) untreated trail plot between 1996 and 2000 at Reeve Field study site in Nabesna District, Wrangell-St. Elias National Park and Preserve, Alaska. This study site had ATV traffic for all four years.

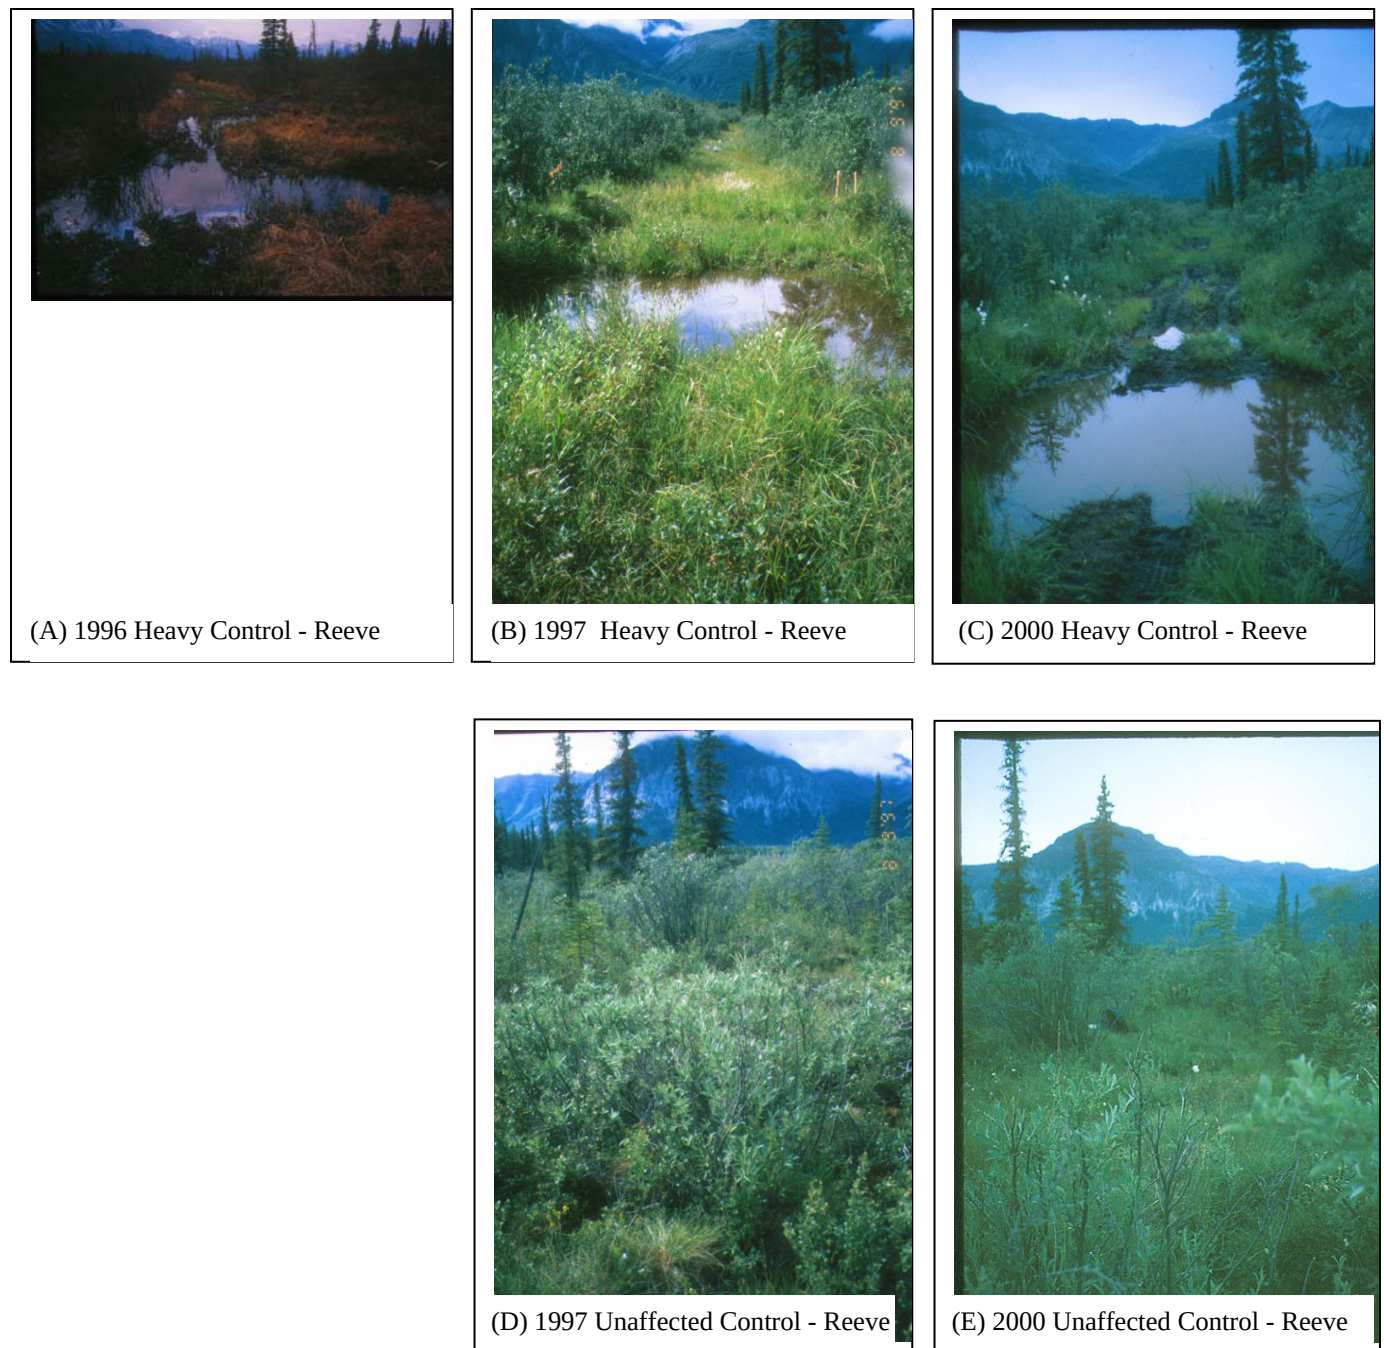
Figure 20. Photo series of the Heavy Control untreated trail plot (A-C) between 1996 and 2000 and Unaffected Control plot in 1997 (D) and 2000 (E) at Reeve Field study site in Nabesna District, Wrangell-St. Elias National Park and Preserve, Alaska. This study site had ATV traffic for all four years, excluding the unaffected area

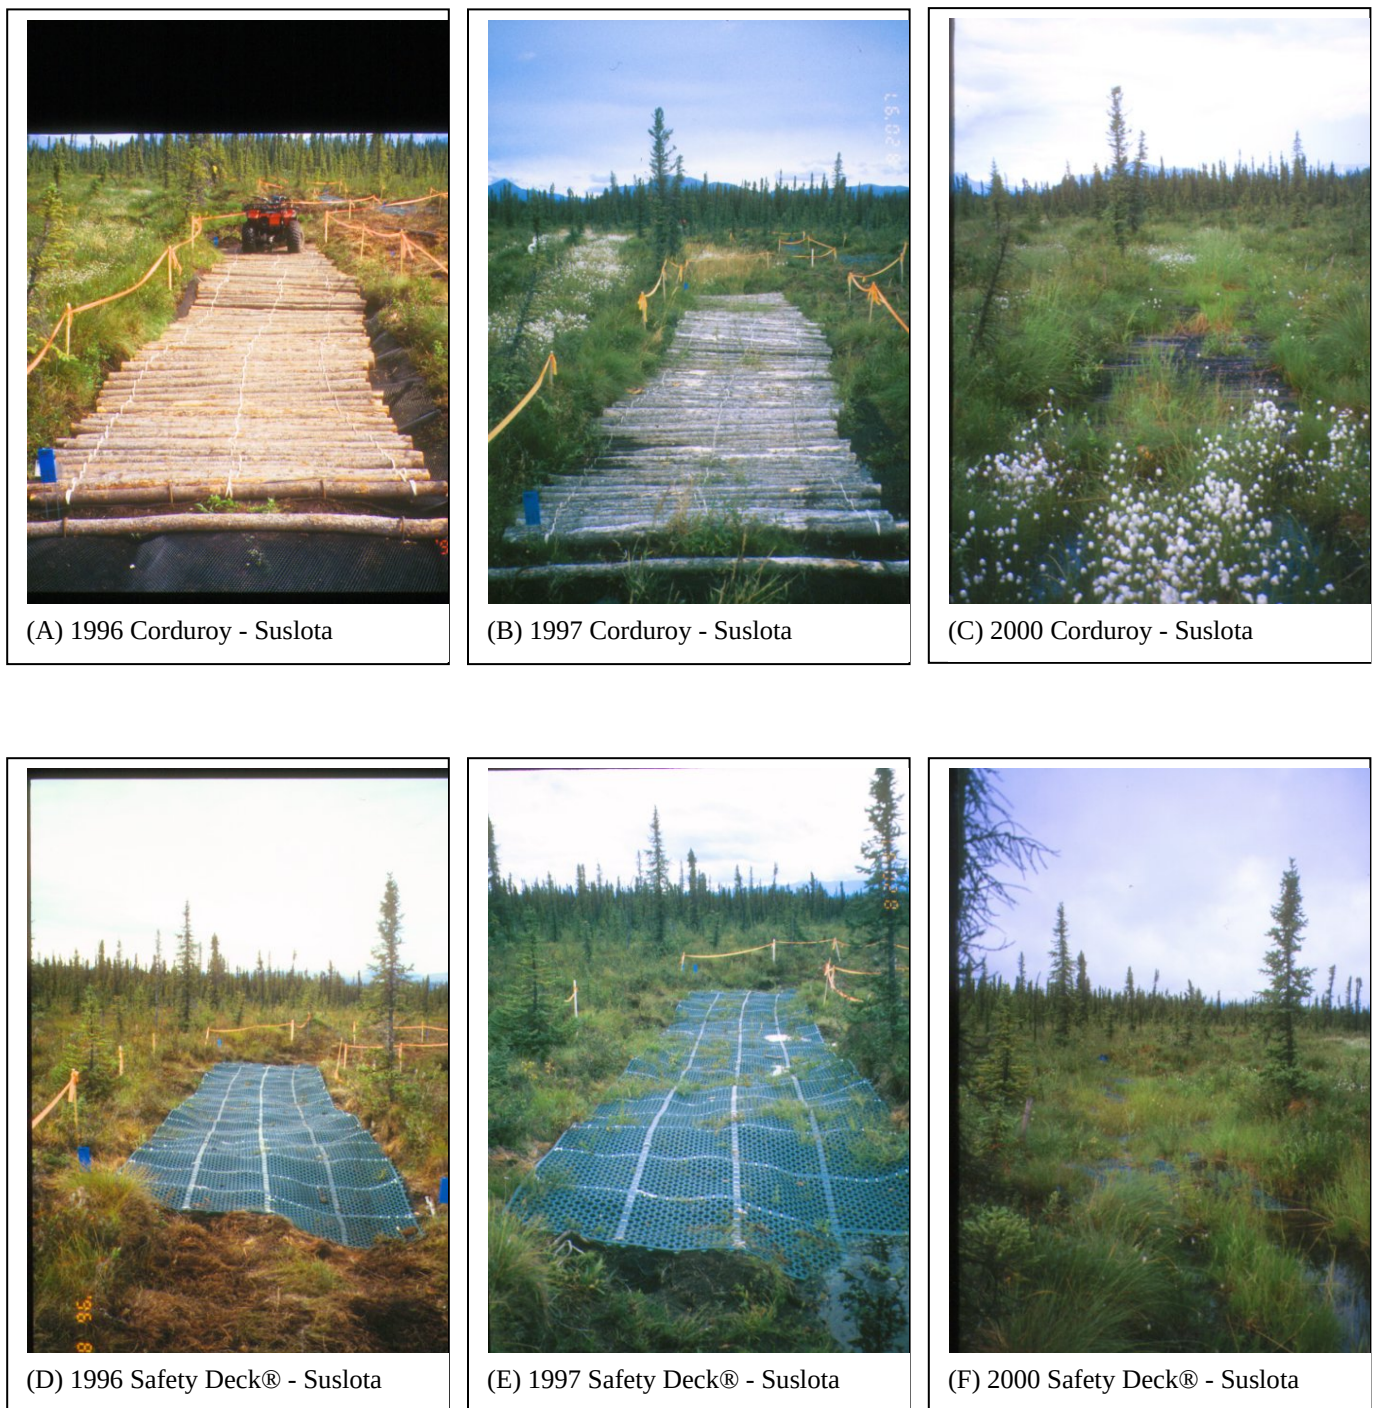
Figure 21. Photo series of Corduroy (A-C) and Safety Deck (D-F) hardening material plots between 1996 and 2000 at Suslota Lake study site in Nabesna District, Wrangell-St. Elias National Park and Preserve, Alaska. This study site had ATV use during 1996 and 1997; an alternative trail was developed in 1998 that by-passed the study plots.

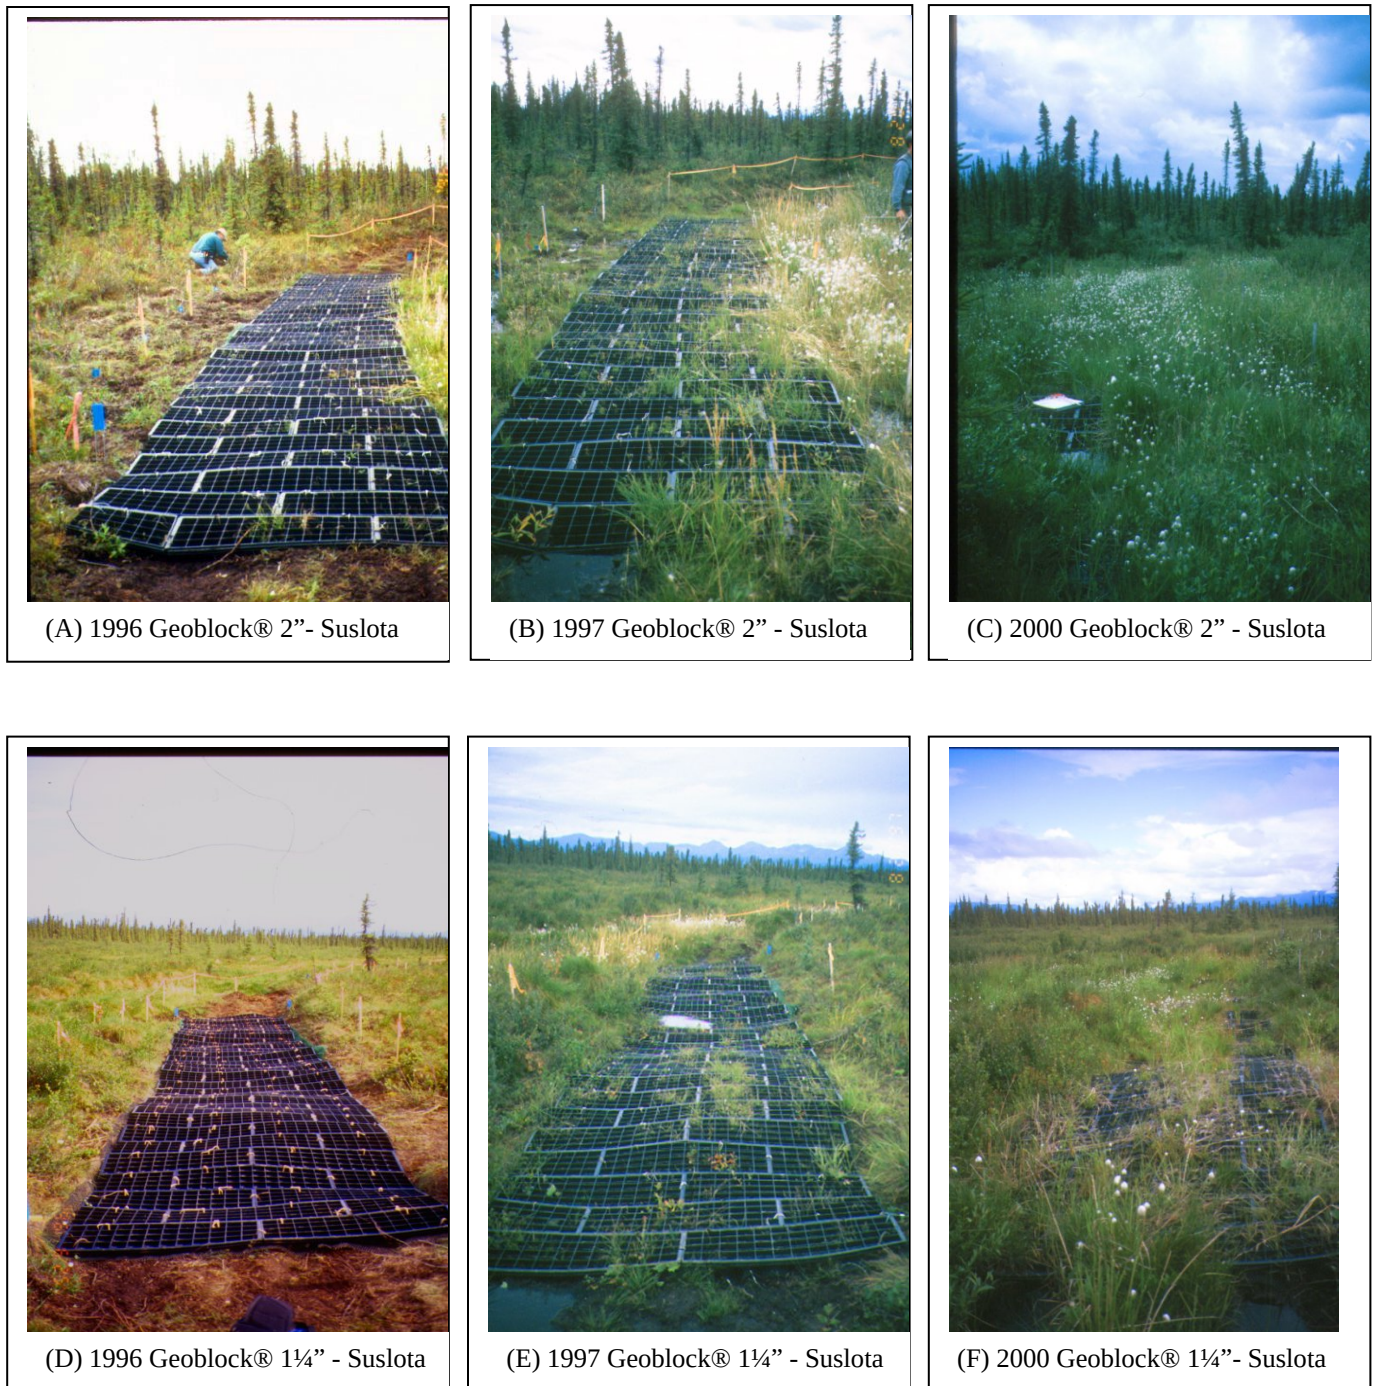
Figure 22 Photo series of Geoblock® 2" (A-C) and Geoblock® 1 1/4" (D-F) hardening material plots between 1996 and 2000 at Suslota Lake study site in Nabesna District, Wrangell-St. Elias National Park and Preserve, Alaska. This study site had ATV use during 1996 and 1997; an alternative trail was developed in 1998 that by-passed the study plots.

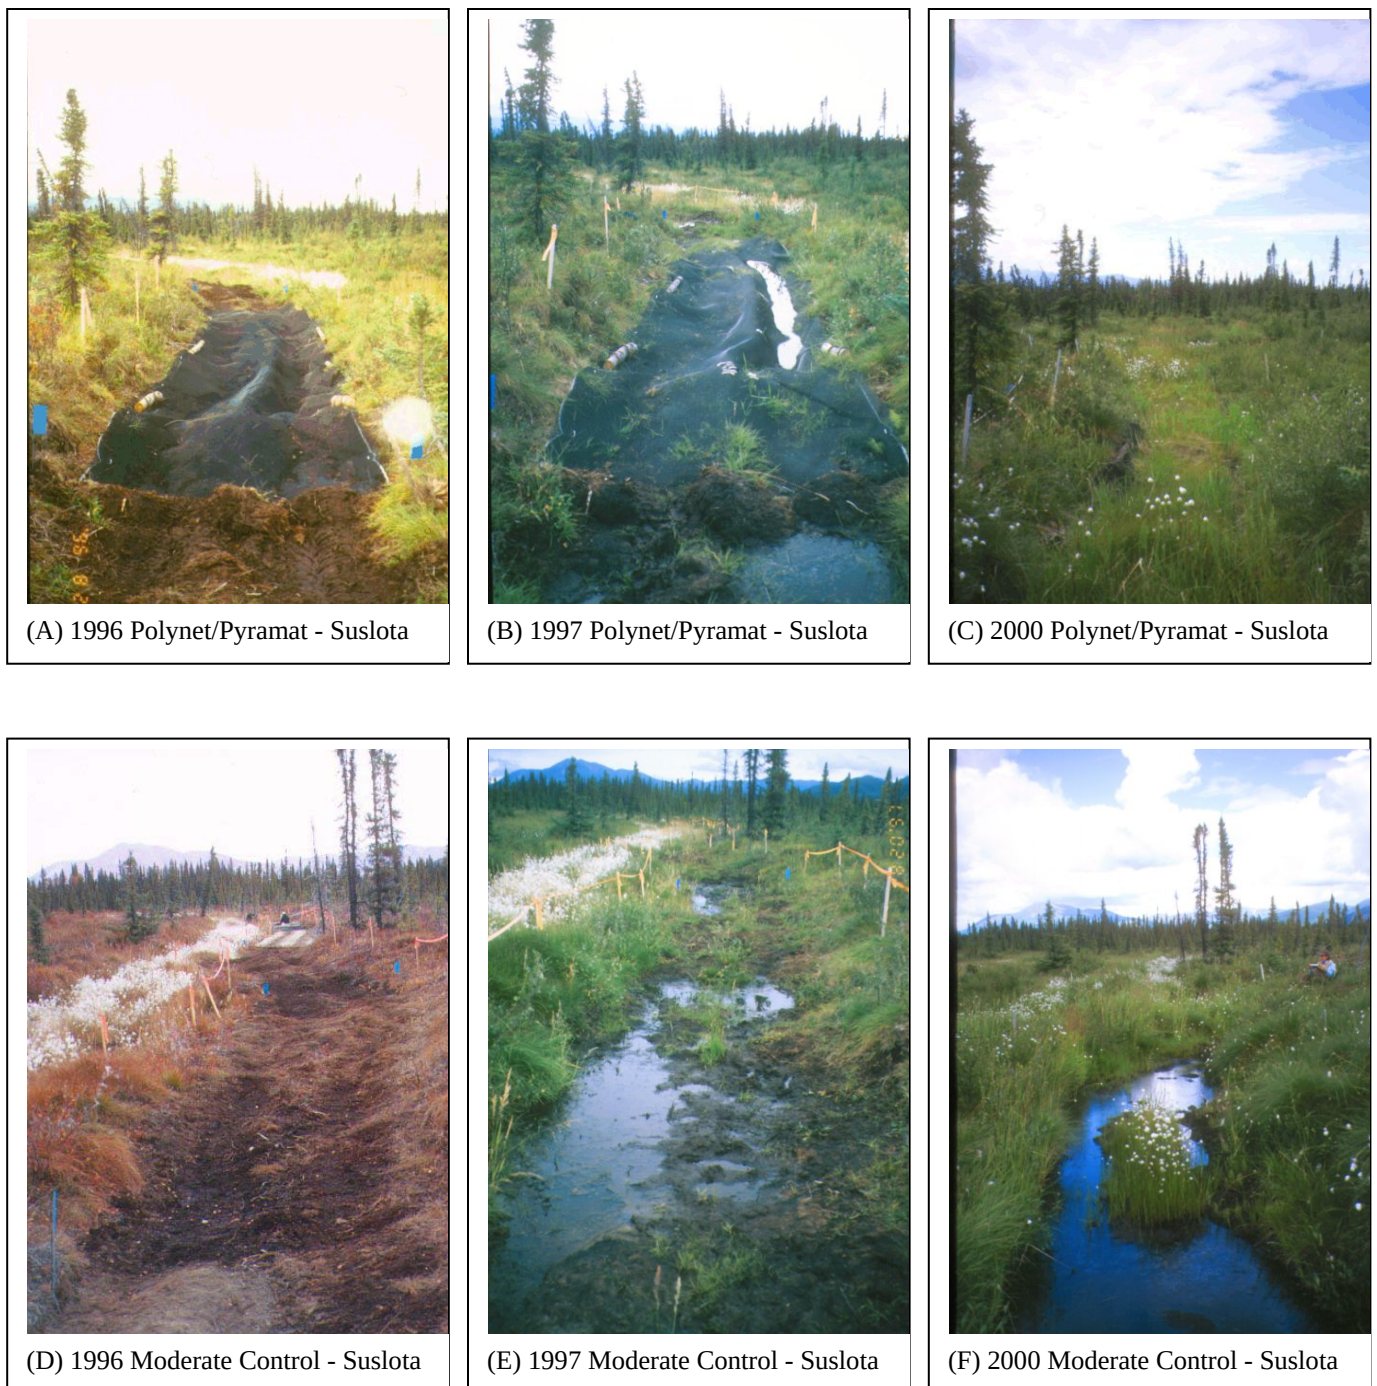
Figure 23. Photo series of Polynet PN-3000/Pyramat™ (A-C) hardening material plot and Moderate Control (D-F) untreated trail plot between 1996 and 2000 at Suslota Lake study site in Nabesna District, Wrangell-St. Elias National Park and Preserve, Alaska. This study site had ATV use during 1996 and 1997; an alternative trail was developed in 1998 that by-passed the study plots.

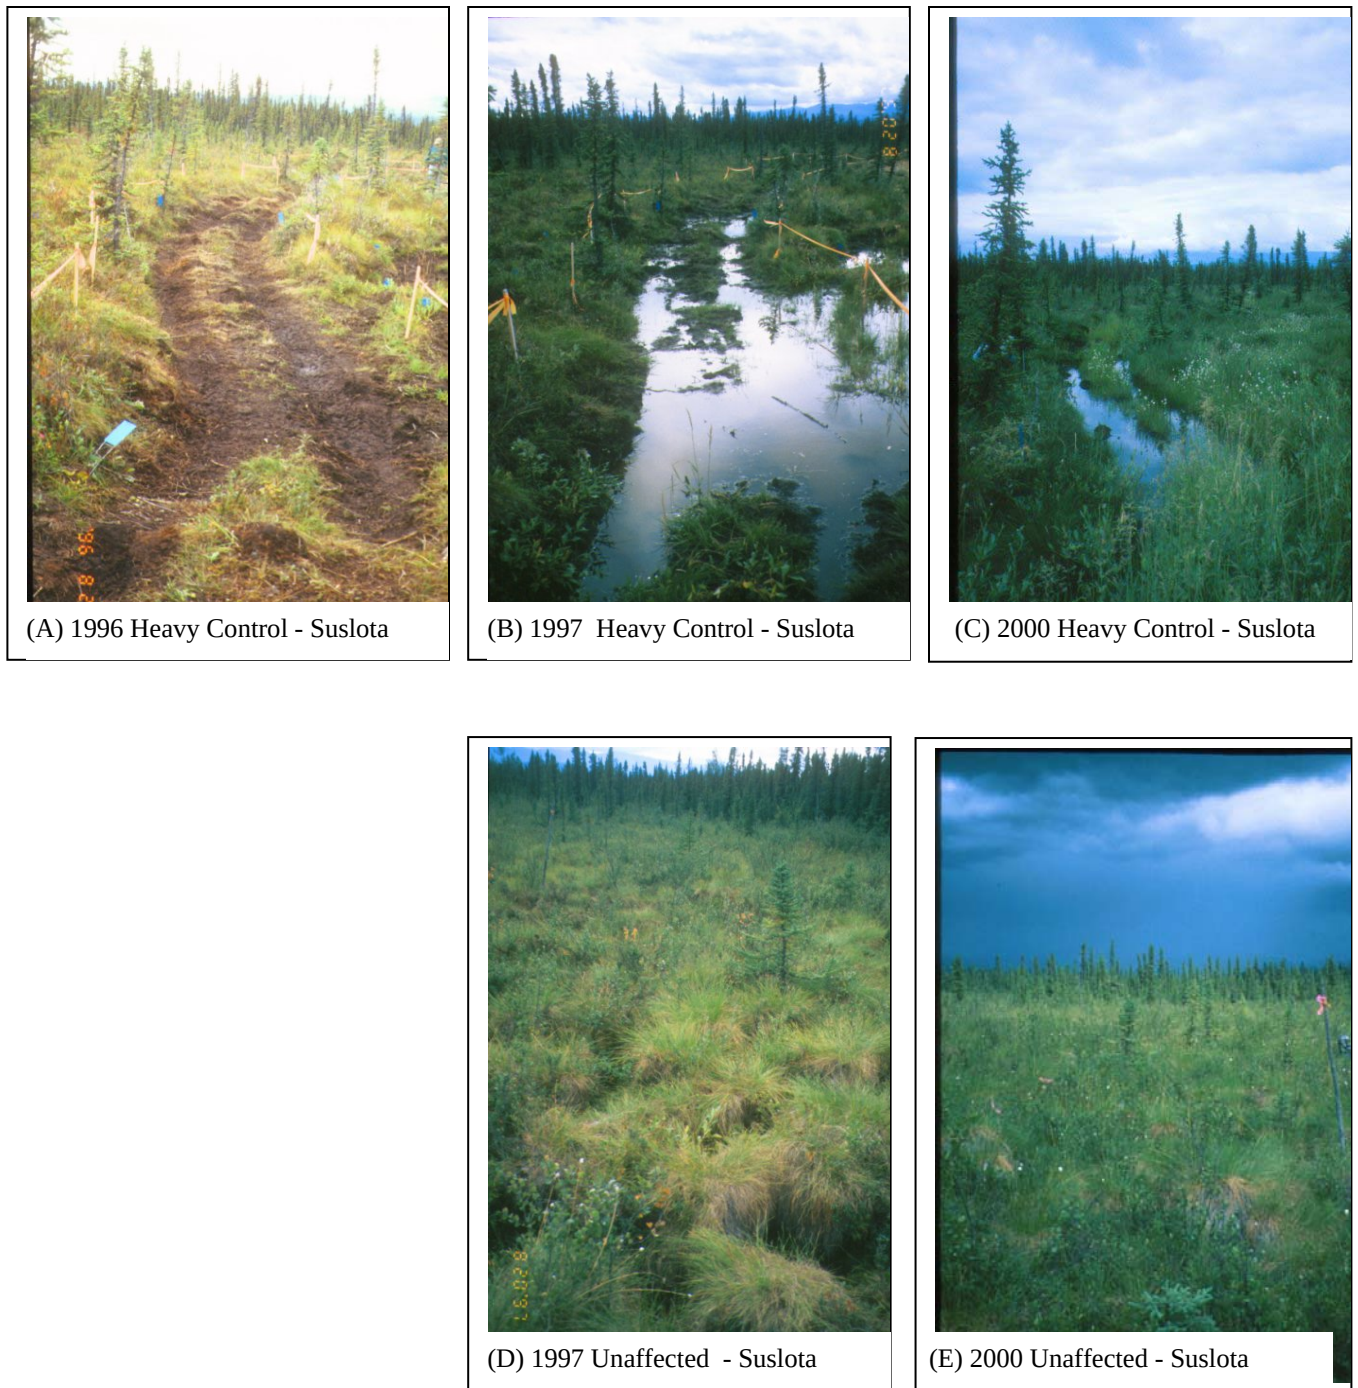
Figure 24. Photo series of the Heavy Control untreated trail plot (A-C) between 1996 and 2000 and Unaffected Control plot in 1997 (D) and 2000 (E) at Suslota Lake study site in Nabesna District, Wrangell-St. Elias National Park and Preserve, Alaska. The unaffected control photo from 1997 was taken to the east of the 2000 photo. This study site had ATV use during 1996 and 1997; an alternative trail was developed in 1998 that by-passed the trail study plots.
