**ALL-TERRAIN VEHICLE (ATV) TRAIL MITIGATION STUDY:  
COMPARISON OF NATURAL AND GEOSYNTHETIC MATERIALS  
FOR SURFACE HARDENING**

Wrangell-St. Elias National Park and Preserve, Alaska.

Wrangell-St. Elias National Park and Preserve Research and Resource Management Report

No. 2001-1

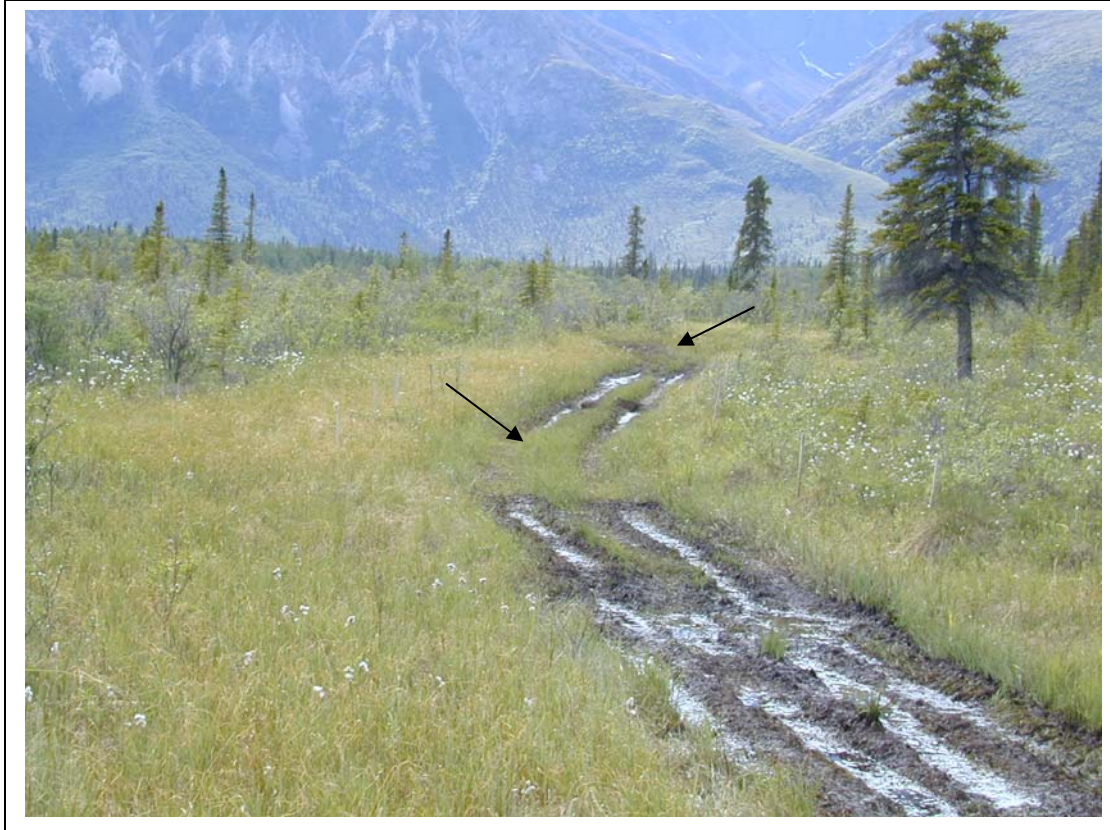
Figure 25. The vegetated and non-rutted sections along the trail (noted by the arrows) are areas with hardening material protection at Reeve Field.
