## **Harding Icefield Trail Impact Monitoring Report 2009**

**Christina Kriedeman and Deborah Kurtz  
Kenai Fjords National Park  
Resource Management Division  
P.O. Box 1727  
Seward, AK 99664**

**September 2009**

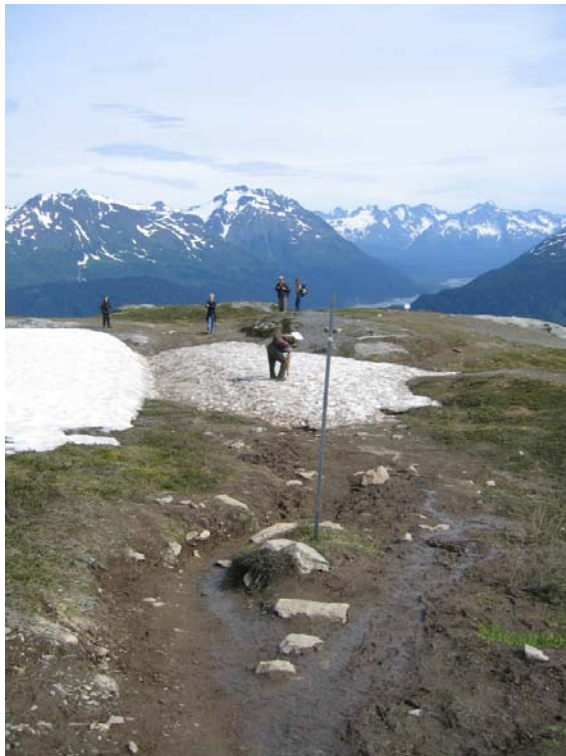
Photo 1.

Photo 1 and 2 below show the different trail conditions during the 2008 and 2009 summer surveys. Surveying was delayed in 2008 to allow more time for snow to melt from the trail and to allow plants to reach a more similar phenology to the sites in previous years, but in some areas the snow never melted off the trail. Photo 1 is taken on August 31, 2008 and Photo 2 was taken on July 15, 2009. The conditions captured in Photo 2 are much more typical along the trail in July.

Top of the Cliffs August 2008. NPS Photo.

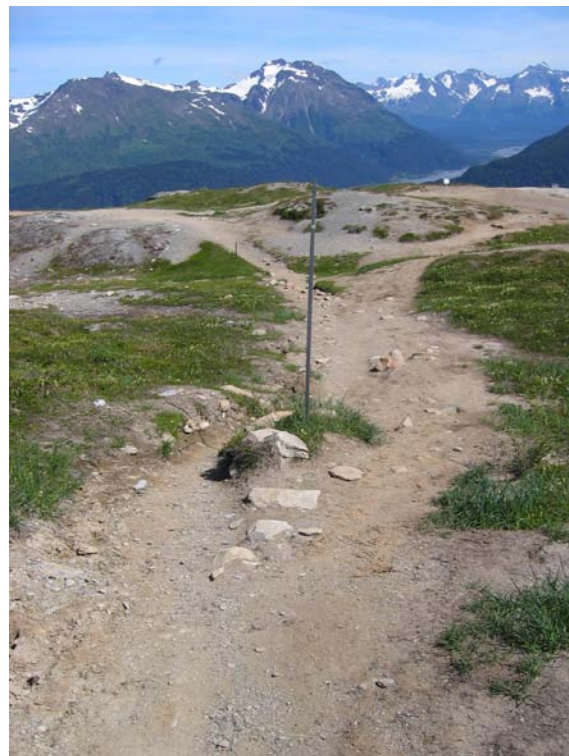
Photo 2.

Top of the Cliffs July 2009. NPS Photo.

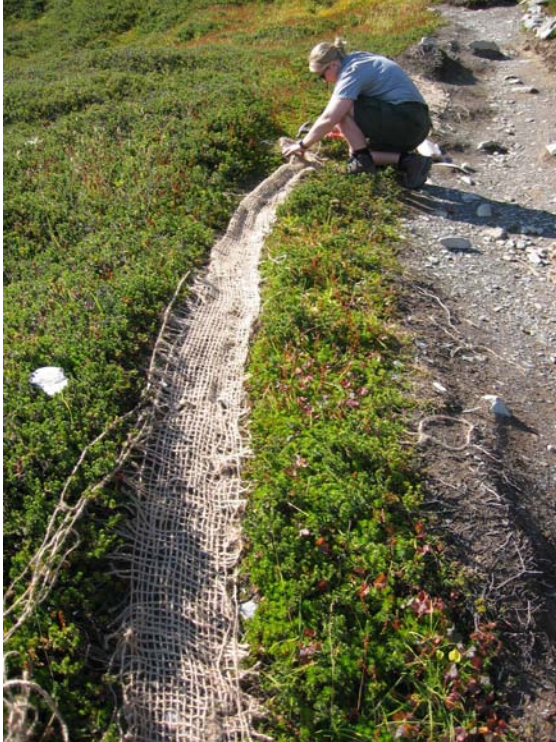
Photo 3.

Jute Mesh Installed Along a Parallel Trail. NPS Photo.

Rehabilitation work was conducted on the trail this year by Resource Management. Jute mesh was installed on impacted sites based on impact monitoring recommendations. It provides a physical barrier on top of impacted sites that can help deter hikers from walking on it, but it is important to install signs that explain the purpose for the jute mesh, so visitors understand its purpose.

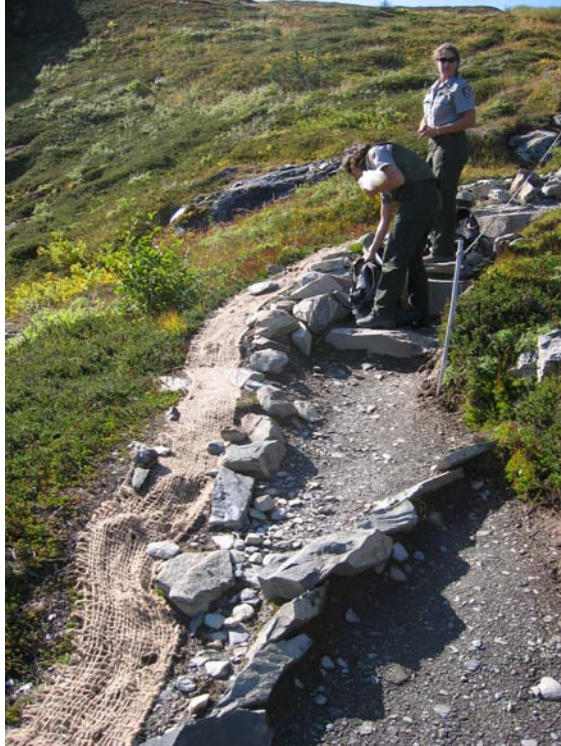
Photo 4.

Biotechs Installing Jute Mesh. NPS Photo.
