# HISTORIC STRUCTURE REPORT FOR THE HEADQUARTERS HISTORIC DISTRICT

## OLYMPIC NATIONAL PARK WASHINGTON

2010

Frederick L. Walters  
Historical Architect  
2752 Burton Lane, P.O. Box 437, Cambridge, Idaho 83610

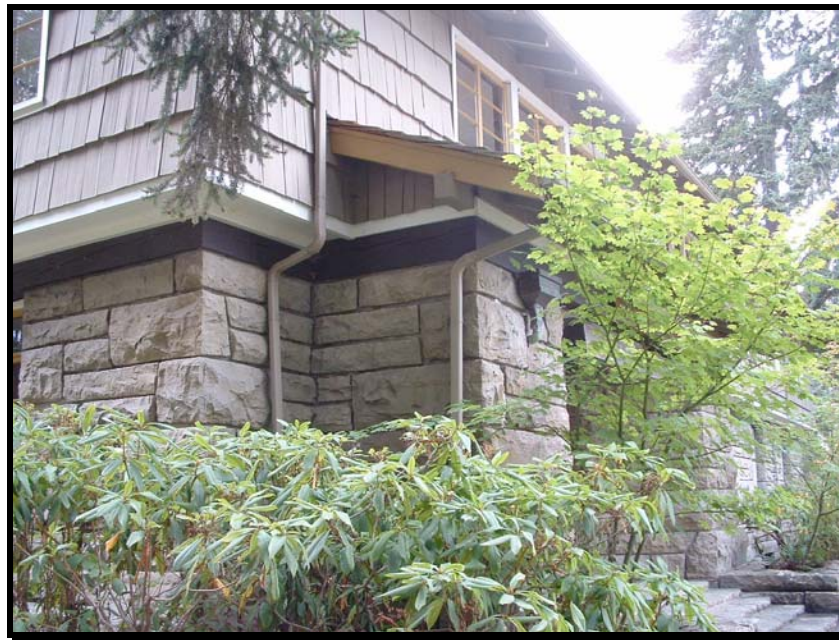
Figure No. 1-6: At the front entry, note abandoned leader box and new routing of downspout.

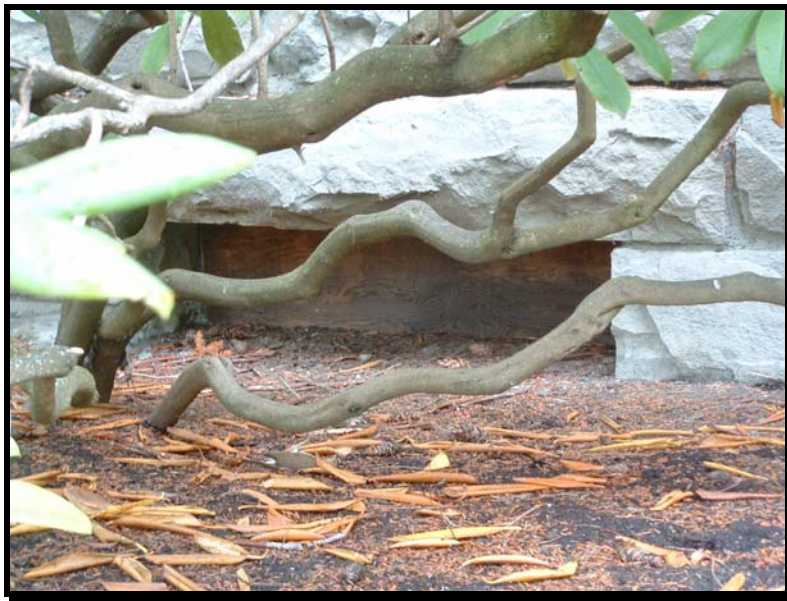
At the base of the wall, foundation vents were incorporated for the crawl spaces beneath the first floor. All the vents have been closed with plywood, though the crawl spaces do not appear to have any excessive moisture levels. The vents were designed to be elevated 5" above grade, and in many instances the openings are not level with grade.

Figure No. 1-7: Foundation vent.

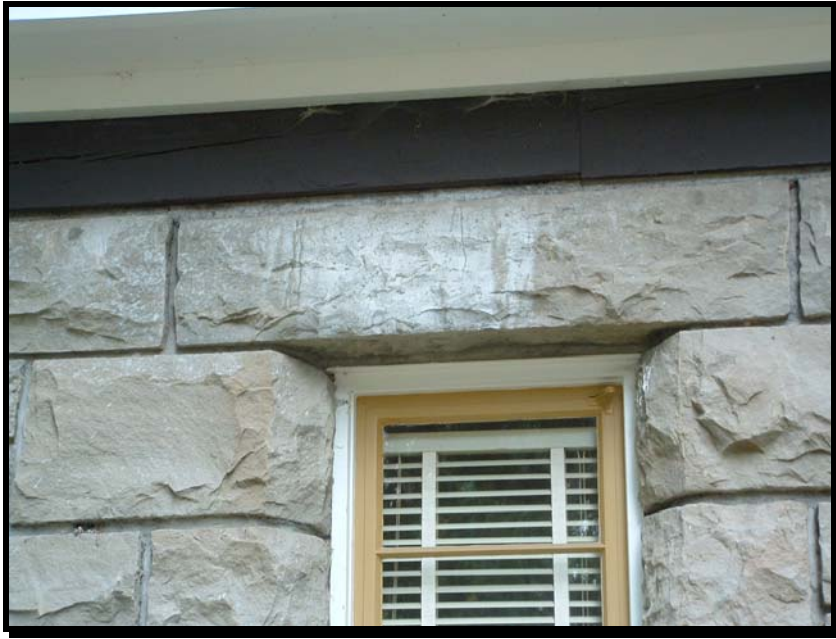
On the west elevation, there is some staining at the top of the stonewall. Its location is directly beneath the second floor women's restroom. The stain exhibits both surface flow and splattering on the stone.

Figure No. 1-9: West elevation, staining of stone

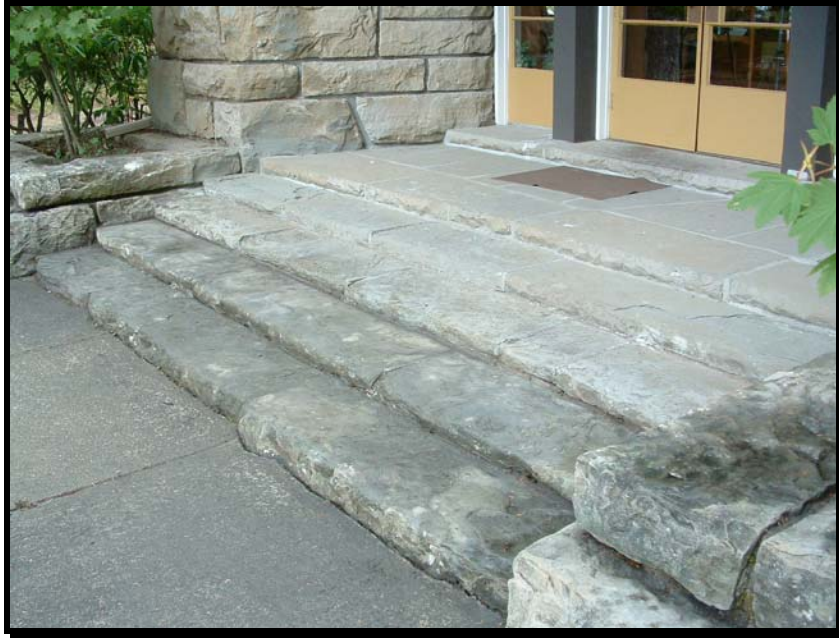
The stone used in construction of the Administration Building is local sandstone. When used in highly exposed environment such as the planters, steps, and landings, it appears to undergo accelerated deterioration. The stone in these locations exhibits a high degree of delamination of the natural bedding layers of this sedimentary stone. In addition, when wet the steps and landings become very slippery. At the rear entry, the original stone steps were covered with a concrete overlay. The front entry still has its original stone steps and landing.

Figure No. 1-12: Front entry steps and landing.

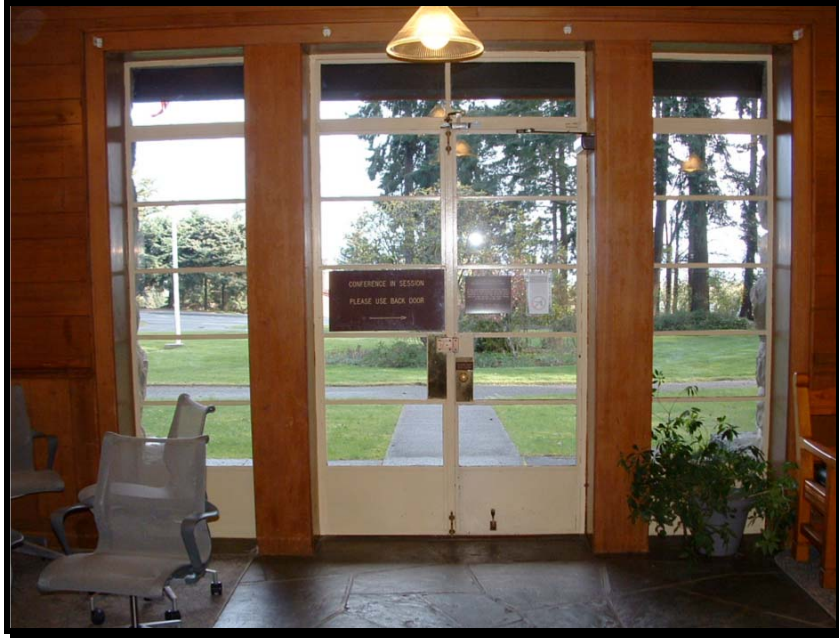
The front exterior doors are steel frame assemblies. They are in fair condition in that the demands of being operational place stress on issues of alignment and secure sealing. They have a slight warp to the frame that causes them to have some drafts. The metal rear door and side-lites are a replacement for the original pair of steel framed doors, installed in 1991 for accessibility.

Figure No. 1-14: Steel front entry doors

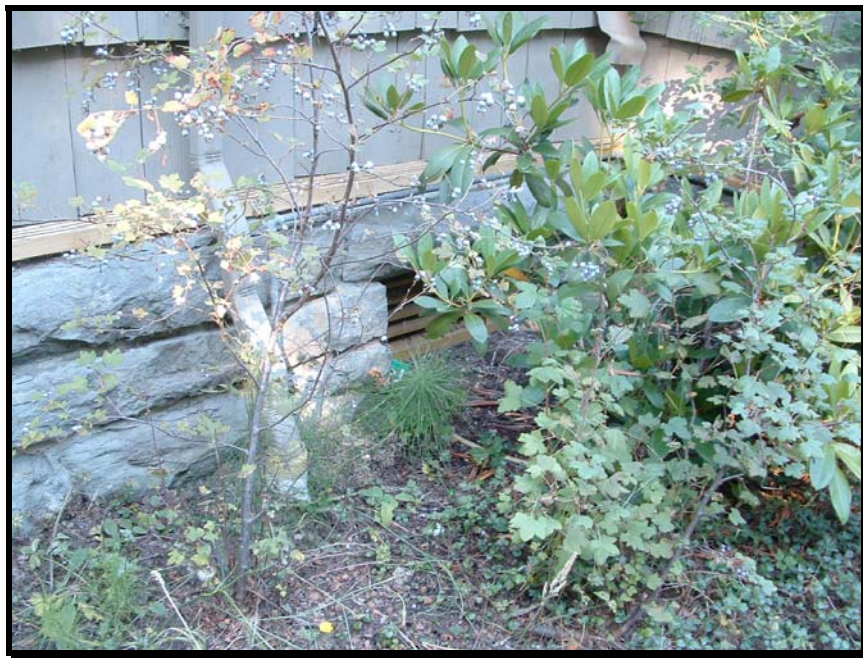
The grade has grown considerable around the building over the years, especially around the back of the building. In several locations, the sills of the foundation vents are at, or slightly below grade. Part of this situation has occurred naturally from vegetation accumulation, but part may also be due to changes in the vent design during construction.

Figure No. 2-6: Existing foundation vent on rear elevation.

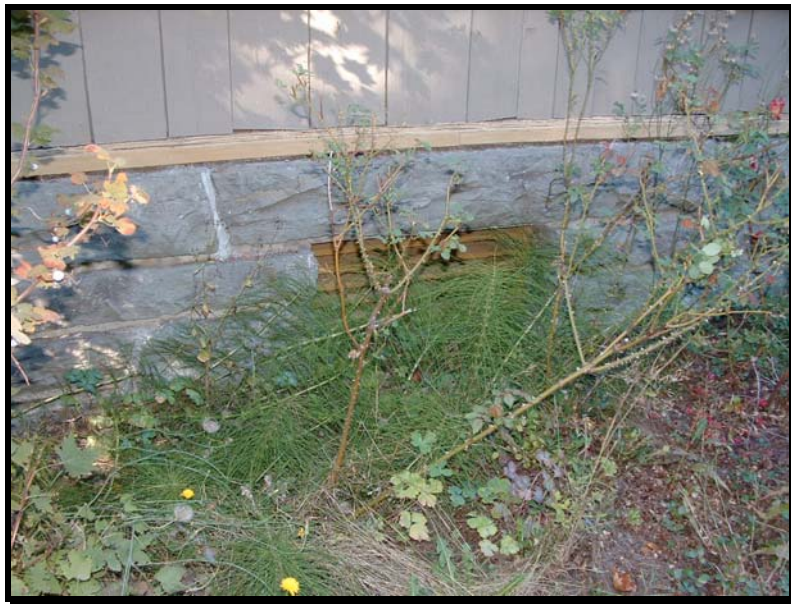
Along the rear elevations, a trim molding was used as a transition between the foundation stone and the lower shingle course. The molding is very deteriorated in places.

Figure No. 2-11: Note the trim moldings atop the stone

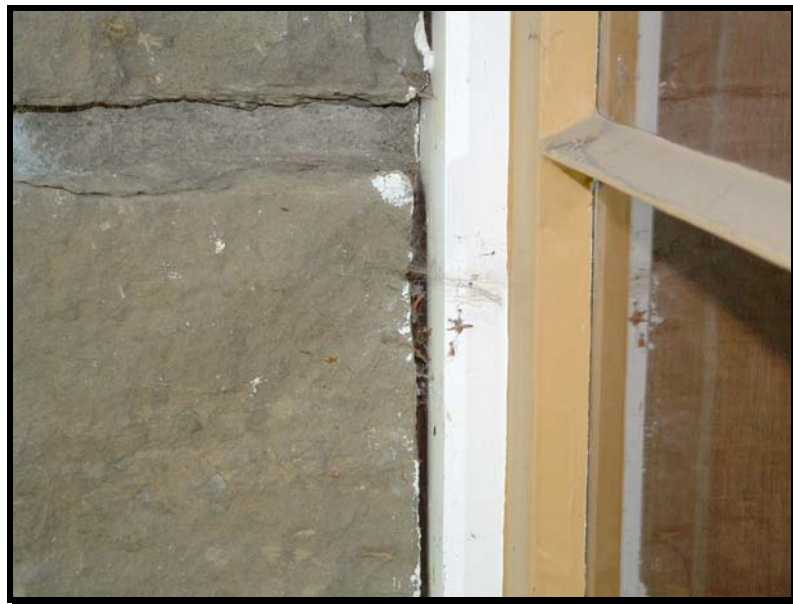
At the first floor stonewalls, the construction detail of the wood frames that hold the steel windows and doors were altered. In changing the design, wood frames were set into a rebate of the outer stone wythe. This created an irregular joint between stone and milled wood. This open joint is accessible to insects.

Figure No. 2-13: Note open joint at wood frame/stone interface.

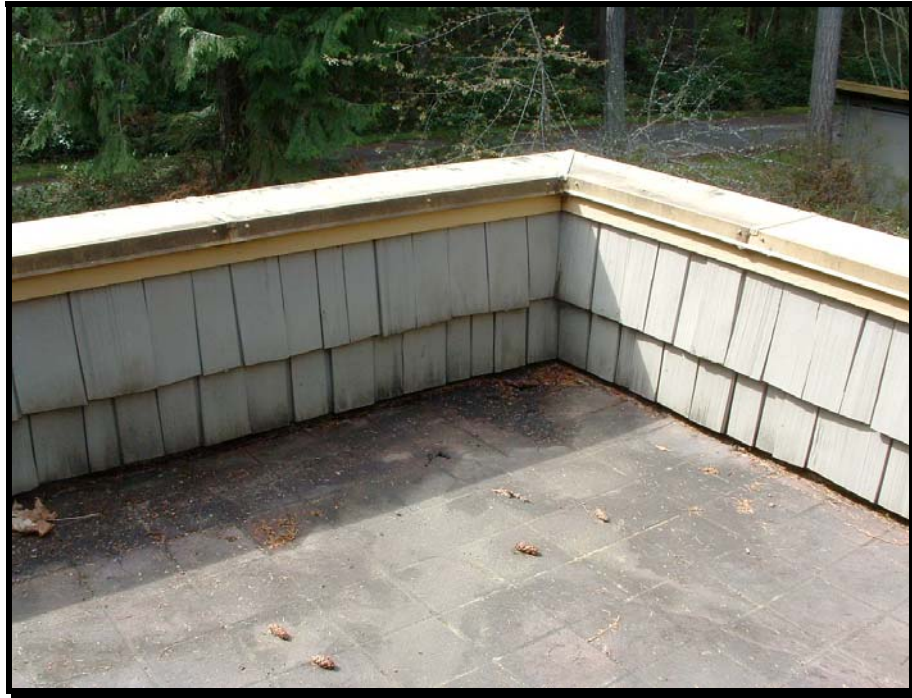
Figure No. 2-15: Quarry tile roof of sundeck; note overflow scupper has been covered.

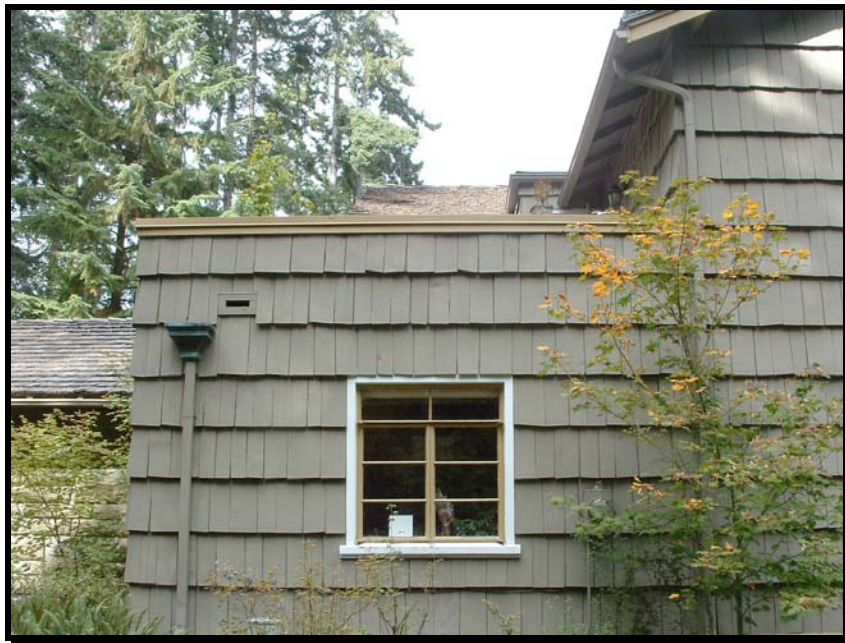
Figure No. 2-16: The drain from the sundeck discharges into the leaderbox; the opening to the right of the leaderbox is the overflow scupper.

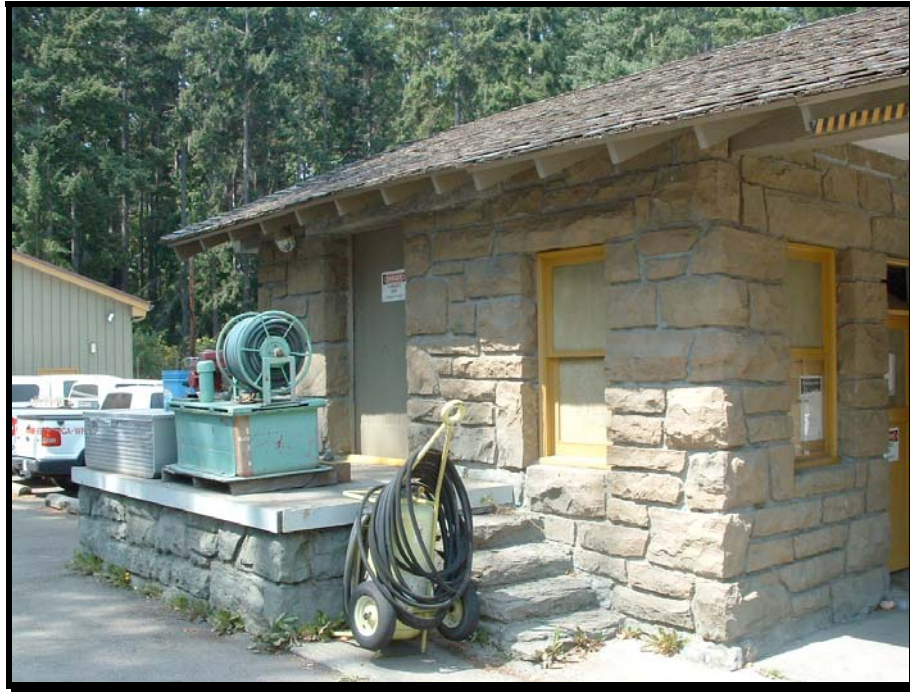
minor surface deterioration. Moderate to serious deterioration of stone has occurred in the stone of the loading dock on the south elevation, especially in the exposed steps, and in the base stones of the columns of the east canopy.

Figure No. 3-4: Note stone weathering in the landing steps.

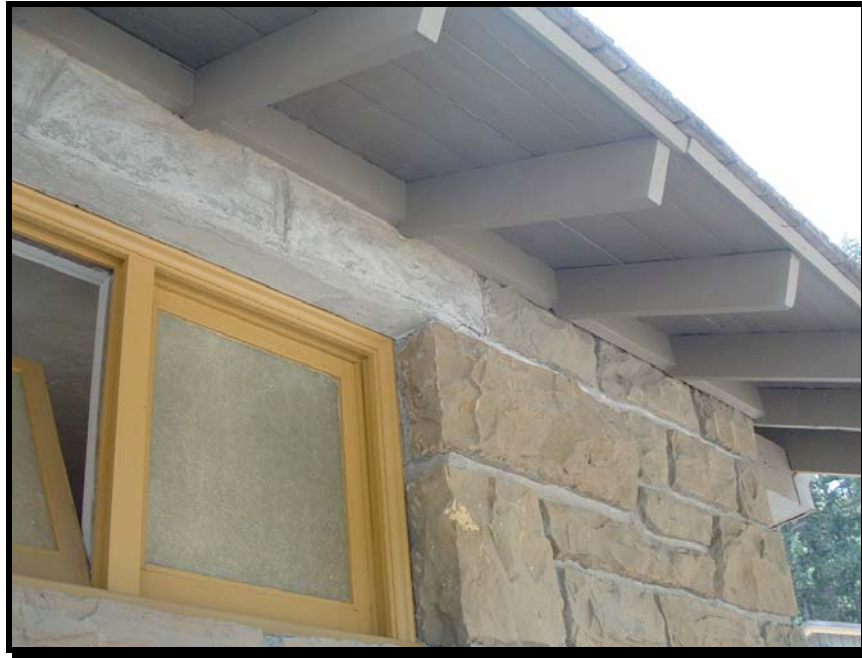
stone of this length would have to have been deeper in depth for the span than there was room within the building design. These wood lintels have been covered with a thin coating of plaster and tooled to look like stone. There is some minor cracking in the plaster.

Figure No. 3-5: Note the faux stone plaster covered wood lintel above the window.

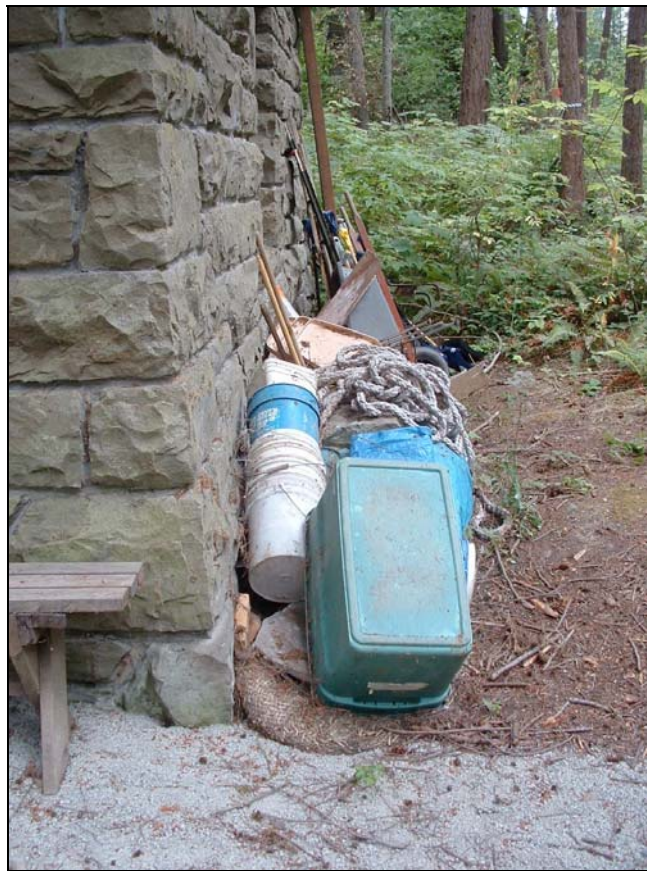
The Transformer and Pumphouse building is sited within the second growth forest just off the original residential circular drive to the west of the maintenance area. A building site was leveled from a gentle gradient descending south to north. On the west, south and east elevations the grade at the base of the structure slopes into the building. On the east side, this is partly due to the level of the roadway as it ascends up the property. On the west elevation, the storage of material and equipment against the building hampers any uphill drainage.

Figure No. 4-3: Equipment and tools stored against the west wall.

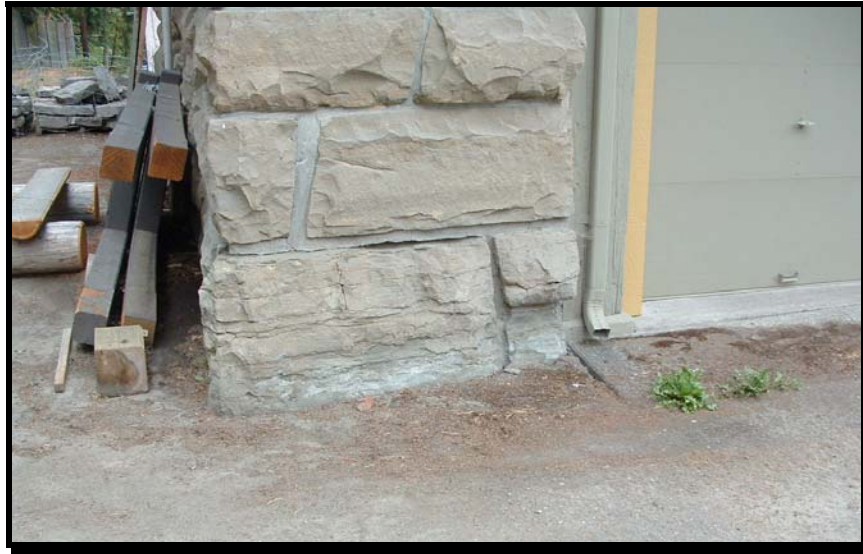
The end downspouts, while draining onto the asphalt, also saturate the stone near the base of the downspout. This has resulted in an accelerated deterioration of the base stone through cracking and delamination.

Figure No. 5-3: Southwest corner; the discoloration of the stone is from excessive moisture from the adjacent downspout; the weathering causes associated mortar cracking and bond loss.

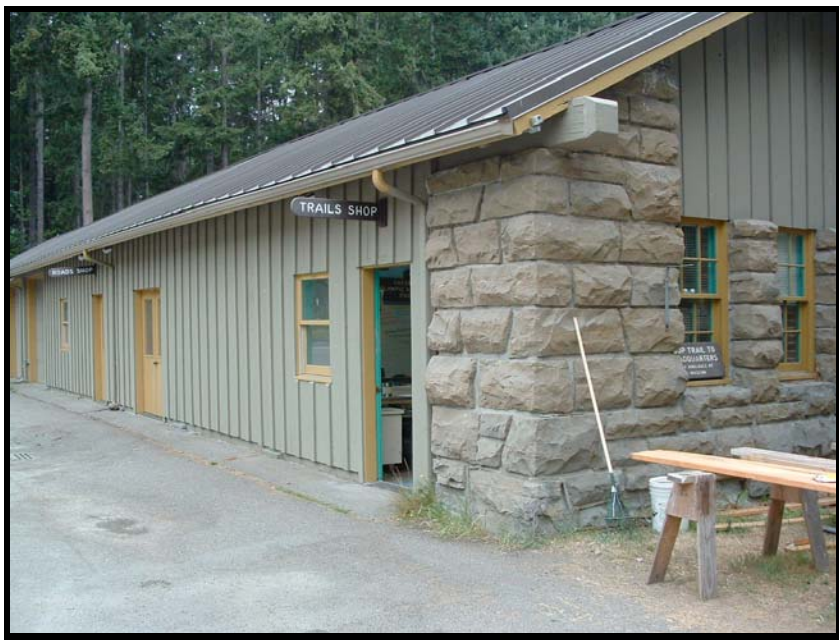
Figure No. 5-5: Test southeast outlooker for deterioration.

Install backer-rod and sealant in joint gaps between windows/wood frame and stone; test outlooker for deterioration.

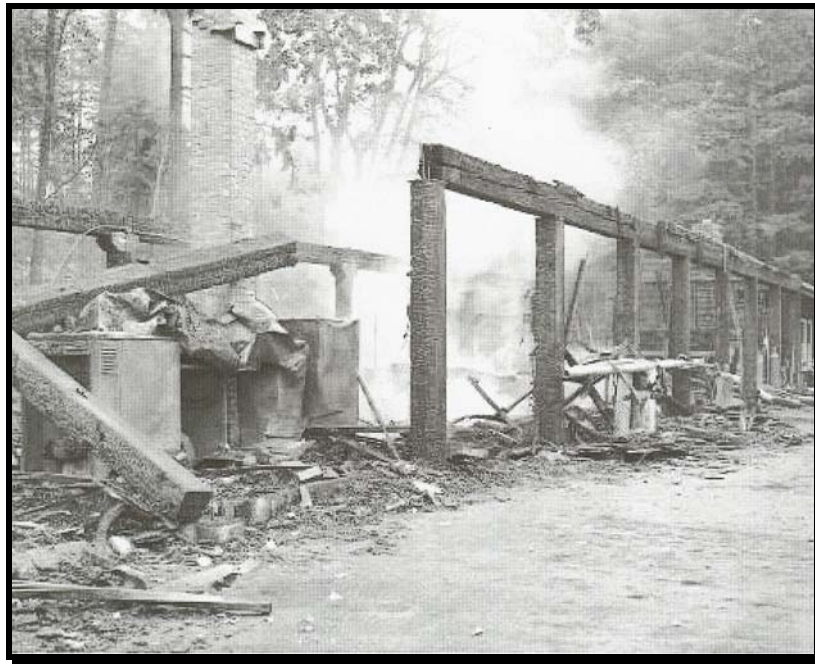
Figure No. 1000-2: Fire damage of 1965.

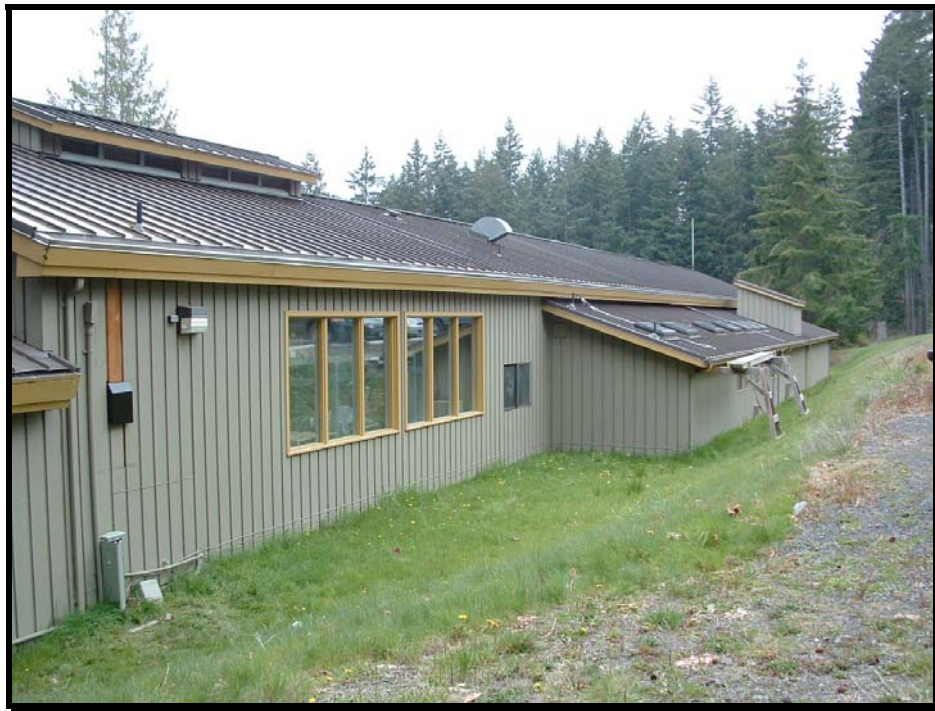
Figure No. 1000-4: At the rear of the building, the building had a grade apron to collect water from the above slope; this has been somewhat compromised by the rear shed addition.

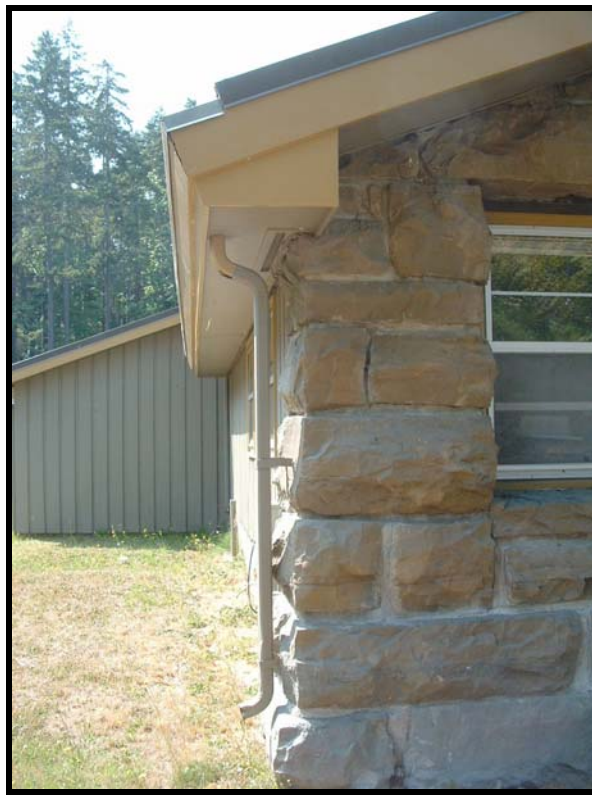
Figure No. 1000-5: Mortar cracking at southeast corner.

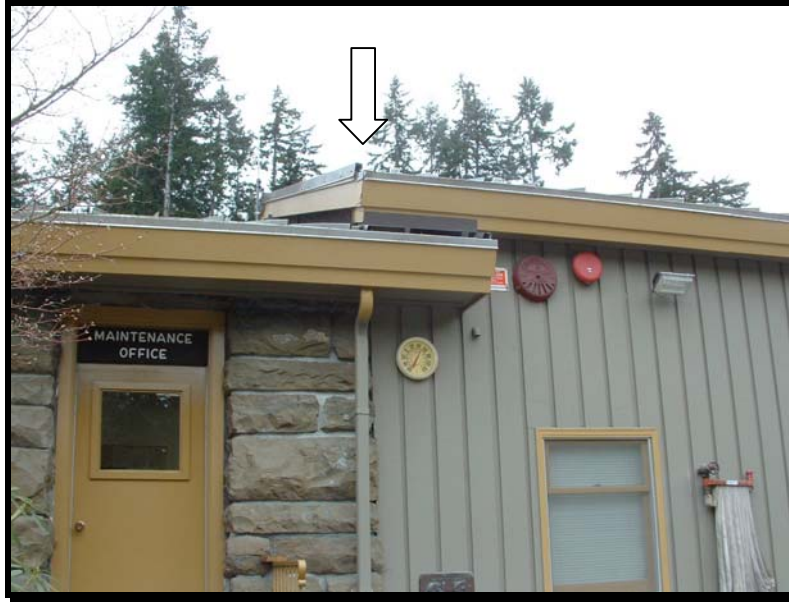
Figure No. 1000-9: Indications of fascia deterioration can be seen at the corner of the rake and eave.

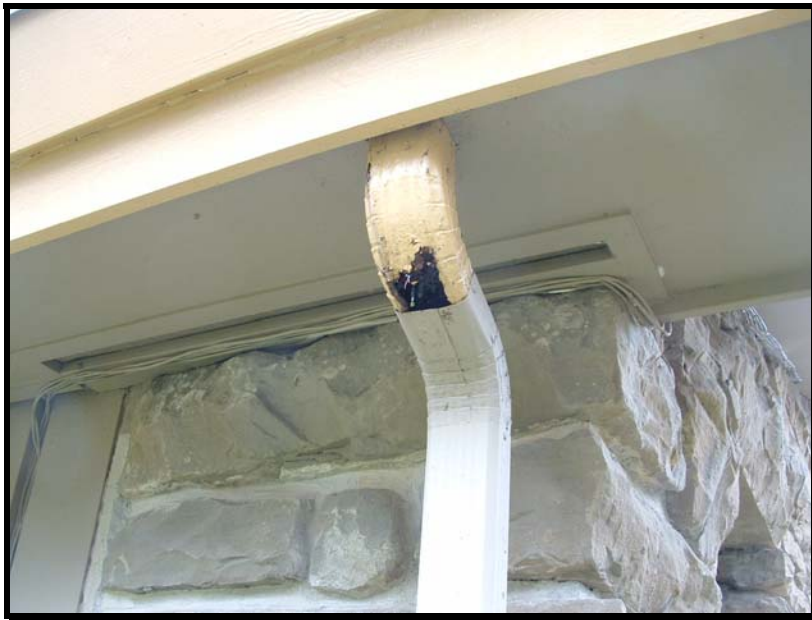
Figure No. 1000-10: Deterioration in the thru-eave downspout section.

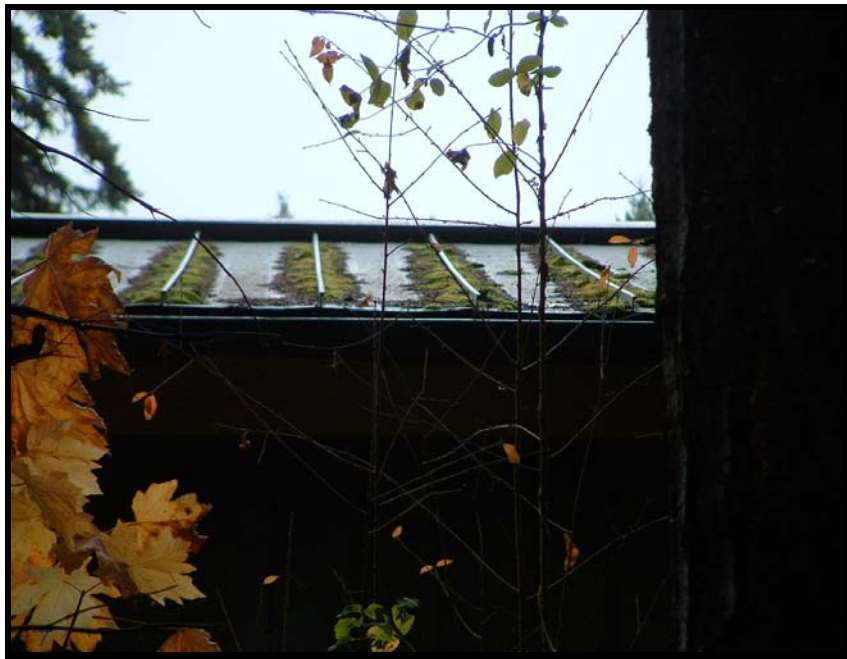
Figure No. 8-2: View north slope of roof; note build-up of moss and duff along standing seams and the deflection of the seams.

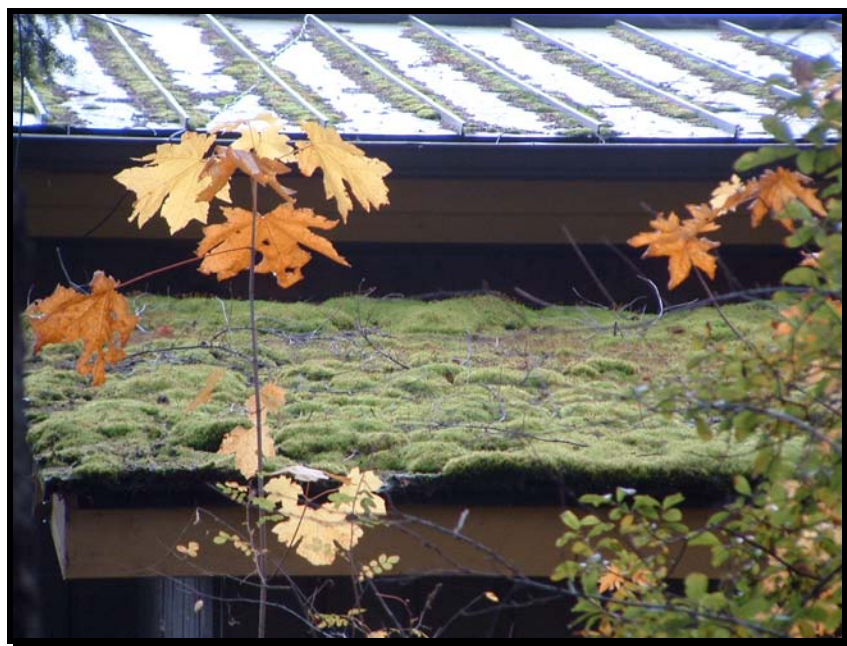
Figure No. 8-3: View of moss build-up on roof of rear ell

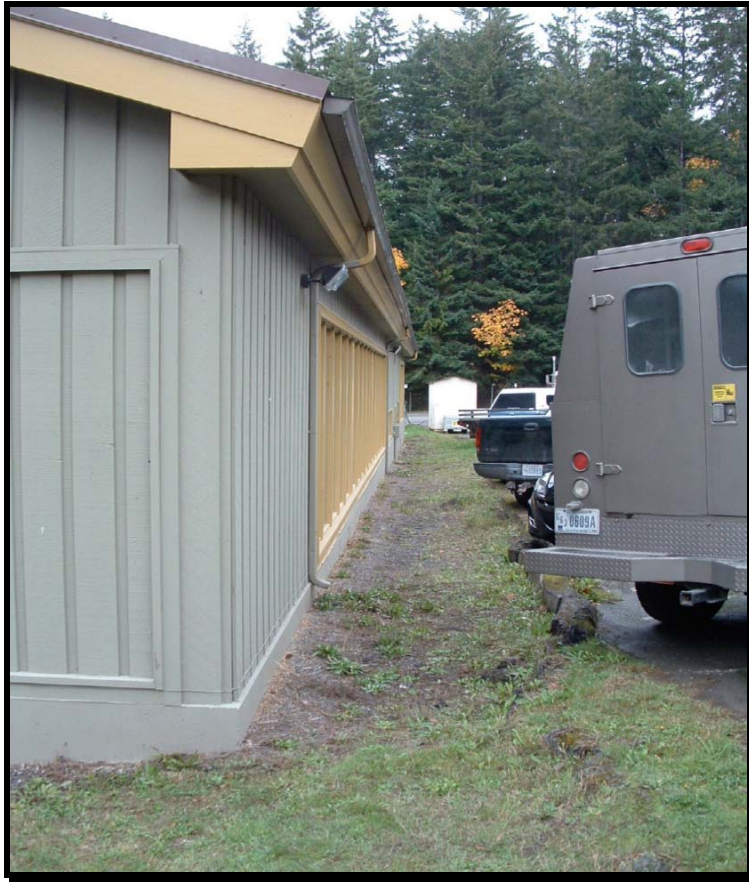
Figure No. 9-3: The uphill side of the building captures both the drainage of the parking area and the roof drainage.

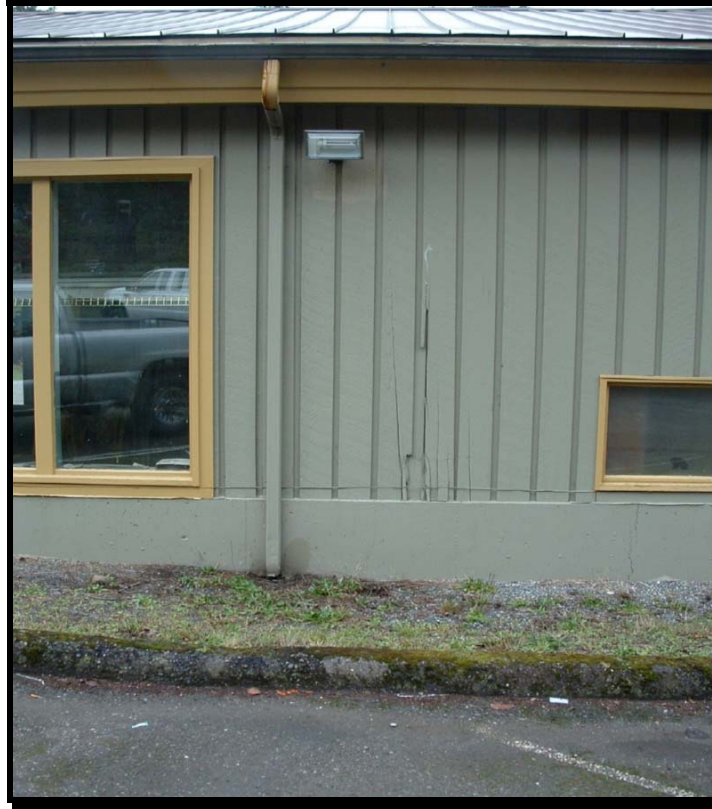
Figure No. 9-4: View of damaged siding

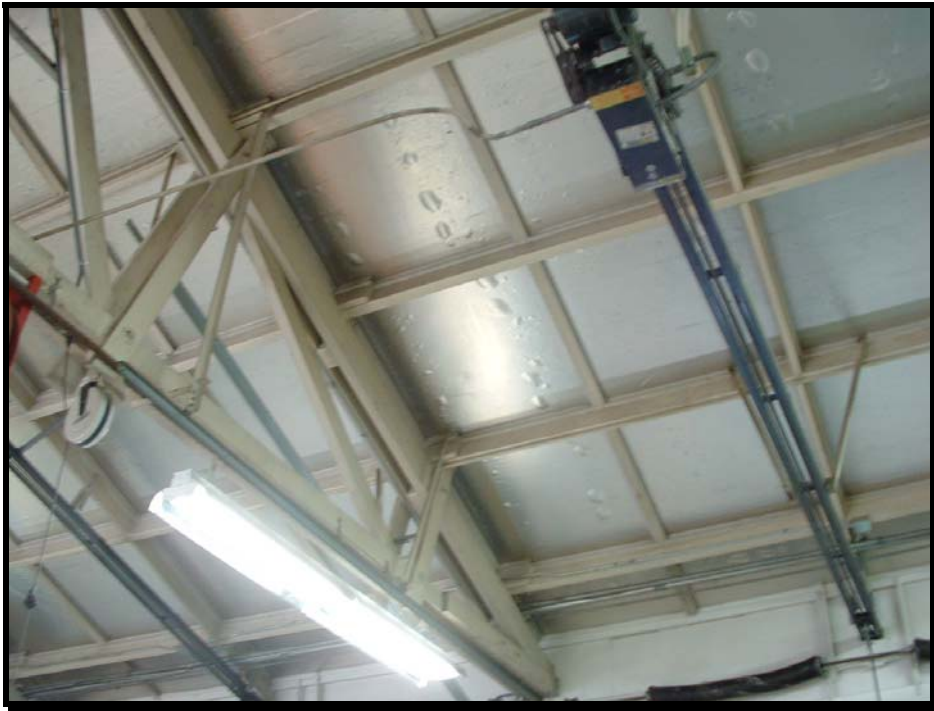
Figure No. 9-9: View of “bubbles” in insulation.

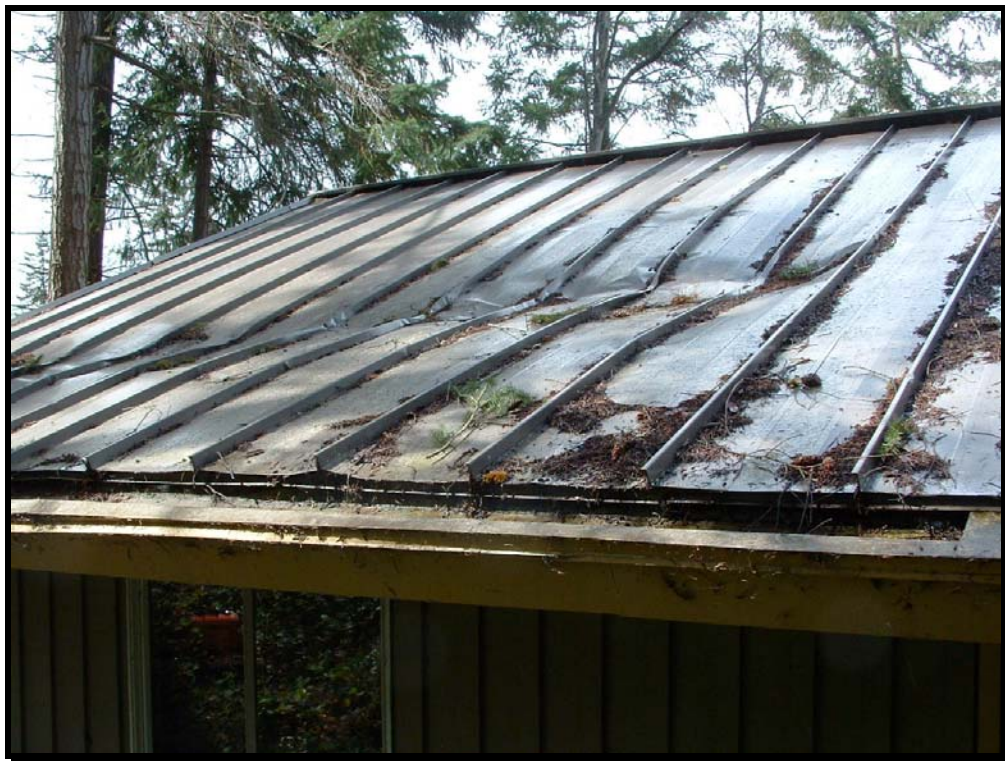
Figure No. 16-2: Southeast corner of the roof showing damage caused by tree fall.

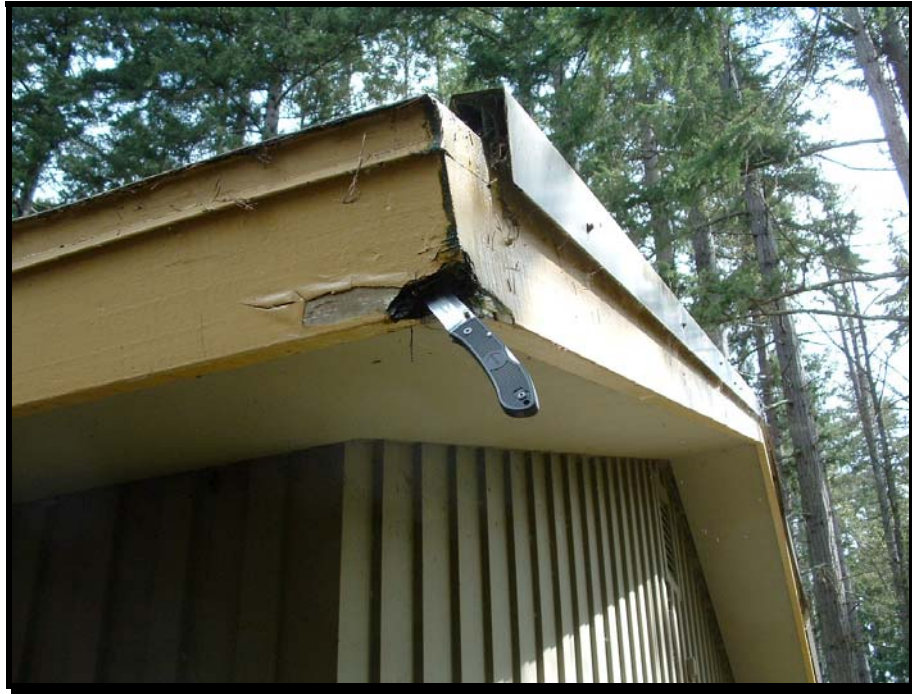
Figure No. 16-4: Southwest corner of roof eave showing current deterioration.

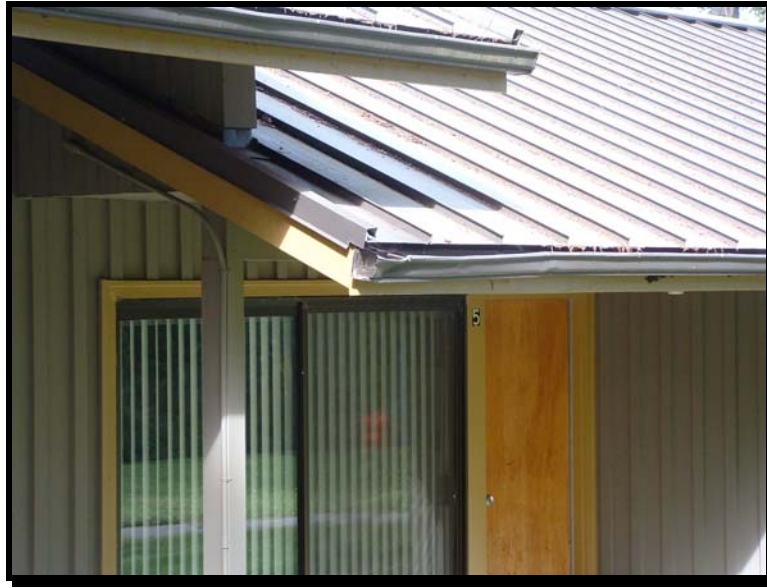
Figure No. 17-3: Existing gutter damage

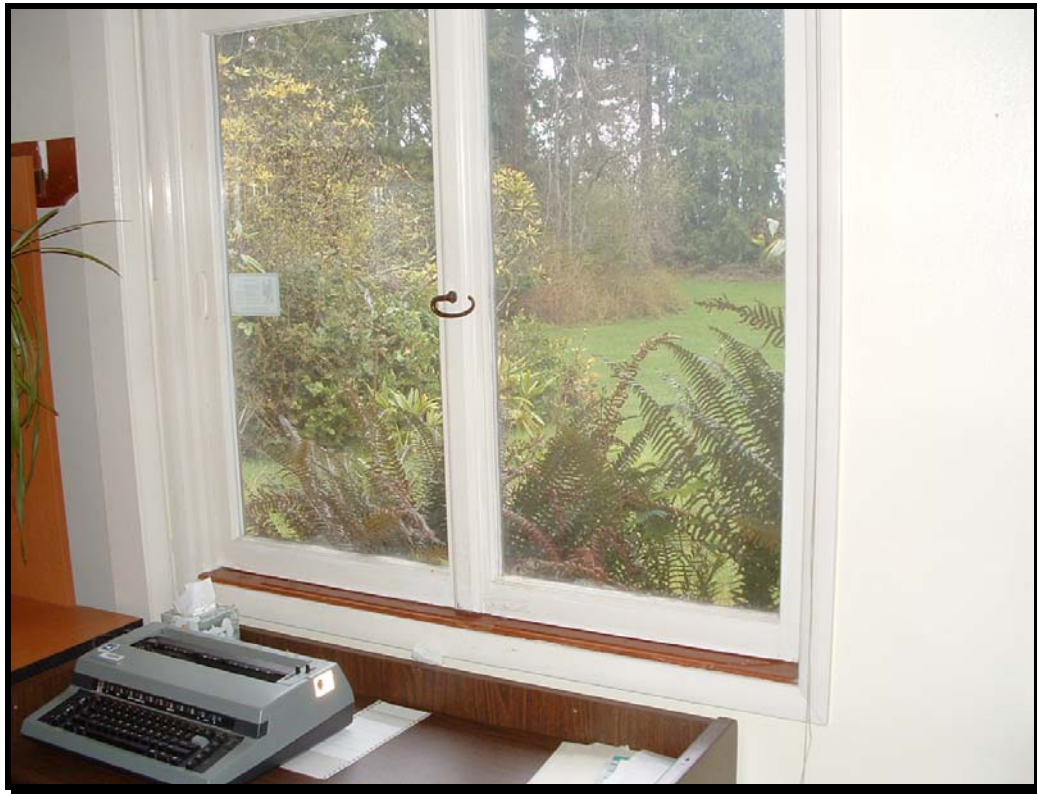
Figure No. 20-3: Offset horizontal slider windows; note groove in the windowsill.

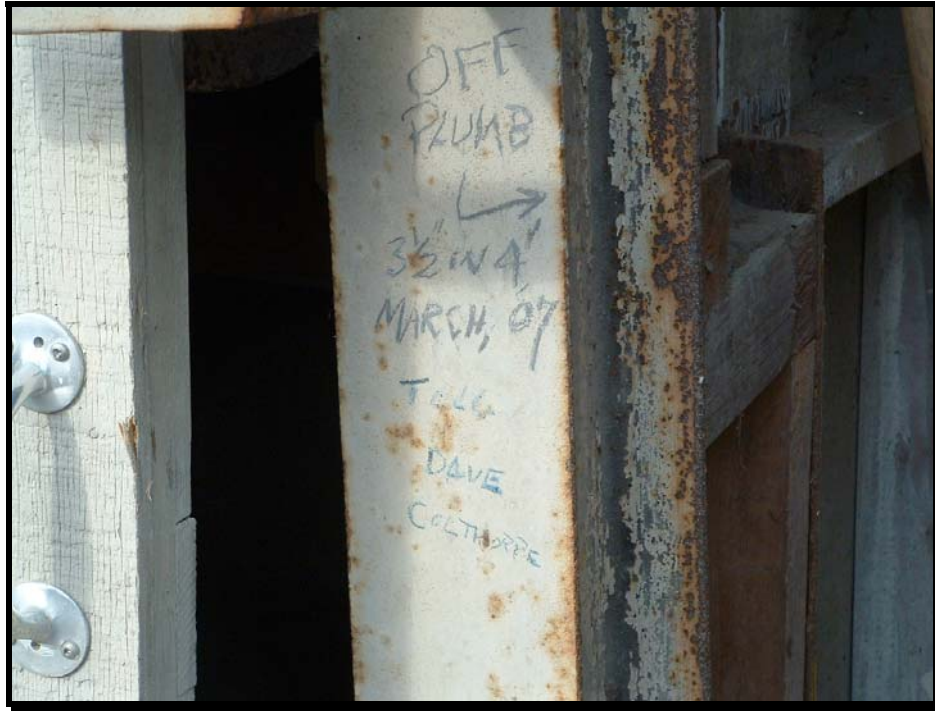
Figure No. 1292-6: Note on steel column recognizes the lateral movement of the frame.
