**Assessment of Slope Stability,  
Fredericksburg National Military Cemetery,  
Fredericksburg, Virginia**

**October 5, 1990  
Our Reference V901098**

# SCHNABEL ENGINEERING ASSOCIATES

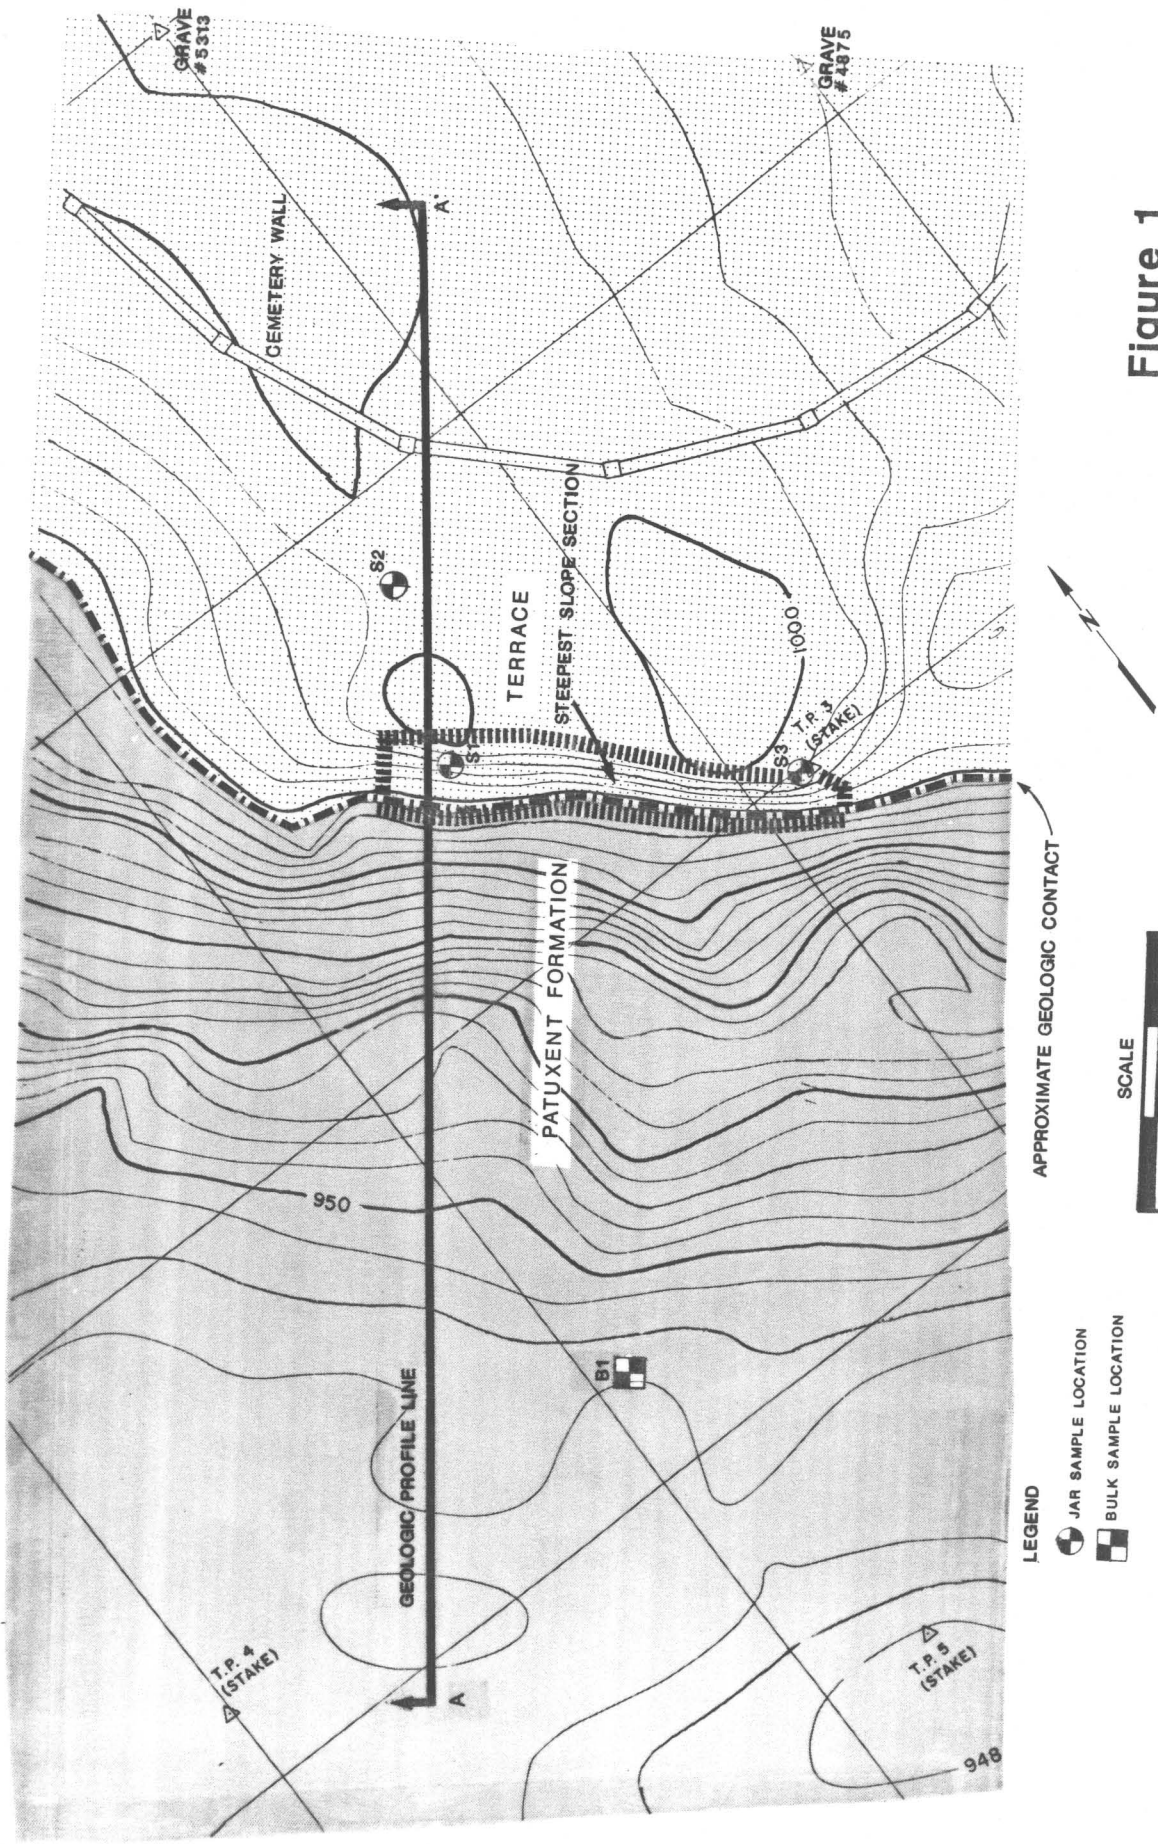
**Figure 1**  
**Site Plan and Geologic Map**

The upper, near-vertical portion of the headwall consists of the Terrace gravels and sands. The Terrace deposits are approximately ten feet thick at the thickest point on the headwall and are very dense. This portion of the slope is not vegetated. The middle and lower portions of the slope consist of the Patuxent formation sands. Several cemented sand and ironite layers were noted within the Patuxent formation sands, approximately half way up the slope. The geologic contact between the Terrace and Patuxent formation is at approximately EL 989 feet.

No evidence of large scale slumping or sliding was noted during our reconnaissance. No springs or seeps were noted on the slope. As indicated previously, hummocky ground and several soil piles were noted at the toe of the slope, probably related to the quarry operations. No bedrock was observed on the site although cemented sands are present in some areas.

A site plan and geologic map summarizing the site geology is presented on Figure 1. A profile through one of the steepest portions of the slope is presented as Figure 2. We have assumed in this profile that the contact between the Terrace deposits and the Patuxent formation is horizontal. Soil sampling locations are also indicated on Figure 1.

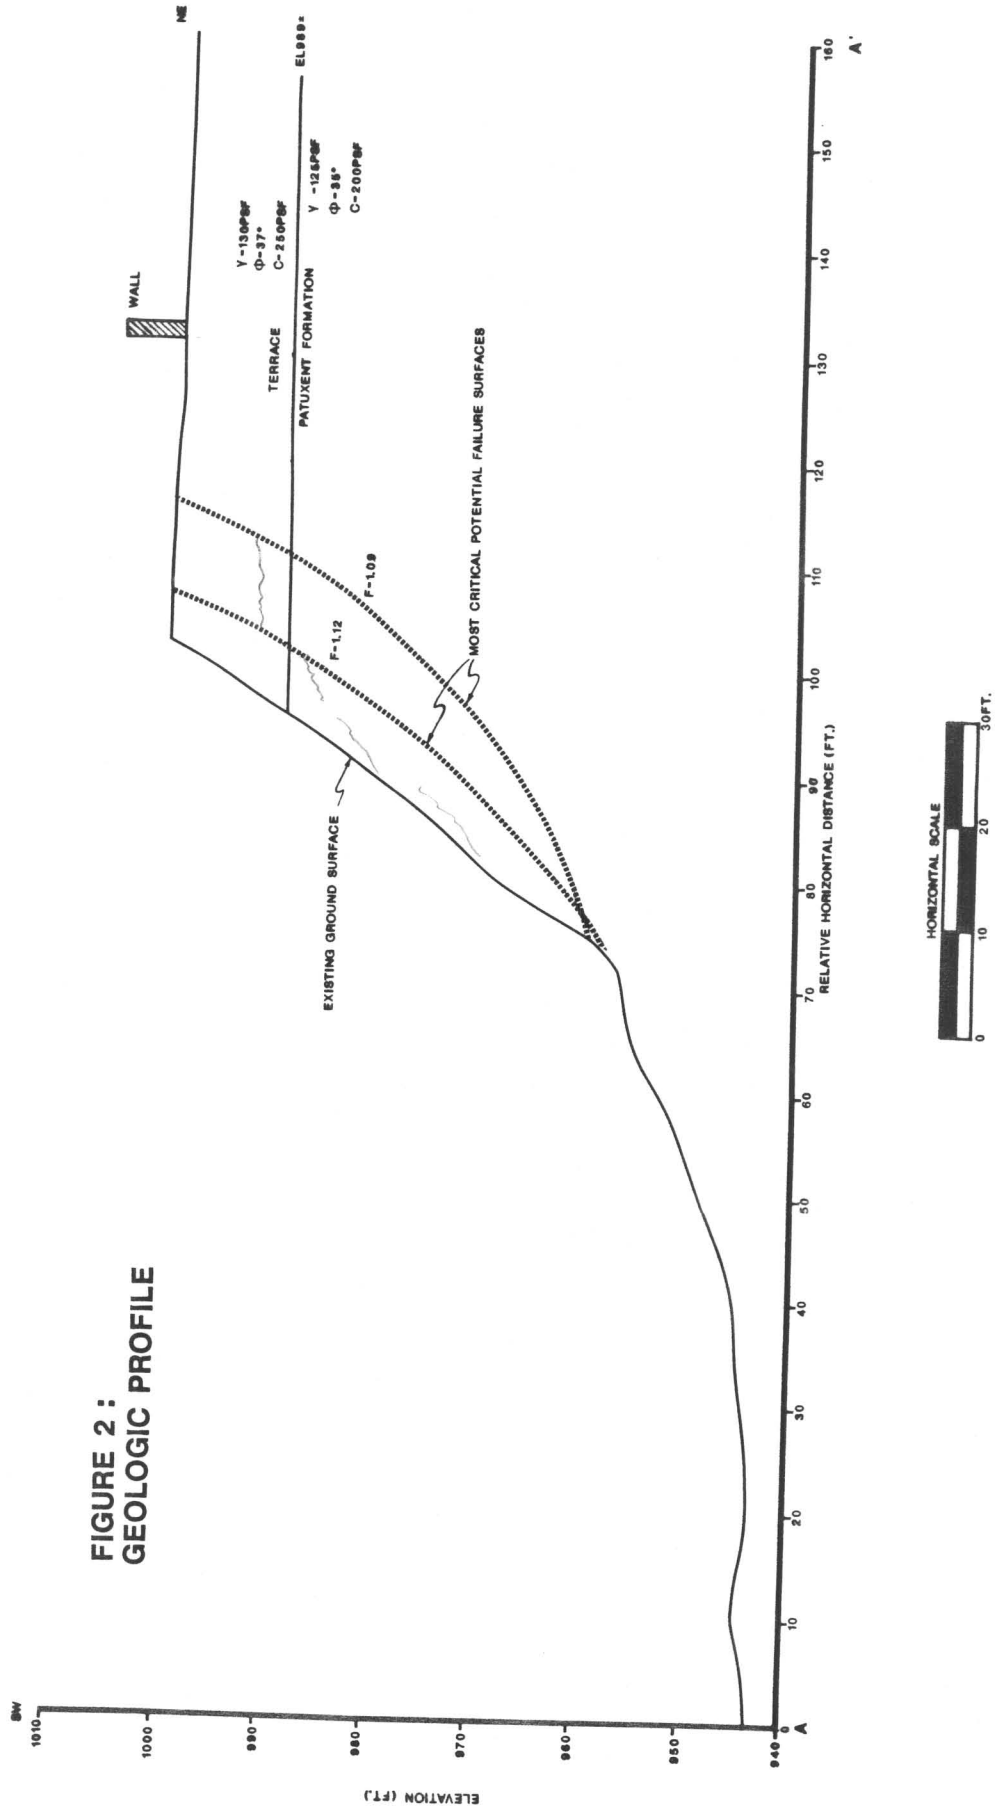
Normally for a permanent slope, we recommend a minimum factor of safety of 1.3. Our analysis indicates factors of safety of 1.09 and 1.12 for the two most critical potential failure surfaces. This indicates that the steeper portions of the slope have a lower factor of safety than would be considered sufficient for most long-term design purposes. However, since the slope has been standing for sometime and shows no signs of distress (other than the head wall erosion), it is our opinion that it will probably remain in approximately the present configuration for some time. This can be attributed somewhat to the dense vegetation on the slope that provides additional strength to the near surface materials and is not accounted for in the stability analysis. Headwall erosion will continue to occur, however, and will tend to gradually flatten the slope. Based on the analyses completed, none of the twenty most critical potential failure surfaces calculated extended to the cemetery wall. We believe, therefore, that there is a low potential for immediate damage to the wall or the cemetery from the slope even if it should fail. It should be noted that changes in the configuration of the slope, the addition of water to the slope or other factors could reduce the factor of safety and induce failure.
