# **BRIDGE INSPECTION REPORT**

OLD U.S. ROUTE 90 BRIDGE

STRUCTURE NO. 5320-002P

DATE OF INSPECTION: 3/26/03

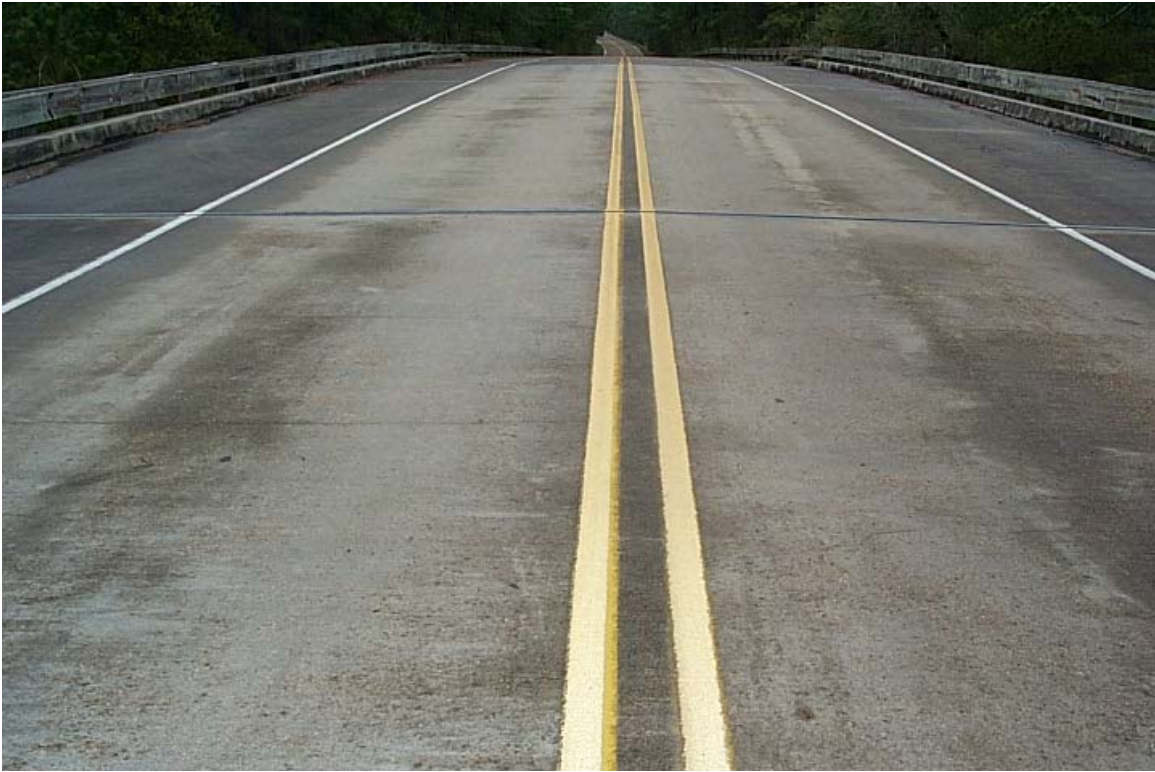
PHOTO #1 - GENERAL VIEW OF DECK (PHOTO FROM 3/20/01 INSPECTION REPORT)

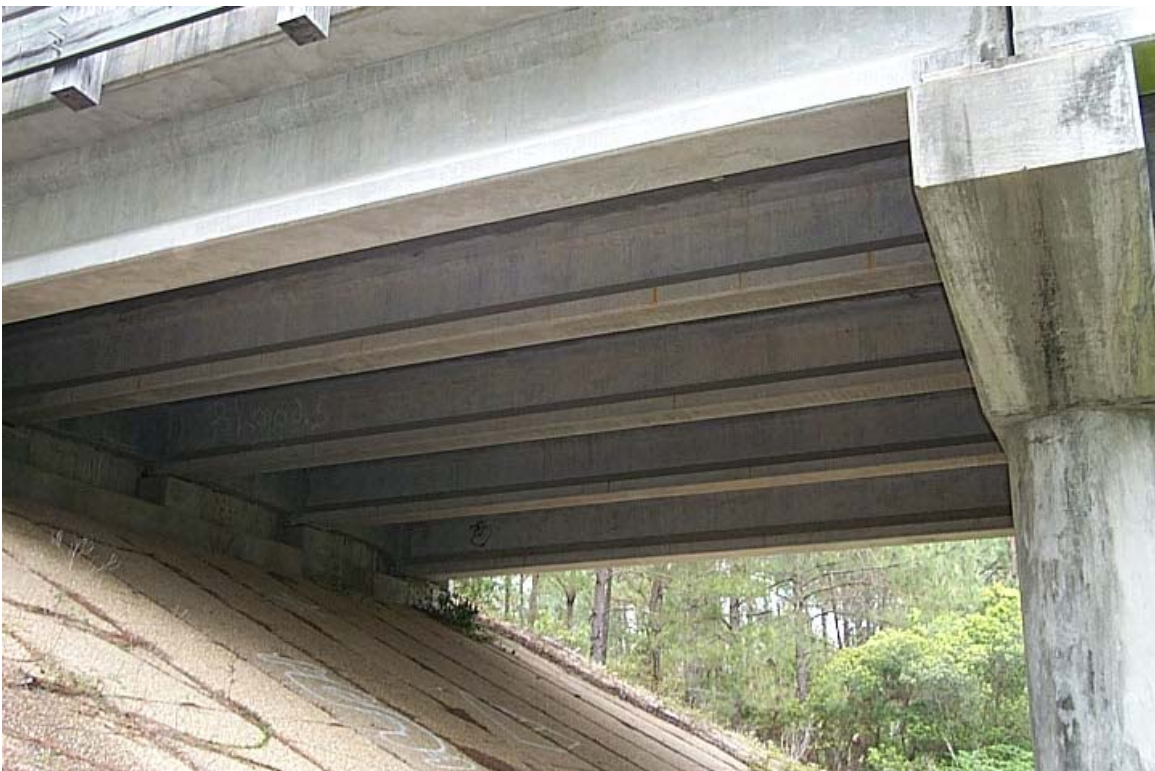
PHOTO #2 - UNDERVIEW OF NORTH SPAN

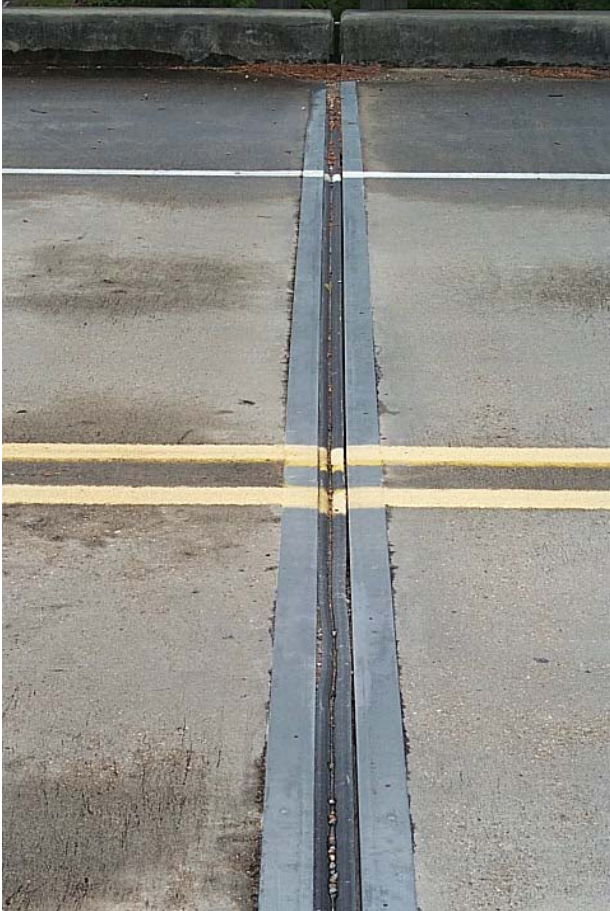
| 58. DECK | | 7 | ITEM REFERENCE AND REMARKS | |
|---|---|---|---|---|
| 2. EXPANSION JOINTS | F | | 58.2 | MODERATE ACCUMULATION OF SOIL AND GRAVEL IN DECK JOINTS, MAINLY AT SHOULDER AREAS. COMPRESSION SEALS IN DECK JOINTS ARE UNDERSIZED AND DO NOT COMPLETELY FILL JOINTS; THIS ALLOWS LEAKAGE THROUGH JOINTS ONTO BRIDGE ELEMENTS BELOW (SEE 60.1,3,15). |

PHOTO #3 - EXPANSION JOINT AT NORTH  
PIER (PHOTO FROM 3/20/01 INSPECTION  
REPORT)

| REC. NO. | ITEM NO. | MAINTENANCE RECOMMENDATIONS<br>(GENERALLY NOT FLHP ELIGIBLE) | PRELIMINARY COST ESTIMATES | |
|---|---|---|---|---|
| 1 | 58.2 | REPLACE EXPANSION JOINT COMPRESSION SEALS WITH LARGER COMPRESSION SEALS (SEE REMARKS BELOW). | \$5,000 | \$10,000 |

New compression seals must be large enough to completely fill expansion joint gaps under low temperatures.

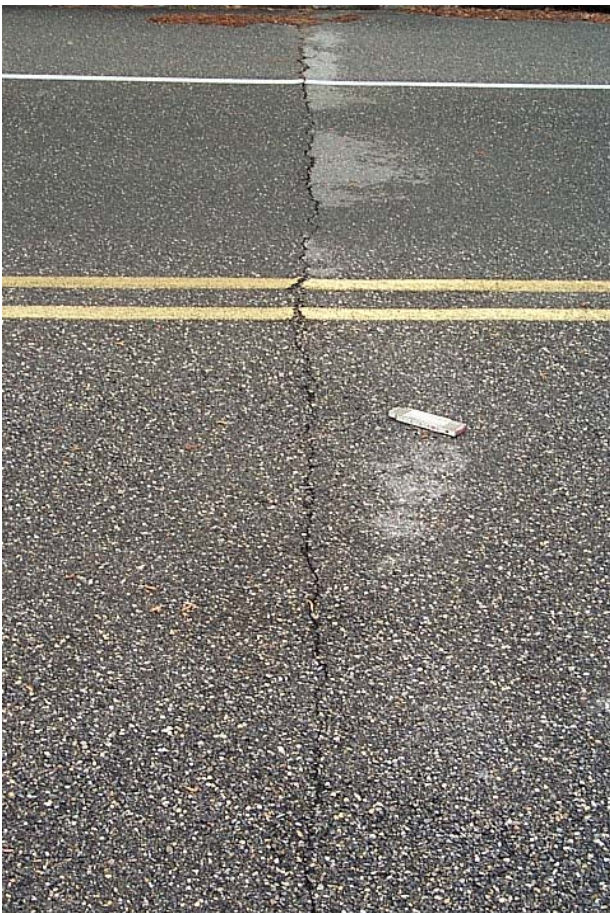
PHOTO #4 - TRANSVERSE CRACKING OF  
ASPHALT AT SOUTH APPROACH (PHOTO  
FROM 3/20/2001 INSPECTION)

| REC. NO. | ITEM NO. | MAINTENANCE RECOMMENDATIONS<br>(GENERALLY NOT FLHP ELIGIBLE) | PRELIMINARY COST ESTIMATES | |
|---|---|---|---|---|
| 3 | 222.4 | SEAL TRANSVERSE CRACKS IN APPROACH ASPHALT LEVELING COURSES WITH AN APPROVED SEALER. | \$1,000 | \$2,000 |

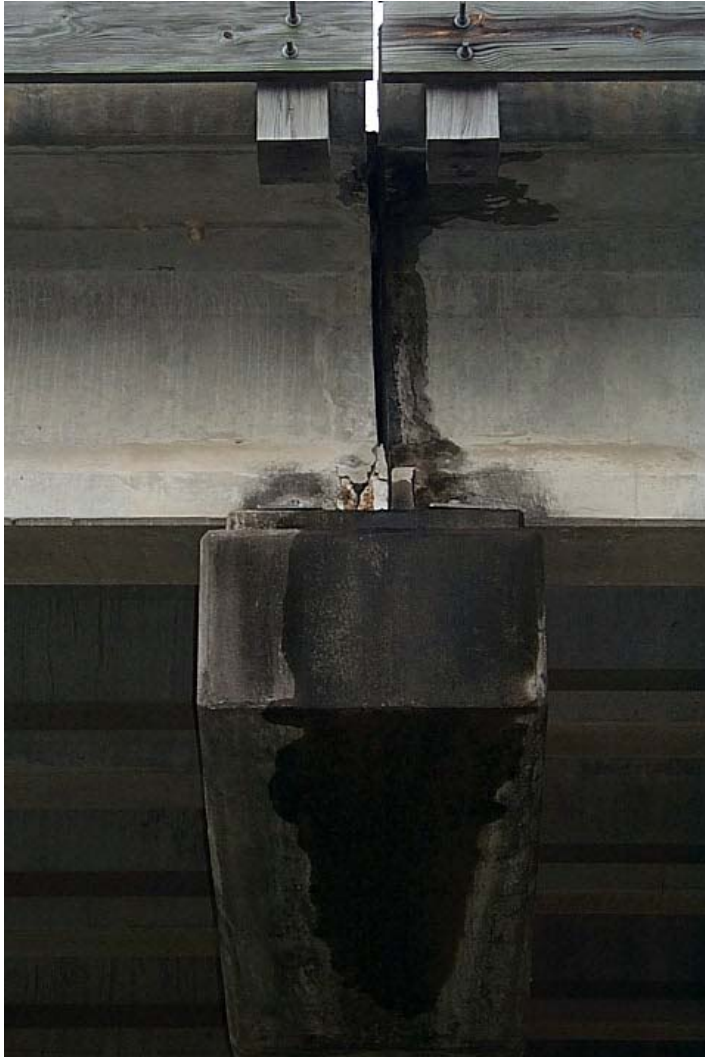
| 58. DECK | | 7 | ITEM REFERENCE AND REMARKS | |
|---|---|---|---|---|
| 7. DRAINS AND DRAINAGE | F | | 59.2, 60.15 | MINOR STAINING OF ENDS OF EXTERIOR BEAMS AND PIER CAPS AT JOINTS. MINOR SPALL AT NORTH END OF BEAM #1 (WEST EXTERIOR BEAM) AT NORTH ABUTMENT. MINOR SPALL AT END OF BEAM #5 (EAST EXTERIOR BEAM) OVER NORTH PIER. |
| 8. UTILITIES | N | | 60.1,3,4,15 | MINOR CRACKING AND EFFLORESCENCE ON SOUTH ABUTMENT BREASTWALL AT PEDESTAL FOR BEAM #4. MODERATE TO HEAVY STAINING OF ABUTMENT CORNERS AND PIER CAP ENDS DUE TO RUNOFF THROUGH DECK JOINTS. |

PHOTO #5 - NORTH PIER, EAST SIDE; NOTE MINOR SPALL AT END OF BEAM AND STAINING OF PIER CAP (PHOTO FROM 3/20/01 INSPECTION REPORT)

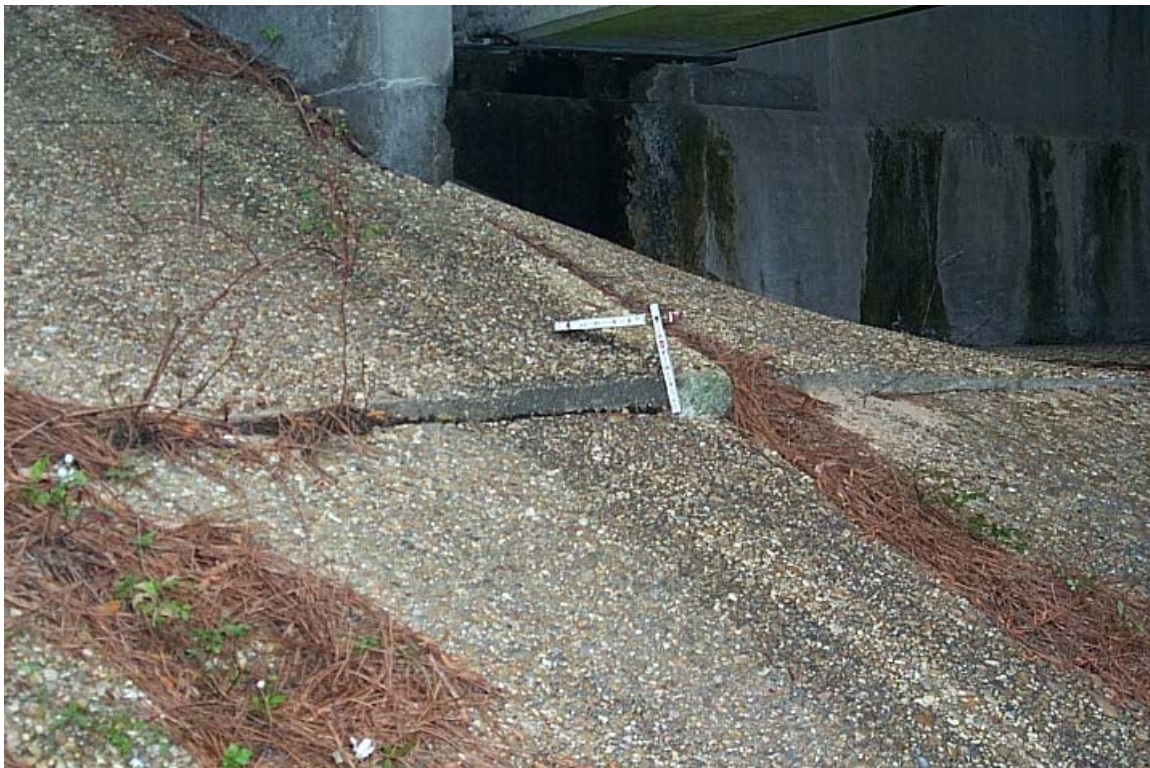
The concrete slope paving has settled considerably and has vegetation growing from the joints and weep holes. The vegetation should be removed. The settlement will continue to be monitored.

| 58. DECK | | 7 | ITEM REFERENCE AND REMARKS | |
|---|---|---|---|---|
| 9. DEFLECTION AND/OR VIBRATION | G | | 60.7,11 | MODERATE SETTLEMENT OF SLOPE PAVING BLOCKS. MODERATE ACCUMULATION OF DEBRIS AND VEGETATION GROWTH ALONG SIDES OF SLOPE PAVING; MINOR VEGETATION GROWTH IN SLOPE PAVING WEEP HOLES AND JOINTS. |

PHOTO #6 - SETTLEMENT OF SLOPE PAVING AT EAST SIDE OF SOUTH ABUTMENT (PHOTO FROM 3/20/01 INSPECTION REPORT)

| REC. NO. | ITEM NO. | MAINTENANCE RECOMMENDATIONS<br>(GENERALLY NOT FLHP ELIGIBLE) | PRELIMINARY COST ESTIMATES | |
|---|---|---|---|---|
| 2 | 58.7,<br>60.7,11 | REMOVE DEBRIS FROM CURBLINES AND INLETS. REMOVE VEGETATION FROM SLOPE PAVING WEEP HOLES AND JOINTS. | \$2,000 | \$4,000 |
