# Floyd Bennett Field Coastal Restoration Plan

Preliminary Report by Rip Kirby, Geologist in Park

August 16, 2006

**Subject:** Preliminary Assessment of Floyd Bennett Field Coastal Restoration Grant Application and Shoreline Erosion Problems

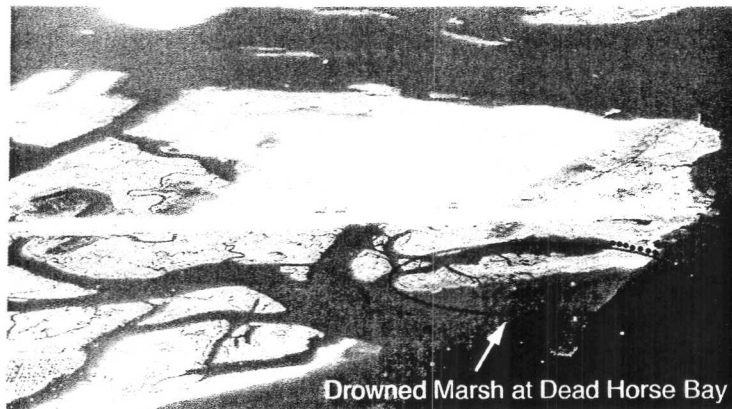
This is a long, scarped sand dune ridge trending NW-SE that is heavily vegetated along the top. Evidence of recent events that created severe undercutting, slump, and erosion is present. Dead Horse Bay is no longer an embayment, but rather it is a deeper slough flanked by the scarped dune line on the east and a drowned marsh on the west (Fig. 1).

**Figure 1.** This circa 1933 image of Floyd Bennett Field shows Dead Horse Bay before the marsh was submerged due to erosion of the marsh sediments supporting vegetation. The dotted line represents the current shoreline.

There may be an ACE sponsored study underway to assess the feasibility of renourishing the Dead Horse Bay coastal marsh. Research is still pending on the status of this ACE sponsored study. Such a project would likely require several million cubic meters of sediment for fill, hundreds of thousands of plantings of salt marsh vegetation, and most likely involve the installation of a sediment erosion barrier that would prevent a recurrence of the loss of this marsh habitat.

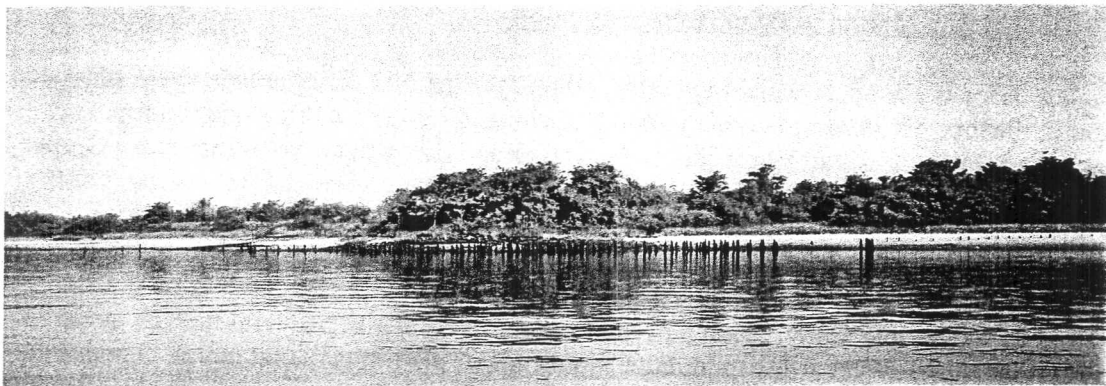
This is a set of two crescent beaches created by the headlands of the Dead Horse Bay point, the old ferry landing area, and the bridge trestles immediately offshore. The old ferry landing area contains tar deposits poured onto the shoreline immediately around the ferry pilings in the swash and tidal zone. These tar deposits are still emitting volatile organic compounds (VOC) easily detected by the human nose. This section of shoreline would be a candidate for a soft shoreline design with a seaward terminus at the line of the old pilings which marks the beginning of steeply descending bottom leading to the edge of the dredged channel maintained by the ACE.

**Figure 2.** Candidate shoreline for soft shoreline design. This is the area where coal tar is present on the shoreface at the old ferry-landing site.

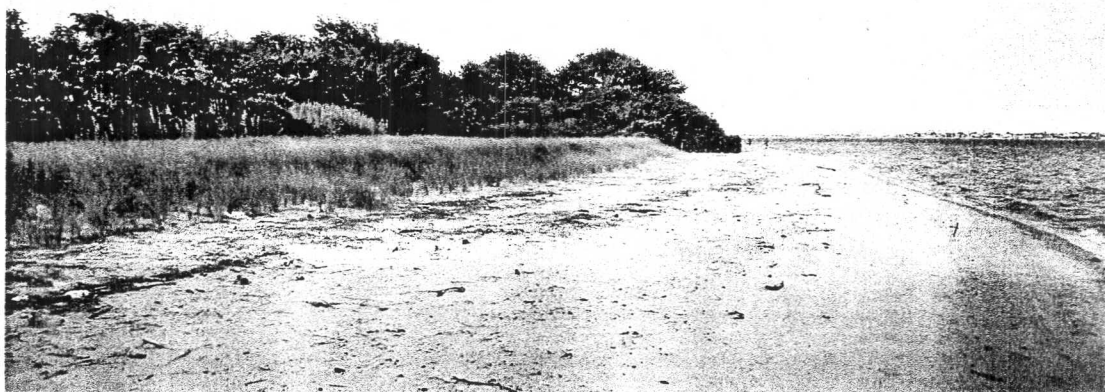
This corner displays an excellent example of what the shoreline would resemble with the SSP removed and no structure added to prevent erosion of the current shoreline boundary (Fig. 3). It is estimated that the back beach extends 50 meters shoreward with another 25-30 meters of upland terrain that is affected by infrequent high water associated with high-energy wave events. In total, some 75-80 meters of upland terrain and habitat would be converted to coastal shoreline habitat without the presence of the SSP shoreline structure or some replacement that defined the landward limit of an erosional boundary of some type.

**Figure 3. Transition to the SSP bulkhead is shown on the right side of the image. A transitional back beach environment is present without the bulkhead.**

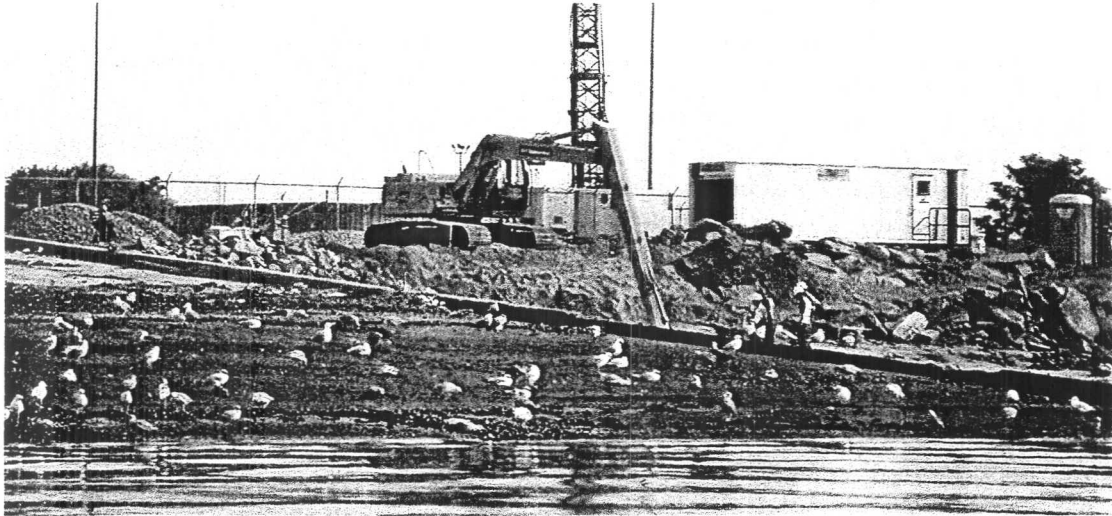
This project is currently underway. The project involves cutting the SSP at the mud line, shaping the shoreface to grade, laying sediment filter cloth, and covering that with successive layers of gravel, rock, and armor stone (Fig.4). This creates a hardened

**Figure 4.** Emplacement of armor stone on the graded slope is underlain by filter cloth to prevent sediment washout through the armor stone face.

The cost for the DoN project was \$3,064,284.00 or \$2,553.57 per foot. A similar expense should be expected for all extensions of this armor stone shoreline solution. Public access walkovers or boardwalks installed above this armor stone would add to the cost of implementing such a solution.

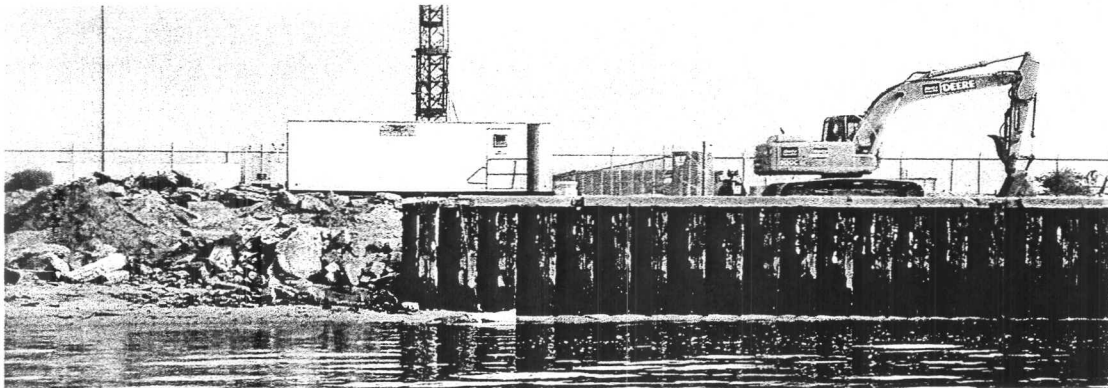
**Figure 5.** Removal of the SSP is done with an articulated bucket on a tracked excavator that grabs the exposed piling and bends it back and forth until metal fatigue allows failure of the uncorroded steel core. At low tide, a crew cuts the remaining stub flush to the mudline using a cutting torch.

Removal of the corroded SSP material is not a job that can be done by NPS maintenance personnel as suggested by one critique comment in the grant rejection letter. It requires a tracked excavator with an articulated bucket to grab the exposed SSP and wiggle it back and forth until it breaks off. The broken material is then removed by this

same hydraulic machine. At low tide, a crew cuts the remaining exposed SSP at the mudline grade with a welding torch. The cut pieces can weigh up to 350 pounds and the scrap is piled for pick up by the tracked excavator after the exposed SSP has been trimmed to grade by the torch crew.

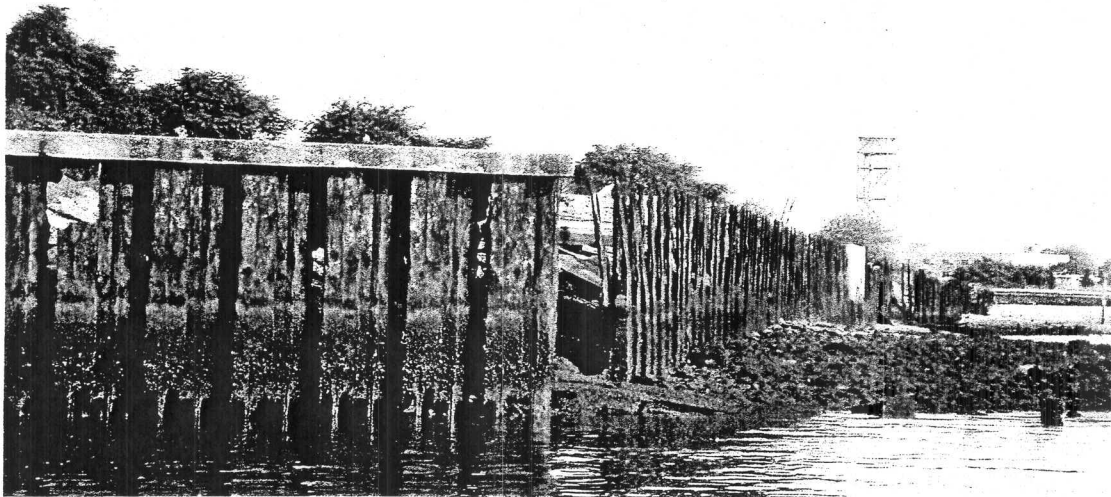
Currently, this stretch of shoreline is a conglomerate of three owners, the USMC, NPS, and NYPD. The DoN shoreline restoration project terminates before reaching the end of the USMC property. Therefore, any continuation of this hardened shoreline will need to be coordinated with the USMC. From the end of the USMC property to the beginning of the NYPD property is NPS land. It is also a high-energy shoreline as is the USMC shoreline that was not included in the DoN shoreline restoration project (Fig. 6). All this shoreline would require a hard shoreline design compatible with the terminus of the DoN shoreline restoration project. If the terminal end of the DoN shoreline restoration project is not mated to future shoreline solutions designed to handle the high energy nature of this stretch of shoreline, extensive erosion along and possible failure of the terminal end of the DoN armor stone shoreface will likely occur within a decade.

**Figure 6. This corner of the shoreline is an erosional hot spot due to the high energy of the corner design. The failure of the SSP bulkhead allowed erosion of the backfilled area behind the bulkhead.**

In addition, failure to address this stretch of shoreline in a timely manner will result in several hundred feet of erosion on NPS property in less than a decade as the

DoN project will create a sediment starved condition immediately updrift of the NPS property. This condition will impact the NPS shoreline much more severely than the NYPD shoreline because the NYPD shoreline has been reinforced with rubble placed in front of the SSP bulkhead. This rubble has allowed the SSP to retain its concrete cap and tieback rods. Corrosion of the SSP, while present, is not as severe as the other sections of the SSP bulkhead because of this maintenance action to minimize erosion.

If a hard shoreline design, such as continuing the armor stone along the current SSP line is implemented, it is likely that sediment will accumulate or can be placed in front of the armor stone and planted with saltmarsh vegetation in the tidal zone. Use of walkovers or boardwalks would enhance the public use of this stretch of shoreline that is currently underutilized due to the poor access and safety issues associated with the danger posed by transiting the corroded SSP bulkhead. Local fishermen use this shoreline to fish during flood tide conditions. During low tide conditions, a few people can be seen digging for clams and other baits that live in the exposed tidal flat.

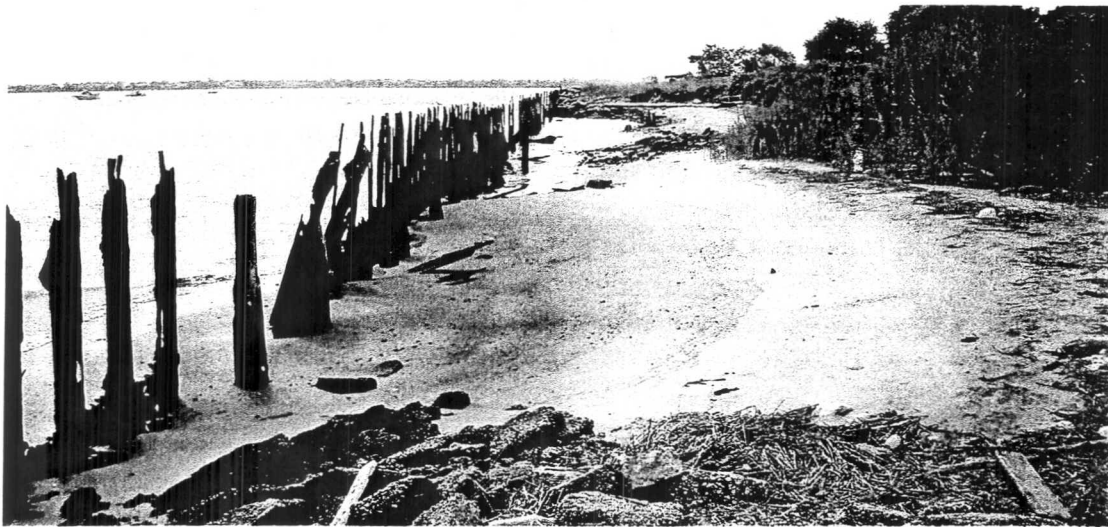
**Figure 7. Looking south toward the hot spot corner shown in Fig. 6. This section could be designed to resemble a soft shoreline design by utilizing buried structure and other submerged sediment traps to prevent sediment deposition in the dredged channel just offshore.**

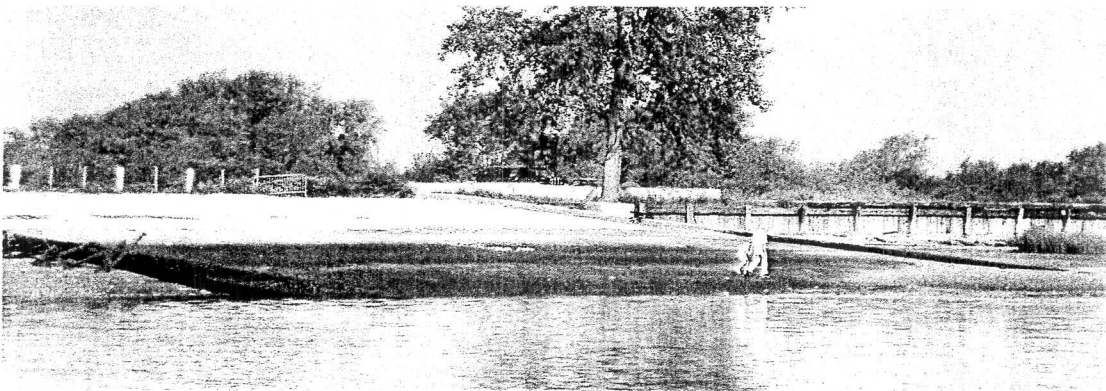
The wooden bulkhead is interrupted by the seaplane ramp that acts as a jetty-like obstacle to sediment flowing north along this section of shoreline. This is evident by the impoundment of sand on the updrift (southern) side. On the downdrift side of the seaplane ramp, sediment is being eroded.

The presence of an outflow drainage culvert approximately 75 meters north of the seaplane ramp provides a source of sediment from rain events that flush loose sediment from the uplands area into the storm water drainage system that empties here. This is evident from the small digitate delta formed from this outflow culvert sediment source. Sediment is then moved downdrift towards a marsh that starts at the northern terminus of the Hangar B parking ramp. The low tide flat is wider here than anywhere else along the FBF shoreline due to this sediment source.

**Figure 8. Looking north past the Hangar B seaplane ramp. Note the wooden bulkhead on the backshore. Sediment has accreted on the south side of the ramp indicating that longshore sediment drift is predominantly northward. Sediment accretion on the north side of the ramp is from the drainage culvert source.**

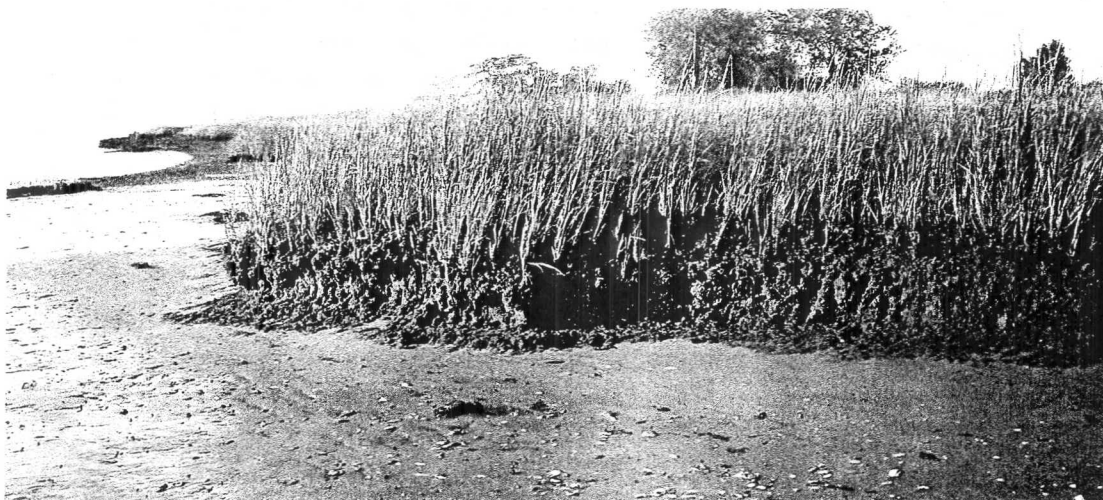
As noted above, the marsh habitat quickly becomes dominant as the influence of the bulkhead is eliminated at the sharp transition point defined by the terminus of the wooden bulkhead. The immediate impact is the growth of marsh grass (*Spartina*) on the mud flats created by the roots of old *Phragmites* and subsequently flooded by the transgressing waters of the Jamaica Bay proper. Concurrently located with this organic root and mud tidal flat substrate are tidal mussels of various species attached to the exposed *Phragmites* root structure and peat substrate. This habitat is supporting several species as evidenced by the numerous bird and small mammal tracks in the freshly exposed tidal flat mud along with the shells of tidal and marine organisms.

**Figure 9. Looking south from the mudflats in the salt marsh north of the end of the Hangar B parking ramp. The marsh grass sediment between here and the next wooden bulkhead to the north appears to be eroding along the face of the peat line.**

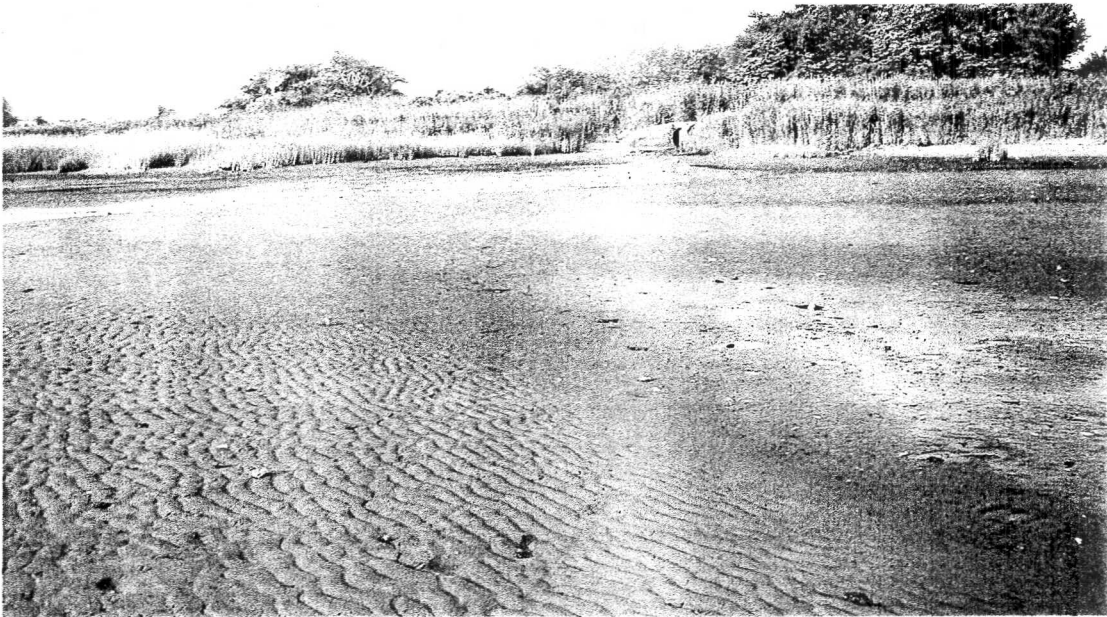
previous marsh habitat by the introduction of fresh water and sediment pulses associated with high-volume storm water discharges causing large erosional impacts. A long meandering sub-tidal creek extends from the culvert face to the low tide line. This drainage channel is approximately 200 meters long. The culvert opening is partially submerged during high tide.

**Figure 10. Fresh water discharging from this drainage culvert carries upland sediment. Vegetation growth in the drainage zone is inhibited by high volume storm water discharges and low salinity. Sediment from this drainage culvert is the main source of sediment being moved by the longshore drift in this section.**

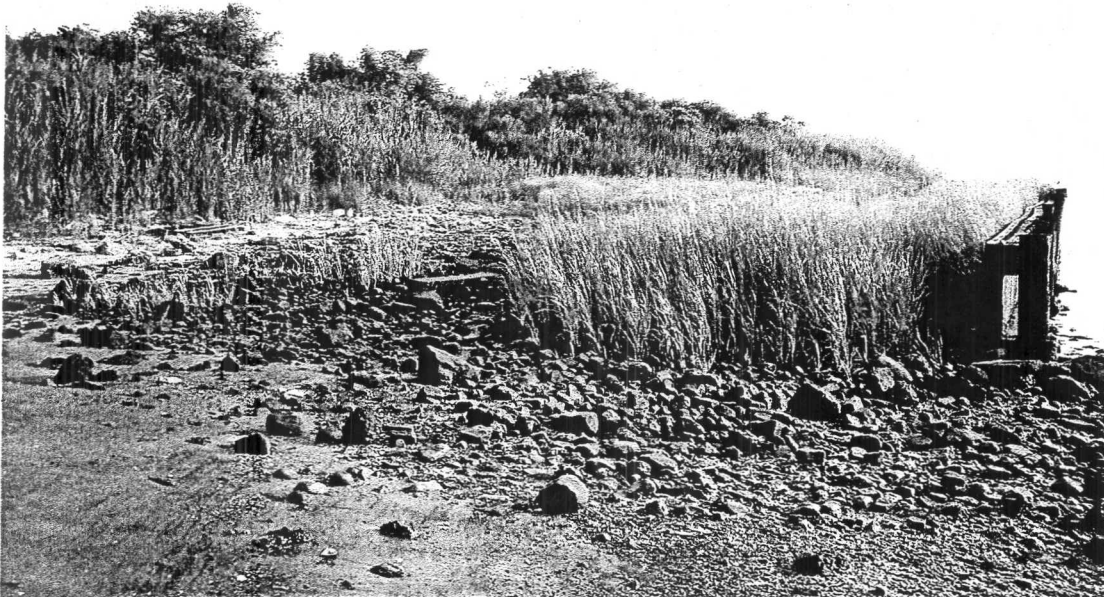
present that consists of cobble and gravel-sized material that is smooth and rounded. However, 15%-25% of the material is anthropogenic such as old brick, glass, and other building construction debris that has become part of this armor layer. This armor layer extends from the vegetation line above the high water level to the wooden seawall backface. Approximately 0.5 meters of the seawall backface is exposed due to the erosion of the subaerial sediment supporting the armor layer and its subsequent settling in place. As a result, the bulkhead is subject to tidal flooding. Several places along this bulkhead have been breached due to the deterioration of the wooden structure from tidal submersion and removal of sediment from the shore side of the bulkhead through erosion. In places where small tidal pools form next to the breaches, *Spartina* populations have taken root along the eroded backside of the wooden bulkhead.

**Figure 11. The backshore area behind the wooden bulkhead is tide dominated. Because the bulkhead maintains an elevated terrain behind it, *Spartina* is able to grow along the edges of the small tidal pools created by the bulkhead.**

The wooden bulkhead was constructed to protect the end of the runway that extends to the NE corner of FBF. This structure has deep water immediately offshore of the wooden bulkhead with varying depths. It was not possible to determine an average depth due to the presence of equipment supporting the Elders Point Marsh Restoration Project operating at the end of the runway area. The operation is dumping sand dredged from Rockaway Channel by ACE maintenance and transpumping this material via slurry pipe almost 2 miles to the Elders Point marsh island. Until this operation ceases, no work can be done on this bulkhead or shoreline.

Along this wooden bulkhead area, given the proximity of the paved runway surface about 80 meters away, the only solution for shore protection on this high energy

point is a hard shoreline solution such as armor stone, repair or replacement of the existing wooden bulkhead structure, or use of buried structure such as sediment baskets. In addition, it would require emplacement of sediment to the south of this bulkhead in order to prevent failure of the southern terminus from erosion due to tidal influence and wave action. The design may end up being a hybrid that uses a center point of hard shoreline structure flanked by a soft shoreline design employing buried structure.

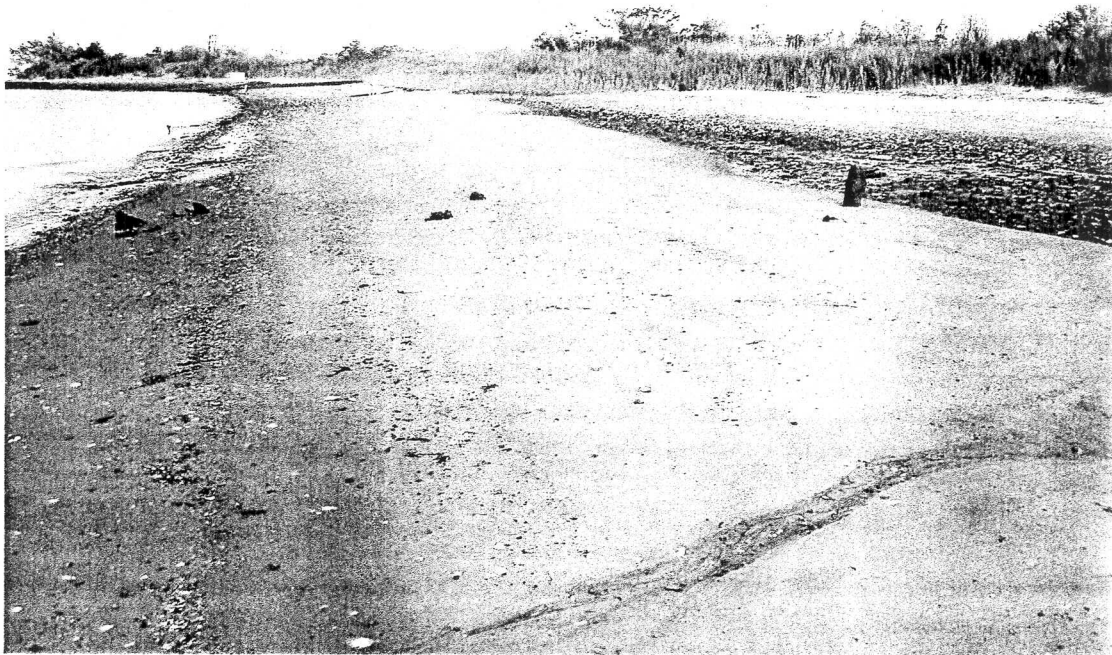
This northern shoreline of FBF has several variations on the erosional theme of previous shorelines. Like the south side of the wooden bulkhead previously discussed, a crescent beach is present on the west side due to erosion of the sand from the dominant longshore sediment transport to the west. This terminates at a wooden jetty approximately 800 meters to the west. Between this wooden jetty and the crescent beach, sand has accumulated and a tidal pond is present behind a small sand dune covered with *Spartina* along its crests and most of its flanks. The drainage channel from this tidal pond is migrating to the west. At times, the berm on this section of beach will dam up the tidal pond. Surface drainage accumulates behind this and when combined with a high tide event or heavy rain event, creates a breach event as ebb tide occurs.

**Figure 12.** Looking east along the northern shoreline of FBF. Note the crescent shape of the shoreface immediately west of the wooden bulkhead in response to the dominant westerly longshore transport. In the foreground is a classic ridge and runnel created by tidal drainage behind the sand bar exposed by low tide.

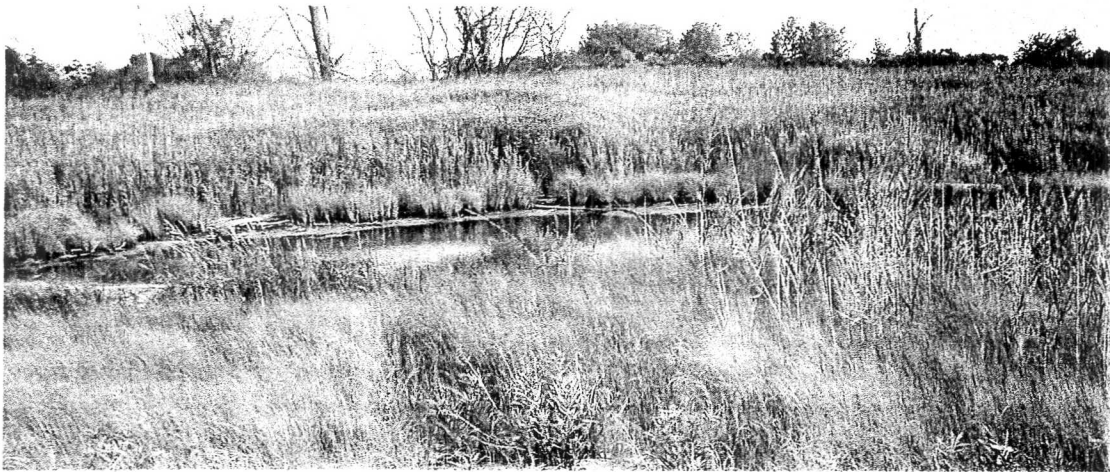
**Figure 13. This is the tidal pond behind the small sand dune north of this position. During low tide, this pond does not drain completely.**

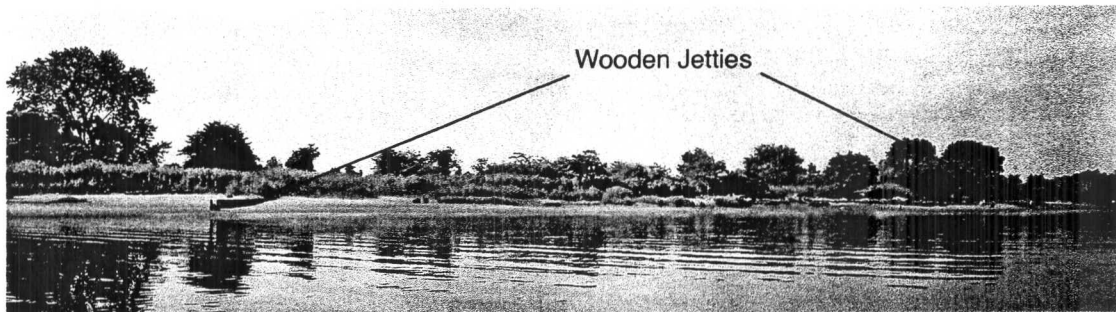
**Figure 14. Looking south from the channel leading to Mill Basin. The tidal pond in Fig. 13 is just outside the left side of this image.**

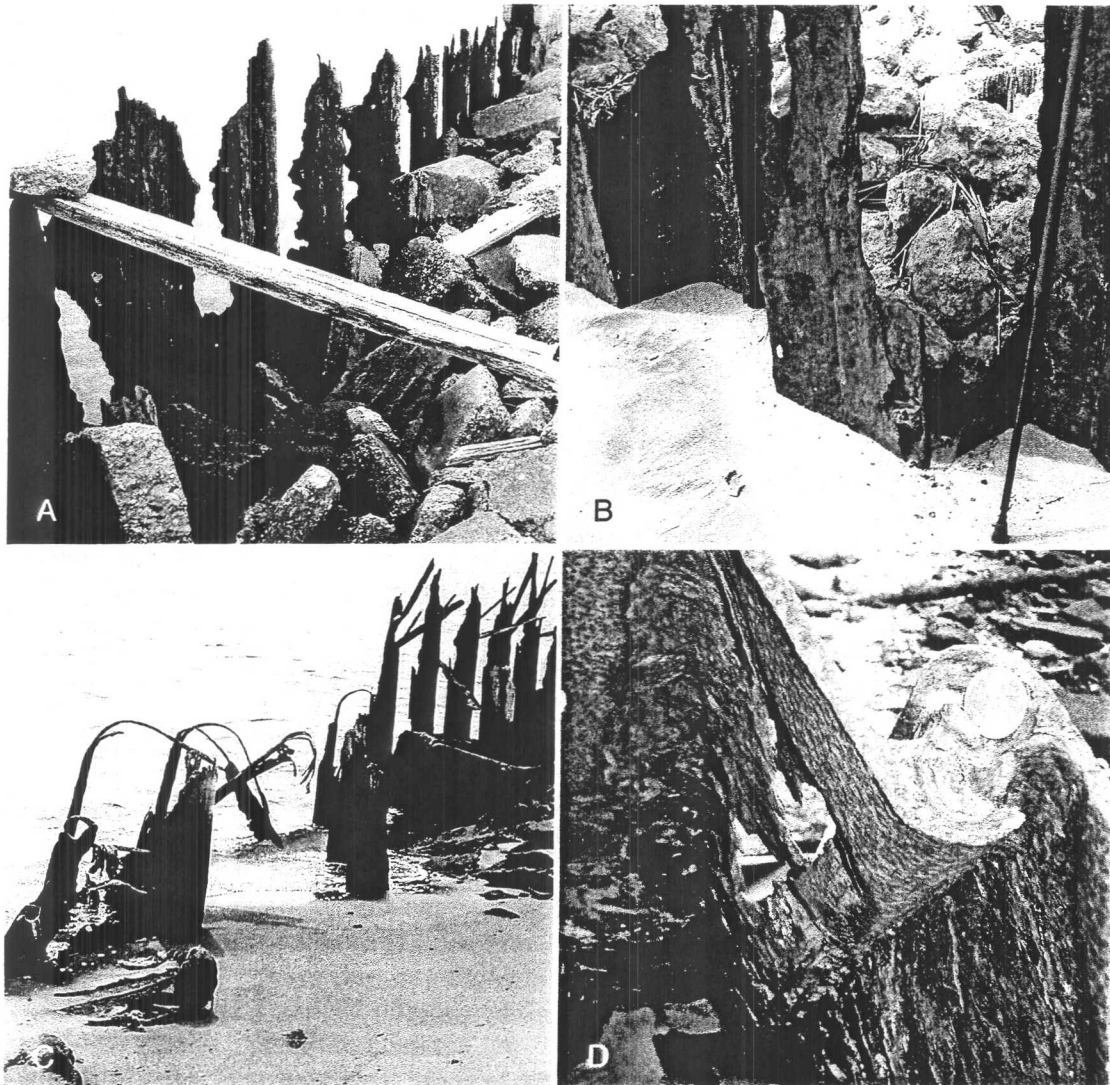
The steel sheet piling appears heavily corroded and frail with many sections curled over in apparent imminent danger of collapse if touched or tread upon. In reality, despite the highly corroded surface, the SSP is difficult to move and impossible to bend by hand or with manual effort. Small pieces may be wiggled back and forth until metal fatigue sets in and the piece breaks off in your hand, but most of the SSP is very sturdy, albeit highly corroded. Therefore, removal of the exposed, corroded steel sheet piling by hand is not an option. The SSP that appears curled and friable to the touch is metal that has been battered by large pieces of waterborne debris such as pilings, docks, and abandoned boats during high-energy storm events with large waves. The highly corroded SSP is the portion exposed to air and tidal flux.

The sheet pile is sunk to a depth of 28-30 feet. It originally was 40-foot Z planks approximately 3/8" thick. Below grade, the corrosion of the steel is not as bad as the tidal zone steel surface exposed to salt water and oxygen.

**Figure 15.** This is a series of images of different SSP sections. (A) Local fishermen often place driftwood planking on the vertical SSP to gain access for fishing. (B) Concrete and rock rubble has been placed behind the corroded SSP to reduce erosion. (C) Where rubble was absent, the SSP was bent from impact with storm driven debris such as drifting boats, docks, and other heavy floating material. (D) Note that the edges have corroded together like a weld. However, unlike a welded joint, this corrosion joint is not structurally sound.

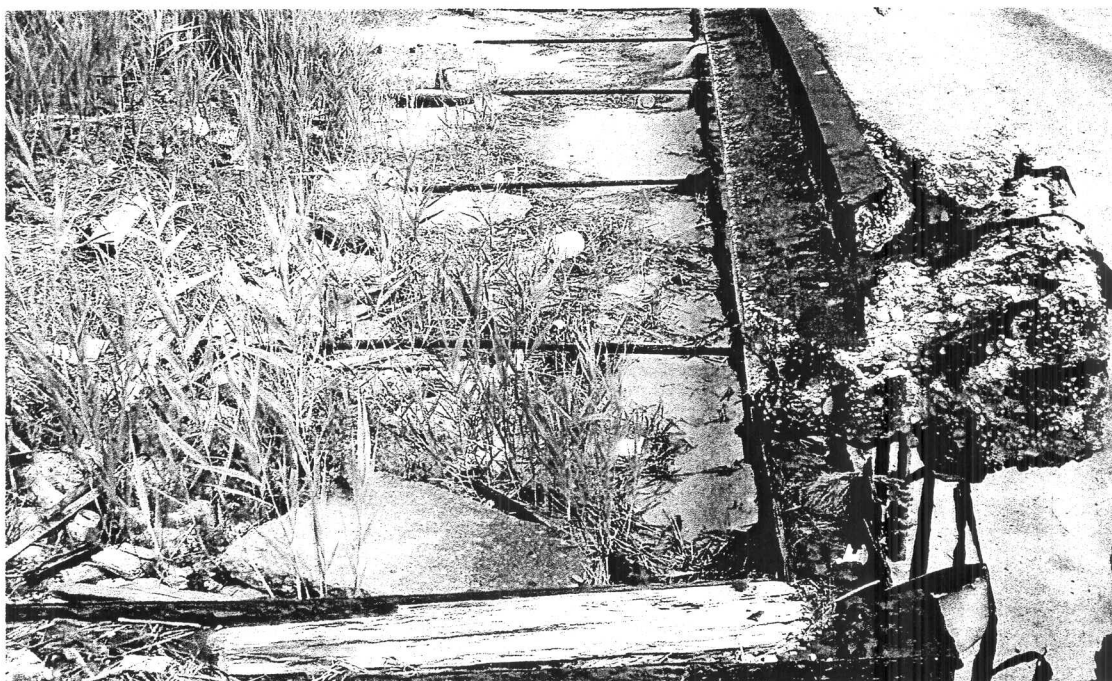
**Figure 16. The SSP originally was engineered against cantilever failure by using steel tie back rods. In all instances along the remaining SSP line, the steel tieback rods have failed due to corrosion.**

Once cut, the remaining subaerial sections of SSP, which originally had a cement cap and steel tieback rods to maintain vertical alignment, would be held in a vertical position only by the sediments on either side of the SSP and the corroded contact along each joint. One issue is the failure of the SSP to retain upland shoreface sediment if the subaqueous sediment (mainly mud) is scoured out by tidal flux and the erosional action of large boat and ships transiting the dredged channel immediately offshore of the SSP wall. Essentially the weight of the upland sediment would have a cantilever effect on the subaqueous surface of the SSP causing it to fail if sufficient scouring of bottom sediment facing the SSP surface occurred. Monitoring of the stability of the subaqueous SSP wall will be needed to ensure structural integrity of the armor stone shoreline is maintained.
