## Historic Structures Report

## HISTORIC STRUCTURES REPORT FOR HARBOR DEFENSE STRUCTURES

*Prepared for the*  
**United States Department of the Interior**  
National Park Service

**April 15, 2000**

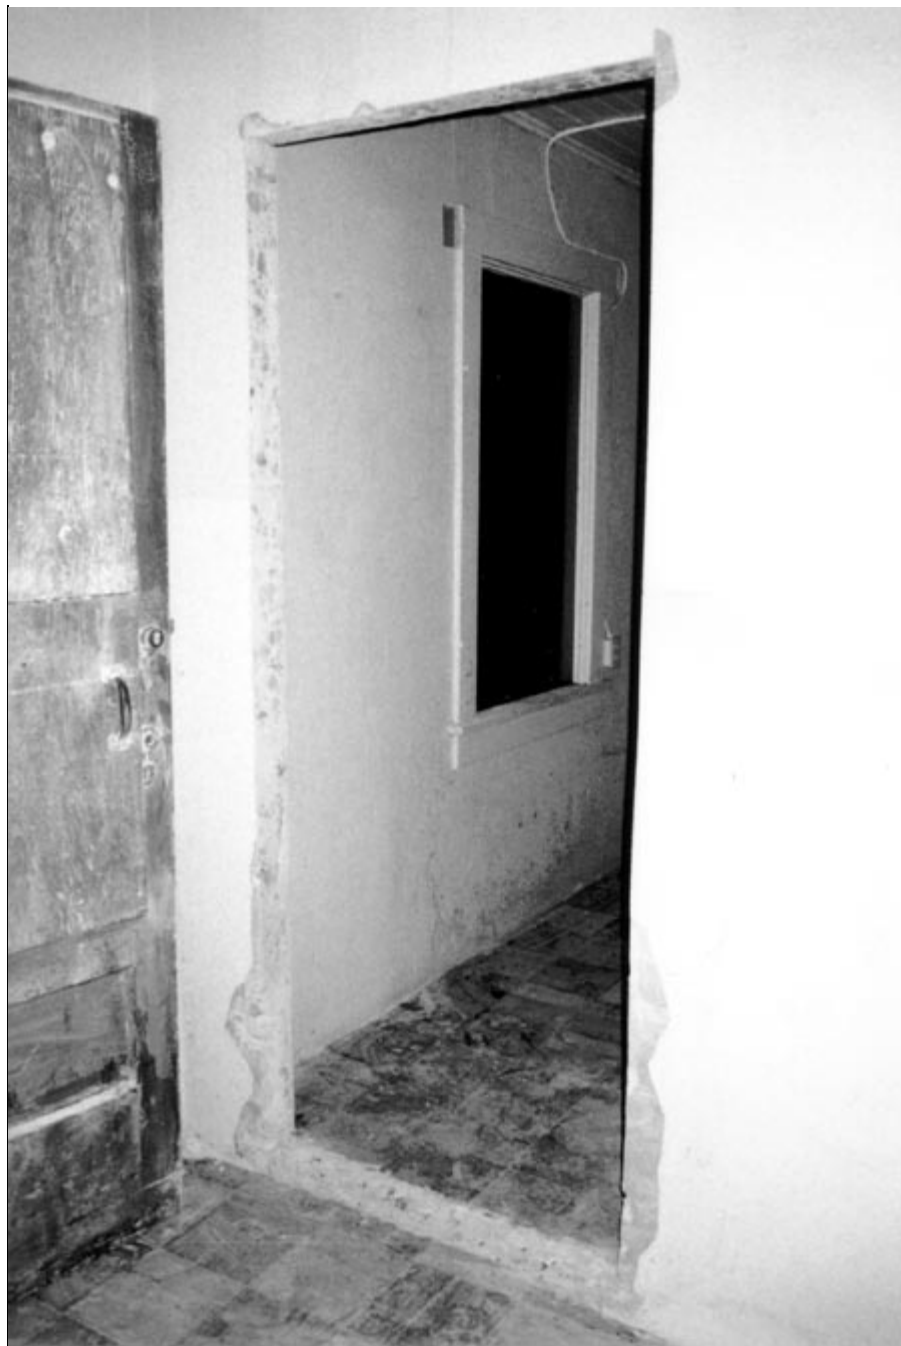
Figure 6. A non-original opening connects the Operating and Motor Generator Rooms.

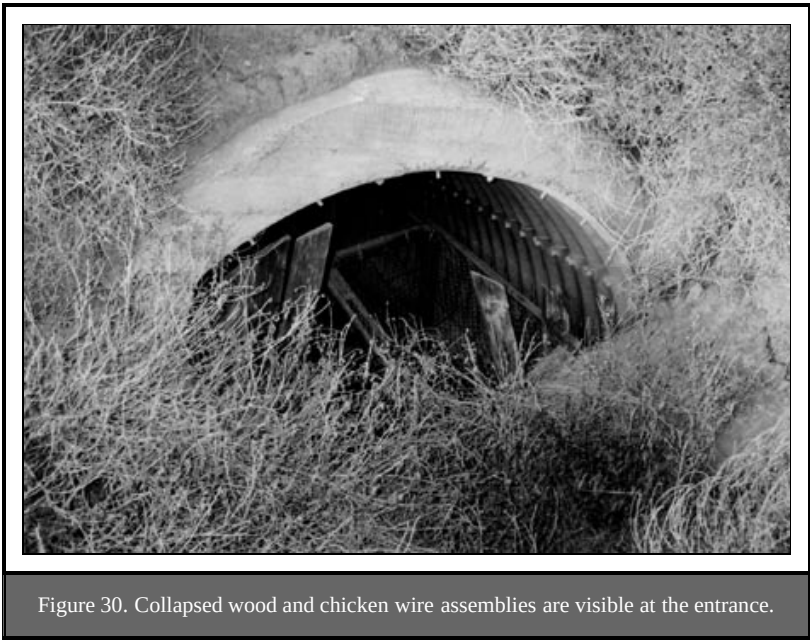
No major structural concerns were noted. The wood retaining wall at the north end of the south bunker at Guns 3 and 4 is decaying and does not appear to be well tied to the steel pipe. Several bolts or nuts that tie together the sections of the steel pipe at the reserve magazine structure are missing, however this is not serious. Sections of the concrete support for the wood bed frames have collapsed, however this does not affect the overall stability of the structure.

Figure 30. Collapsed wood and chicken wire assemblies are visible at the entrance.

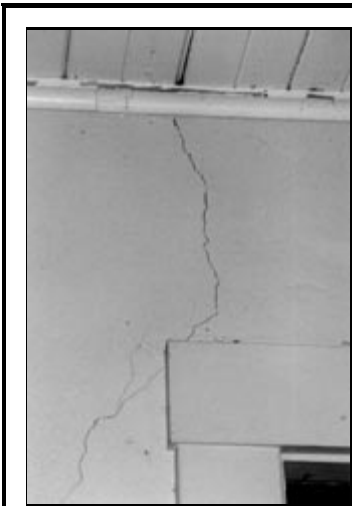
Figure 31. Concrete cracks at Army Radio Station headers.

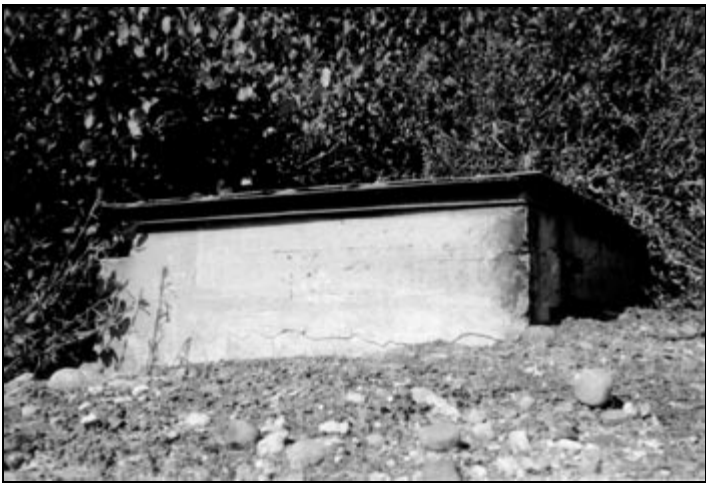
Figure 32. Concrete cracks at Base of Battery Calef & Wilkeson Base-End Station hatch.

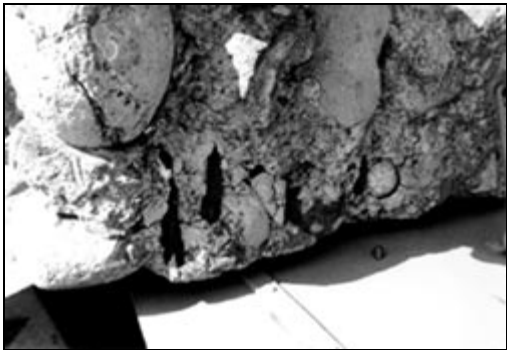
| Figure 33. Spalled concrete at Searchlight Shelter No. 15. | Figure 34. Missing corner and exposed reinforcing rod at lower Billy Goat Point Base-End Station. | Figure 35. Exposed reinforcing rod and post spalls at Calef & Wilkeson. |

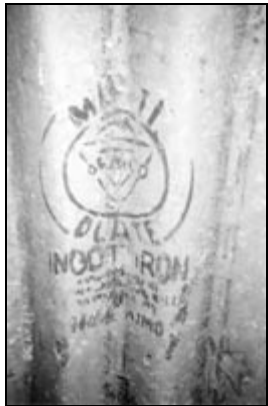
Figure 42. Graffiti on corrugated metal at Battery Point Loma Bunker Complex.

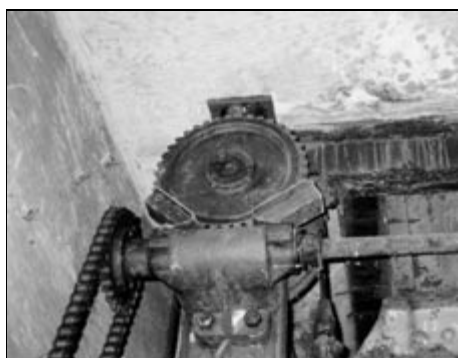
Figure 36. Coating failure and corrosion at Searchlight Shelter No. 15.

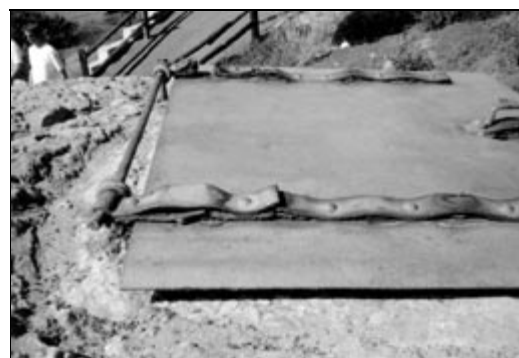
Figure 37. Metal corrosion of hatch at the Battery Commander Station, Battery Humphreys.

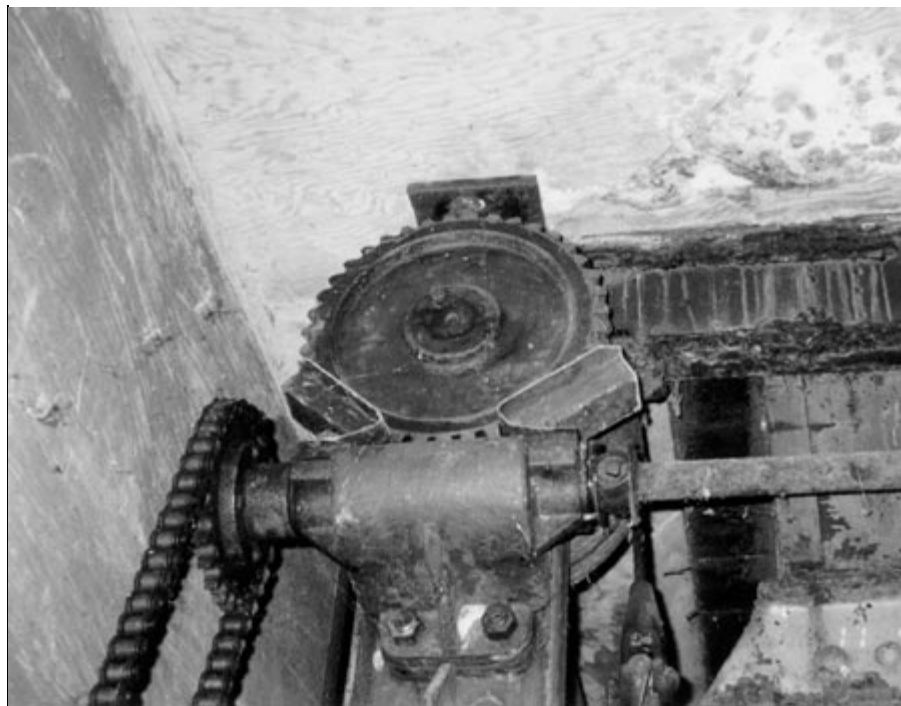
Also similar to Searchlight No. 19, the steel elevator platform and frame for the searchlight, and the steel roof cover, are corroded. For the most part, this appears to be primarily superficial and is unlikely to have compromised the structural capacity of the main steel members. However the capacity of the bolts and brackets connecting the members together may have been reduced significantly.

Figure 9. Interior view of the elevator platform operating mechanism.

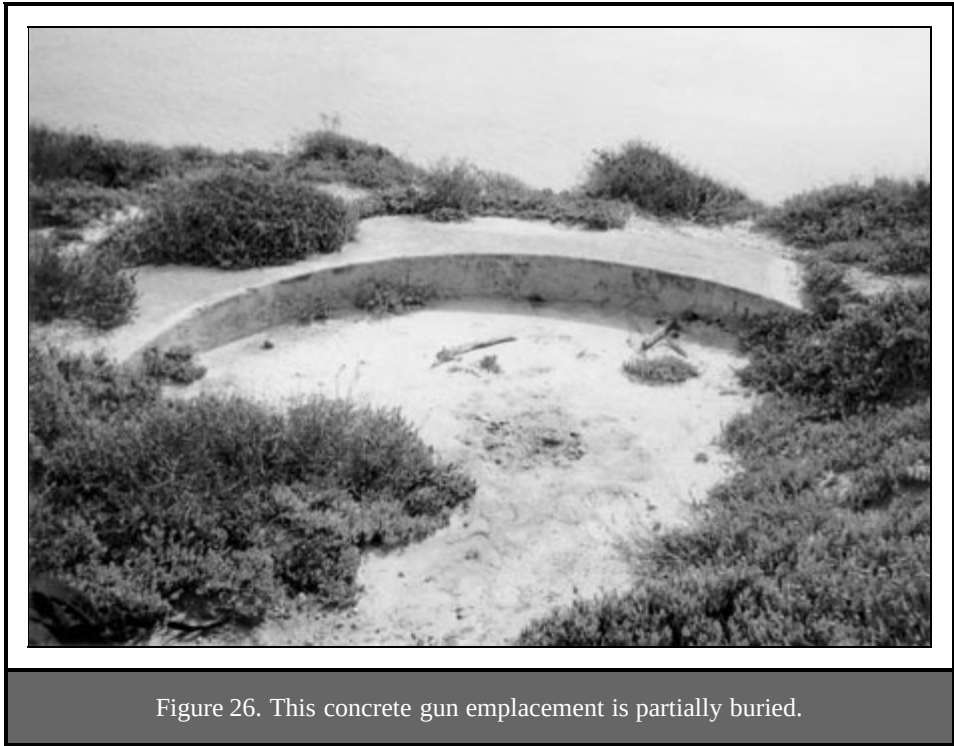
Figure 26. This concrete gun emplacement is partially buried.

The major concern associated with these emplacements is the stability of the cliff-top where they are located. The edge of the cliff is only two or three feet from the front of the north emplacement, and it is only a matter of time before the cliff erodes back to the face of the emplacement. The south emplacement is further back from the cliff-top, however it appears to have settled at the front side and is now slightly tilted. The concrete ring structures themselves are in reasonable condition, although the south emplacement has large circumferential cracks (up to one-half-inch wide) in the concrete.

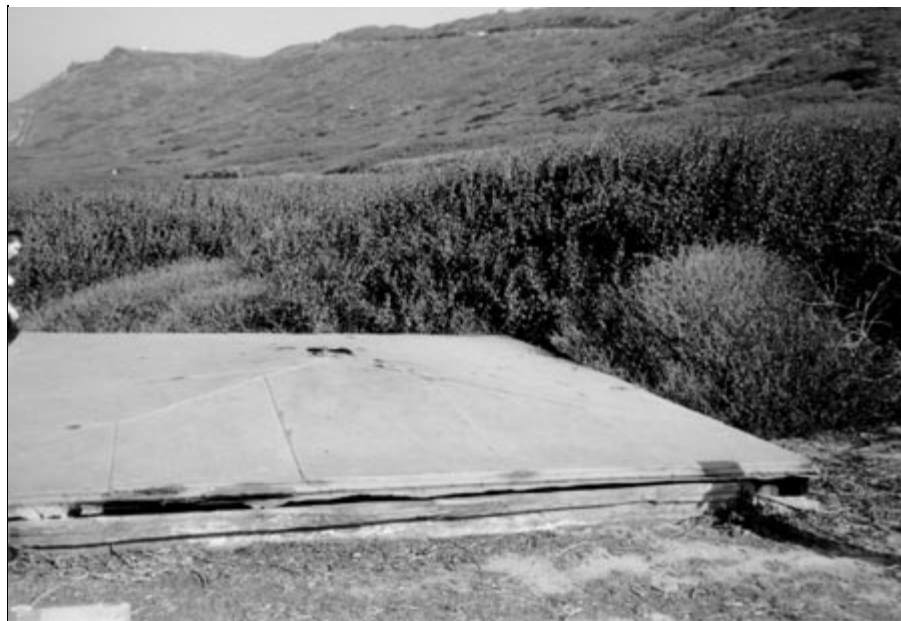
Figure 39. Deteriorated wood curb at Searchlight Shelter No. 15.

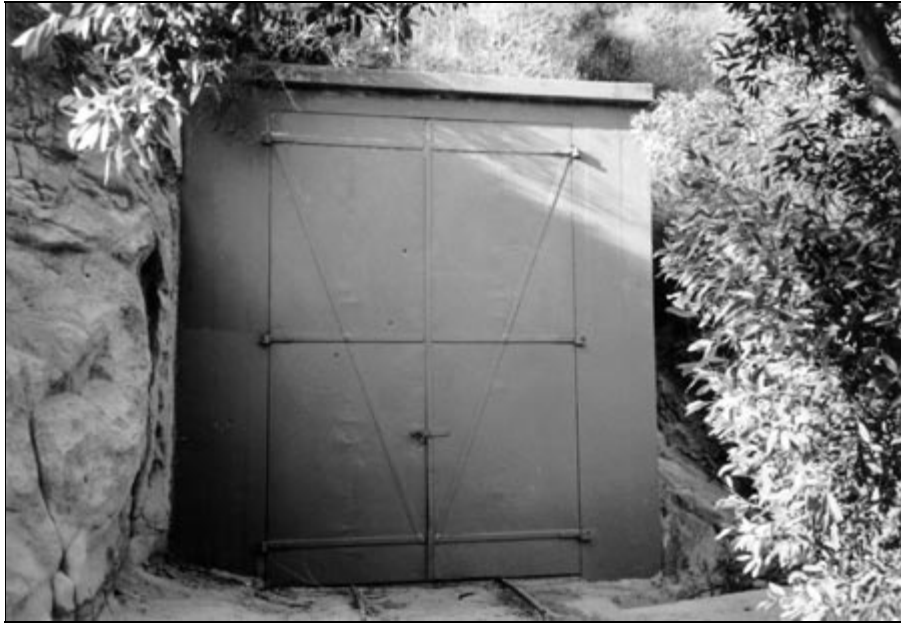
Figure 10. Originally 75-feet of narrow-gauge rail extended out, but only five feet remain today.

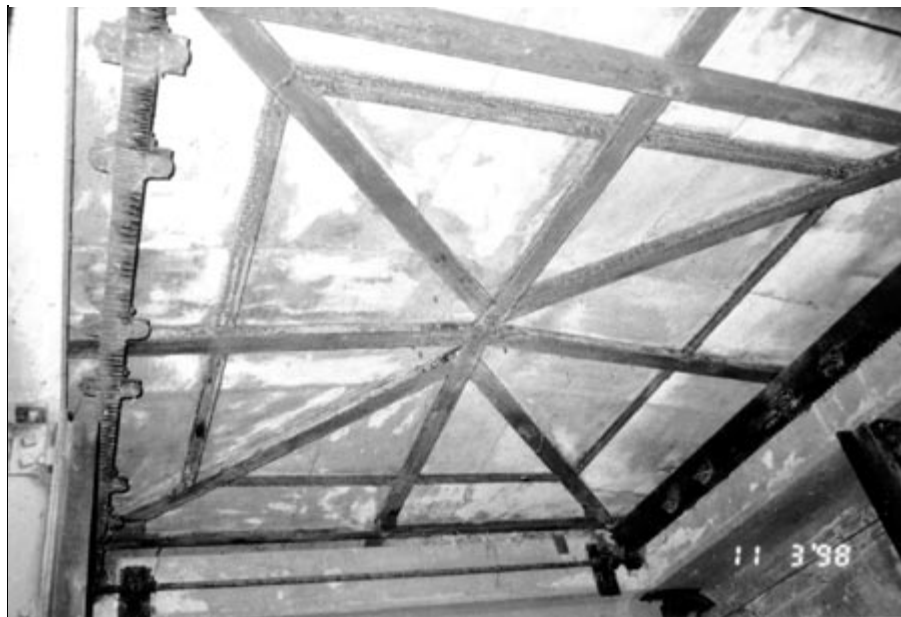
As noted above, the steel elevator platform and frame for the searchlight, and the steel roof cover, are corroded. For the most part, this appears to be primarily superficial and is unlikely to have compromised the structural capacity of the main steel members. However the capacity of the bolts and brackets connecting the members together may have been reduced significantly.

Figure 13. The underside of the elevator platform viewed from the pit.

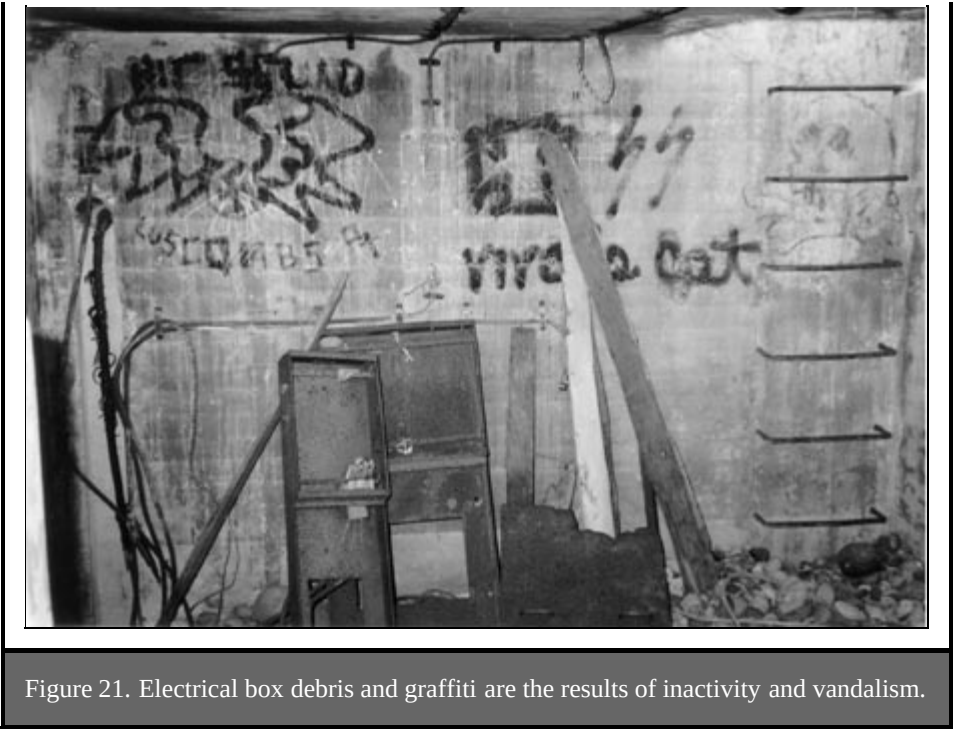
Figure 21. Electrical box debris and graffiti are the results of inactivity and vandalism.

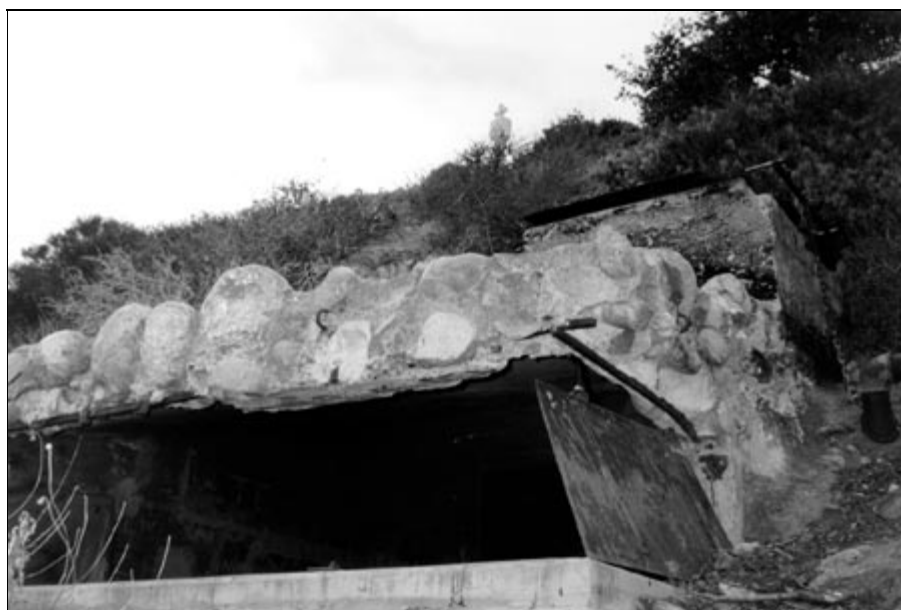
Figure 16. The missing metal observation slot shutters are located inside this structure.
