# Weather station maintenance in Southwest Alaska Network parks

*Summary for the 2011 hydrologic year*

Natural Resource Data Series NPS/SWAN/NRDS—2011/196

Chuck Lindsay

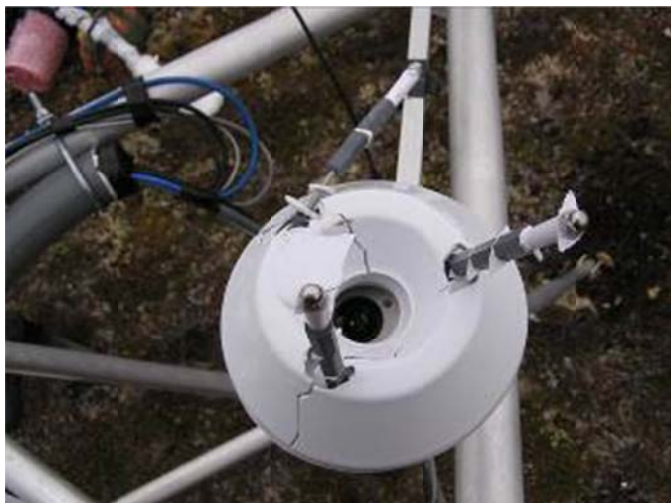
**Figure 6.** AT-RH sensor was destroyed (Contact Creek RAWS).

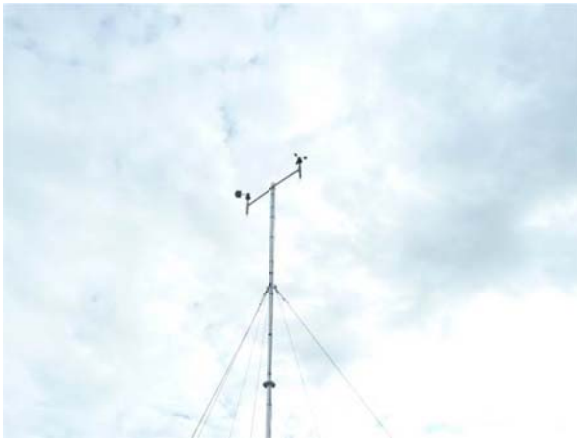
**Figure 13.** The tail (fletching) had broken off the wind direction sensor (Fourpeaked RAWS).

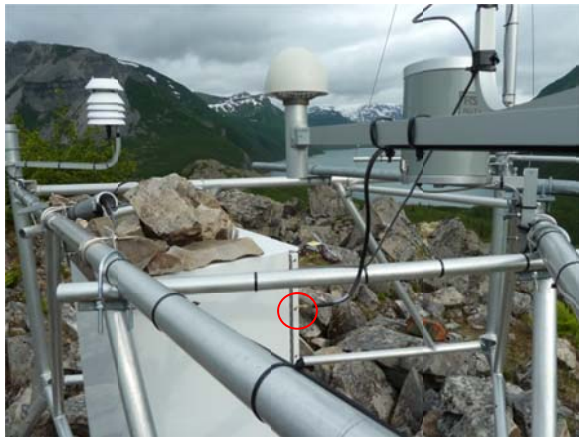
Scheduled maintenance also called for battery replacement. Initial inspection of the weather station showed that the GPS antenna had bite marks and that the GPS antenna cable had been cut (Figure 16). The GOES antenna, WS sensor, and SD sensor cables also looked like they had been damaged, but were not cut. There was some damage to the plastic shielding on the AT-RH sensor (Figure 17).

**Figure 16.** The GPS antenna cable was cut (circled) and there were bite marks on the GPS antenna (Hickerson Lake RAWS).

All data were downloaded from the station. All sensor observations had been logged internally during the time that the station was not transmitting (the G5 GOES transmitter automatically stops transmitting 28 days after GPS time is lost, which happened when the GPS cable was cut). The AT-RH, SR, and RG-TB sensors were replaced. The tipping bucket was replaced, tested, and the rain count was reset to zero. The snow depth sensor was replaced with a SR50A sensor and a new cable. The GPS antenna and cable were replaced. The GOES antenna cable and WS

sensor cable were replaced. The data logger program was replaced with one that is compatible with the SR50A sensor. The new data logger program running is HILA\_DLP\_SR50A\_20110707.prg. Snow depth was zeroed to an average reading of -0.5 inches to account for fluctuation without reporting misleading snow depth readings. All bolts were checked and tightened if loose and cables were taped and zip-tied. Station observations and GOES transmission quality were not checked before departure because of time constraints (scheduled aircraft departure). Before departure the station was photographed (Figure 18) from eight directions (every 45°) and the inside of the instrument enclosure (Figure 19) was also photographed. Rocks were piled on top of the instrument enclosure where sensor cables enter the flexible conduit to mitigate damage from bears.

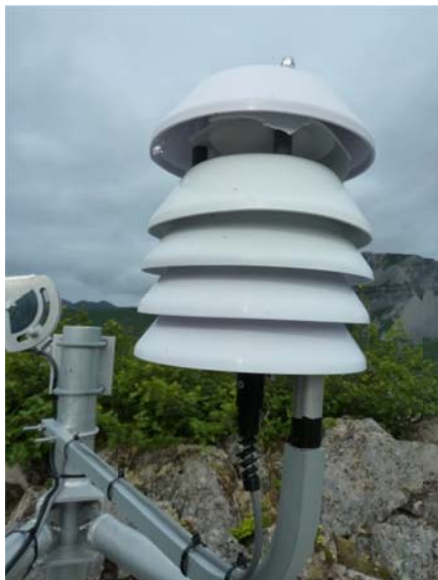
**Figure 17.** Damage to the AT-RH sensor shielding (Hickerson Lake RAWS).

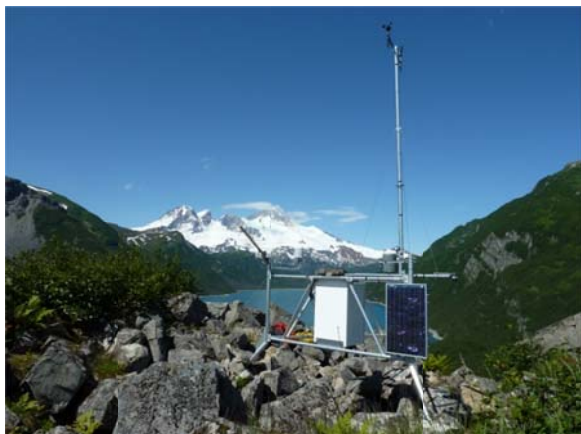
Initial inspection of the weather station showed that there was no continuity on the inner conductor (copper wire) of the GOES antenna (coaxial) cable. A sharp radius bend in the cable where it entered the flexible conduit had probably broken the inner conductor, which is a solid copper wire. The GOES antenna cable was replaced. All data were downloaded from the station. Station observations and GOES transmission quality were checked. Observations and transmissions were verified from the WFMI website by Doug Peratrovich (NPS Radio Shop) in Anchorage and relayed by satellite phone. Rocks were piled on top of the instrument enclosure to mitigate damage from bears where the cables enter the flexible conduit (Figure 20).

**Figure 20.** Hickerson Lake RAWS viewed from the southeast.

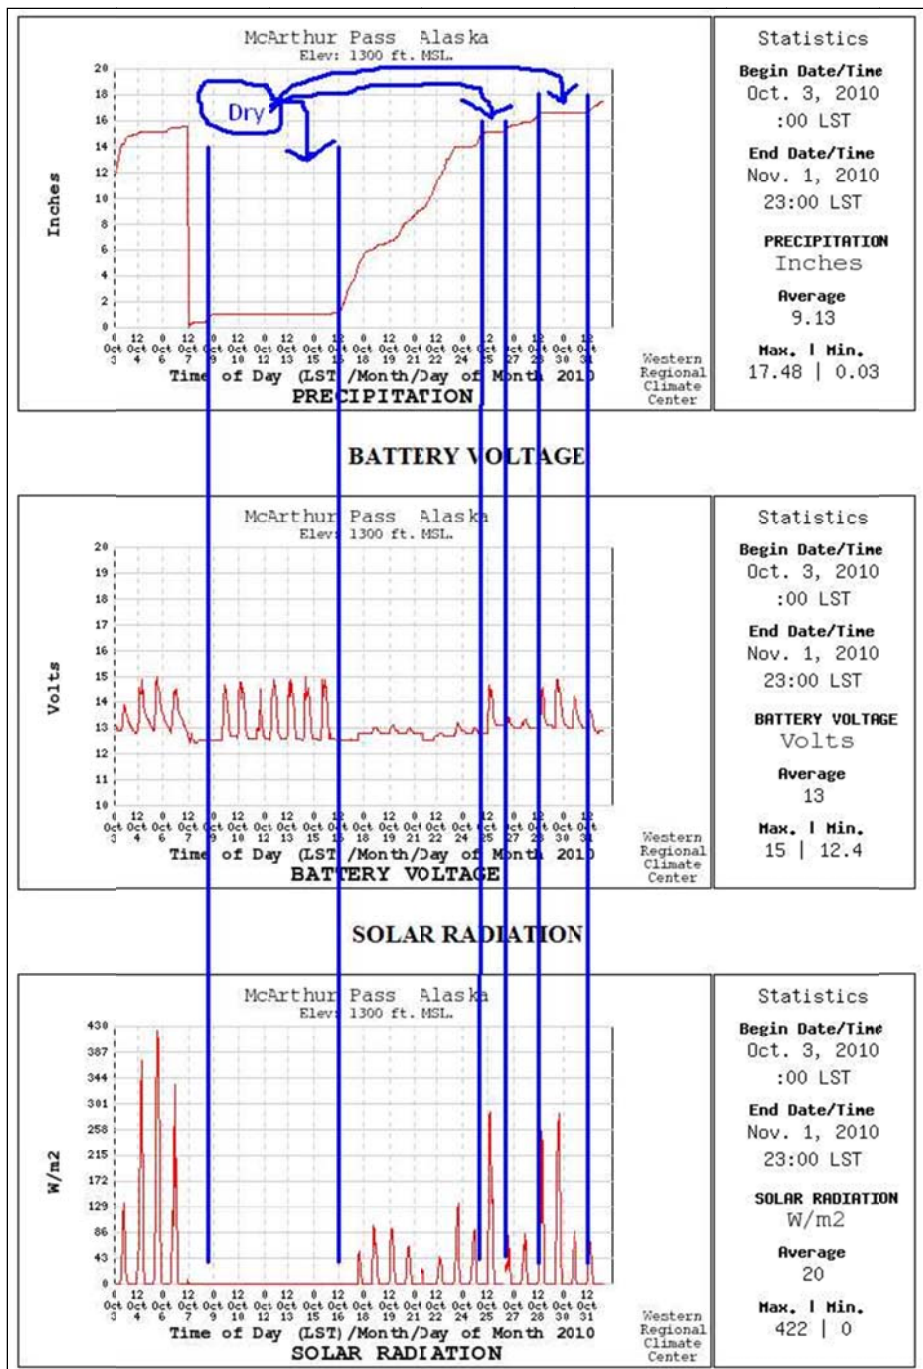
An event on October 7, 2010 caused the station to power down and reset (confirmed by zeroing of rain count). Starting on this date, battery voltage and solar radiation exhibited anomalous behavior. There seemed to be a correlation between precipitation, battery voltage, and solar radiation (Figure 21). It was assumed that wet conditions were causing exposed electrical connections to short. Battery voltages that dropped to 12.4 V on sunny days raised concern that power issues might cause the station to shut down and stop operating.

**Figure 21.** Precipitation, battery voltage, and solar radiation at McArthur Pass RAWS (Oct. 3 to Nov 1), dry periods are bracketed by blue vertical lines. Plots generated from the Western Regional Climate Center (WRCC) website.

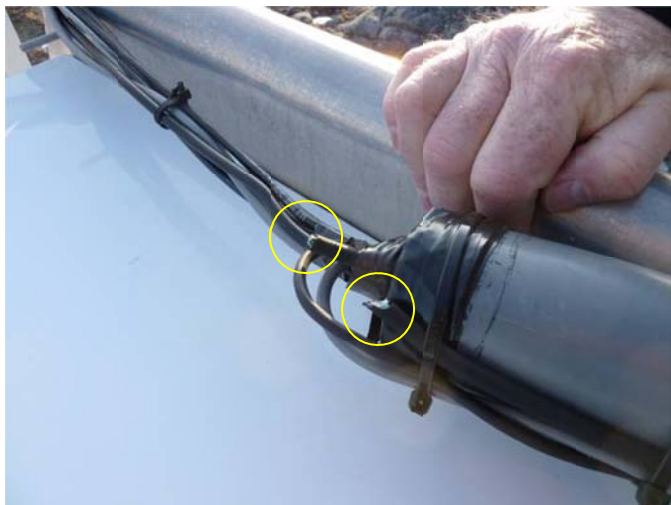
Upon arrival the station appeared to be in good condition. Closer inspection revealed that the snow depth (SD) sensor cable was completely cut at the point where it enters the modified cable gland (Figure 22). It was also damaged in another location closer to the SD sensor (Figure 23). The SD sensor was removed and was not replaced (SD has proven difficult to measure at McArthur Pass because abundant precipitation coupled with high wind at this location forces water into the externally vented ultrasonic range finder where oxidation occurs, eventually rendering it inoperable). Although no damage to the solar radiation sensor or cable was visible, the sensor was replaced as planned. All data was downloaded from the weather station. The data logger program was not modified, so the station will misleadingly report 77.40 inches of snow depth (this is the tare value – the distance from the sensor to the ground surface used to calculate SD). While maintaining the station, the relative humidity / air temperature (RH/AT) sensor began anomalously reporting 100% RH. The RH was 23% when maintenance was initiated. This sensor wasn't handled during the maintenance so it is unclear why this problem developed. This issue is not resolved.

It isn't clear what damaged the SD sensor cable. Bears have damaged the station in the past; however precise damage to only one cable isn't characteristic of bear damage. An ermine repeatedly approached the field crew during a maintenance trip on August 17, 2010. Maybe this weasel chewed the wire. Recommendations to mitigate damage from wildlife include erecting an electric fence and/or armoring sensor cables with flexible conduit.

**Figure 22.** Severed snow depth sensor cable (McArthur Pass RAWS).

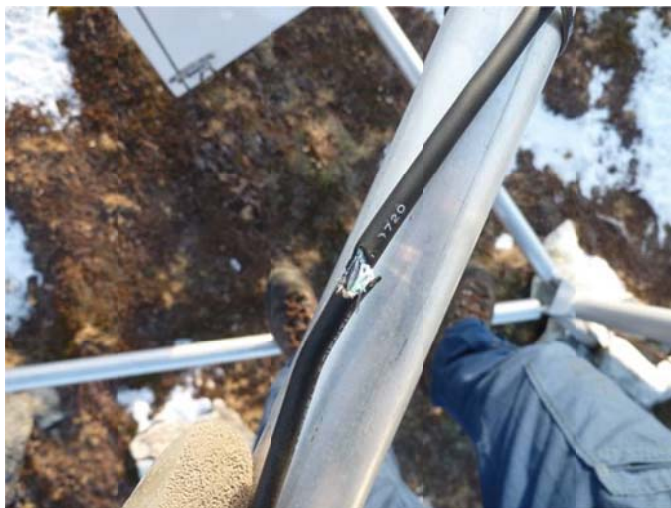
**Figure 23.** Damaged snow depth sensor cable (McArthur Pass RAWS).

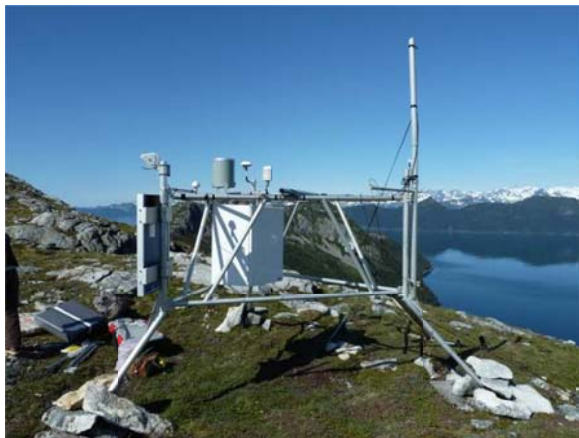
Scheduled maintenance called for replacement of AT-RH, WS, WD, SD, SR, and RG-TB sensors. Scheduled maintenance also called for battery replacement although it was determined that the batteries wouldn't be replaced and that their condition would be monitored and replacement considered after five years of operation (i.e. in 2013). Initial inspection of the weather station showed that the mast had broken and that the WS, WD, wind sensor support arm, and wind sensor cables were wrecked (Figures 25 and 26). The GOES antenna had also broken (Figure 27).

**Figure 25.** The wind sensors, 20 foot mast, and GOES antenna were wrecked (McArthur Pass RAWS).

All data were downloaded from the station. Most sensor observations were logged internally during the time that the station was not transmitting; however wind direction and speed are missing from April 3 to July 7, 2011. A new 20 foot mast was installed and the three extra reinforcing guy lines were also replaced. The wind sensor support arm was replaced. The GOES antenna and antenna cable were replaced. The AT-RH, WS, WD, and RG-TB sensors were replaced. The four cardinal directions on the WD sensor were checked. The RG-TB was replaced, tested, and the rain count was reset to zero. The SR sensor was not replaced (it was left

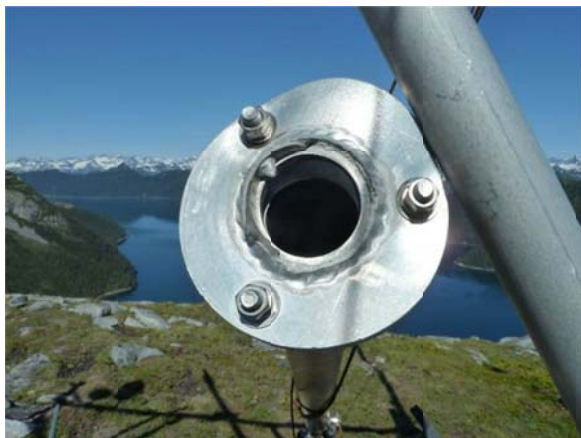
**Figure 26.** The 20 ft mast broke at the junction weld (McArthur Pass RAWS). Upper 10 ft section and both halves of the junction are visible.

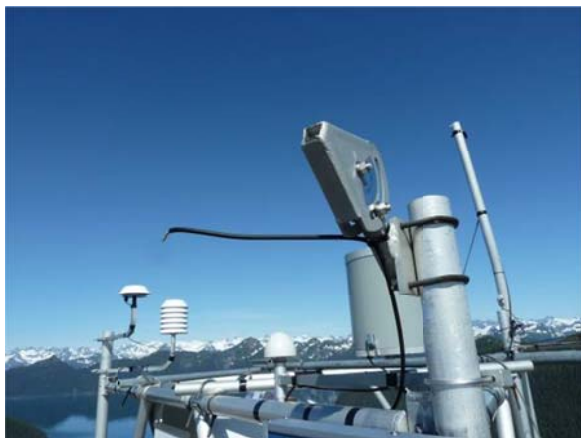
**Figure 27.** Broken GOES antenna (McArthur Pass RAWS).

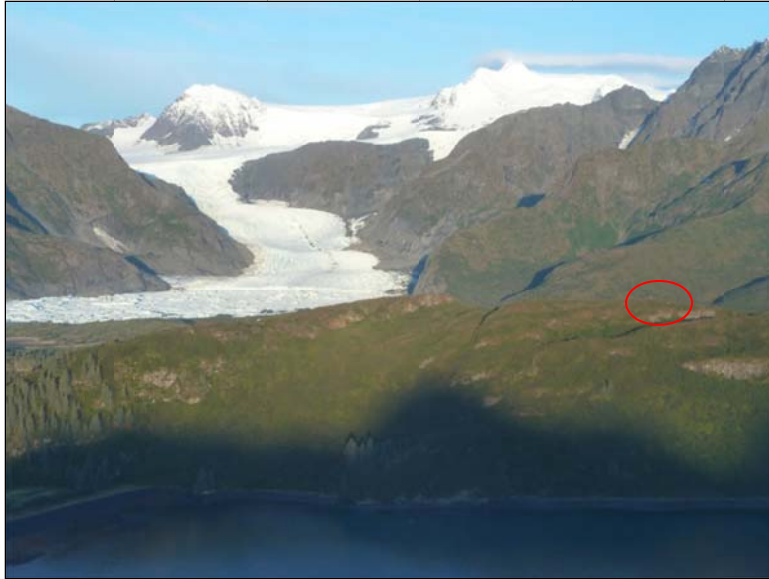
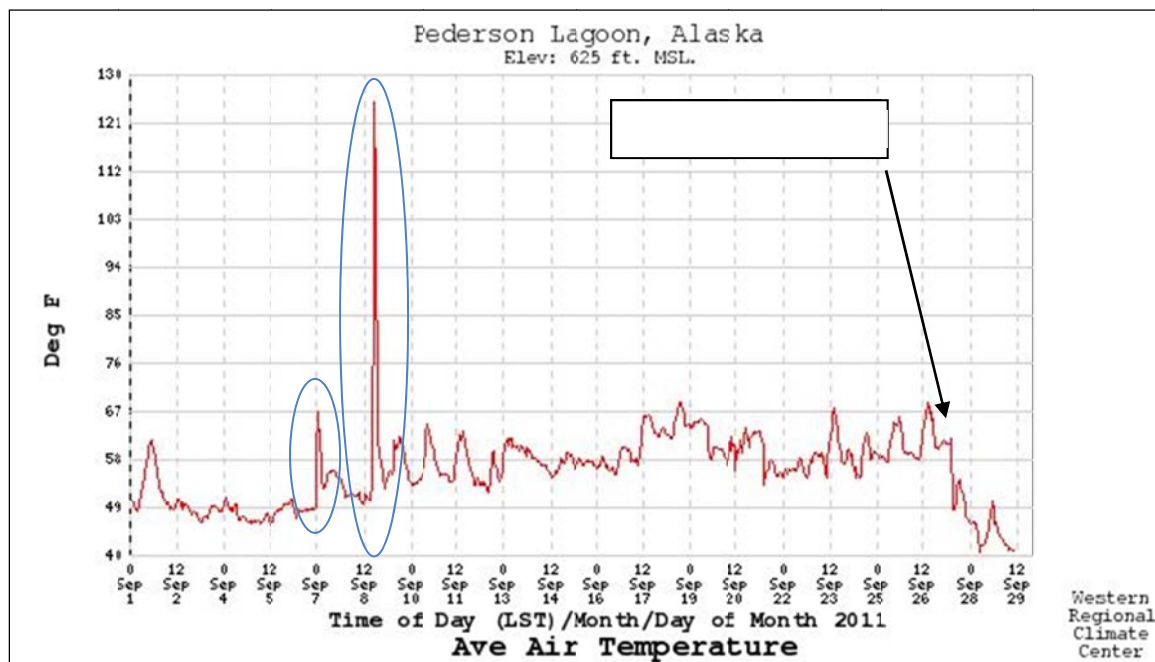
The AT-RH sensor on the Pedersen Lagoon weather station (Figure 40) was replaced on September 27. Something happened to this sensor on September 6. Temperatures reported September 6-27 are warmer than the actual temperatures, by approximately 10-15 degrees Fahrenheit (Figure 41). There was no visible damage (from wildlife or storms) to the sensor; it seems to have malfunctioned. Strands of barbed wire were also added above all sides of the tri-leg tower in order to mitigate possible damage from wildlife (Figure 42). The helicopter pilot requested that additional brushing occur at the helispot in the future so that departure to the northeast can take place without having to hover (out of ground effect) before departure.

**Figure 41.** Air temperature recorded at the Pedersen Lagoon weather station September 1 to September 29, 2011. Blue circles indicate data spikes and sensor failure on September 6 and September 8. The arrow indicates sensor replacement on September 27, 2011.
