**Bates Well Ranch**

**Organ Pipe National Monument**

## **Emergency Treatment Recommendations**

### Emergency Stabilization Report

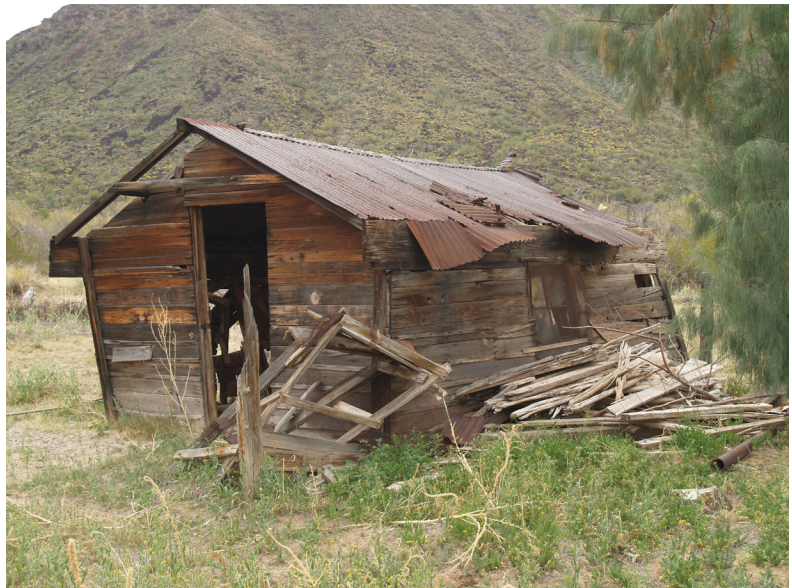
This structure (Figure 1) is in an active state of collapse. (See HSR for description.) Unless treated very soon,

this structure will be lost. It is very important to a comprehensive understanding of the site, as all auxiliary structures are in ranch landscapes. It is a lightly framed one room structure. The northeast corner has failed and the roof is collapsing in the corner. As with many of the ranch structures the posts are set into the ground and they have rotted at their bases. The northeast end rafter is no longer in place.. Within the last five years the ramada on the west side of the house was destroyed by a tree falling on it. Much of the debris from the ramada is piled next to the house. A pie safe located on the southwest corner is collapsing and almost completely deteriorated. Some remaining floor boards for the house are set in the dirt.

*Figure 1: Front view of Chico's House (the Small Residence) showing how the structure is leaning to the left. Without rapid intervention, this building will collapse.*

In order to prevent this structure from collapsing (Figure 2), a simple super structure consisting of treated 4 by 4 posts and beams will be assembled on the north and south interiors to hold the remaining framing up. These can be left in place to serve as modern stabilizing elements. Temporary shoring and jacks can be used to stand the structure up and get it into alignment. Once it is adjusted within reason then new supporting members can be added. The two frames will be set directly on the grade and be attached to one another with diagonal 1 by 4s. These diagonals will be placed on the inside surface of the 4 by 4. To keep them in plane the first diagonal attached will be let into a slot prepared before assembly and the second one attached to the flush surface of the 4 by 4. The top beam of the 4 by 4 frame will extend several inches beyond the width of the frame in order to pick up the load of two parallel plates supporting the roof. The frames themselves will be fitted with small diagonal bracing to keep them square in their corners. It is important that these frames be carefully constructed, tightly joined with slots and pockets, and be built with good quality materials. It will be dry fitted and prepared outside using templates and measurements attained from the somewhat straightened structure and then assembled inside. Since the structure is very light weight (it can easily be moved by one person pushing/lifting) there should be no problem adjusting the various remaining parts. The new frame will be date stamped and

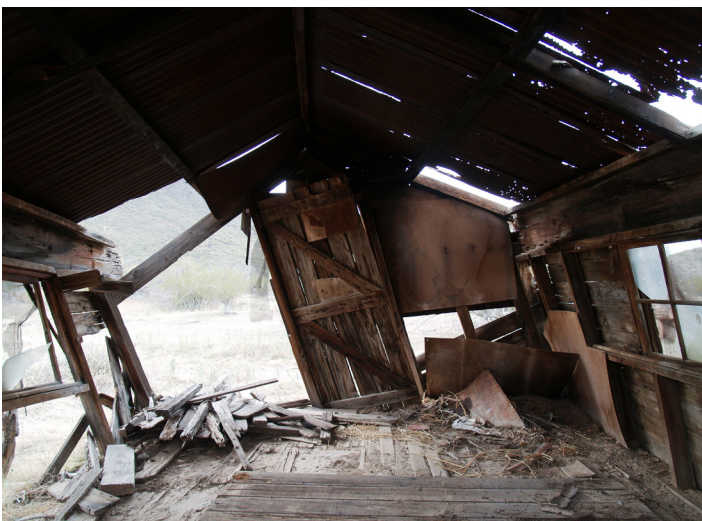
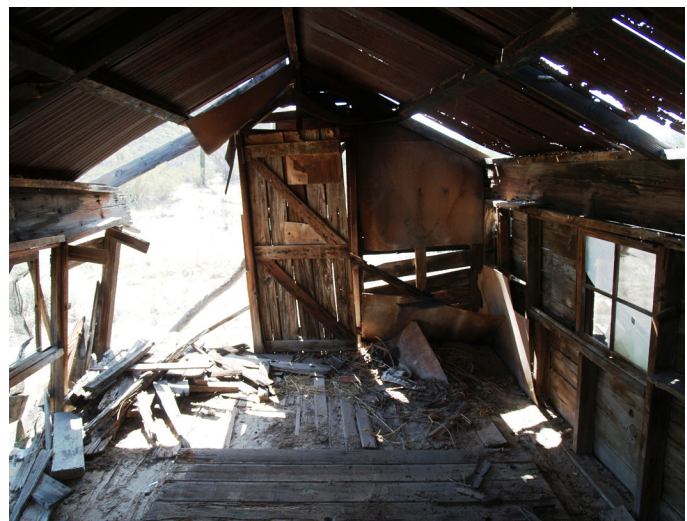
*Figure 2: Interior view of Chico's House before and after the building was straightened and a temporary brace installed. This straightening was accomplished without tools, and braced with materials found on-site. Without permanent bracing, this building will soon collapse.*

stained grey to be more compatible with the older original wood. Loose framing, siding, and trim parts can be fastened back onto the structure when the plates have been attached to the 4 by 4. The south end gable rafter will have to be fitted with a new 2 by 4 since the original is gone. This can be accomplished with tie wire or pre-drilled frame screws. A four light sash is still in place on the west side and this should be left and encased in a protective frame until the future time when this window can be stabilized properly. The protective frame consists of 2 matching 1 by 4 frames slightly larger than the original opening which can be through fastened to each other sandwiching the historic piece without fastening to it. A piece of hardware cloth is to be attached to the inside of the outside frame in a prepared rabbet. Once the bracing frames are in place, a few boards need to be placed back on the plates to support missing corrugated roofing which should be screwed back down after pre-drilling. Here and there supplemental framing pieces may be required to stabilize a section. These will be reversible, date stamped, and stained grey to match all new pieces added.

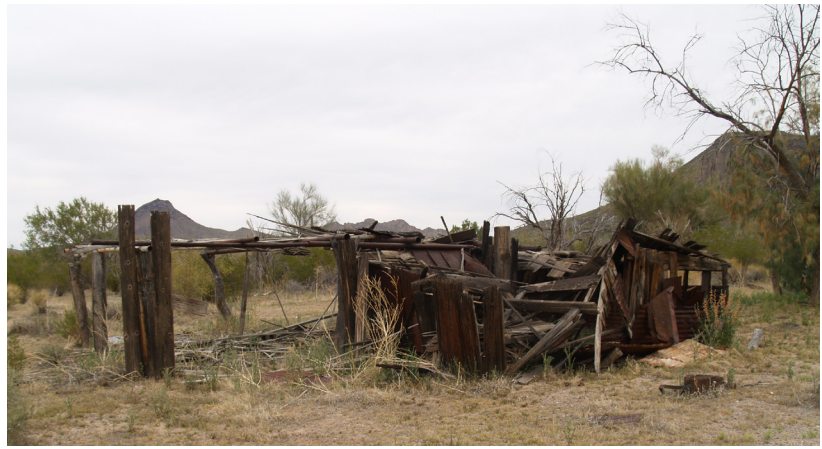
The center most post has become dislodged and fallen eastward. This post supports the ridge beam for the enclosed portion as well as contributes to supporting the central steel pipe beam of the ramada. A splice can be added to the existing post and it can be reset to support the ridge pieces. It may need a diagonal to hold it upright. It will be necessary to use tie wire to hold all this together. The ridge down the enclosed section will have to be spliced and reset. The east end wall has to be tied into the ridge. The northwest corner will require some supplemental timber to be reestablished minimally enough to establish the design of the protruding corner which is an architectural anomaly of unknown use. Likewise the post for the southwest corner of the

*Figure 3: The Blacksmith Shop with the ramada shown to the left. This building has suffered significant deterioration over the past two years, but has not yet reached the point where it cannot be preserved. Photo: Randall Skeirik, NPS*

If pieces of wood lying on the ground can be reinstated by locating where they came from with certitude, they should be replaced. It is not the intent to reintegrate the structure totally at this time.

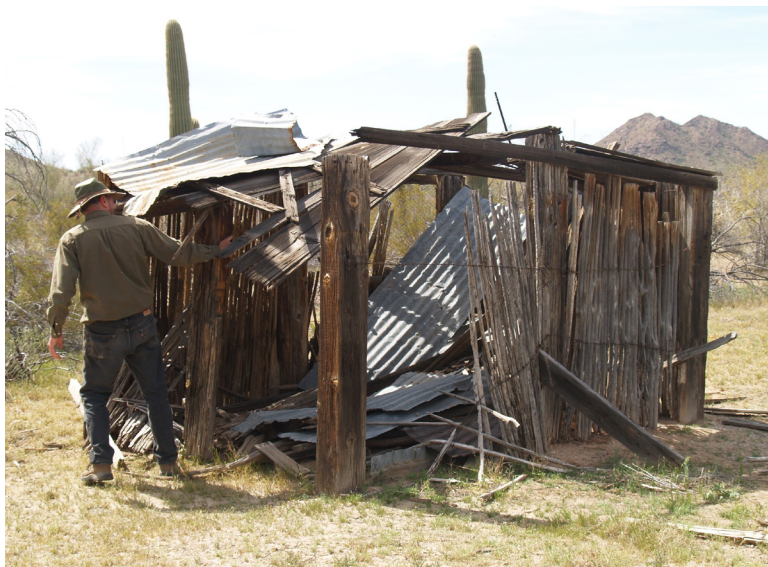
The Ocotillo Shed (Figure 4), which is actually constructed of posts set into the ground with saguaro ribs wired together to serve as siding, is falling down. A few important measures can prevent imma-

*Figure 4: Jake Barrow, VT exhibit specialist inspecting the Ocotillo Shed. Actually constructed of saguaro ribs strung between railroad tie posts, this small structure needs immediate treatment to prevent collapse.*

nent collapse. The fallen debris from inside the structure should be examined carefully noting the provenience of the pieces. Pieces will be wired back in place if the original location can be determined. Saguaro laying around will be wired back in place. Some corrugated roofing pieces can be screwed or wired back down in a few places where enough deck can be reinstated to provide minimal support. On either side two 1 by 4 boards which serve as outside rafter roof supports have been nailed out of place probably in an effort to alter the roof to a shed from a pitch. Earlier photos show this roof as a pitch. These should be fastened in their original position and a 1 by 4 header across the door opening will be replaced in kind. Keeping the doorway integral to the shed is important. Loose pieces laying on the ground which can be re-attached where they were originally should be reattached.

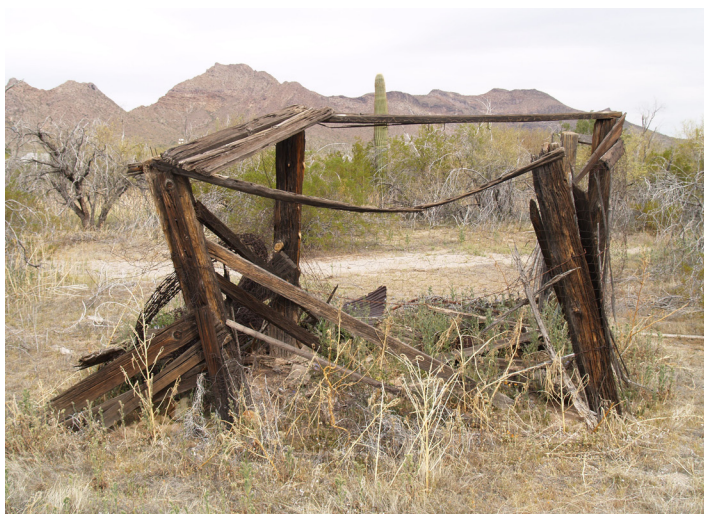
Not far from Chico's house heading northeast, a small chicken wired structure remains which is not identified in the HSR (Figure 5), thus there is no site number. This structure is still standing and deserves to be stabilized to prevent total loss. This element serves to provide tangible evidence of its history and location. Future research may identify this feature. A chicken feeder and the wrapping of chicken wire suggests that it may have served as a chicken house. It is rapidly deteriorating. A few limited actions can preserve remnants of this feature. The gate and post it hung on have fallen over. This should be reestablished by splicing a new bottom on the post and resetting it in position. An alternative would be to set two "T" posts and wire the post/jamb to it. Alternative steel type posts can be used instead of the green "T" posts. The existing corners will be stabilized with "T" posts in the same manner as fencing is being stabilized on site.

*Figure 5: Not identified in the HSR, this small structure was enclosed with both saguaro ribs and chicken wire, and was possibly a chicken coop.*

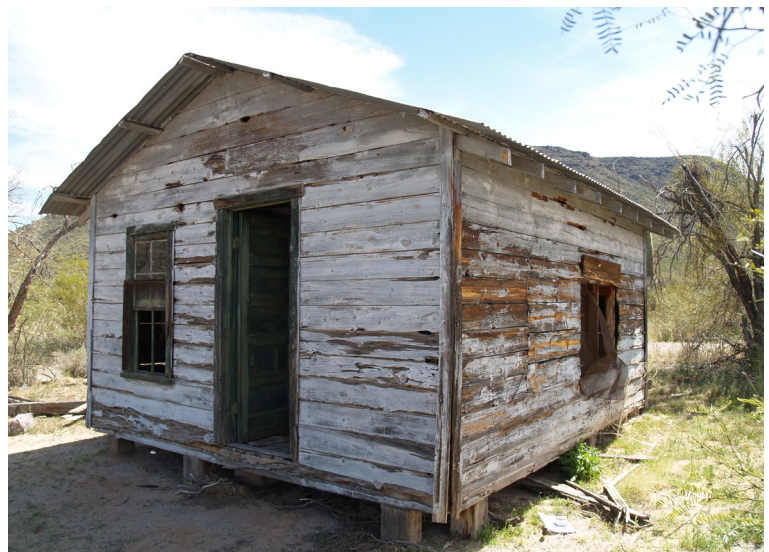
The bunkhouse is a lightly framed structure with emergency conditions related to flooring and substrate floor framing. Only the most serious issues are being addressed at this time. The building is constructed on 8 by 8 wood post piers buried in the ground on the perimeter. For some reason these posts are not on the outside corners but set as much as 12 inches with the corners cantilevered in space. Flat laid plates (2 by 6) are set on these posts along the north south axis. A 2 ½" by 7 ½" beam laid flat runs down the center supporting 2

Figure 6: The Bunkhouse  
Photo: Joe Tuomey, NPS

The emergency treatment recommendations are limited to replacing the rotted post, supporting the floor, selective replacement of deteriorated floor boards, and securing widows and doors.

In order to replace the SE corner post the original one will have to be excavated under the supervision of the archeologist. Temporary interior diagonal bracing can be added to keep framing in place, but this might not be necessary as the structure is so light weight. A new treated post can be installed on top of a solid rock set on undisturbed ground. Shimming will be required to maintain loading. The 2 by 4 joist has deteriorated in the corner and will have to be supplemented with a new piece to pick up the floor and frame above. It is not necessary to attempt to level the building as it is likely that this condition has existed for a very long time. The goal is the stabilize the structure and prevent further settlement.

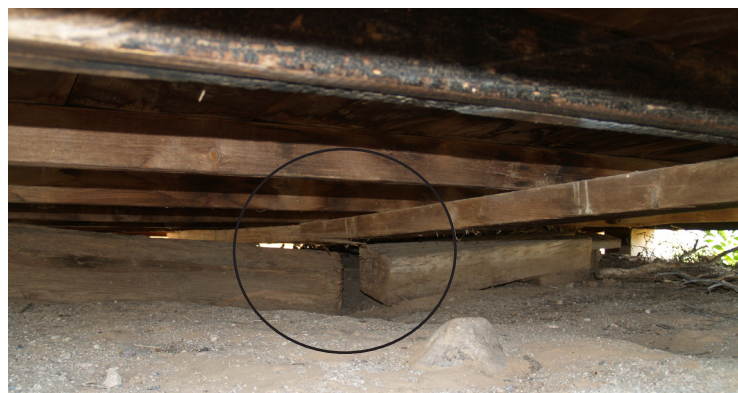
*Figure 7: The longitudinal beam in the floor of the Bunkhouse is cracked. Timber supports were added some time in the past, but have been displaced.*

be carefully lifted. Once repairs are made, these will be replaced. Sections of missing floor and areas which are rotted will have to be replaced. Only missing and completely deteriorated wood will be replaced and joints will be made on the centers of joists for splices. It is currently assumed that these floor boards are #2 (tight knots) pine without surface finish but this needs to be verified so that the new boards are similar in character. When these center boards are up, repairs can be made to the substrate. The center failed section of the main beam (Figure 7) will be sistered with supplemental treated timber on either side fastened at least 24" onto solid wood in both directions. The existing timber supports will be reset to pick up the loads. While open other weak areas will have solid blocking applied to undisturbed soil to provide support, such as the cracked 2 by 4 joist.

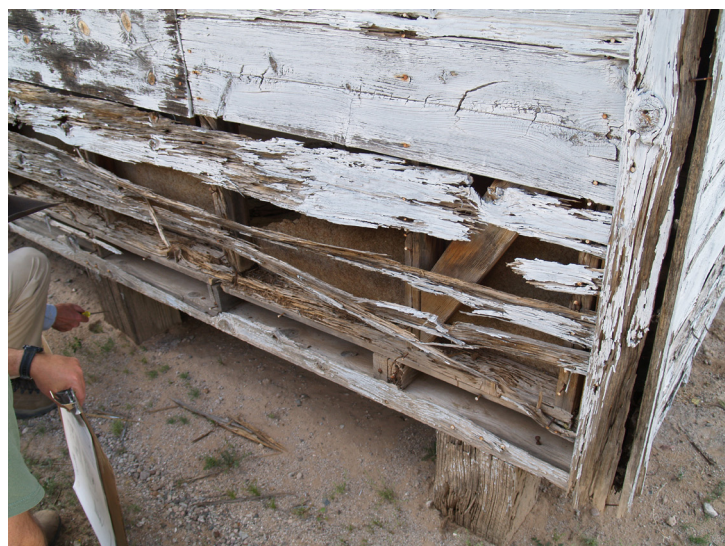
*Figure 8: Some sections of the wood siding on the Bunkhouse have suffered severe termite damage. Replacement of this material may be desirable in the long-term, but it is not a high priority.*

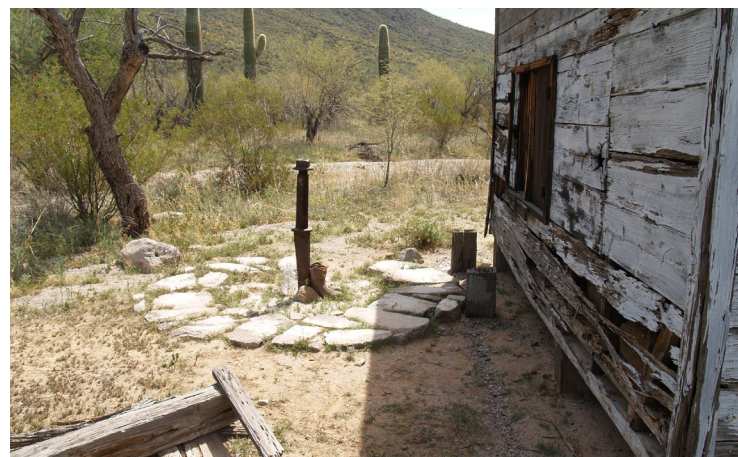
The Arrastra (Figure 9) feature located to the east side of the building is a very significant feature from an earlier period. Vegetation is growing all around and under this feature. In order that this feature not be lost, weeding the Arrastra is recommended.

*Figure 9: The Arrastra, a device for milling ore, is located immediately adjacent to the Bunkhouse. Because it would have been impossible to use the arrastra as it is currently located, it is assumed that it was in place prior to the placement of the bunkhouse, and was no longer in use at that time.*

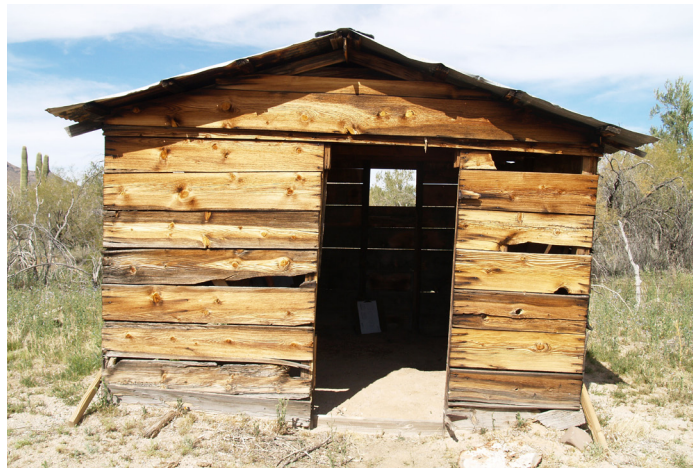
The tack house (Figure 10) is constructed of 4 by 4 posts set directly into the ground and horizontal 1 by 4 siding is nailed to the exterior of these posts. There is no floor. It has a corrugated roof. The basic problem with the tack house is that the posts have rotted at the base. Therefore the building is settling and could be moved by a heavy wind. Emergency treatment recommended is to install 1 by 4 diagonal bracing throughout the interior attached with double headed nails to the existing 4 by 4 posts. Pre-drilling will prevent split outs of the diagonals. In some locations blocking will have to be added to keep the braces in line and where the 4 by 4s have deteriorated the braces will be nailed onto the solid wood portions. Borate treatment as has been specified for wood in contact with the soil is recommended.

*Figure 10: The Tack House is an important component of the ranch complex. Constructed with posts buried directly into the ground, the bottom ends of those posts have completely deteriorated.*

The door has come off the jamb and is laying on the ground. It should be reattached in the open position and fixed as such with some grade stakes driven on either side into the ground. A frame with hardware cloth should be constructed and fixed over the opening to prevent entry. If attached with screws it can be removed for maintenance.

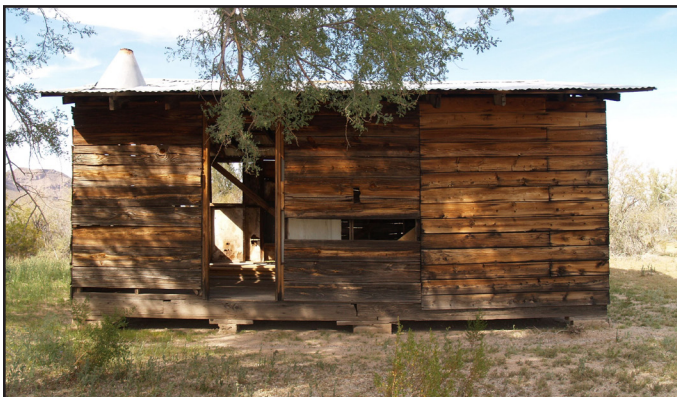
The hay barn (Figure 11) is a very unusual structure due to the unique framing. It is basically constructed of assembled panels which are approximately 4' by 8'. The panels are made of 2 by 4 framing and have horizontal siding of various types attached. These panels are then nailed together edge to edge to make the walls. The walls had no diagonal bracing and it might be assumed that the panels performed some kind of diaphragm action to resist racking. Perhaps the way the barn is constructed contributes to the idea that this building was moved from another location and may be composed of pieces from different buildings. Now that deterioration has taken its toll, modifications are required.

*Figure 11: The Hay Barn. The vertical seam visible in the siding to the right of the door indicates where two different framing panels were joined. Because construction and siding types differ between some of the panels it can be inferred that this building was assembled with pieces removed from more than one structure. It is likely that the panels came from buildings originally associated with the nearby Growler Mine.*

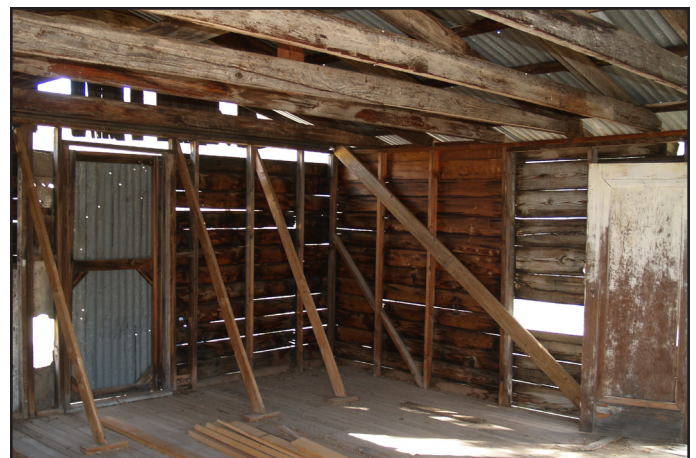
The hay barn has benefitted from temporary bracing that was installed to prevent collapse. (Figure 12) The basic problem with this structure is that the framing has no internal bracing mechanism to prevent racking and the gable ends are not tied to the rafters to prevent over turning. Diagonal and end wall bracing installed in 2007 has helped prevent collapse but these elements should be replaced for more efficient framing. In addition the northeast corner and north side of the sill and plate are completely deteriorated and have fallen out of place. If left, this side of the building will likely collapse. There are a significant number of holes in the roof and much missing siding. The barn has two doors and what appear to be five windows openings without sash. Doors are in place. Gaps exist where siding has deteriorated and fallen off. Siding has been prepared and is on hand to match the various types.

*Figure 12: The gable-end walls of the Hay Barn have been braced because the wall's top plate and the tie to the bottom chord of the rafter are structurally inadequate. This temporary bracing should be removed and replaced with a more permanent and aesthetic solution.*

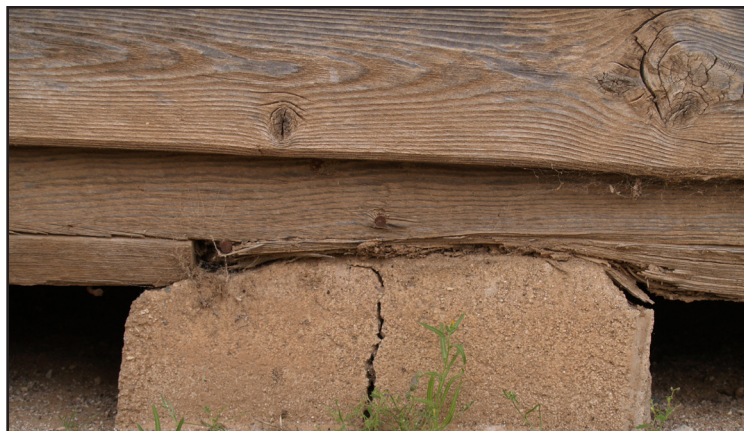
Emergency treatments will address the most serious and pressing problems only. The sill and plate on the northeast side (Figure 13) need to be replaced and pulled back into alignment. As with all wood replacement any solid portion of a piece will be retained and only the rotted deteriorated portion will be replaced. This will be done by splicing using adhesives, pins, and joints cut into the wood. A solid block footing is required to maintain the existing level and prevent further

*Figure 13: Along the north elevation of the hay barn, the 2x6 sill plate of the wall is severely deteriorated. This photo shows a point at mid-span where the plate is completely crushed where it sits on a concrete foundation block.*

listing. New diagonal bracing will be installed to the interior frame. This installation will not block any openings. Diagonals will work around the openings. Two bracing boards will be attached to the chords of the rafters running the length of the building and these will attach to the end walls to prevent over turning. These will effectively divide the ceiling space into thirds. All new bracing will be attached with framing screws, be date stamped and stained grey to mitigate the appearance. Bracing will be carefully installed and cut to fit precisely as this work helps to enhance the appearance of the structure, being distinguishable but compatible and not obscuring any historic fabric. Once the rafter chord ties have been installed, the angle bracing currently attached to the floors can be removed.

All missing siding pieces will be replaced in kind and substrate deficiencies can be addressed by installing sistering splices at points where solid nailing exists. Nails will match historic and not be galvanized so that staining continues as it did historically. The window openings are simply 2 by 4 jambs without any evidence of sash. No stops or rabbets are in place. Frames with hardware cloth will be assembled to secure these openings. Since there are no stops, 1 by 2 stop will be attached to the center of the 2 by 4 jamb to which the screened frames can be attached using through bolts to tie the two frames together. The new stops must be stamped and grey stained so that they can not be misinterpreted for original pieces.

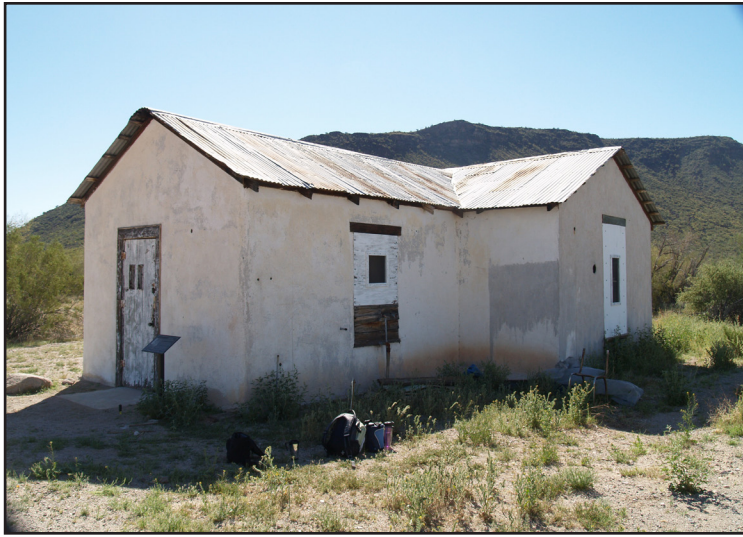
The Main Ranch House (Figure 14) is the most conventionally built of any of the structures at Bates Well. It consists of 2 by 4 framing set on timber sills with a poured concrete floor. Conventional but lightly construct-

*Figure 14: The Main House at Bates Well Ranch. The house was assembled from two separate buildings that were moved to the ranch from the nearby Growler Mine site after the mine closed. Photo: Joe Tuomey, NPS*

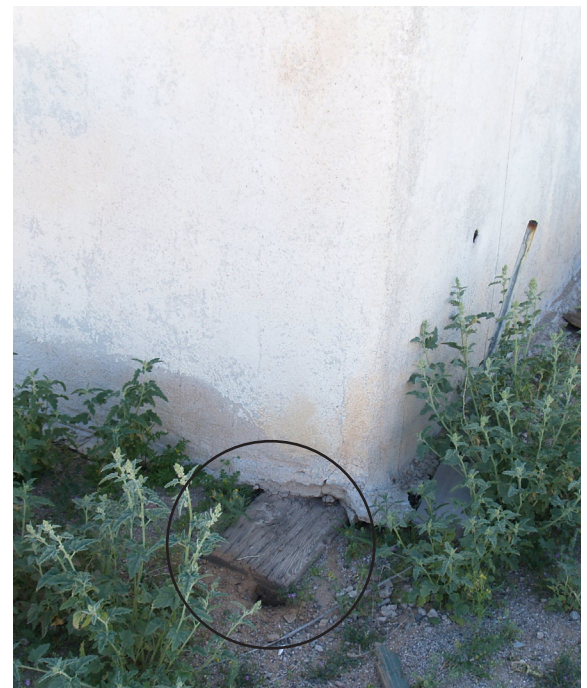
The sills of the ranch house (Figure 15) appear to be railroad ties reused set into the earth at grade. It is unlikely that there is any foundation or footing for these sills. It appears as if the concrete

*Figure 15: The timber footing projects out beyond the northwest corner of the building, the only place where it can be observed without excavation. Photo: Joe Tuomey, NPS*

Rotted sills or sections of sills will have to be replaced. Rodent proofing will be installed during this action. In order to accomplish this task, excavation along the sides of the building will be required to be accomplished one side at a time. Bracing the interior roof rafters at bearing points with a temporary superstructure mounted on the interior set onto the concrete slab can prevent any settling from occurring during the construction. Excavations will have to be monitored by the park archeologist. This is very important since archeological record of the site is limited and much useful information may be retrieved which can inform the record. When the excavation is complete and the rotted sill removed and documented, a new treated sill may be installed. If any part of the historic sill is viable, it will be saved by splicing in the new to the old. It will be necessary to establish solid bearing on the disturbed soil by setting solid block on undisturbed soil and shimming up the sill to the plates. Where visible the base plates have been destroyed by termite activity and these will also have to be replaced. These can be removed from the excavation side and the nails cut or pulled out as well. New plates can be installed from the excavation side, inserted up to the studs, braced and fastened with galvanized framing screws. Concealed "TECO" type connections may be used to connect pieces. Care should be taken to pre-

Before backfilling the trenches stainless steel hardware cloth will be installed to approximately 18” beneath grade laid out along the angle of repose from the base of the sill support and up into the rear side of the stucco. Maintaining the angle of repose along the foundation will prevent any out of plane forces to effect or move blocks set to support the new sills.

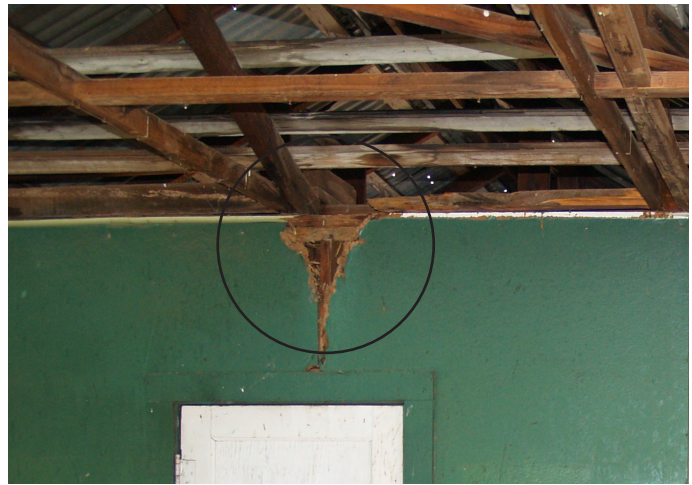
south wing which loads to the framing of the wall partition between the two wings. The plate and framing beneath this rafter has been destroyed by termites. (Figure 16) At the time of this assessment no settlement was evident but with time this section will fail. The framing consists of the door jamb, header, and cripple structure above the opening. Repair consists of carefully removing the trim from the door jamb and removal of the Homosote wall material from around and over the door. Care must be taken with this removal since the intention will be to reinstall these materials when the repairs have been made. Plates will have to cut out where they are termite destroyed and spliced in an over lapping way to disperse the loads. Deteriorated studs and cripples can be “sistered” so the original stays in place. Attachment of the original rafter foot to the new supplemental framing can be accomplished using a standard “Teco” type framing connection. Once the structure has been repaired, documented, and date stamped, the Homosote and the door trims can be reattached. Trim and wall coverings that are no longer attached or on site will not be replaced consistent with a Vanishing Treasures philosophical approach.

*Figure 16: Area of the top plate of this wall has suffered termite damage at the point where it carries one of the roof rafters.*

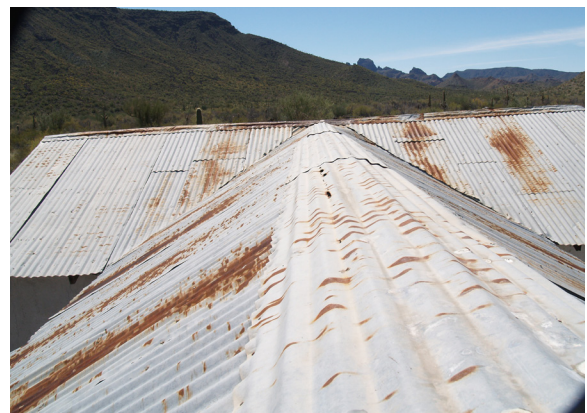
The roof is currently leaking and one section is rusted through. (Figure 17) The north east corner of the south wing is loose and wind has been lifting this corner causing nails to pop. Repairs will consist of cutting a section of like material- galvanized corrugated sheet metal roofing 13” by approximately 60” long to be installed over the rotted sections on the north end of the north wing. The piece will be attached down through the existing by pre-drilling and attaching it with gasketted roofing screws down to the rafters below. Hammering down nails on this roof will only further damage the existing by vibrating existing nails and roof loose.

*Figure 17: Nail hole patterns strongly suggest that the corrugated metal roofing on the Ranch House has been reused. Although it shows numerous rust patches only area has rusted through at this time.*

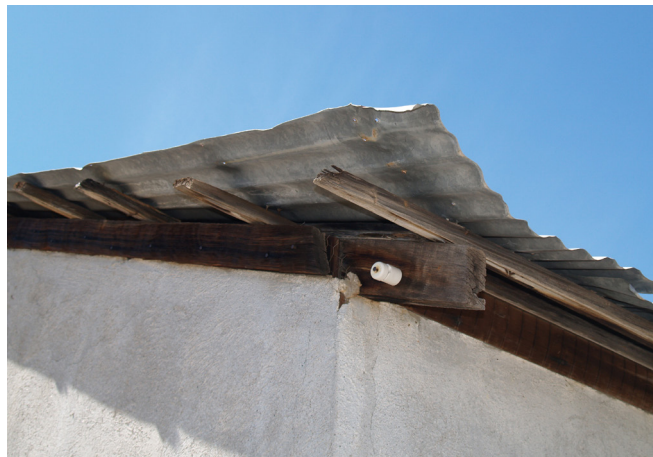
At the north east side of the south wing, the roofing is loose at the eave and the purlins are also loose. (Figure 18) While some of these materials are deteriorated they do not have to be replaced at this time. Reversible repairs consist of using plumbers perforated strapping to tie the purlins back down to the rafter tails. This can be attached on the rear sides of the rafter tails to be less visible. These should be fastened with screws to avoid vibration hammering. The corrugated roofing and be attached back down to the purlins and rafters where appropriate by drilling a hole down through the materials and installing a gasketted carriage bolt, (ca. 5/16”) down through the section

*Figure 18: Deterioration of the purlins at this corner has allowed the nails that attach the roofing to pull out. The wind has caught this corner and is working more nails loose. Without reattachment, this section of roof will soon fail.*

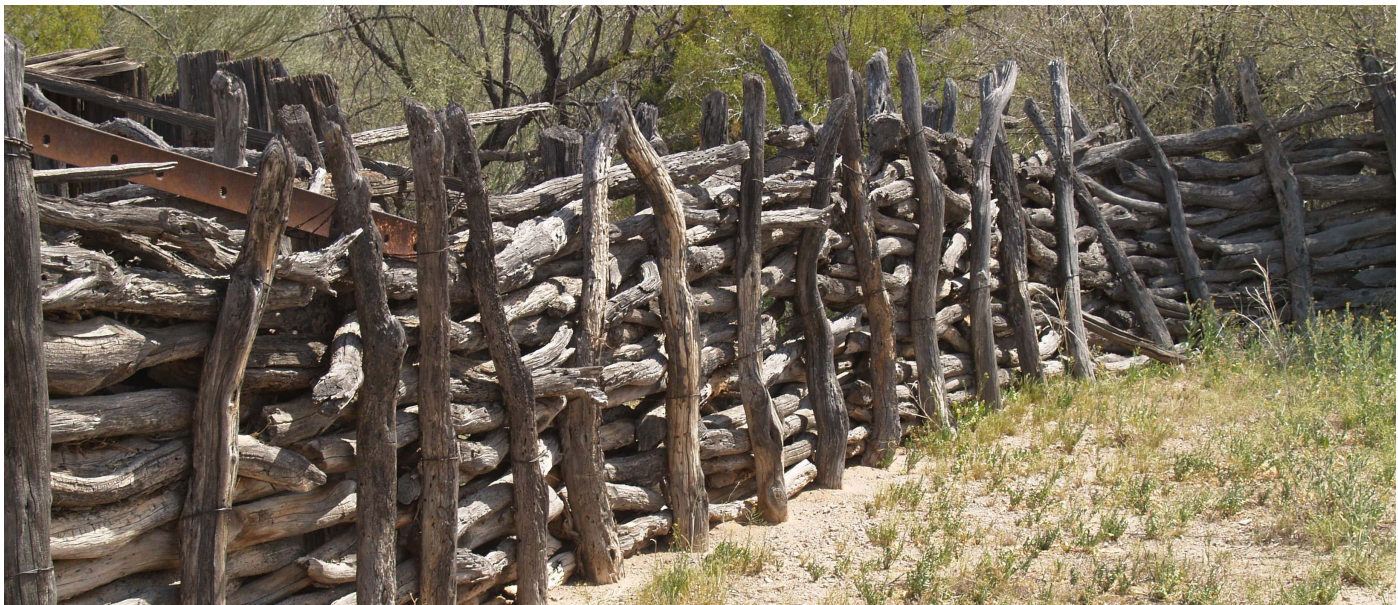
*Figure 19: Constructed of interlocked, stacked mesquite poles supported by paired mesquite posts, this fencing represents a type made entirely of indigenous materials. The buried portions of the mesquite posts are highly susceptible to insect infestation and rot and as a result, many of the posts have failed allowing sections of this type of fence to collapse.*

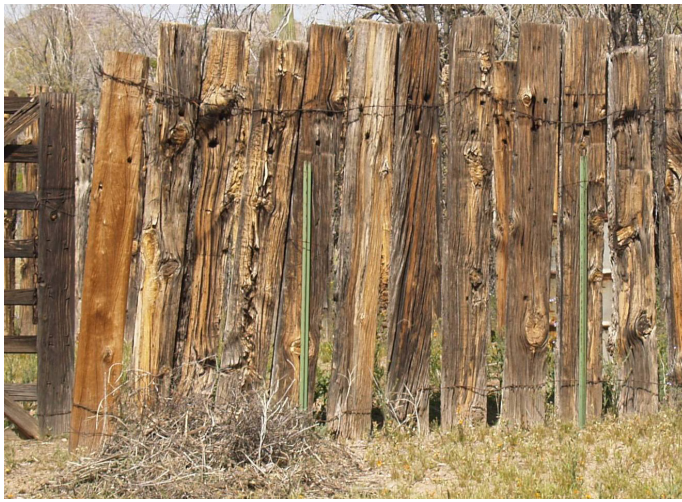
*Figure 20: Stockade type fencing made from reused railroad ties. Even though these timbers were originally treated with creosote, the below-grade sections have deteriorated over the years. Note the green “T” posts that have been installed to help keep the fence upright.*  
Photo: Randall Skeirik, NPS

A system that is already in use at Bates Well Ranch (See Figure 20) appears to present the greatest opportunity for structural stability and the retention of original fabric, with relatively little visual impact. Sections of fencing have been stabilized simply by driving metal “T” posts into the ground adjacent to the original deteriorated posts. The metal posts are wired to the originals providing support and preventing collapse. To provide adequate support, six-foot long posts should be used, with two feet driven into the ground.

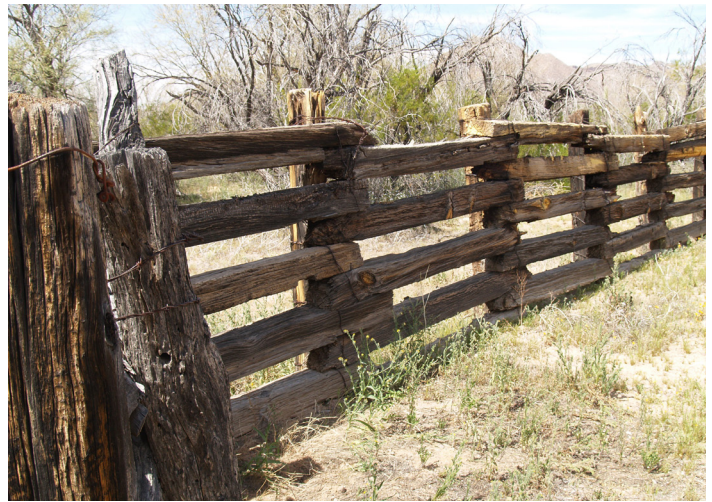
*Figure 21: Stacked timber fencing made from reused railroad ties utilized material more efficiently than the stockade type. Although inherently more stable, the overlapping section of each run is supported by a post, and like the stockade fence, these posts have rotted below grade allowing sections to fall.*  
Photo: Randall Skeirik, NPS

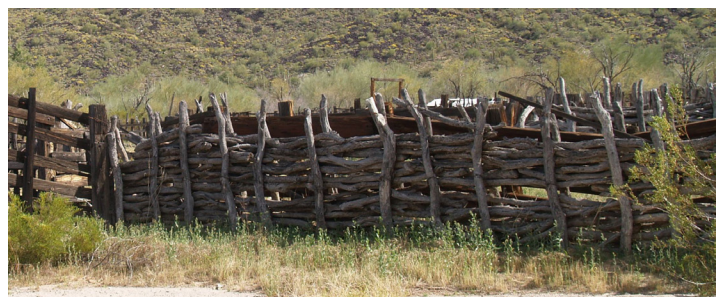
*Figure 22: Constructed of interlocked, stacked mesquite rails supported by paired mesquite posts, this fencing represents a type made entirely of indigenous materials. The buried portions of the mesquite posts are highly susceptible to insect infestation and rot and as a result, many of the posts have failed allowing sections of this type of fence to collapse.*  
Photo: Randall Skeirik, NPS

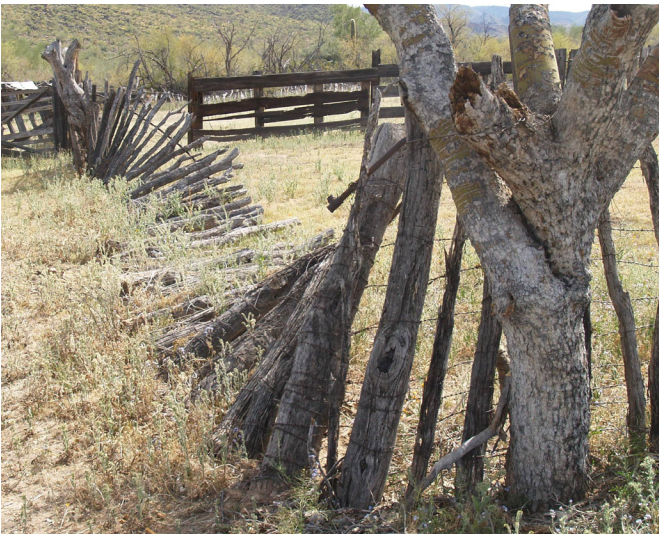
Figure 23: Stockade type fencing made from closely spaced mesquite posts strung with barbed wire. As with other fence types that use mesquite posts, many of the posts have rotted off below grade causing the fence to collapse.  
Photo: Randall Skeirik, NPS

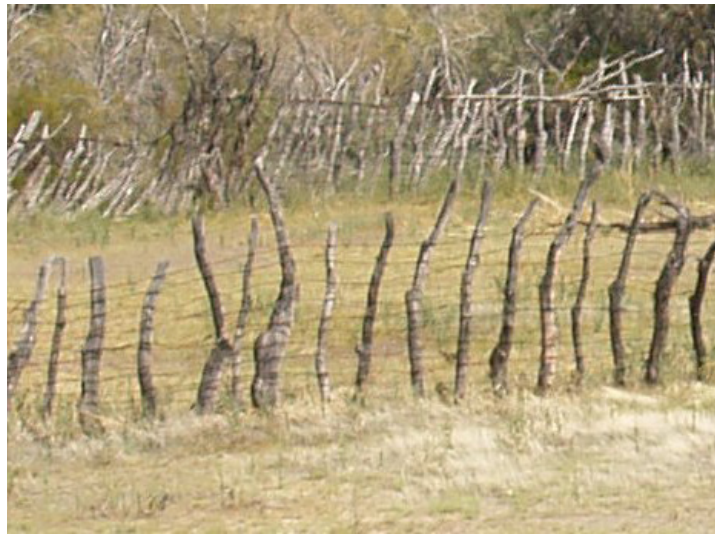
Figure 24: A more typical barbed wire fence made with mesquite posts strung with barbed wire. As with other fence types that use mesquite posts, many of the posts have rotted off below grade causing the fence to collapse.  
Photo: Randall Skeirik, NPS

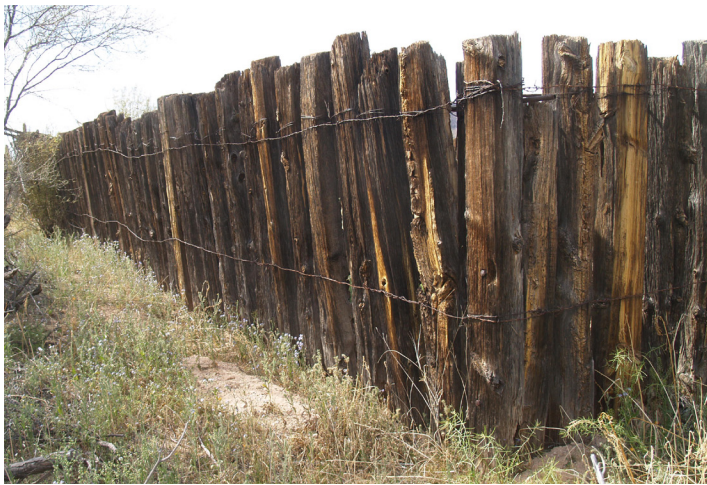
Figure 25: Stockade type fencing made from closely spaced timbers strung with barbed wire. Even though these posts have been treated with creosote, many have rotted off below grade causing sections of this type of fence to collapse. Photo: Randall Skeirik, NPS

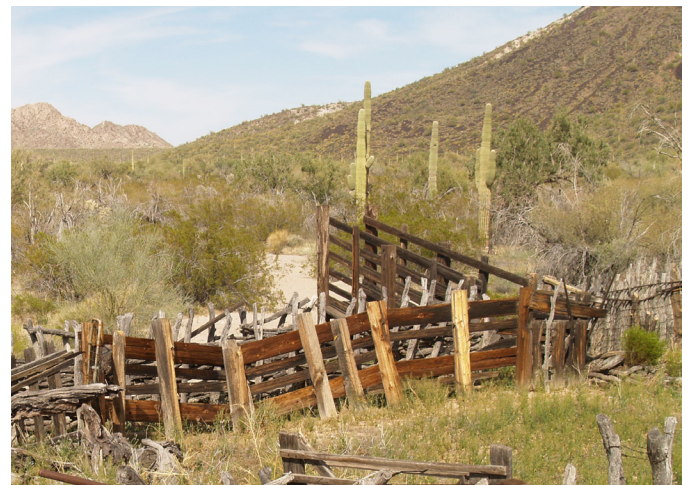
Figure 26: Post and board fencing made from widely spaced timber posts and dimensional lumber rails. This is the least common type of fencing at Bates Well Ranch and is mostly associated with the cattle chute, which is of similar construction. Photo: Randall Skeirik, NPS

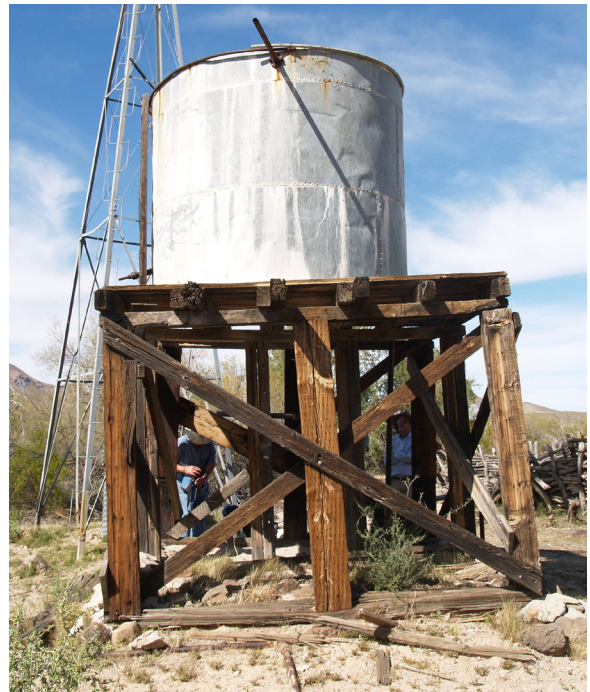
*Figure 27: Water tank associated with Windmill Number 2. Note that the sill beam at the bottom front is badly deteriorated. This deterioration has allowed the support frame to wrack and has required the installation of additional diagonal bracing. Because the tank no longer holds water, the danger of collapse is small, nevertheless, the deteriorated framing members should be repaired or replaced.*

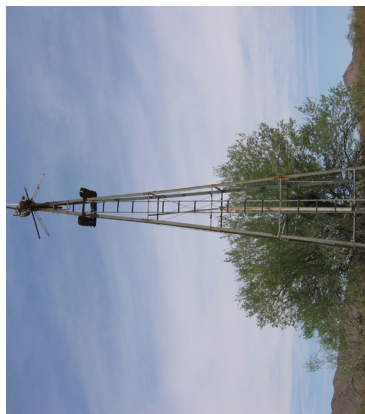
*Figure 28: Windmill Number 1. Note blades at base of tower.  
Photo: ORPI Photo Collection*

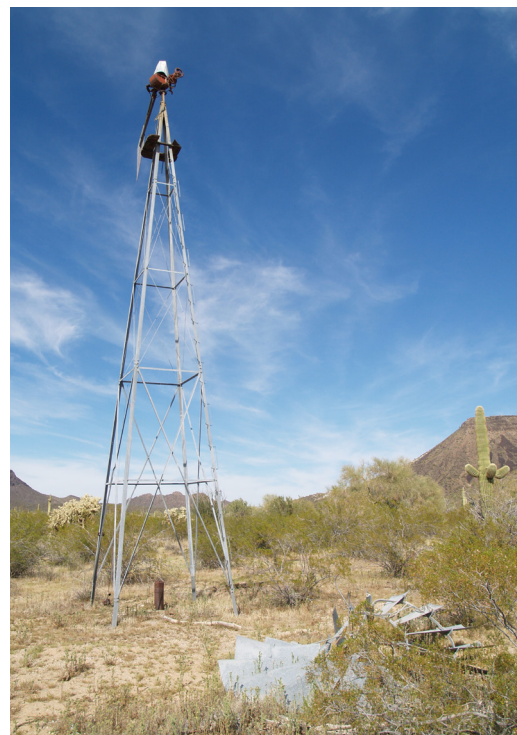
*Figure 30: Windmill Number 3. Note the blades on the ground in the lower right.  
Photo: Randall Skeirik, NPS*
