REPORT OF INSPECTION OF  
CABRILLO NATIONAL MONUMENT

Sept. 11 to 15, 1934

W. G. Carnes  
Chief, Western Division  
Branch of Plans and Design

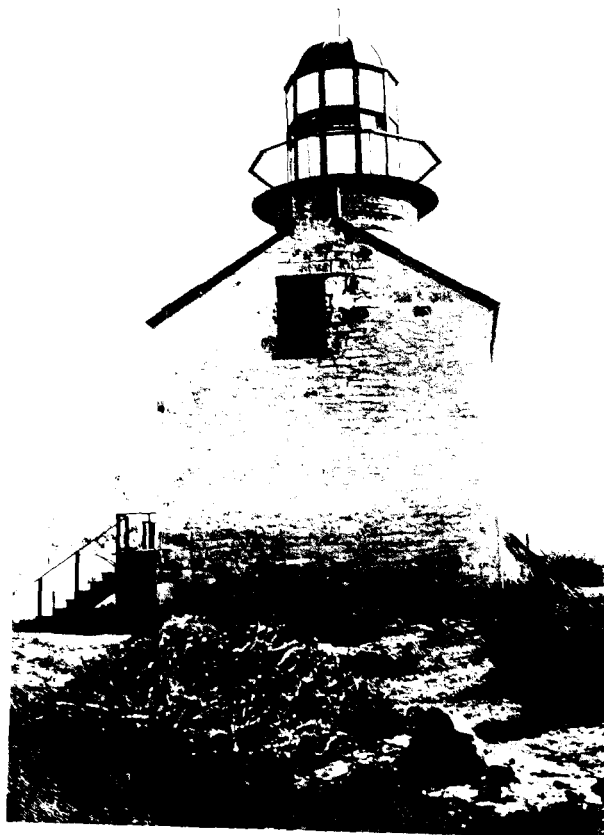
North elevation of Lighthouse.  
Outside stairs to basement may be seen at  
lower right-hand corner of building.

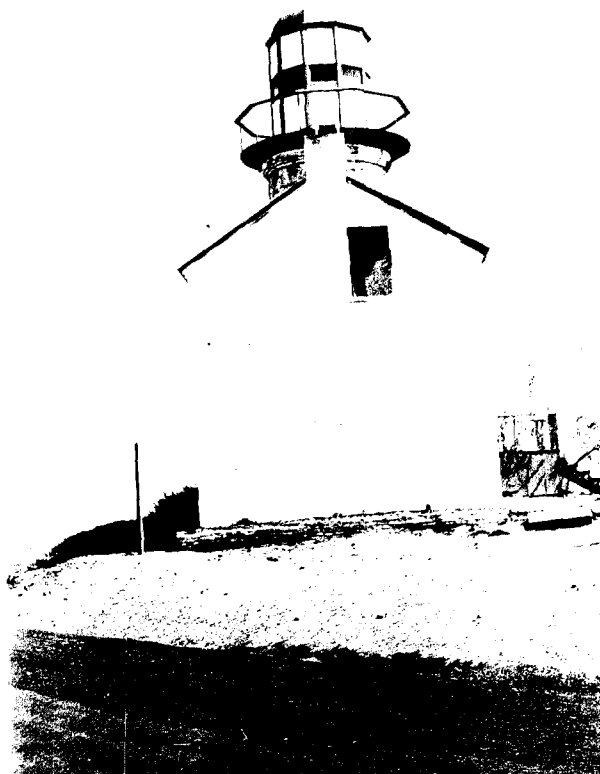
South elevation of "Old Spanish Lighthouse."  
Note amount of old advertising and  
initial carving to be removed.

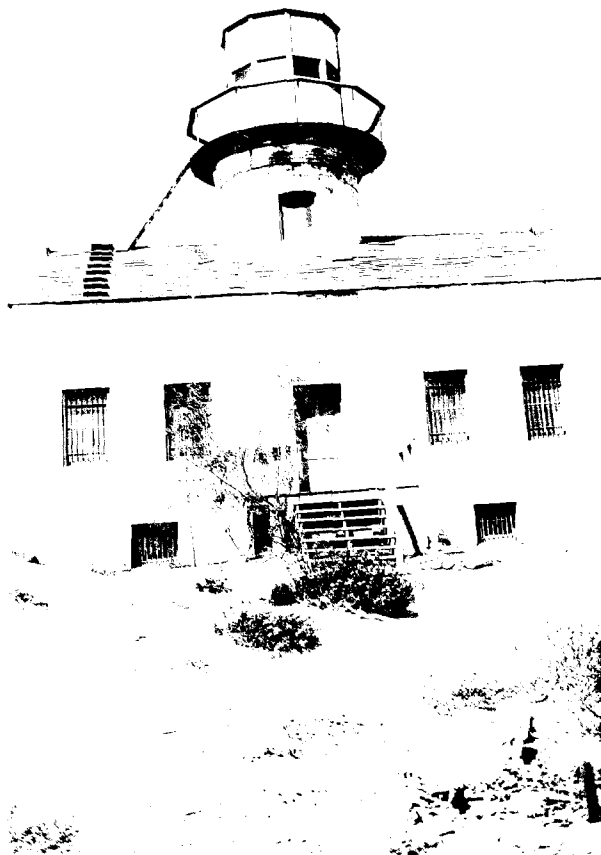
The front porch and steps are at present of wood. The original plan had a flight of stone steps leading straight down from the front door.

Some thirty years after the lighthouse was built, the basement cistern which stored the roof run-off having proved an insufficient water supply, the entire front yard of the lighthouse was paved with concrete as a watershed, which drained into two large underground cisterns. The concrete watershed is virtually all crumbled away, and it is proposed to clean up the debris, and preserve one of the cisterns (the lower one, to which the pump was attached) as a matter of historical interest.

East elevation of "Old Spanish Lighthouse".  
The wooden porch and steps should be replaced  
by stone steps. In the foreground are remnants  
of the concrete watershed which once covered  
the entire front yard.

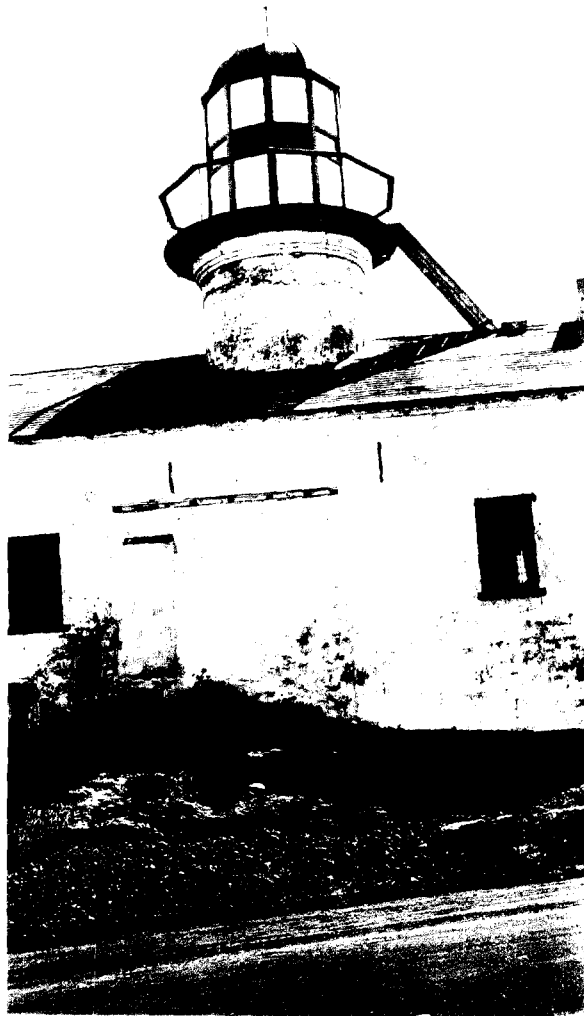
**West elevation of Lighthouse.**

The wall shows marks of where the old kitchen lean-to joined the main building. The close proximity of the State Highway (visible in lower part of picture) makes it inadvisable to attempt restoration of the kitchen.

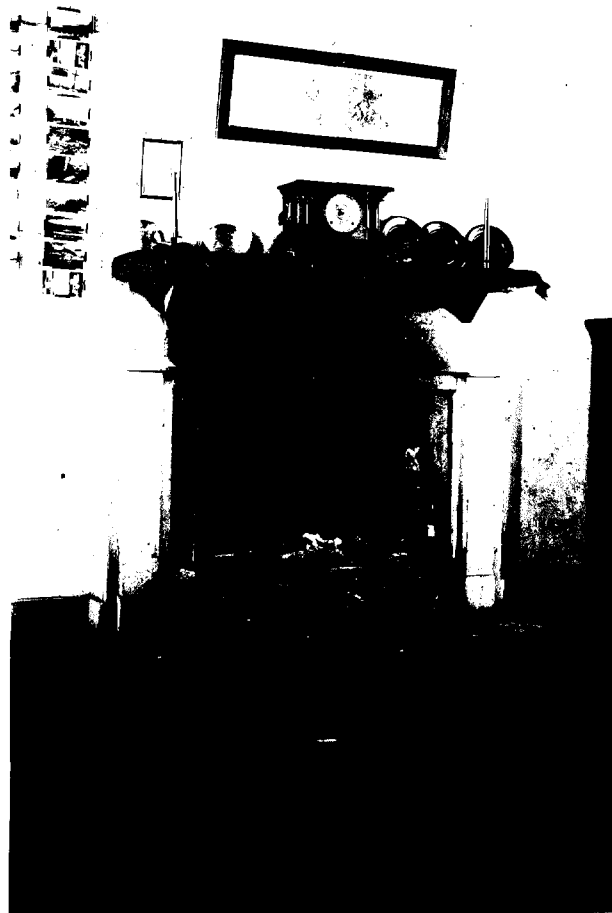
The south end is now devoted to the selling of post cards, curios, and confections. A discussion with the niece and son of one of the early lighthouse keepers brought out the fact that, in the early days, the lighthouse keeper's wife sold shells, moss baskets and photographs in this room, so that its present use seems to be that to which it was formerly devoted.

The first floor fireplace, in the south room. This room devoted to sale of pictures, souvenirs and confections. It was so used by the wife of one of the early lighthouse keepers.
