National Park Service  
U.S. Department of the Interior

Organ Pipe Cactus  
National Monument

**Biological Assessment**  
**Emergency Actions to Stabilize Quitobaquito Pond**  
**Part II: Renovating the Southeast Corner**  
**ESA Emergency Consultation #22410-2008-FE-0273**  
**October 2009**

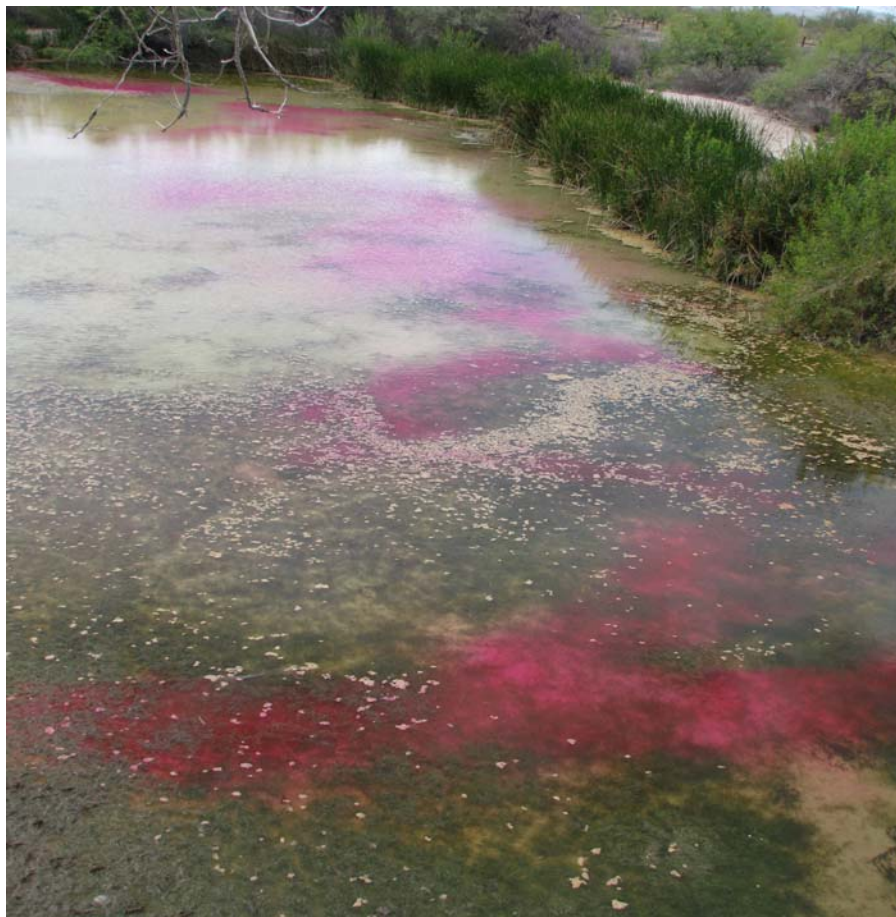
Figure 3a. Quitobaquito Pond, immediately after placing red nontoxic tracer dye. View is from the leaning cottonwood southeast, into southeast corner. Dye was squirted from the retaining berm (right) and across the southeast corner (back center). June 12, 2009.

The tracer dye exercise reinforced existing suspicions regarding the southeast corner. That corner has an area of about 400 square feet where the pond bottom is 18" or more deeper than the rest of the pond. The records of the 1962 renovation are insufficient to determine whether that area was dredged/excavated that much deeper, or if the deeper area developed since 1962. If the former, it is possible the 1962 work dug too deep, into water-permeable substrates, and it simply took 45 years for a problem to develop. If the latter, then some defect in the southeast corner has caused it to subside over the years, and begin leaking in 2005-2006. In addition, for many years a metal fence T-post was in the deep "well" area of the southeast corner, driven about 8" deep into the pond bottom. In March 2009 the post was removed, and the hole filled with bentonite and the area covered with pond liner. No change in the pond level resulted, so the T-post may not have been a leak source. However, it is possible the post hole was a leak, and simply was not sealed and continued to leak. Finally, several large trees were rooted on the inside edge of the retaining berm at the southeast corner. One of these was a decadent Goodding's willow (the "bee willow"); that tree and most of its root system were removed as part of the 2008 diaphragm wall project. However, one screwbean mesquite remained on the berm in the southeast corner, and the root system of a velvet mesquite whose above-ground mass was removed in 2008. Any of these trees, all inside the diaphragm wall on the inside edge of the berm, could account for a defect in the pond sidewall.

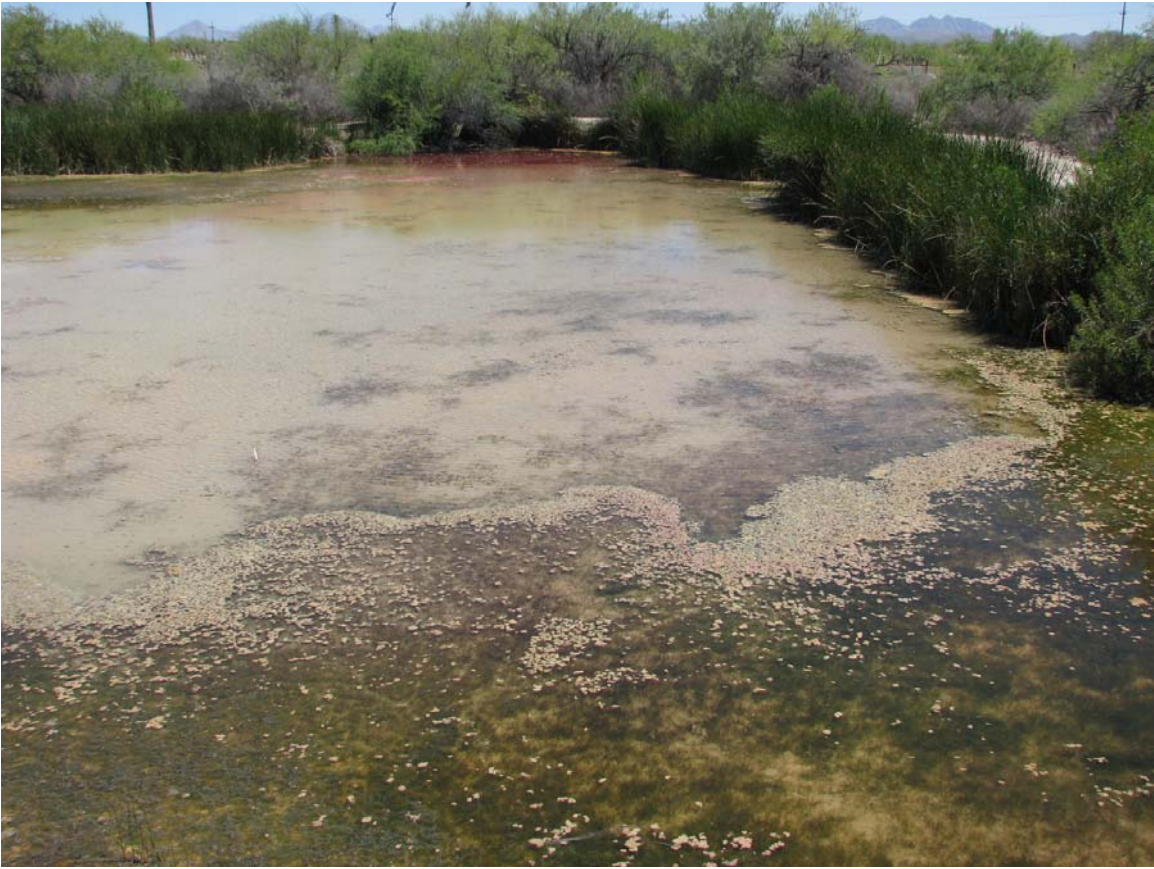
Figure 3b. Quitobaquito Pond, three hours after placing the nontoxic tracer dye in Figure 3a. View is from the leaning cottonwood southeast, into southeast corner. Virtually all dye has moved from along the south/berm shore (right) into the southeast corner (back center), where a pinkish hue is visible. June 12, 2009.

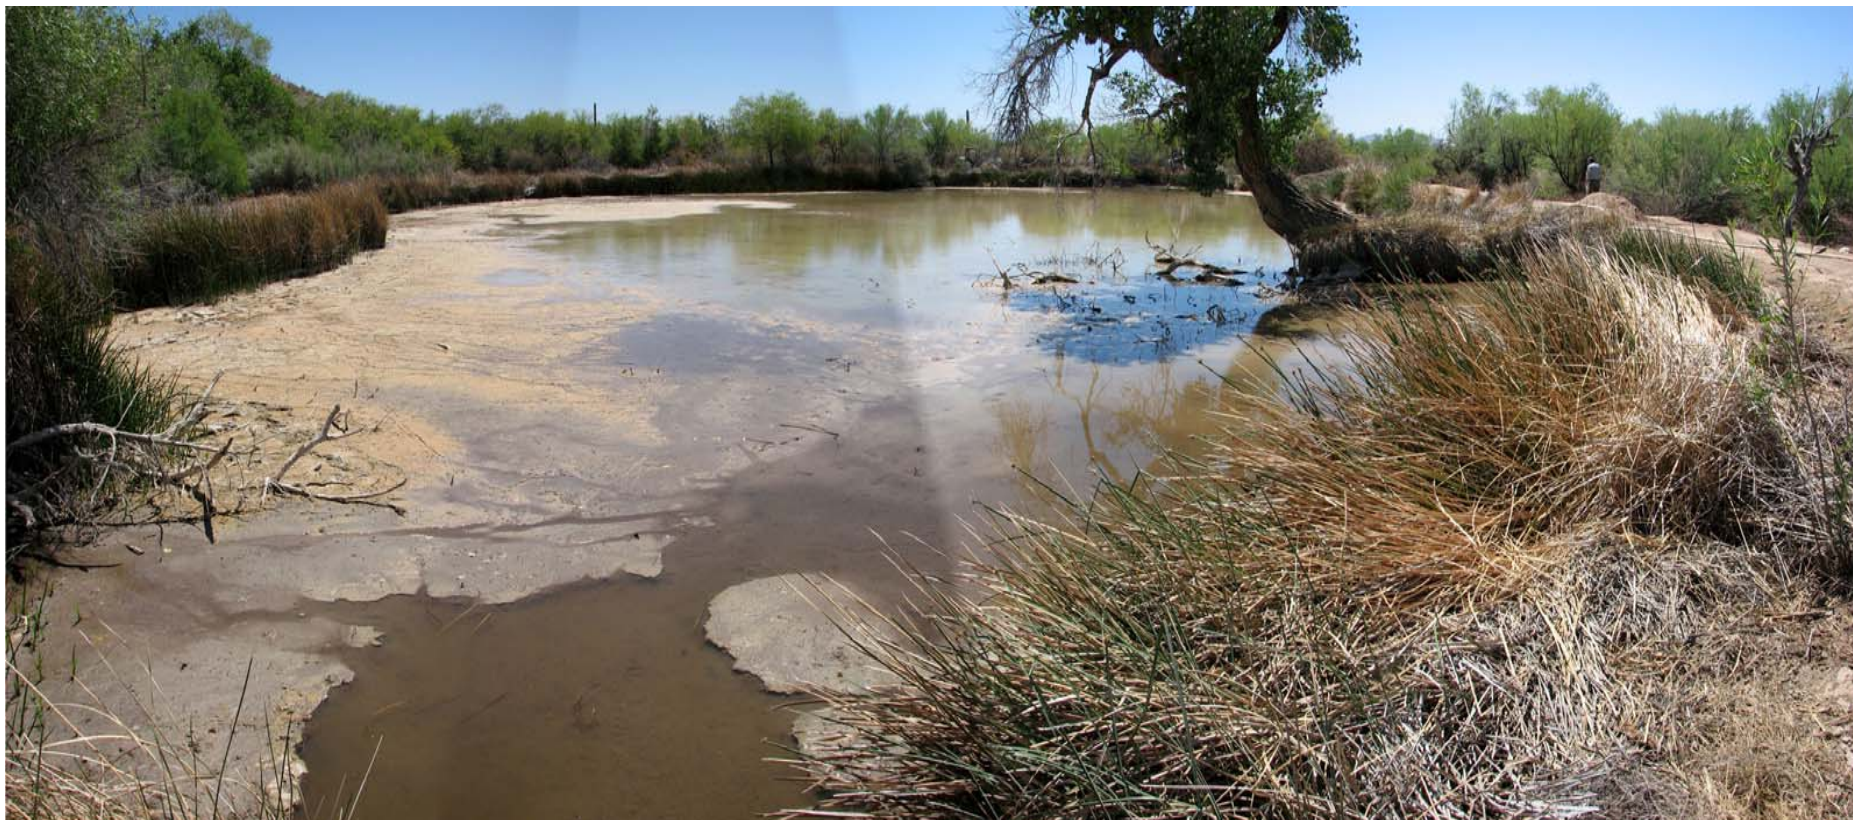
Figure 4. Quitobaquito Pond at minus 26" level. May 2, 2008. Panoramic view looking southeast from the west viewing bench. The exposed brown flats of mud and detritus would normally be covered by 18" to 26" of water. Most of remaining pond is 1" to 4" deep. Organ Pipe Cactus National Monument, Arizona.

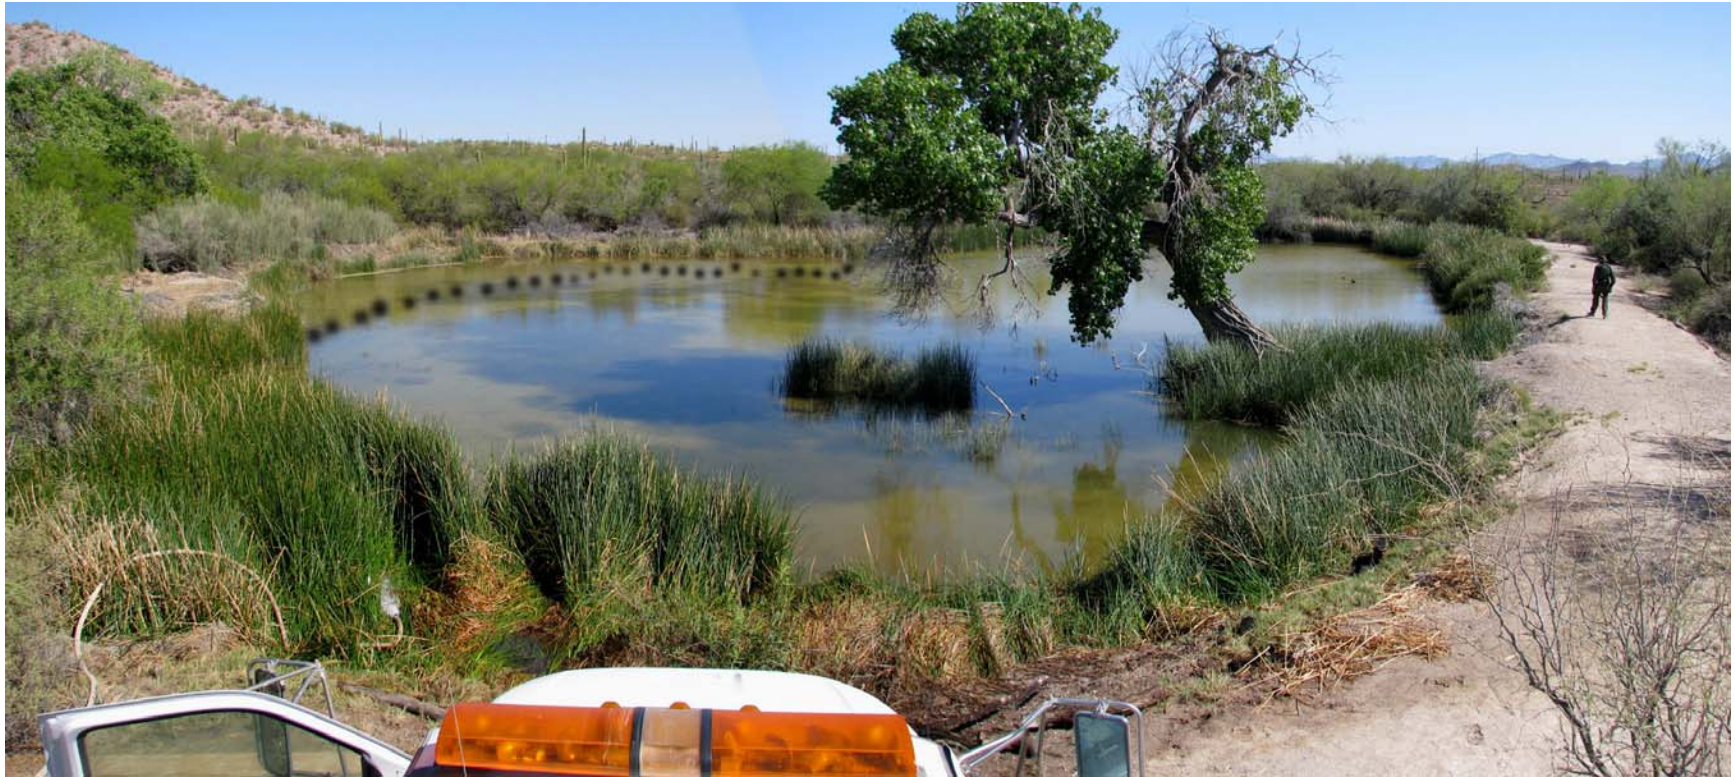
Figure 5. Quitobaquito Pond, elevated view east from west bench, March 27, 2009. Pond level is minus 14.5 inches after large-scale water supplementation. Line of black dots at northeast shore (left rear) indicates area of bulrush removed in winter 2008-2009. Note enlarging bulrush island under cottonwood tree, in comparison with Figure 1.

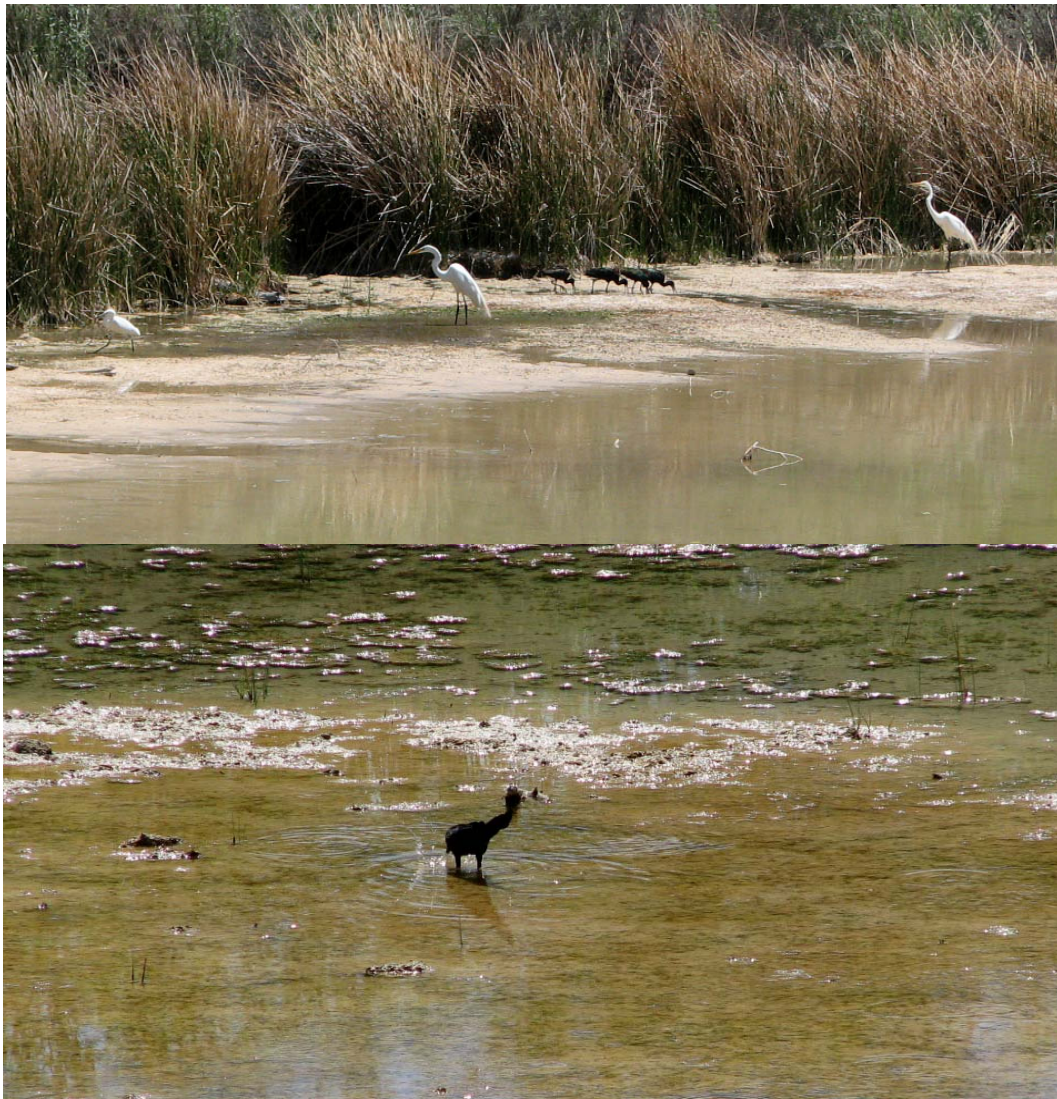
Figure 6. Above: Piscivorous birds (snowy egret, great egret, white-faced ibis) feeding on Quitobaquito pupfish in abnormally shallow water, May 2008. Below: Omnivorous songbird, great-tailed grackle, feeding on pupfish in abnormally shallow water, June 2009. Quitobaquito Pond, Organ Pipe Cactus National Monument.

In spring-summer 2008 and 2009, we observed another, new threat to Quitobaquito pupfish resulting from extreme low water levels. During these times, the pond surface was 24" to 28" below the outflow pipe, leaving most of the remaining pond only 1" to 4" deep. This made pupfish vulnerable to piscivorous birds, in a way they are not when the water is deeper (Figure 6). During this time, we observed mixed groups of wading birds feeding heavily on pupfish, a phenomenon seen rarely if at all at normal water levels. Depredating birds included great egret, snowy egret, green heron, black-crowned night heron, black-necked stilt, and white-faced ibis. The latter two species are known more for feeding on invertebrates, not fish. However, at Quitobaquito they methodically took pupfish exposed and stranded in very shallow water. With up to 15 or 20 predatory birds sometimes present, we estimated up to 100 pupfish per hour were being predated during some parts of the day. This predation problem diminished in May, after the bird migration season had passed. In spring 2009, when the pond again fell below minus 26", even great-tailed grackles were observed feeding on pupfish (Figure 6). Vulnerability of pupfish to this omnivorous songbird underscores the severity of the situation.

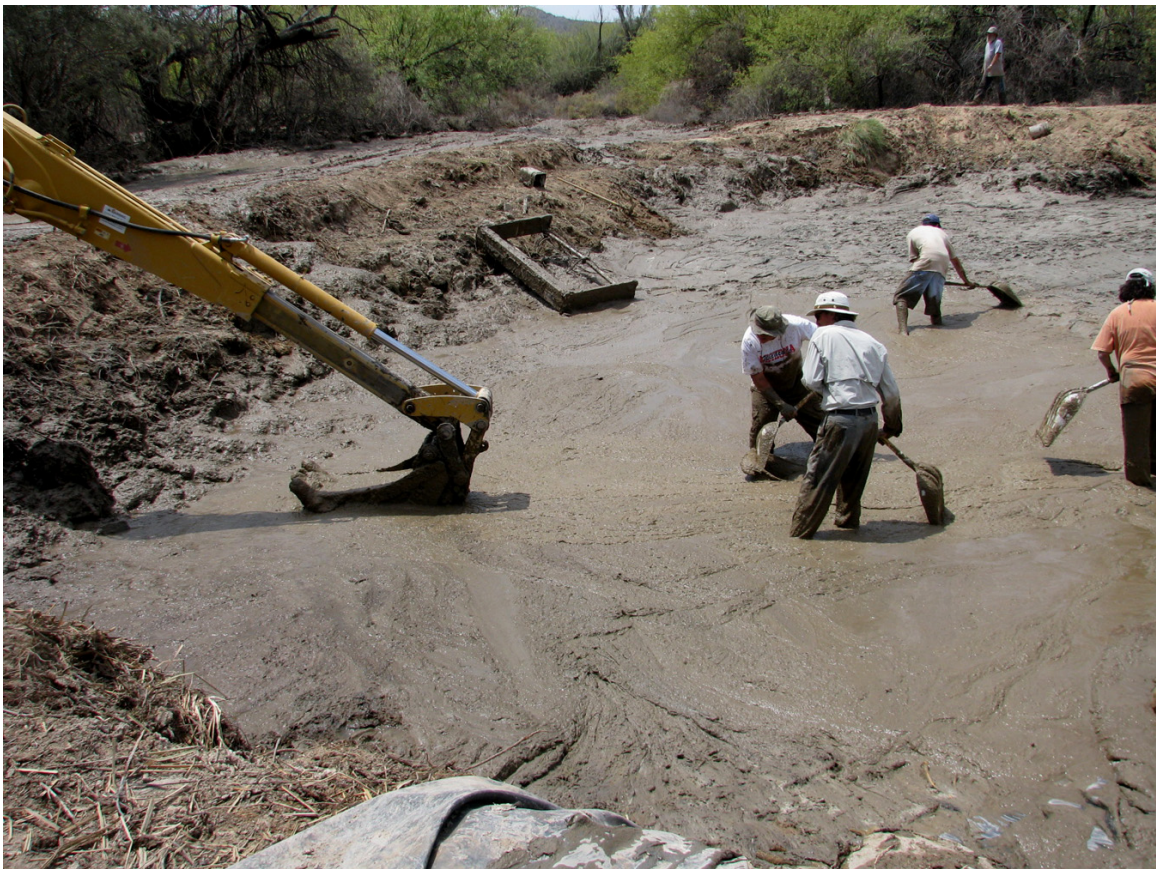
As the firm bottom of the pond became exposed, it was found to be a uniform, smooth, hard-packed material of very high clay content. It appeared to be a constructed clay bottom. Historical records are not clear when this clay bottom was built. It may have been part of the major 1962 renovation of the entire pond, or might be much older. A distinct trough over 80 feet long was discovered in the hard clay bottom (Figure 13). It extended from the deepest part of the southeast corner, northwestward parallel to the berm, under the coffer dam, and into the main pond area. The trough was about 4" wide and 3" deep. This trough may have been a small man-made channel to conduct the spring-flow to the deepest part of the pond during the 1962 (or earlier) renovation. Its appearance also suggested a possible surface expression of an earth fissure, resulting from changes in the ground underlying the pond. On the inner face of the retaining berm, multiple areas of possible seepage were found, associated with the root systems of trees that had been allowed to grow on the retaining berm.

Figure 12. Removing mud and organic detritus from the southeast corner of Quitobaquito Pond. August 21, 2009.

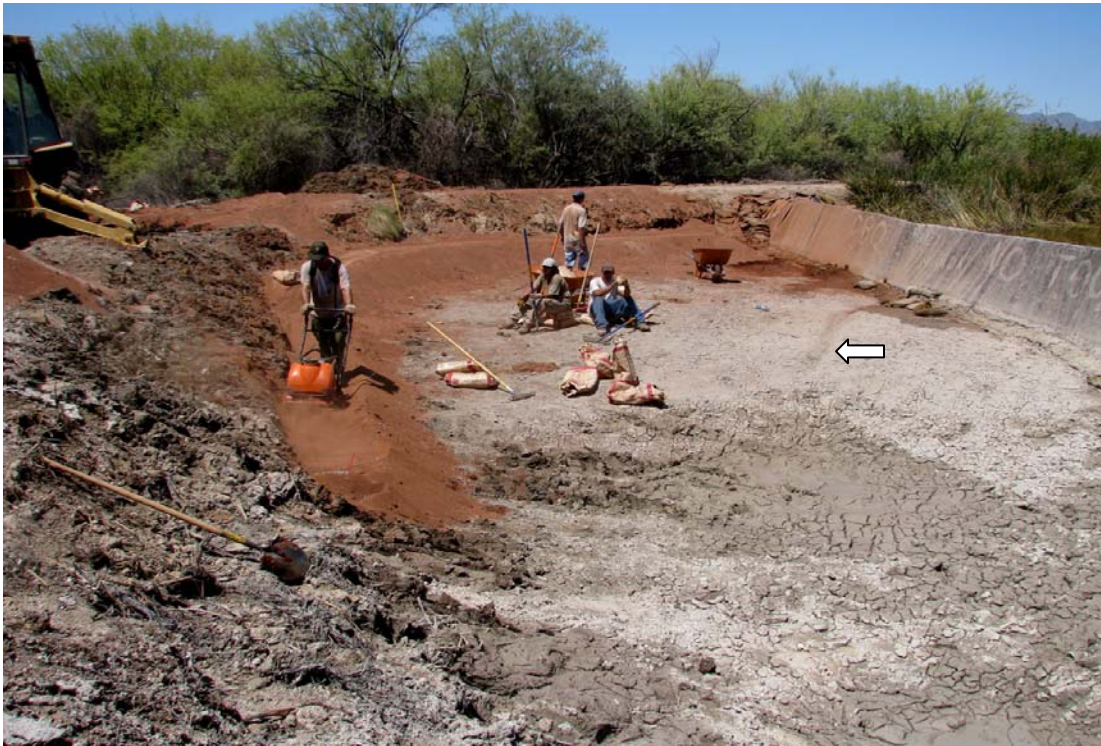
Figure 13. Compacting bentonite-enriched fill against exposed inner face of the retaining berm. The pre-existing clay pond bottom is visible as a grey floor, drying out. The white arrow points to "the trough," visible as a faint dark linear feature fading into the damp area at the base of the coffer dam. August 25, 2009.

The southeast corner was allowed to dry out over the weekend of August 22 and 23. On this sixth workday on-site, work began to expand the retaining berm inward. A clean, reddish fill material consisting of particles 2mm diameter and smaller, with moderate clay content, was spread in 6" courses (lifts) approximately 4 feet wide, against the inner face of the retaining berm. A trench approximately 10" wide was then dug down the center of each course, to the depth of the course below (or the clay pond bottom, for the bottom course). Granular bentonite (3/8" "hole plug" grade) was then poured into this trench, and mixed with the material dug out to create the trench. Thus an inner wall of bentonite-enriched fill was created, at a concentration of 30% to 50% bentonite. Each course was then compacted with a vibratory plate compactor (Figure 13). As successive courses were built against the berm face, the new inner face sloped backwards at angles varying with and reflecting the inner slope of the original berm. Great care was taken to assure that the bentonite-enriched wall within each course was contiguous with the one below it. This served to create a single, continuous bentonite-enriched wall within the new fill, extending from the existing clay pond bottom to the top of the new fill material. Bentonite was no longer added to the new fill material, after the berm enlargement had been built up to a level approximately equal to the top of the outflow pipe.

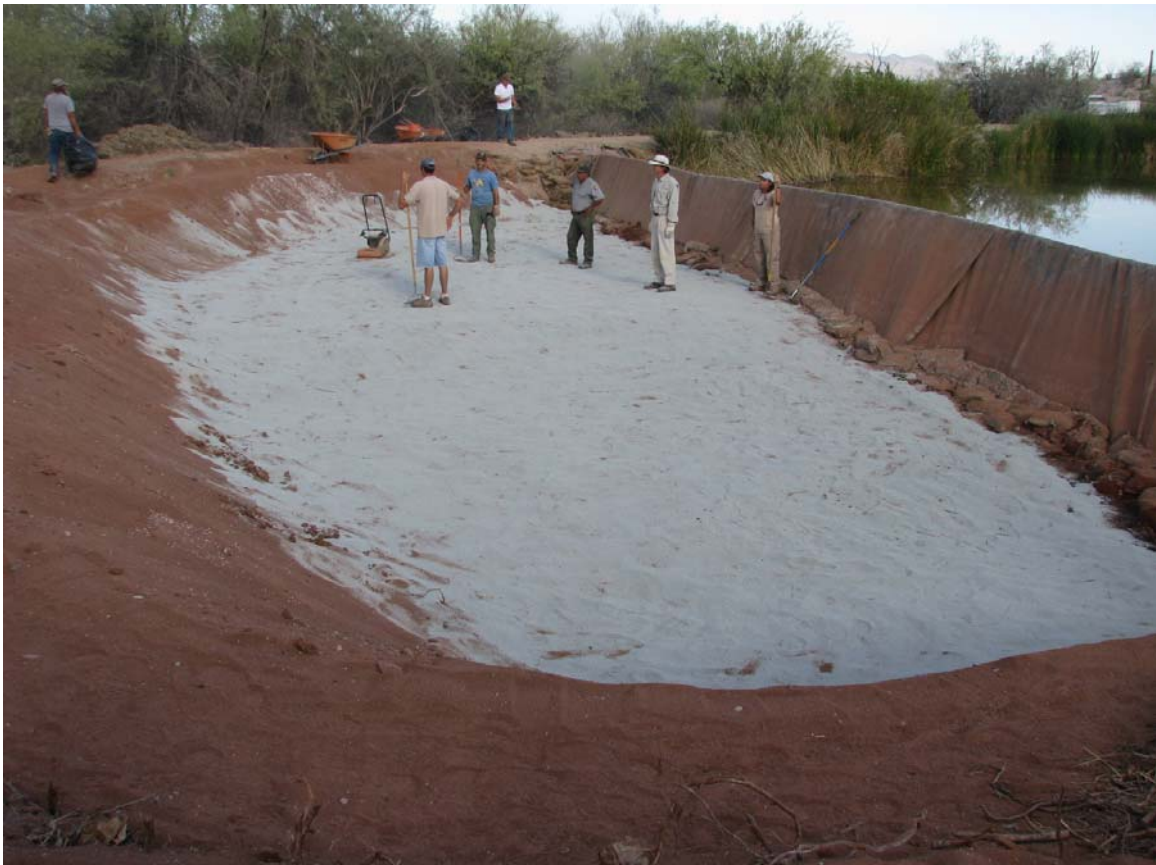
Figure 14. Layer of bentonite (white) spread on the pond bottom, awaiting overlayer of red fill material prior to compacting. The former deep well area was in the lower left corner of this view. August 28, 2009.

On this date, reinforcing the pond bottom was completed. Another layer of bentonite was spread on the pond bottom, at approximately 2 lb per square foot (Figure 14). Following that, approximately 2” of fill material were spread on top of the bentonite and the entire bottom compacted. This sequence was repeated once again. The resulting new bottom was approximately 5” to 6” thick after compaction, with about 4 to 5 lbs of bentonite per square foot (Figure 15). The small deep well area of the southeast corner, approximately 10 feet in diameter, was originally about 20 inches deeper than the adjacent parts of the southeast corner. It was filled almost level with the rest of the pond bottom, using fill with high concentrations of bentonite.

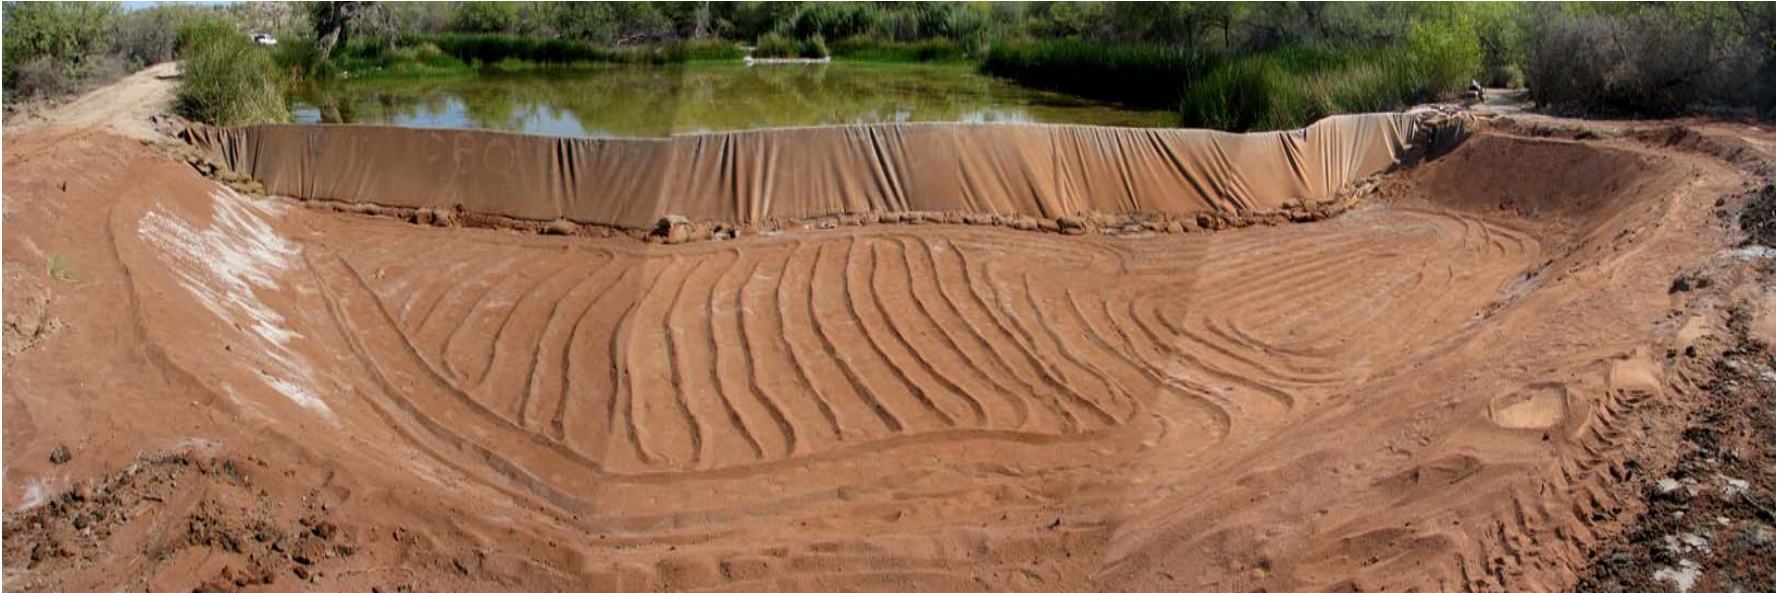
Figure 15. Southeast corner of Quitobaquito Pond, renovated and sealed with a compacted mixture of clean earth and bentonite. August 28, 2009.

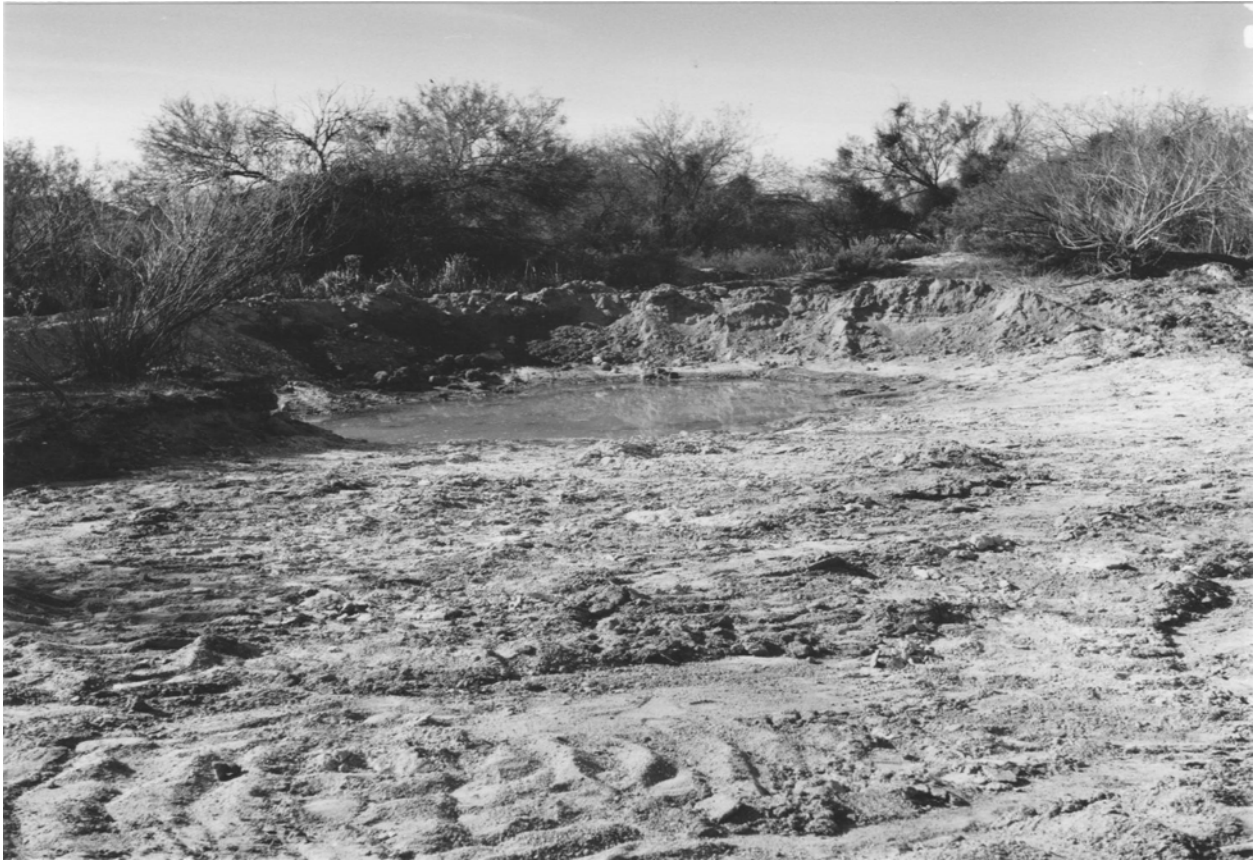
Figure 18. Quitobaquito Pond, view from center of pond southeast, into southeast corner, January 1962. Photograph taken during major 1962 renovation. NPS File photo, W.F. Steenburg.

- The 1962 renovation may have compromised a pre-existing clay-sealed pond bottom, by digging the “well” area &/or by cutting the “trench” feature. The damage may simply have taken 45 years to manifest.

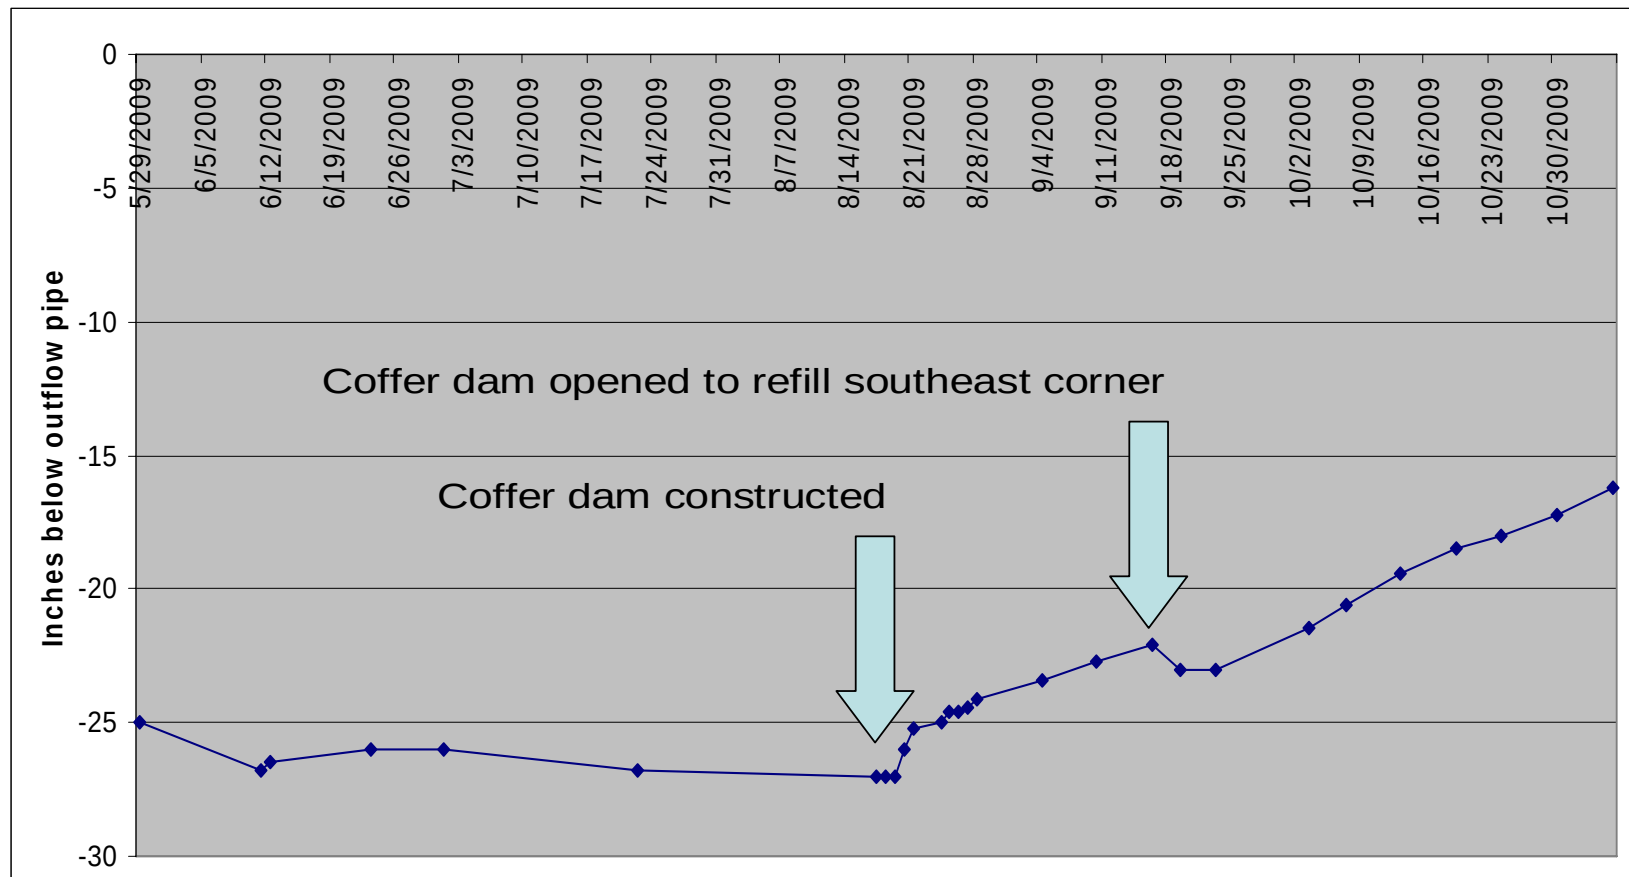
As more weeks pass since the southeast corner renovation, with a steadily rising pond level, it appears more and more evident this project corrected a major part of the water deficit in Quitobaquito Pond. The specific location and cause of that leakage was not confirmed. If it was in the southeast corner, it was most likely one or several of the following:

Figure 19. Trend in surface elevation of Quitobaquito Pond, May 29 – November 5, 2009. Rising trend began when the southeast corner was sealed off with a temporary coffer dam August 18. The southeast corner was drained, renovated and re-sealed August 17-28 and was re-filled September 16-19. The coffer dam was removed September 23. Organ Pipe Cactus National Monument, Arizona.
