**Project Summary**  
**Quitobaquito Pond – Cottonwood Sealing**  
**October 18 - 28, 2010**

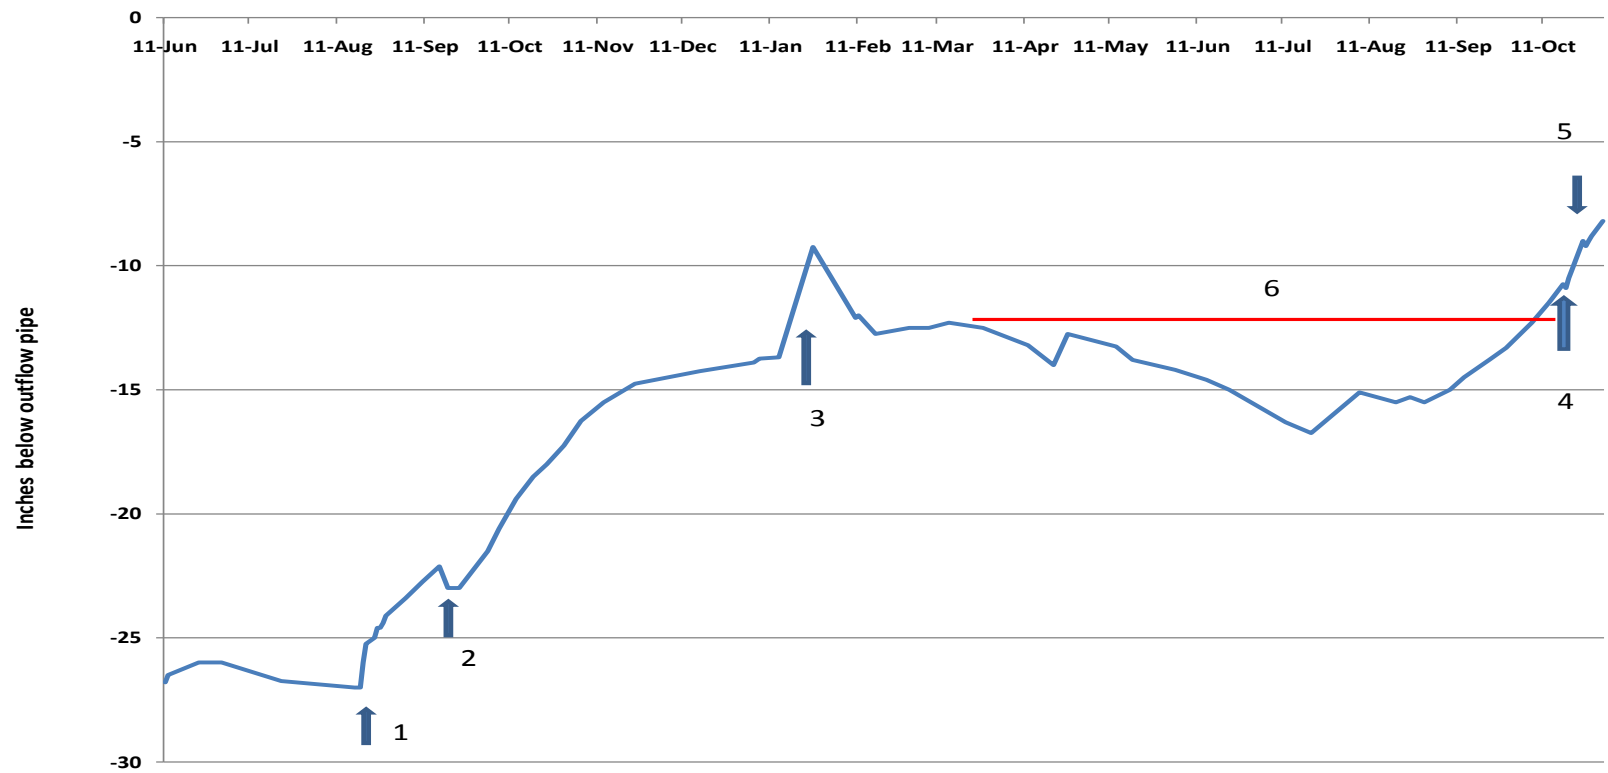
Figure 1. Trend in surface elevation of Quitobaquito Pond, June 2009 – November 2010. 1) Southeast corner renovation initiated; 2) SE corner re-filled, using water from main pond; 3) Large rains of Jan '10, followed by rapid water loss 4) Cottonwood sealing project initiated; 5) Cottonwood sealing project ended; 6) Apparent maximum possible pond level (minus 12") following loss of January rain input.

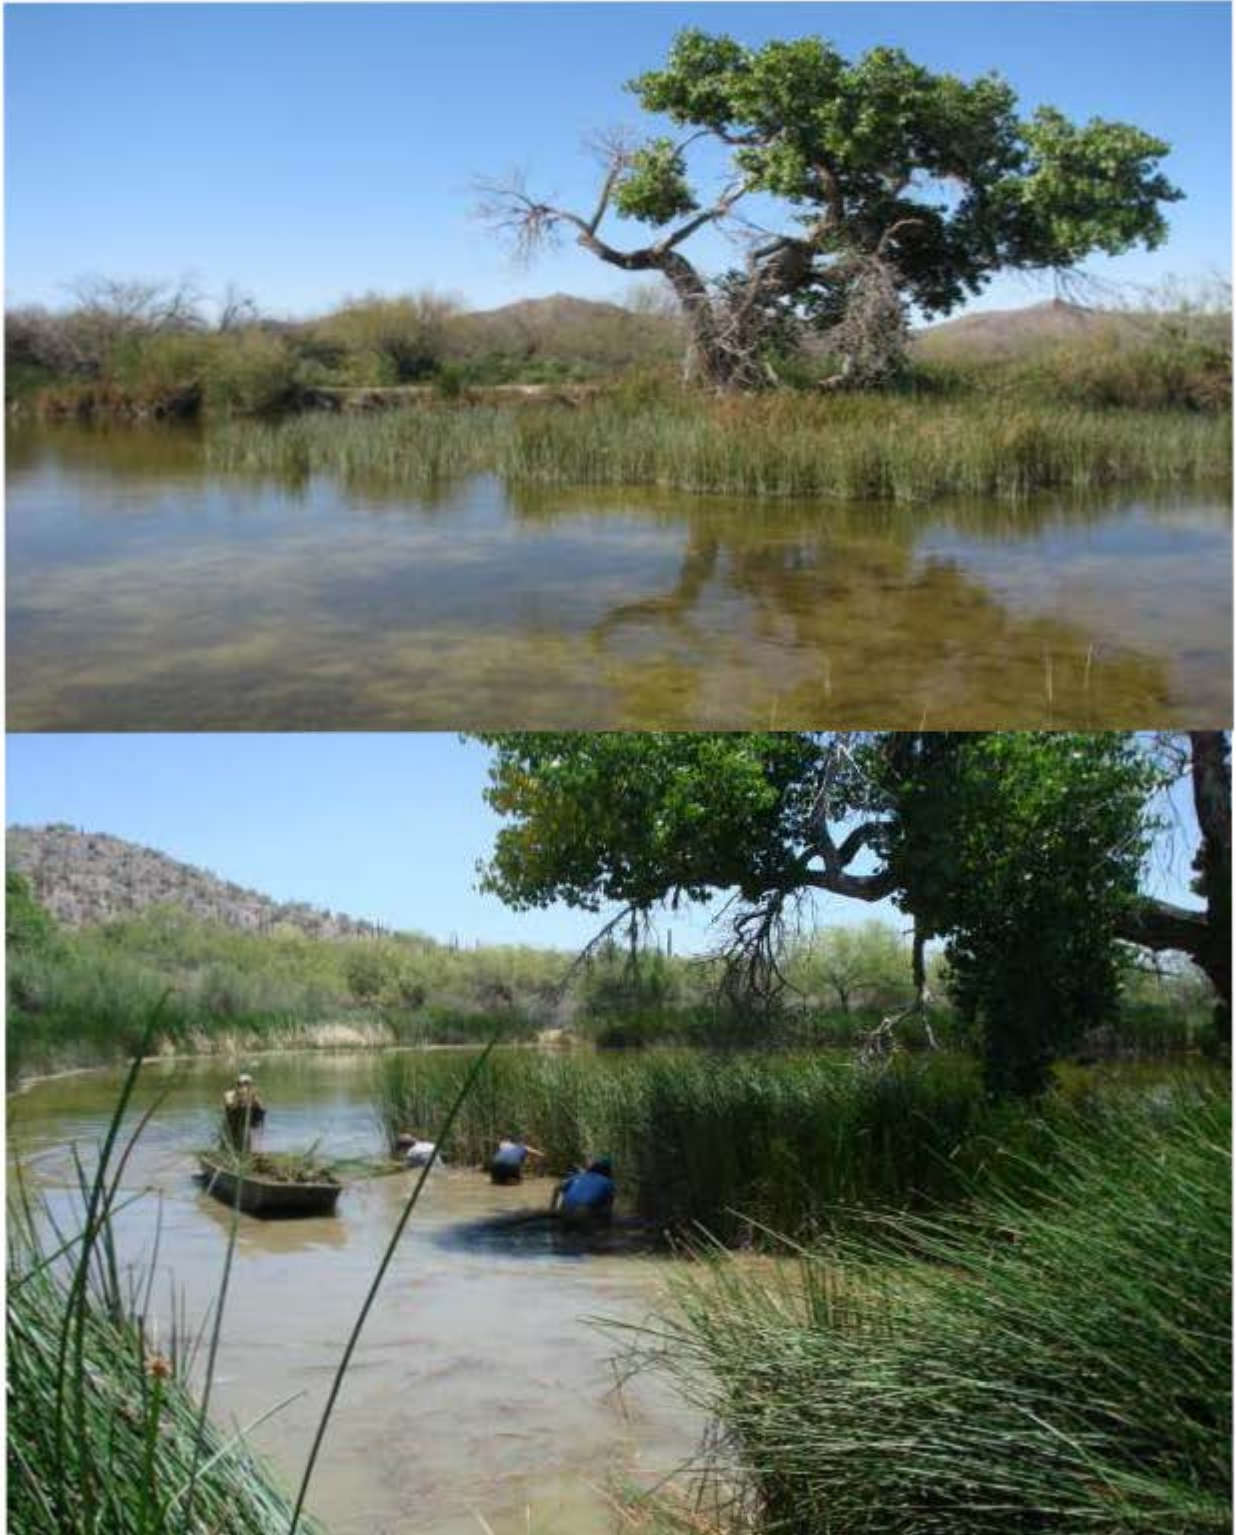
Figure 2. New bulrush stands surrounding the cottonwood, established since 2008. Upper view is from north shore to the south, lower view is from northwest shore bench to east, with workers removing bulrush.

- 1) During the spring and summer of 2010, a large peninsula of bulrush extending from the cottonwood into the pond was removed manually (Figure 2). During low-water periods since 2008, this peninsula had grown almost all the way across the pond, and had set the stage for the entire northwest end of the pond to fill in with bulrush (Compare Figure 2 with 12b, which predates the bulrush encroachment). Approximately 1200 ft<sup>2</sup> of this bulrush was removed manually, because it was beyond the reach of a backhoe operating on shore. Bulrush

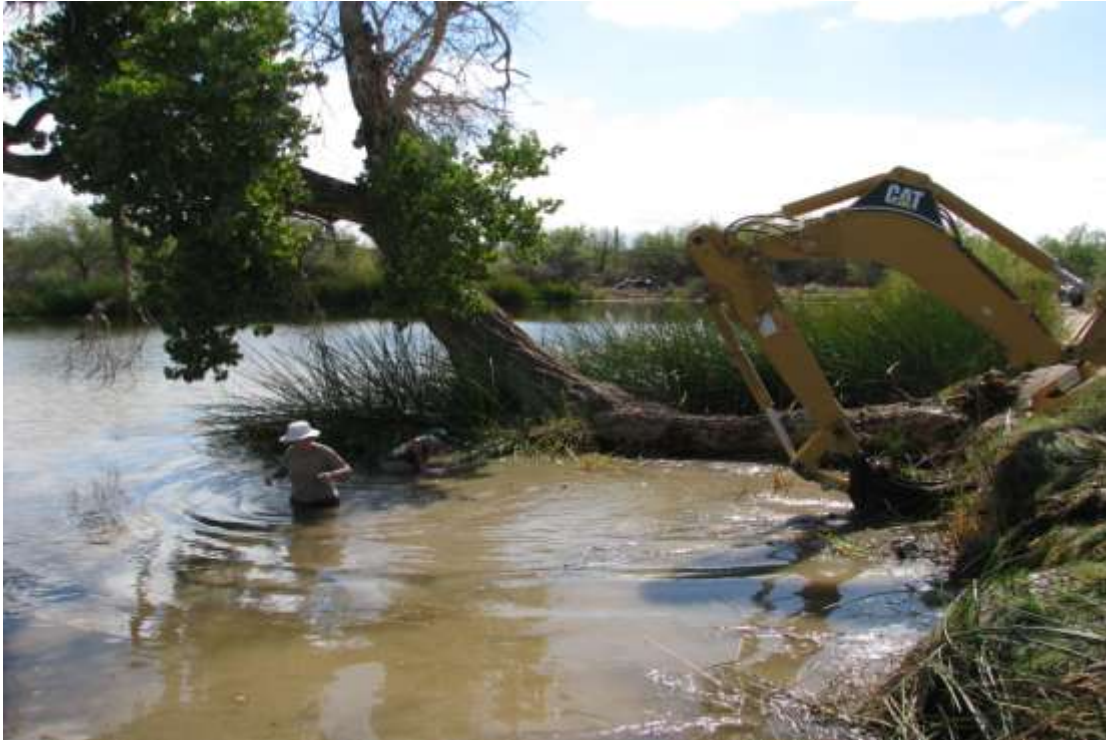
Figure 3. Removing bulrush encroachment and inspecting for Sonoyta mud turtles. The near side of the tree has been stripped of bulrush; bulrush remains on the far side. October 18, 2010.

2) October 18, a backhoe was used to carefully remove the remaining, extensive dense bulrush stands alongside the cottonwood, and along the inner face of the berm for about 50 feet on either side of the tree (Figure 3). Great care was taken to avoid disturbing the pond bottom or retaining berm with the backhoe. As bulrush was removed from the pond and placed on the retaining berm, workers examined the root masses to locate and remove Sonoyta mud turtles. Nine were found in the removed bulrush. Another 19 mud turtles were trapped in the pond. All 28 mud turtles were taken to monument HQ to be held for the duration of the project. The bulrush was then removed from the site.

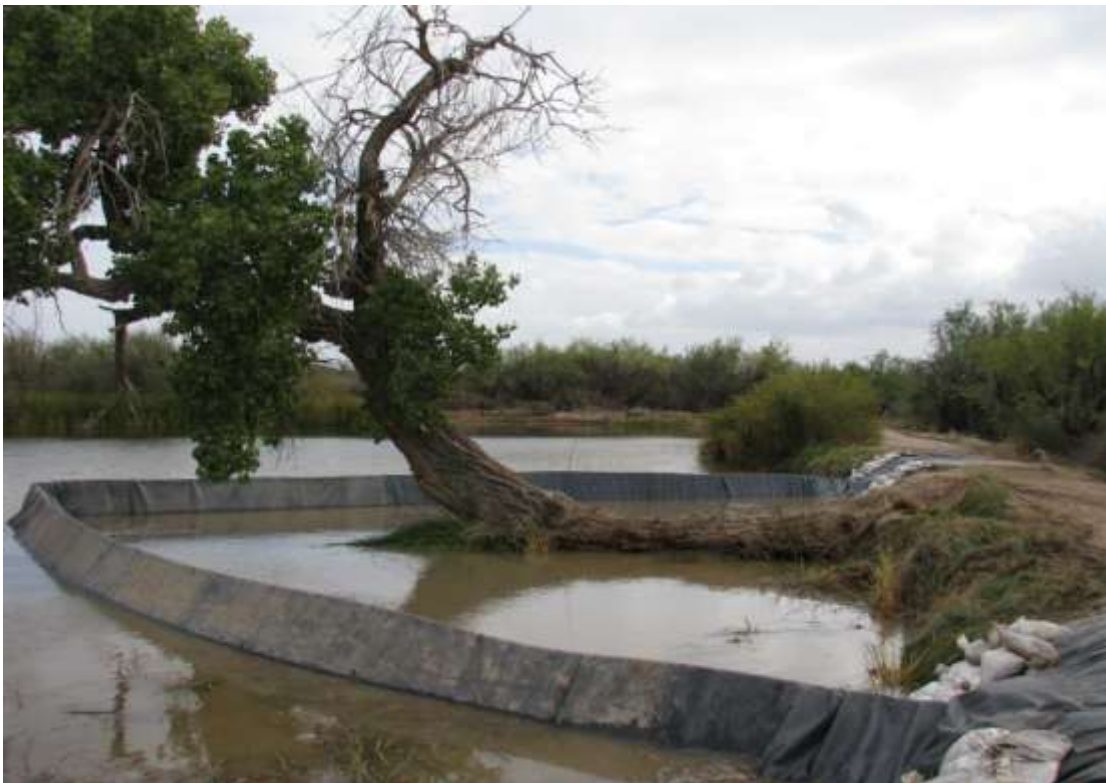
Figure 4. Cofferdam in place. October 19, 2010.

3) October 19, an area of about 1,250 square feet around the cottonwood tree was sealed off from the remainder of the pond, using a 112-foot long temporary coffer dam consisting of vinyl pond liner material draped over a PVC-pipe frame, stabilized and sealed by sandbags (Figure 4). This was the same coffer dam used successfully in the southeast corner renovation in August 2009.

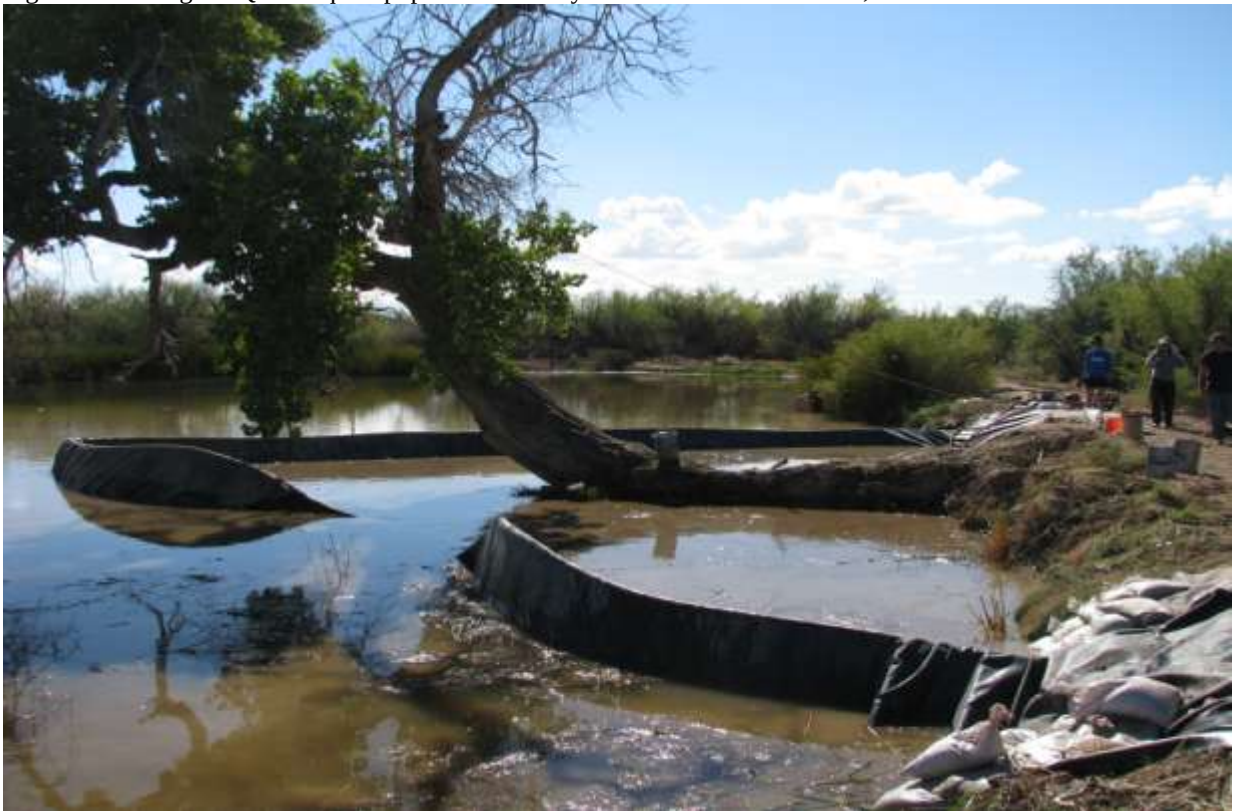
5) October 21, the pond surface had again raised 0.4" overnight (see Discussion). Water pumping resumed. When the pond project area water had been lowered about 7", the other side of the coffer dam failed (Figure 6). That side was taken apart, and rebuilt with interior and exterior reinforcement. Water pumping resumed, and the dam failed a third time, when the interior water level had been lowered about 8". With proof that the temporary dam was not capable of holding back the newly-restored water column in the pond, on-site activities were concluded for the week.

Figure 6. Cofferd dam failure. October 21, 2009.

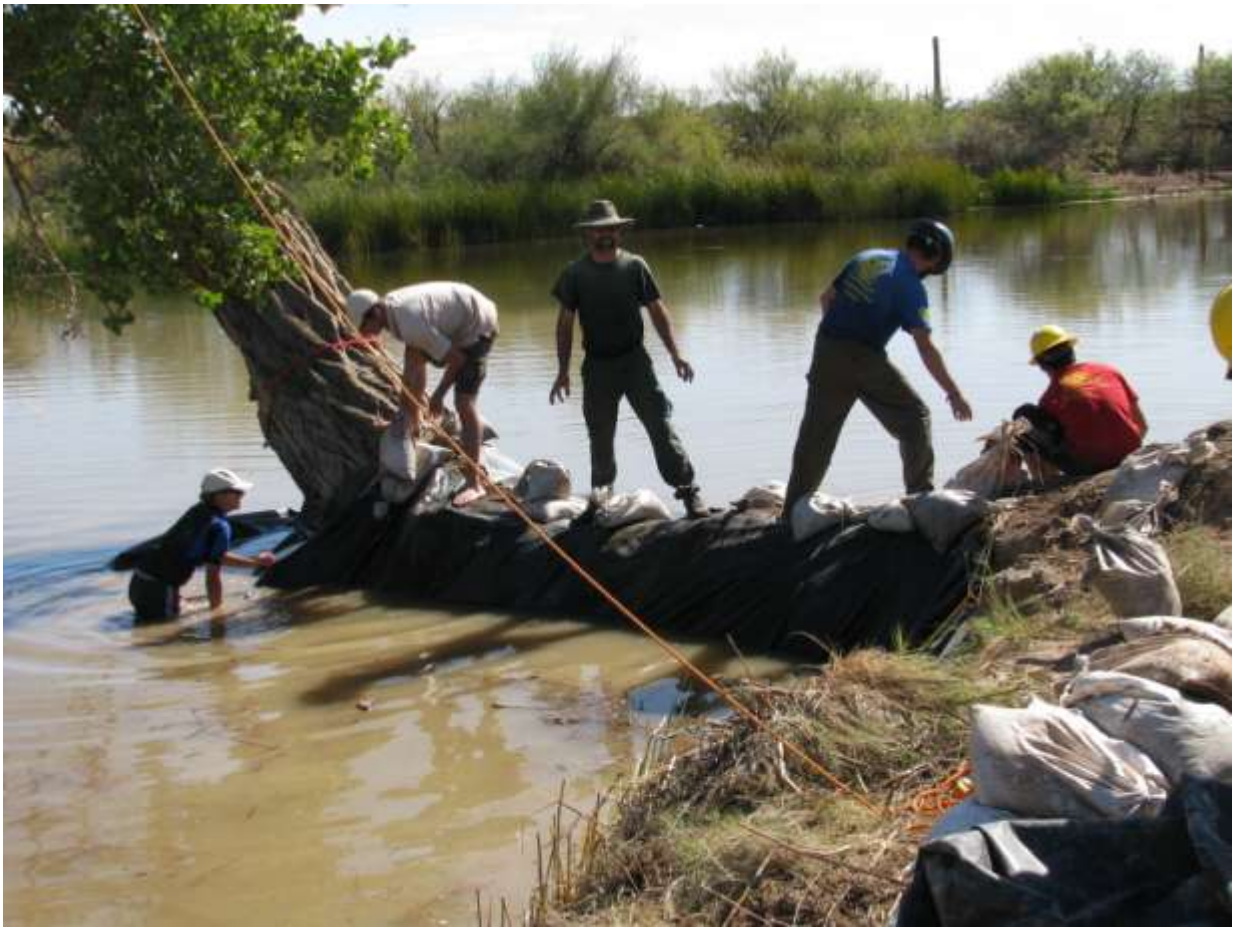
Figure 7. Sealing tree with pond liner. October 26, 2010.

The temporary coffer dam was disassembled and removed from Quitobaquito. A 72-foot long and 15-foot wide piece of pond liner was then draped around the cottonwood, and against the inner face of the retaining berm for about 8 feet to either side of the tree. The pond liner was sealed in place with sandbags, and rope holding it to the underside of the tree’s curve (Figure 7). On this day additional bulrush was removed from the west end of the pond, using a backhoe working from shore.

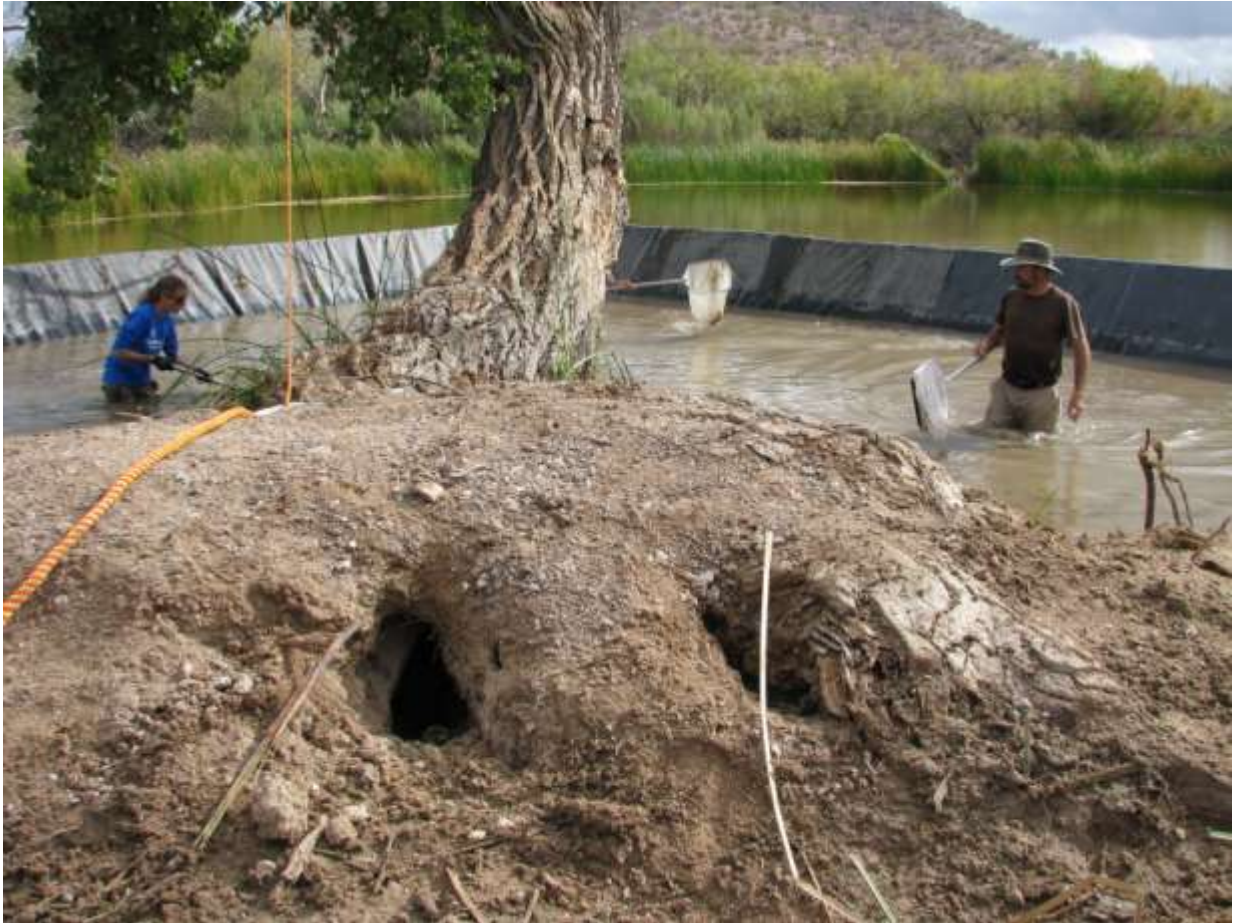
Minutes before the dam began to fail the 3rd time, a preliminary inspection of the underside of the cottonwood was begun. In the center of the old branch scar, a 1.5" to 2" diameter hole was located. A shovel handle was inserted into the hole for a distance of 3 ft or more, with little resistance. The hole is at about the "minus 12 inches" level where a large remaining leak is suspected. Approximately a half-bag (25 lbs) of bentonite was pushed down the hole just as the dam collapsed, again inundating the area.

9) October 28, the pond surface had raised 0.2” overnight, to minus 8.8 inches. The hole at the base of the tree was probed again, and found to extend at least 5 feet down into the berm interior, within the inside face of the berm and among cottonwood roots. Another 145 lbs of bentonite were pushed into the hole, using a tamping rod and water. This brought the quantity of bentonite in the hole to about 175 pounds, or 3 ½ bags. Although the hole might have nothing to do with water loss from the pond, it was also consistent with conceptual models of a large-volume leak, given the circumstances of the tree. It was decided that filling it with bentonite could do no harm.

Figure 9. Holes at base of cottonwood, among roots and extending into berm. Eventually found to extend 5 feet down and toward pond. October 20, 2010.

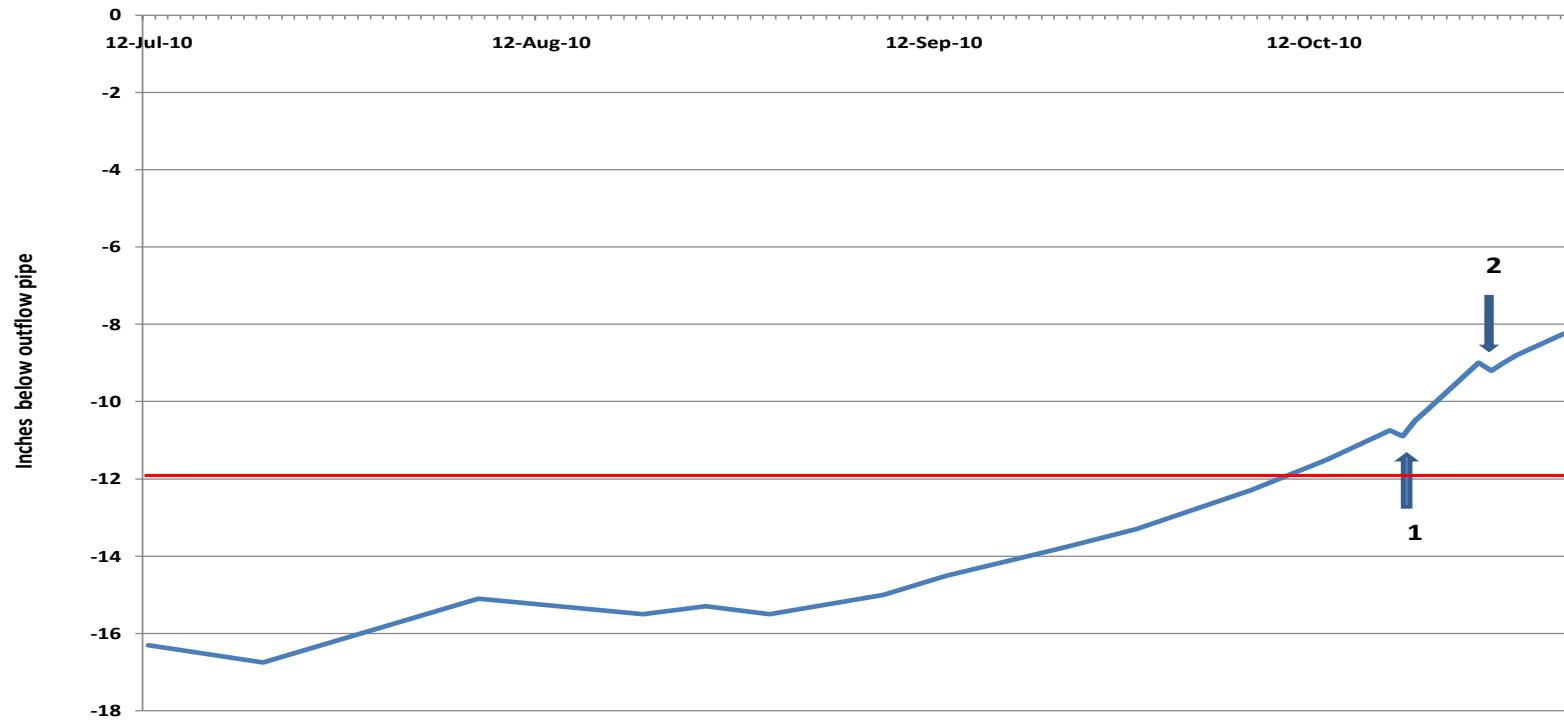
The accelerated rate of the increasing pond level observed during this recent project strongly indicates substantial water loss via the cottonwood tree (Figure 10). As noted above, the rate of vertical rise approximately tripled, during the period that the cottonwood was separated from the pond by the coffer dam, and after bentonite had been inserted into a hole in the tree. The loss of 0.2" observed between October 25 and 26 may suggest that sufficient water pressure had built up to re-activate a leak in the cottonwood tree. October 26, funnel-shaped holes were seen in the bentonite that had been packed into the tree, suggesting water had forced bentonite farther into the hole. That hole is now separated from the pond by pond liner, and has had

additional bentonite inserted into it. The rate of increase has diminished, from 0.4" per 18 hours when the coffer dam was in place, to 0.15" per 24 hours Oct 28-Nov 1, after the tree had been wrapped with pond liner. This diminished rate may mean that the pond liner seal around the cottonwood is not as complete a seal as the coffer dam was. The rate observed Oct 28-Nov 1 is essentially the same as that observed in the week prior to the project. However, an important distinction exists. As the pond's water column rises, the surface area increases. Particularly along the north and northeast shorelines, the pond edge is a gentle slope – unlike the vertical bank of the retaining berm. As the water level rises, new areas are saturated along the north and east shores; much of that area consists of new land built by bulrush encroachment since 1962. And much of that land has not been saturated at current levels since 2006. In short, on November 1, the pond was rising 0.15" per day, nearing the minus 8" level. This may indicate an even greater daily net gain of pond volume than on October 13, when the pond was rising at 0.13" per day but was 3.5" lower, nearing 11.5".

Figure 10. Trend in surface elevation of Quitobaquito Pond, 12 July – 1 November 2010. 1) Cottonwood sealing project initiated, with initial 0.25" loss due to bulrush removal; 2) Cottonwood sealing project ended, with 0.25" loss due to actual loss, bulrush removal, &/or observer variation. Note steeper curve between points 1 and 2, indicating faster increase in water level. Red line indicates apparent maximum possible pond level (minus 12") observed just prior to and after loss of large January 2010 rain input (Figure 1.).

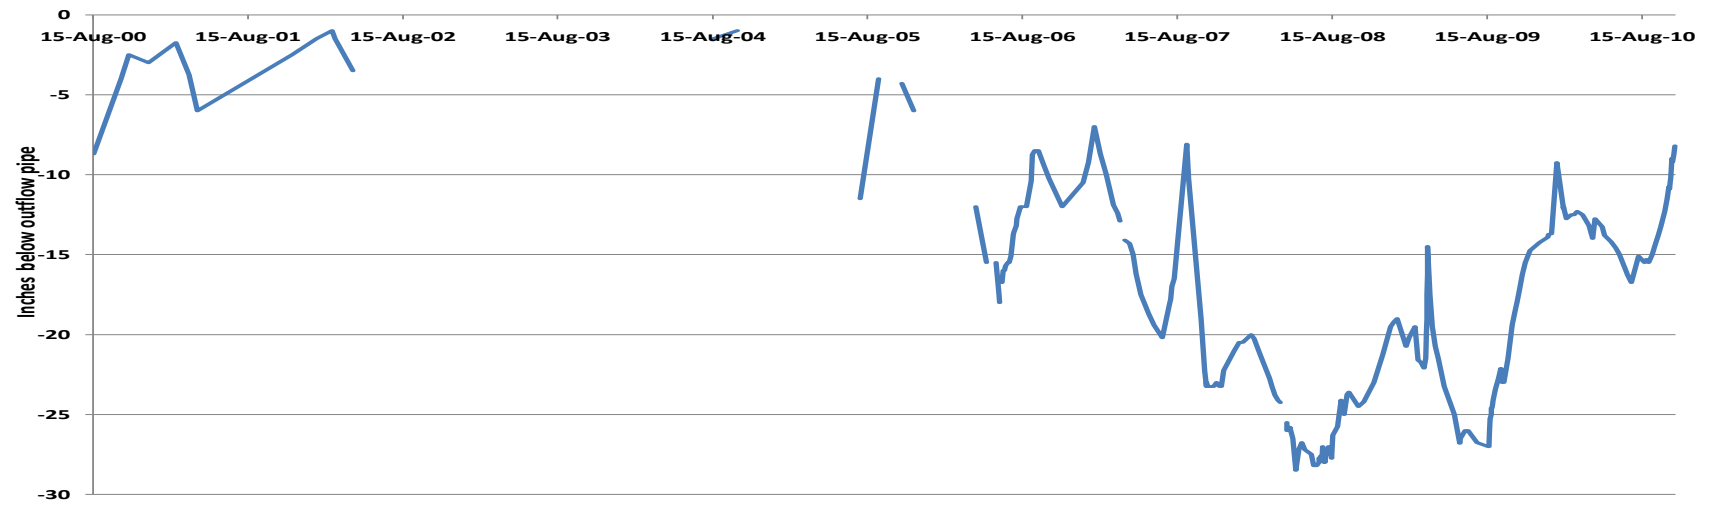
As of November 1, the pond was at minus 8.2". This was the highest, most stable pond level since early 2006 (Figures 11 and 12), and was nearly 4" higher than a maximum capacity of minus 12" that was believed to exist through most of 2010. It is not possible to conclude how much temporarily sealing the cottonwood tree is contributing to the current increase in pond level, or the pond's ability to continue rising above the minus 12" level. It is possible that the positive trend in late 2010 would have persisted even without temporarily sealing the cottonwood. It is possible the positive trend in late 2010 is a delayed effect of the August 2009 southeast corner renovation. That project had immediate positive effect (Figure 1), but a full year may have been required for its full effects to develop. It is also possible that some unknown leak (e.g. rodent burrow or tree root cavity) that opened naturally 3 to 4 years ago has now closed naturally. Regardless of the reason, Quitobaquito Pond has been restored to approximately 80% of its normal post-1962 depth, and may continue to rise. The increasing water pressure may re-activate leakage, but that remains to be seen. Considerable pond area (possibly 25%) has been displaced by bulrush encroachment during the low-water period of 2006-2010. However, the deeper water should now inhibit further rapid bulrush encroachment.

Figure 11. Surface elevation of Quitobaquito Pond, Organ Pipe Cactus National Monument, August 2000 to November 2010.
