National Park Service  
Cultural Landscapes Inventory  
2010

Seneca Lock  
Chesapeake and Ohio Canal National Historical Park

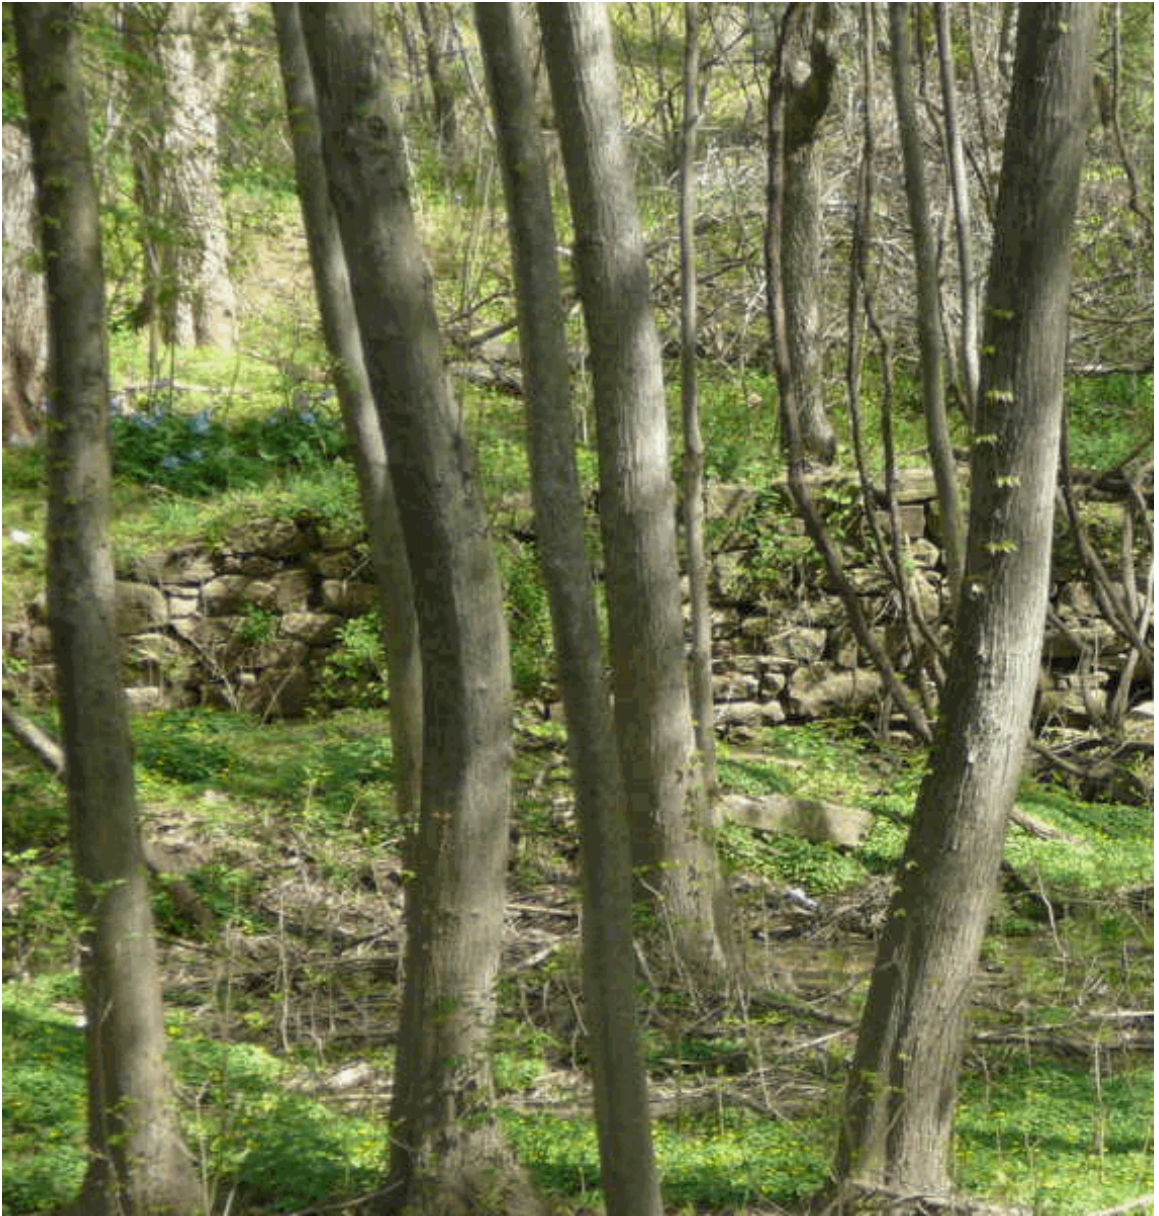
Today the remnants of these ruined warehouses can still be found along the berm wall of the prism, just east of the remains of the east basin. The ruins are difficult to interpret and should be investigated further to determine their extent and provenience.

*Warehouse Ruins (CLP,2010)*

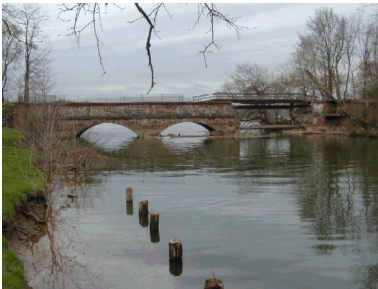
The upstream face of the aqueduct up from the spring of the arch to the coping stone has a noticeable tilt towards upstream. The running water of the canal has worn away the mortar joints, the spring blocks of the piers and abutments have settled, and one inch cracks at the spring near the upstream side of the barrel of the arch become four inches at the crown. These cracks appear old and the spreading has been so gradual that the upstream wall face has tilted as a whole rather than developing multiple joint cracks. This pulling away of the face has weakened the barrel vault and resulted in cracks and missing stones on those interior surfaces.

*Seneca Aqueduct, inlet side. Seneca Creek is in the foreground. (NPS/LCS 2005)*

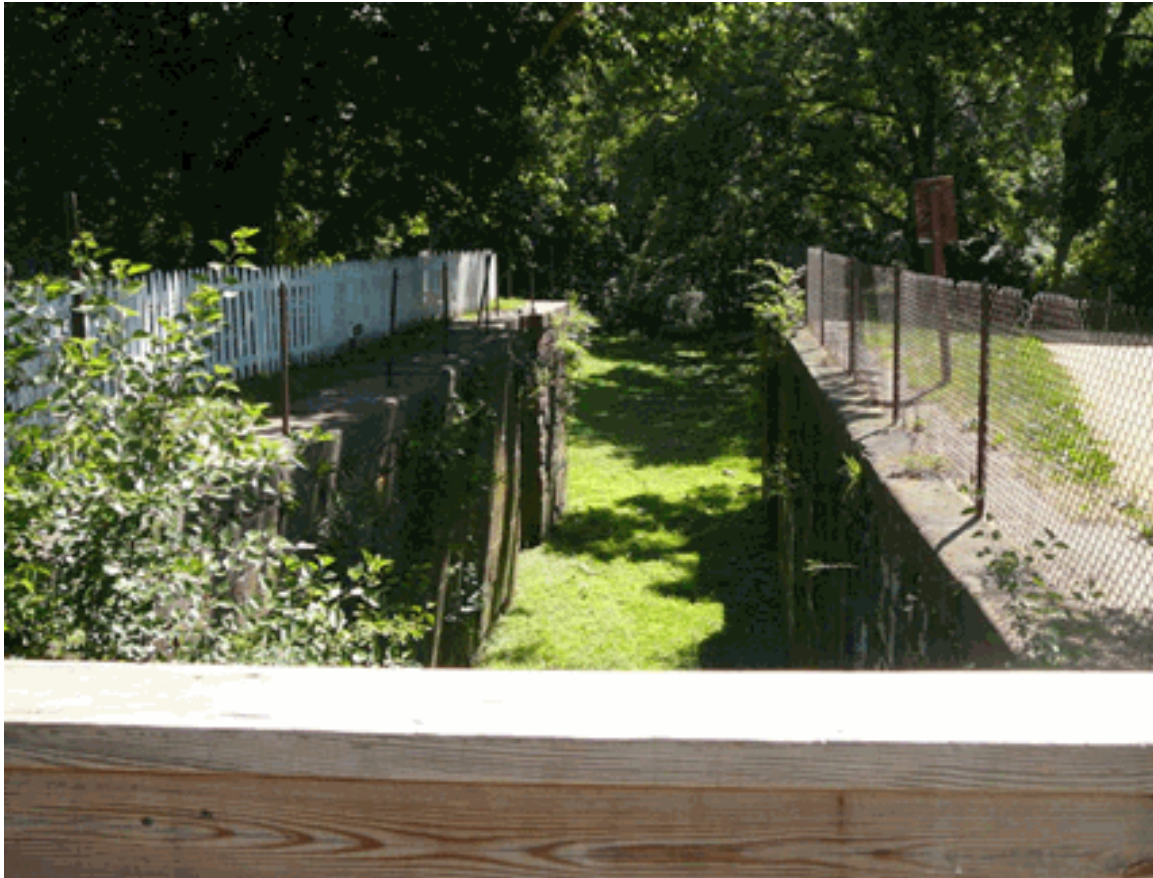
The lock, which is not watered, is currently a stable structure. The wooden lock gates are gone. Archaeological testing of the lock floor indicates that it was made of wood, as was typical of C&O Canal locks, and was repaired with concrete and asphalt in the early 1900s (Ziek 1979). It is listed on the LCS as a ruin. Sometime after the NPS acquired the canal, a metal link fence was installed along the top of the lock and aqueduct. The metal fence posts have been inserted into the coping stones of both structures and this has a negative impact on the structure.

*Lock 24, looking east. (CLP, 2010)*
