**National Park Service  
Cultural Landscapes Inventory  
2005**

**Anacapa Island Light Station  
Channel Islands National Park**

# Cultural Landscape Inventory: Anacapa Island Light Station

CONDITION ASSESSMENT: **GOOD**

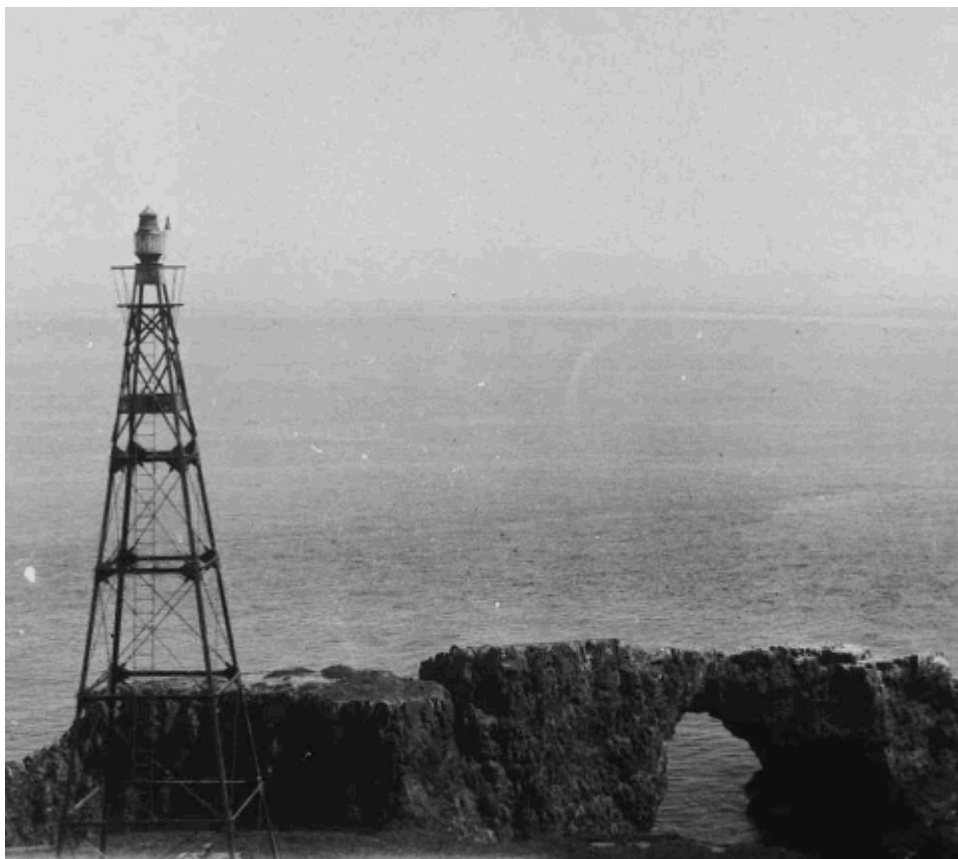
*History #2: Circa 1911 to 1932 photo of the original acetylene light was a simple steel skeleton tower, fifty feet east of the present lighthouse. (US Coast Guard Historians Office collection)*

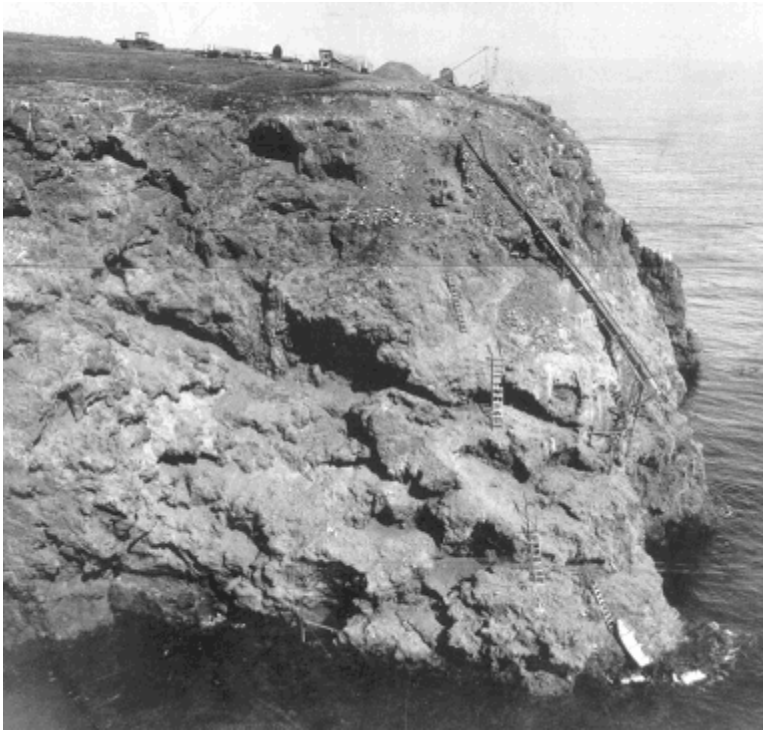
*History #3: In September 1930, the Roth Construction Company had not yet constructed the landing cove stairs. The job was supposed to be thirty percent done at this time. (Circa 1930, Channel Islands National Park archives)*

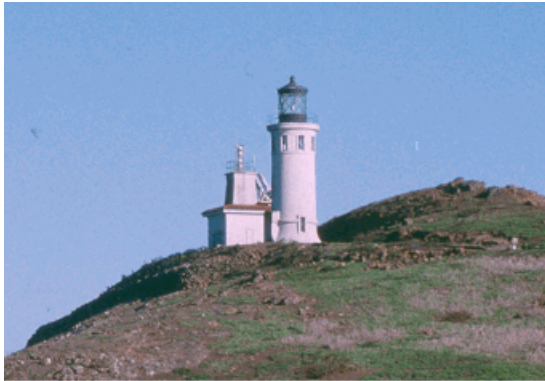
A riprap stone retaining wall is located below the lighthouse (see photo, Buildings and Structures #1). The approximately 168-foot long wall does not appear to be associated with any cut and fill in the area, rather the stabilization of the easily erodable slope. A gradient of stone sizes compose the wall with larger stones found at the bottom of the two- to eight-foot high wall.

*Buildings and Structures #1: The lighthouse and fog signal building were constructed of reinforced concrete on eastern tip of the island. The retaining wall is located to the left of the structures. (PWR, CLI, CHIS-S-0013-10, 2004)*

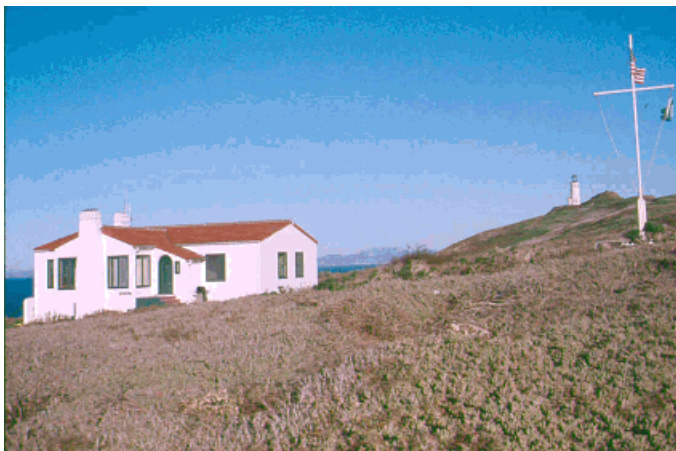
Spanish Revival design includes a red tile roof, stucco exterior and arched doorway. The tile roof was replaced in 1973 in kind (see photo, Buildings and Structures #2). The asbestos shingles that covered the original stucco walls since 1968 were also removed at that time. New flashing and some of the copper gutters and downspouts were also replaced. A low stucco wall and attached entrance which surrounded part of the yard were removed at an unknown date.

*Buildings and Structures #2: The last of the four residences with the flagpole, the lighthouse is in the background. (PWR, CLI, CHIS-S-0013-11, 2004)*

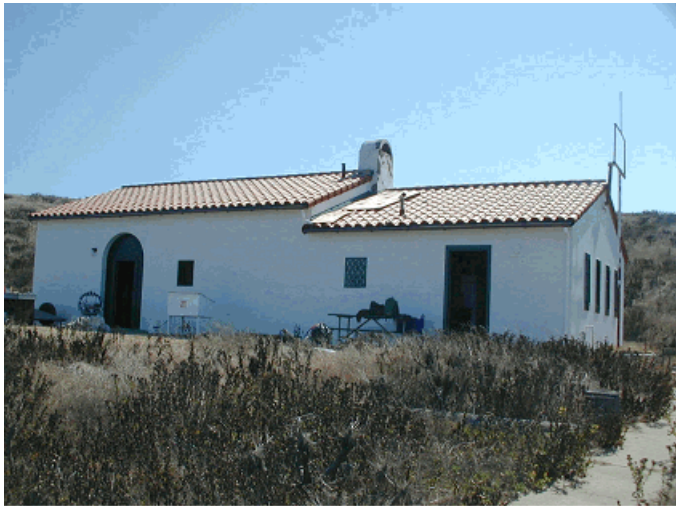
The reinforced concrete Spanish Revival utility structure provided electrical power to the light station. The power house has stucco walls and red tile gable roof. A chimney with a half-barrel chimney cap is situated at the location of the height change on the two-level roof (see photos, Buildings and Structures #3). The 25 x 65 foot building includes a shop and generator room. A room on the west end served as a radio room. An addition was constructed on the west end in 1978 by the National Park Service, at which time the roofing tiles were replaced in kind. (personal communication between the author and Kent Bullard.

*Buildings and Structures #3: Note the stepped roof line and half-barrel chimney cap on the power house. (PGSO, LCS, 2001)*

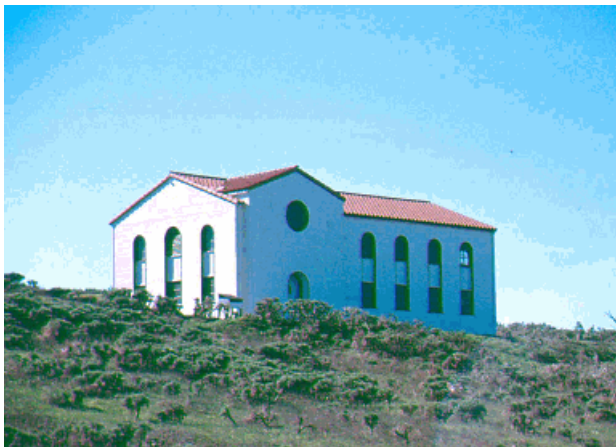
maintain the buildings comprising the light station. In 2001, the assistant keeper's residence, power house, general service building and tank house were painted as part of cyclic maintenance. And in 2004, the redwood water tanks, which continue to hold the water supply for the island, were repaired.

*Buildings and Structures #4: The tank house contains the original two 50,000 gallon redwood tanks which still hold water for the island, pumped up from boats in Landing Cove. (PGSO, CLI, CHIS-S-0012-13, 2004LCS, 2001)*

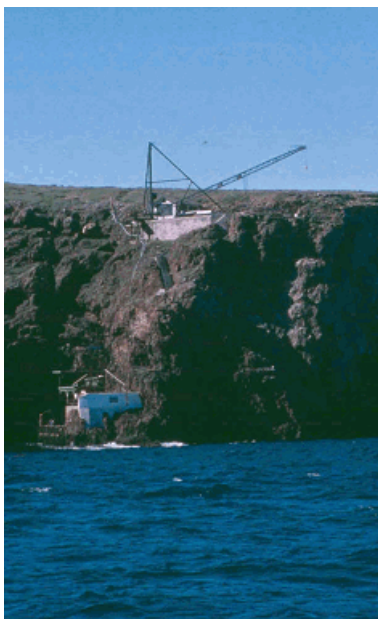
*Buildings and Structures #5: The dock, lower landing, stairways, derrick, upper landing, and derrick building provide the only way to transport goods to and from the island. (PWR, CLI, CHIS-S-0012-9, 2004)*

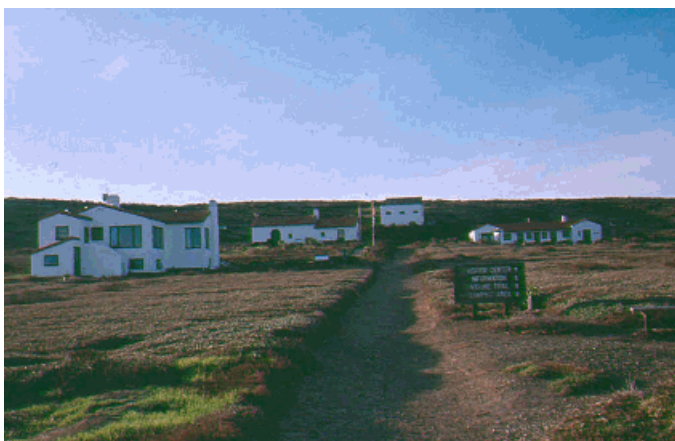
*Circulation #1: The residence and power house are on the left side of the road from the landing through the light complex while the general service building is on the right. The oil house is at the end of the road. (PWR, CLI, CHIS-S-0013-34, 2004)*

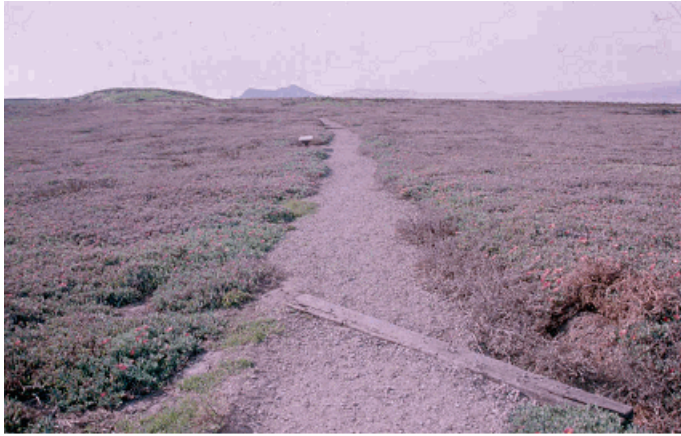
*Circulation #2: A typical example of the trail on Anacapa Island. Ice plant blankets the surroundings. (PWR, CLI, CHIS-S-0014-26, 2004)*

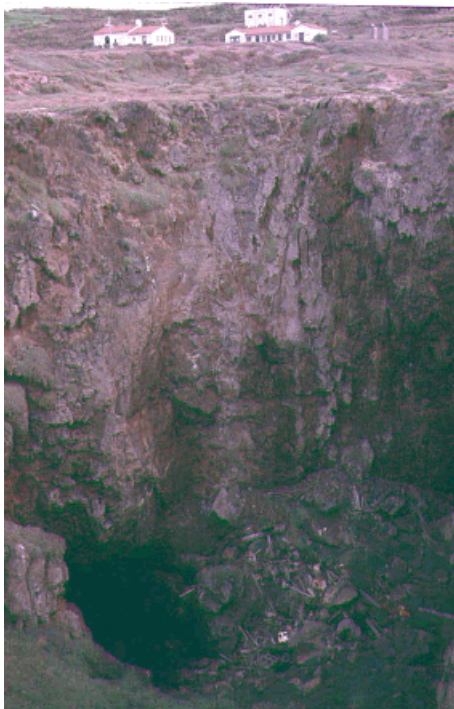
The refuse generated by the residents of East Anacapa Island was dumped over the edge of the island into “Trash Cove,” northwest of the lighthouse complex (see photo, Land Use #1). Debris scatters can be found around the top of the cove and trash can be seen at the bottom of the cove. While Trash Cove is no longer used as dump, debris from over seventy years remains on the protected terrace below. Garbage generated on the island is now removed via park boats.

*Land Use #1: Trash Cove provided light station residence with an easy way to remove debris. Rope and plastic hose can still be seen hanging from the ragged cliff edge. (PWR, CLI, CHIS-S-0014-32, 2004)*

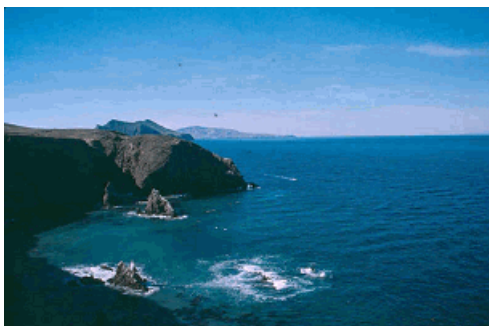
*Natural Systems and Features #1: View from Cathedral Point of the sheer cliffs and rugged shoreline of Anacapa Island. (PWR, CLI, CHIS-S-0012-19, 2004)*

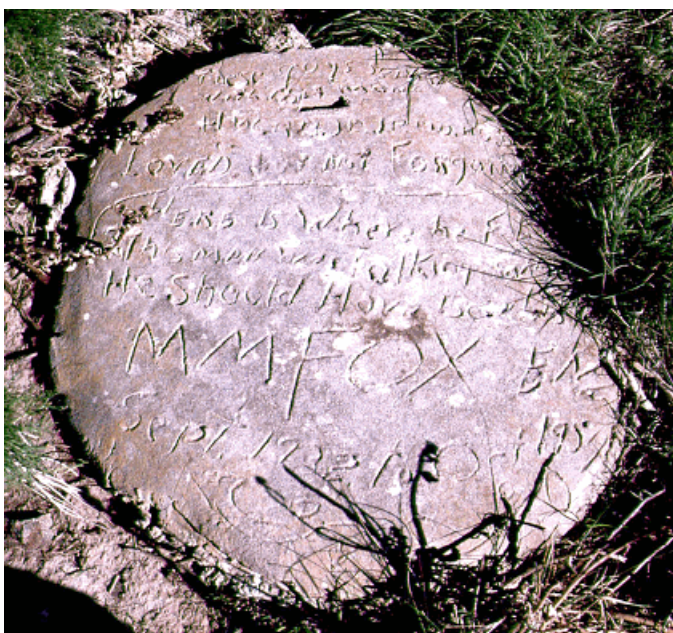
*Small Scale Features #1: One of the thirteen known commemorative plaques within the district. This plaque has more involved text, telling the story of an accident on the island. (PWR, CLI, CHIS-S-0013-27, 2004)*

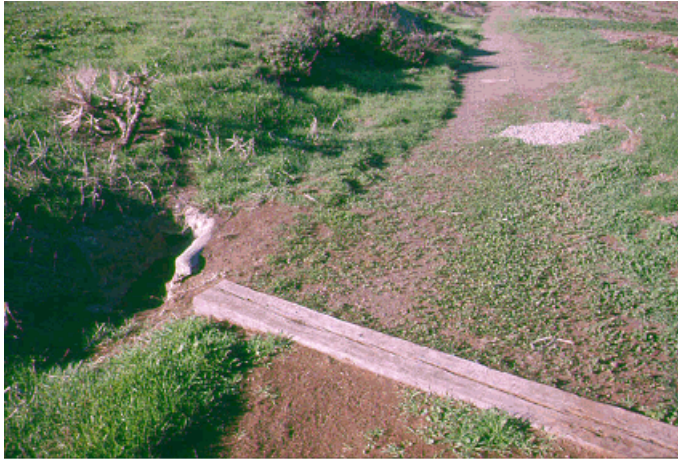
*Small Scale Features #2: Railroad ties angle across the roads and trails to assist in channeling the water of the road to prevent wash-outs, often directing water into one of the many concrete culverts. (PWR, CLI, CHIS-S-0014-11, 2004)*

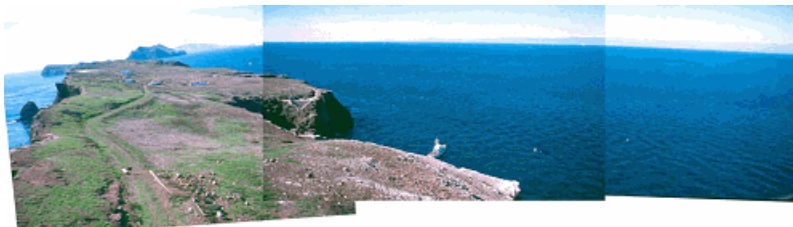
*Views and Vistas #1: The view from the lighthouse, overlooking Anacapa Island and Santa Cruz Island to the west. The Santa Barbara Channel is to the north and northeast. (PWR, CLI, CHIS-S-0012-32, 33, 34, 2004)*
