# **RUINS STABILIZATION IN THE SOUTHWESTERN UNITED STATES**

Compiled by  
ROLAND VON S. RICHERT and  
R. GORDON VIVIAN

**National Park Service**

U. S. Department of the Interior  
Washington 1974

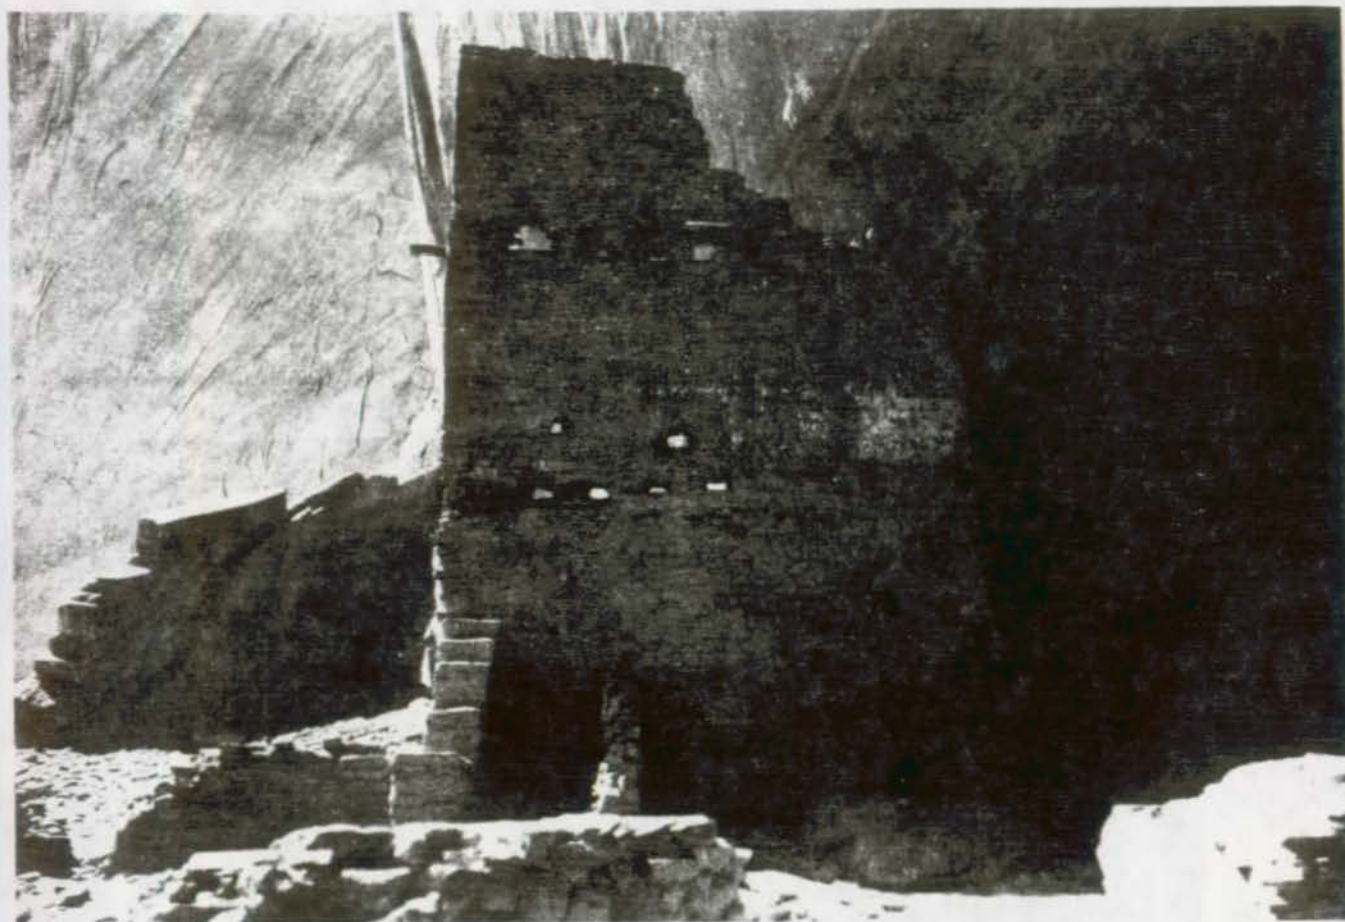
FIGURE 1. Settling caused by lack of foundations and unstable fill. Bond between stone and soil mortar is poor. Holes are caused by decay or theft of wood members. (Antelope House Ruin, Canyon de Chelly National Monument, Ariz.)

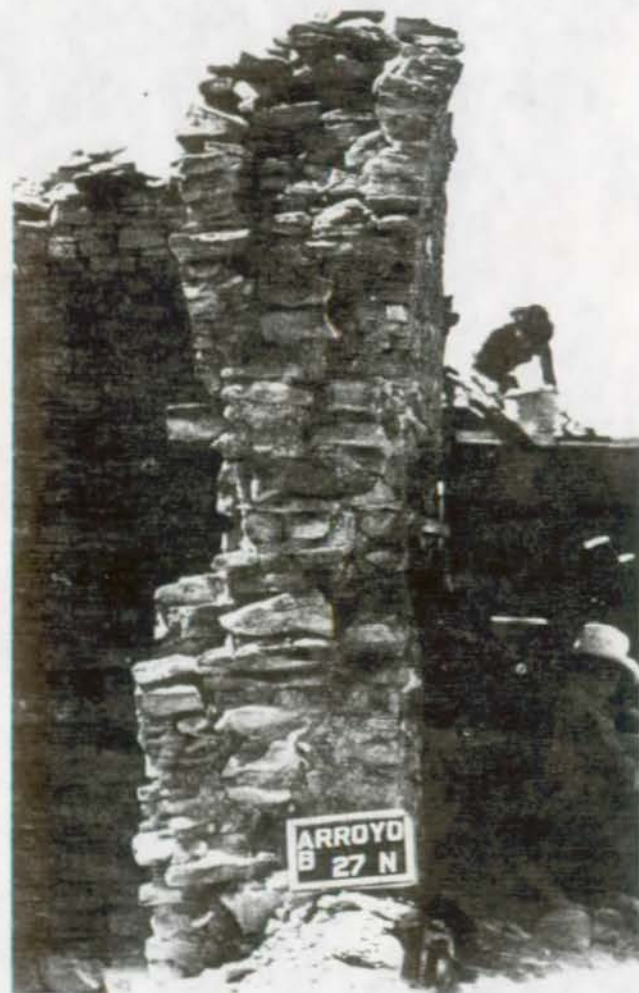
FIGURE 2. Aboriginal construction often left narrow strips at ceiling line. This wall is much wider at the top than in the center. (Room 27, north wall, Pueblo del Arroyo Ruin, Chaco Canyon National Monument, N. M.)

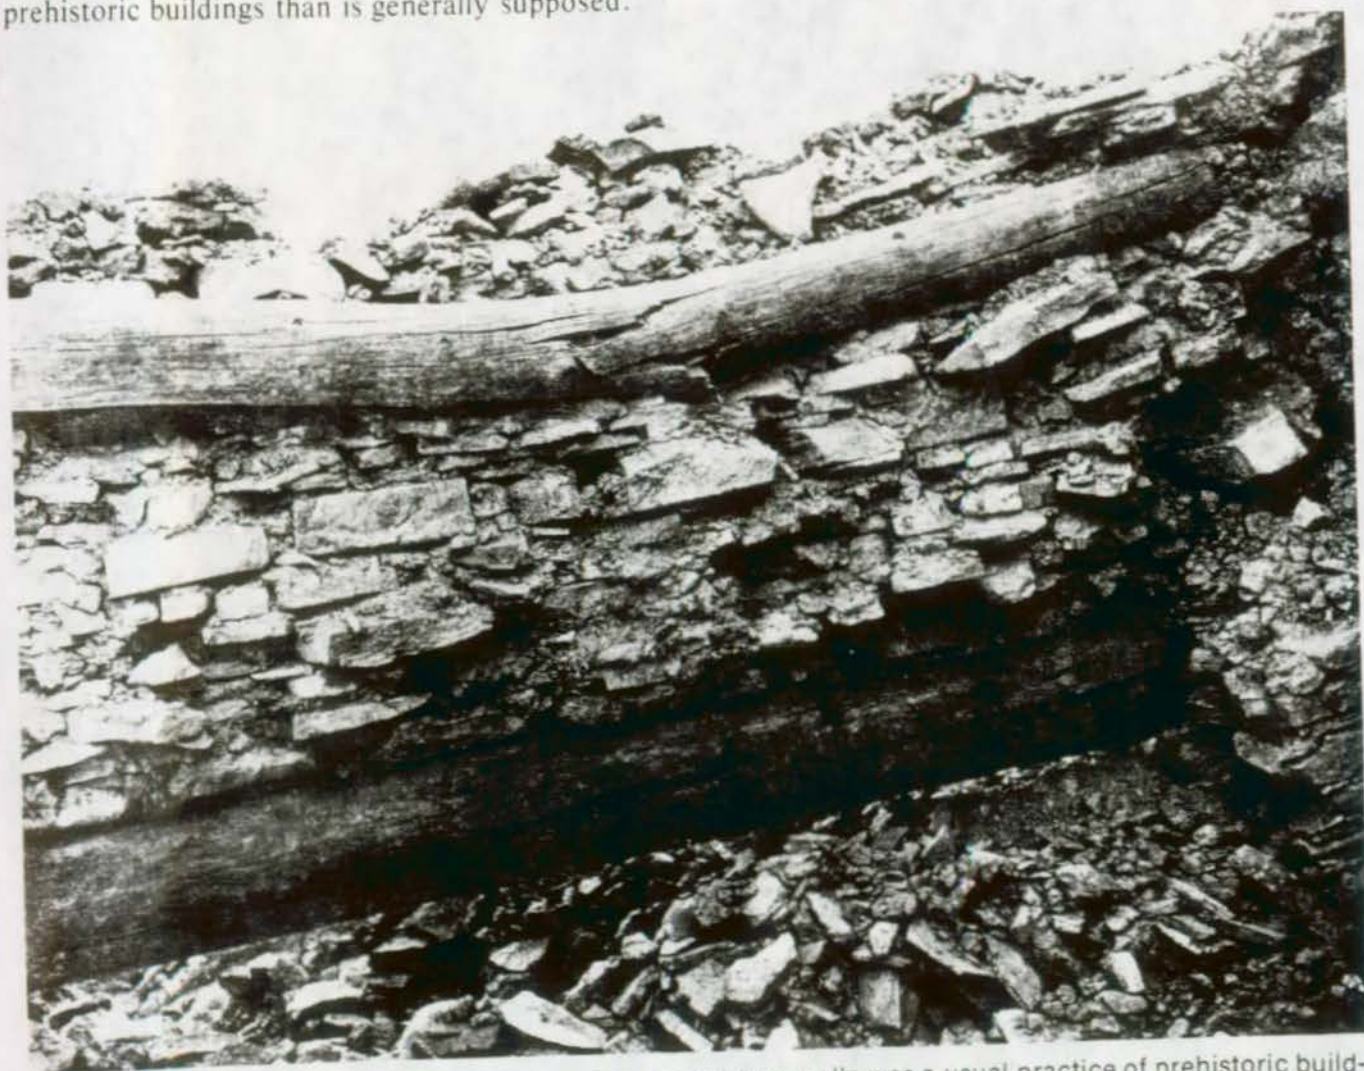
FIGURE 3. The inclusion of heavy timbers within cored-type walls was a usual practice of prehistoric builders. Collapse of walls from flood damage at Chetro Kettle exposed 300 logs similar to those above. (Chetro Kettle Ruin, Chaco Canyon National Monument, N. M.)

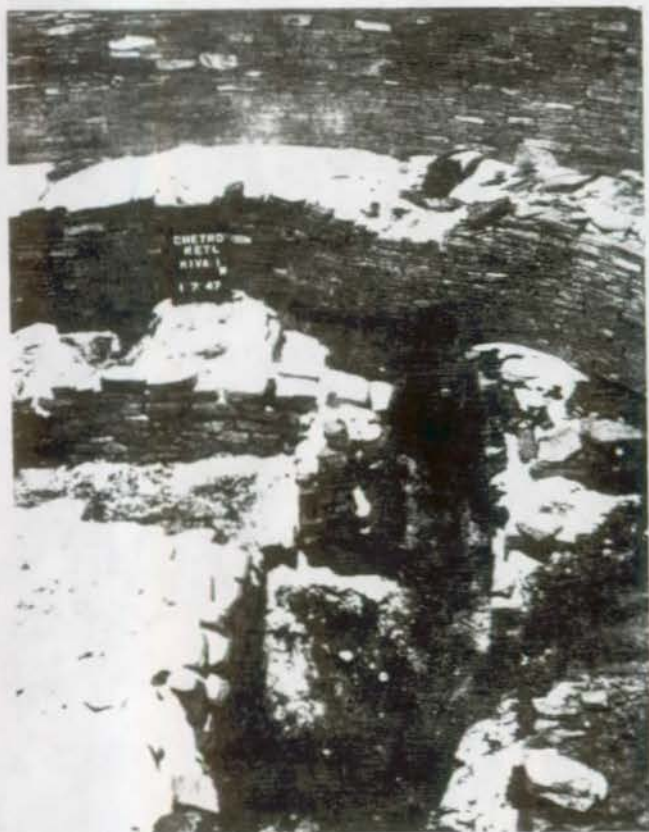
FIGURE 4. Excavation neither proceeds nor ends on a single plane and often leaves walls unsupported. (Kiva I, west perimeter, Chetro Kettle Ruin, Chaco Canyon National Monument, N. M.)

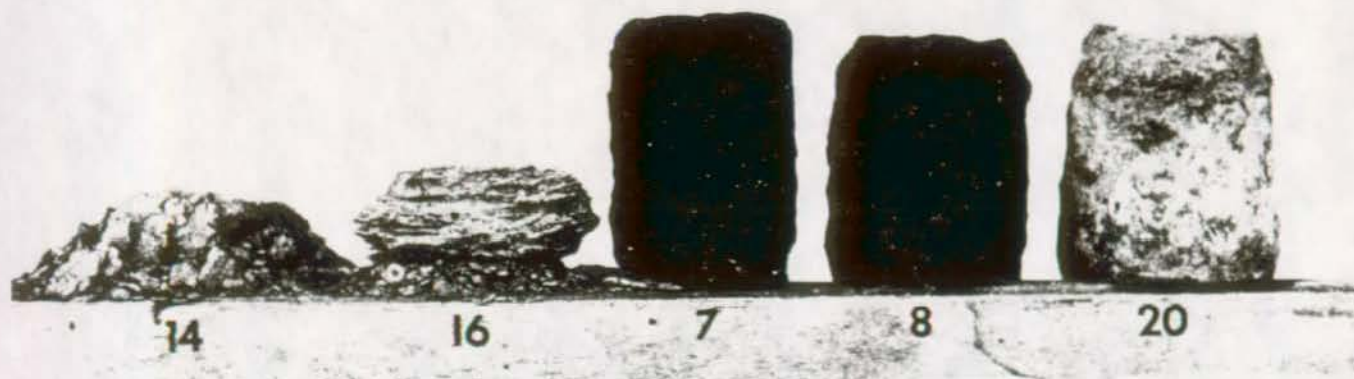
FIGURE 7. Selected cylinders subjected to freeze-thaw test. Nos. 14 and 16, with 10 and 12 percent cement by volume respectively, failed at the third cycle. Both were made up with equal parts clay and silt-loam. No. 20, with 15 percent cement by volume, is shown at the 12th cycle. Nos. 7 and 8, consisting of three parts clay, two parts silt-loam, and emulsified bitumen, were tested in conjunction with the soil-cement and are shown at the 15th cycle.

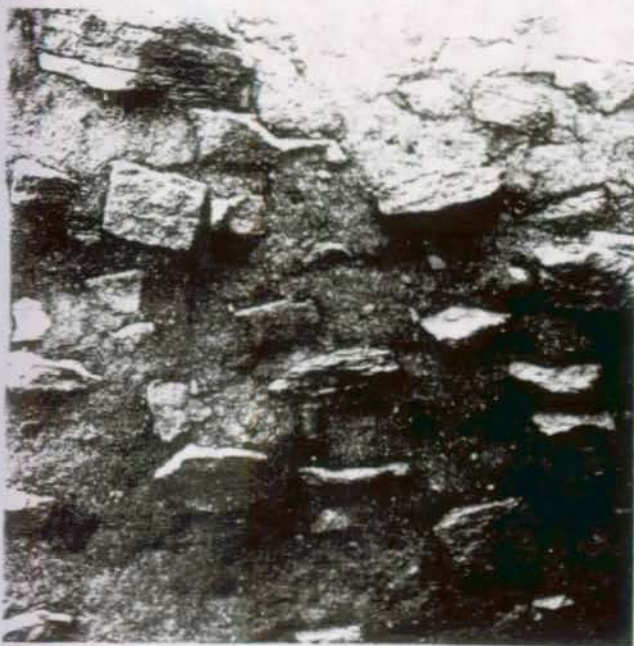
FIGURE 8. The use of heavy grouting to replace native soil between random stone; after 10 years exposure to the elements. (West Ruin, Aztec Ruins National Monument, N. M.)

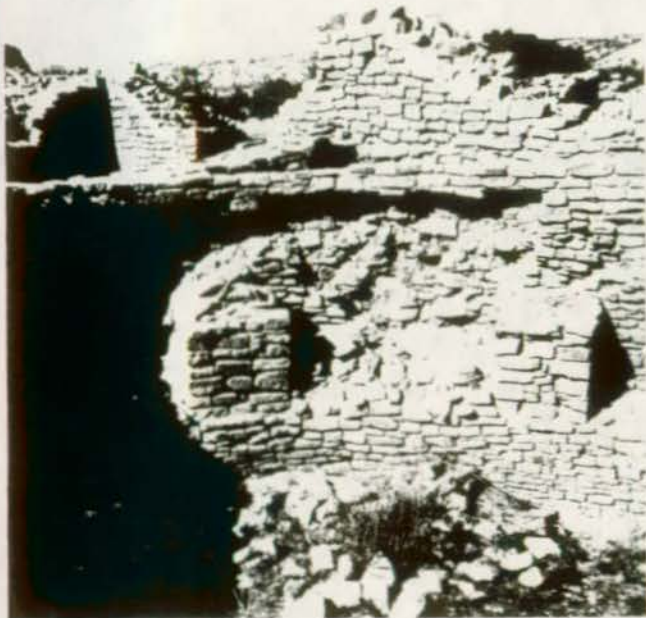
FIGURE 15. Damage caused by outward movement of moisture from fill behind kiva wall. The most severe disintegration is at the limit of capillary rise, just below the concrete capping. (Clan Kiva, West Ruin, Aztec Ruins National Monument, N. M.)

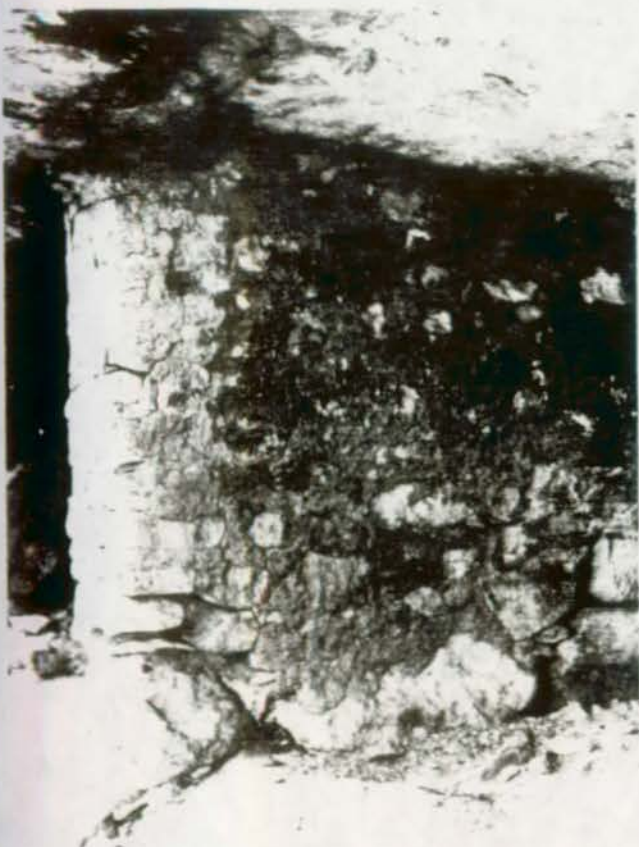
FIGURE 16. Damage as the result of rising moisture from melting snow. Note that decay is confined to the limit of capillary rise in the mortar column. (Cliff dwelling in Walnut Canyon National Monument, Ariz.)

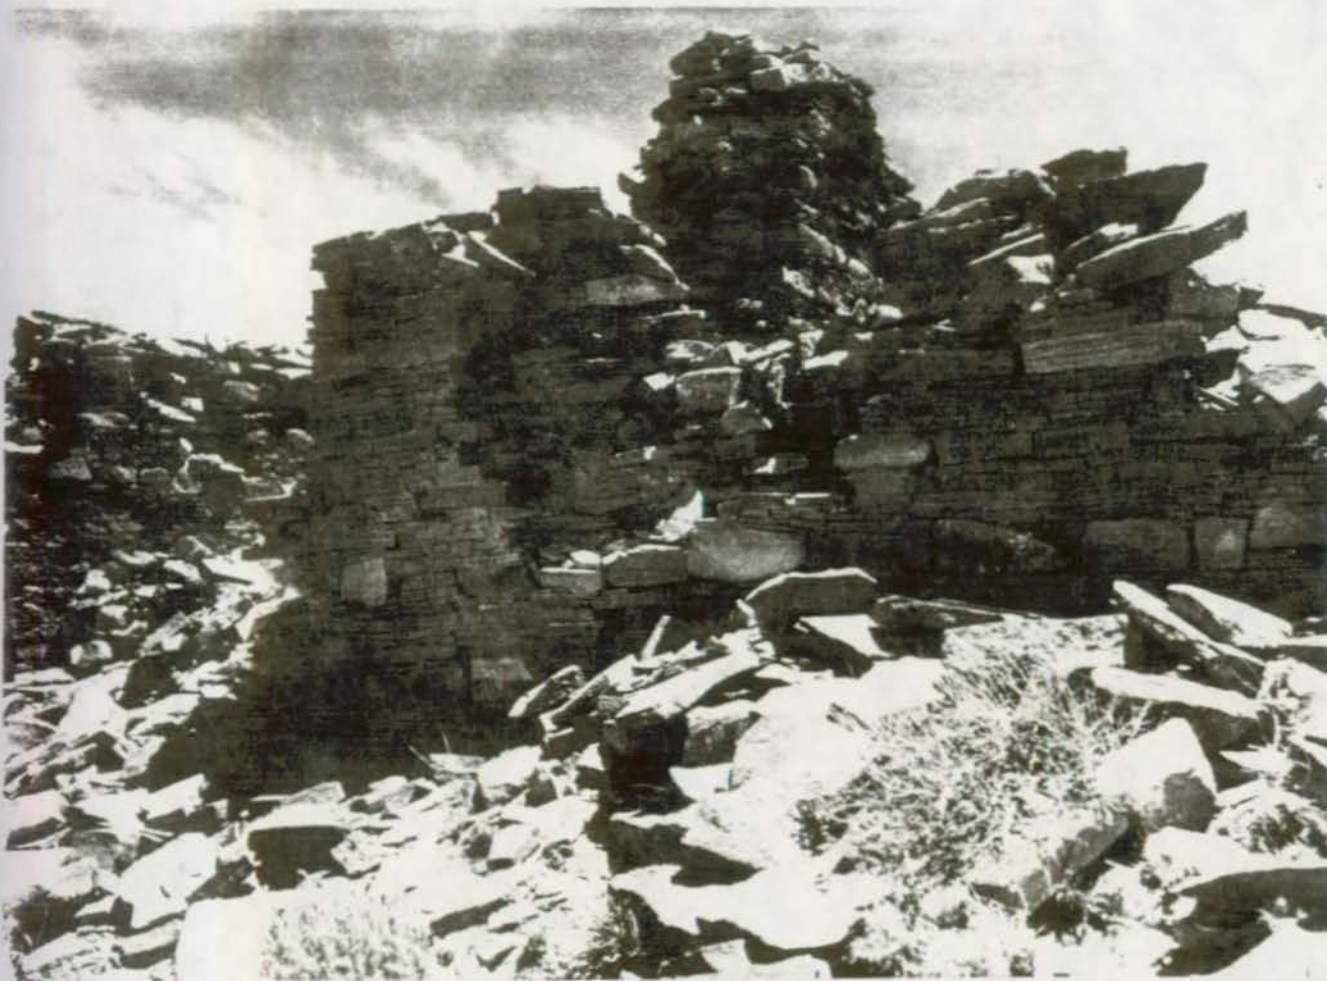
FIGURE 23. An example of soft, pecked and dimpled stone in random areas over wall surface. Replacement of the stone requires extreme care if the character of the wall is not to be changed. (Peñasco Blanco Ruin, Chaco Canyon National Monument, N. M.)

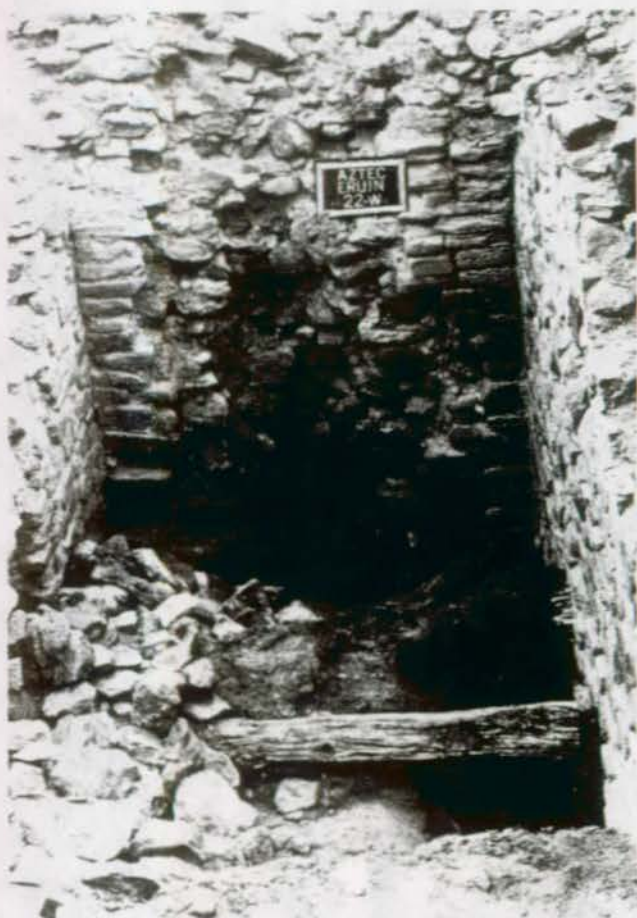
FIGURE 24. Wall break in a partially excavated site. A patch must be designed to prevent further flow of water and fill at the top, and some excavation will be required to base patch on sound masonry. (East Ruin, Aztec Ruins National Monument, N. M.)

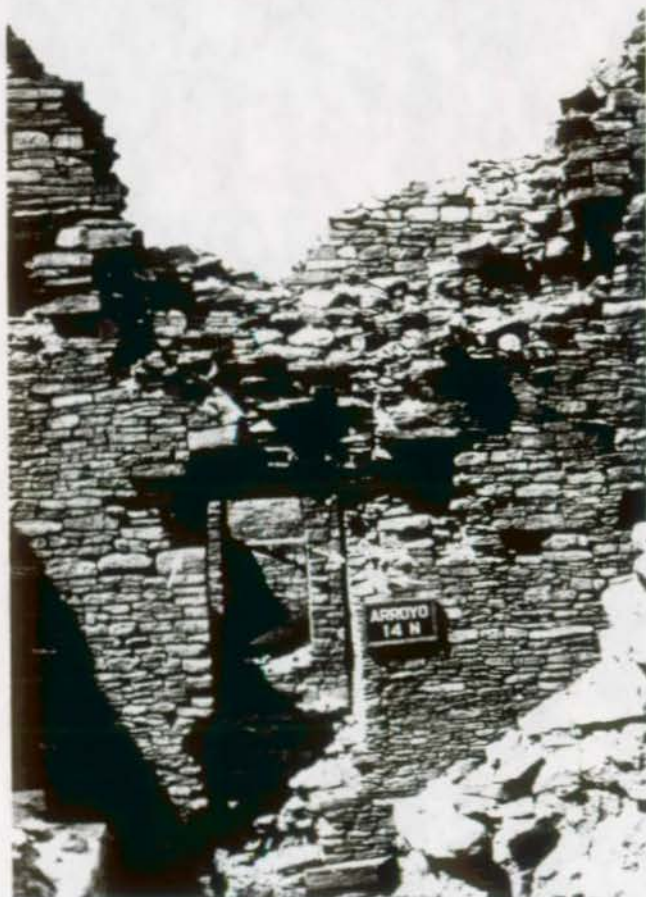
FIGURE 25. Repair at the position of the arrows will be based on a very small area in comparison with the total size of break. Every effort should be made to tie such patches securely to the existing wall. (Pueblo del Arroyo Ruin, Room 14, north wall, Chaco Canyon National Monument, N. M.)

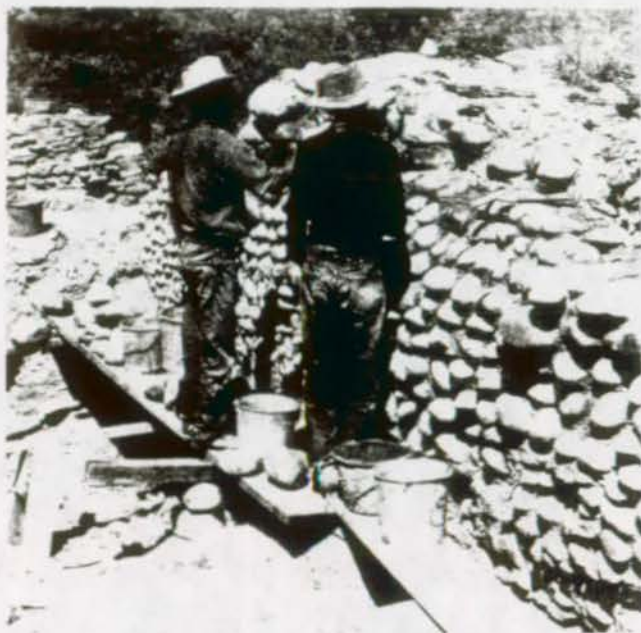
FIGURE 26. Deep grouting with soil-cement on the badly weathered face of this cobblestone wall will not change its appearance, but will halt the rapid rate of erosion. (East Ruin, Aztec Ruins National Monument, N. M.)

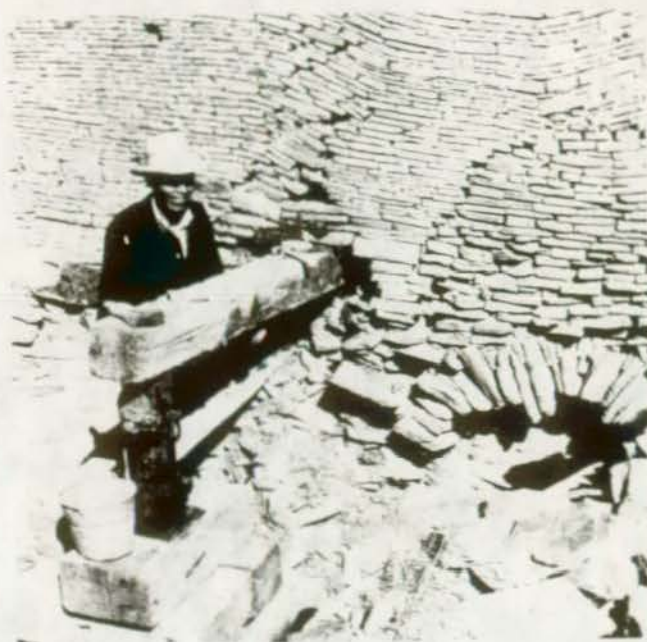
FIGURE 28. The temporary support of a heavy wall with timber. The arch at lower right was constructed in the 1920's as a repair measure. The first step in stabilization involved the placing of a beam through a hole adjacent to the arch. Not of aboriginal origin, the arch was subsequently removed. (Room 1, Chetro Kettle Ruin, Chaco Canyon National Monument, N. M.)

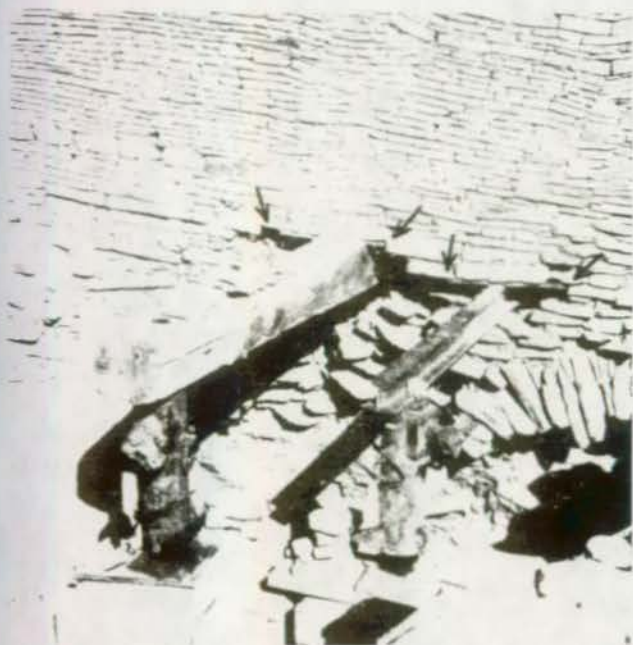
FIGURE 29. A second beam resting on jacks is placed through the wall depicted in figure 28. Arrows indicate extent of steel plates above the beam. The area of settling was reduced with upward pressure.

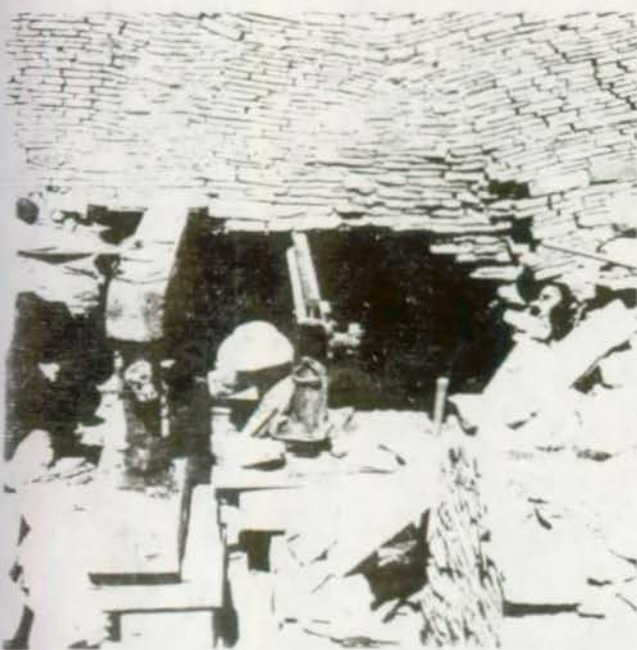
FIGURE 30. Jacks and beams provide support of wall depicted in figures 28 and 29 while arch section is removed. The break is filled with repair masonry.

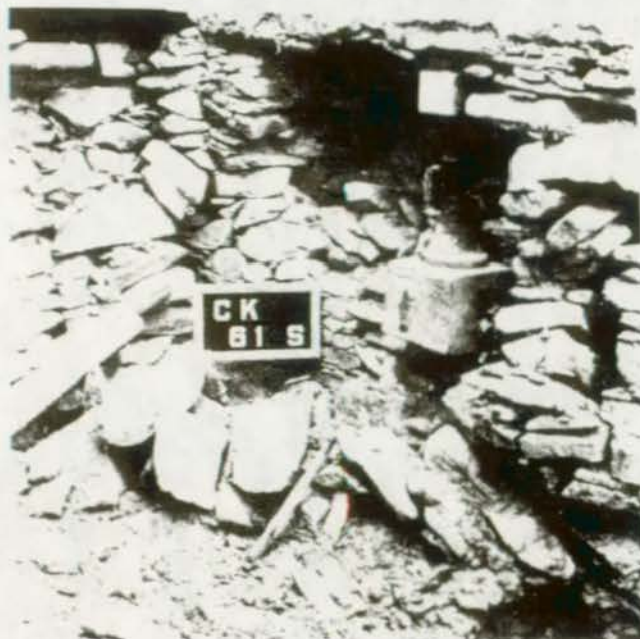
FIGURE 31. Placement of jack in line with shattered facing near the bottom of a 14-foot wall. The jack provided support while the broken area at the right was being replaced. (Chetro Kettle Ruin, Chaco Canyon National Monument, N. M.)

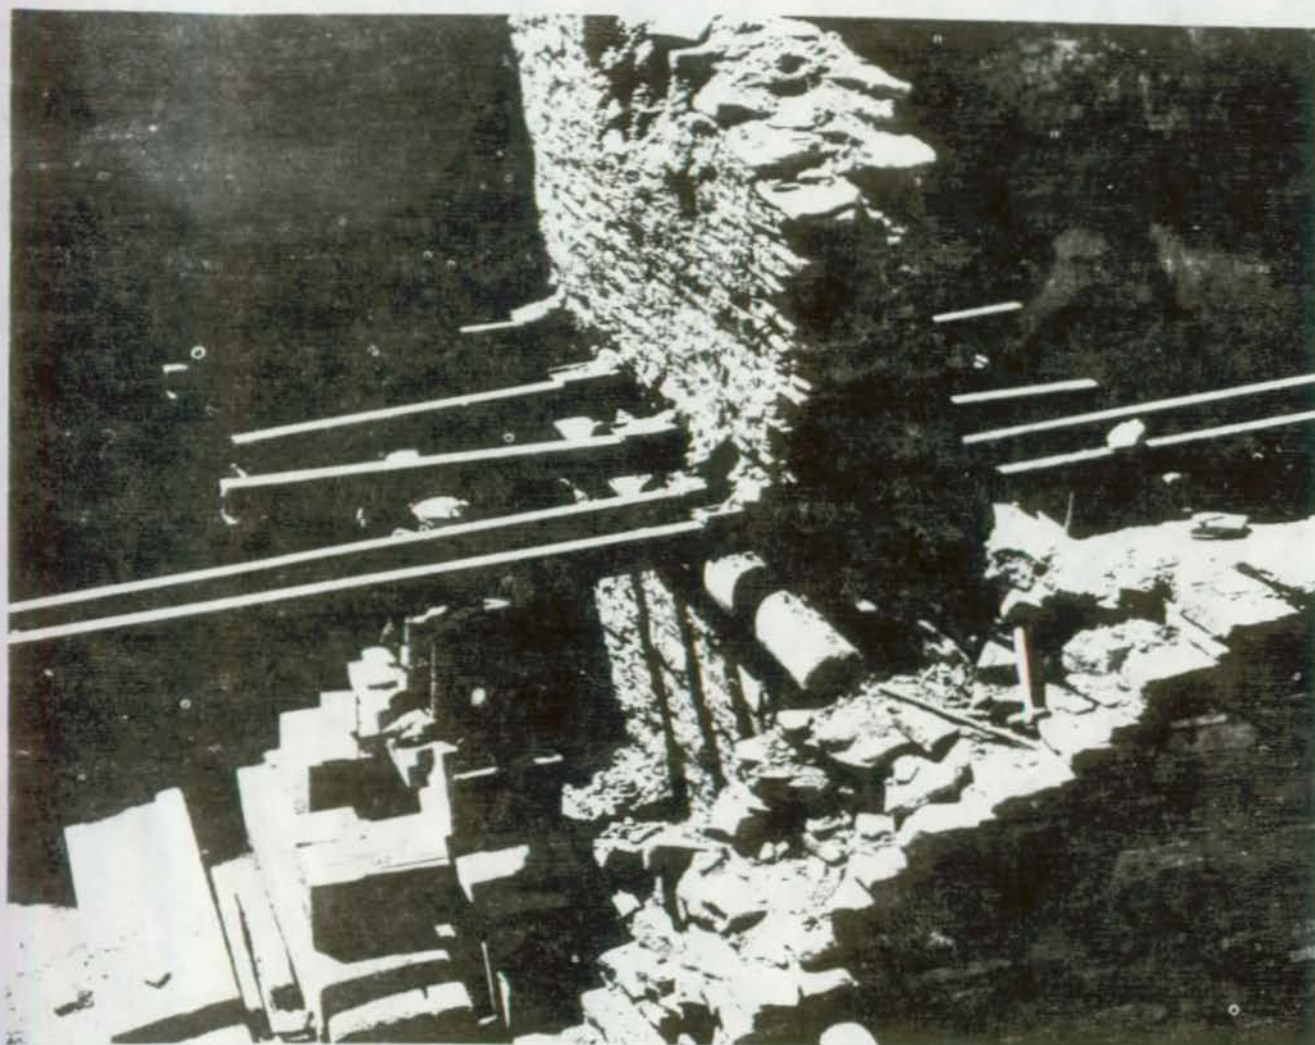
FIGURE 32. A temporary support. Six steel beams buttress the upper half of the wall while a decayed horizontal timber is replaced. The timber is partly removed here. With care, steel beams can be run through pole sockets or other natural openings without damage to the wall. (Chetro Kettle Ruin, Chaco Canyon National Monument, N. M.)

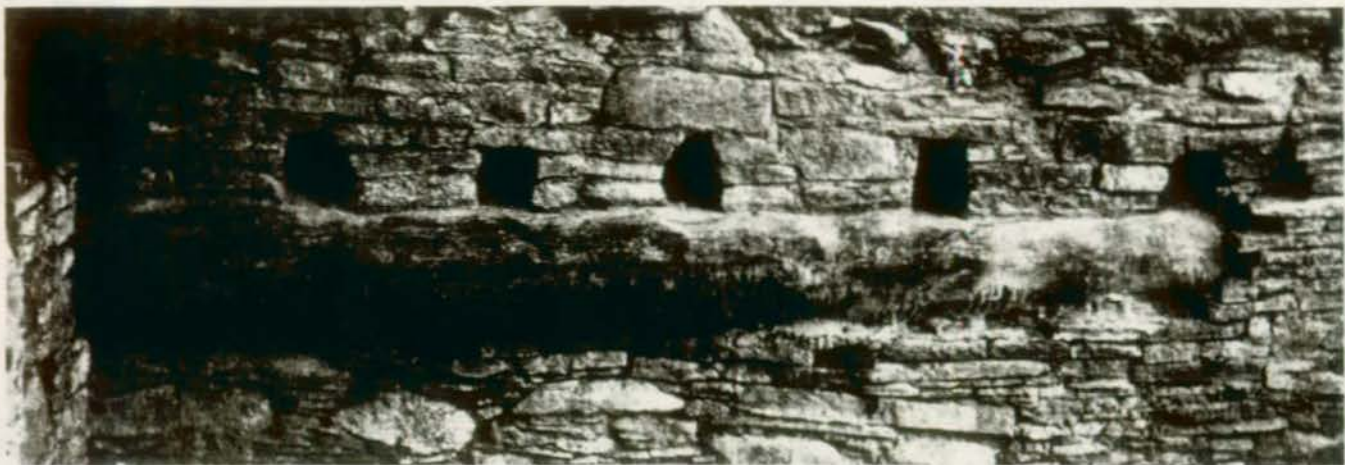
FIGURE 38. A horizontal cast log replaces the original timber which had rotted on the interior and in the embedded portions. (Chettro Kettle Ruin, Chaco Canyon National Monument, N.M.)

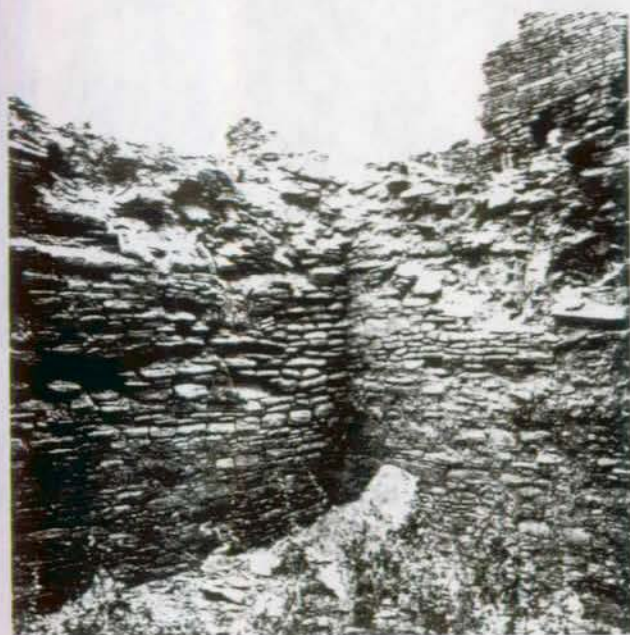
FIGURE 44. In many cases such as that depicted above it will be difficult to draw a distinction between general wall repairs and capping. This wall will have to be carried up to the level of the outside fill to prevent further washing over the top. Whatever type of mortar is used for such wall repairs, the top courses must be set in a cement mortar to provide as durable and waterproof a cap as possible. (Pueblo del Arroyo, Chaco Canyon National Monument, N.M.)

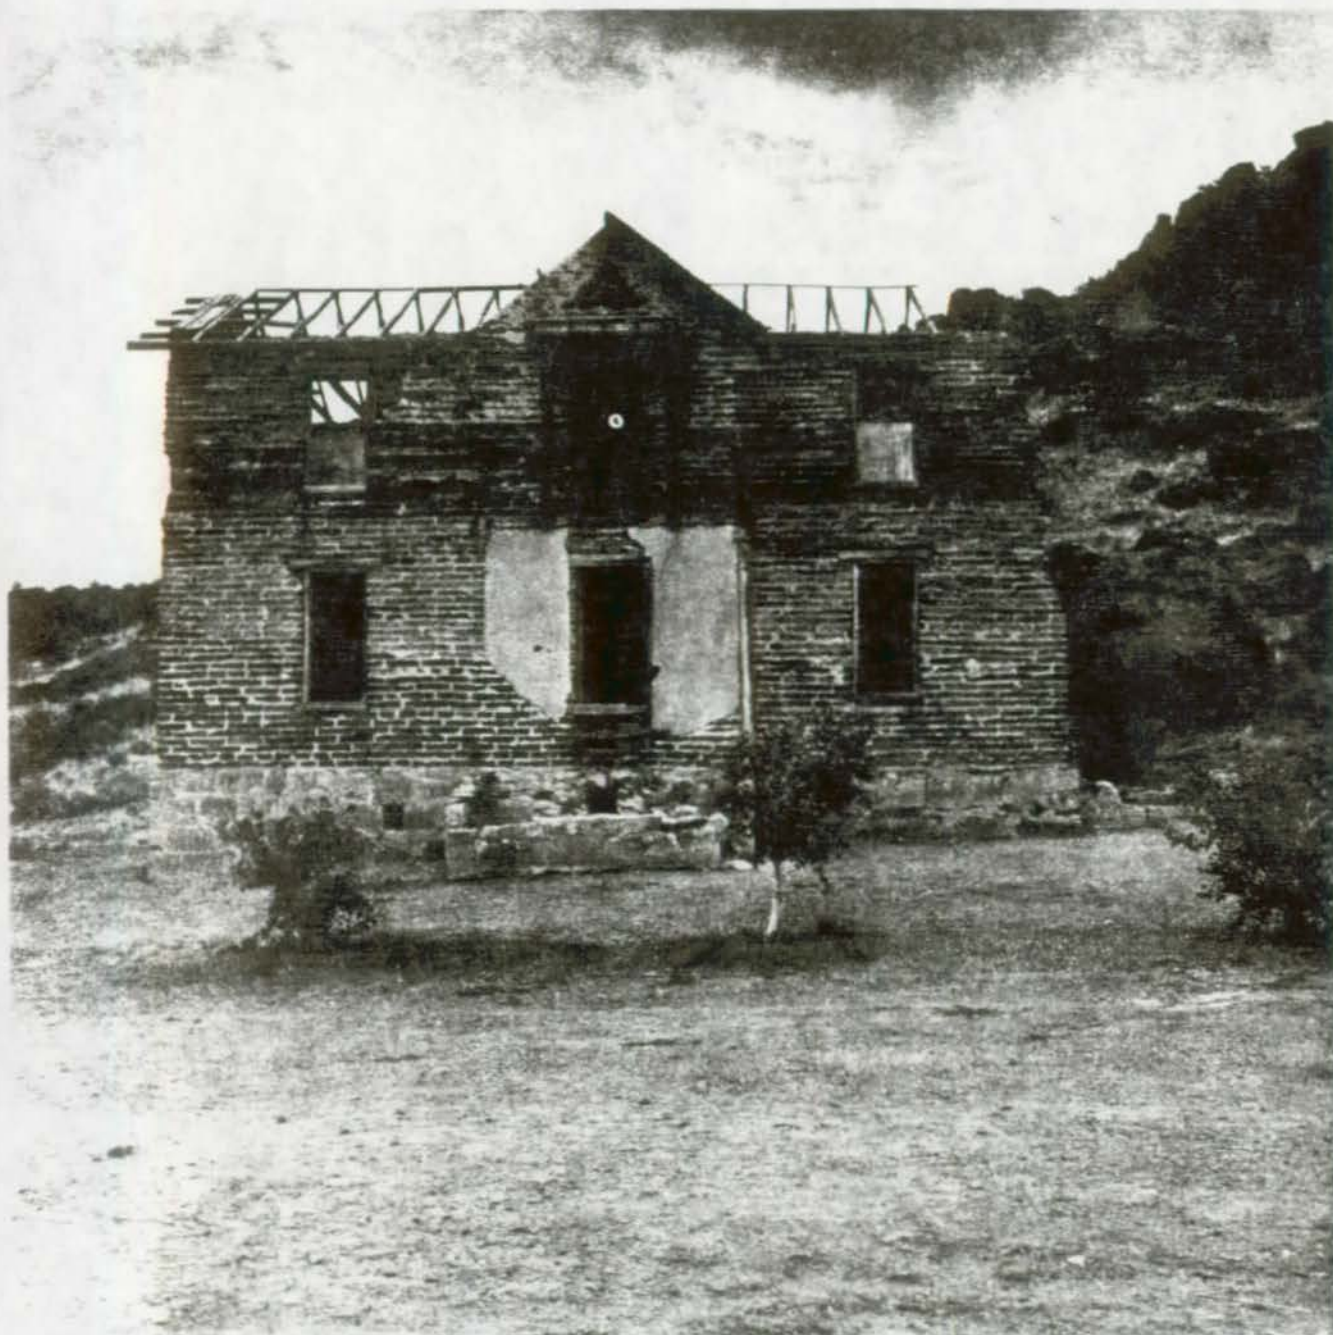
FIGURE 55 One of four 2-story adobe structures, designated HB-14, at Fort Davis National Historic Site. The building was probably used as a residence for important non-commissioned officers. Front view in 1964 before repairs were undertaken by the National Park Service.

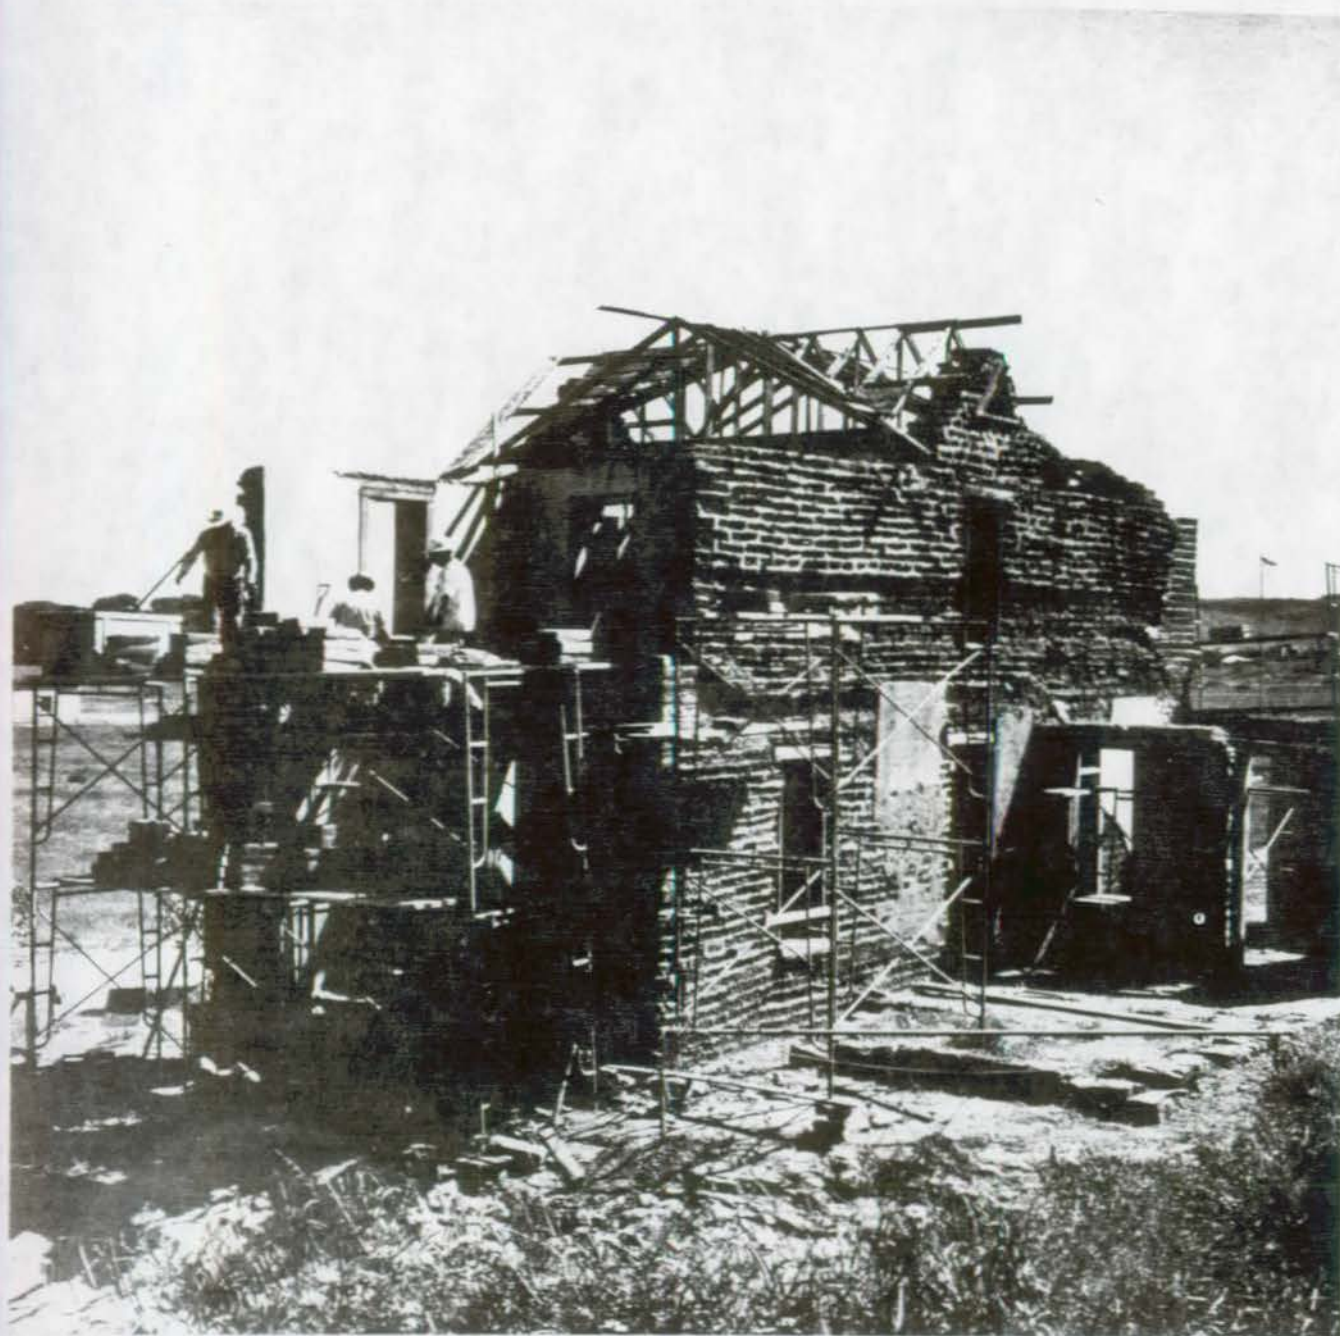
FIGURE 56. Stabilization and modified restoration in process at HB-14, shown in figure 55. Soil-cement adobes were used for repairing walls. A concealed integral bond beam was installed around the building between the first and second story levels. Concrete bearing beams were installed at roof line to support restored roof.

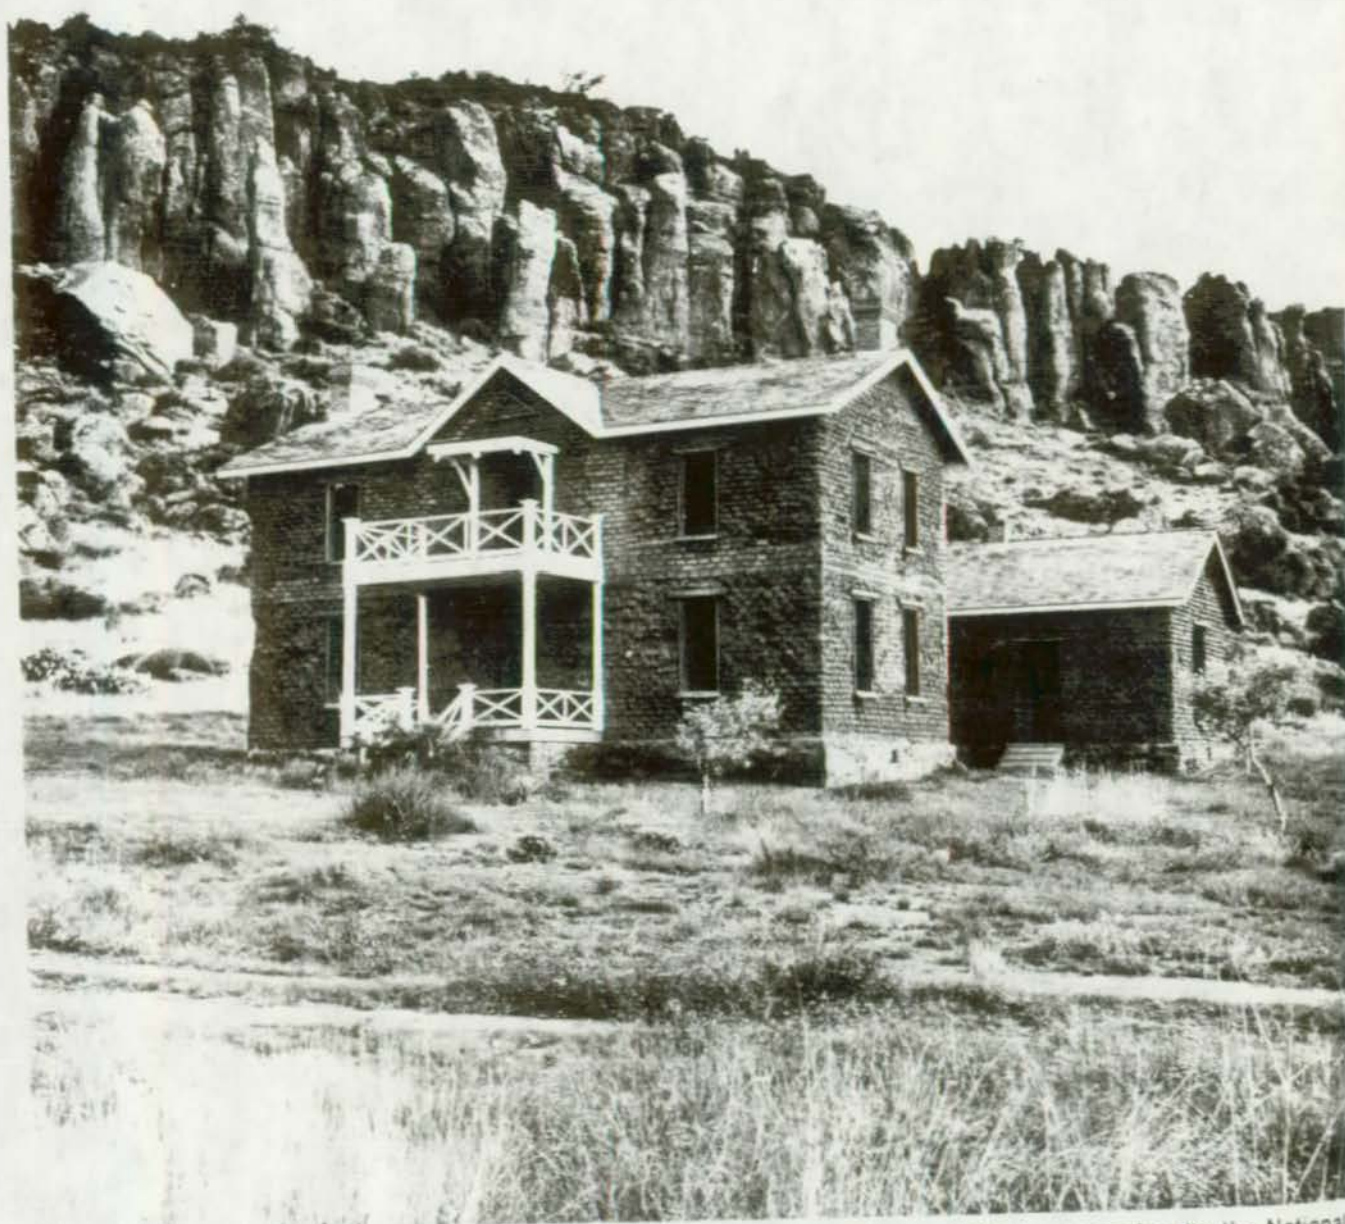
FIGURE 59. Building HB-15 and its outbuilding, a kitchen, following modified restoration by the National Park Service. Soil-cement adobes simulating original adobes were used as modular units of repair. Compare with figure 58.

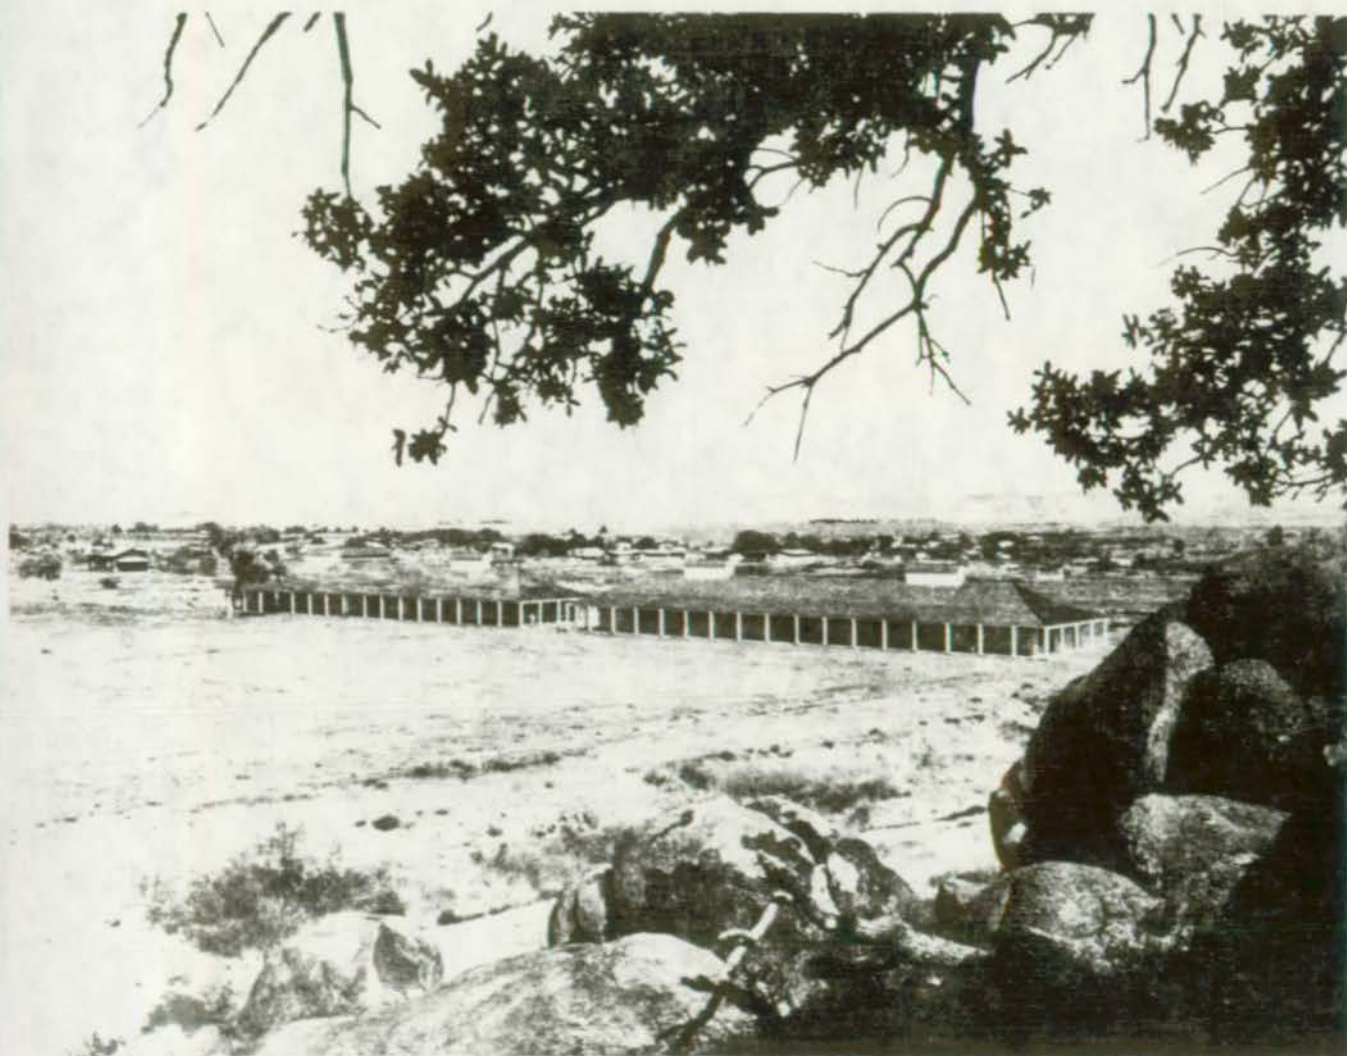
FIGURE 61. A view of the Fort Davis barracks after restoration. The ruinous shell seen in figure 60 was veneered with hand molded soil cement bricks, 4" x 4" x 12". They were made with one part portland cement (untinted), three parts unwashed sand, and three parts native soil. The bricks laid in masonry mortar with rough joints, set with spalls, were wire-brushed. Original walls were pared down where required to accommodate the veneer brick and to retain original wall dimensions and thickness. Bond beams were installed at roof line to support the restored, hipped, shingled roof. The soil cement brick walls were painted with white cement paint, although originally they were whitewashed. The building is used functionally today as the Visitor Center. Cost of the restoration: \$129,000 or \$12.90 per square foot.

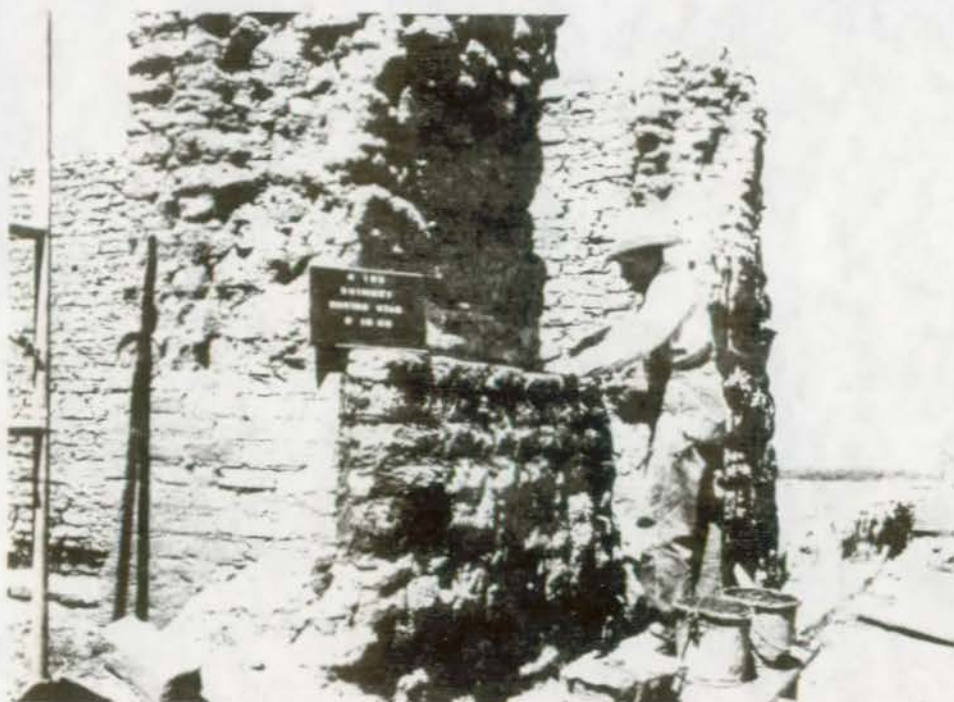
FIGURE 97. Building 6-160, Room 163, flue and chimney in east wall, during stabilization. Soil adobes are being laid to replace those that had fallen away. Fort Union National Monument.

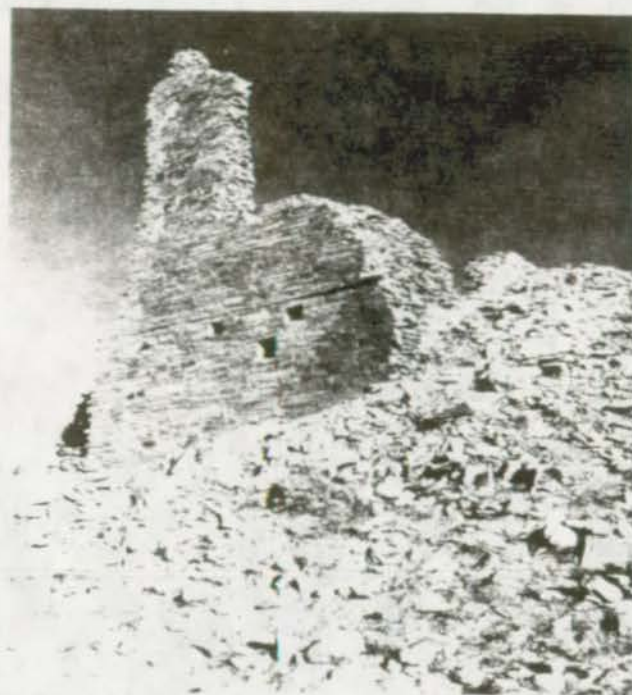
FIGURE 102. Hole at base, square openings (the two upper held beams, the lower was a ventilator) and insets repaired and wall stubs capped. Beam stub at left and two beam holes in line above (arrows) either represent reinforcing ties for kiva corner or supports for some sort of prehistoric scaffolding used in construction or a balcony.

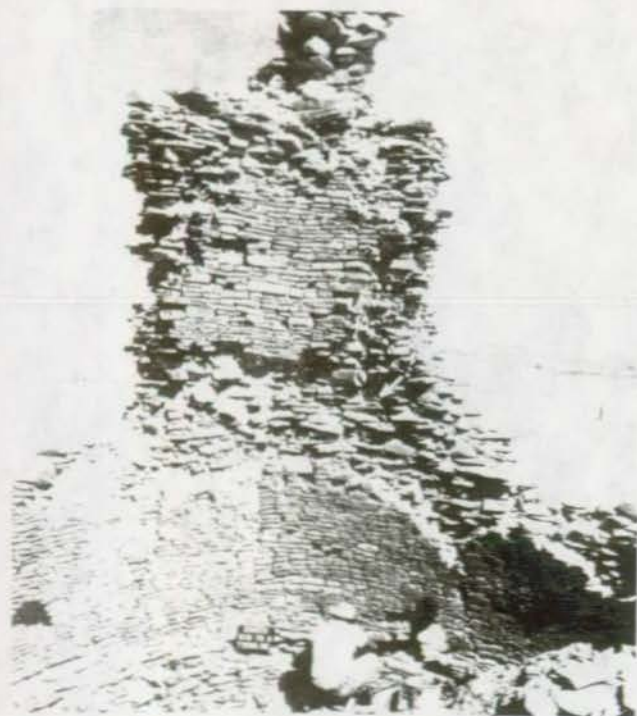
FIGURE 103. General view of northeast interior of Tower Kiva at start of project. The circular wall is stepped back or inset at two points: (1) at narrow ledge or bench where workman is beginning repairs, and (2) where facing is gone, exposing core (arrow).
