# **RUINS STABILIZATION IN THE SOUTHWESTERN UNITED STATES**

Compiled by  
ROLAND VON S. RICHERT and  
R. GORDON VIVIAN

**National Park Service**

U. S. Department of the Interior  
Washington 1974

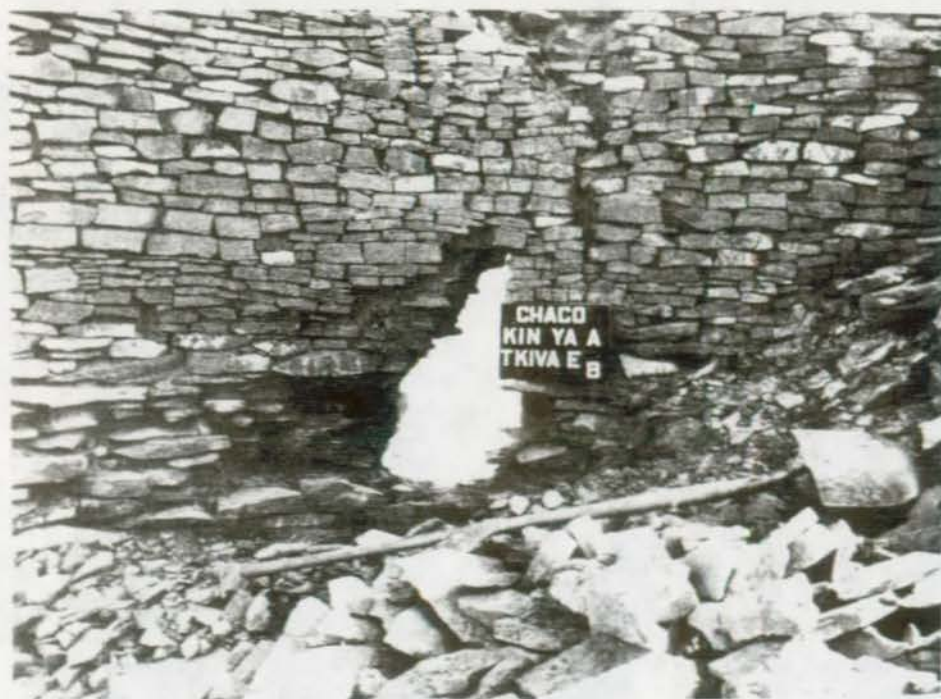
FIGURE 105. Detail of hole in Tower Kiva caused by breakdown of savino sockets. The beams for the sockets extended part way into this wall from the opposite side, and originally supported the ceiling of the adjacent room.

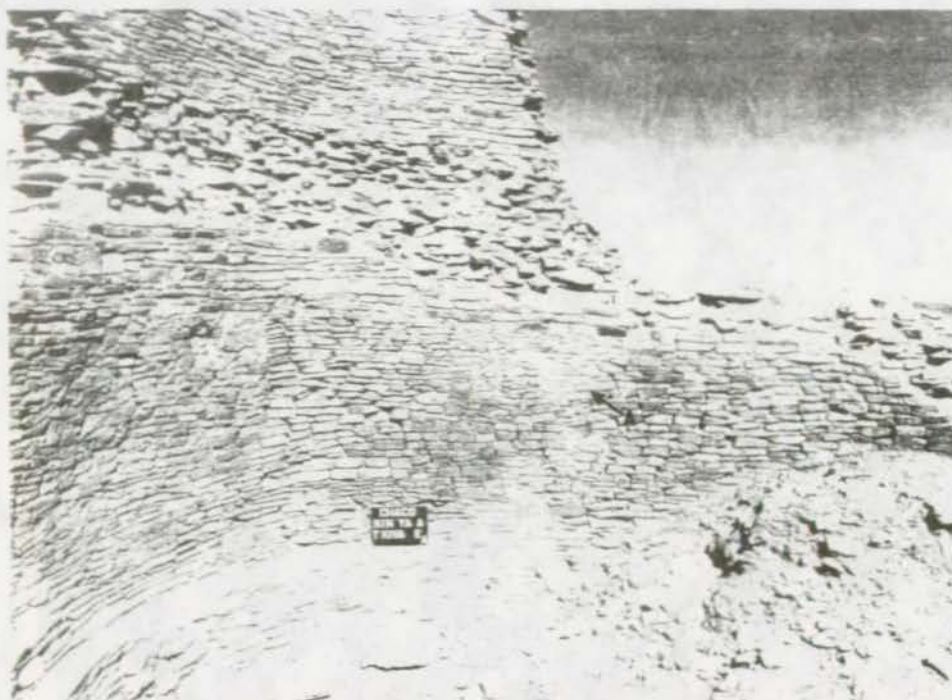
FIGURE 106. Lower portion of Tower Kiva, north and east segments, after stabilization. Offset ledges repaired, holes filled with repair masonry, facing reset (arrows A), top capped and inset core (arrow B) grouted.

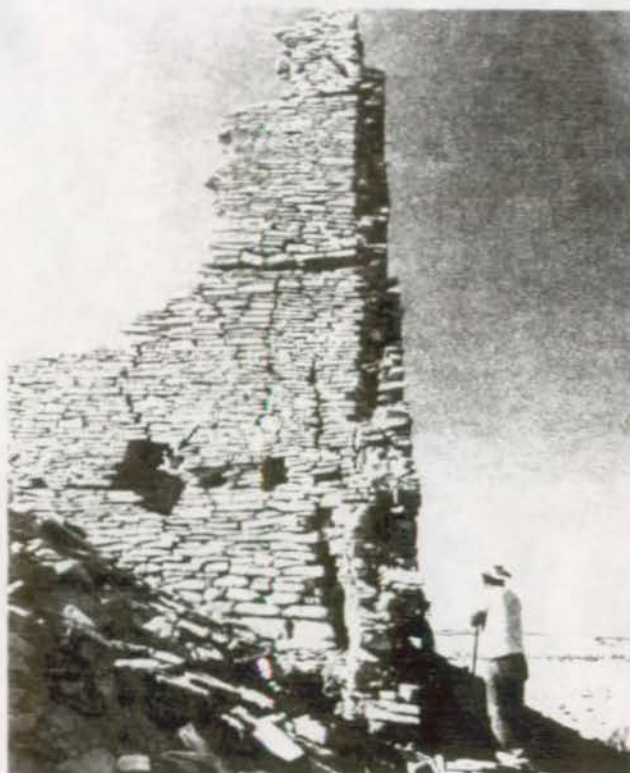
FIGURE 112. Tower Kiva, east wall exterior at juncture with north wall stub (at sign). Note the vertical cracks, eroded savino sockets (arrows) and loose, fragile spire. Portions of 4 stories are visible.

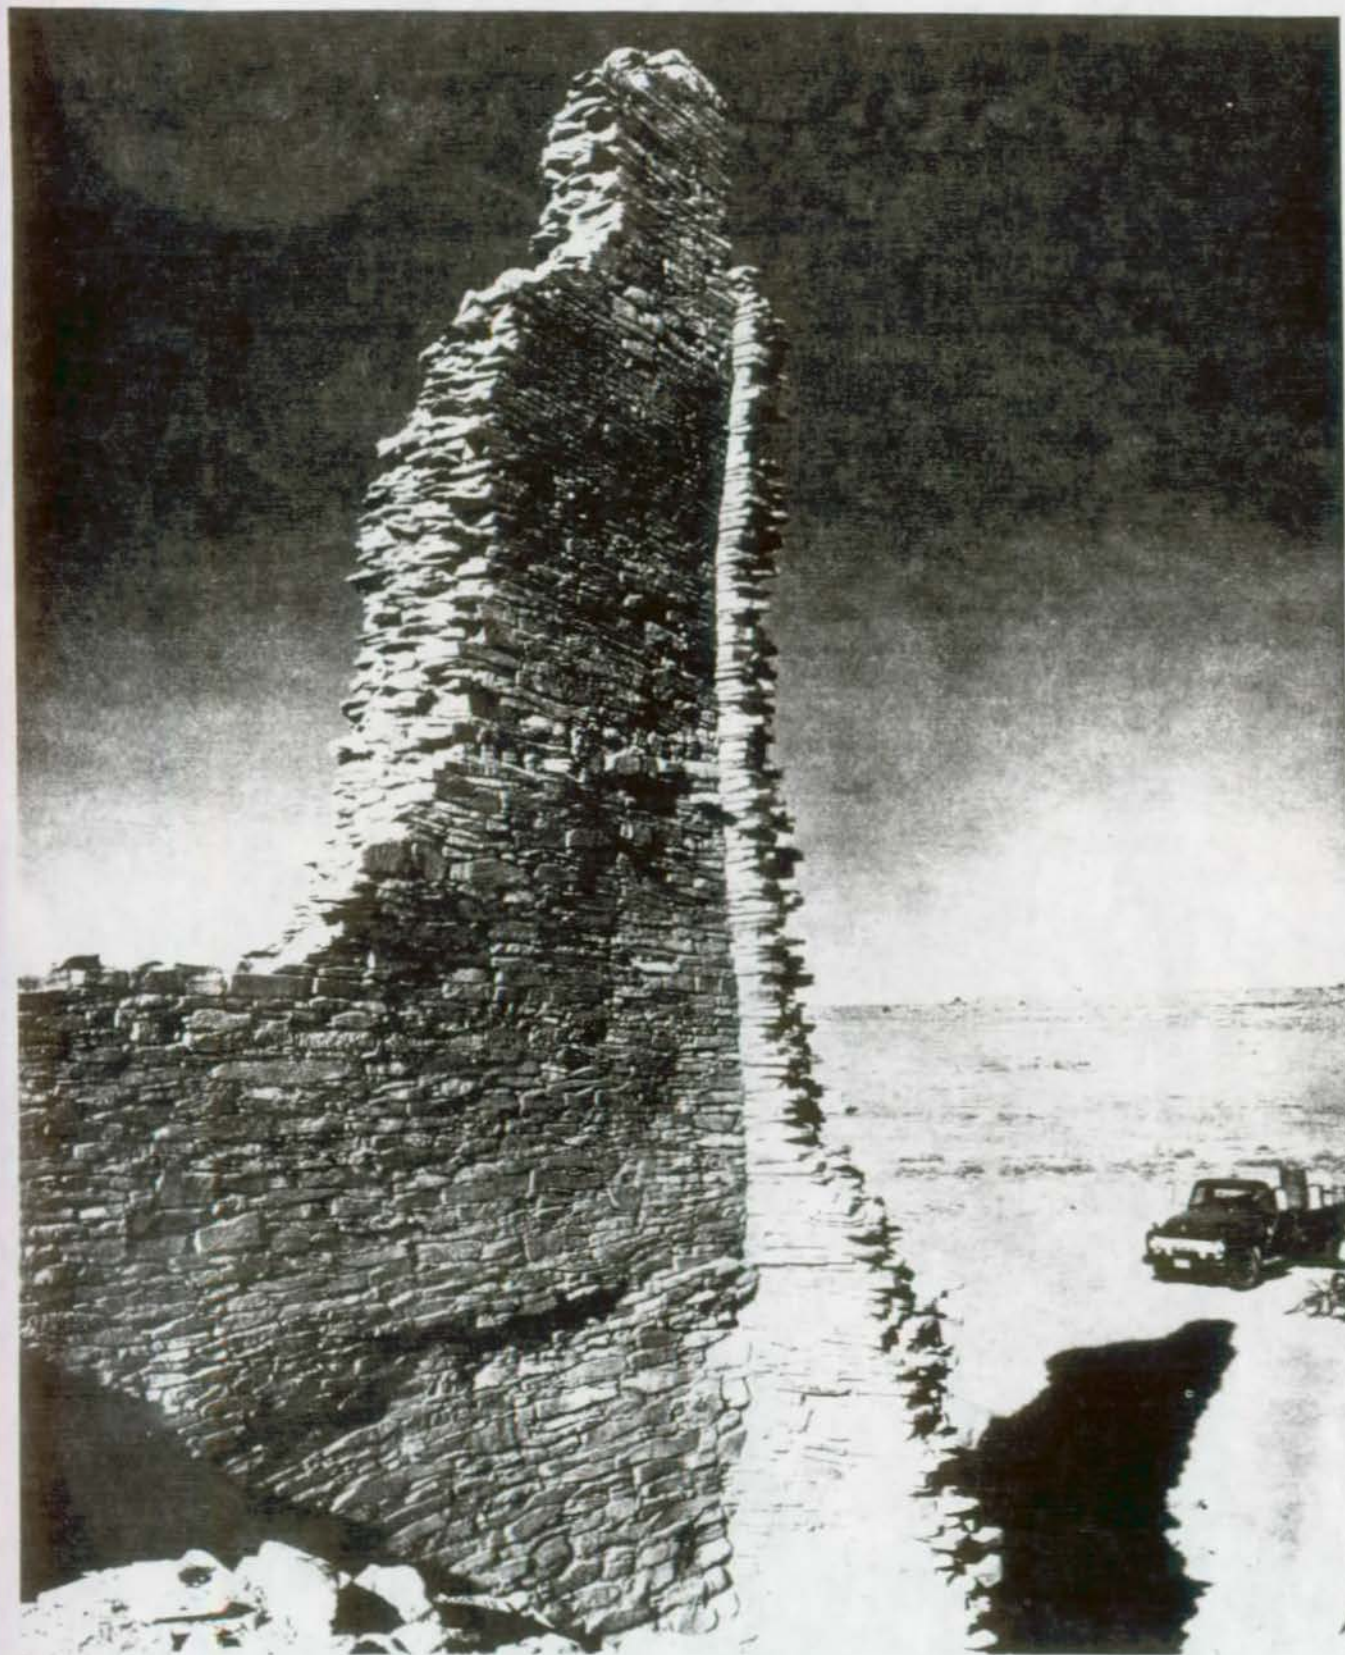
FIGURE 114. View of Tower Kiva showing north wall stub buttressed, cracks repaired, savino sockets re-molded, and facing grouted.
