# Weather Station Maintenance in Southwest Alaska Network Parks

*Summary for the 2012 Hydrologic Year*

Natural Resource Data Series NPS/SWAN/NRDS—2012/394

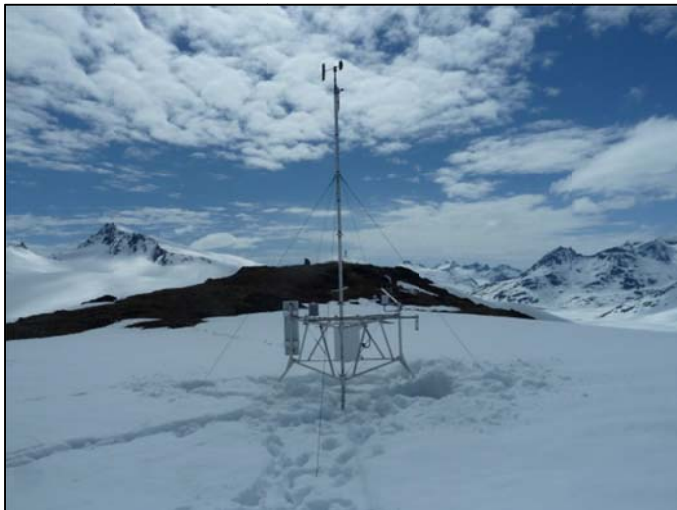
**Figure 3.** Chigmit Mountain RAWS - Snow was dug out below the SD sensor prior to zeroing the DLP. This snow was then replaced in order to approximate the 22 inches of snow that were still on the ground.

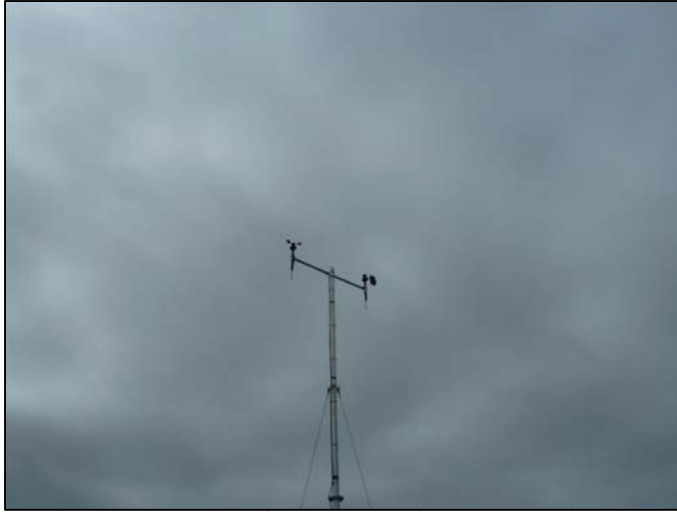
The station was in good shape except that the tail had fallen off the wind direction sensor (this probably occurred on November 13, 2011; Figure 8) and the mount on the AT-RH sensor was broken. WD observations were off by 180 degrees between November 13, 2011 and June 21, 2012. The erroneous WD observations (between December 21, 2011 and July 30, 2012) were intercepted using the WFMI system and were not passed on to client websites (e.g. WRCC). The AT-RH sensor, WS sensor, and WD sensor were all replaced. A wind direction sensor test was done. The rain count for the tipping bucket was zeroed. The SD sensor was replaced (with a Campbell Scientific SR50, which was rehabbed with new transducer plates and desiccant. The data logger program COVI\_DLP\_SR50\_20120620.prg was loaded to support the SR50 SD sensor. SD in the DLP was edited to zero the sensor. SD was zeroed to an average reading of -0.5 inches to account for fluctuation without reporting misleading snow depth readings. All data in the data logger were downloaded to send to WRCC in order to update the archive. Spare sensors that were ordered for this station were not used. Station observations and GOES transmission quality were checked before departure. Observations and transmissions were verified from the WFMI website by SWAN staff in Anchorage and relayed by satellite phone. All bolts on the station were checked and tightened if loose and cables were zip-tied. Before departure the station was photographed from eight directions (every 45°) and the inside of the instrument enclosure (Figure 9) was also photographed. An additional time-lapse camera (Campbell Scientific CC5MPX), 10 W solar panel, and 35 Ah battery were installed on the weather station (Figure 10).

**Figure 8.** Coville RAWS – Wind direction sensor with no tail.

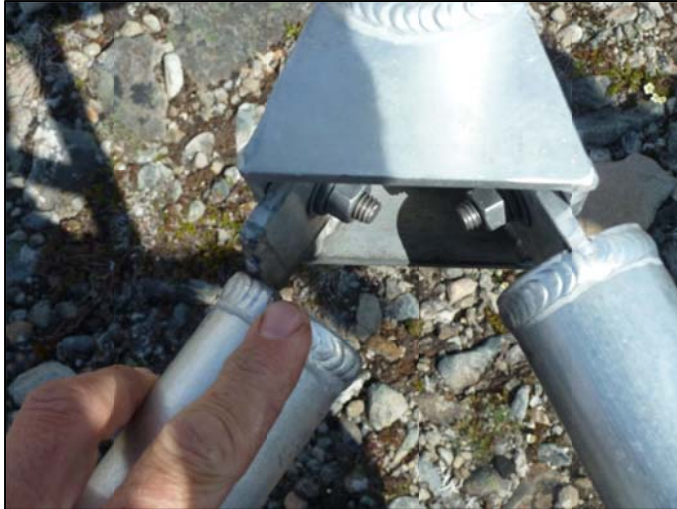
Access to the Fourpeaked weather station was by helicopter from Homer. The station was in poor condition. There were breaks to the welds on two of the tri-leg tower panels (Figure 11). The AT-RH sensor had blown away (Figure 12). The GPS antenna cable had been pulled out of the antenna (Figure 13) probably because of the weight of ice buildup during winter storms. The tip had fallen off the WD sensor (Figure 14). The AT-RH sensor, WS sensor, WD sensor, and SR sensor were replaced. Both wind sensors on this station are replaced each year because of harsh conditions at the site. A WD sensor direction test was done. The Campbell Scientific SD sensor was removed and not replaced because ultrasonic distance ranging sensors don't work well at this location (moisture builds on the transducer plates) and most snow is blown away from this location. The SDI expansion port that was needed to run both the SD and SR sensors was also removed because it was no longer necessary. Both batteries were replaced with two new Sunlyte 100 Ah sealed batteries. The tri-leg tower frame was repaired using aircraft cable, turnbuckles, and shackles (Figure 15). The GPS antenna cable was replaced. The rain count for the tipping bucket was zeroed and a tipping bucket test was done. The current DLP running is DLP\_FOUR\_SR50A\_20120607.prg. SD in the DLP was edited to force all SD observations to zero. This element will be deactivated in WFMI, so that a potentially false zero snow depth isn't passed on to client websites (e.g. WRCC) during winter months. All bolts on the station were checked and tightened if loose and cables were zip-tied. Station observations and GOES transmission quality were checked before departure. Observations and transmissions were verified from the WFMI website by NIFC and relayed by satellite phone. Before departure the station was photographed from eight directions (every 45°) and the inside of the instrument enclosure (Figure 16) was also photographed.

**Figure 11.** Fourpeaked RAWS – Broken weld on lower north corner of tri-leg tower frame.

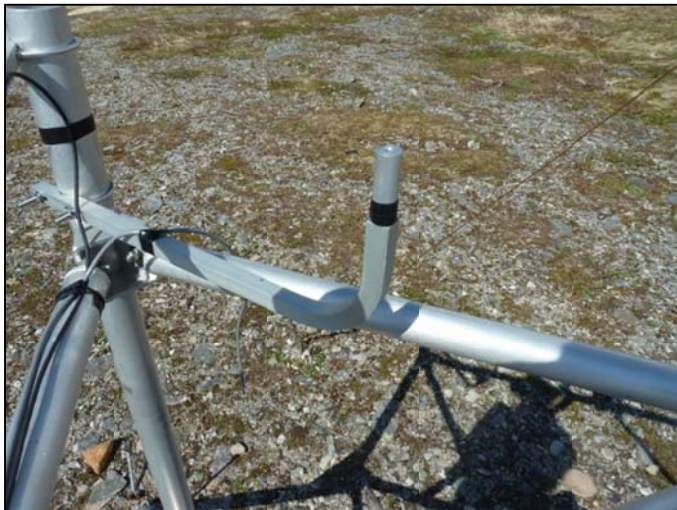
**Figure 12.** Fourpeaked RAWS – AT-RH sensor was missing.

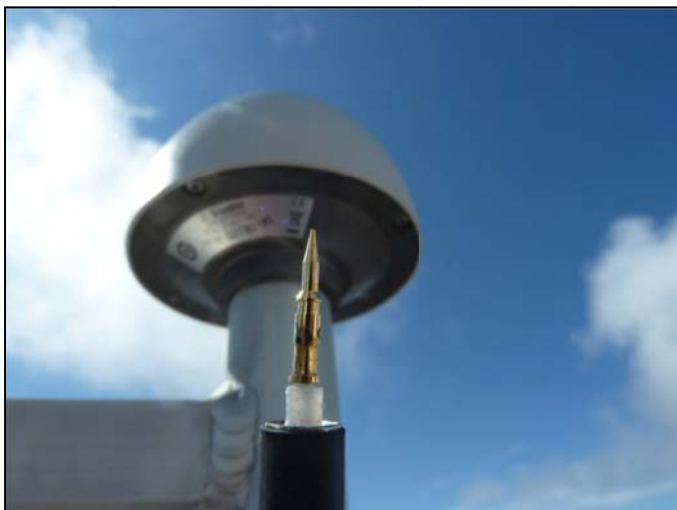
**Figure 13.** Fourpeaked RAWS – GPS antenna cable had been pulled out of the antenna.

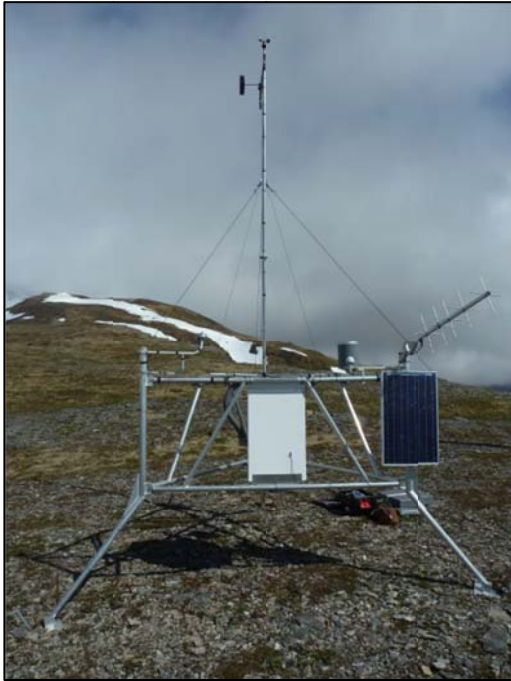
**Figure 14.** Fourpeaked RAWS – Wind direction sensor with no tip.

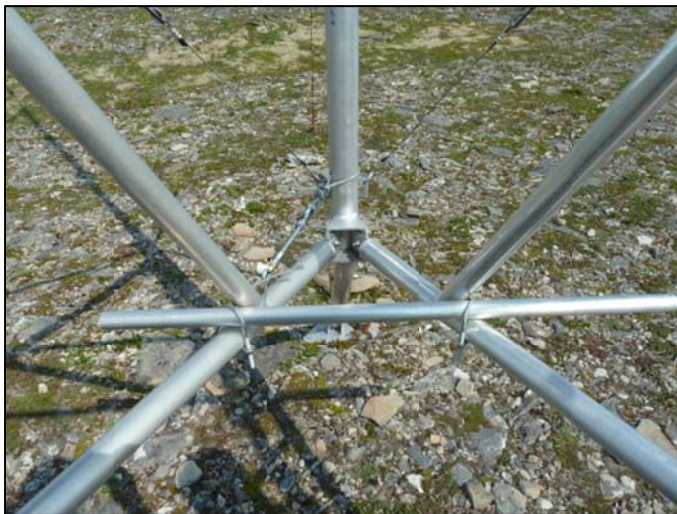
The station stopped transmitting on June 15, 2012, about a week after annual maintenance was done (June 7, 2012). Access to the Fourpeaked weather station was by helicopter from Homer. Station was not transmitting and the last few observations before the station stopped transmitting included parity errors in the message. There was no obvious damage to station. The LEDs on the GOES transmitter did not indicate any problems. All data in data logger was downloaded to send to WRCC in order to update the archive. The data logger, GOES transmitter, and the GPS antenna were replaced. The replacement data logger had been updated with firmware v. 6.7 (on June 12, 2012). The GOES antenna, GOES antenna cable, and GPS antenna cable were not replaced because there was no indication that anything was wrong with them. The GOES antenna orientation was verified (it was OK at 159 degrees and 21 degrees inclination). The NIFC RAWS Depot was contacted after repairs in order to verify that a transmission was received with good signal strength. The faulty data logger was returned to the RAWS Depot for repair. Aluminum pipe sections were attached to the tri-leg tower frame using U-bolts in order to help hold the broken frame welds together (Figure 17).

**Figure 17.** Fourpeaked RAWS – Aluminum pipe attached to help hold the broken tower frame welds together.

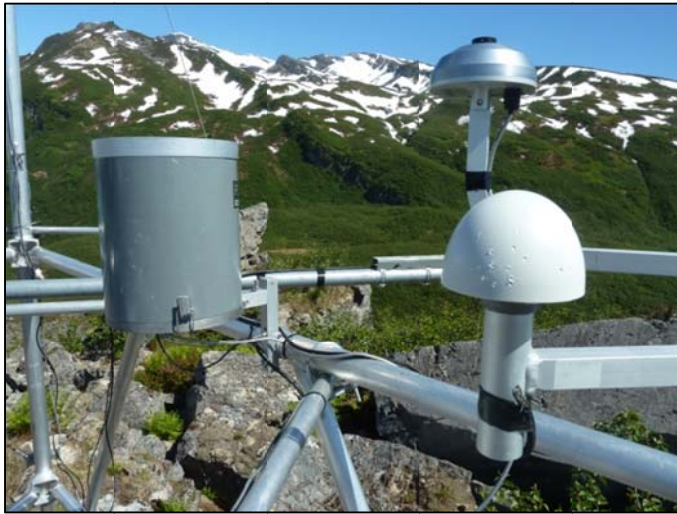
The station was significantly damaged by wildlife (black bear) on June 8, 2012. The GPS cable was cut. The GPS antenna was chewed-on (Figure 22). The RH/AT shielding (plastic louvers) was damaged (Figure 23), the wind speed cable was cut (Figure 24), and the GOES antenna cable was chewed-on (Figure 25). The AT-RH sensor, WS sensor, and WD sensor were all replaced. Both wind sensors on this station are replaced each year because of harsh conditions at the site. Both WS and WD sensor cables were replaced. A WD direction test was done. The GPS antenna and GPS antenna cable were replaced. The GOES antenna cable was replaced and the connection was sealed with mastic tape. The rain count for the tipping bucket was zeroed and a tipping bucket test was done. The SD sensor was replaced with a Campbell Scientific SR50 SD sensor, which was rehabbed with new transducer plates and desiccant. All data in the data logger was downloaded to send to the WRCC in order to update the archive. The data logger program HILA\_DLP\_SR50\_20120616.prg was loaded to support the SR50 SD sensor. Snow depth was zeroed to an average reading of -0.5 inches to account for fluctuation without reporting misleading snow depth readings. All bolts on the station were checked and tightened if loose and cables were zip-tied. Station observations and GOES transmission quality were checked before departure. Observations and transmissions were verified from the WFMI website by NPS Radio Shop staff and relayed by satellite phone. Before departure the station was photographed from eight directions (every 45°) and the inside of the instrument enclosure (Figure 26) was also photographed.

**Figure 22.** Hickerson Lake RAWS – GPS antenna with bear teeth marks.

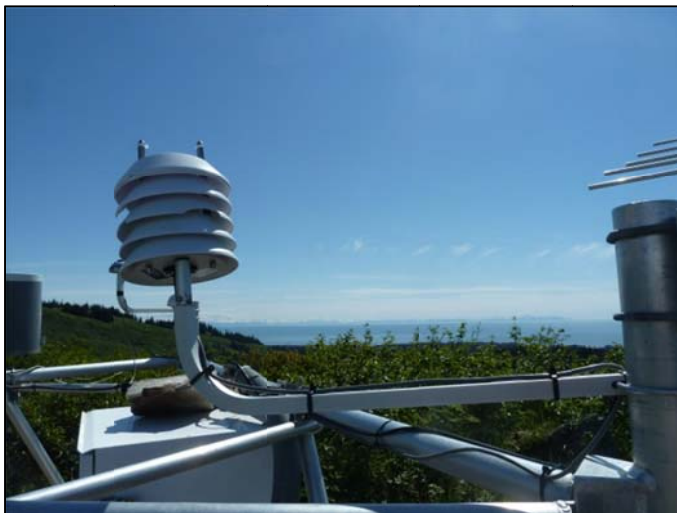
**Figure 23.** Hickerson Lake RAWS – Damage to the plastic louvers on the AT-RH sensor.

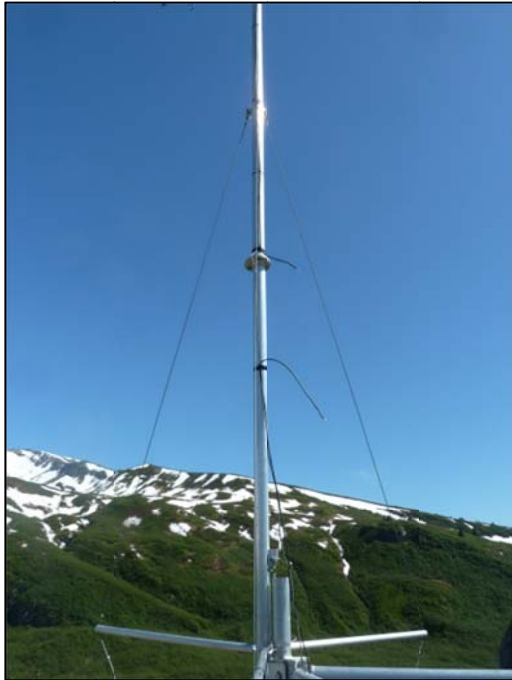
**Figure 24.** Hickerson Lake RAWS – The wind speed cable was cut, likely because it was pulled.

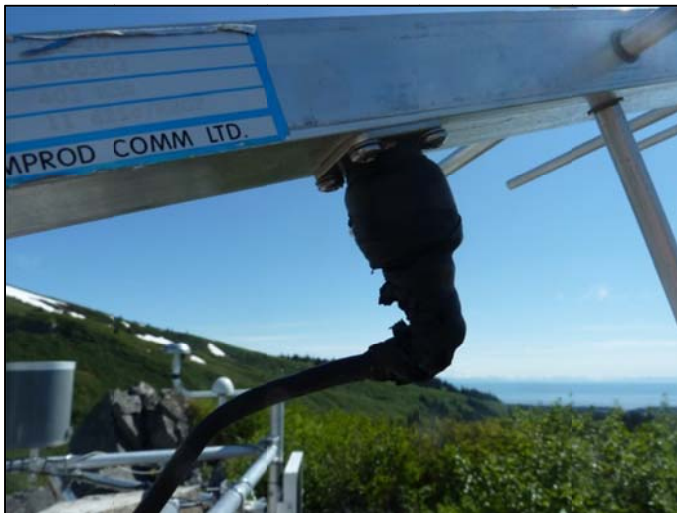
**Figure 25.** Hickerson Lake RAWS – The GOES antenna cable was chewed on.

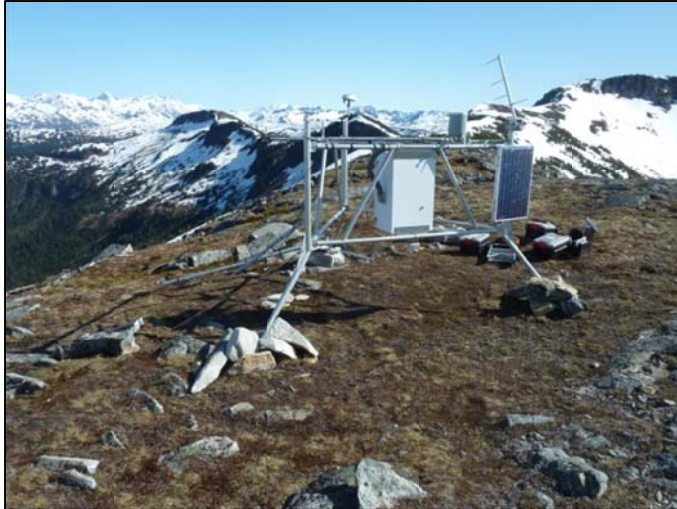
A helicopter from Homer was used for access. The station was in poor condition (Figure 28). The 20-ft mast had broken (Figure 29) and wind sensors, support arm, and cables were destroyed. The AT-RH sensor had blown away and the GOES antenna was bent upwards. The 20 ft mast, guylines, spreader bars and additional guy lines were all replaced. The wind sensor support arm was replaced. The AT-RH sensor, WS sensor, and WD sensor were all replaced. Additionally, the WS and WD sensor cables were replaced. Both wind sensors on this station are typically replaced each year because of harsh conditions at this site. A WD sensor direction test was done. The GOES antenna and cable were replaced. The GPS antenna and cable were replaced. The SR sensor was replaced. The RG-TB was replaced, the rain count was zeroed, and a tipping bucket test was done. All data in the data logger was downloaded to send to the WRCC in order to update the archive. The SD sensor was removed and it will not be replaced because it doesn't work at this location - there's too much moisture. The SDI expansion port was also removed because it wasn't needed any more (only one SDI sensor is currently present). The current DLP running is DLP\_MCPA\_SR50A\_20120605.prg. SD in the DLP was edited to force all SD observations to zero. This element will be deactivated in WFMI, so that a potentially false zero snow depth isn't passed on to client websites (e.g. WRCC) during winter months. Station observations and GOES transmission quality were checked before departure. Observations and transmissions were verified from the WFMI website by NIFC and relayed by satellite phone. Before departure the station was photographed from eight directions (every 45°; Figure 30) and the inside of the instrument enclosure (Figure 31) was also photographed.

**Figure 28.** McArthur Pass RAWS – Damage to station from winter storms.

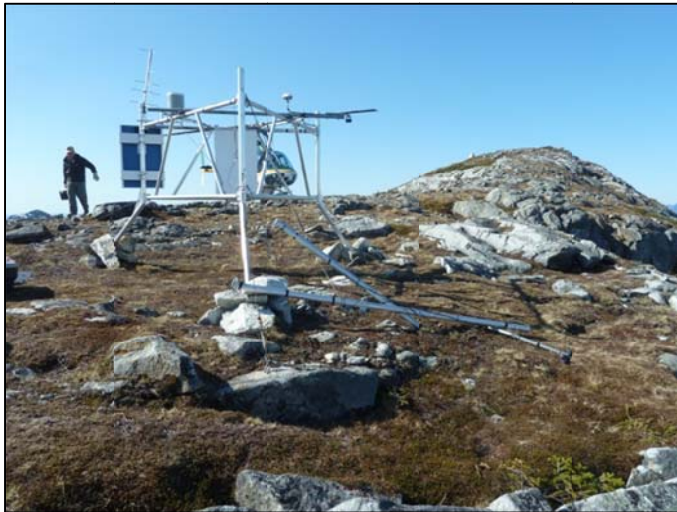
**Figure 29.** McArthur Pass RAWS – Broken 20-ft wind sensor mast.

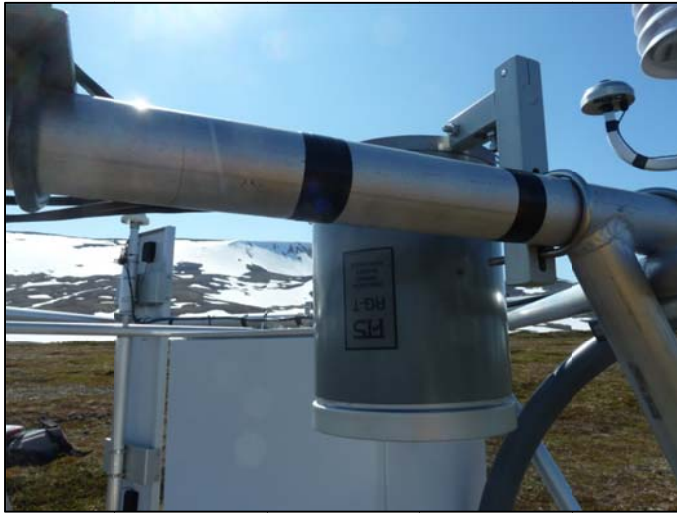
Access to the Pfaff Mine weather station was by park wheel plane. The station was in good shape except the rain gauge tipping bucket was upside down (Figure 36). The AT-RH sensor, WS sensor, and WD sensor were all replaced (Figure 37). A WD sensor direction test was done. The WS and WD sensor cables should be replaced during the next maintenance trip because the cable sheaths are showing signs of wear. The RG-TB was replaced, the rain count was zeroed, and a tipping bucket test was done. Unfortunately, no precipitation was recorded since the last maintenance visit on June 15, 2011. The horizontal axis adjustment bolt on the sensor mounting arm wasn't tight and this is why the RG-TB was upside down. The SD sensor was replaced with a Campbell Scientific SR50A SD sensor, which had been rehabbed with new transducer plates and desiccant. The data logger was replaced with another FTS 12S data logger running firmware version 6.6. Dual soil temperature probes, custom made by FTS, were installed at depths of 10 and 50 cm (Figure 38). Soil temperature sensors were installed in-line with the SW tower footing, 1 m away from the footing (Figure 39). The datalogger firmware and program had to be updated to incorporate this sensor. The data logger program

**Figure 36.** Pfaff Mine RAWS – The rain gauge tipping bucket was upside down and wasn't recording precipitation.
