Cape Lookout National Seashore

Cape Lookout Lighthouse

**Historic Structure Report**

December 2008

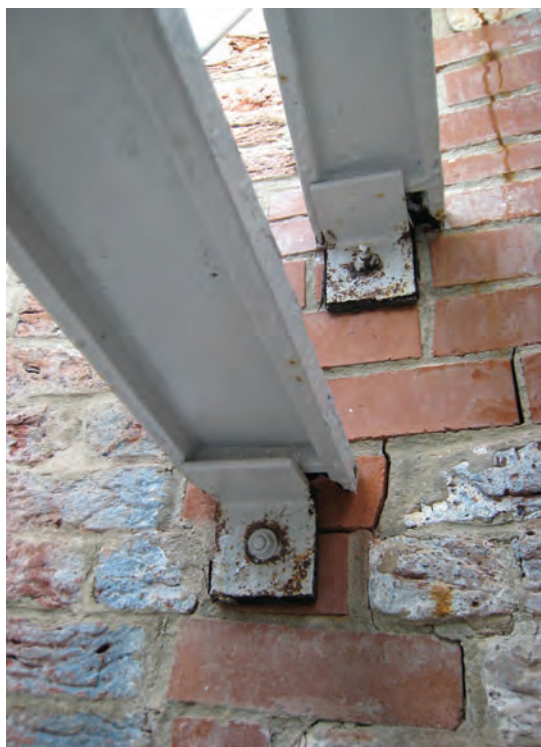
**Figure C-8** Modern masonry repairs in Watch Room.

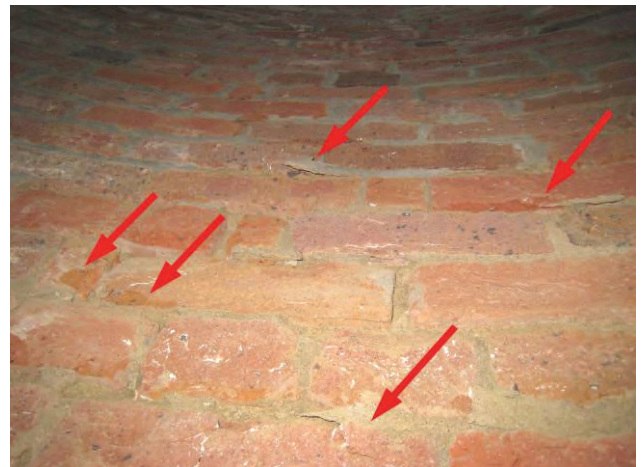
The mortar joints of both the outside and inside walls have a width of about ½" and are struck flush. However, on the core wall interior face, it is clearly evident that portions of the brickwork have been re-pointed with a hard, Portland cement-rich mortar. The re-pointing mortar is also fairly impermeable as evidenced by the re-pointed joints sitting proud, hard and rigid, while the adjoining bricks have spalled well back from the face of the mortar. Similar spalling has not occurred on bricks adjoining the earlier mortar.

**Figure C-10** Spalling brick adjoining Portland cement-rich repointing mortar.

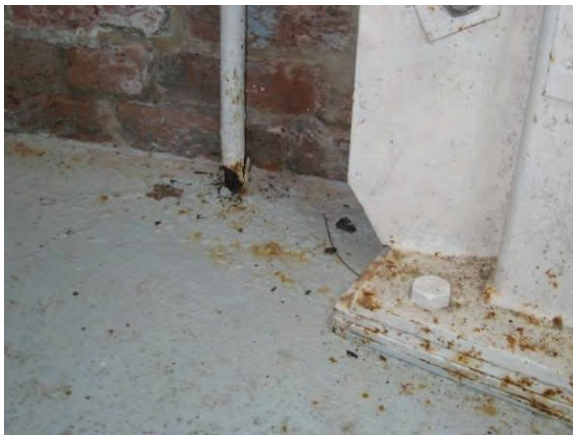
**Figure C-22** *Corroded connecting rod at Watch Room floor plate.*

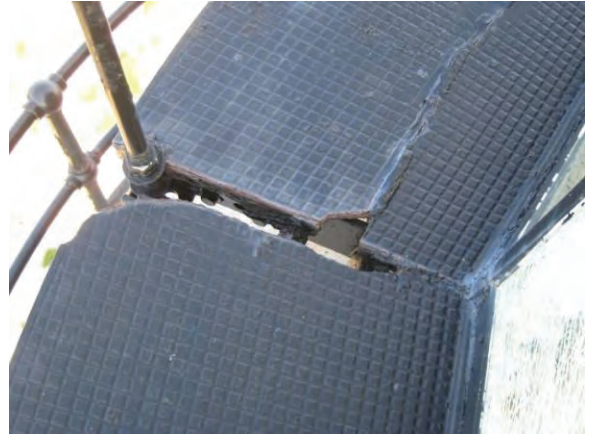
**Figure C-23** *Broken floor plates of Lantern Gallery.*

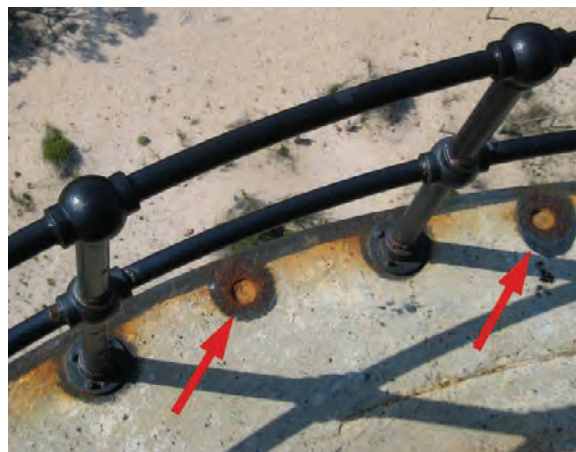
At unknown date(s), the original 1914 railing and air lock were removed. The imprint of the air lock is still visible in the deck's cement. Remnants of the stanchion anchors remain in place (Figure C-25). A salvaged section of the 1914 railing is in the North Carolina Maritime Museum (Figure C-24). The current railing is a replica of the original 1914 railing. It stands 45" tall and is constructed of two 2" round rails and 2½" round stanchions, all of steel.

**Figure C-25** Remnants of 1914 stanchion anchors and replacement railings of unknown date.

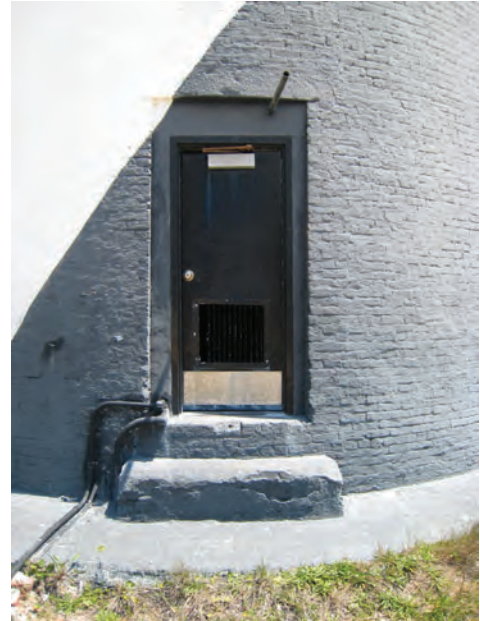
At both the First Floor and Second Floor, the original doorway framing and door were replaced c. 1980 with steel frame and steel, flush-panel door. (These doors were severely rusted when they were replaced in 1999 with the current doors of same design.) In both locations, the original door was probably board-and-batten with wrought-iron strap hinges and pintels. Such a door is

**Figure C-28** Original masonry opening for First Floor doorway with modern infill and steel door.

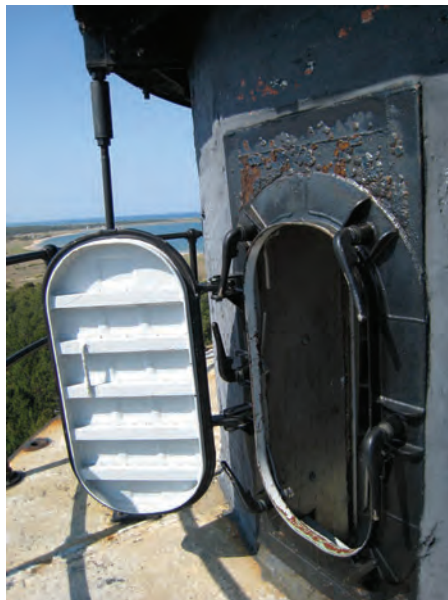
**Figure C-30** Ship's Hatch at Observation Deck

The original masonry opening is sound and the hatch door is in good condition and operational.

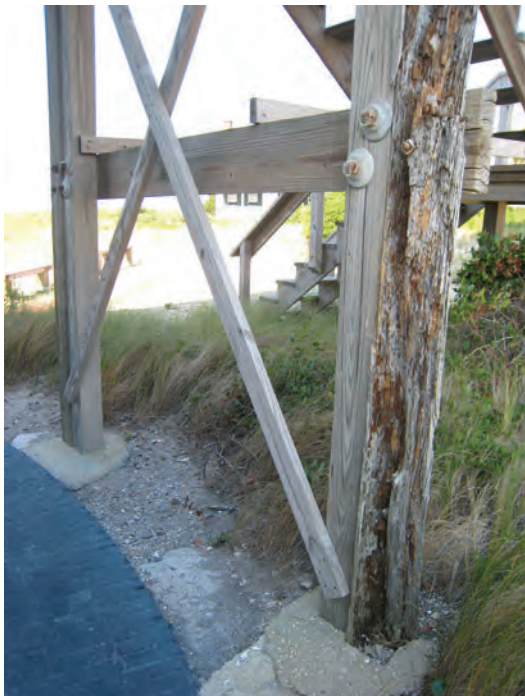
**Figure C-34** Two earlier but twentieth-century and severely deteriorated wood posts and one cross beam

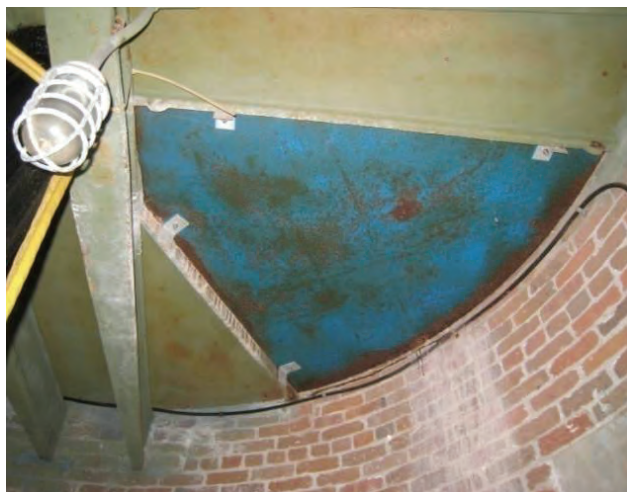
One exception is a single plate among the six at the Second Floor which is clearly a modern replacement. Its design is unlike any other floor plate and it is painted a

**Figure C-44** Modern replacement floor plate at Second Floor landing.

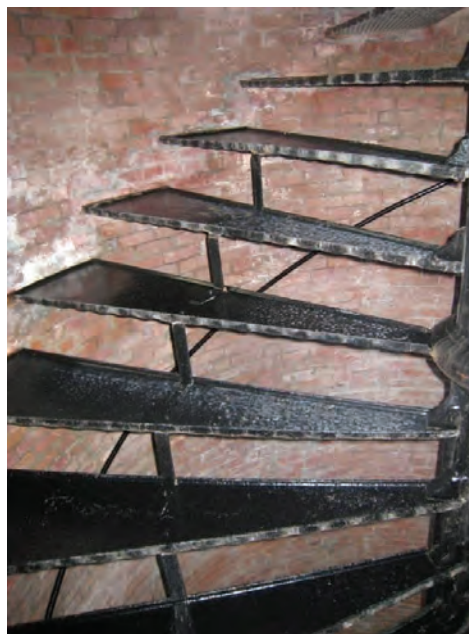
**Figure C-74** Metal strap reinforcement of unknown installation date.

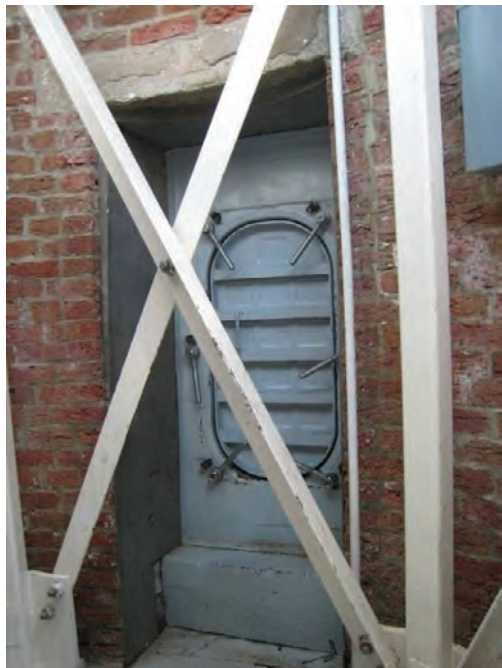
**Figure C-87** Reinforcing steel added in 1989 partially blocks ship's hatch to Observation Deck.

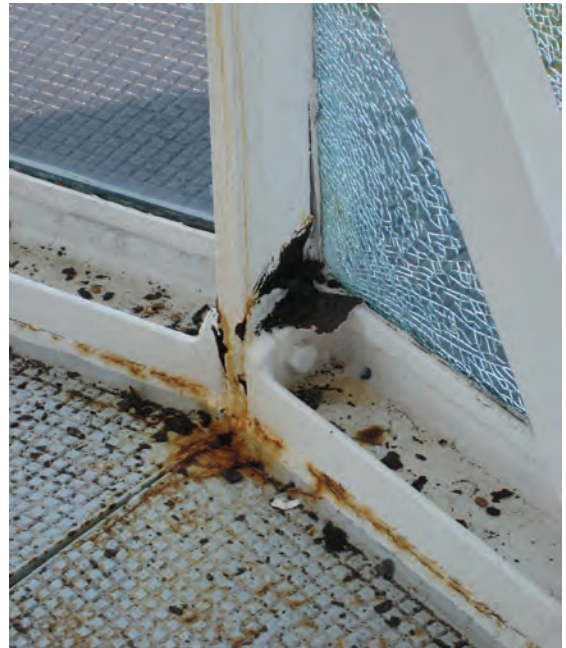
*Figure C-98 Deteriorated iron framing.*

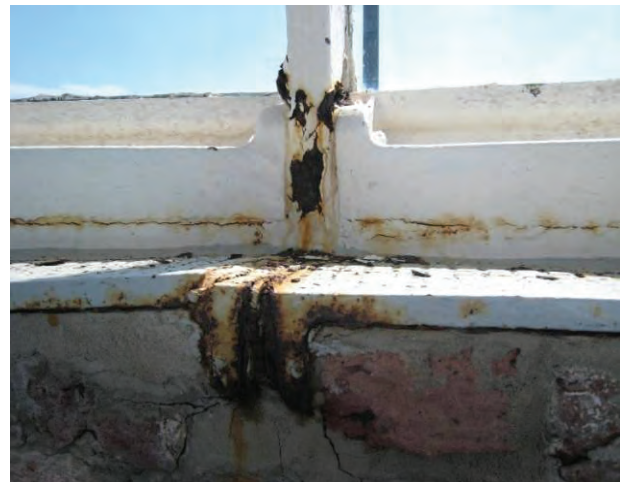
**Figure C-104** Extensive corrosion of cast-iron framing.

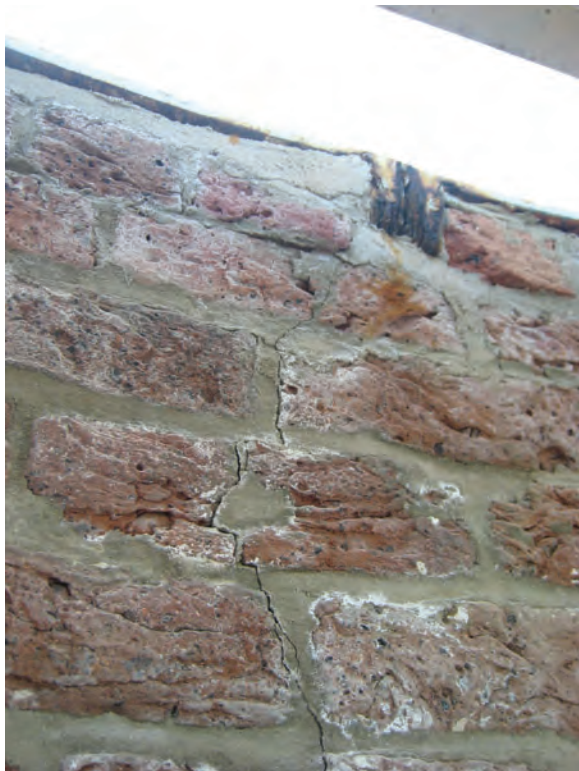
**Figure C-105** *Through-wall cracks in masonry at top of Tower.*

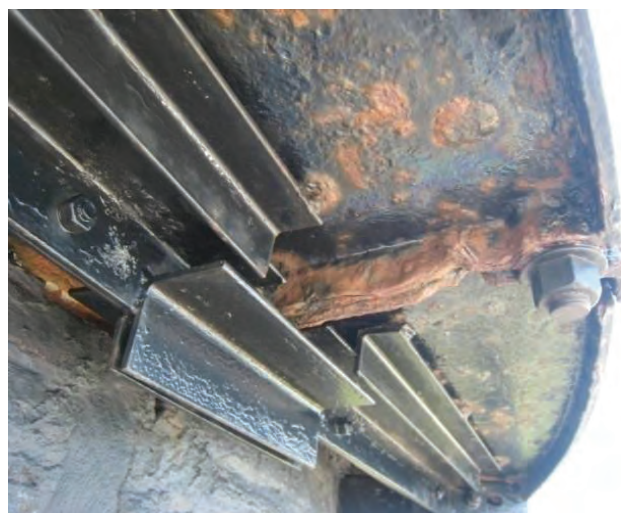
**Figure C-106** *Underside of Lantern Gallery reinforced in 1989.*

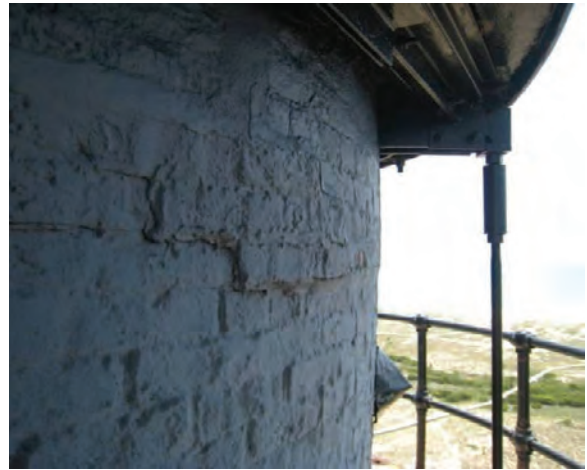
**Figure C-107** Displaced masonry and supplemental tie rods.

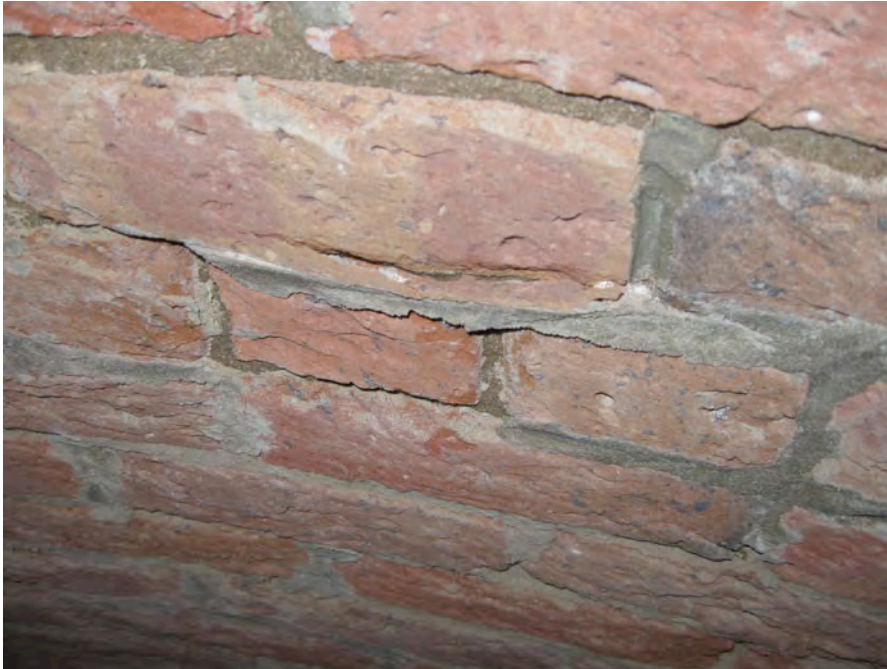
**Figure 20.** Cape Lookout Lighthouse, September 2008. An area where inappropriate Portland cement based re-pointing mortar has caused the original brick to spall and the original mortar to deteriorate. Photograph by author.

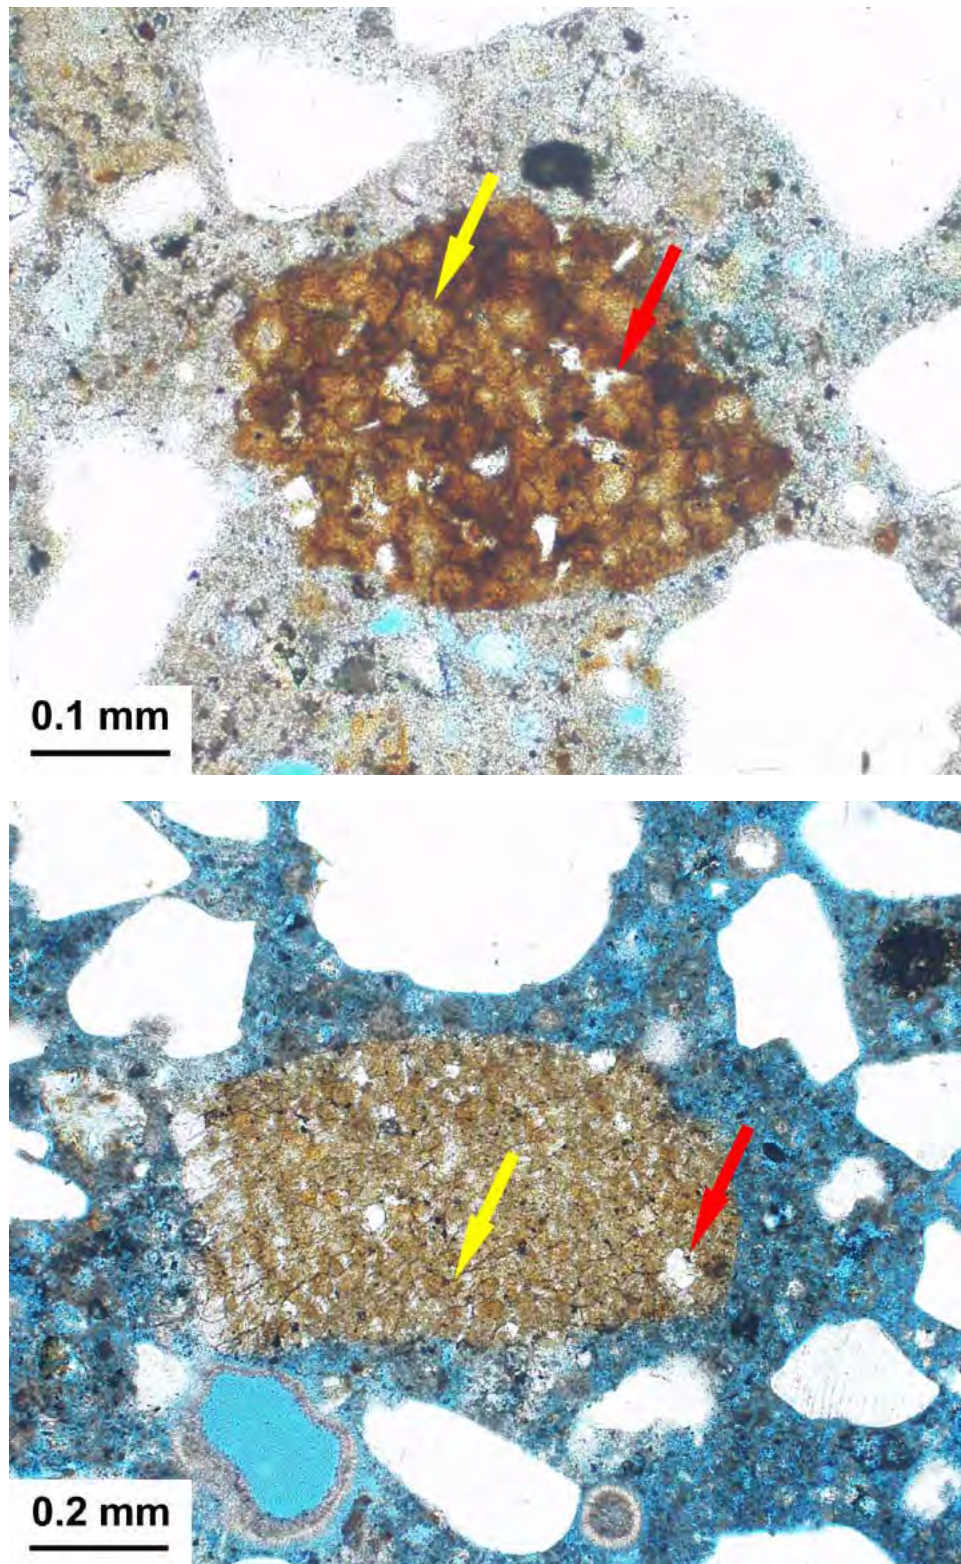
**Figure 5:** PPL photomicrographs illustrating natural cement grains in mortar samples CALO.Mortar.1 (top) and CALO.Mortar.2 (bottom). The yellow arrows indicate original dolomite crystals now lined with iron-bearing cement phases. The red arrows represent quartz silt grains that have not combined during cement calcination. These textures are typical of nineteenth century American natural cements. No residual lime binder is detected petrographically in either sample.
