# NPS Structural/Seismic Evaluation: Cabrillo National Monument

San Diego, California

## Final Report

October 29, 2010

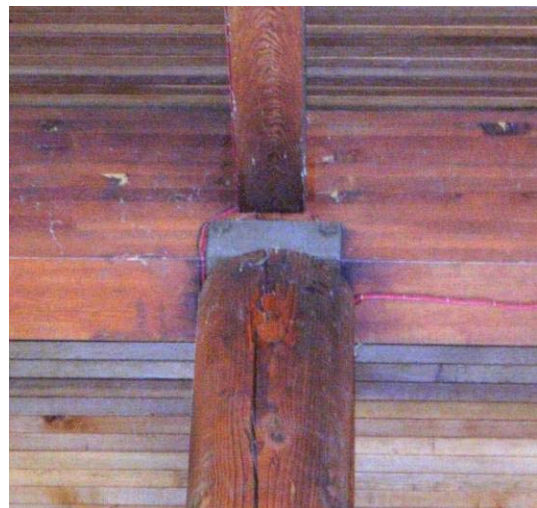
Figure 8: Column Split

The primary lateral-force-resisting system consists of the plywood-sheathed roof diaphragm and the cantilevered columns. These columns are highly flexible and offer little in the way of seismic force resistance. Deformations are expected to be quite large and the glass between columns will most likely break under large earthquake induced motion. These columns alone are not a sufficient lateral-force-resisting system. Furthermore, one of the tallest columns holding the ridge beam has a split directly through the bolt plane that holds the ridge beam in place as shown in Figure 8. Although this crack is likely a shrinkage crack, the connection may be vulnerable in a seismic event.

Construct steel moment frames around the perimeter of the building. Provide a minimum of one frame per elevation, similar to locations shown in Figure 5. Moment frames should consist of single bay frames made of steel wide flange columns, beams, and welded joints. Extend to the underside of the roof framing and attach with a positive connection to the roof framing. Provide new reinforced concrete grade beam foundations where needed to handle the overturning forces expected to be delivered by the moment frames. See Figure 9.

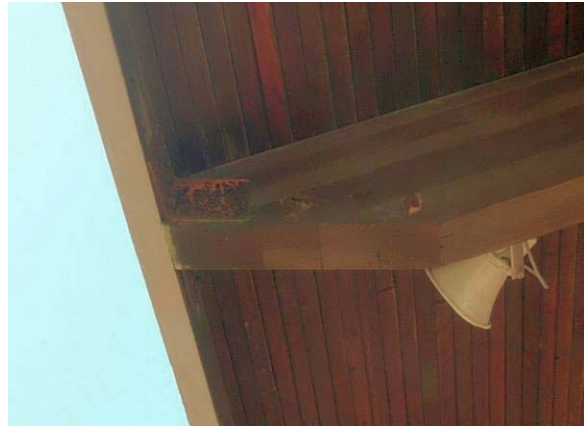
*Figure 10: Rusted Hardware at Eave*

Overall the building was observed to be in good condition. Some hardware connecting the eave fascia to the glued laminated eaves showed signs of rust. A thin crack through the tile was observed running north-south at the eastern end of the building. It could be a sign of differential settlement in the building or hillside, but does not appear to be an indicator of a significant hazard. In general, the structure appears serviceable with no obvious signs of deterioration or distress.

Replace rusted hardware at the eaves on the exterior of the building like that shown in Figure 10 with weatherproof (galvanized or painted) hardware.

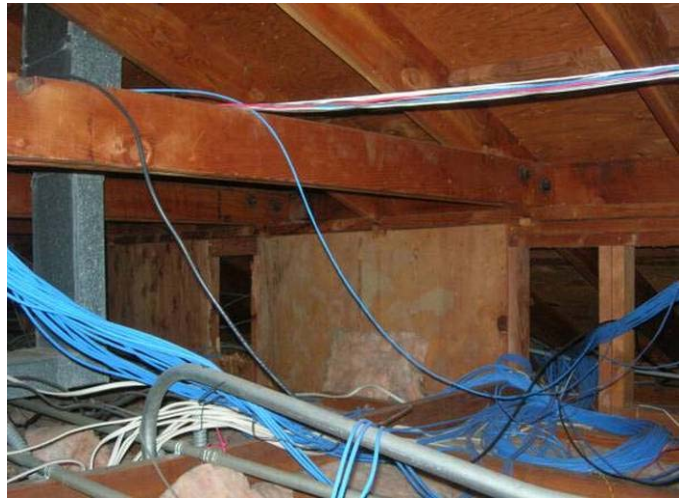
Figure 12: Rafter Ties and Shearwall

The let-in braces are likely insufficient to resist north-south lateral loading. We also observed that the top of the eastern shearwall, shown in Figure 12, has a large opening cut into it to accommodate ethernet and other computer cables, weakening the capacity of the existing shearwall. Roof-to-wall and wall-to-floor connections are similar to those in the east-west direction.

Replace let-in braces with plywood sheathing (44 feet minimum). Provide a minimum of 3/8-inch plywood sheathing with 8d nails at 6 inches-on-center at panel edges and 8d nails at 12 inches-on-center as interim nailing. Provide for a load path between the roof diaphragm and the new wall sheathing by adding blocking, nails, and uplift clips as necessary. See Figure 14 and Figure 15 for typical shear wall definitions and configuration.

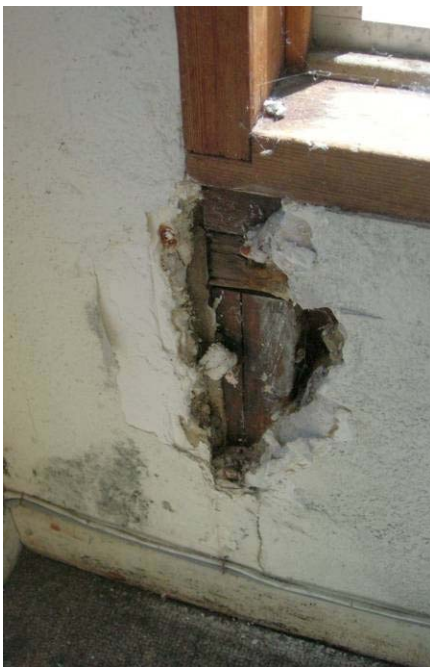
Figure 13: Water Damage

Overall the building was observed to be in good condition. The north-eastern corner of the northern extension showed signs of recent water damage due to a leak and should be repaired. Otherwise, the structure appears serviceable with no obvious signs of significant deterioration or distress.

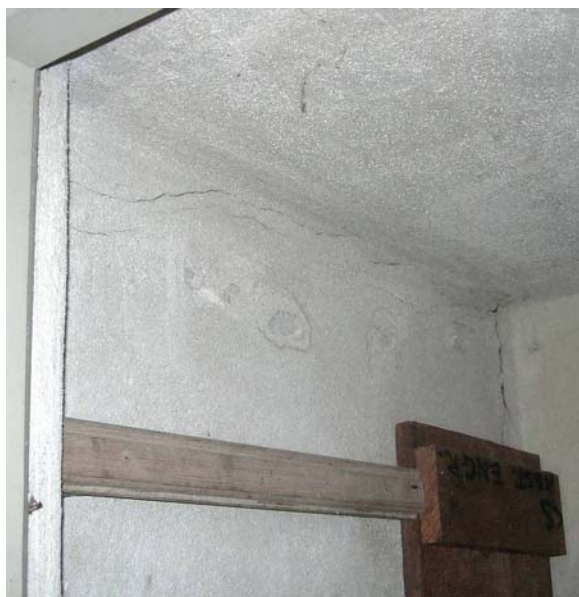
*Figure 26: Crack at top of Basement Wall*

For its age, the building is in good condition. The reports state that fire damaged members were repaired or replaced and that all wood, historical wood included, was chemically treated against termites. Minor water damage was observed in the plaster in the basement. Minor cracks in the northern part of the basement appear to be superficial cracks in the paint. There are some larger cracks at the top of the basement wall in the southwestern corner as shown in Figure 26. They are less than an eighth of an inch wide and are not likely an indication of a serious hazard. In the external walls, mortar and sandstone appear to be thinning in several places, specifically the south-east corner, the south elevation, and south-west corner. This is likely due to corrosion from sea-air. Overall, the structure appeared serviceable with no signs of significant damage or distress.

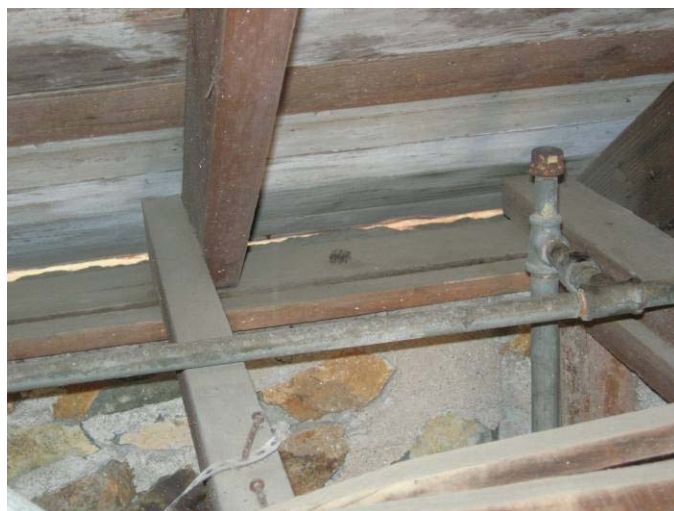
Figure 30: Roof Rafter, Top Plate, and Ceiling Framing

At the roof eave, there was no indication of uplift anchorage hardware, and only one anchor bolt was observed at the wood sill, as shown in Figure 30. Rafters were not blocked over their supports and vulnerable to rolling in an earthquake. There did not appear to be a direct lateral load path from the rafters to the stone walls. The walls along the pipe chase do not extend to the roof and cannot take any seismic force generated in the roof. Furthermore, the pipe chase walls are covered in lath and plaster, which provides little to no shear resistance, and cannot effectively brace the stone walls out-of-plane.

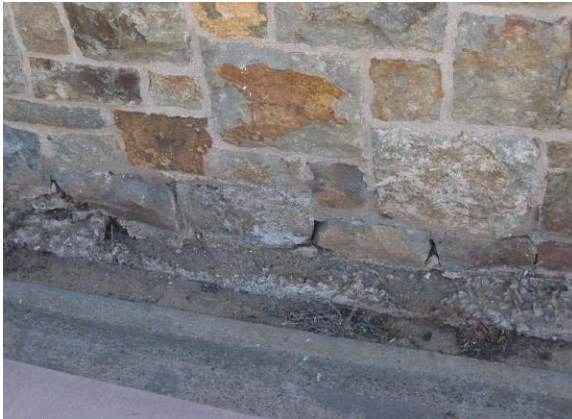
Figure 31: Mortar Deterioration

Overall, the building appeared to be in good condition. The mortar between stones at the base of the east facade had occasionally disintegrated such that there were large, deep gaps around stones. A masonry wall that abuts the building on the north side is separated from it by a large crack in the mortar attaching it to the building, but this does not represent a hazard to the building itself. Otherwise, the structure appeared serviceable with no significant signs of damage or distress.

In addition to the roof-to-wall connections, the wall-to-floor and foundation connections are critical to a functioning lateral-force-resisting system. The building beyond the site walls and specifically the west wall were not accessible due to the site slope. The condition of the footings on the downhill slope side could not be observed to see if they are in good condition and bear on competent material. In addition, the east wall showed signs of mortar deterioration, as well as some concrete deterioration as seen in Figure 31.

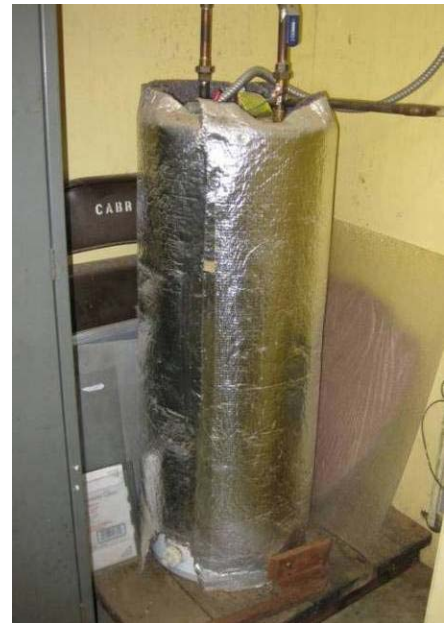
*Figure 38: Unbraced Water Heater*

Some tall cabinets have the potential to be a falling hazard in an earthquake. A water heater, shown in Figure 38, was also not braced. Proper anchorage is critical for minimizing the fire hazard due to a broken gas line during an earthquake.

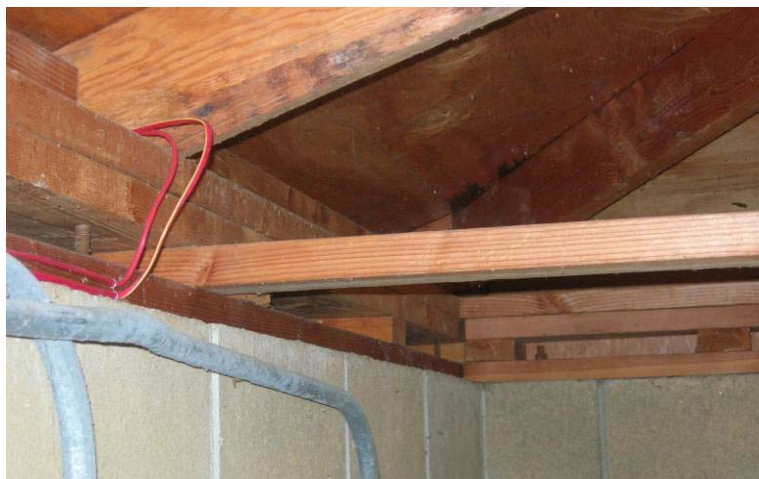
Figure 42: Joists, Top Plates, and Anchor On CMU Wall

Heavy CMU walls need to be braced out-of-plane. Hip roof joists running perpendicular to the north-south oriented walls should be able to brace those walls. Trusses brace the walls oriented east-west, provided that there is a positive connection between the top of the wall and the joists. Wall anchors attaching the top plate to the CMU wall as shown in Figure 42 were observed, although their frequency is uncertain and likely

inadequate. In addition, the effectiveness of the roof framing acting as out-of-plane anchorage is compromised by the vertical offset between the top of the wall and the roof framing.

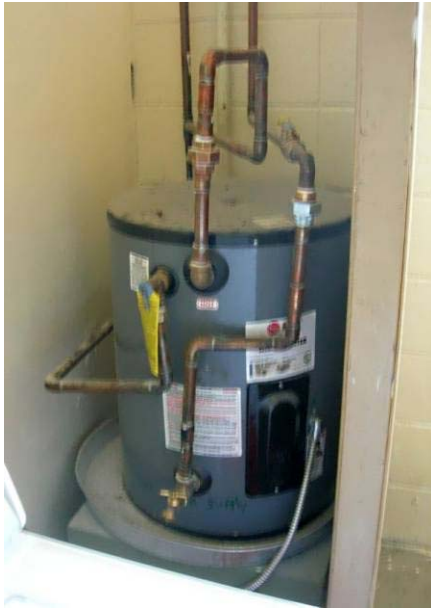
Figure 43: Unbraced Water Heater

There are numerous storage shelves in this facility, most of which are attached to the walls via a ledger and hardware. Given that some are directly connected to the walls and that this building is to be infrequently occupied, these represent a very low hazard. There is a small water heater, shown in Figure 43, that should be anchored to framing to minimize the chance of broken gas line and fire in an earthquake.
