## COLE DIGGES HOUSE A Historic Structure Report

*Formerly known as the Thomas Pate House*

*Prepared for*  
National Park Service  
Colonial National Historical Park  
Yorktown, Virginia

*Written by*  
**Edward A. Chappell**

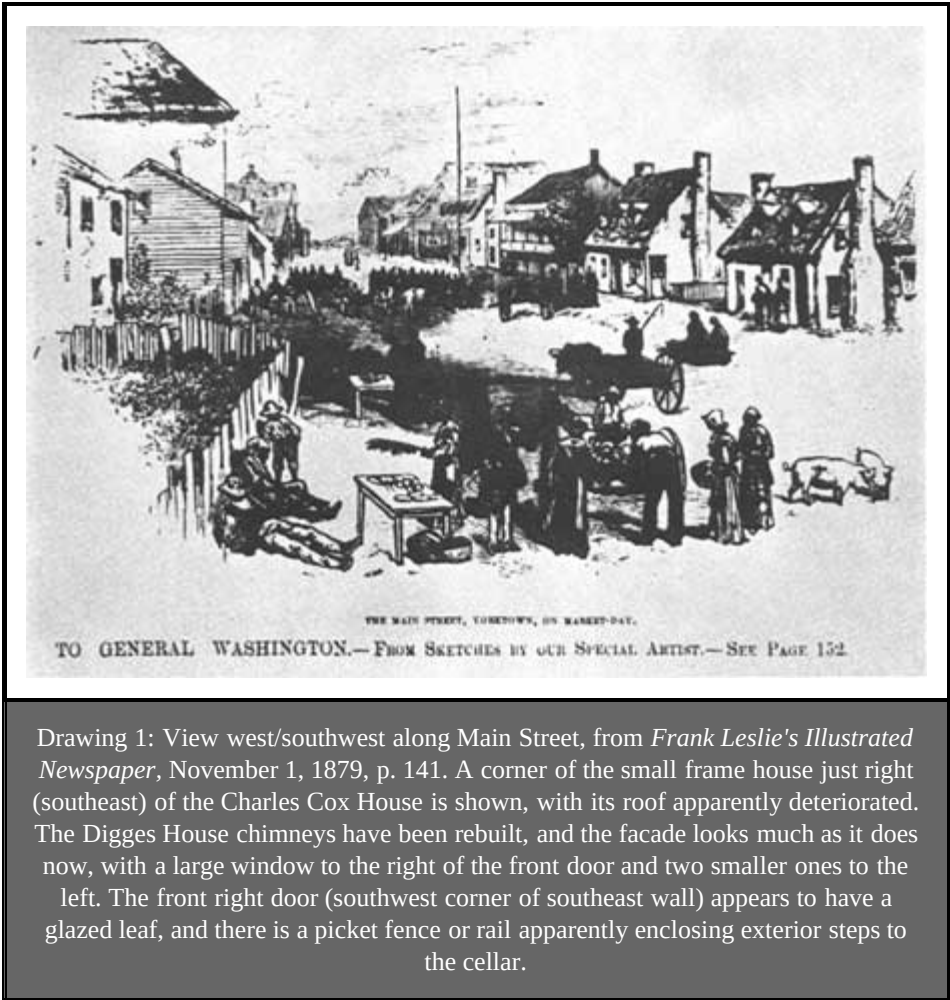
Sizable portions of the original front wall survive in spite of its partially painted and shopworn appearance. The major area of missing masonry is all that between the two left windows. This, combined with the absence of evidence for original jambs for these openings, suggests that the house may have initially had a three-bay front, with a central door flanked by single windows roughly centered on the wall to either side of the doorway. [8] The right opening began as a window. Closers along its left edge reveal this as an original jamb, and one closer as well as courses once butted against now-lost closers indicate that the window rose to the top of the wall, much like the two present left windows on the facade. The opposite side of the right window is cut through original brickwork, and so began as a narrower opening. The top of the opening was lowered to create a doorway, perhaps during a late 18th-century remodeling as a shop, and was closed by the time an engraving of Main Street was published in *Frank Leslie's illustrated Newspaper* on November 1, 1879. [9] ([drawing 1](#)) The present window dates from c.1925.

Drawing 1: View west/southwest along Main Street, from *Frank Leslie's Illustrated Newspaper*, November 1, 1879, p. 141. A corner of the small frame house just right (southeast) of the Charles Cox House is shown, with its roof apparently deteriorated. The Digges House chimneys have been rebuilt, and the facade looks much as it does now, with a large window to the right of the front door and two smaller ones to the left. The front right door (southwest corner of southeast wall) appears to have a glazed leaf, and there is a picket fence or rail apparently enclosing exterior steps to the cellar.

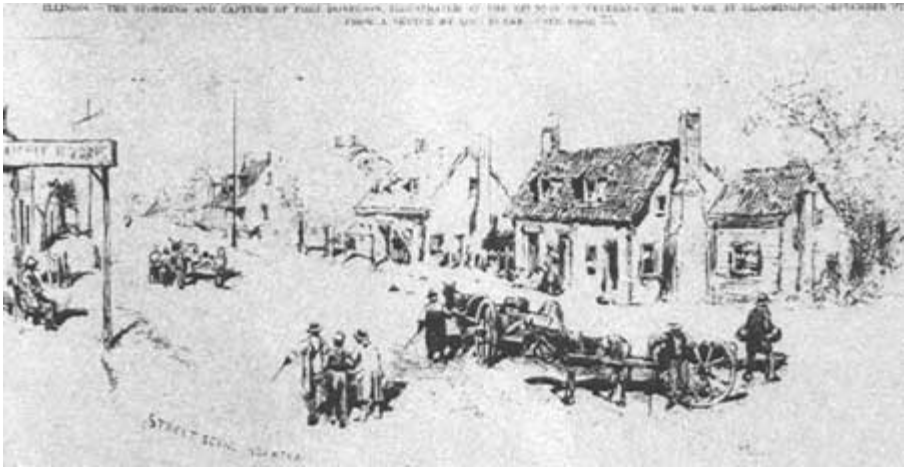
Drawing 2: Similar view from south, from *Frank Leslie's illustrated Newspaper*, October 1, 1881. The Digges House is in the approximate center. This appears to show a small shed-roofed porch at the left front. On the right is the dilapidated Cox House.

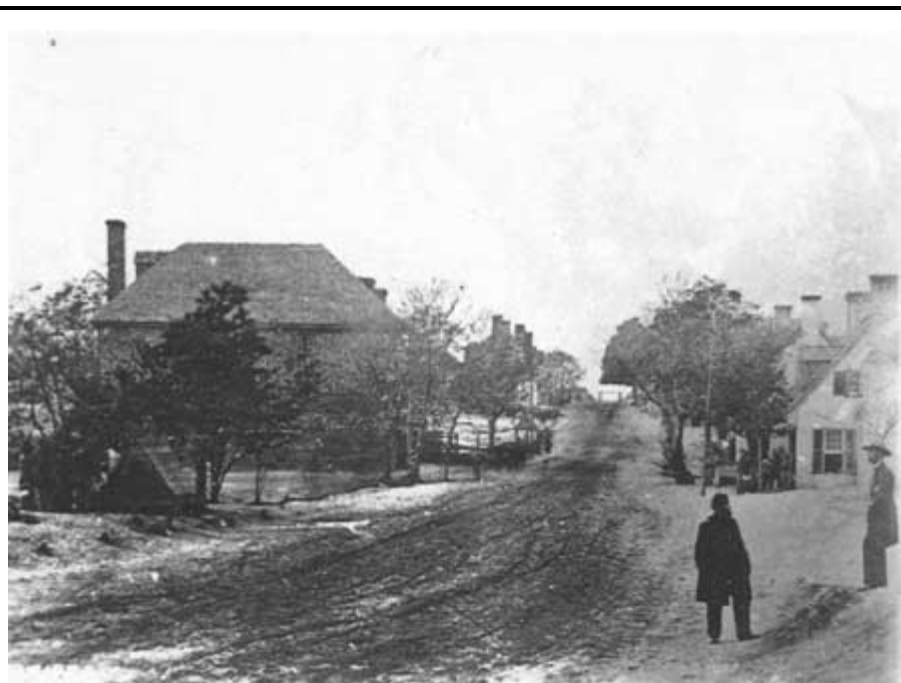
The famous 1863 Mathew Brady photograph of Main Street ([photograph 1](#)) offers a glimpse of the Cole Digges House, and appears to show an exterior chimney centered on this end. Much of the brickwork has been cut out at the center of the first floor and below the gable window, so it seems likely that the right chimney was added, probably during the Greek Revival remodeling, and was removed by the late 19th century. Views of the street in *Frank Leslie's Illustrated Newspaper*, November 1, 1879, and October 1, 1881 (drawings [1](#) and [2](#)), and contemporary photographs show a spindly exterior chimney that replaced the old addition, the later one associated with stoves rather than fireplaces and located sufficiently far to right to leave the gable window unobstructed. The exterior stairway to the cellar appears to have been excavated at the same time, and an end doorway into the first floor was cut in at the corner, just beyond the new stair. This would seem to have made a front doorway to the south room redundant, and the illustrations show that the latter was closed by the late 19th century. Charlottesville architects Browne, Eichman, Dalglish, Gilpin and Paxton recommended extending the exterior stair toward the front to meet building code requirements, and this was done in the summer of 1998, necessitating addition of a larger masonry wall, iron railing, and comparable ironwork blocking the doorway at the head of the steps. [\[14\]](#) Correspondence indicates a 19th-century side porch incorporating the cellar steps was removed during the restoration, but the photograph from D. W. Griffith's film *America* shows it already removed ([photograph 14](#)). [\[15\]](#)

Photograph 1: View northwest along Main Street, with Custom House to left and Charles Cox and Coles Digges houses on the right. Winter of 1863, during Union occupation but apparently before the Swan Tavern blew up. Said to be a Mathew Brady photo. Right (southeast gable) and the exterior chimney centered on it as well as the centered left (northwest) chimney are visible behind the Cox House. This may be the only known photo showing the old right chimney. The house shows a fresh coat of white paint, or more likely, whitewash, at this time.

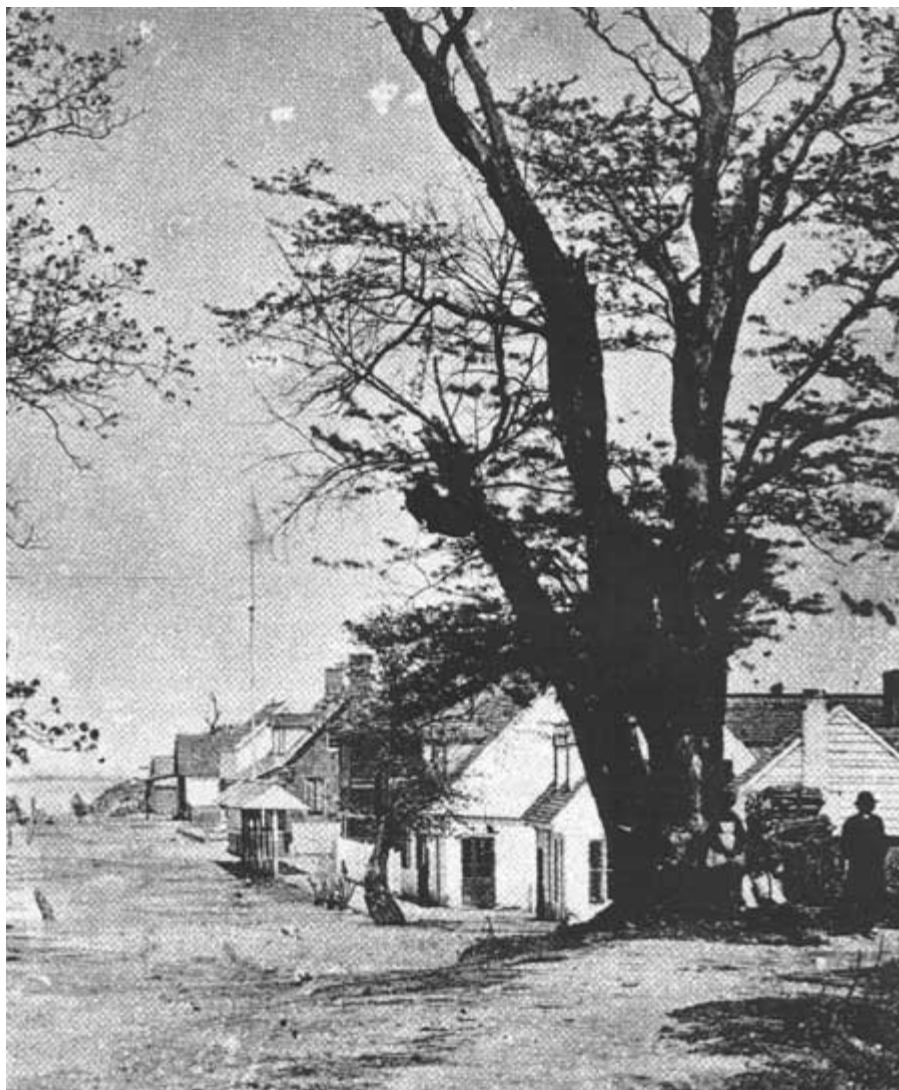
Photograph 2: Cook Collection photo (from Valentine Museum, Richmond) looking northwest along Main Street, with the river visible in the distance. Possibly c. 1865-75 because the small frame house in right foreground beside the Charles Cox House appears well maintained, and this building was already deteriorating when a piece of it was shown in a sketch of a similar view published in *Frank Leslie's Illustrated Newspaper*, November 1, 1879. The photo shows the Cox and Digges houses freshly painted. There is a glazed door in the right front corner (southwest end of southeast wall) of the Digges House.

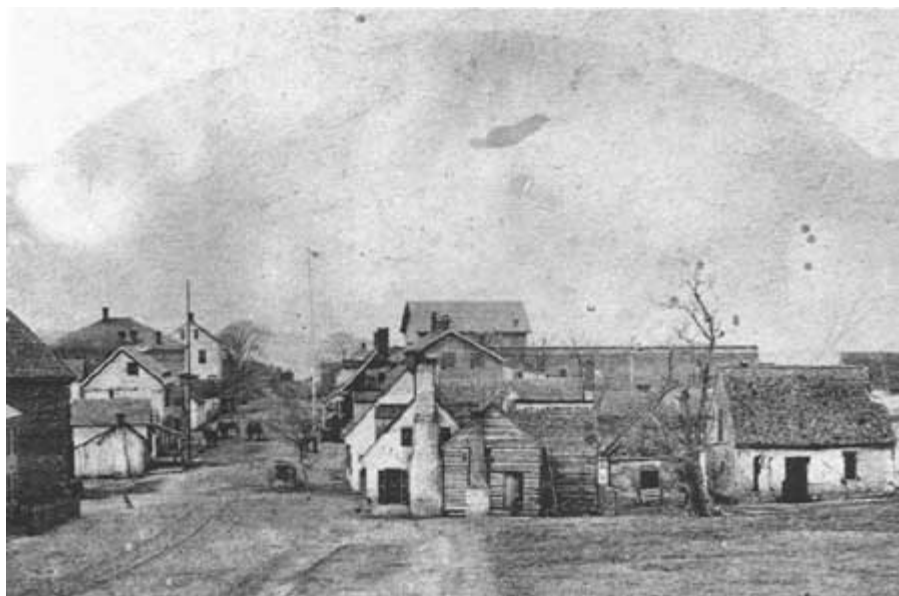
Photograph 3: View northwest along Main Street with Custom House and 19th-century wooden houses on the left, Cox House with scruffy outbuildings, Cole Digges, and Somerwell House (probably owned by Lightfoot) to the right. Probably c. 1870-80. The old right (southeast) chimney is missing, and its replacement is partially visible behind the left Cox House chimney. The left (northwest) chimney has been rebuilt with the stack behind the ridge. Brickwork appears freshly painted white, except the chimneys. The two-story frame house visible just beyond the Cole Digges House in this photo, is absent from Photo 1. Here it has either dark paint or very little white paint.

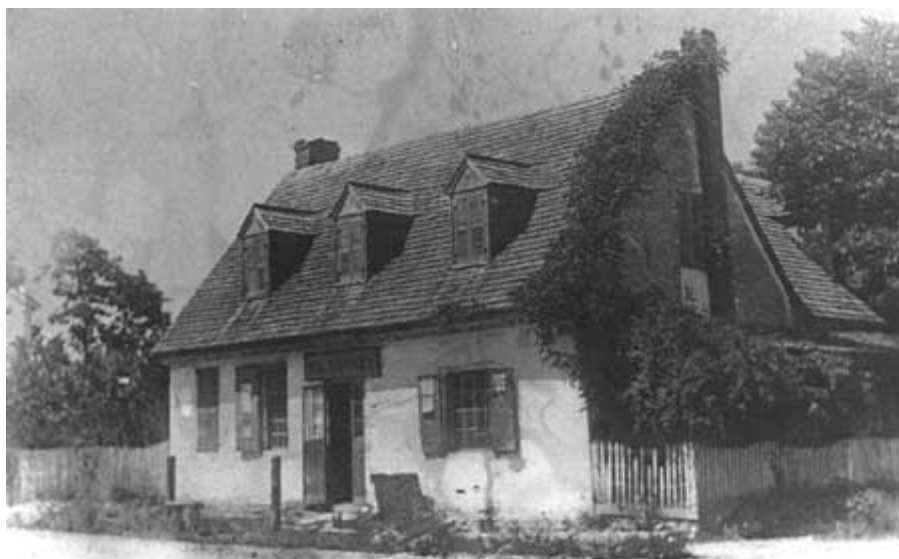
Photograph 4: Summer view of Cole Digges House from the south, c.1880-1900. Elizabeth A. Cooper's tearoom sign is in place over the front door of the Digges House. It is thought that Cooper opened the tearoom in the cellar by 1881, and she died in 1901. The door has two six-light leaves, opening out. Louvered shutters on the first-floor windows and dormers. Picket fence to the right (southeast), surrounding shed-roofed porch, square-butt shingle roof with traditional combing at the ridges and swept valleys, installed precisely like 18th- and early 19th-century Chesapeake shingles. It is likely that this is mid-19th-century roof covering. Front painted white, relatively fresh, right side dirty, upper woodwork unpainted or dark paint. Shows second left (northwest) chimney with some damage and scrawny stove

chimney on right (southeast).

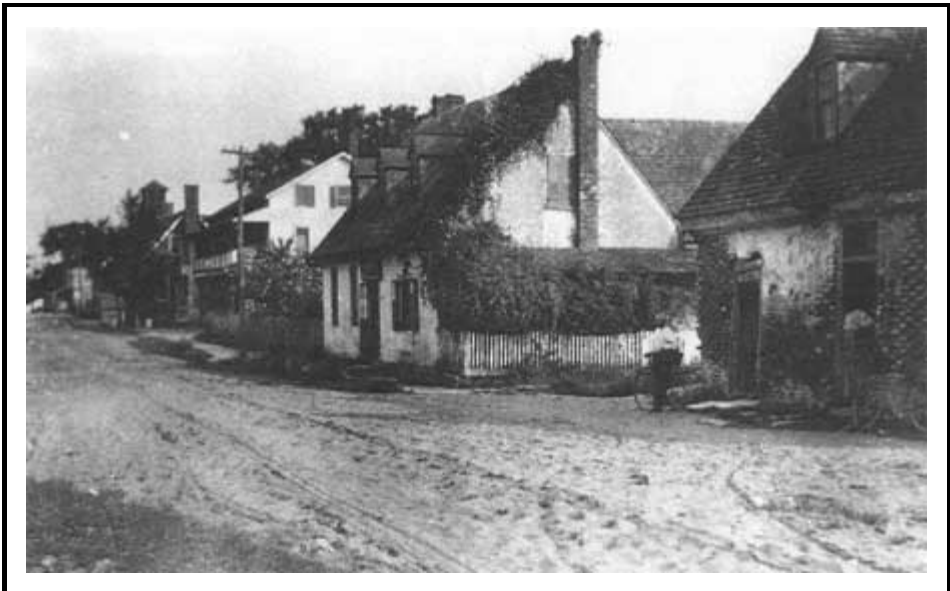
Photograph 5: Another summer view from the south, also showing the derelict Cox House to the right, within a year or two of the fourth photo, judging from extent of vines on the right gable and shrubs inside the picket fence. Shows the E. A. Cooper sign, shingles, glazed front doors and louvered shutters. The two-story frame Old York Tavern visible to the left of the Cole Digges House looks freshly painted.

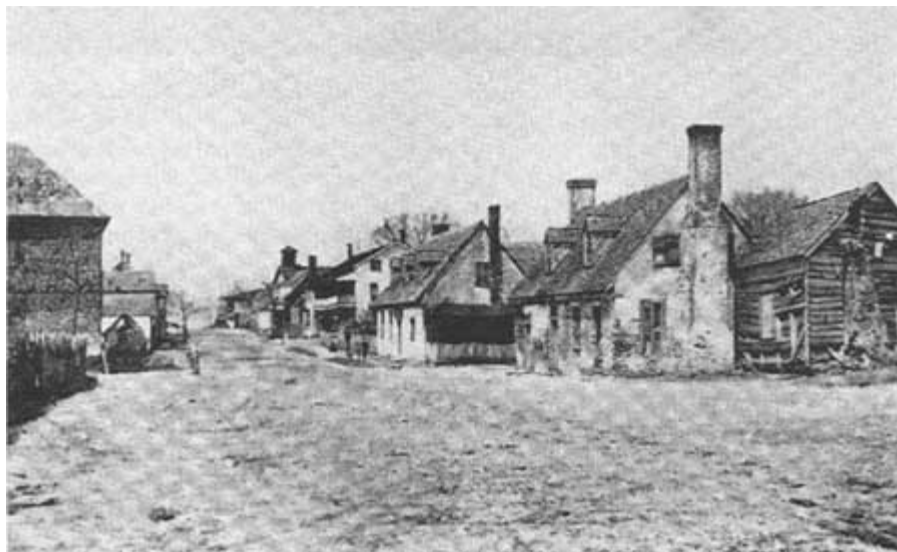
Photograph 6: A printed winter view looking north/northwest along Main Street, roughly contemporary with photos 3 and 4. The ramshackle single-bay wooden house east of the Cox House has substantially deteriorated since photo 2 was taken. The J. S. deNeuville store has not yet been built northwest of the Digges House.

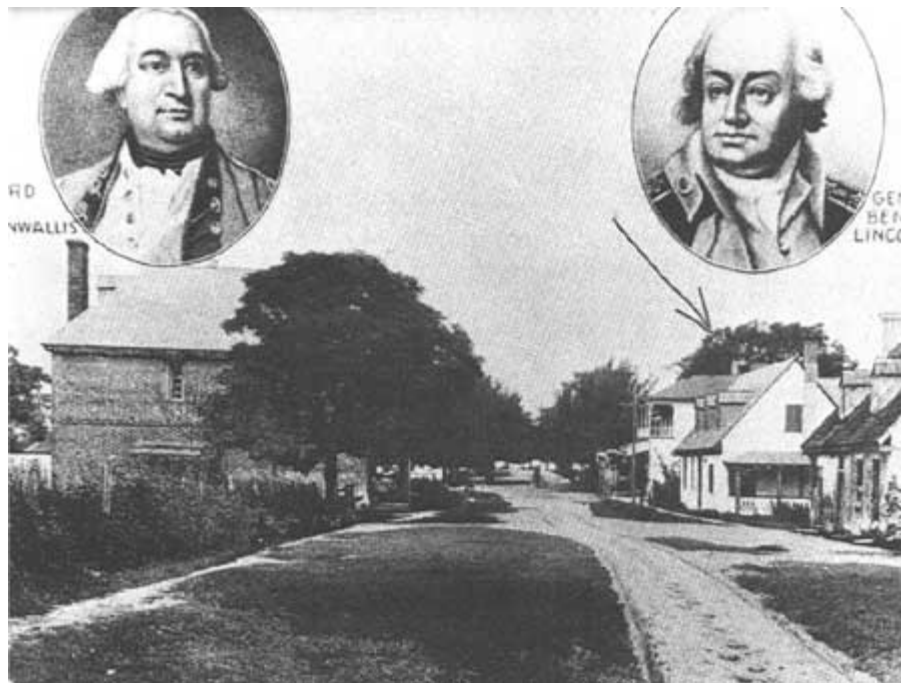
Photograph 7: View looking northwest along Main Street published in Charles H. Callahan, *Washington: The Man and the Mason*, (c. 1913), with the Custom House on the left. The Digges House appears in better condition, freshly painted white (except woodwork and upper chimneystacks), and with a new sawn-work porch railing enclosing the exterior cellar steps at right end. The front right door is visible inside this enclosure, and louvered shutters remains in place. The Cox House, which apparently burned in 1912, remains standing, and the turn-of-the-century J. S. deNeuville store is now standing.<sup>1</sup>

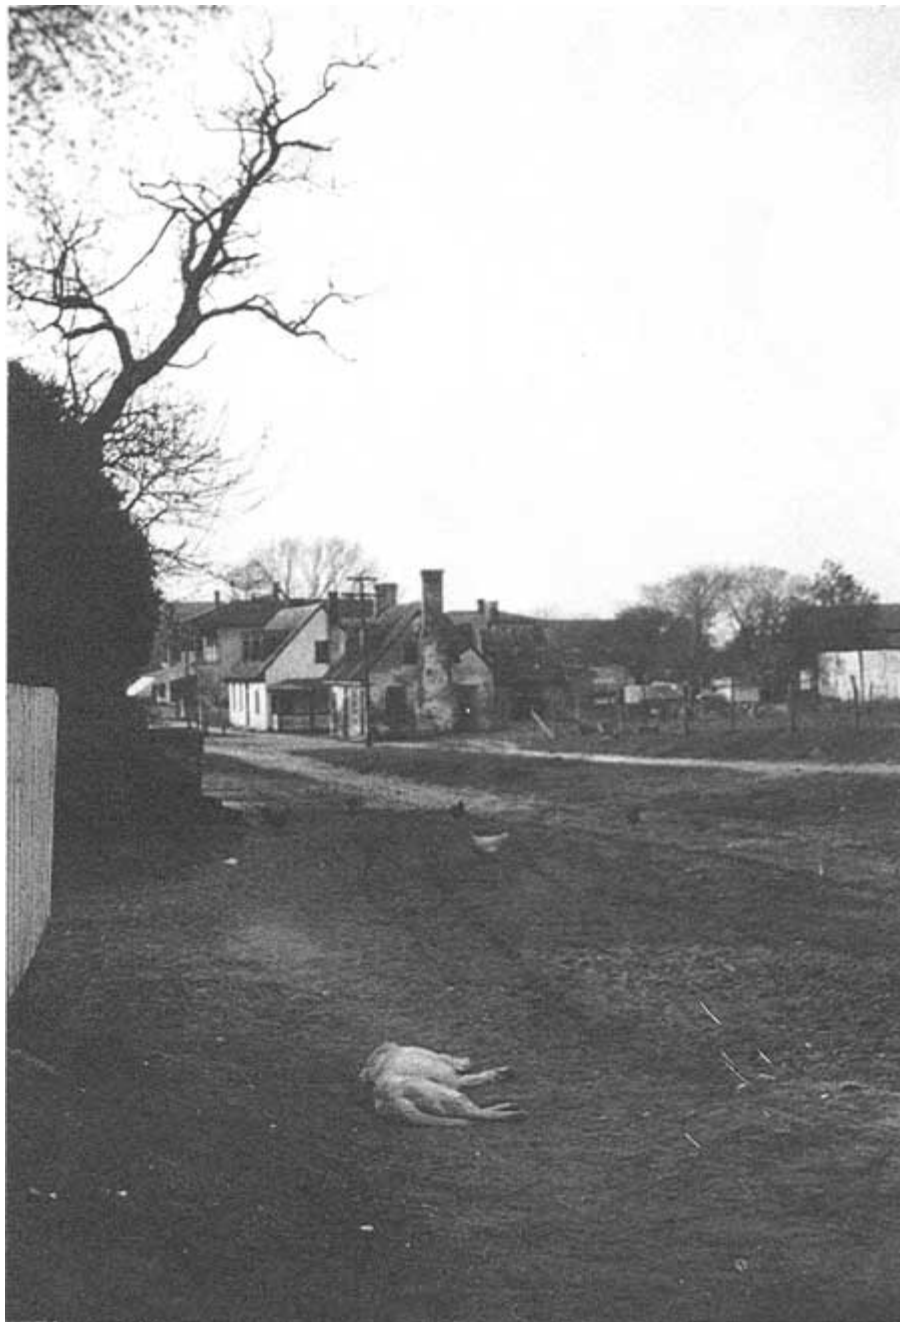
Photograph 8: Photograph taken from near the Nelson House, looking northwest, offering a clear view of the Cox and Cole Digges houses, with chickens and sleeping dog in the foreground. Taken somewhat later than photo 6 because the one-story wooden extension has disappeared from the east end of the Cox House by this time.

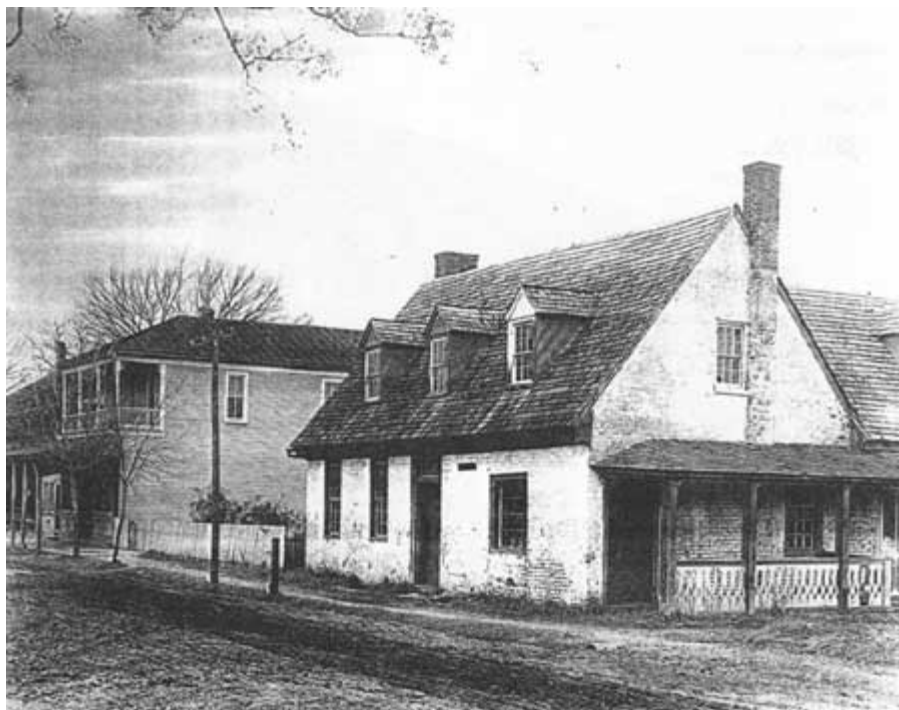
Photograph 9: View of the Digges House from the south, across a rutted dirt Main Street, with a telegraph pole to the left. The house seems to have declined somewhat. All shutters have been removed from front and visible right windows. A solid front door has replaced the glazed leaves, and an old nail-studded leaf is in the right front door. There are nine-over-nine sash with wide muntins in the right window lighting the right front room, perhaps the earliest surviving sash visible in any of the photographs. A small rectangular sign has been attached to the right of the front door transom.

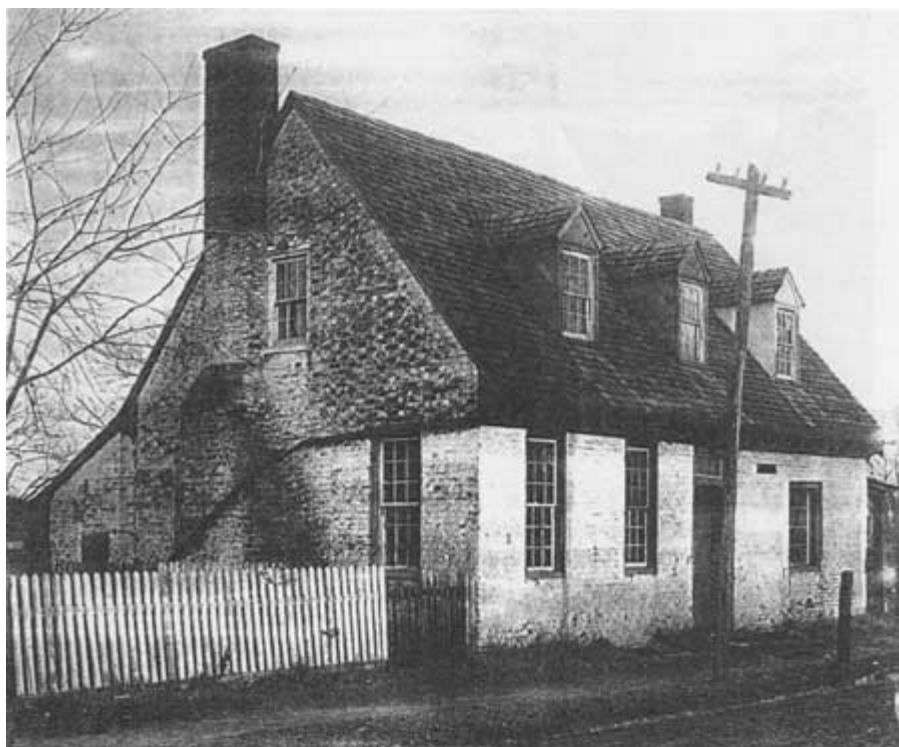
Photograph 10: A view from the west contemporary with photo 8. In this rare view, one glimpses the mid-19th-century brick-walled rear shed across a white-painted

brick fence. Two front window wells intended to light the cellar are clearly visible. Shutters are absent on the left wall as well.
