**ALANSON SWAN  
HOUSE**  
Cuyahoga Valley National  
Recreation Area  
**HISTORIC STRUCTURES  
REPORT  
ARCHITECTURAL DATA  
SECTION**

**Prepared by**  
**S. Elizabeth Sasser**  
Historical Architect

**March 1987**

National Park Service  
Denver Service Center  
Williamsport Preservation Training Center

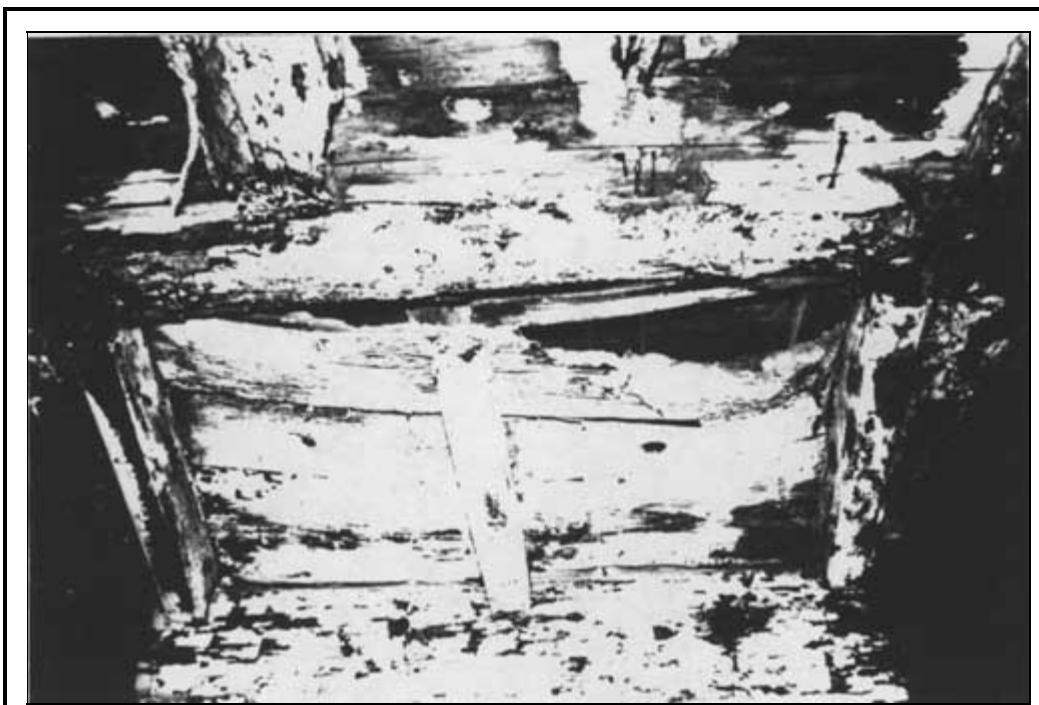
5A. Room 001 Detail of Hearth Support

east and north faces of  
cribbed timber feature.  
12"x12" to 12"x16" hand hewn  
squared oak timbers. Horizontal  
joints chinked with lime  
mortar and small stones.  
the interior of the feature  
appears to be packed with  
earth and rubble.  
The entire feature is approximately  
5'x6', including a 2'-0" stone  
buttress at the west wall.

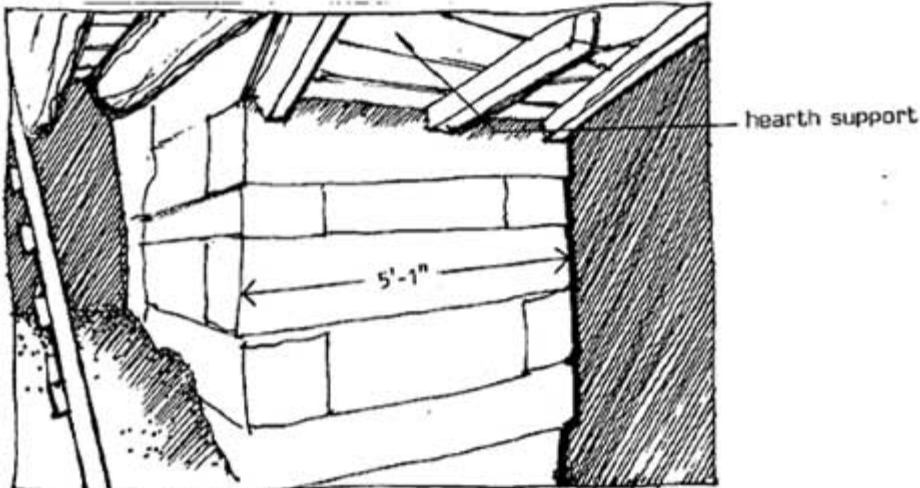
7A. Room 001 Cribbed timber chimney footing

South and east faces of cribbed timber feature. This feature appears to represent a footing for a large masonry fireplace and chimney, no longer extant. The feature dates to the original construction of the house as evidenced by the spacing of the log joists on either side of the feature, and the manner of notching in the hearth support header. The stone buttress on the west side of the feature shows continuity with the masonry work of the west foundation wall.

The size of the feature suggests that the original fireplace was used for cooking as well as heating, predating the general introduction of cast iron stoves for both purposes in the 1830s. It is also unlikely that cast iron stoves would have been generally available in the area before the completion of the Ohio and Erie Canal in 1827.

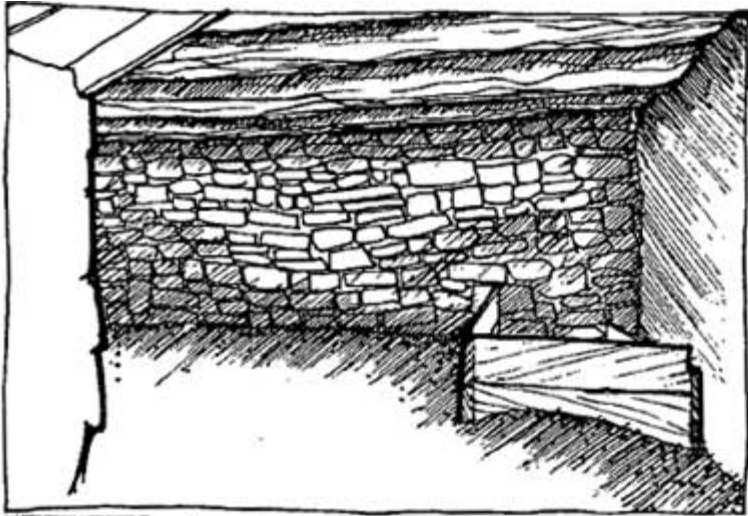
10A. Room 001 North Wall of Cellar

Uncoursed rubble stone foundation wall, approximately 6 ft high. when this photograph was taken in March 1986, the wall had developed a bulge at its midsection, with a lateral displacement of about 2'-0". The upper third of the wall collapsed in September 1986, leaving the north sill beam unsupported except at its extreme ends over a span of approximately 9'-0".

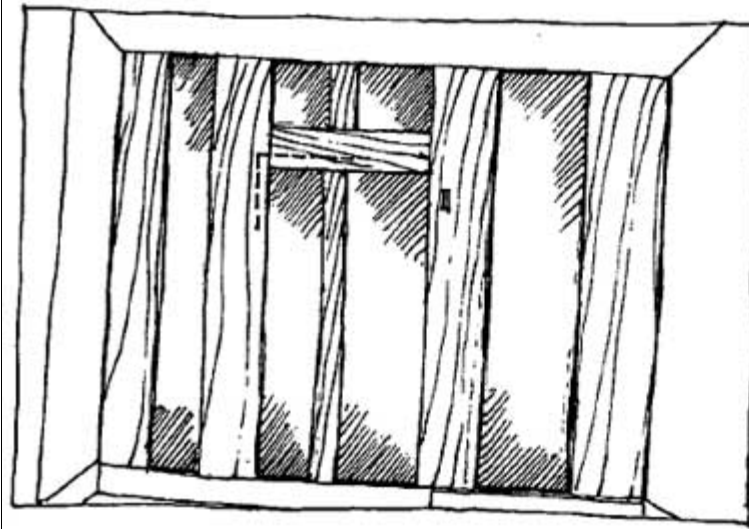
16C. Schematic of Plank Partition Room 101 West Wall

2"x12" to 16" oak planks appear to be hand hewn. The 2"x9" horizontal member is the header for a former door opening. Its bottom edge is 5'-11 1/2" above the floor. The surface of the planks is whitewashed underneath the the applied wood lath. On the upper left corner of the header and plank intersection a 2" wide strip of bare wood indicates the ghost of a door casing. Broken off square nails within the outline show the method of attachment of a frame. However, the nails did not protrude enough to determine the method of their manufacture. A square mortised hole approximately 3/4"x 2" in the right jamb appears to have received a pintle for a wrought iron strap hinge.
