## United States Department of the Interior

Padre Island National Seashore

May 4, 2007

RE: Site Inspection of South Sprint Operations at Padre Island National Seashore

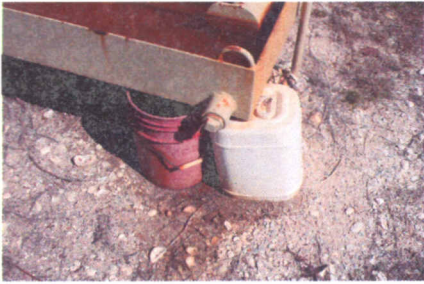
Photo 1.

- When the South Sprint facility was under the ownership of Enron Oil & Gas (EOG) issues with surface and groundwater contamination became evident, and EOG and the NPS formulated a plan to begin clean-up and monitoring activities. When Locin took possession of this facility, responsibility for the previous contamination and remediation issues was assumed by Locin. Groundwater was monitored between 1994 and 1998 and samples taken in 2004 indicated the presence of dissolved phase hydrocarbons. The most contaminated area is the groundwater under and near the tank battery. Current issues associated with contamination are described in the bullets below:
- Several instances of ground staining were observed throughout the operation site, most notably around the compressor and back separator, as well as around numerous buckets scattered throughout the site (photos 1-3).

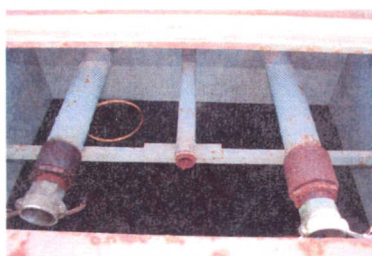
Photo 5.

- The connection box was full of oil and water (Photos 4 and 5), and needs to be vacuumed and cleaned out. Necessary steps must be taken to prevent this box from filling in the future.

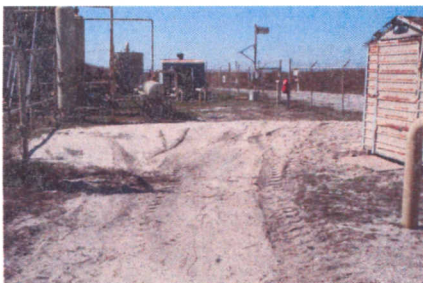
Photo 6.

- It was brought to our attention that Locin employees or a sub-contractor entered the Locin South Sprint location on February 8, 2007 and conducted activities involving digging with a bucket loader (Photos 6-8). After these activities occurred, the park was contacted by a Locin representative requesting permission to conduct excavation activities to replace an existing flowline with a larger one. This request was granted after the park received a plan outlining the necessary steps, locations, and activities that would be entailed.
- Proposed activities must be provided to Padre Island National Seashore's Resource Management personnel a minimum of 5 days prior to the proposed activity.

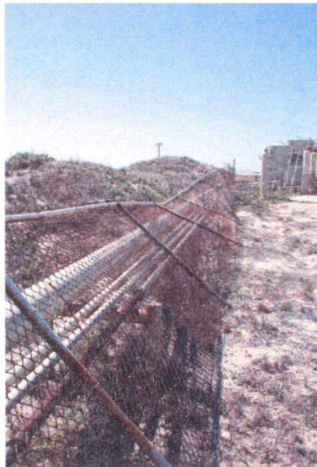
Photo 9.

- Numerous sections of fence around the perimeter of the operation site are falling down (Photo 9), and multiple gates are not functional, are not closed, or are not locked (Photos 10-11). There are also multiple sections of fence that are completely missing and that are missing barbed wire around the top (Photo 12). The fence, gates, and barbed wire need to be repaired or replaced to provide the recommended amount of security to protect visitors and natural resources.

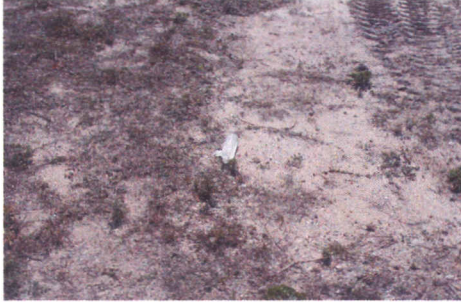
Photo 13.

- Numerous pieces of consumer trash are located throughout the site, thrown on the ground (Photo 13), or in a hole that was dug and filled with garbage (Photo 14). A gauging sheet was also found wadded up and stuffed between pipes next to a gauging station (Photo 15). All trash must be removed by Locin personnel after each visit to the site.
- Unused equipment such as pipes, fittings, buckets, hose, and support beams are being stored in and around the sheds and perimeter of the location (Photos 16-18). These items need to be removed.

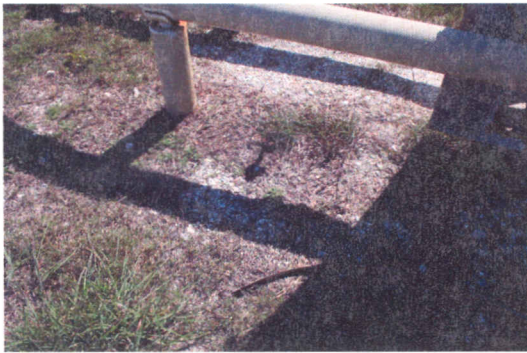
Photo 20.

- One of the sheds in the site has a broken tie-down strap (Photo 20), as well as a non-functional door that needs to be replaced (Photo 21).

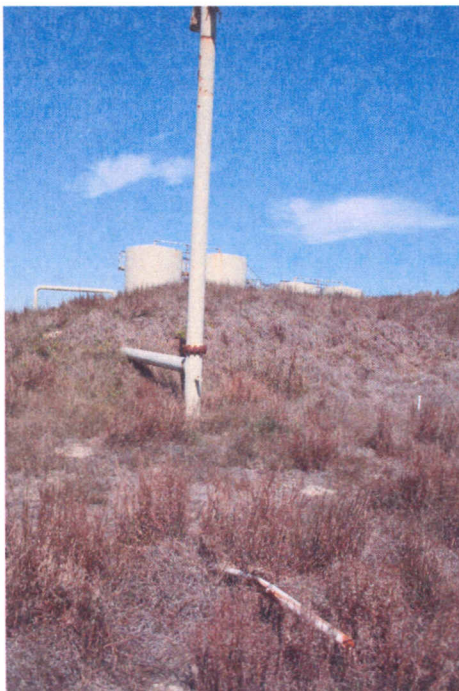
Photo 22.

- A stand pipe located near the back of the site is no longer supported by guy wires (Photo 22). The wires have broken and need to be replaced. Hurricane straps on one of the sheds are also broken and need to be replaced (Photo 23).

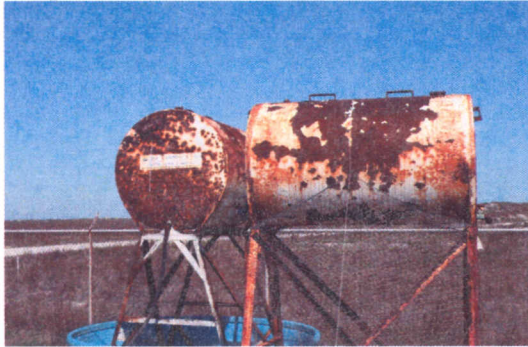
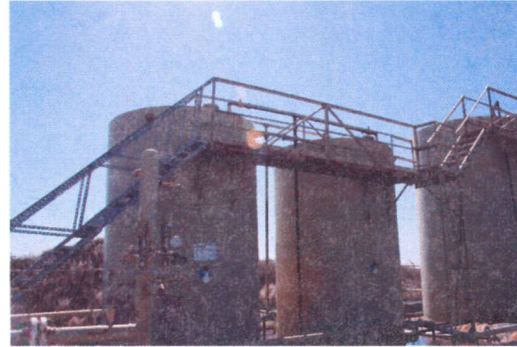
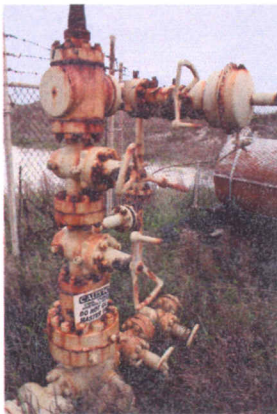
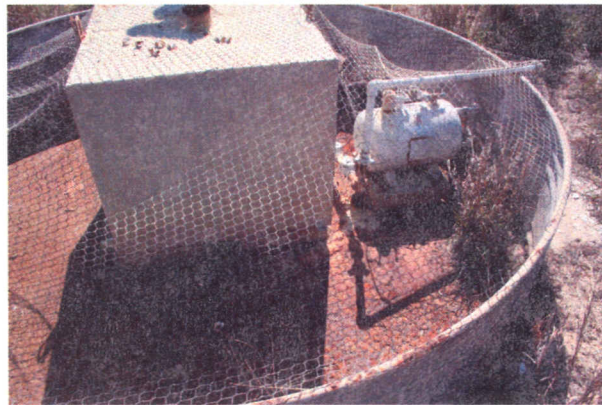
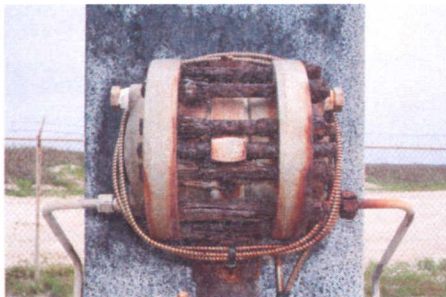
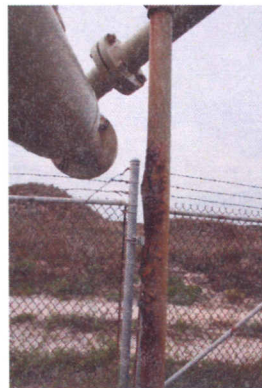
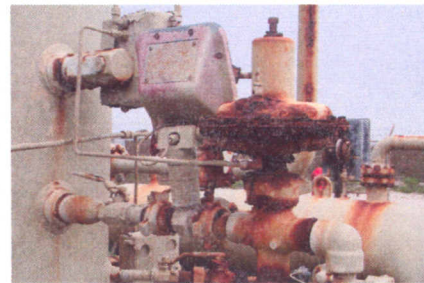
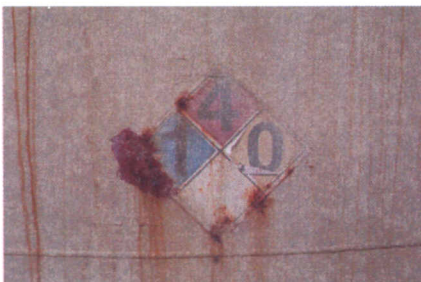
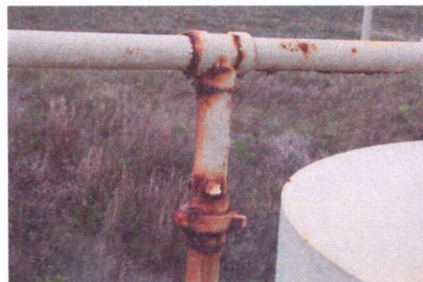
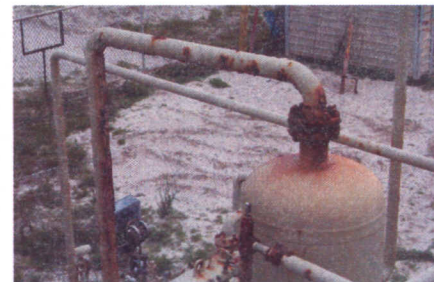
- The general overall condition of the storage tanks, pipe, secondary containment, a section of catwalk, and wellhead are rusted, cracked, broken, and in some cases non-functioning or non-serviceable (Photos 24-33). All items must be repainted a color that is acceptable to the NPS to help them blend in with the natural background. Operators are required to paint their operations an NPS-approved sand or burlap color, such as Sherwin-Williams, code # 6137.

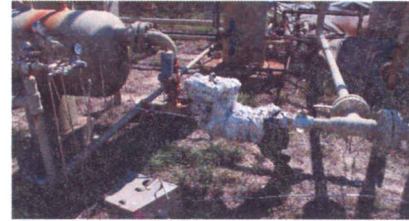
Photo 34.

- A pipe fitting that has been wrapped with an unknown material has become a concern due to its weathered condition (Photo 34). If this material is in place to prevent a leak, then the fitting needs to be replaced.

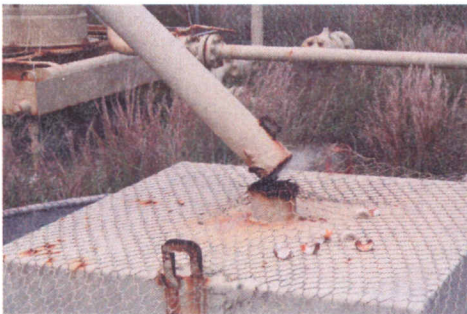
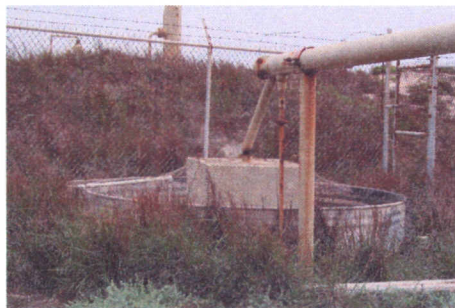
- A piece of rusted and corroded equipment is emitting an unknown vapor into the atmosphere (Photos 35 and 36) with a noticeably strong hydrocarbon odor detected downwind and condensate is dripping from the open end of the pipe. This equipment needs to be replaced immediately to prevent further emissions into the air and potential contamination of soil and groundwater.

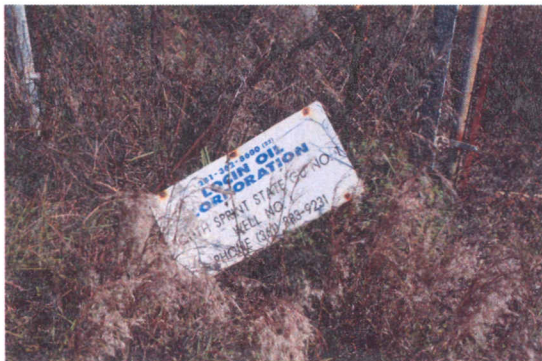
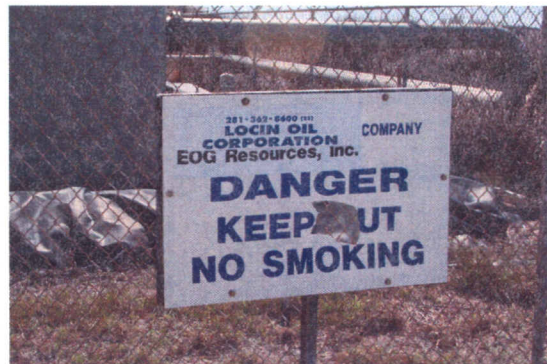
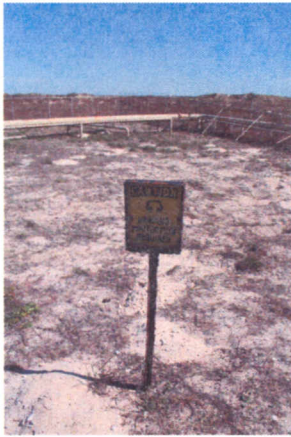
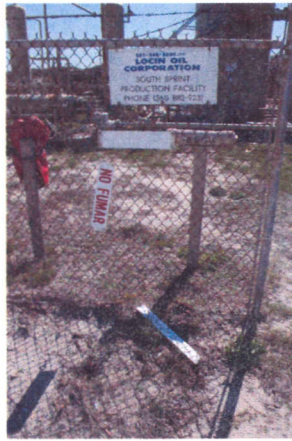
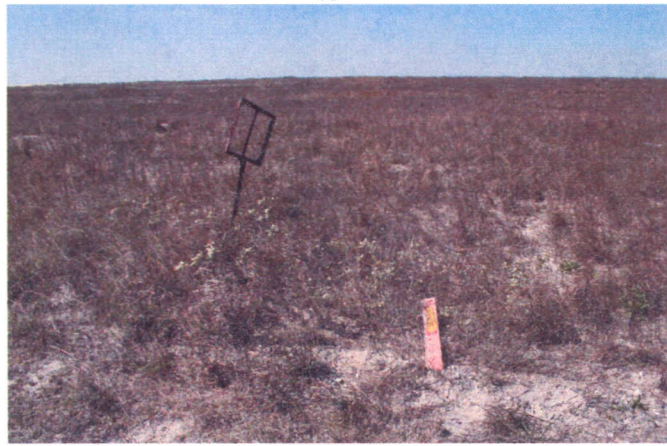
- Numerous signs are falling, missing, or contain outdated information throughout the entire South Sprint area. There are empty sign holders in the ground and a pipeline marker is knocked down. All signs need to be securely attached and must contain current ownership and contact information for the South Sprint operation area (Photos 37-41).

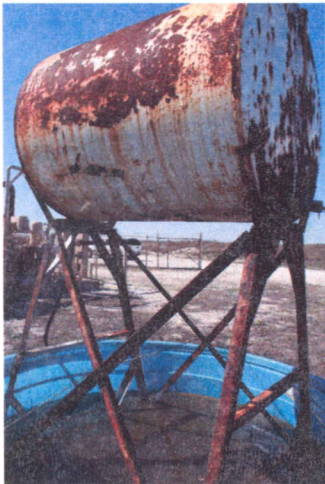
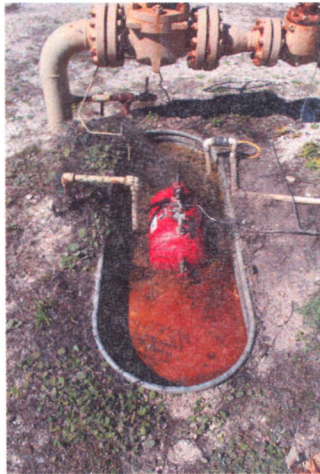
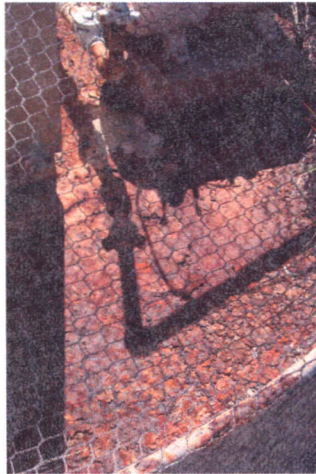
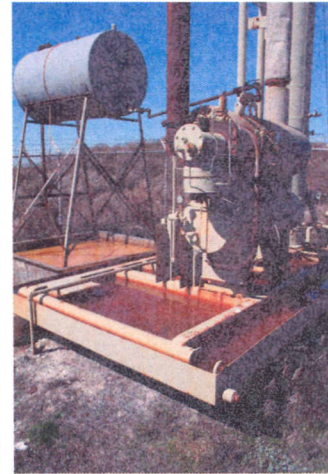
- Some containment tanks are not netted or the netting is falling or has holes, thus negating its purpose to prevent birds and other wildlife from entering and trying to access liquids held in the containment (Photos 42-45). All secondary containment is required to have functional netting in place that does not reach the ground or contain any gaps.

- Nearly all of the secondary containment is full of rainwater (Photos 42-45 and 48-52) that needs to be removed by vacuum truck so as not to be a wildlife attractant and to prevent wildlife poisoning or soil or water contamination. The collected liquid needs to be removed after each weather or leak event.
- Several of the secondary containment areas are not holding water. In one instance it is due to a corroded and cracked metal containment tub (Photos 44 and 51). In another instance there is a bermed tank that is not properly lined and water is escaping through seams in the liner (Photo 52).

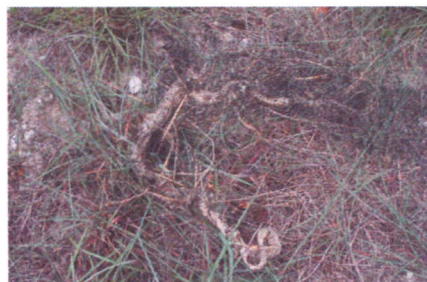
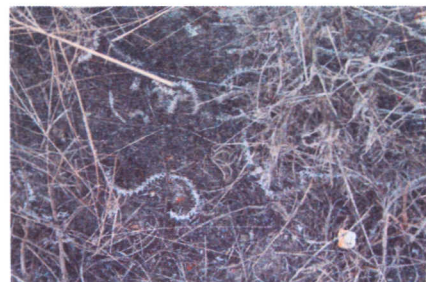
- One of the improperly netted secondary containment areas has been responsible for the death of numerous snakes (Photos 46 and 47). The skeletons are visible around the tank in question and can be seen entangled in the netting that has fallen to the ground. Netting that is properly installed and maintained will prevent these deaths.
