# Inventory of Coastal Engineering Projects in Colonial National Historical Park

Natural Resource Technical Report NPS/NRSS/GRD/NRTR—2013/690

Kate Dallas

March 2013

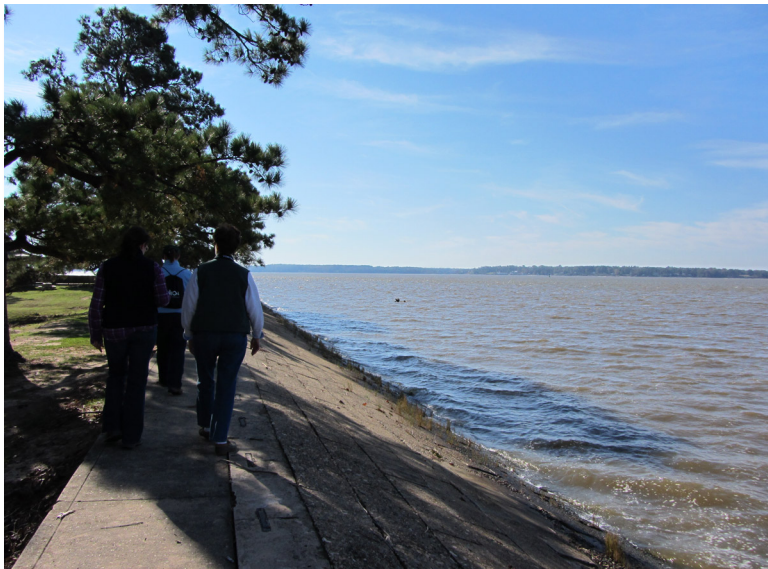
At Historic Jamestowne the shoreline has eroded more than 120 m (400 ft) since the first landing in 1607 (Johnson et al. 2001). A sloped 730-meter (2,395 ft) long concrete seawall (structure #13 Figures 6 & 7), built by the U.S. Army Corps of Engineers (USACE) from 1900 to 1905 and rehabilitated in 1969 and 1982, protects the Jamestown site (USACE 2002, John Milner Associates et al. 2006). The Historic Jamestowne property and seawall are owned and maintained by Preservation Virginia. Immediately downstream (southeast) from the seawall is a 970-meter (3,180 ft) long revetment (#14 Figure 6) originally built by the NPS in 1935–1936 (John Milner Associates et al. 2006).

**Figure 7.** A concrete seawall protects Historic Jamestowne along the James River (#13 Figure 6). View is to the southeast.

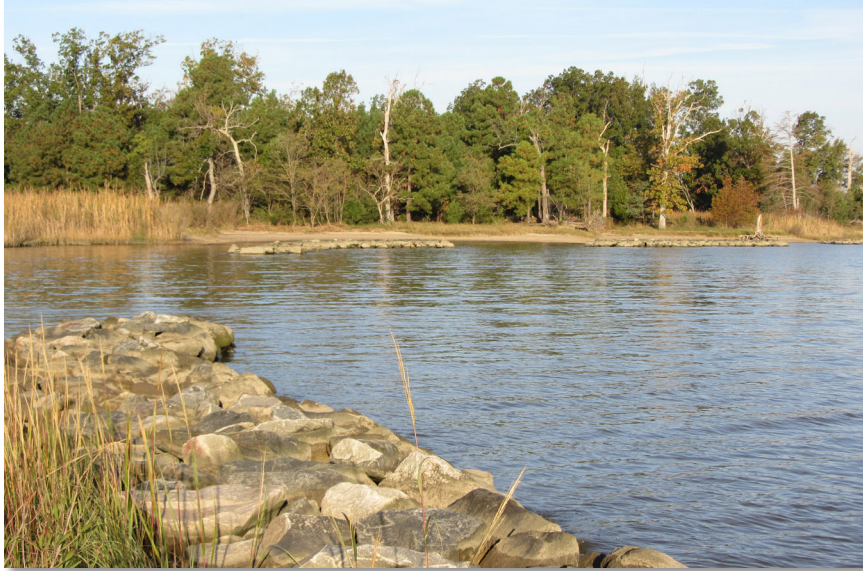
**Figure 8.** Rock sills near Black Point, Jamestown Island (#35–37 Figure 6). View is to the northwest.

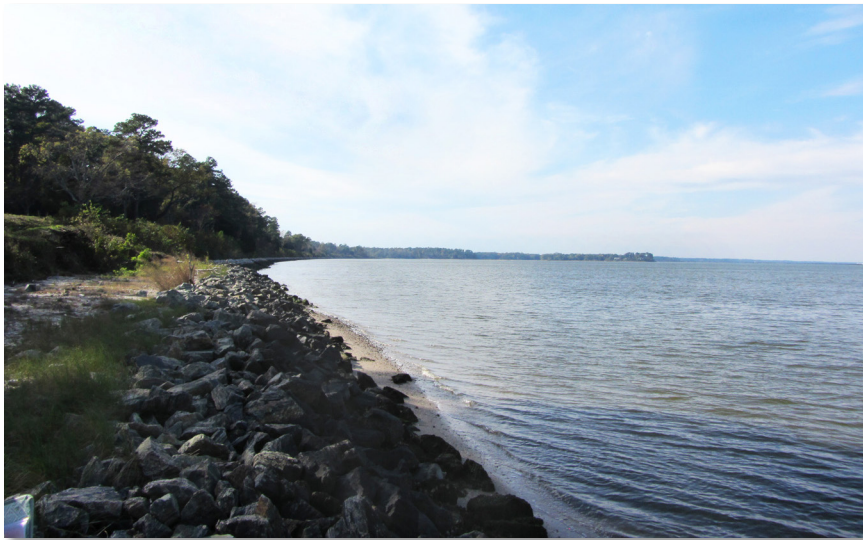
**Figure 10.** Revetment at Bellfield Straight along the York River (#83 Figure 9). View is to the west.

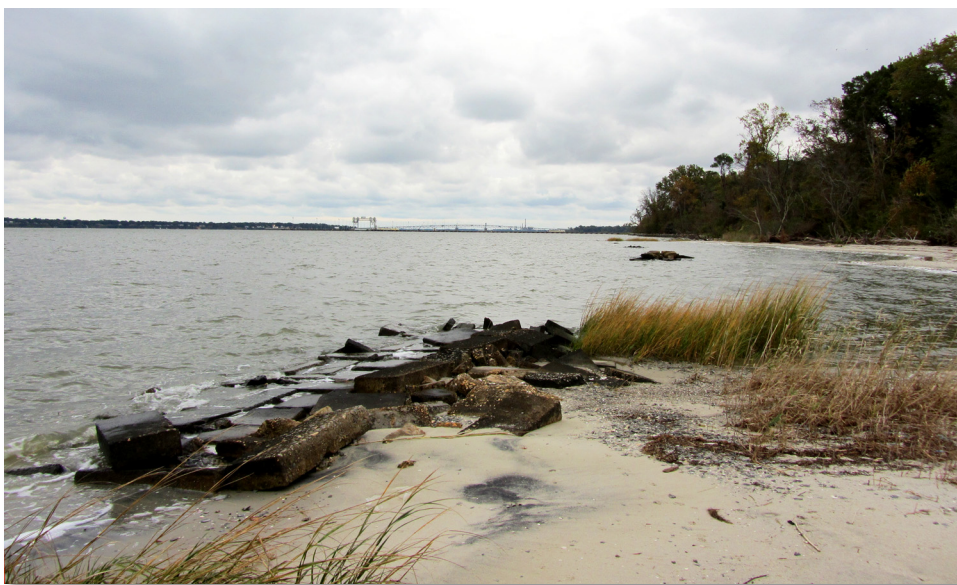
Continuing along the shoreline, there are five small breakwaters, called the NPS breakwaters (#87–91 Figure 9 and Figure 11). These breakwaters were constructed in 1985 of broken concrete to control shoreline erosion (NPS 2011). However, the low elevation of these breakwaters (0.6 to 0.9 m MLLW [2 to 3 ft]) provides little protection during storms (NPS 2011).

**Figure 11.** NPS broken concrete breakwaters along the York River (#87–91 Figure 9). View is to the southeast.

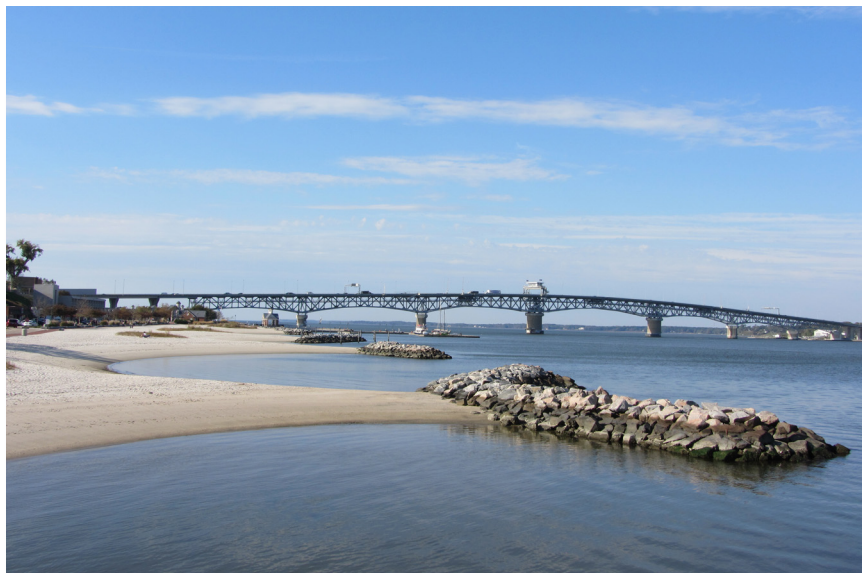
**Figure 13.** Rock breakwaters at Yorktown Beach along the York River (#116–118 Figure 12). Coleman Bridge in the background carries U.S. Highway 17. View is to the northwest.

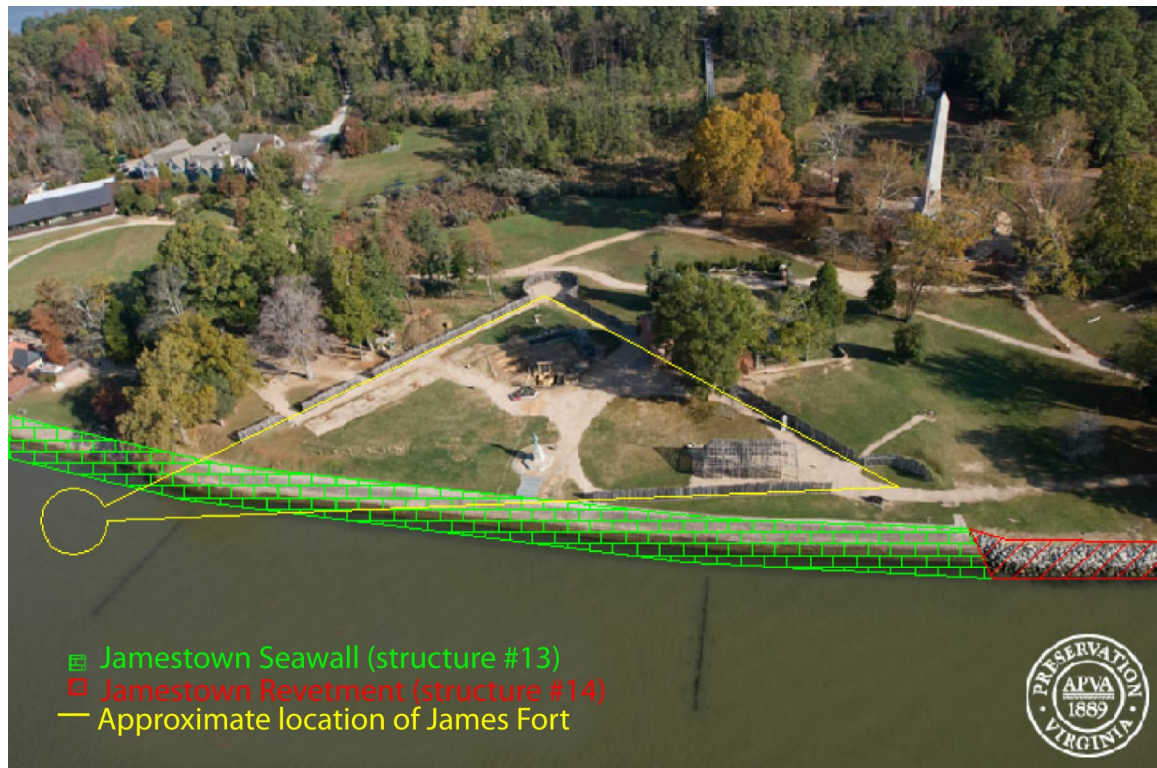
The Jamestown seawall (#13 Figures 6, 7 & 16) was designed and built by the USACE from 1900–1905 (USACE 2002). This 730-meter (2,395 ft) long concrete structure protects the original settlement site and has eliminated bank erosion since its installation. The seawall in conjunction with adjacent hard structures (most notably revetment #14 Figure 6) effectively holds the Historic Jamestowne shoreline in place.

**Figure 16.** Aerial image of the Jamestown seawall. View is to the northeast (modified from PV 2012).

Historically, this area was actively eroding. In the three hundred years from the first settlement to the construction of the seawall the shoreline receded nearly 120 m (400 ft), suggesting an average shoreline change rate of about -0.4 m/yr (-1.3 ft/yr) (Johnson et al. 2001). It is therefore estimated that the Jamestown seawall has potentially preserved more than 30 m (100 ft) of shoreline from eroding over the last century. However, the result of this armoring has also deprived Jamestown Island and the surrounding areas of a sediment source. This has likely contributed to the need for additional coastal stabilization in downstream locations.

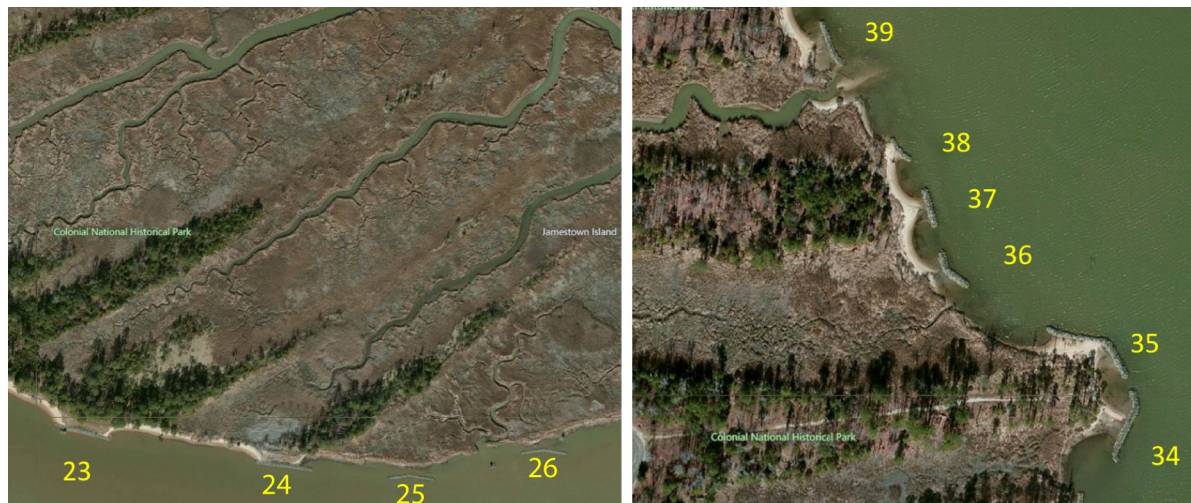
In 2011 the breakwaters on Jamestown Island had accretion formations at various stages of development (Figure 17). Breakwaters #23, 24 and 37 (Figure 17) had attached formations, while breakwaters #25 and 26 had only minor accretion bulges. In both cases, the system will ideally reach a dynamic equilibrium and the natural flow of sediment will be able to bypass the structure. As a regional approach to sediment management, the Jamestown Island breakwater system was designed to armor existing headlands and fortify the shoreline at intervals such that equilibrium beaches may form to stabilize the backshore (Hardaway et al. 1999).

**Figure 17.** Aerial imagery of Jamestown Island breakwaters (images from ESRI Bing Maps basemap layer 2012).
